2013 Site Visit Report

for the NIRB's Monitoring of
Agnico-Eagle Mines Ltd.'s Meadowbank Gold Project

Project: Meadowbank Gold Project
Project Location: Kivalliq Region, Nunavut

Site visit dates: September 13, 2013
Last site visit: September 12-13, 2012

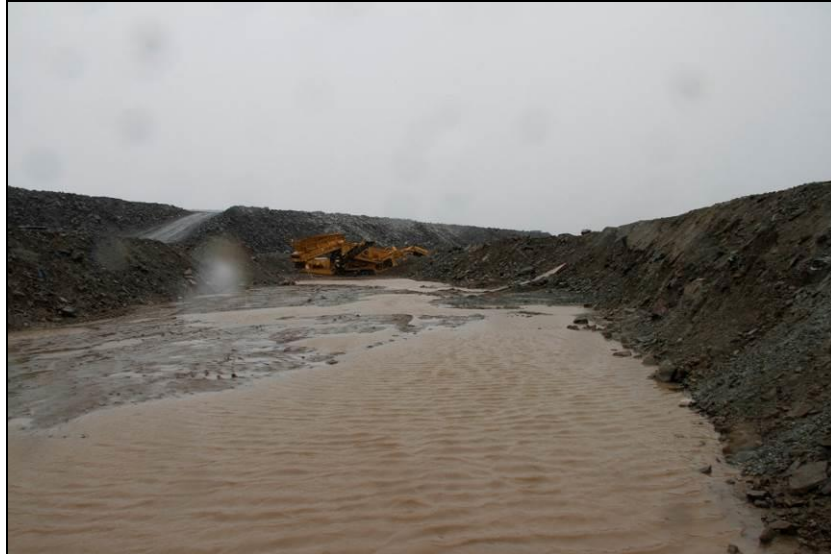
Photo 1: Contaminated soil storage/pilot remediation site

contaminated hydrocarbon soil worked very well and that AEM was planning on using the same technique next year for all hydrocarbon contaminated soils (see Photo 1). This method would be used instead of general landfarming techniques (see Landfarm Plan for further information [AEM, 2013]).

The Monitoring Officer notes that the pilot remediation program undertaken this year at the Meadowbank mine site appeared to have worked well. The Monitoring Officer was informed that the rate of biodegradation of the contaminated soil containing nutrients (sewage sludge) was faster compared to contaminated soils with no nutrients added. AEM indicated that it plans to use this method again next year for the treatment of all of its contaminated soils.

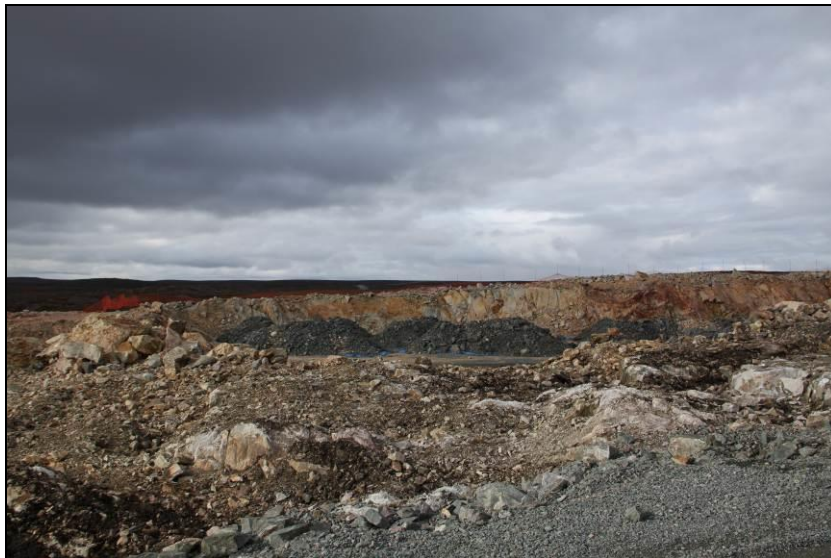
Photo 2: Quarry 5 in 2011 containing contaminated soil from fuel spill at kilometre 22 along the access road

- c. AEM indicated that additional grid samples would be taken at both Quarry 5 and Quarry 22 (both sites previously used for storage of contaminated hydrocarbon soil) and confirmed that if samples indicate that no hydrocarbons are present, remediation of both quarries would commence. Photo 2 through Photo 4 show the condition of Quarry 5 from the storage of contaminated soils in 2011 to clean-up in 2013, while Photo 5 and Photo 6 show the condition of Quarry 22 in 2012 and 2013.

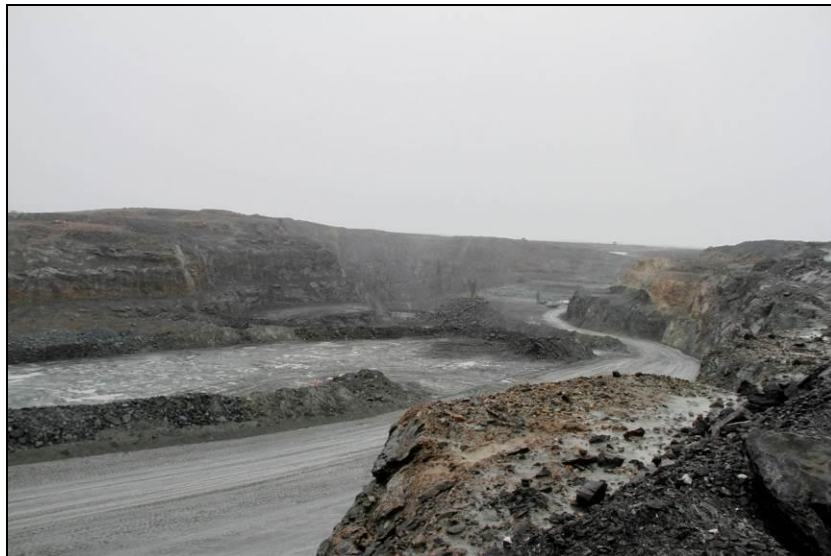
Photo 7: Portage Pit

- d. The Monitoring Officer noted that the environmental emergency sea-cans containing booms, shovels, absorbent pads, and other miscellaneous spill response equipment were located at most bridge crossing (one was not observed at the km 22/23 bridge). Further, two additional environmental emergency sea-cans, one containing spill response equipment and another containing a boat with motor were located at the Baker Lake laydown facility.
- e. Active blasting and drilling were ongoing at the North, Central and South Portage pits, with daily geotechnical inspections being undertaken to ensure the safety of all employees and contractors working in the active mine area (see Photo 7).

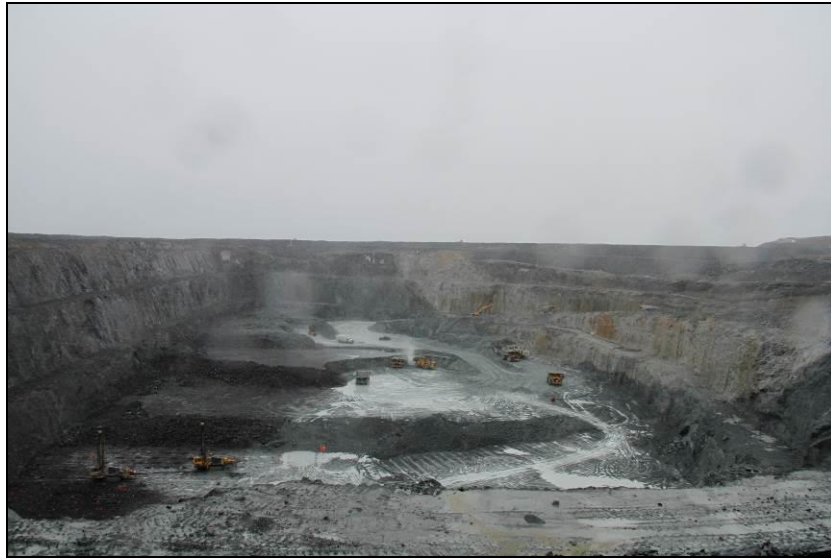
Photo 8: Bay-Goose basin

- f. Development of the Bay-Goose Dike and causeway was completed in 2010 with the instrumentation on the Bay-Goose Dike and the jet grouting program completed in 2011. Mining of the Bay-Goose basin started in May 2012 (Photo 8).

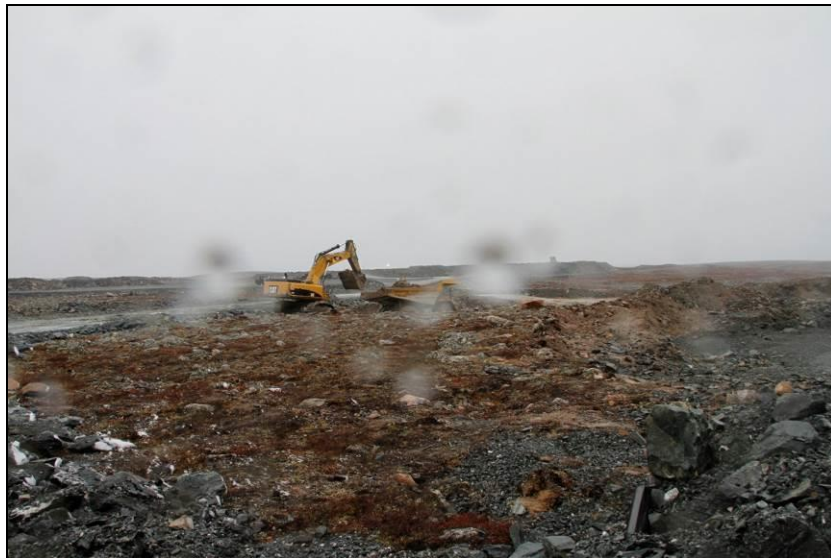
Photo 9: Vault Lake Quarry site

- g. Construction of the Vault Road was completed by the end of 2012 and AEM commenced stripping, quarrying and related construction activities in 2013 (Photo 9). During the site visit, it was noted that dewatering of Vault Lake would commence in late September, once the fish-out program had been completed (see Photo 10). Mining of Vault Pit is planned for 2014.

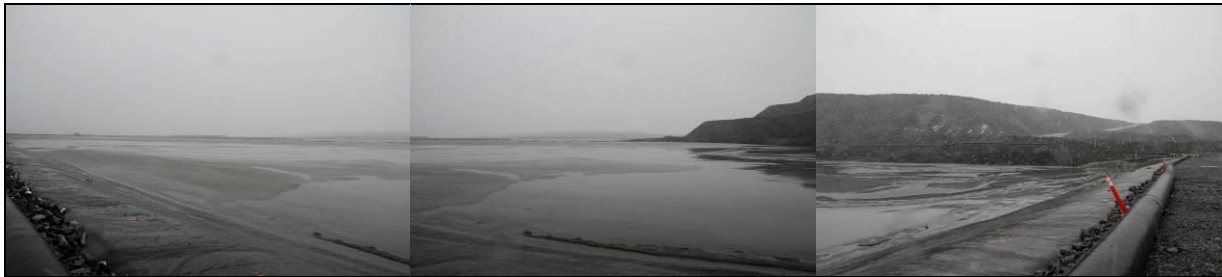
Photo 11: Tailings storage facility

- h. Inspection of the tailings storage facility did not reveal any apparent rips to the liners that were exposed within Saddle Dam #1 and Saddle Dam #2 (Photo 11).

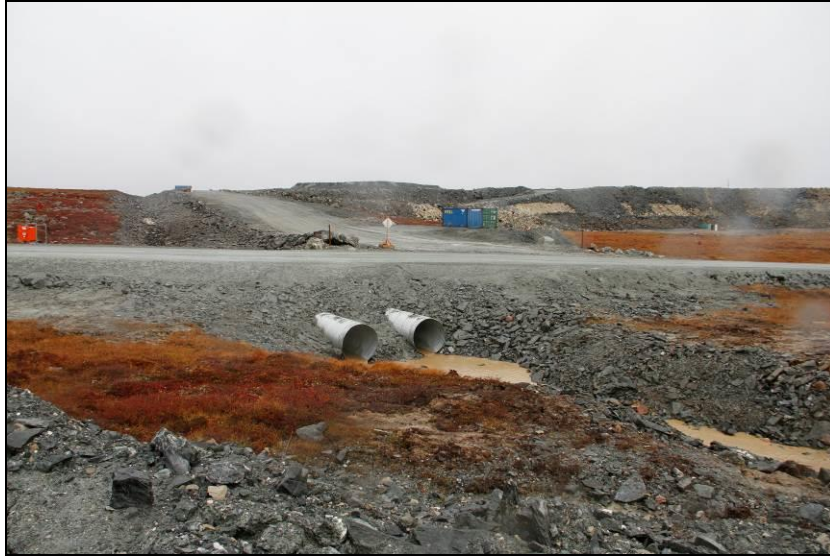
- i. Mr. Buck indicated that the extension of the airstrip was completed in April 2013. This extension was previously screened and approved pursuant to NIRB File No. 10XN039.
- j. The Monitoring Officer noted that the water within the diversion ditch constructed around the tailings facility and flowing into Third Portage Lake appeared to be turbid, likely due to the high volume of rainfall over the previous few days (see Photo 12). Further, the silt curtains installed in Third Portage Lake did not appear to be functioning properly as there was evidence of turbid water/sediment along the shoreline of Third Portage Lake and flowing into the lake. The diversion ditch was built to control freshet water from entering the tailings facility (see Photo 13).

Photo 12: Diversion ditch around tailings facility

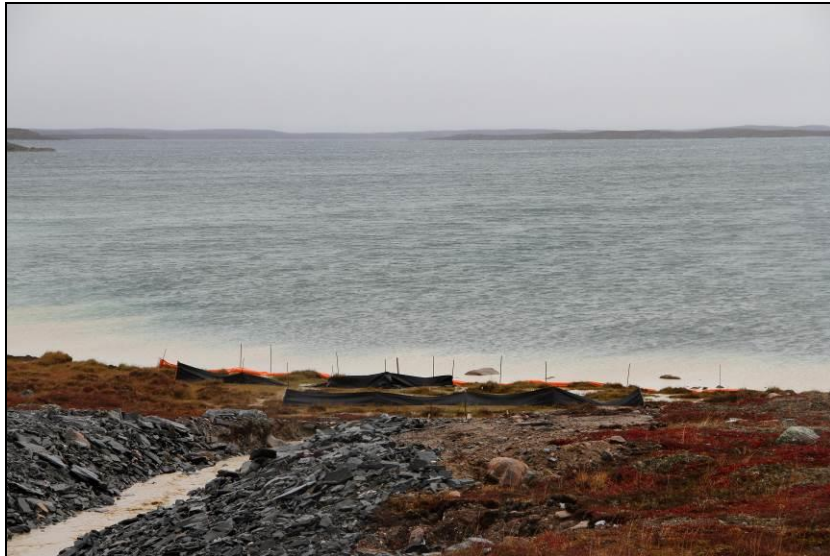
Photo 13: Turbid water entering Third Portage Lake

The Monitoring Officer also noted that the silt curtains put in place downstream of the diversion ditch flowing into Third Portage Lake did not appear to be functioning properly as sedimentation was evident around the shoreline and flowing into the lake.

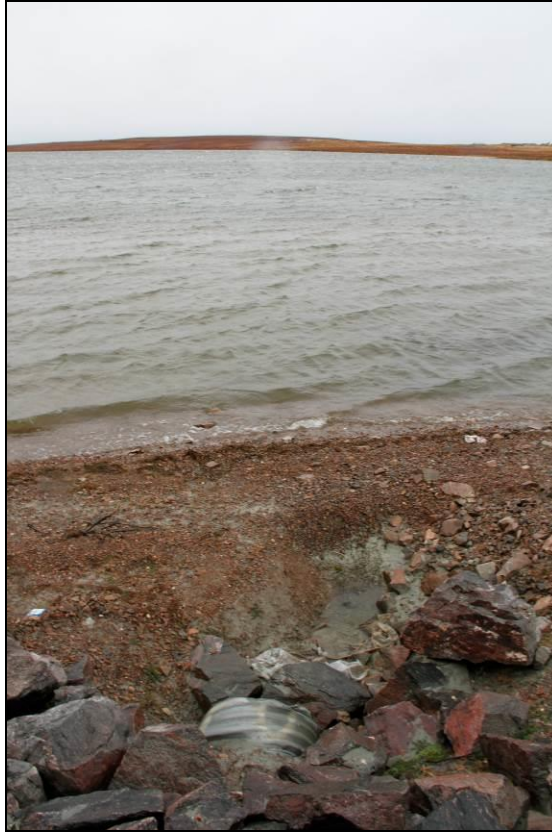
- k. While travelling along the access road from Meadowbank back to Baker Lake, the Monitoring Officer noted that the culvert crossing at kilometre 1 was damaged and that there was evidence of sediment deposit at the outflow of the culvert into Airport Lake. AEM indicated that it would assist the hamlet of Baker Lake in any work(s) required to upgrade/repair the culvert. AEM indicated that this particular section of the access road is owned by the hamlet and is not leased by AEM (see Photo 14).

Photo 14: Culvert crossing at kilometre 1

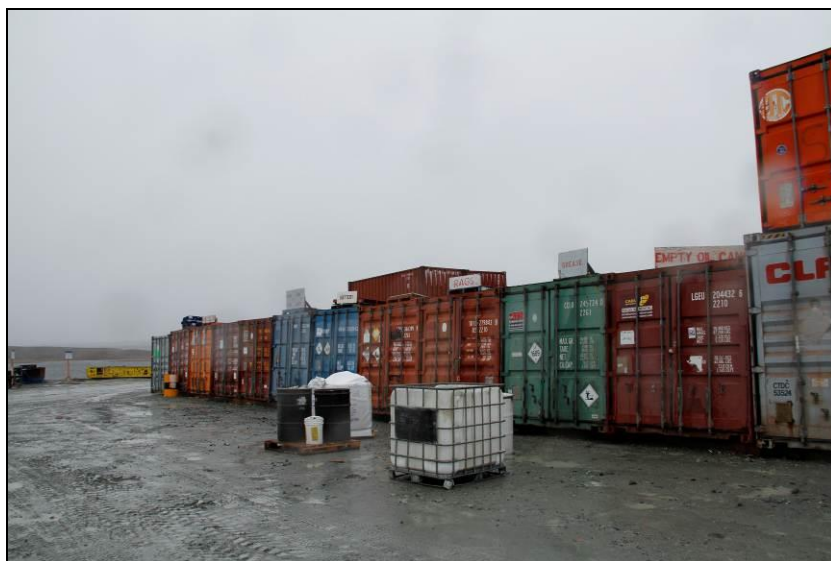
As per previous site visits, the Monitoring Officer noted in 2013 that AEM continued to segregate and store all domestic, hazardous, and combustible wastes in marked sea-cans prior to these materials being incinerated or shipped to appropriate and approved off-site disposal facilities (Photo 15). AEM indicated that sea-cans filled with waste are backhauled via truck haul to Baker Lake and are then moved via the annual sea lift to southern Canada (Photo 16). AEM has also initiated other recycling programs to reduce the amount of wastes going to the landfill; e.g., puncturing aerosol cans which could then be recycled as metal (Photo 17 and Photo 18).

Photo 15: Sea-cans used for waste segregation and storage area

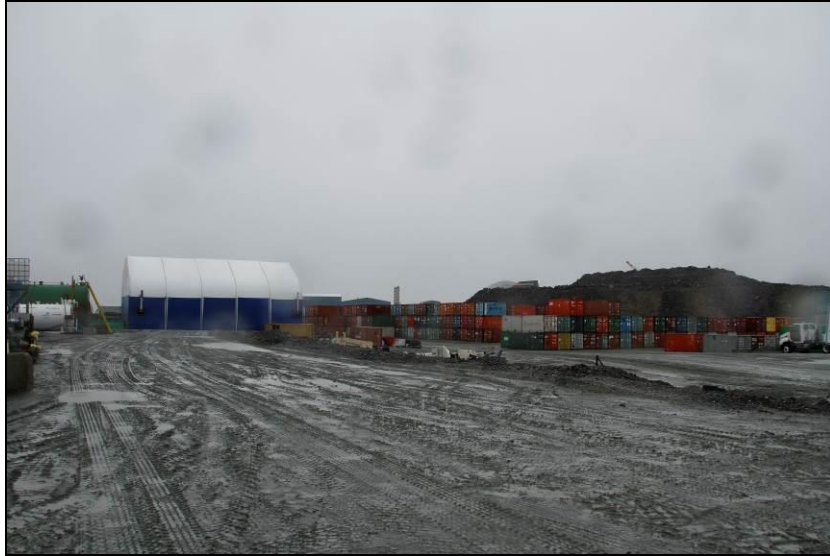
Photo 16: Sea-cans waiting to be backhauled

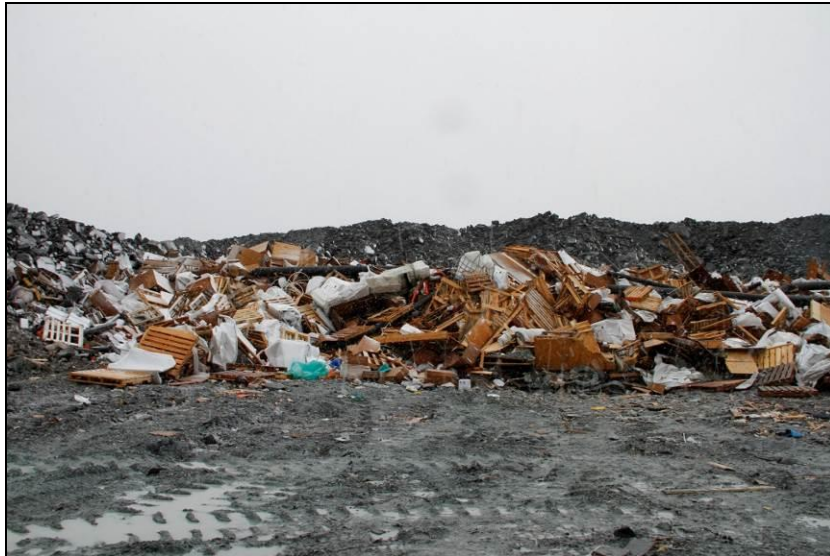
Photo 17: Landfill at Meadowbank mine site

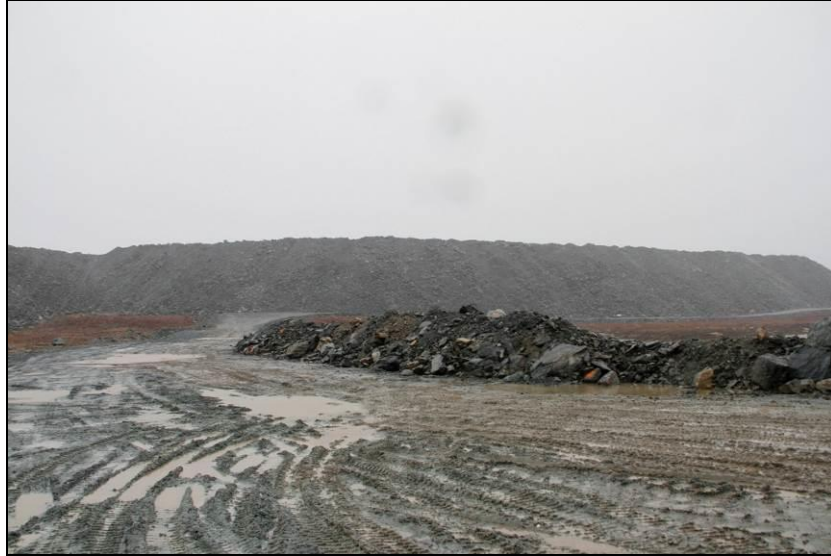
Photo 18: Waste rock facility

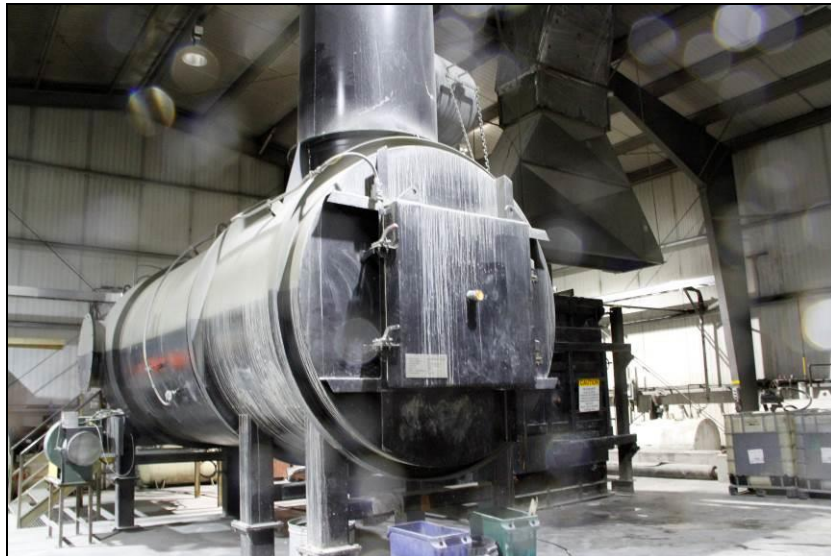
The Meadowbank site dual chamber forced air incinerator remains in service for the combustion of all non-hazardous, combustible materials at the site (Photo 19). AEM staff noted that approximately 1.7 tonnes of domestic garbage is incinerated per day; however, Mr. Buck indicated AEM has plans in place to continually improve waste management by reducing the amount of domestic garbage produced at site. Some examples include completely replacing paper coffee cups with plastic coffee cups, using plastic lunch boxes and trays instead of paper bags, recycling wood products by finding second uses for these at site or by backhauling it to Baker Lake where it may be claimed and used by community members.

Photo 19: Dual chamber forced air incinerator at the Meadowbank site

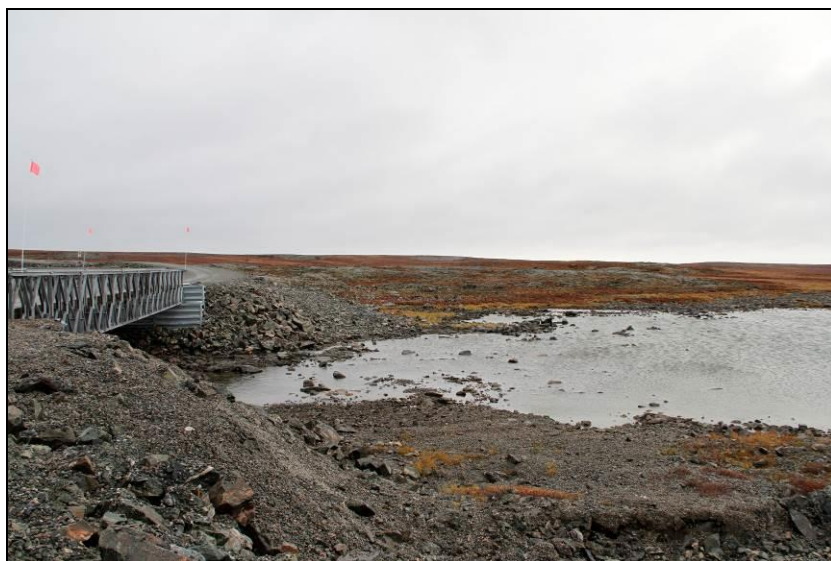
Photo 20: Bridge near kilometre 22

Mr. Buck indicated that clean-up of the spill that occurred near kilometre 22 of the access road in October 2010 was complete and the booms previously deployed in the watercourse had been removed in July 2013 (Photo 20). Mr. Buck confirmed that the site would continue to be monitored as part of AEM’s aquatic effects monitoring program.

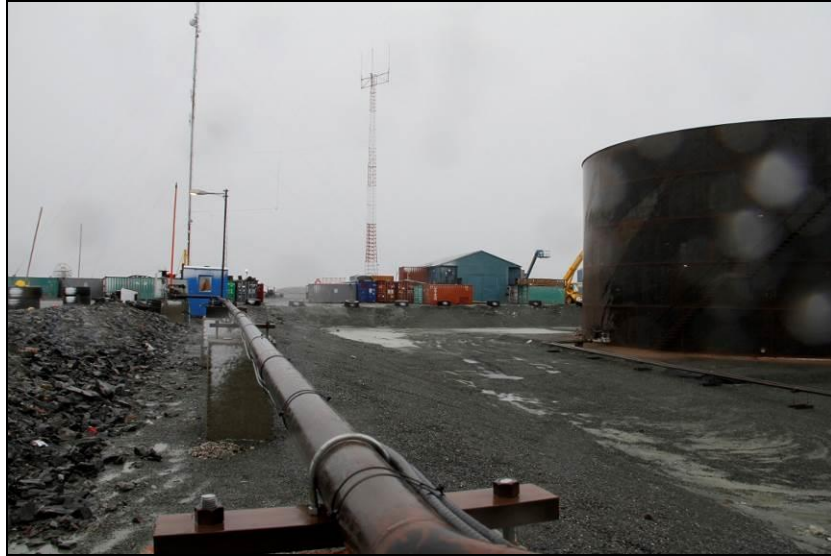
Photo 21: Meadowbank on-site fuel tank farm

During the 2013 site visit, the Monitoring Officer observed that all of AEM’s fuel and hazardous materials associated with the Meadowbank project appeared to be stored in a safe and environmentally protective manner (i.e. secondary containment at fuel storage areas and secure containment of hazardous materials; see Photo 21 and Photo 22).

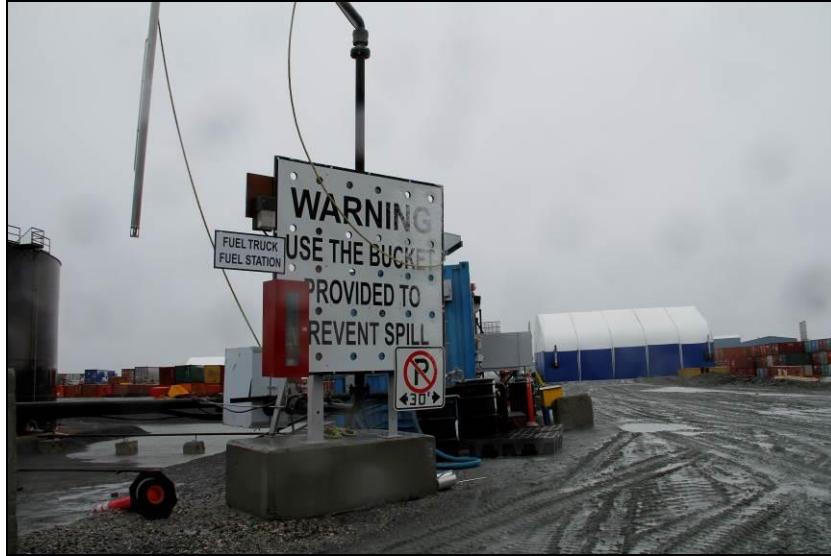
Photo 23: Meadowbank on-site fuel transfer station

The fuel transfer stations on site (Photo 23) and at the Baker Lake bulk fuel storage facility (Photo 24) appeared to be well contained and properly set up for the re-fuelling of vehicles. No hydrocarbon odours were noted at either the Meadowbank fuel tank farm or the Baker Lake bulk fuel storage facility. No sheen was observed on the water within the Meadowbank fuel tank farm or the Baker Lake bulk fuel storage facility.

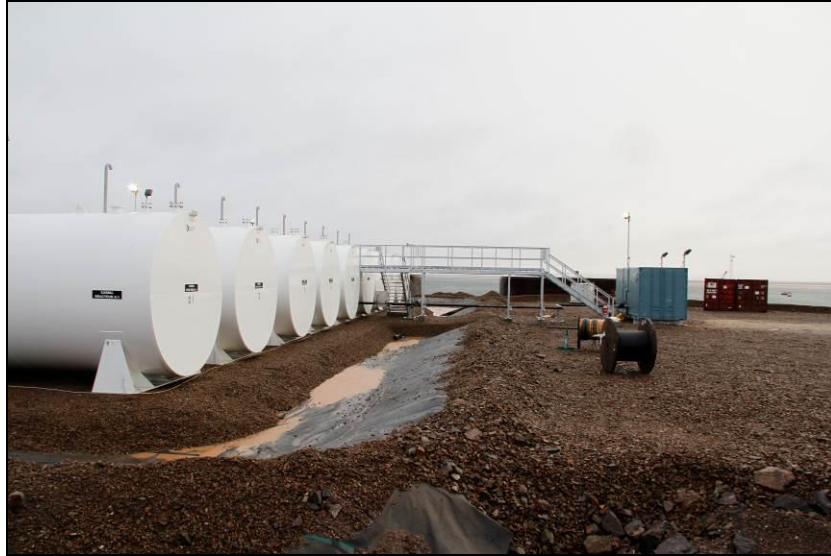
Photo 25: Jet-A pad at Baker Lake storage facility

The Monitoring Officer noted that a Jet-A pad had been installed near the Baker Lake bulk fuel storage facility and that it had 20 fuel tanks in place (Photo 25).

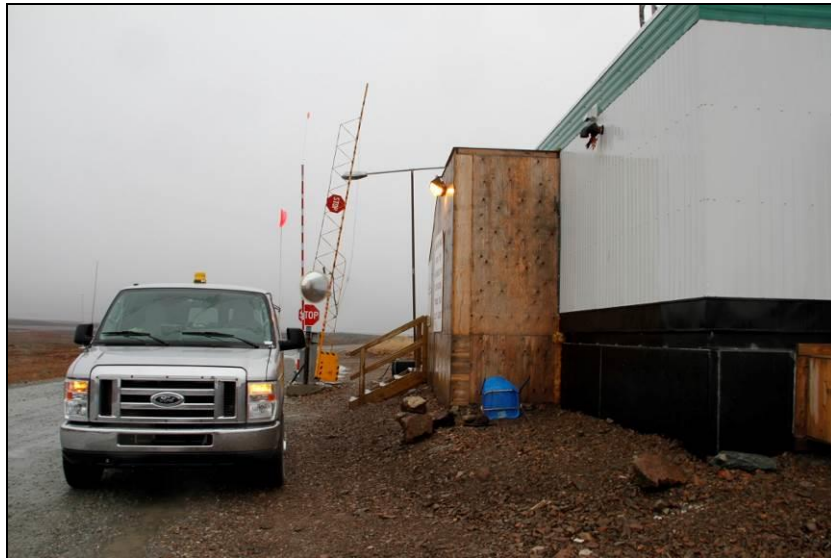
Photo 26: Gatehouse at kilometre 5, near Baker Lake

AEM maintains one gatehouse at kilometre 5 of the access road, and another gatehouse close to the entrance to the mine site and camp at Meadowbank. Both gatehouses are manned by guards who monitor the safety and security of all personnel using the road. All traffic is required to check in (via radio or in person) with the employee at the gatehouse prior to proceeding past either gatehouse along the road (see Photo 26). The AEM employee manning the kilometre 5 gatehouse maintains a daily logbook of all persons travelling the access road for non-mine use. Members of the public travelling along the road are required to sign-off an indication of having read AEM's *All Weather Private Access Road Safety Rules & Procedures for Road Access* policy prior to being granted access to the road.

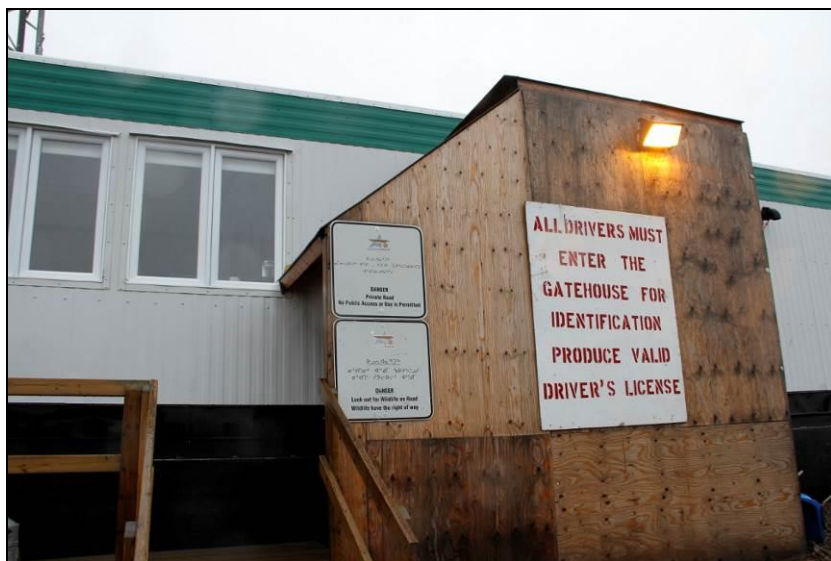
Photo 27: Signs posted at gatehouse at kilometre 5

As per Condition 32(b), AEM submitted a copy of its updated Transportation Management Plan to the NIRB on May 13, 2010. One of the features of the access road as described within the plan is the placement of refuge stations every 10 kilometres. The Monitoring Officer noted that these refuge stations (emergency sea-cans) were not located on the road and was informed by Mr. Buck in 2012 that the sea-cans were removed because items within the stations were being stolen and that the refuge stations were not serving the original and intended purpose. The signs as required per Condition 32(c) were posted in both English and Inuktitut at the gatehouse (Photo 27), at each major bridge crossing (on the side of the environmental emergency sea-cans) and at every 10 kilometre intervals along the road.

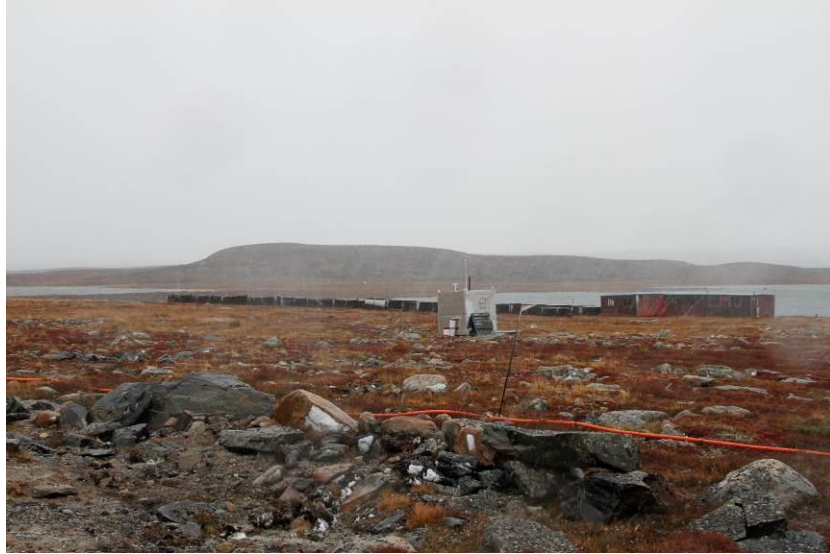
Photo 28: Air monitoring station

The air monitoring stations were installed by the end of October 2011 and monitoring started in November 2011 (see Photo 28). The partisol sampling stations required heated shelter and electricity in order to operate properly, and these were installed in 2012. During the 2013 site visit, Mr. Buck noted that an air monitoring station installed in 2012 near the Vault Lake road had been relocated. The road alignment to Vault Lake was modified from the original design plan which in turn required that the air monitoring station be moved to a location further away from the road.

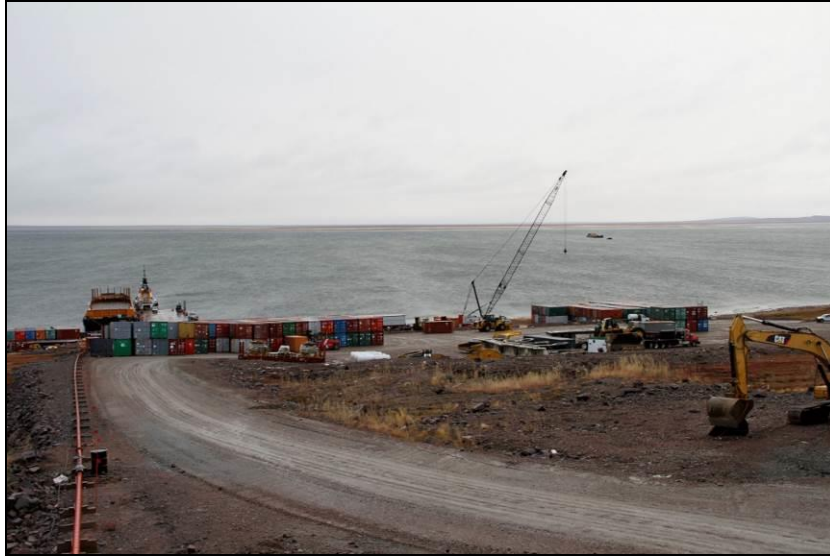
Photo 29: Bake Lake dock and laydown facility

During the visit to the Baker Lake bulk fuel storage facility/marshalling area, the Monitoring Officer noted that a security office was located at the shore with AEM employees on site. The Monitoring Officer did note that these areas were kept impressively clean with sea-cans well organized during the 2013 site visit (see Photo 29).
