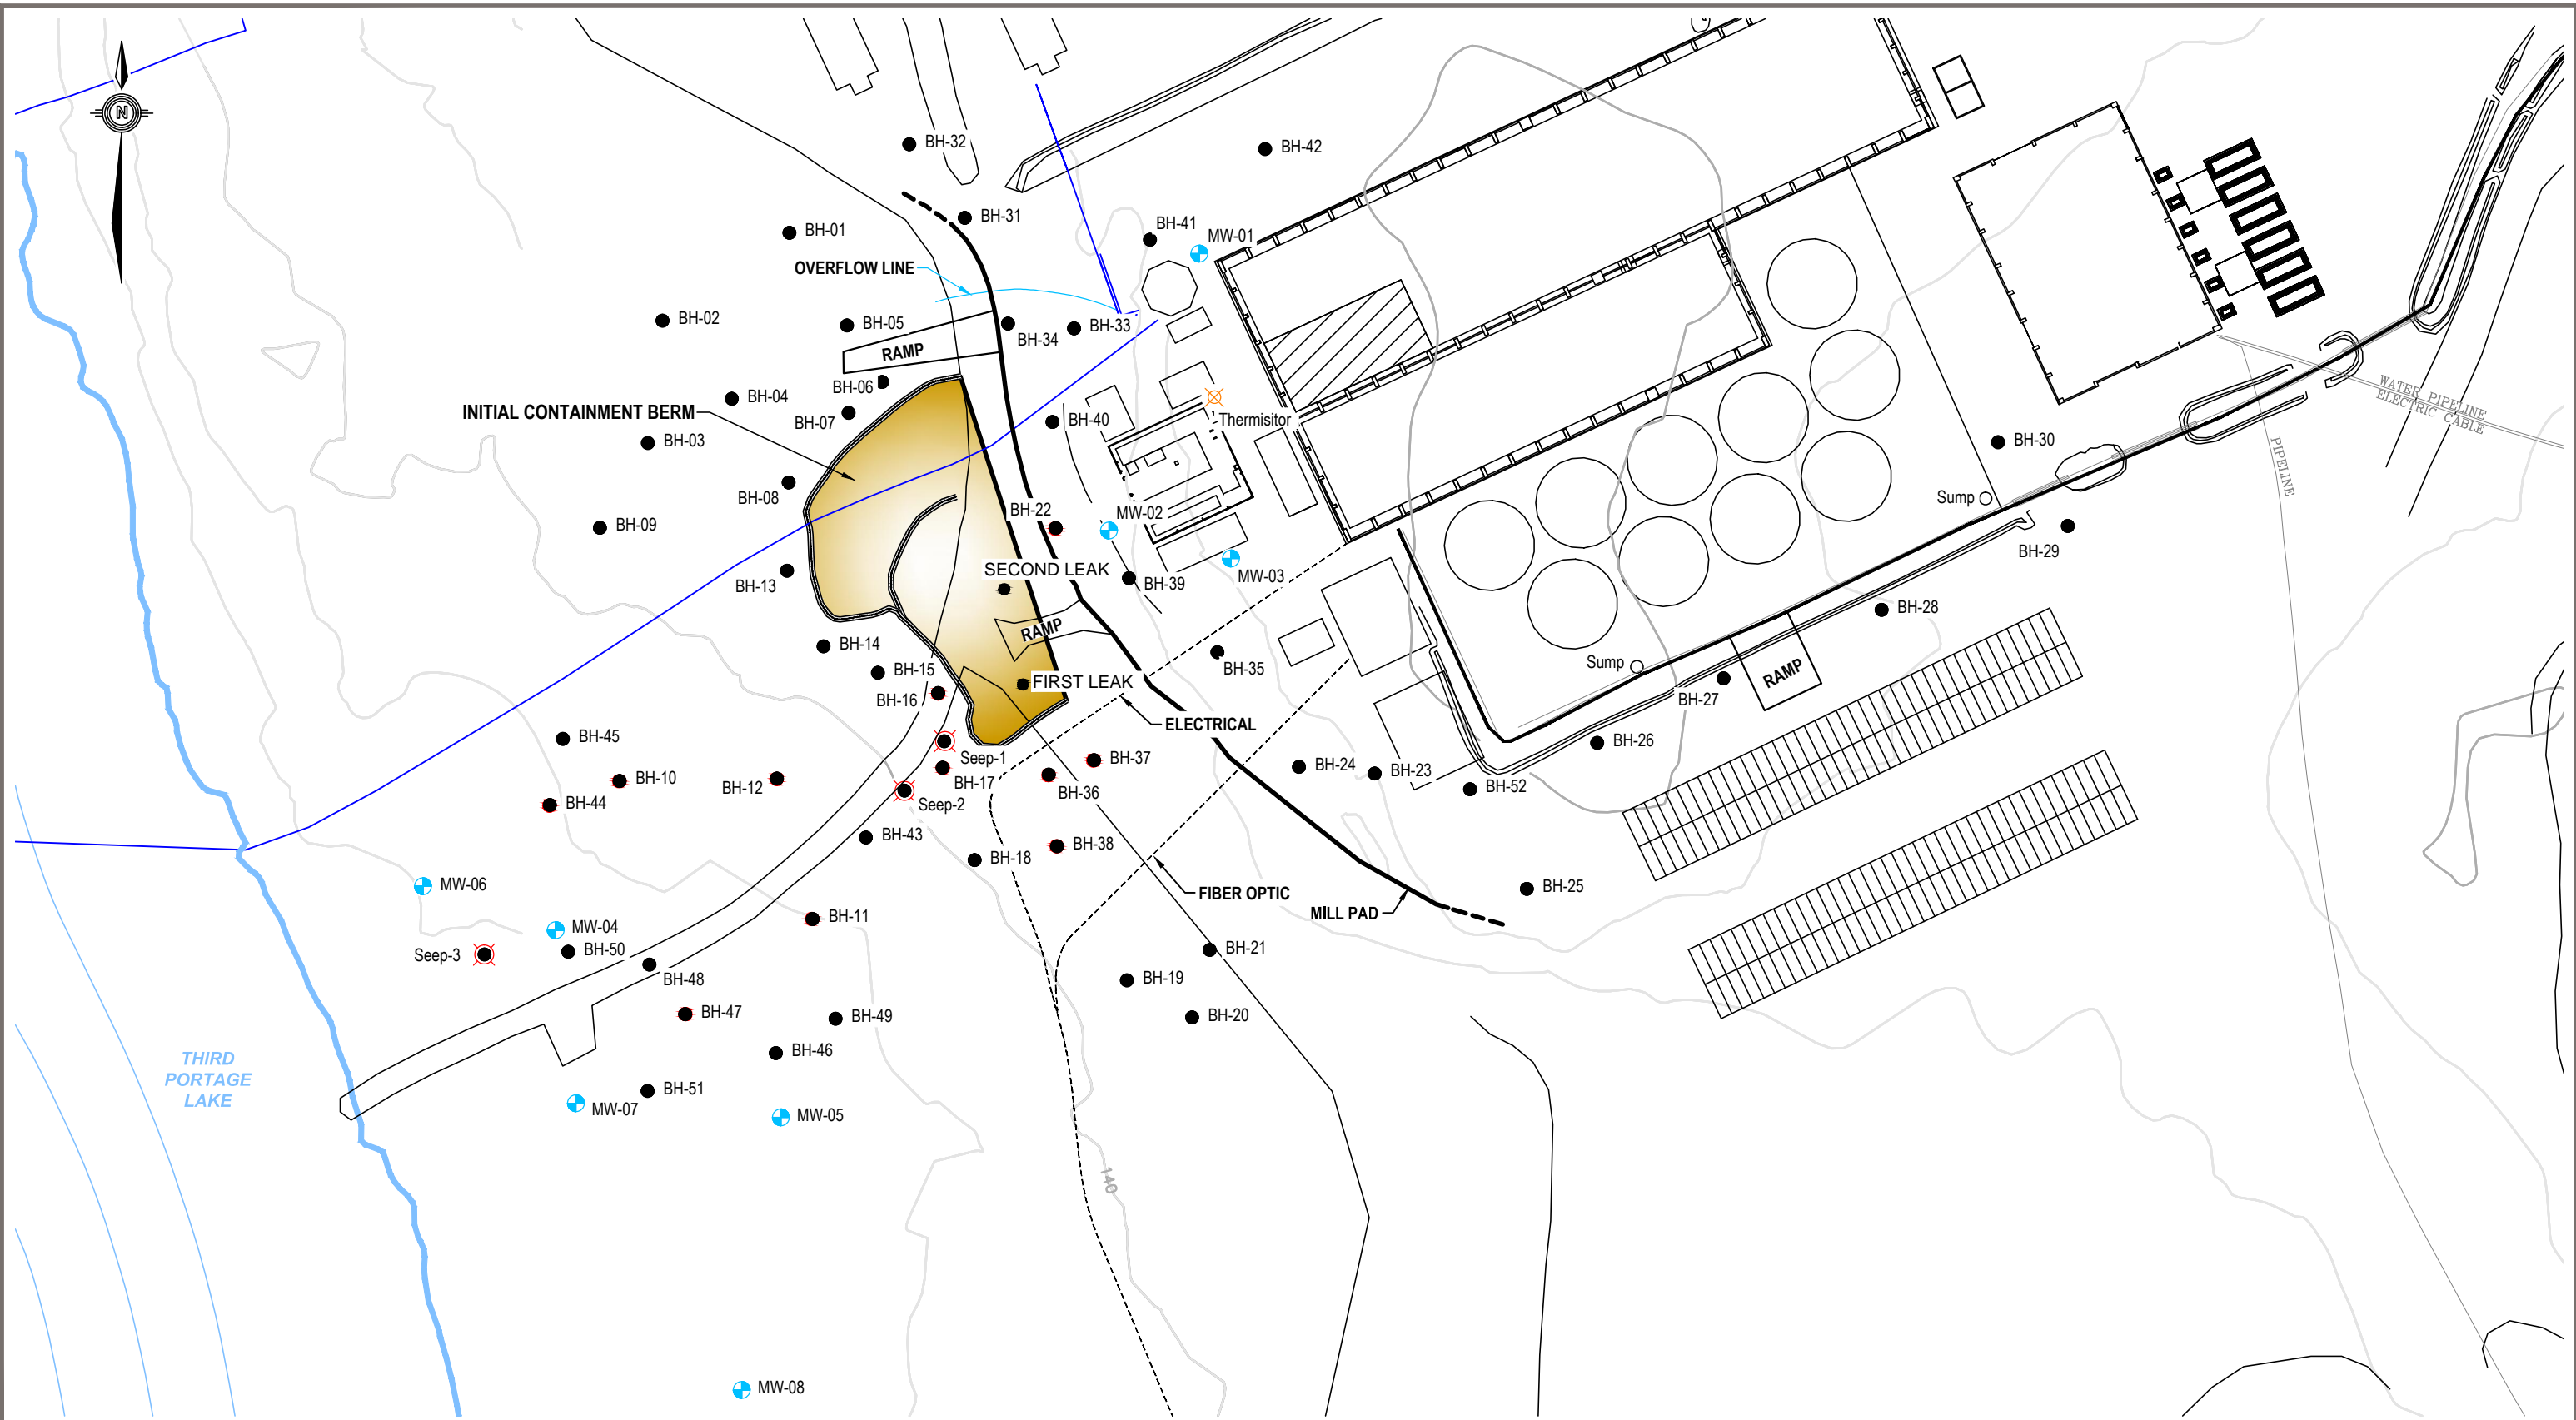
Figure 2

A total of 52 boreholes were drilled in various areas (Figure 2). All holes were drilled using a downhole hammer-air rotary drill without water. Samples were collected from the drill using either plywood or a metal pan and then scooped into plastic bags using a metal spoon. After the collection of each sample, the pans, spoon, and plywood were brushed off to minimize cross contamination. In addition, before drilling each hole, the drill was purged using compressed air to clean off the drill bit. When moving from a known contaminated site on the pad to the tundra, the drill rod and drill bit were exchanged for clean rods and drill bits.

NOTES
SEEP 3 HAD LOW LEVELS OF CYANIDE
(CNTOT = 0.192 ppm CNWAD = 0.033 ppm)

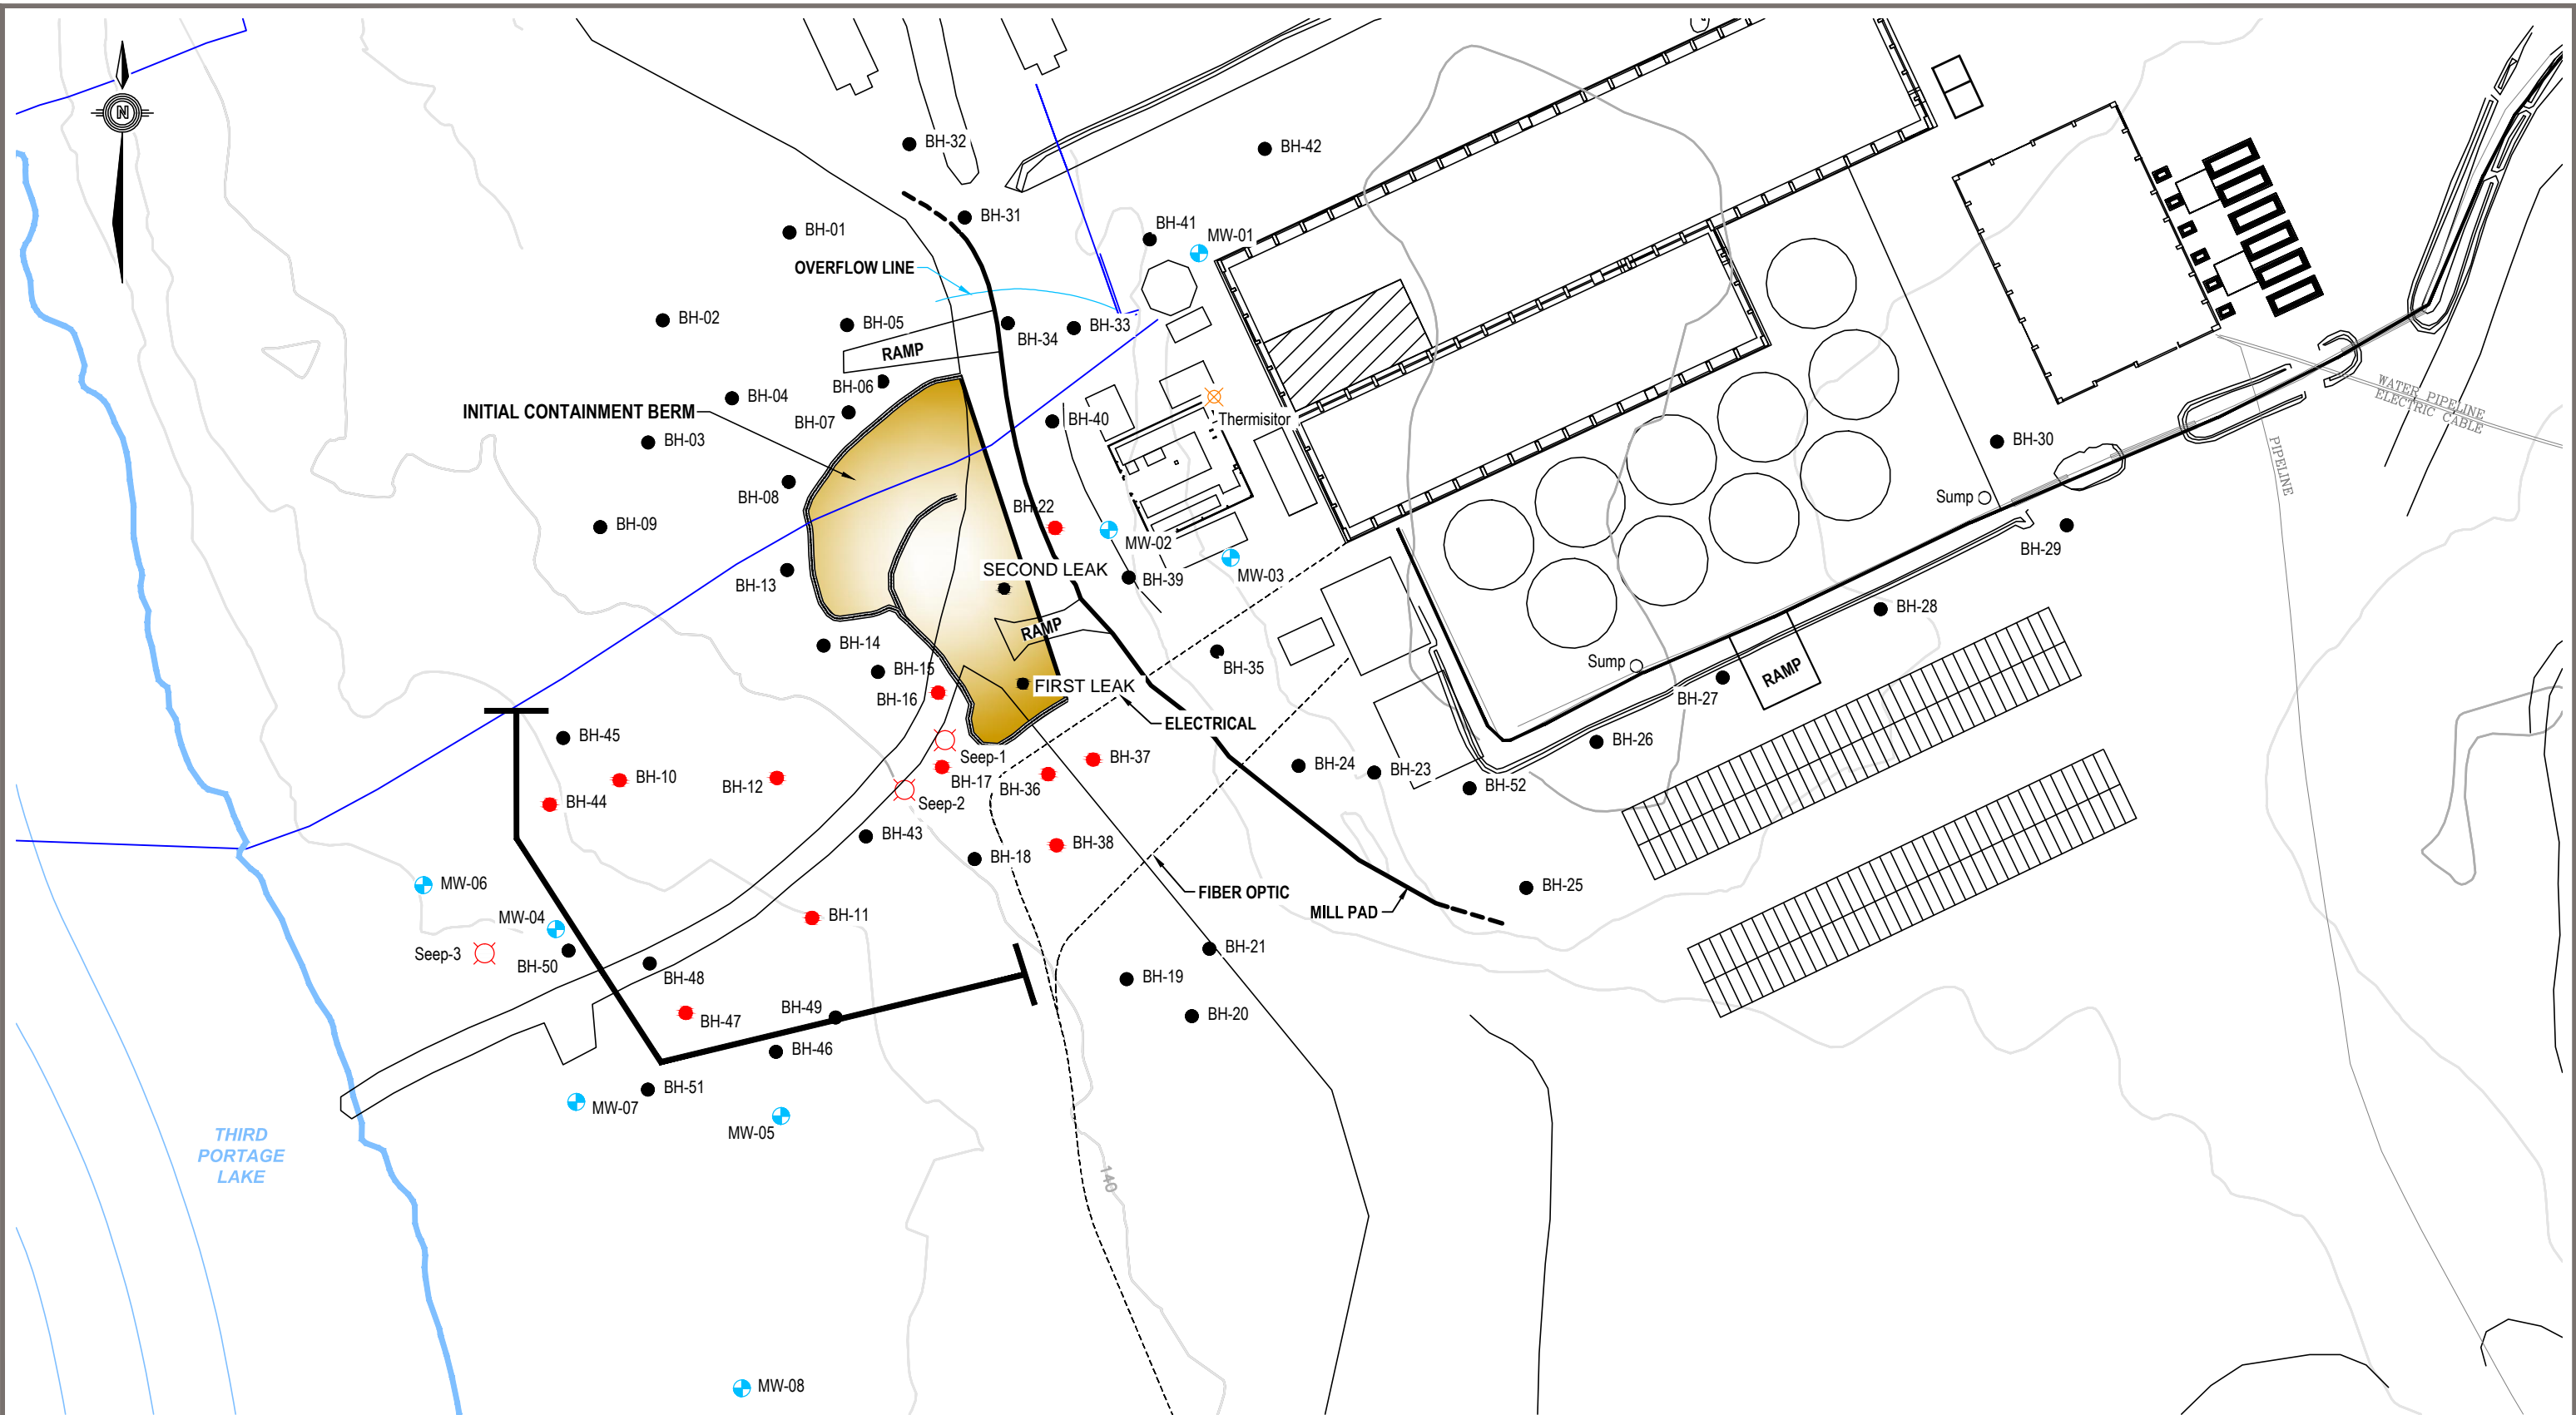
Figure 3

The interception trench design was developed by AEM with consultation by Tetra Tech EBA. The trench was located to minimize disturbance to the natural terrain, act as a barrier between detected cyanide and the lake, while staying at least 30 m away from Third Portage Lake. The approximate location of the interception trench is shown on Figure 3.

It was decided that the interception trench be installed between Seep 3 and BH-47. The decision for the location of the interception trench was based on the premise to minimize disturbance to the natural terrain, and act as a barrier between detected cyanide and the lake, while staying at least 30 m away from Third Portage Lake. An interception trench at this location should prevent cyanide contamination reaching Third Portage Lake. It is recommended that any pooled water within the collection area of the interception trench be pumped out immediately.

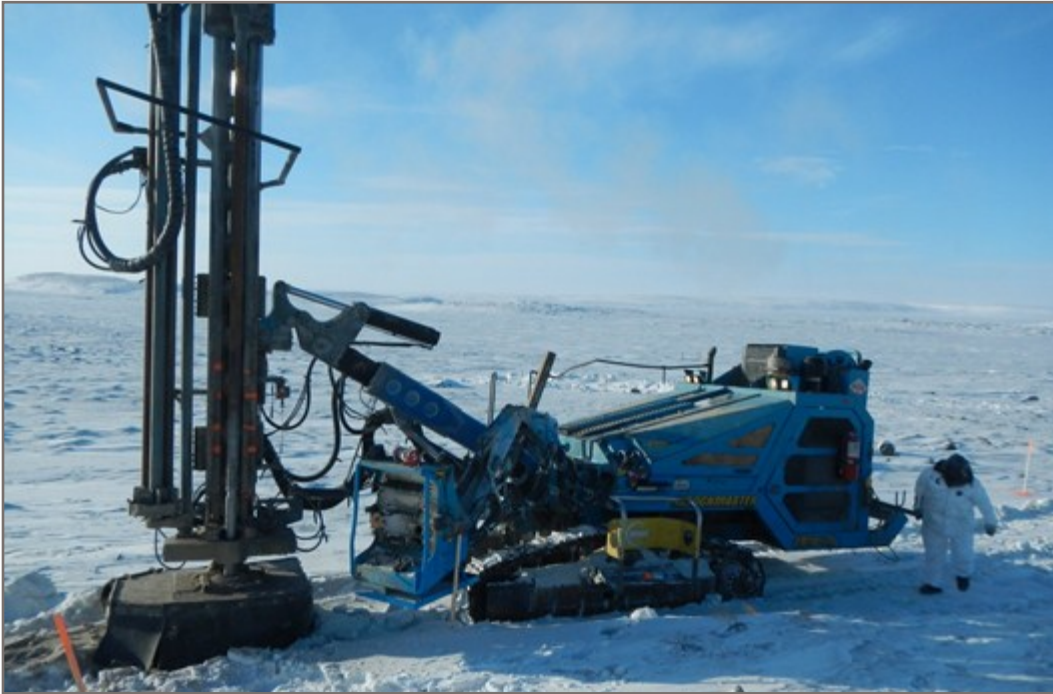
Photo 1: Southwest view of the down hole air hammer drill drilling BH-18.

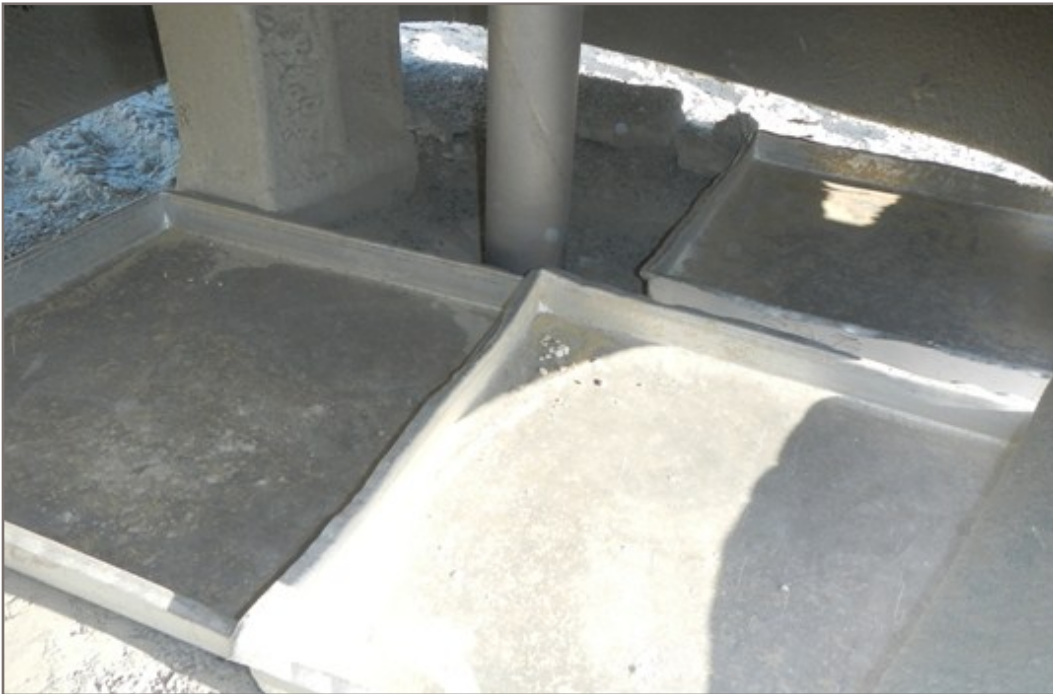
Photo 2: Metal containers underneath the curtain of the drill to collect soil samples.

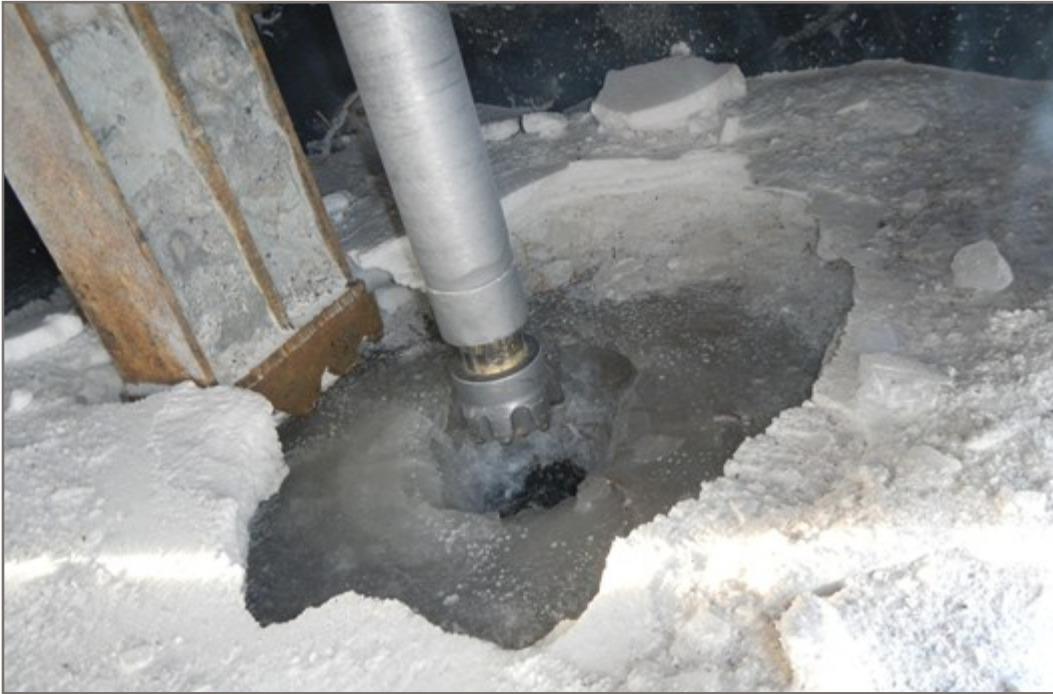
Photo 3: Ice (~12 cm thick) located at BH-11.

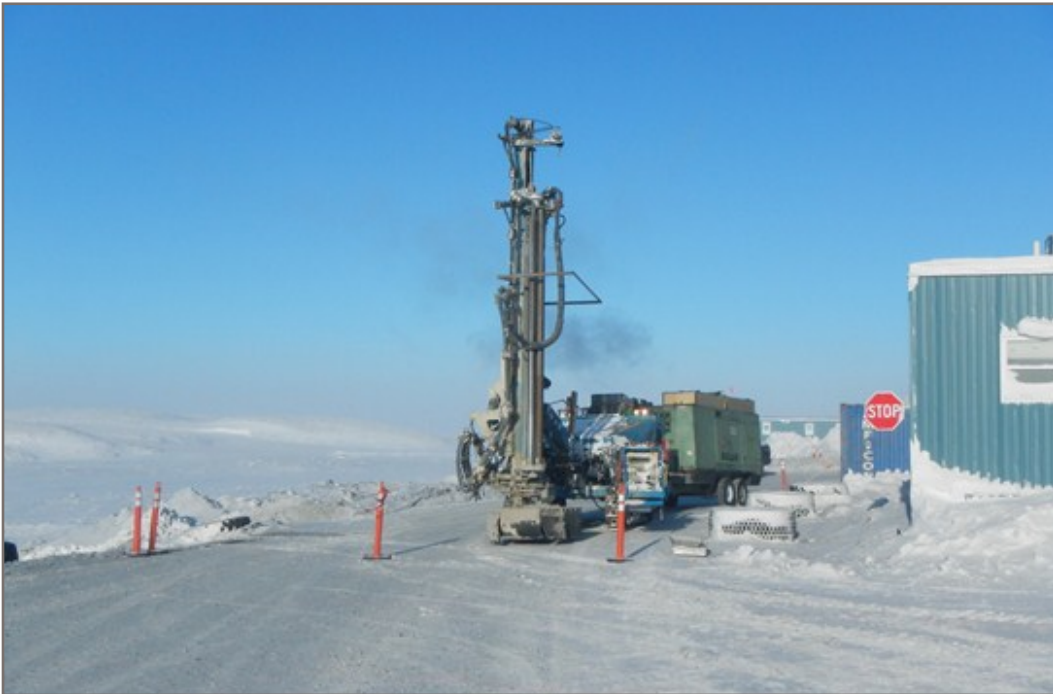
There were a total of 30 soil samples submitted for analysis of Total and WAD Cyanide from boreholes drilled through the pad. Of those 30 samples, there was one sample (BH-22, 1.7 mg/kg) where Total Cyanide was detected. No WAD Cyanide was detected. Water was observed in BH-22 and MW-02, which was located in front of the Assay Lab.

There was one water sample (BH-22) submitted for analysis of Total and WAD Cyanide from boreholes drilled in the pad. The Total Cyanide detected was 24.59 ppm and WAD Cyanide was 10.6 ppm. The Total Cyanide exceeds the effluent discharge established in the Water Licence No. 2AM-MEA0815.

Photo 4: Northwest view of drill, drilling BH-39 in front of the Assay Lab.

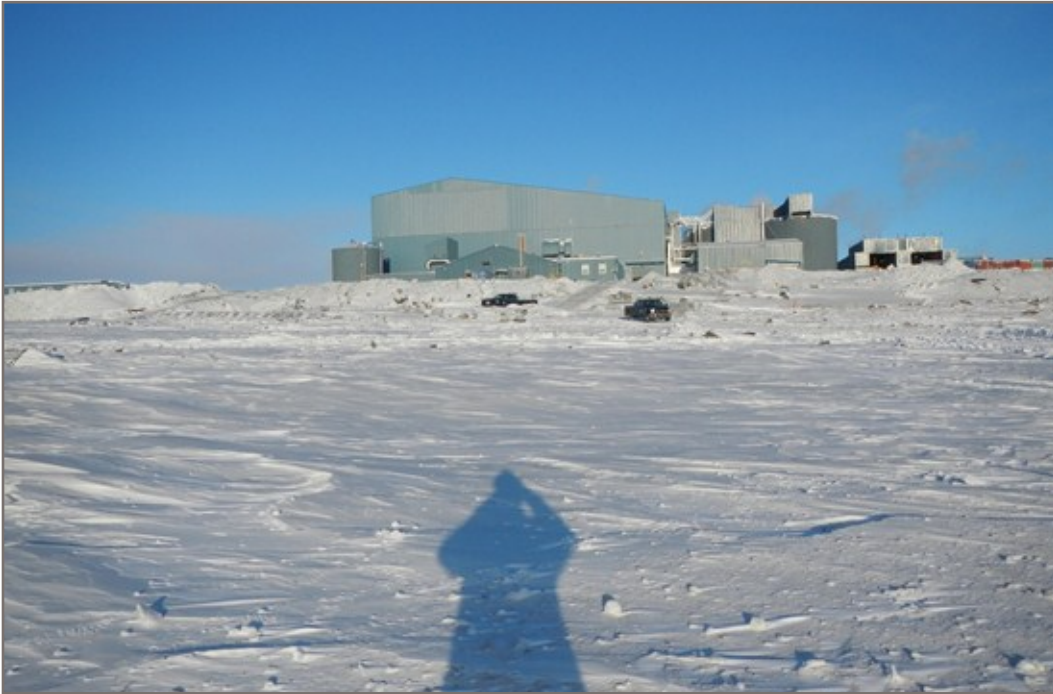
Photo 5: View from MW-04 facing northeast towards the Assay Lab.

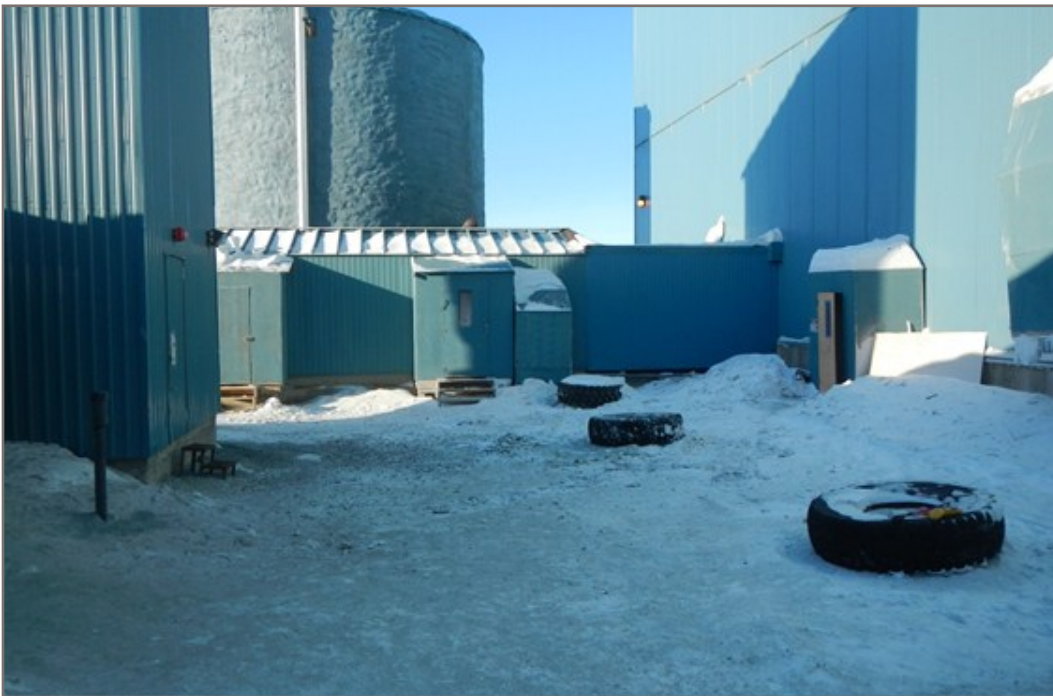
A thermistor cable was installed to 15.5 mbgs behind the Assay Lab near old monitoring wells 201, 202, and 203. The thermistor cable was completed with a 3" PVC solid pipe with caps at the bottom and top. The inside of the PVC pipe was filled with fine crushed gravel to the top of the PVC pipe. Readings were taken at the time of installation and every few days afterwards to determine the ground temperature. Appendix E presents the measured ground temperature and the calibration for the thermistor cable.

Photo 6: Northwest view of the location for the three old wells (201, 202, and 203) located in the tires and the location of the thermistor cable just southeast of the tires. This area is located between the Assay Lab and the Mill.

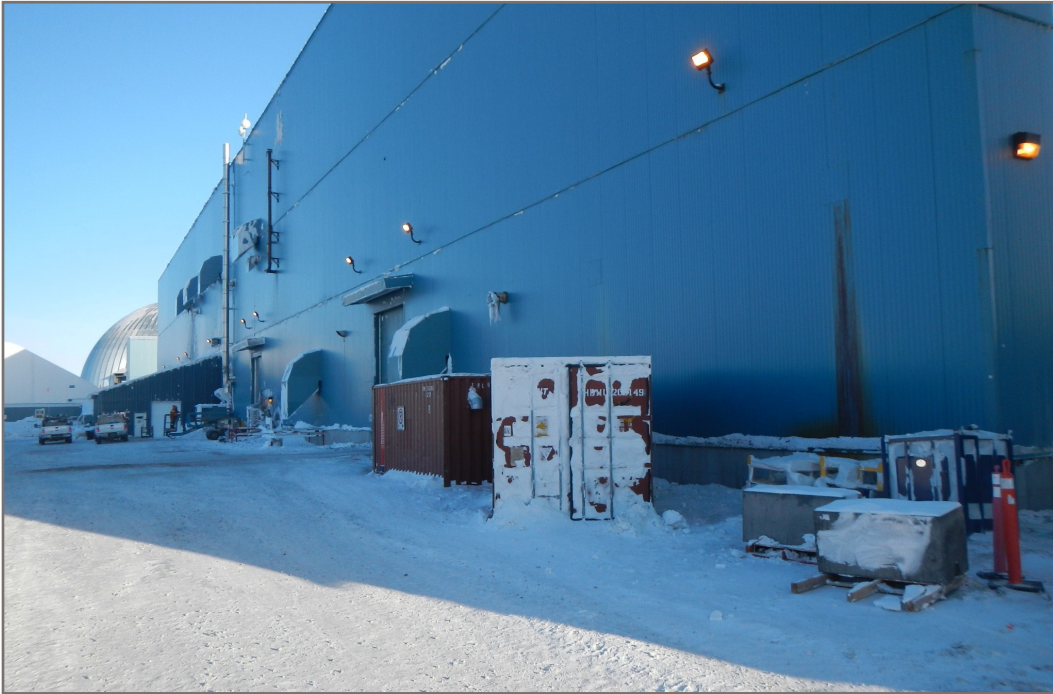
Photo 7: View of the North side of the Mill , illustrating the location of monitoring well MW01 behind the two cement blocks.

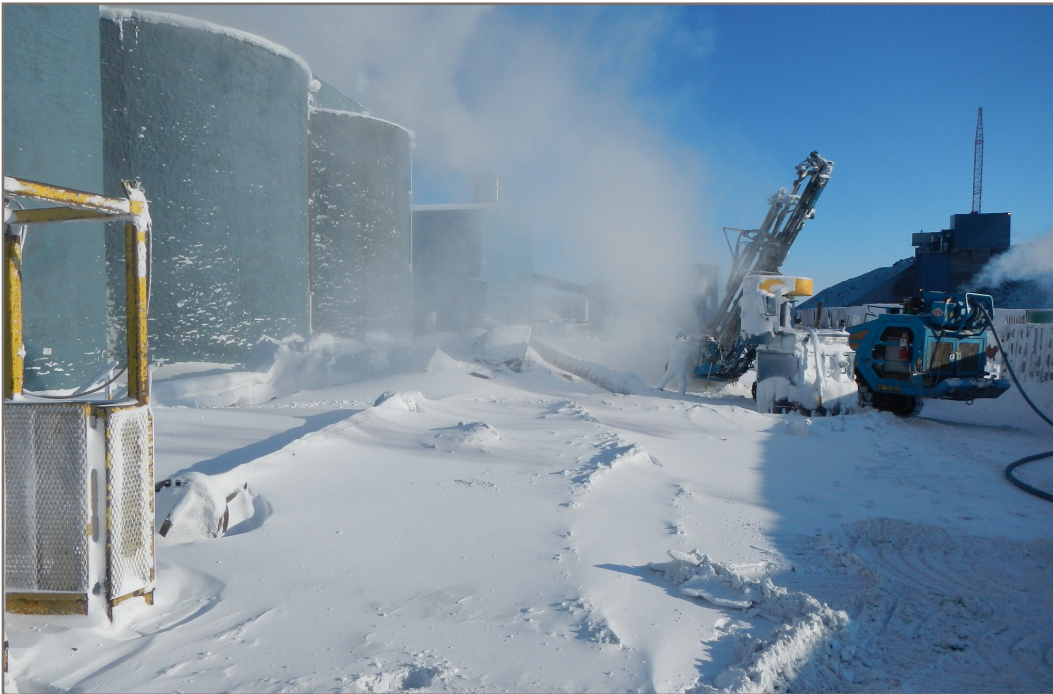
Photo 8: View on the south side of the tank farm drilling BH-27.

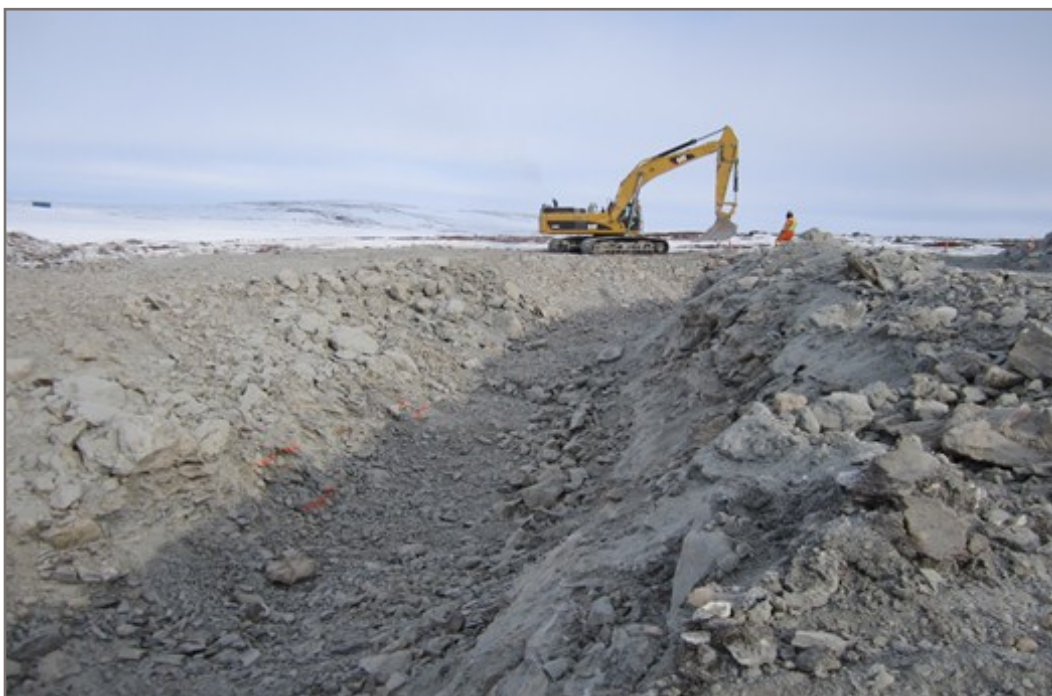
The excavation of blast debris from the interception trench was ongoing when Tetra Tech EBA arrived on site on April 24, 2014. Excavation was carried out with a Caterpillar (CAT) 365 excavator positioned parallel to the trench. Excavation removed the bulk of the blast material down to refusal on bedrock. The contractor was directed to remove all smaller rock fragments and unsound rock that remained at the bottom of the interception trench with the smaller CAT 345 backhoe equipped with a small (1 m wide) bucket fitted with “duck teeth”. Almost the entire excavation was located within sound bedrock. The bottom of the trench was somewhat irregular as a result of the inaccuracies of blasting. Photos 9 and 10 show the interception trench after the initial removal of blast material and after final cleaning, respectively.

Photo 9: West End of Interception Trench Facing Northwest
Trench Bottom Prior to Cleaning

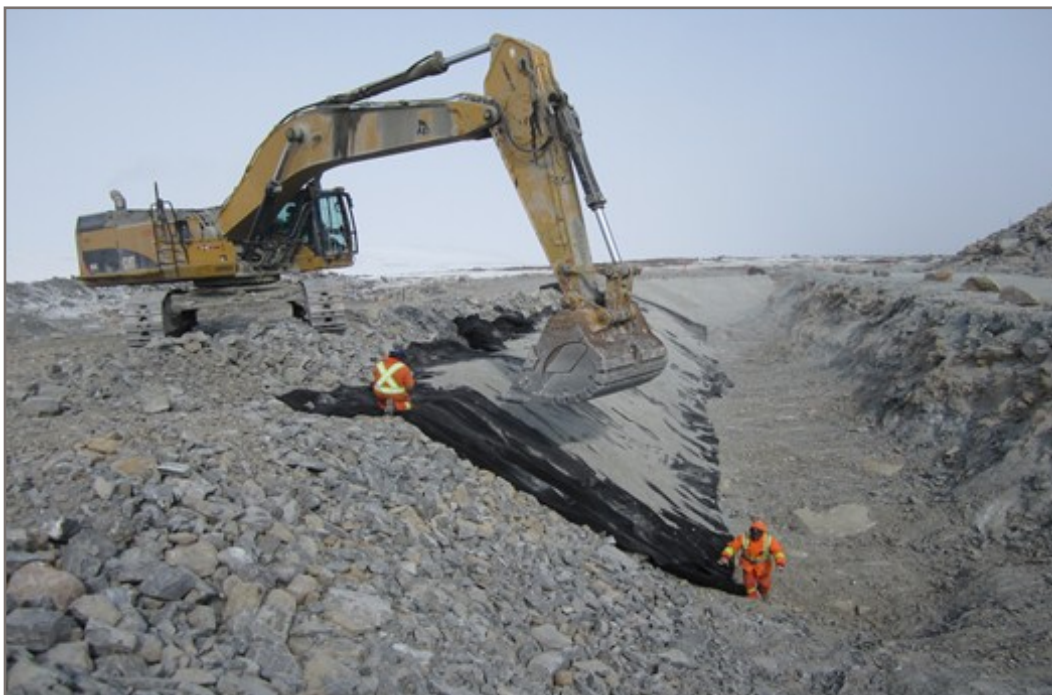
Geotextile was placed on the downstream slope of the interception trench under observation of Tetra Tech EBA. The geotextile was placed with a minimum panel overlap of 300 mm, and with approximately 1000 mm tied in at the top of the downstream slope. Photo 11 shows the geotextile on the downstream slope as it is being tied in.

Photo 10: West End of Interception Trench Facing Northwest
Trench Bottom after Cleaning. Contractors Laying Geotextile on Downstream Slope

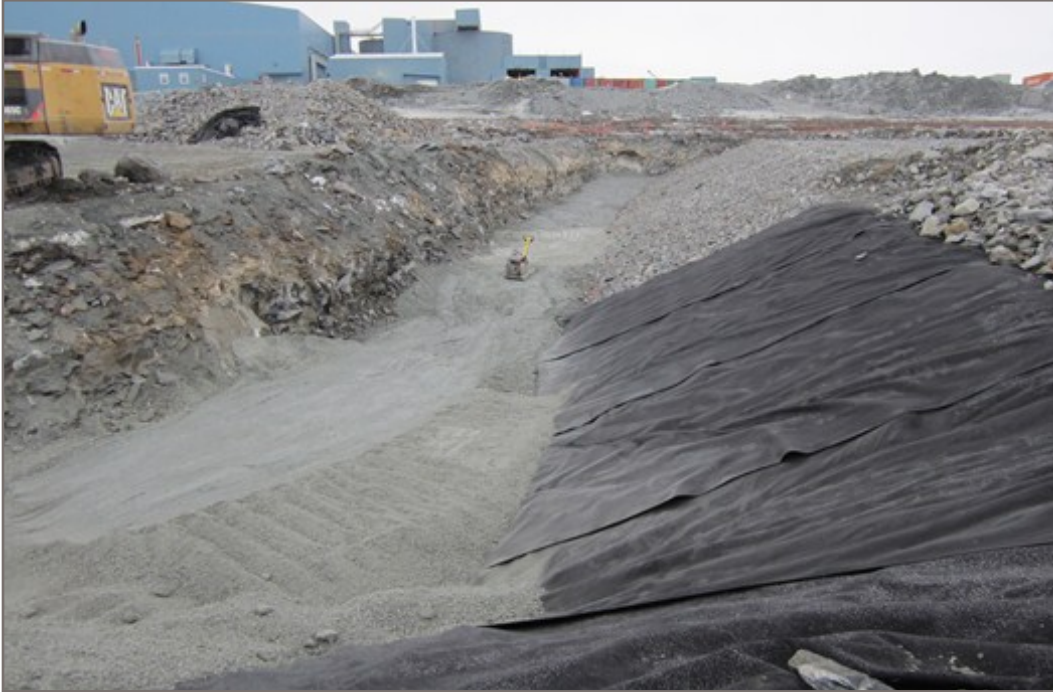
Photo 11: East End of Interception Trench Facing Northeast
Geotextile Placement with Overlap and Tie-in at Top

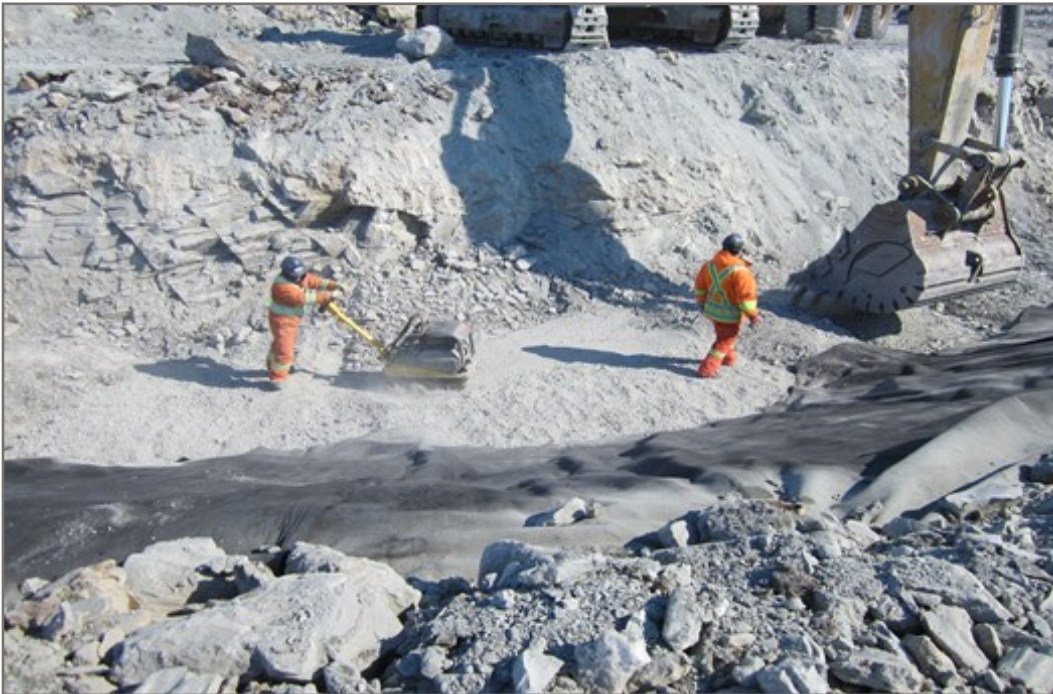
A mixture of 20 mm crushed aggregate with 8% bentonite (bentonite material) was placed on the bottom of the interception trench following inspection by Tetra Tech EBA. The bentonite material was compacted using a Wacker DPU 5045H Vibrating Plate with a minimum of four passes per lift; compaction activities are shown in Photo 12.

The aggregate/bentonite material was first placed to fill in the low (over-blasted) areas of the interception trench. Lift thicknesses between 200 and 300 mm were used. The bottom of the interception trench was built up in this manner until the desired thicknesses and grades were reached, as measured by the on-site surveyor. To meet the design intent, a minimum bentonite material thickness of 500 mm above the bedrock and minimum grades of 1.5 percent towards the collection area were achieved.

Photo 12: West End of Interception Trench Facing North
Contractor Filling in and Compacting Low Areas

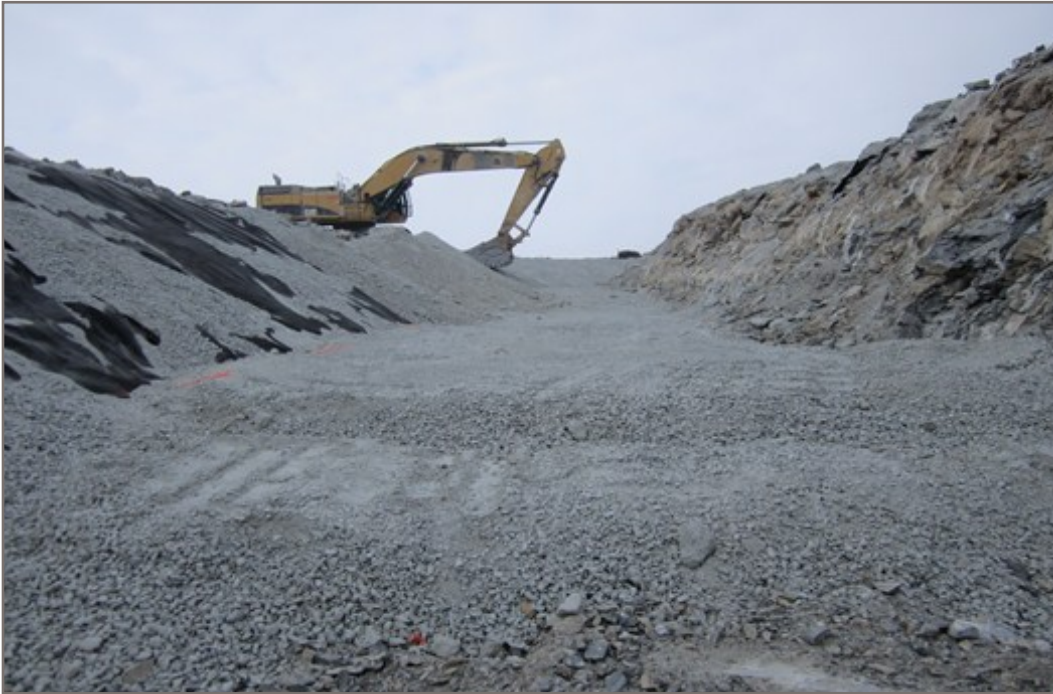
Bentonite material was placed on the downstream slope of the trench in two lifts (300 mm and 200 mm) and compacted with the CAT 365 excavator bucket for a total thickness of 500 mm. Photo 13 shows the CAT 365 excavator compacting two lifts of bentonite material on the downstream slope.

Photo 13: West End of Interception Trench Facing Northwest
Background: CAT 365 Excavator Bucket Compacting Two Lifts of Bentonite Material on Downstream Slope. Foreground: Two Lifts of Bentonite Material Visible

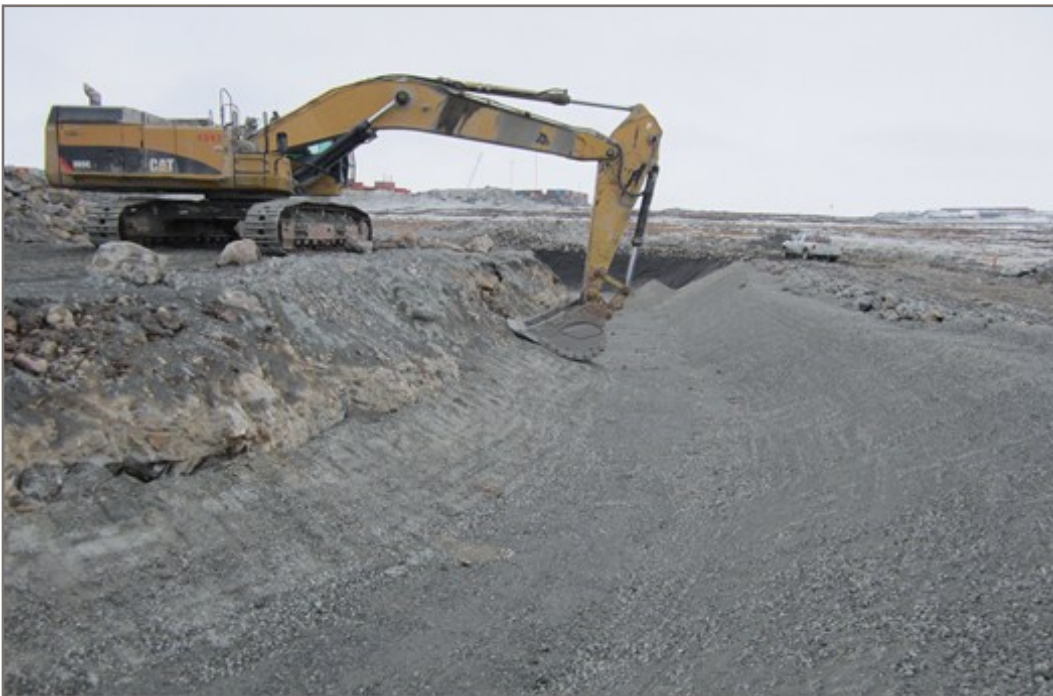
Bentonite material was placed along the upstream slope to direct any flowing subsurface water (most likely flowing in the active layer at the overburden/bedrock contact) into the interception trench. Compaction was carried out with the CAT 365 excavator bucket. The contractor was directed to ensure there was no gap or “gutter” between the upstream wall and bentonite material. Care was taken so that the top of the bentonite material was below the overburden/bedrock contact. Photos 13 to 16 show bentonite placement on the upstream slope.

Photo 14: West End of Interception Trench Facing Southeast
CAT 365 Excavator Bucket Compacting Upstream Bentonite Material Slope Below the Bedrock Contact

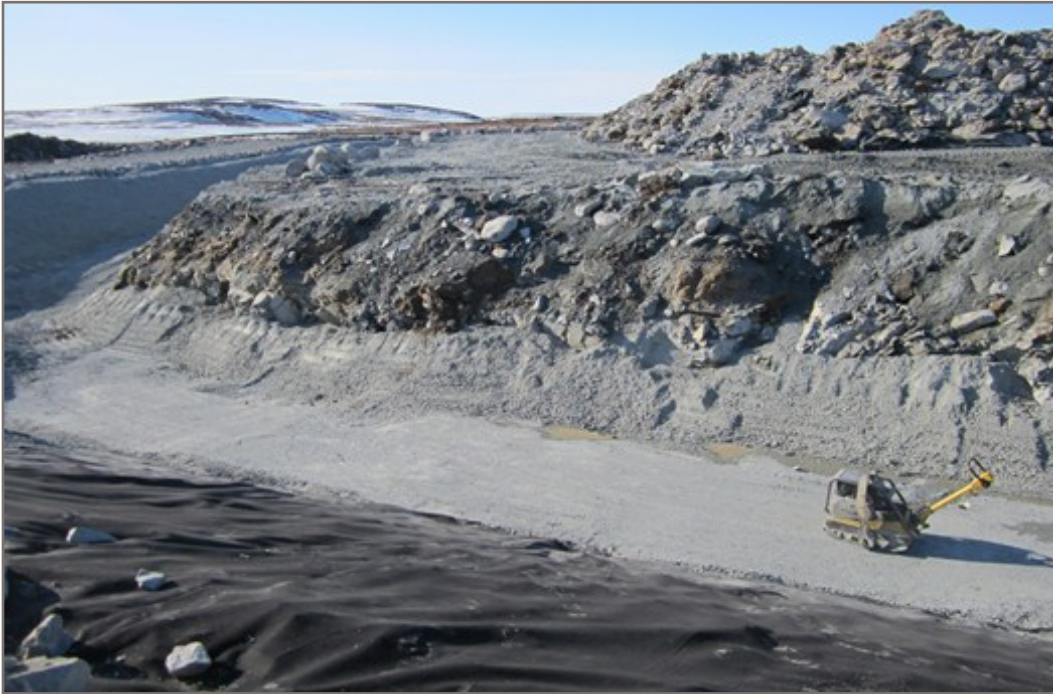
Photo 15: East End of Interception Trench Facing Northwest
Bentonite Material on Upstream Slope Below Bedrock Contact

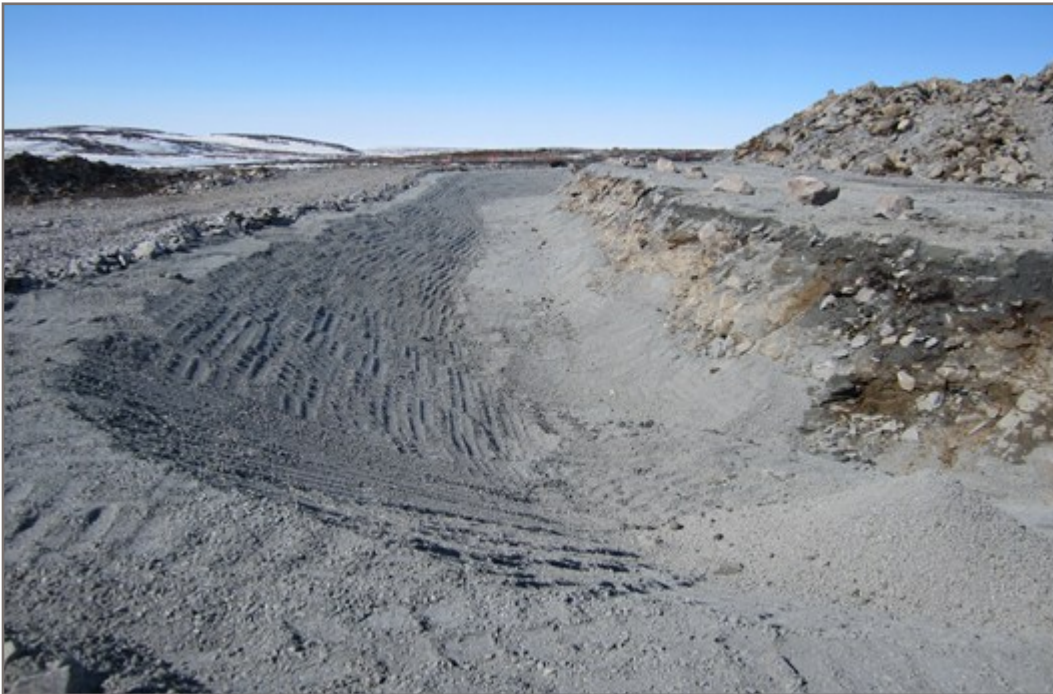
Photo 16: West End of Interception Trench Facing Northwest
Completed Bentonite Placement

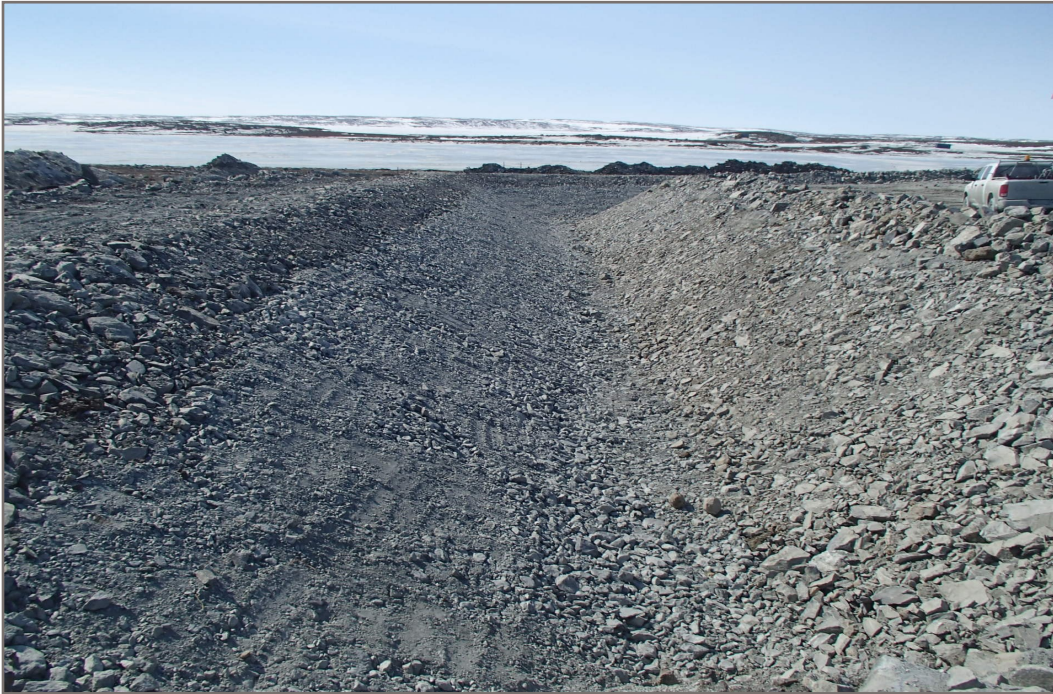
The placement of the 150 mm and Rock Fill material was done after Tetra Tech EBA had left the site. This stage was not as crucial to the performance of the interception trench as the bentonite material placement. Photo 17 shows the interception trench at completion, photos courtesy of AEM.

Photo 17: East End of Interception Trench Facing Southwest
Completed Interception Trench Covered in Rockfill
(Photo courtesy AEM)
