October 7th, 2016

Mr. Bertin Paradis
General Manager
Agnico-Eagle Mines, Meadowbank Division
Baker Lake Office

Report No 19
Meadowbank Mine Dike Review Board
Meeting September 19-22, 2016

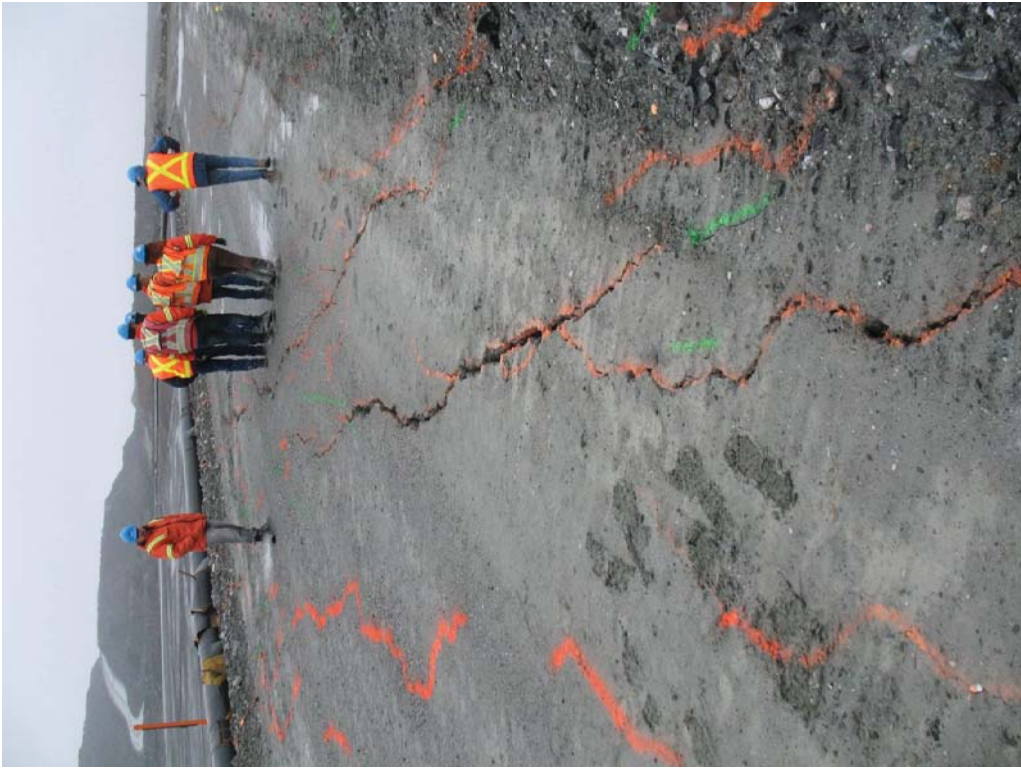
The site team noted the first signs of cracking on the crest of the Stormwater Dike on August 24th. These have subsequently spread and widened and indicate a deep seated movement. It was concluded by AEM and Golder Associates (GAL) that the deformation originated in the sediments in the dike foundation. Stability analyses led to the decision to construct a rockfill berm at the toe.

On arrival to the mine site, the Board was taken to the dike to observe the current status. The extent of the cracking can be appreciated from Photos nos. 1 and 2 in Appendix C. The toe berm is well advanced as shown in Photo no. 3.

The Board judges that the site response to the situation was correct but creep movements are likely to continue albeit at a reduced rate. To prevent ingress of rainwater, it would be advisable to fill the cracks with a deformable clay type of material. This action would reduce the risk of pressures in the back scarp cracks that could accelerate deformation.

non-permafrost “talik” zone. As the permafrost aggraded, under the downstream toe of the new dike, segregated ground ice would be expected to form in the fine grained lakebed sediments now supporting the downstream shell of the dam. The recent South Cell pond raising has now submerged this area. This new pond is a heat source that has initiated degradation of the frozen ground condition. The decreased shear resistance led to the initiation of shear movements in the thawed and thawing sediments. Moreover, creep displacements can be expected to continue through the ice in the warm permafrost and along the frozen-unfrozen interface.

Photo no. 1 Cracking on Stormwater Dike Crest

The Board recommends verifying the causes and establishing supporting evidence for the mitigation measures by:

- Drilling and sampling with HQ size triple core barrel using chilled brine as a drilling fluid;
- Logging the core for ice content;
- Measuring shear strength in the laboratory by consolidated undrained triaxial tests with pore pressure measurement;

- Installing thermistors to determine the temperatures in the foundation (it is noted that the instruments P13265 and T147-1 have been destroyed by the berm construction). Replacement of this deep (about 60m) instrument is recommended as it provides useful data on permafrost response from both above and below the old talik zone;

- Establish serviceability criteria for membrane integrity;
- Install survey monuments on the dike crest (downstream side) over the full length;
- Evaluate the role of future pond rise on the potential for extension of the deformation.

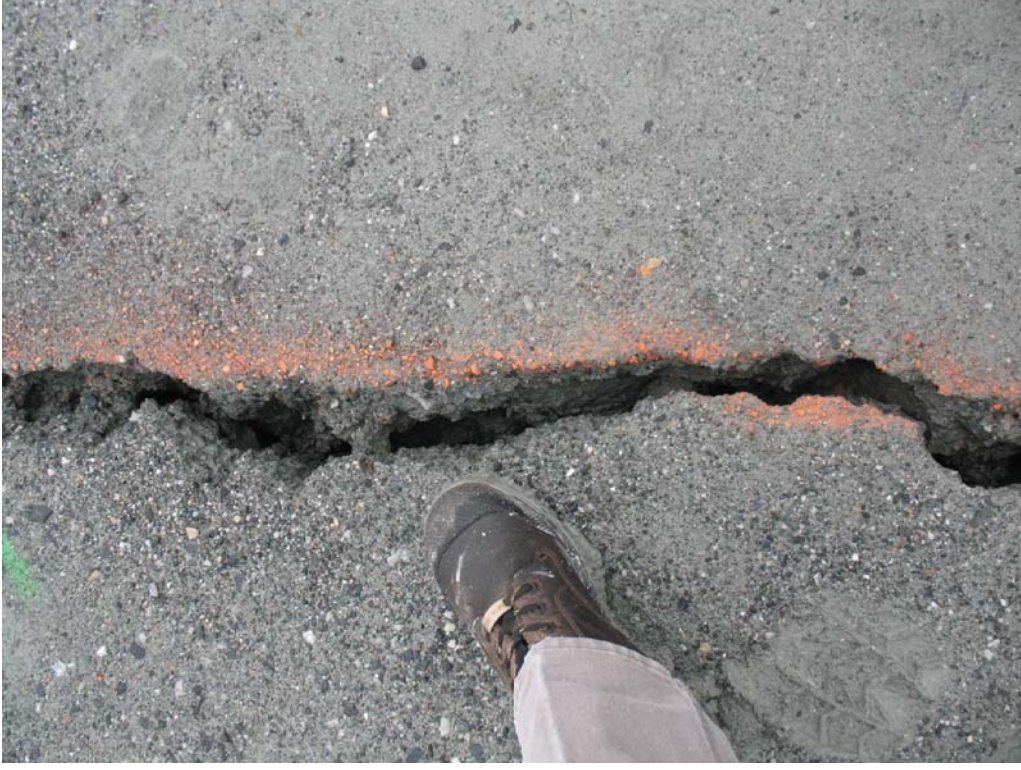
Photo no. 2 Crack width

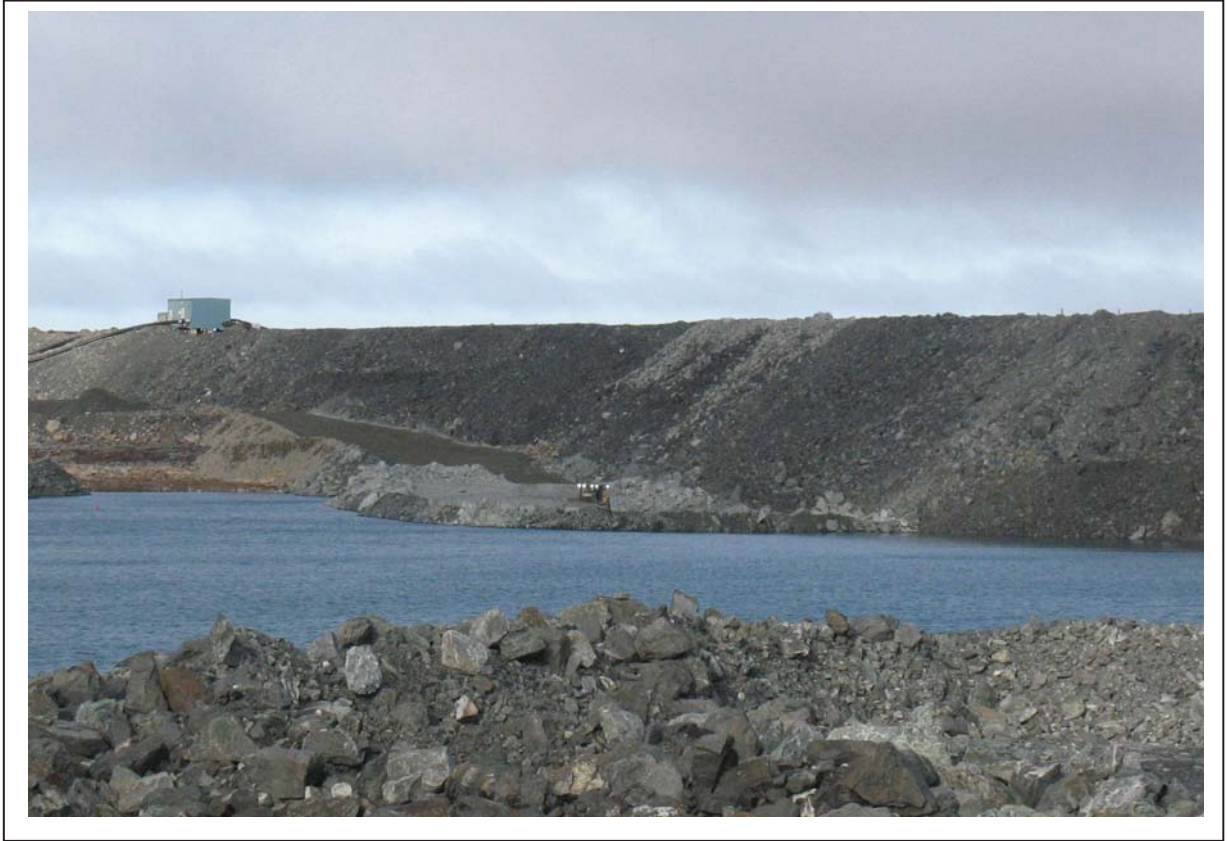
Photo no. 3 Construction of Stormwater Dike Toe Buttress

- Establish design criteria for both investigating the mechanisms and validating the role of the buttress support with due regard for the currently envisaged service life (around 10 years before encapsulation by the tailings) and the tolerable deformations;

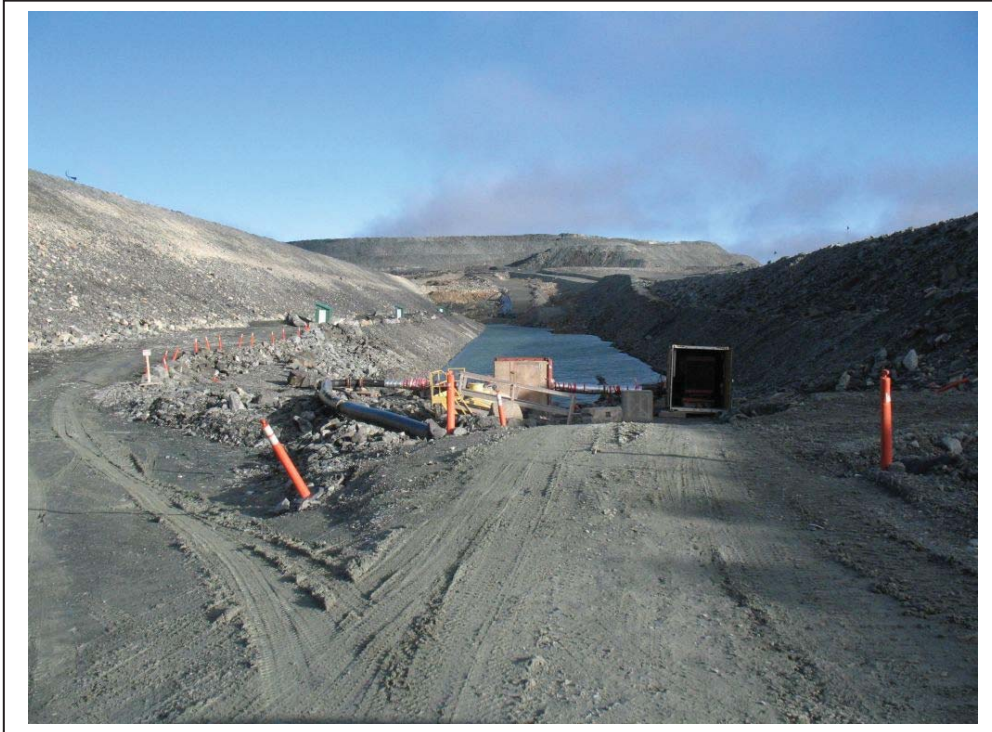
A site visit permitted the Board to appreciate the pumping installations that have been operated of late (photo no. 4) and to learn of plans to install electrically powered pumps to facilitate the control of flow rates and thus the pool elevation. The pool depth is sufficient to submerge the points of inflow. No concentration of suspended sediments was in evidence at the time of the visit nor has any been noticed by the site team outside of freshet run-off period. However, the pond water is not completely clear as can be noted from photo no. 5. The leakage appears to be managed effectively at present.

Photo no. 4 Central Dike Toe Area and Pump Installations

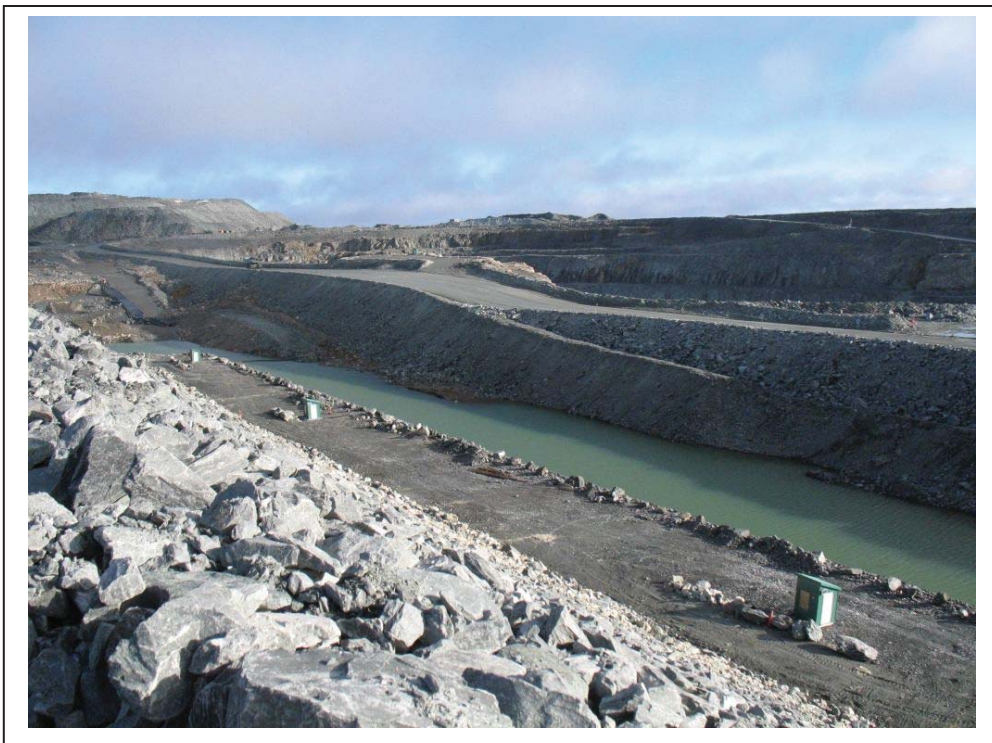
Photo no. 5 Pond at Toe of Central Dike

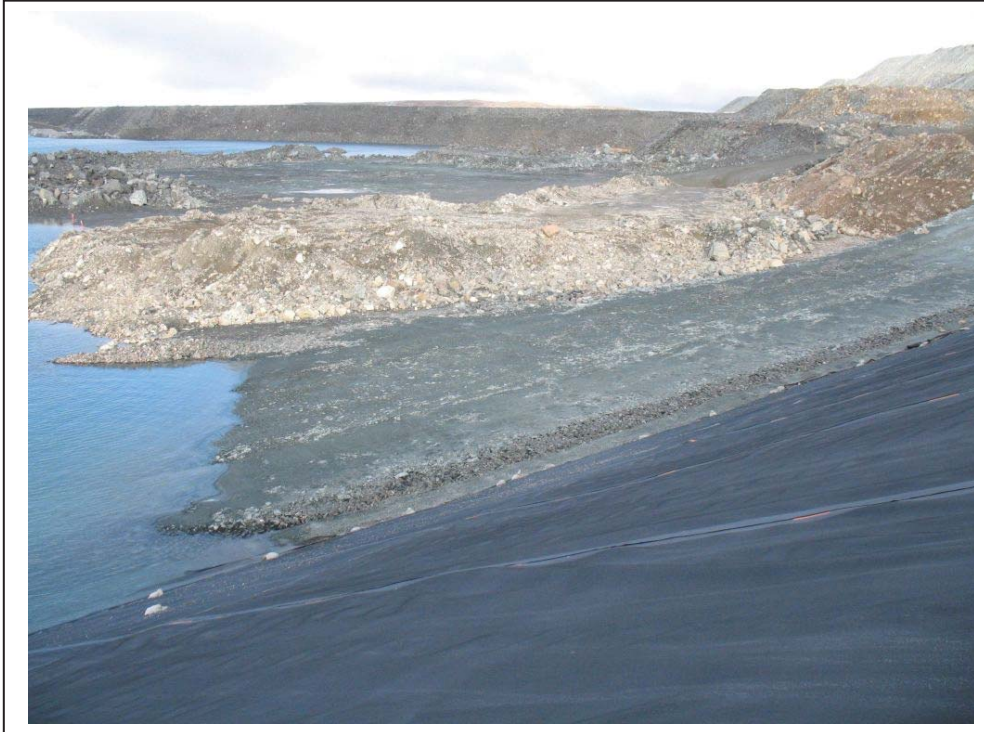
Photo no. 6 Rockfill Cover on Central Dike Key Trench

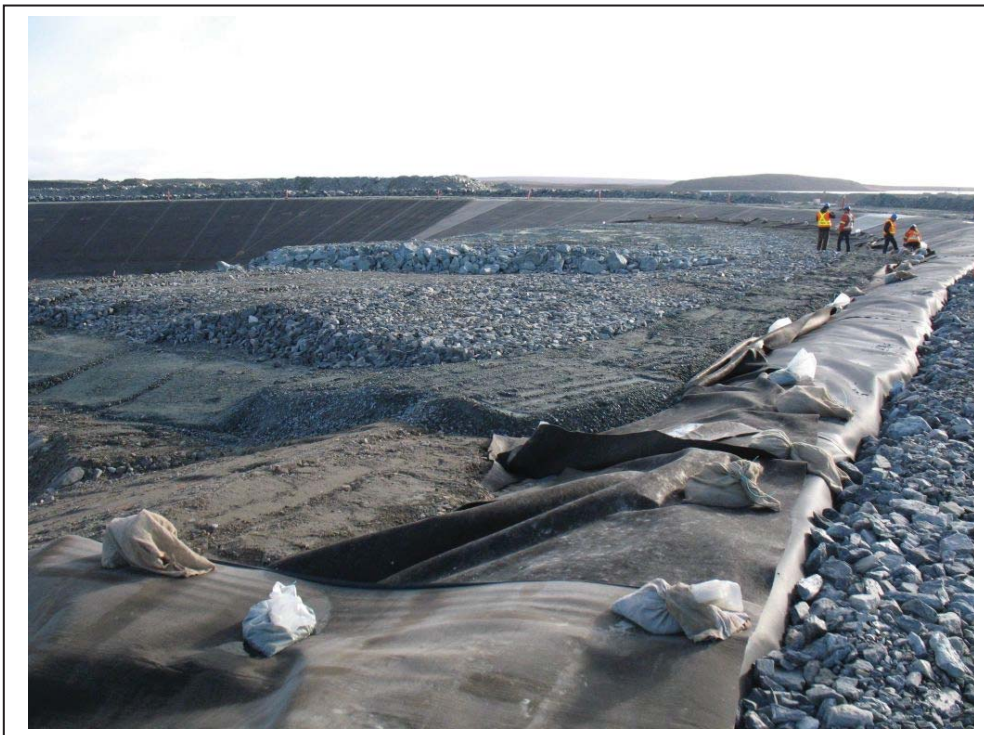
The Project team raises questions with respect to the erosion protection layer that has been specified by GAL to protect the till backfill of the key trench at the upstream toe of the dikes (photo no. 6). The Board shares this concern, not so much from a cost angle but, from the amount of mechanical activity on the membrane coupled with the flow path through the crushed stone and rockfill that conveys full pond pressure everywhere over the liner and in particular over any imperfections. This prevents the tailings blanket from contributing to reduce seepage. The protection has been designed in the same manner as a rip-rap zone on a dam face subjected to wave attack (photo no. 7), with filter and transition zones to protect the underlying till. However, the Board questions whether the potential for harm exceeds the implied value of the detail and recommends review of this detail with GAL.

Photo no. 7 Construction of Key Trench Protection at Saddle Dam SD5
