Mr. Luc Chouinard  
General Manager  
Agnico-Eagle Mines, Meadowbank Division  
Baker Lake Office

Report No 22  
Meadowbank Mine Dike Review Board  
Meeting September 4-7, 2017

The objectives were to review the status of the design, construction and operation of water and tailings retention structures at Meadowbank, and adaptation of the facilities to accommodate the production of the Amaruq project. A visit to the latter site was also included in the activities.

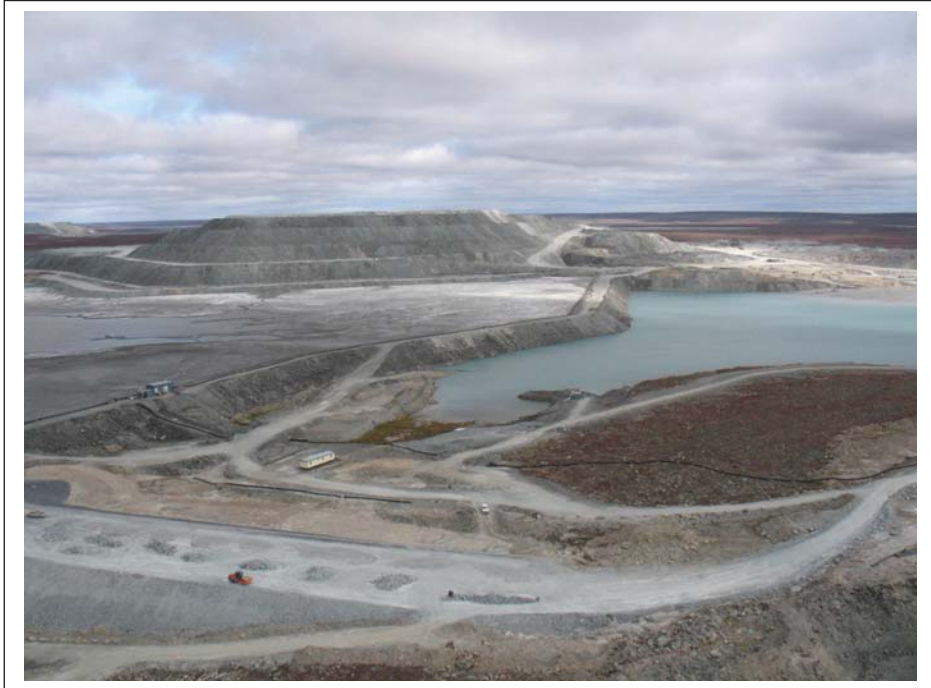
As the South Cell pond level rises (131 m in September 2016, 137 m in September 2017) inundating a greater length of the Stormwater Dike footprint (Photo #1), additional thaw settlement could be expected. This effect has materialized and additional movements and cracking have been observed since July 2017. Settlement at the downstream side of the crest has attained 70 cm (Photo #2), though it is noted that the deformation on the upstream side is considerably less and the integrity of the Coletanche liner is not jeopardized. Furthermore, the tailings deposited in the North Cell adjacent to the liner are now frozen. The area influenced by cracking now extends from Stn. 10+425 to Stn. 11+050. Additional prisms mounted on large boulders (Photo #3) and wire extensometers have been added to complement those installed in 2016.

Photo #1 Stormwater dike

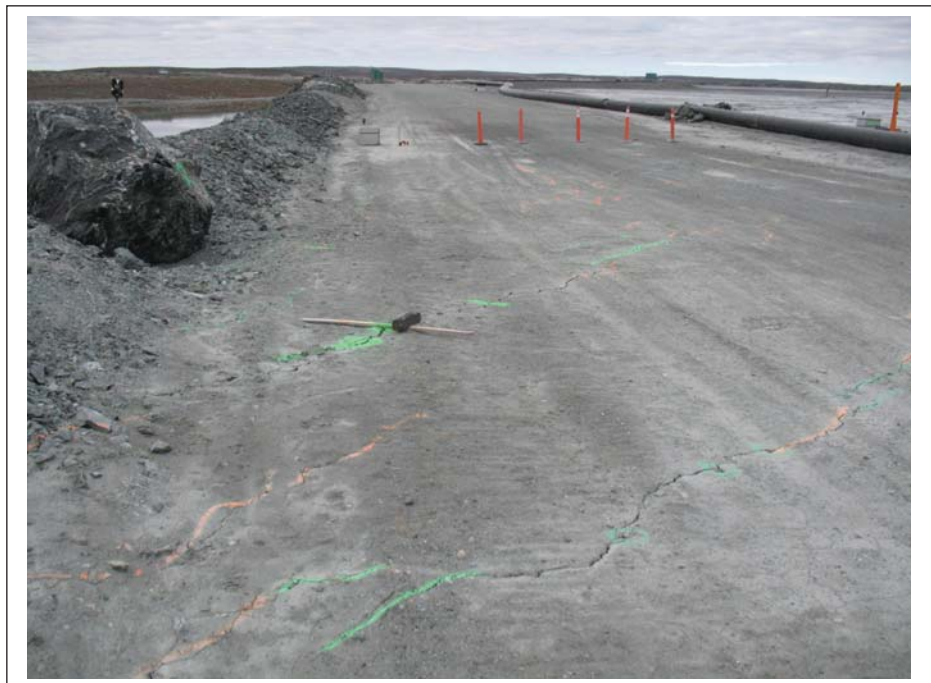
Photo #2 Location of new depression. 70cm max settlement on D/S (left)

In the previous report the Board recommended filling the cracks on the crest with bentonite to prevent ingress of rainwater, it would be advisable to continue this operation for the recent cracks. The finer cracks could be filled with bentonite but the wider ones could be treated with a bentonite-sand mixture to reduce shrinkage. This action would reduce the risk of pressures in the back scarp that could accelerate deformation.

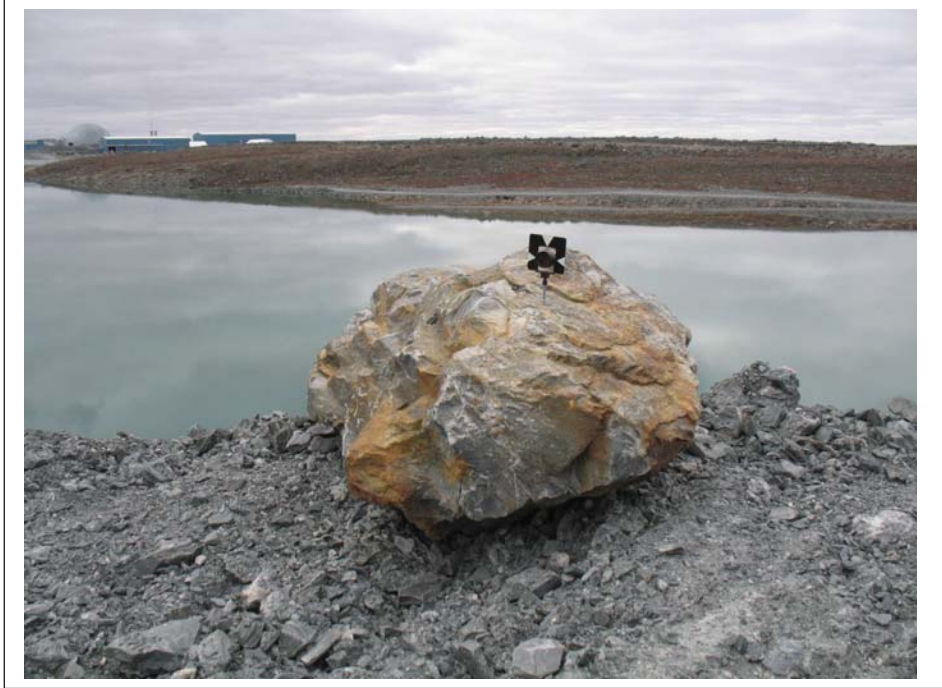
Survey prisms have been installed on large boulders as may be appreciated from photo #3. The results indicate a tendency for the blocks to undergo local movement due to freezing of the crest and subsequent thaw. This limits their ability to represent true crest movements at these times. Evolution during the summer season may be adequately monitored but the evaluation of apparent movements in the spring and fall requires judgement.

Photo #3      Typical survey prism mounted on large boulder

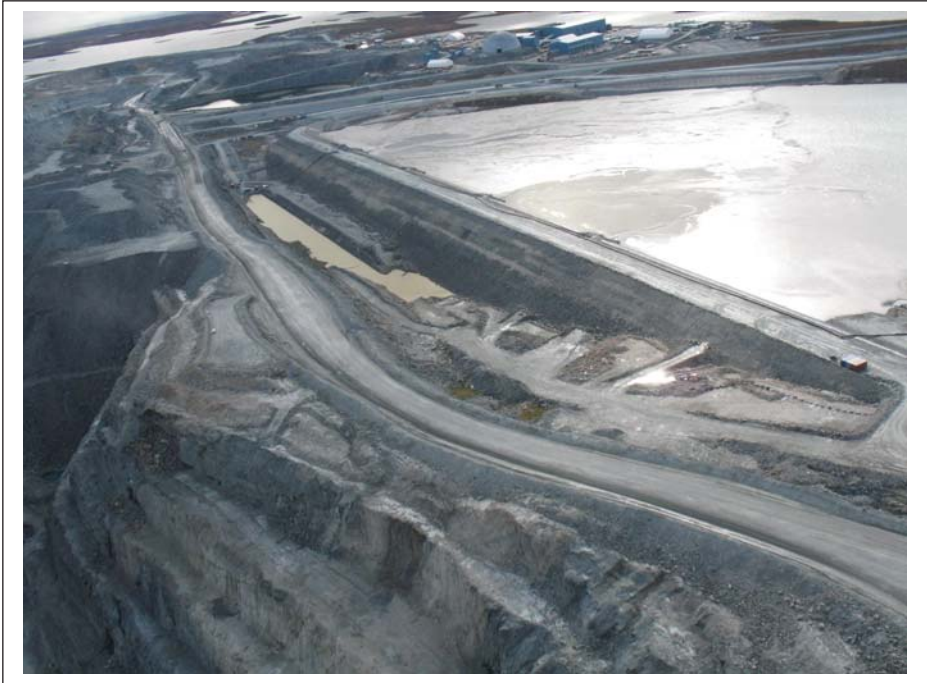
The Board had been previously advised (Teleconference Meeting No. 20) of the appearance of chemical/bacteriological deposits in the seepage collection pond at the Central Dike toe (Photos #4 and #6). The comprehensive monitoring, both visual and by instrumentation, is on-going. The situation seems to be basically stable given the boundary conditions of south cell pond rise and continued tailings deposition.

Photo #4 Central Dike. Portage Pit to the left of photo.

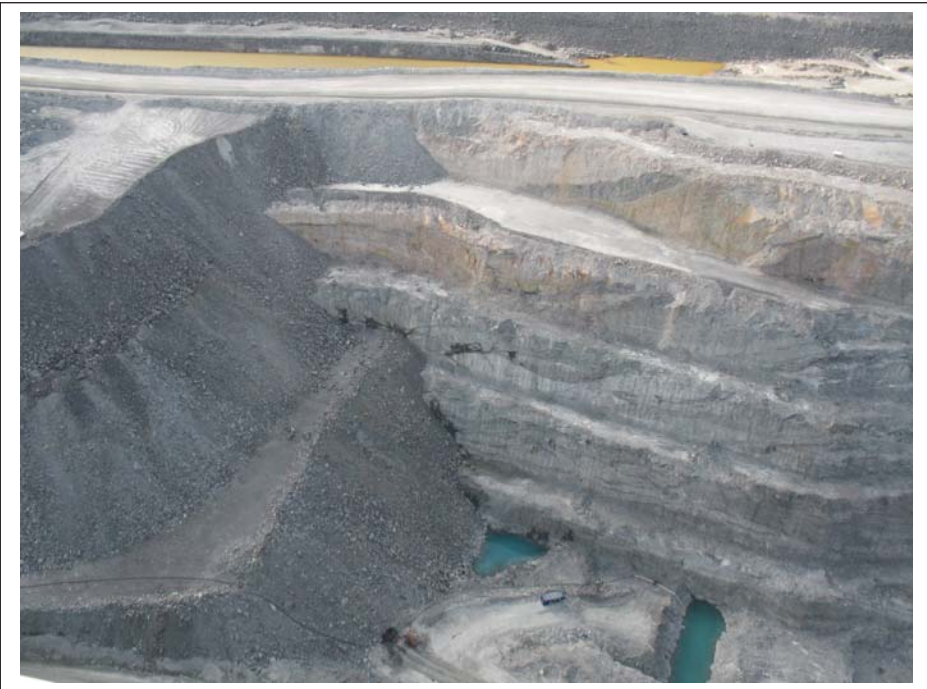
The temperature measurements still indicate a talik beneath the West Road in the vicinity of instruments 875-P3 and 975-P3. The potential for seepage flow to the Portage Pit (Photo #5) exists but flow captured by the in-pit pumping is apparently inferior to the quantity pumped from the seepage collection pond at the dike toe.

Photo #5 Wall of Portage Pit downstream of Central Dike

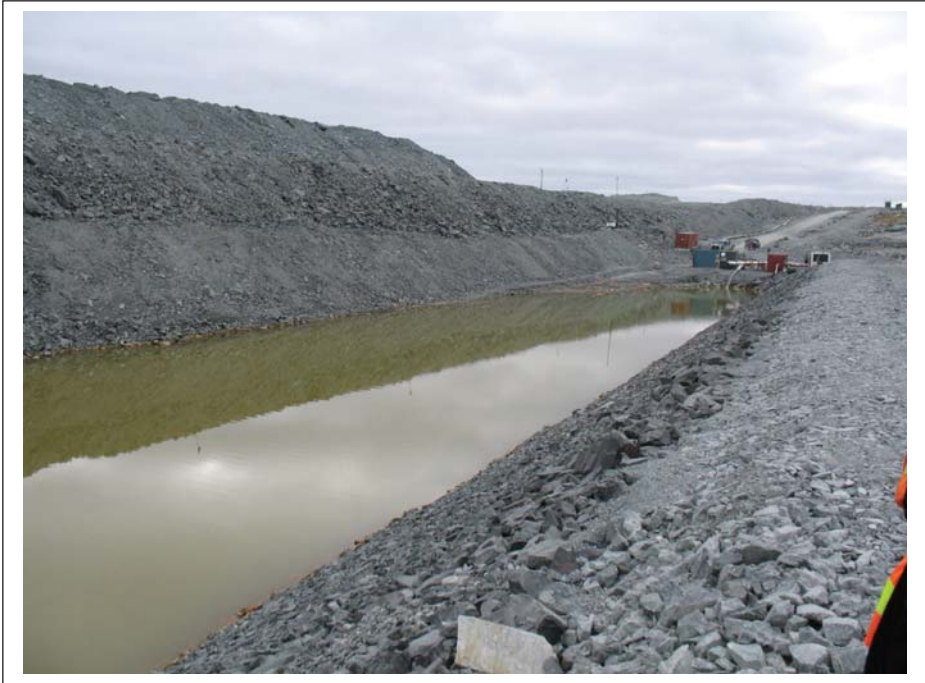
Note that visual observation of the toe of the Central Dike cannot be made due to the presence of the pond as shown in Photo #6. Maintaining the pond at el. 115 m provides useful back pressure to control seepage and the Board concurs with this approach.

At the downstream toe of Central Dike, the current turbidity level was noted and it is readily apparent that little detailed observation of local flows is possible. Rockfill baffles across the pool may assist observation during the summer period but would be of little use during the winter and would exacerbate ice accumulation. Consequently, reliance has to be placed on frequent monitoring of pumping flow rates and the results of water sampling. A rapid determination of turbidity and/or TSS is obviously part of the procedure.

Photo #6 Seepage collection pond at toe of Central Dike

The Board suggests that geophysical specialists be consulted to ascertain whether Ground Penetrating Radar (GPR) and/or resistivity surveys could be expected to give useful results in the conditions (rockfill) at the location of hole 700-P1. Subsequent drilling would focus on any anomalies revealed by such surveys.

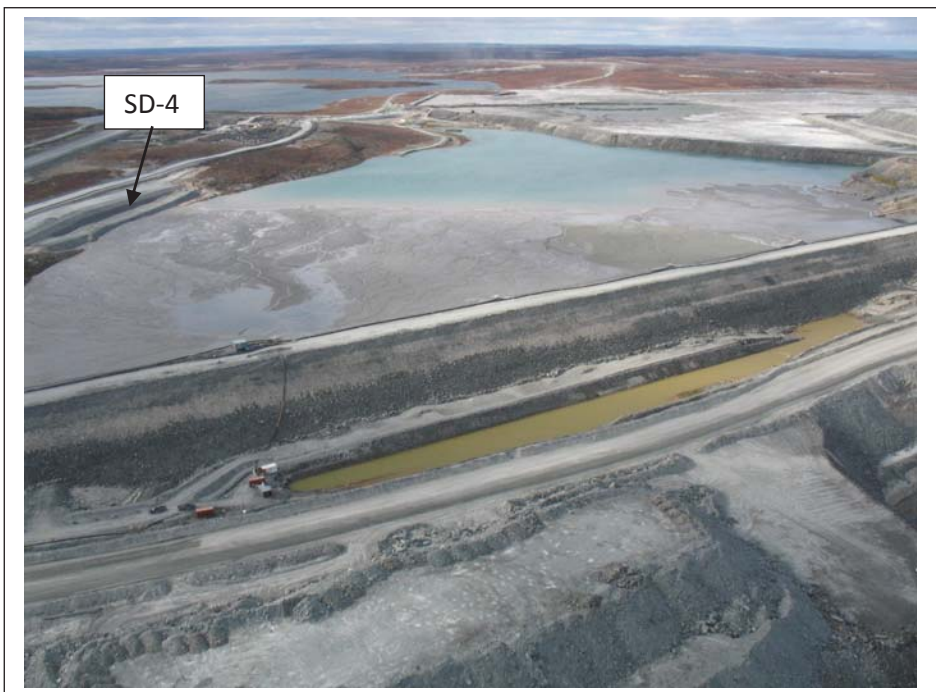
Photo #7 South Cell of TFS

The Board recommends continuation of a deposition plan to encourage beaching along the SD-4 to SD-3 shoreline (Photo #7).

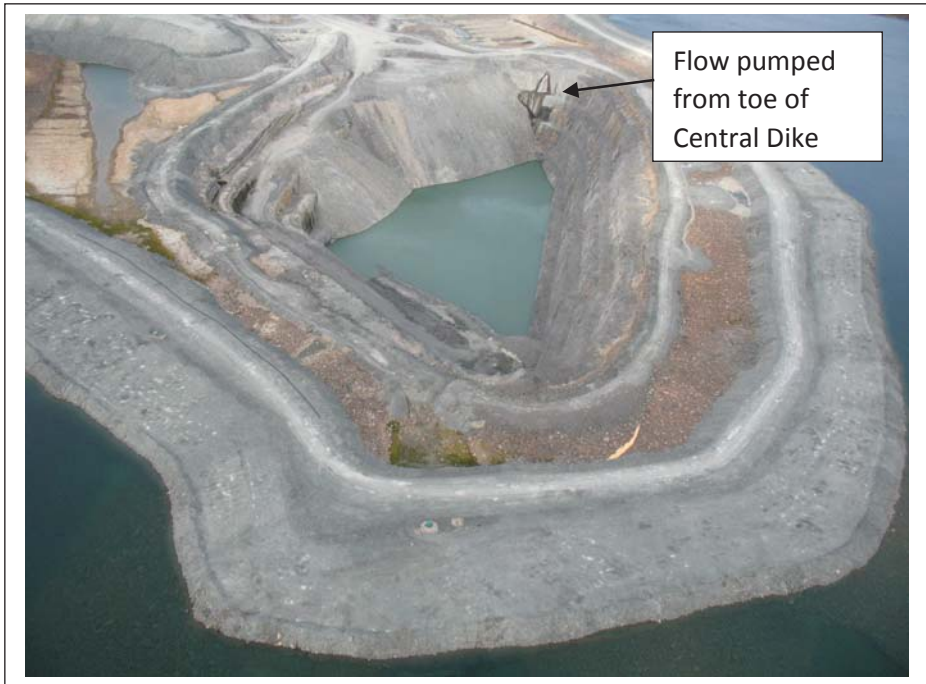
Photo #8      Goose Pit

A strategy of minimizing the south cell pond elevation while ensuring adequate water reclaim is part of the exercise. Consequently, seepage water is no longer pumped back into the South Cell but directed to the Bay-Goose Pit (Photo #8).

Flow pumped  
from toe of  
Central Dike

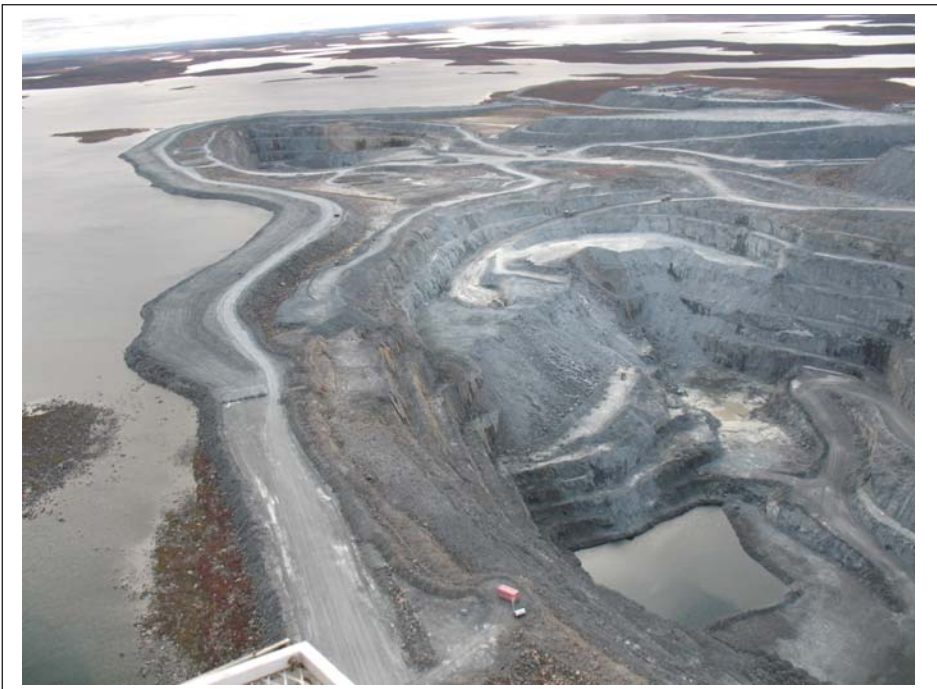
As far as Portage Pit E is concerned, where push-back is on-going (Photo #9), instability of the Ultramafics is also noted but overall pit slope performance is judged to be good. In-place inclinometers and Time Domane Reflectometer cables have been added to the instrumentation. Reliability of the inclinometers is considered marginal possibly due to inadequate grout installation of the casing. A Trigger Action Response Plan has been developed for the operation of this pit.

Photo #9      Push-back in Portage Pit E5
