WATER LICENCE INSPECTION FORM

Licensee	Licensee Representative		
Agnico Eagle Mines Limited (AEM)	Martin Archambault		
Licence No. / Expiry	Representative's Title		
2AM-MEA1526	Environmental Coordinator		
Land / Other Authorizations	Land / Other Authorizations		
Date of Inspection	Inspector		
June 14 th -17 th 2019	Jeremy Fraser		
Activities Inspected			
☐ Camp ☐ Drilling ☐ Mining ☐ Roads/Hauling ☐ Other:

On June 14th 2019 a Water Licence Inspection was conducted on the Agnico Eagle Mines Ltd. (AEM) Meadowbank project. This Inspection was to ensure compliance with the water licence 2AM-MEA1526 and the Acts; Nunavut Planning and Project Assessment Act (NUPPA), Nunavut Waters and Nunavut Surface Rights Tribunal Act (NWNSRTA), and Arctic Waters Pollution Prevention Act (AWPPA).

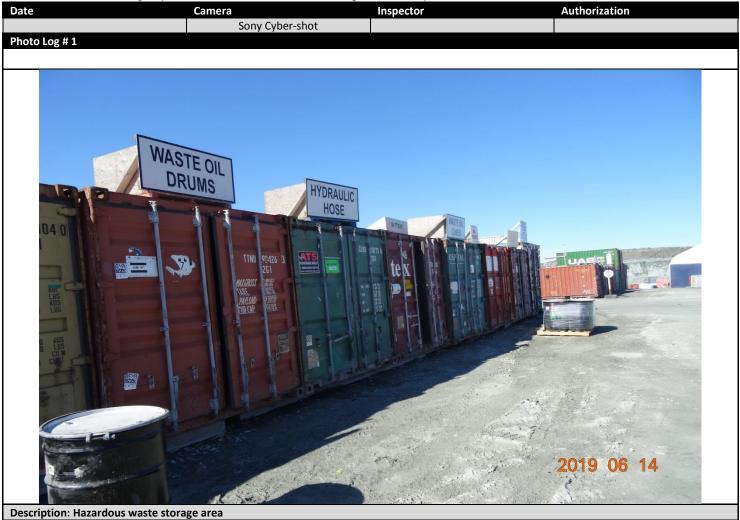
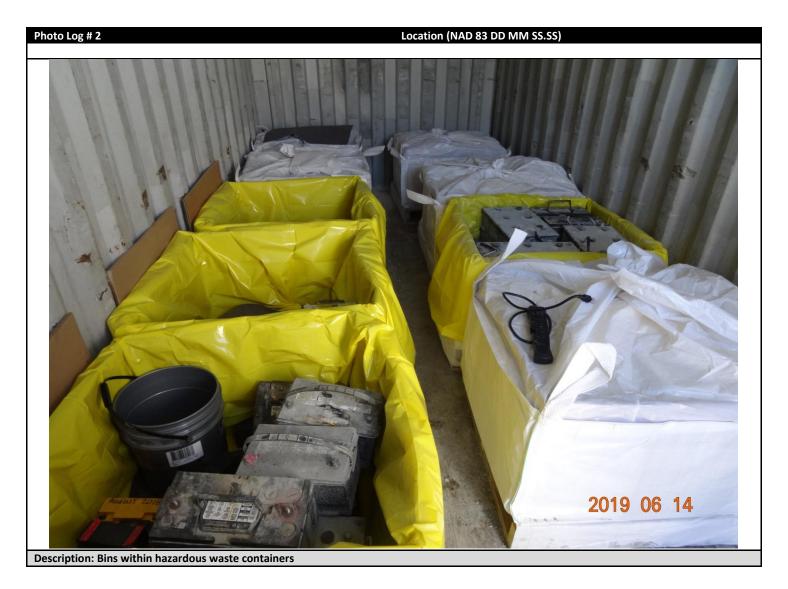
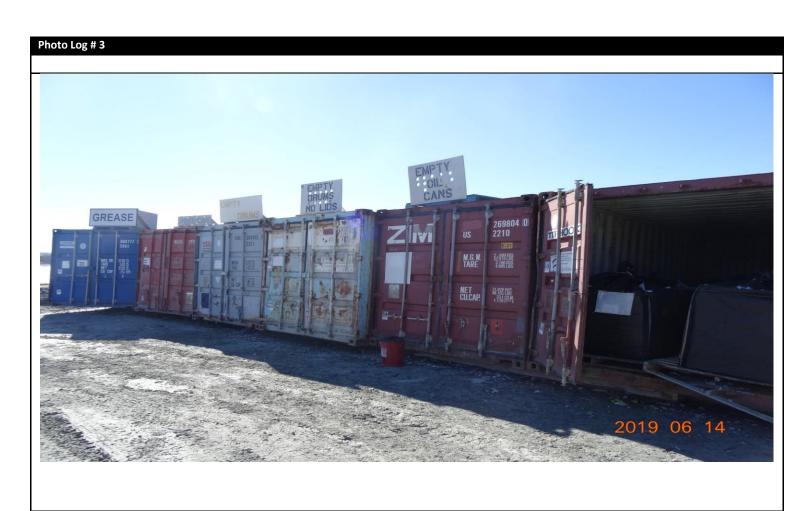
AEM is currently segregating all Hazardous Waste into multiple sea cans separating items such as batteries, waste oils, used rags etc. and shipping generated waste off site as a requirement of the license Part F Item 16 & 17. (see photo 1,2 &3). AEM has addressed concerns regarding this area identified in the previous inspection dated April 8th 2019.

Description: Hazardous waste material storage area

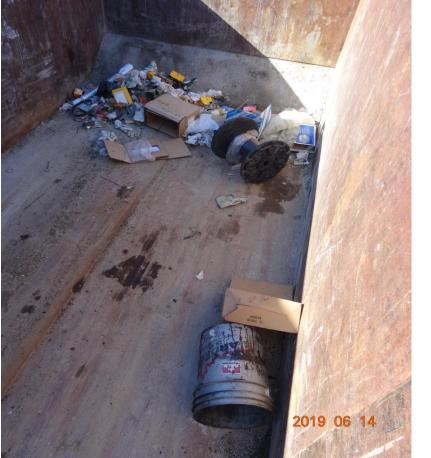
Photo Log # 4

It was noted that some minor concerns regarding the disposal of waste generated within the contractor's laydown (see photo 4). The inspector identified used lubrication pales and used oil rags have been disposed of in a garbage bin not marked for hazardous material. When the inspector questioned the final destination of the garbage bin the inspector was informed it was to be put in the landfill. The inspector verbally ordered AEM staff to remove all hazardous material prior to landfill disposal.

Description: Used oil rags and oily bucket found within garbage bins on FGL contractors site

AEM must discontinue the disposal of hazardous waste into the non-hazardous waste landfill. If this continues, the facility will be classified as hazardous and appropriate remedial efforts will be required to rectify this.

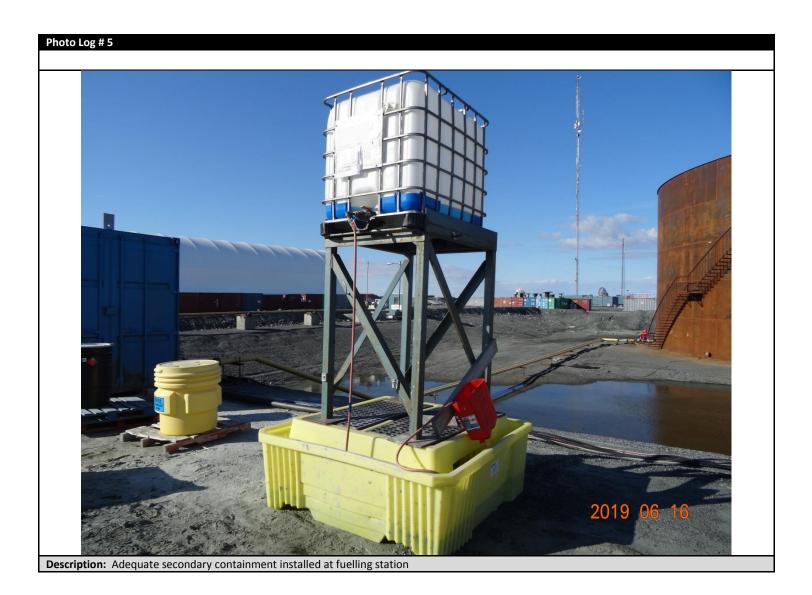
AEM has addressed concerns from the previous inspection in regards to this facility. Adequate secondary containment has been put in place to capture any residual liquids within this facility (see photo 5). The inspector noted some water within the single tank farm (see photo 6); AEM has sampled the water and results indicate the water meets discharge requirements set by the NWB regarding the Licence 2AM-MEA1526 Part F Item 9 . No concerns regarding this facility.

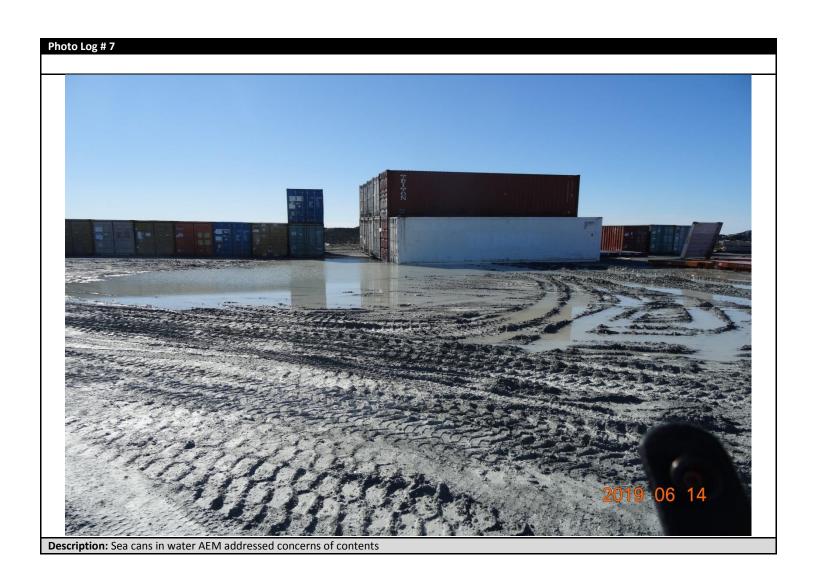
During the inspection of this facility it was noted that some pooling of water in what appears to be a low spot beneath a sea can on the pad. The sea can was labelled "super Heavy" and locked at this time; the inspector was unable to determine what is stored in the sea can (see photo 7). After further review of information provided by AEM it was determined that the container is housing dry goods only and no chemical products. No concerns were identified

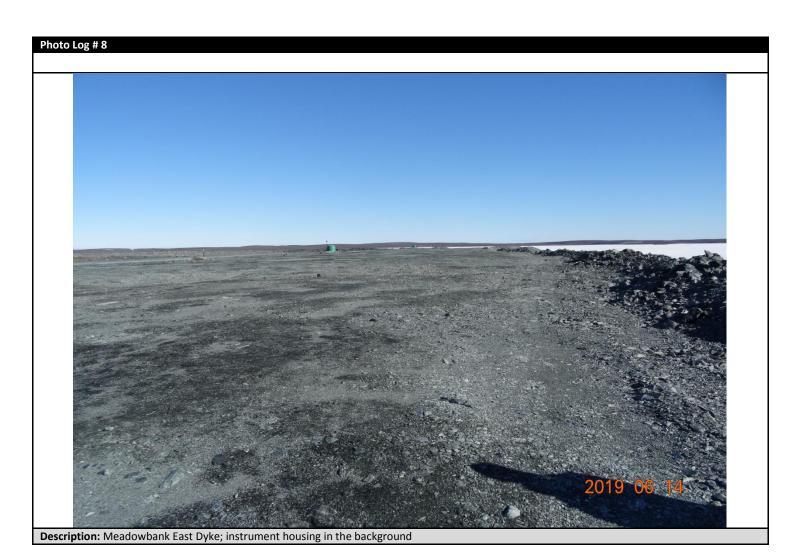
It was noted that the East Dyke appears to be operating as intended. AEM is continuing monitoring occurring with data collecting instrumentation including temperature sensors and piezometers installed within the dyke (see photo 8). There were no concerns identified regarding this structure.

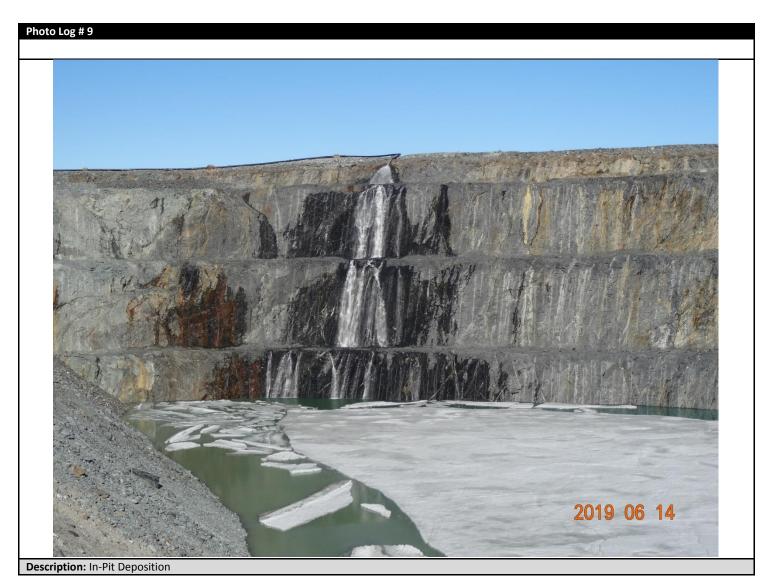
During this inspection AEM was in the progress of using the in-pit disposal authorization to deposit water that was seeping through the Central Dyke into a ditch and pumping it to the Goose Pit (see photos 9). There were no concerns regarding the deposition of waste at this time.

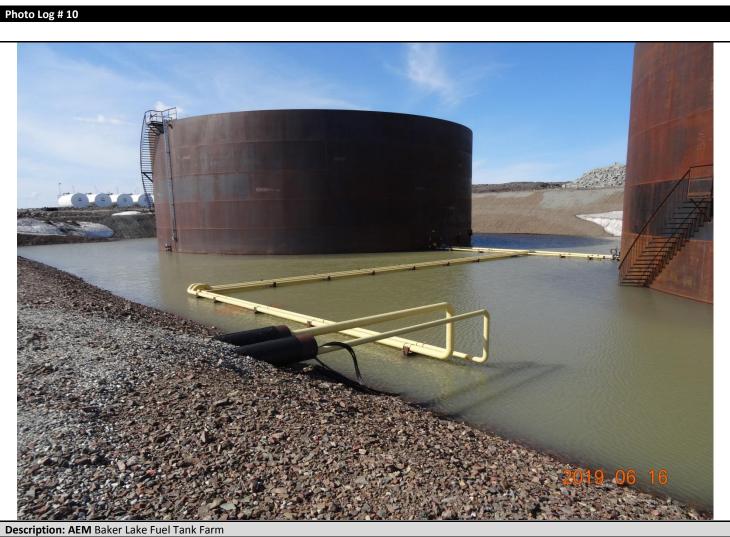
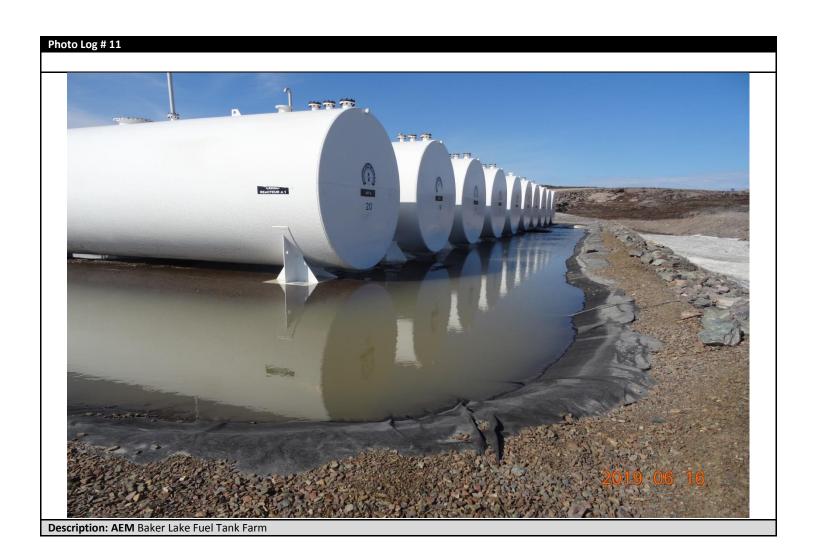
During the inspection the inspector noted approximately 300m³ of water within the berms. The tanks appeared to be mostly empty with one mostly full remaining tank of diesel (see photo 10 & 11), AEM has taken samples of the water and sent the collected samples to the laboratory in Winnipeg. Once Results return indicating the water meets the criteria of the licence and AEM is planning to discharge. There were no other concerns identified with this facility.
