WATER LICENCE INSPECTION FORM

| Agnico Eagle Mines Limited (AEM) | Martin Archambault |
| 2AM-MEA1526 | Environmental Coordinator |
| June 14 <sup>th</sup> -17 <sup>th</sup> 2019 | Jeremy Fraser |

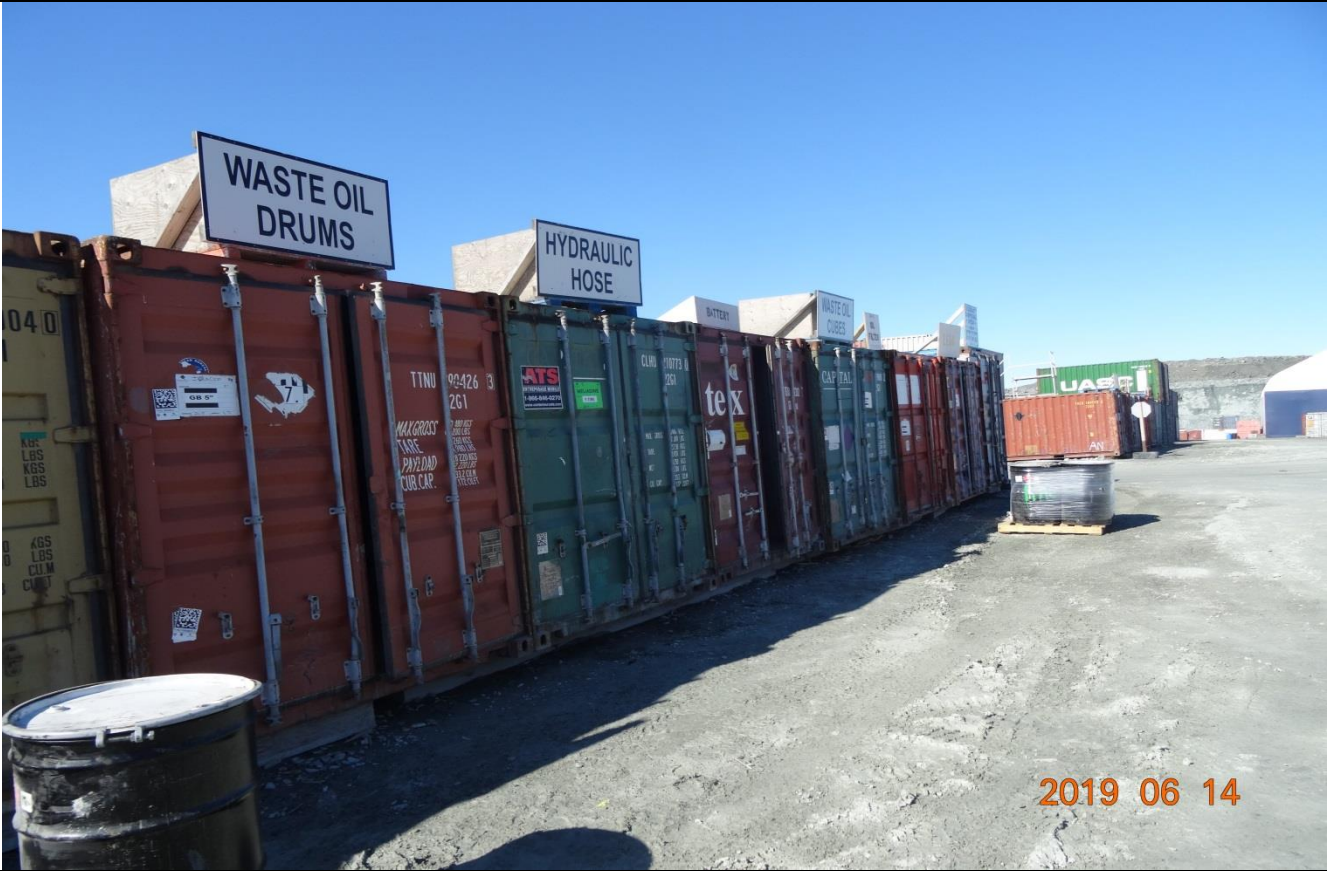
| Date | Camera | Inspector | Authorization |
|---|---|---|---|
| Photo #1 | | N | W |

AEM is currently segregating all Hazardous Waste into multiple sea cans separating items such as batteries, waste oils, used rags etc. and shipping generated waste off site as a requirement of the license *Part F Item 16 & 17. (see photo 1,2 &3)*. AEM has addressed concerns regarding this area identified in the previous inspection dated April 8th 2019.

| Date | Camera | Inspector | Authorization |
|---|---|---|---|
| Description: hazardous waste storage area | | | |

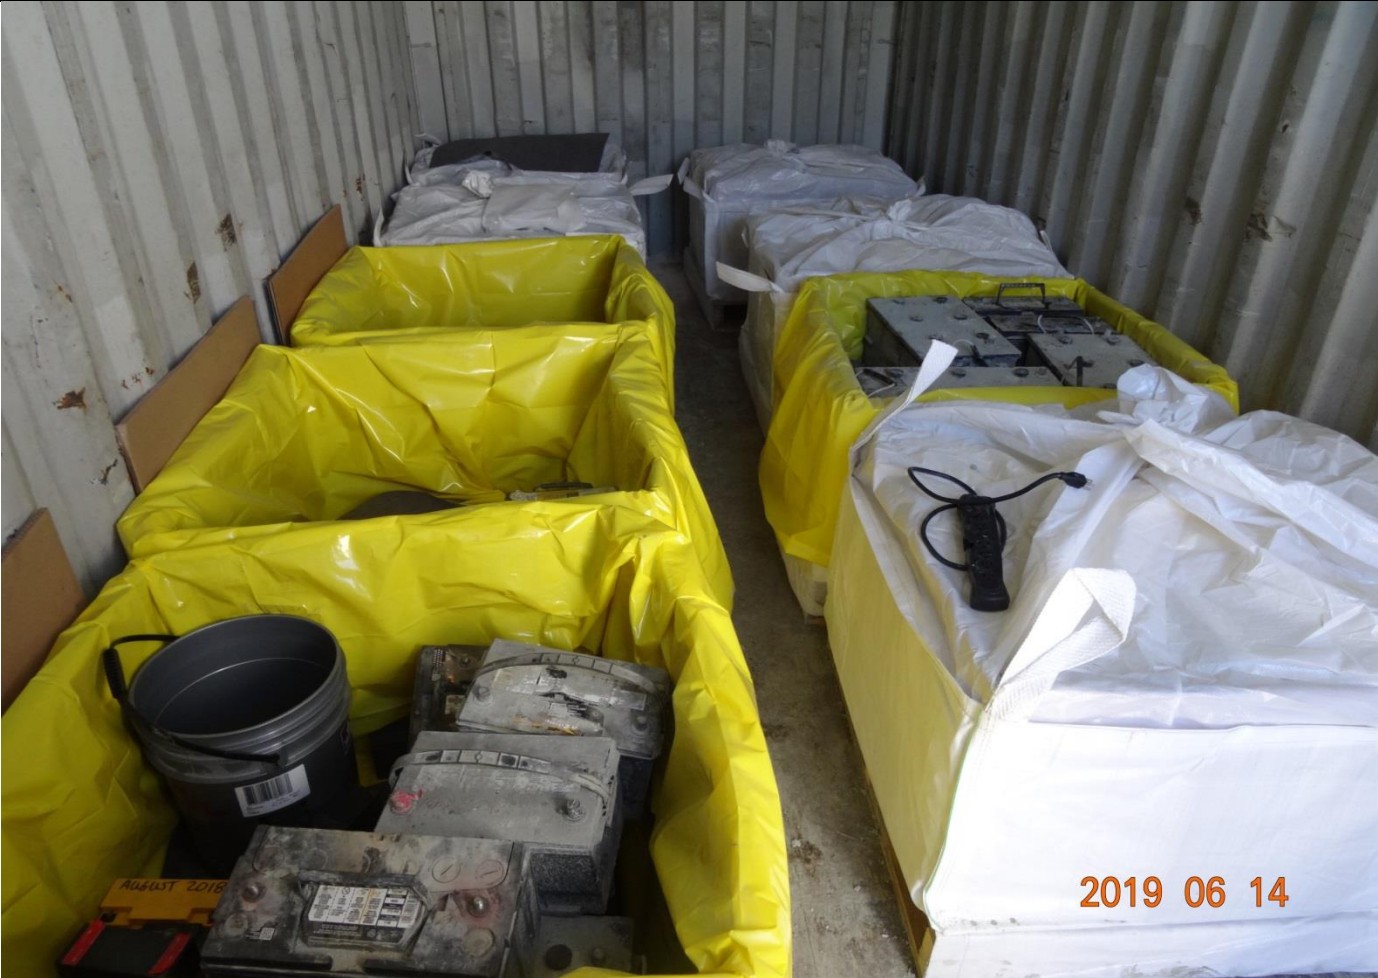
Photo #2

Description: battery bins within hazardous waste containers

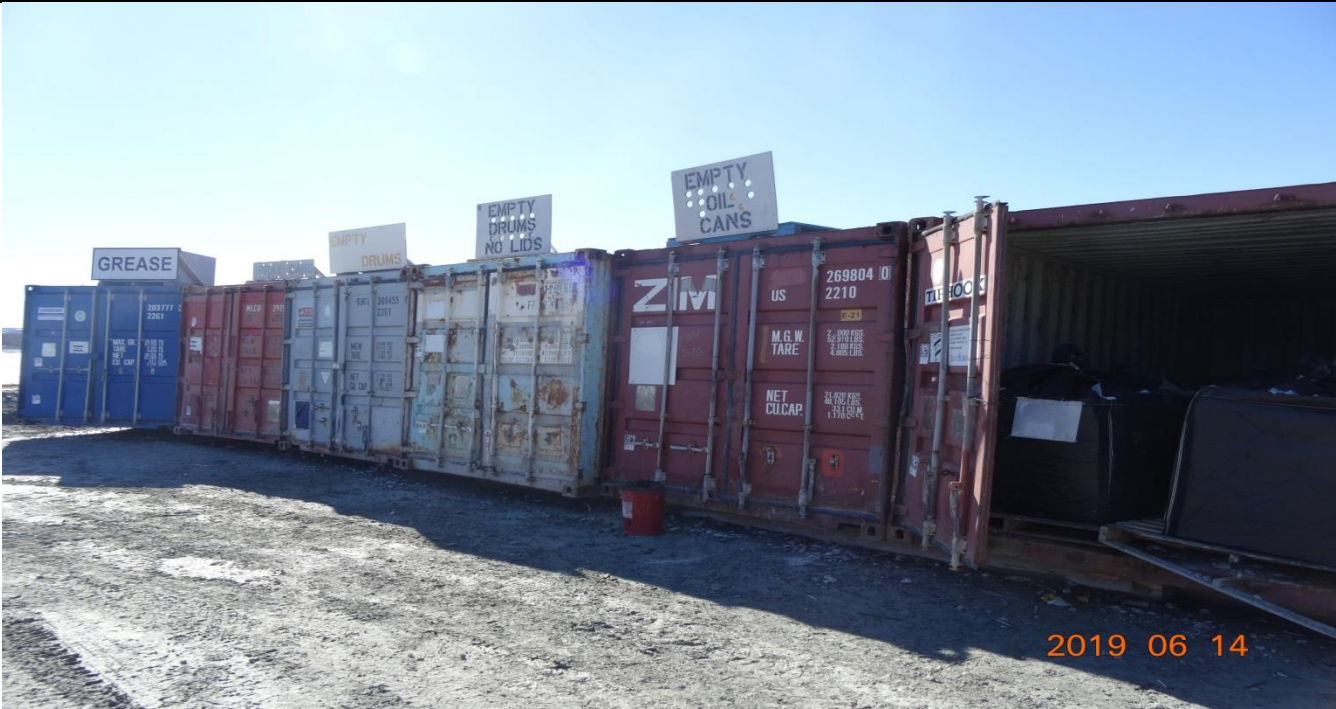
Photo #3

Description: hazardous waste material storage area

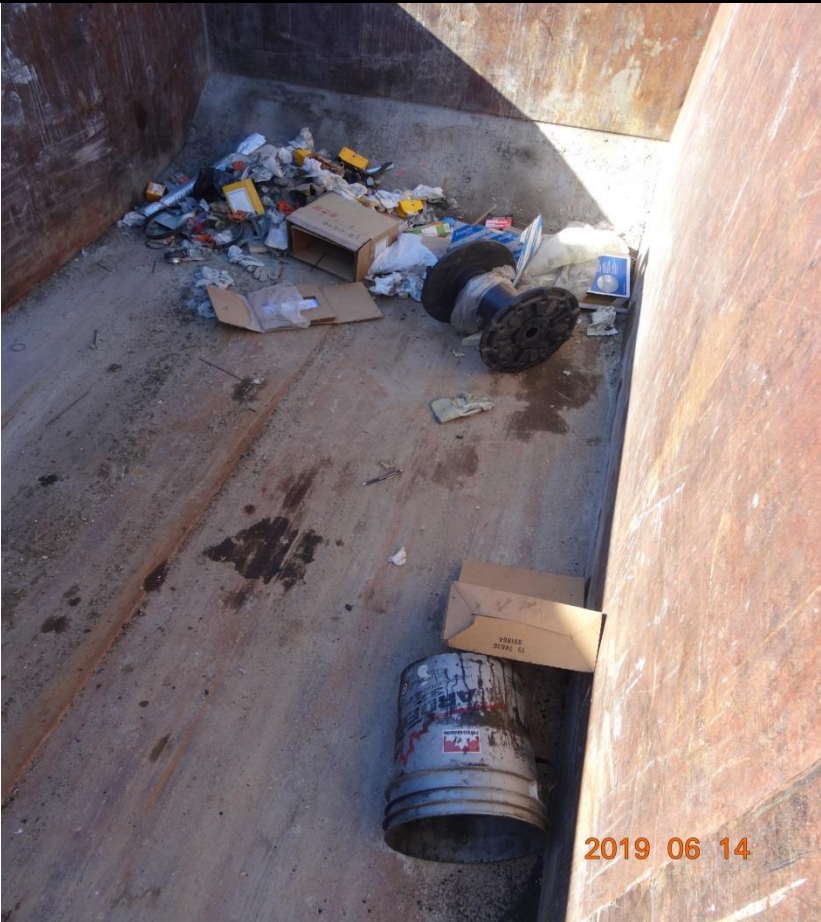
Photo #4

It was noted that some minor concerns regarding the disposal of waste generated within the contractor’s laydown (*see photo 4*). The inspector identified used lubrication pales and used oil rags have been disposed of in a garbage bin not marked for hazardous material. When the inspector questioned the final destination of the garbage bin the inspector was informed it was to be put in the landfill. The inspector verbally ordered AEM staff to remove all hazardous material prior to landfill disposal.

Description: used oil rags and oily bucket found within garbage bins on FGL contractors site

- The inspector is requesting that AEM remove all hazardous material from garbage bins prior to being deposited to the Landfill.

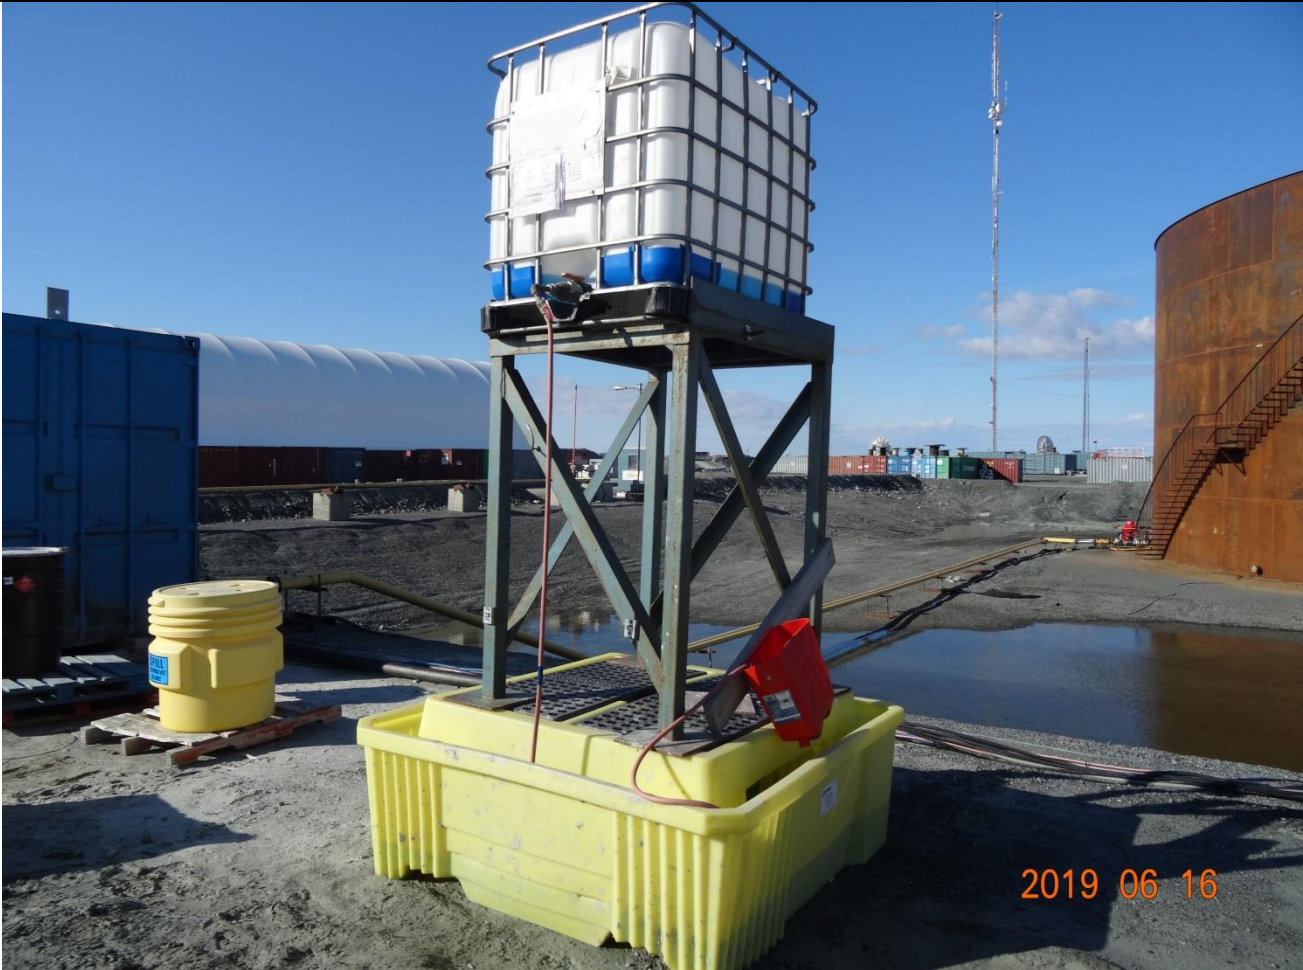
Photo #5

AEM has addressed concerns from the previous inspection in regards to this facility. Adequate secondary containment has been put in place to capture any residual liquids within this facility (*see photo 5*). The inspector noted some water within the single tank farm (*see photo 6*); AEM has sampled the water and results indicate the water meets discharge requirements set by the NWB regarding the Licence 2AM-MEA1526 *Part F Item 9* . No concerns regarding this facility.

Description: adequate secondary containment installed at fuelling station

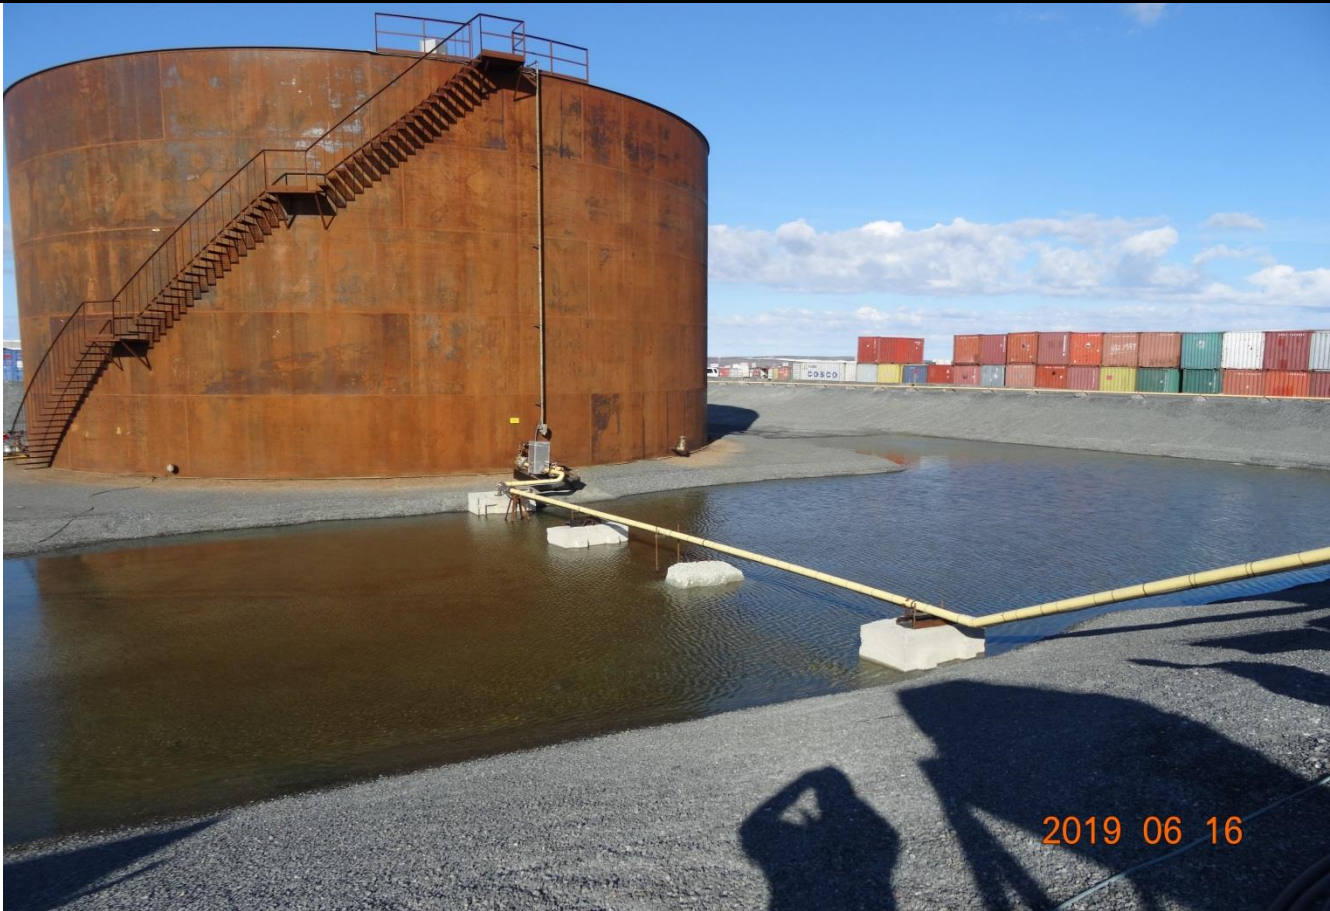
Photo #6

Description: single tank farm at Meadowbank site

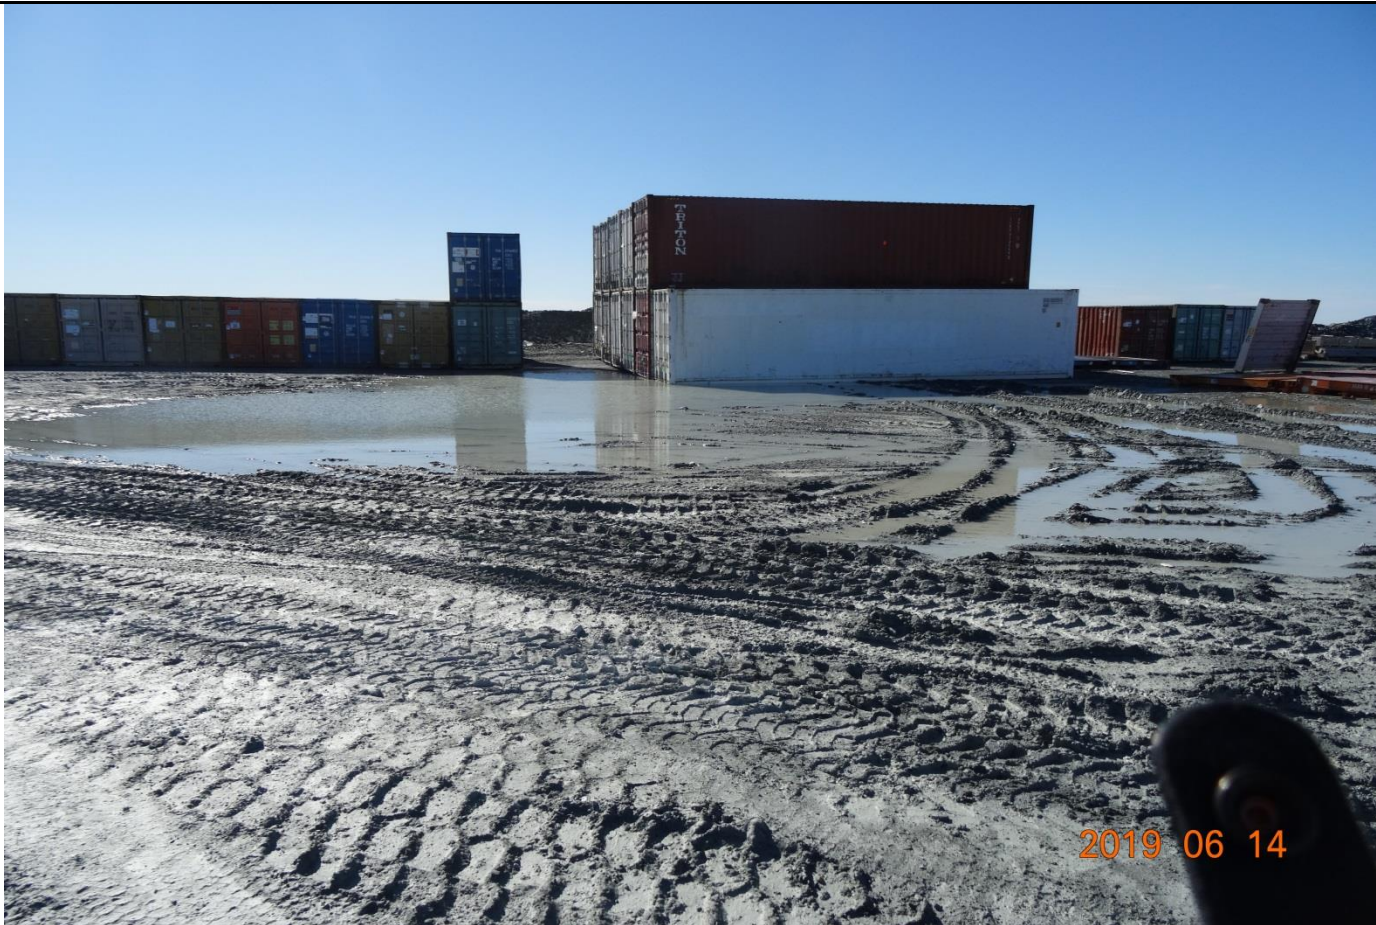
Photo #7

During the inspection of this facility it was noted that some pooling of water in what appears to be a low spot beneath a sea can on the pad. The sea can was labelled “super Heavy” and locked at this time; the inspector was unable to determine what is stored in the sea can (*see photo 7*). After further review of information provided by AEM it was determined that the container is housing dry goods only and no chemical products. No concerns were identified

Description: Sea cans in water AEM addressed concerns of contents

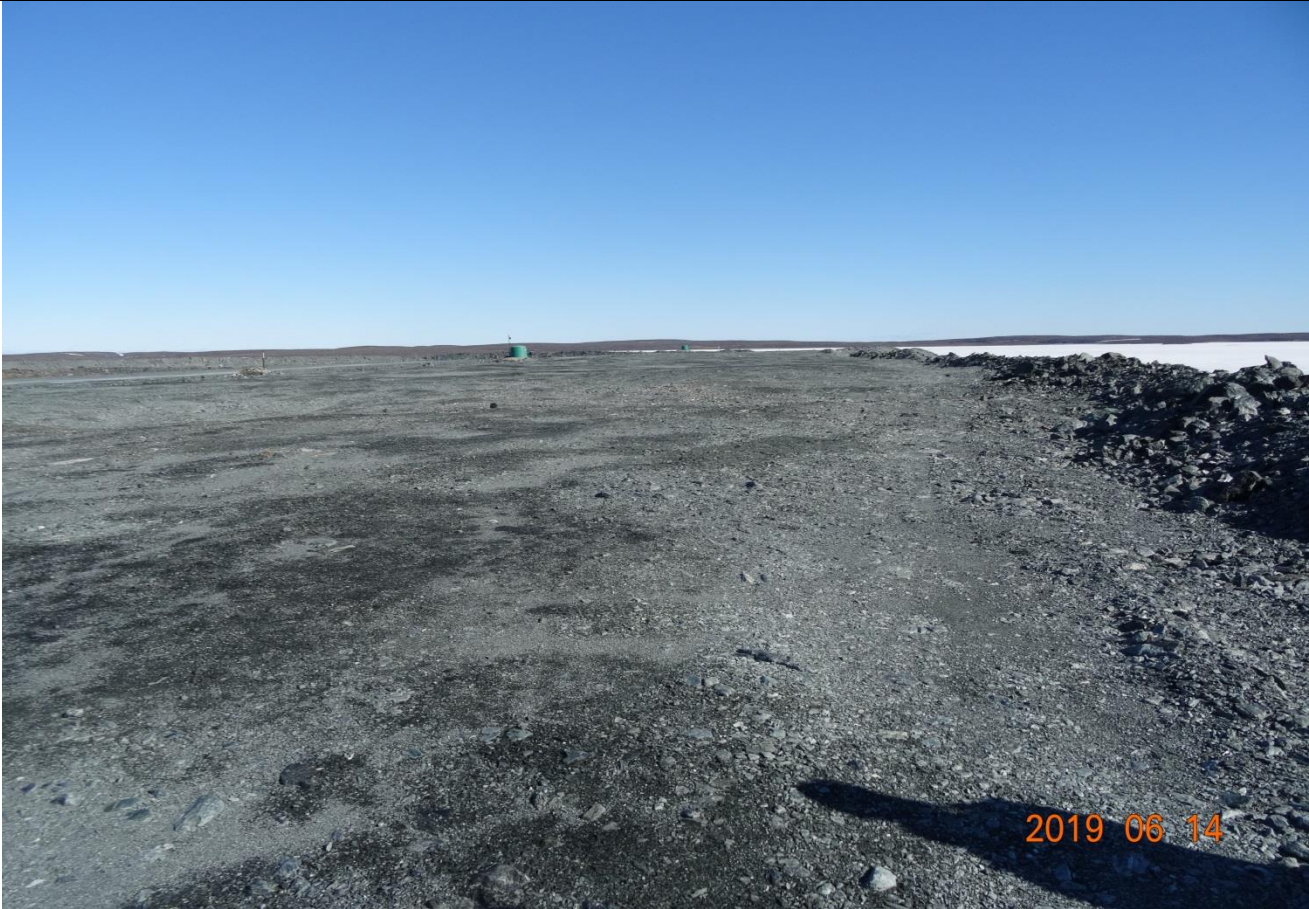
Photo #8

It was noted that the East Dyke appears to be operating as intended. AEM is continuing monitoring occurring with data collecting instrumentation including temperature sensors and piezometers installed within the dyke (see photo 8). There were no concerns identified regarding this structure.

Description: Meadowbank East Dyke; instrument housing in the background

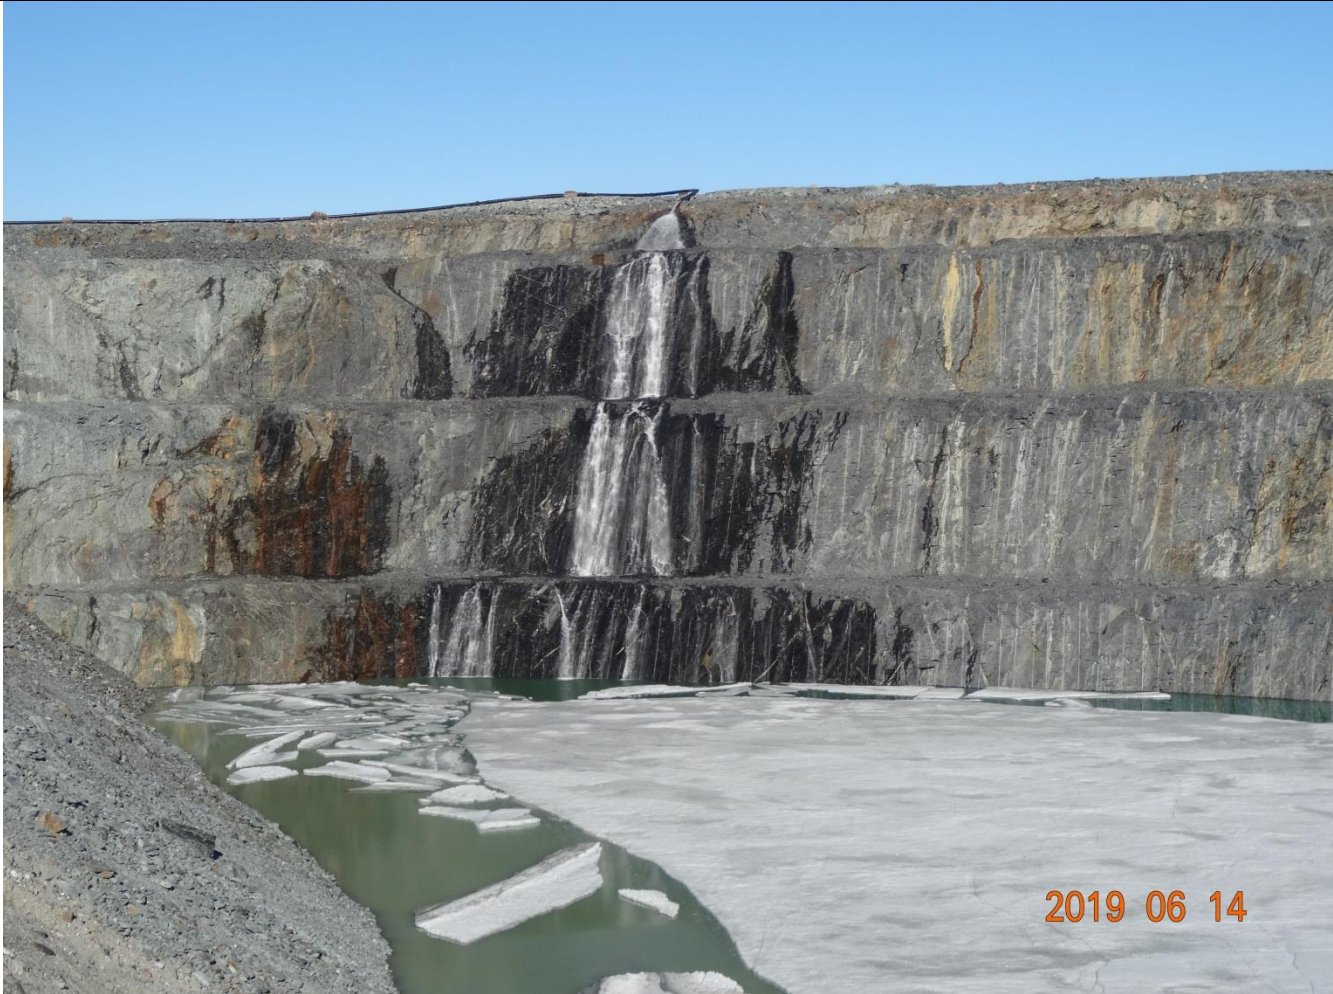
Photo #9

During this inspection AEM was in the progress of using the in-pit disposal authorization to deposit water that was seeping through the Central Dyke into a ditch and pumping it to the Goose Pit (see photos 9). There were no concerns regarding the deposition of waste at this time.

Description: In-Pit Deposition

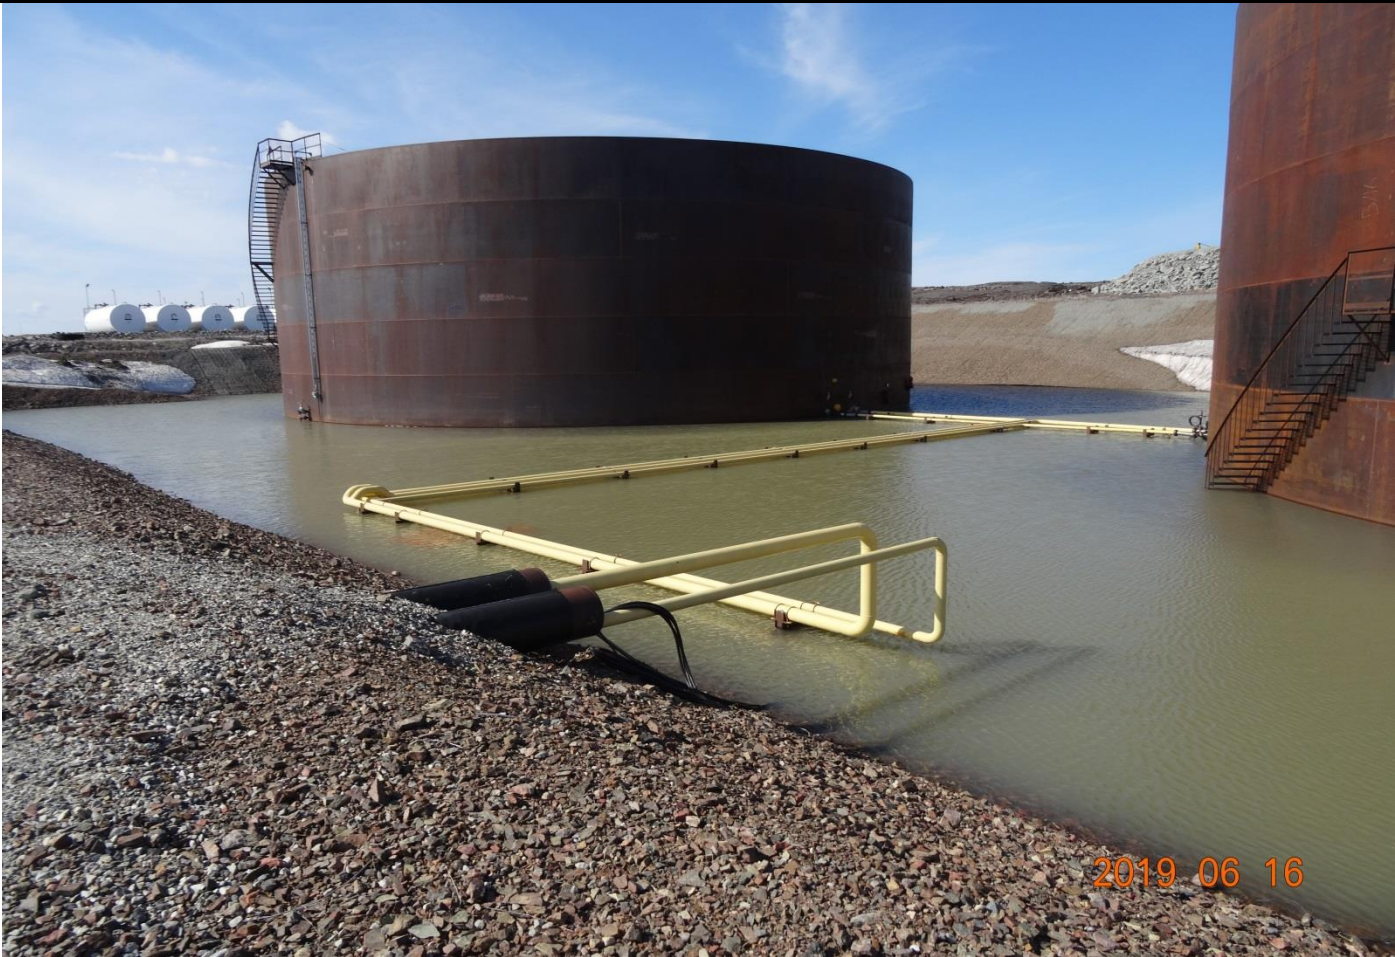
Photo #10

During the inspection the inspector noted approximately 300m<sup>3</sup> of water within the berms. The tanks appeared to be mostly empty with one mostly full remaining tank of diesel (see photo 10 & 11), AEM has taken samples of the water and sent the collected samples to the laboratory in Winnipeg. Once Results return indicating the water meets the criteria of the licence and AEM is planning to discharge. There were no other concerns identified with this facility.

Description: AEM Baker Lake Fuel Tank Farm

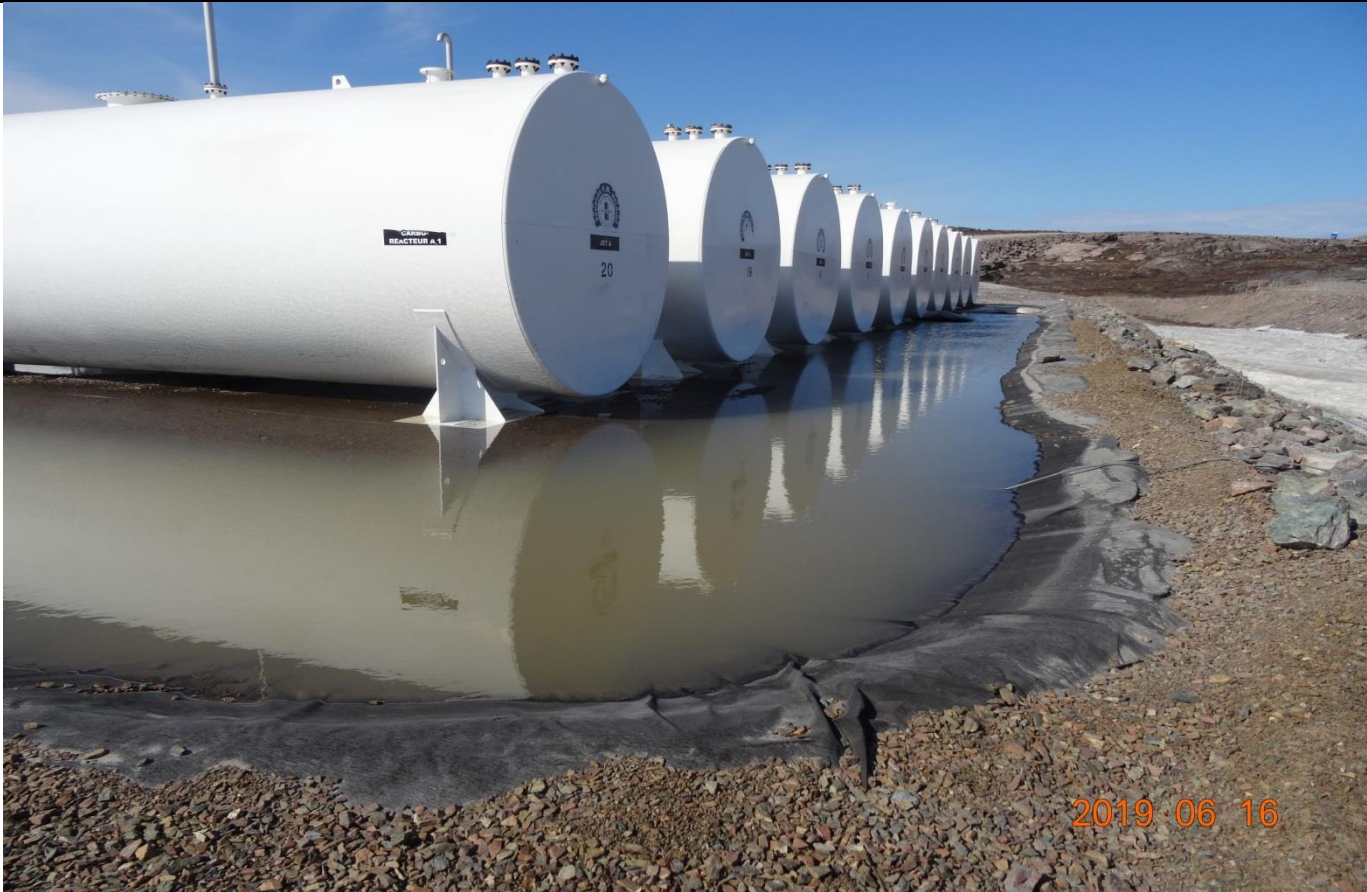
Photo #11

Description: AEM Baker Lake Fuel Tank Farm
