November 12, 2013

RE: RESPONSE TO WATER USE INSPECTION REPORT – DATED JULY 29th-30th, 2013 – LIC#: 2AM-

MEA0816

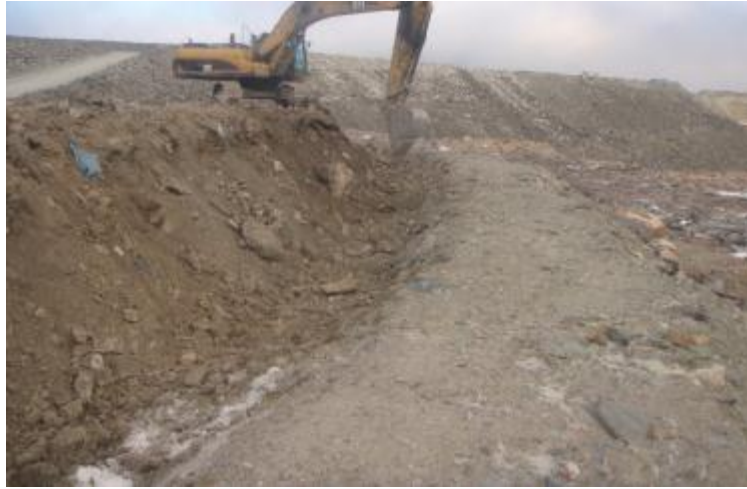
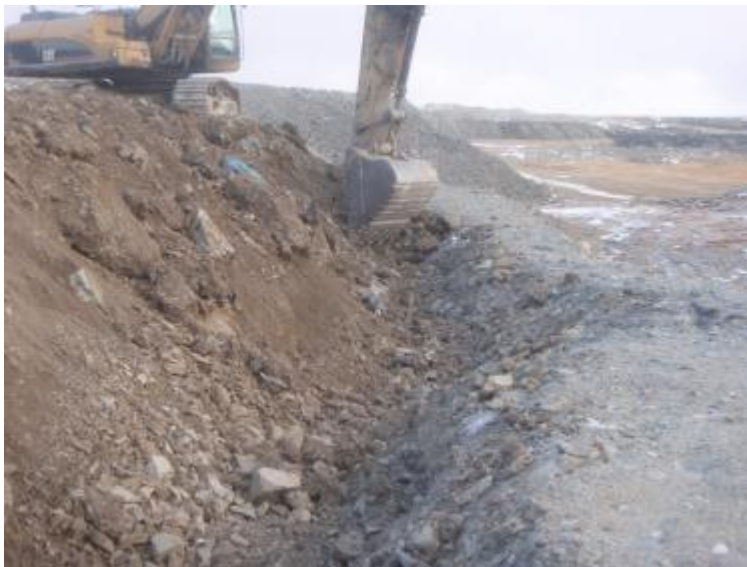
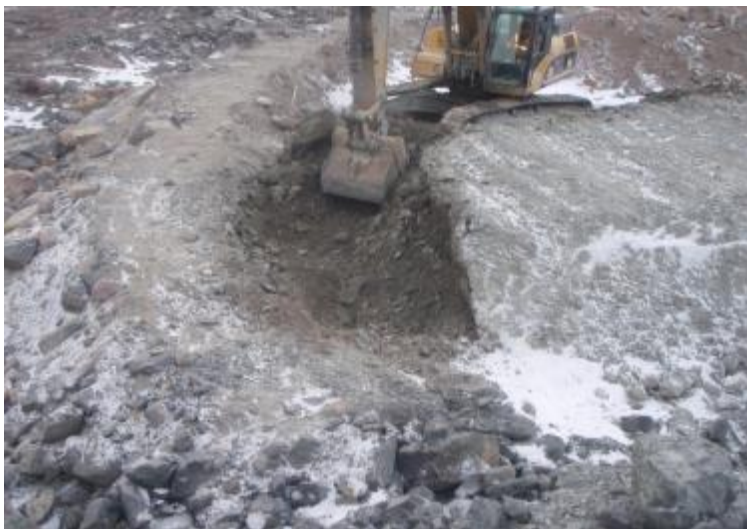
- ***Contaminated soil piled against the rear wall of the landfarm containment berm. AEM has committed to pushing the piles back once the rear pile is aerated. This is an ongoing concern from inspections conducted in 2012, specifically with regards to the containment of contaminated water.***

On October 18th the edges of the contaminated soil piles within the Landfarm were moved to allow for accumulation of potential run off water. Please see pictures below. This was preformed around the entire edge not just the pile against the rear wall. As a result any water collected will be diverted to the landfarm floor. As per our Landfarm Management Plan this water is sampled and would be pumped to the Tailings Facility (if necessary at freshet – in 2012 it was not necessary to pump any water out).

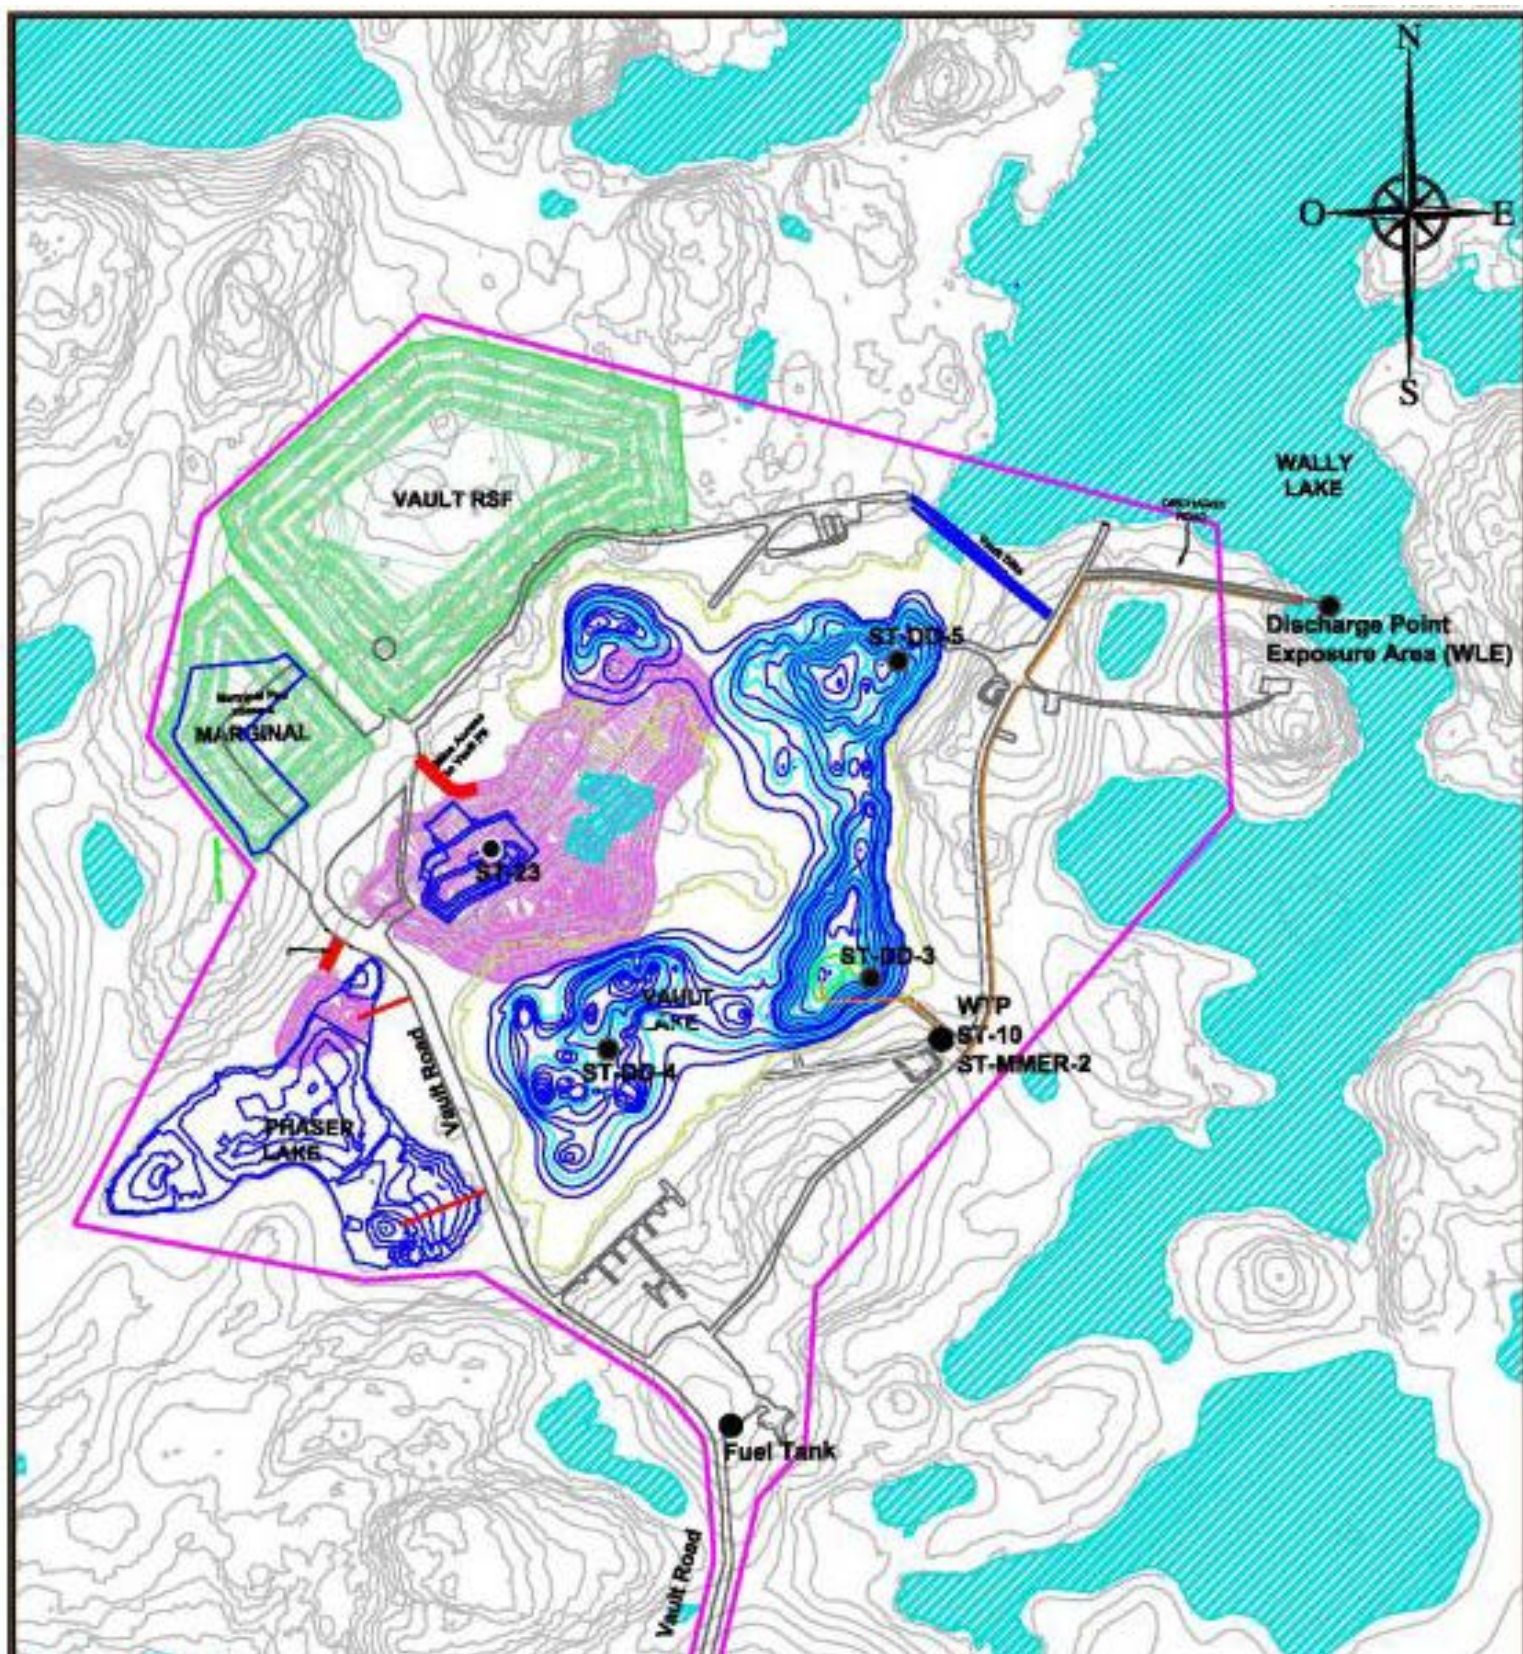
- *Waste rock is being sorted and deposited at the vault waste rock storage facility. The Inspector requested a map detailing the proposed monitoring locations within the Vault deposit area.*

Please find the following map depicting the monitoring locations within the Vault area.

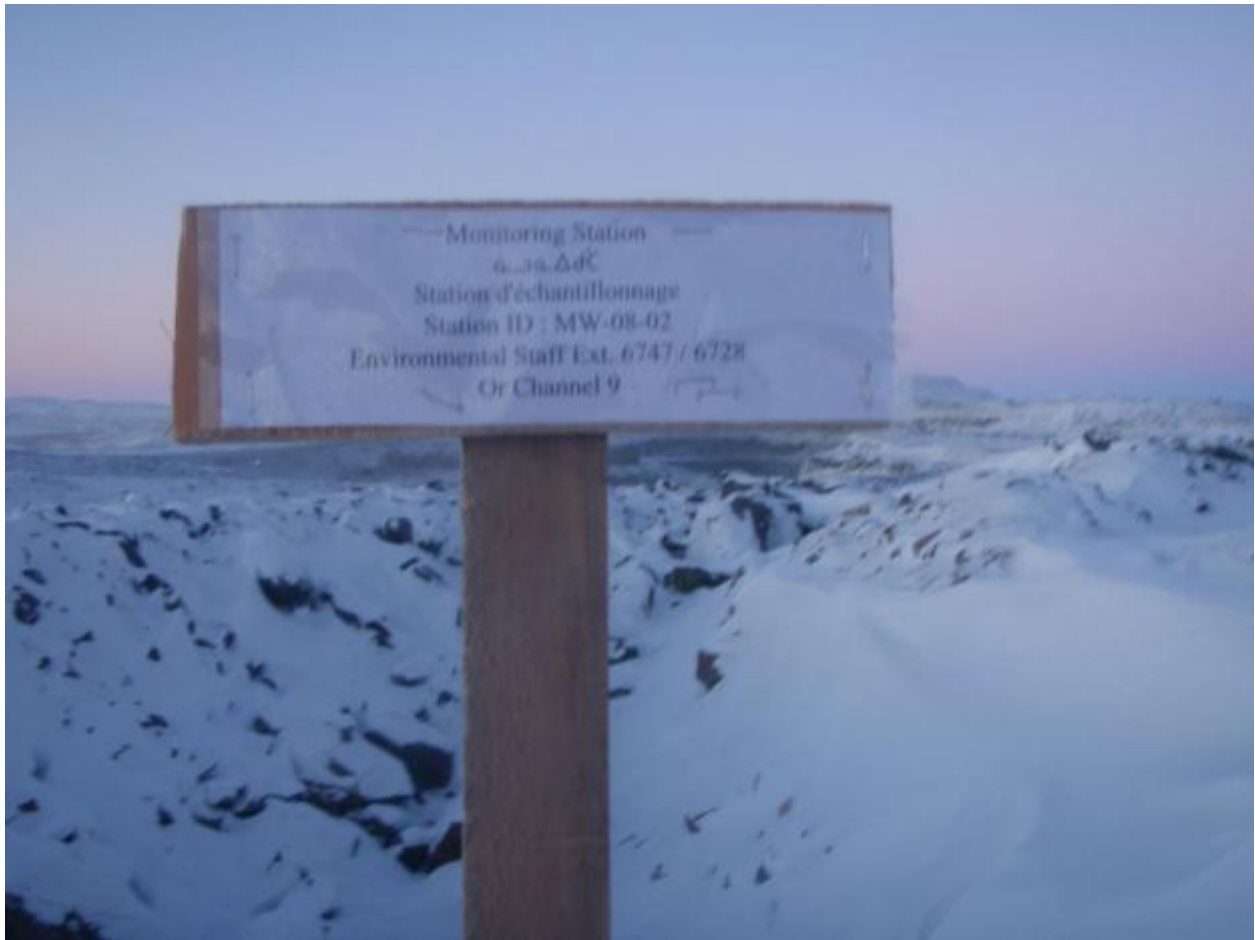
MW-08-02

- Sampling locations are lacking signage. This is ongoing from previous years. All sampling location will be fitted with signage before the November 1st, 2013. These locations will be photographed and logged for sampling consistency purposes and submitted to the Inspector before June 15, 2014.***

As discussed with the inspector all signs had been erected in the fall of 2012 and the particular location in which the inspector had not seen a sign was due to the increase in water of the area during the freshet.

All monitoring stations do have appropriate signage. Please find the attached pictures.

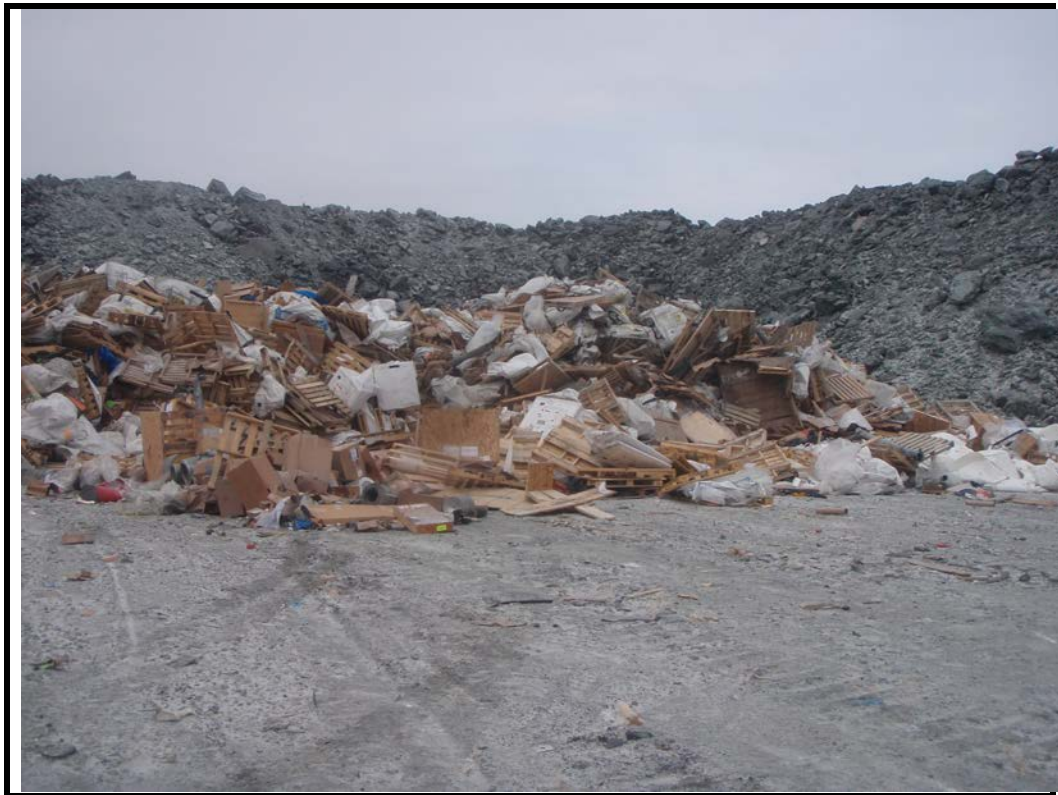
Picture 1: Landfill

Comments: Very windy the day of the inspection, some debris were flying but not going out of the landfill as the rockfill berm were about 10 meters high.
We need the amount of waste transfer to the landfill for the month of September

Recommendations: Make sure to keep track of every load going in the landfill and to send the month end report to the environment department
