WATER LICENCE INSPECTION FORM

Licensee		Licensee Representative	
Agnico Eagle Gold Mines Limited		Erika Voyer	
Licence No. / Expiry		Representative Title	
2AM-MEA0815/ November 27 <sup>th</sup> , 2015		Environmental Coordinator	
Land Authorization No.		Land Authorization Expiry	
66A/8-71-2, AWPAP		66A/8-72-2 Quarrying lease	
Date of Inspection		Inspector	
July 24 <sup>th</sup> , 2015		WRO Wilson	
Activities Inspected			
<input checked="" type="checkbox"/> Camp	<input checked="" type="checkbox"/> Water Management	<input checked="" type="checkbox"/> Mining	<input checked="" type="checkbox"/> Construction
<input checked="" type="checkbox"/> Roads/Hauling	<input checked="" type="checkbox"/> Other: Water Discharge	<input checked="" type="checkbox"/> Other: Spills	<input checked="" type="checkbox"/> Reclamation
<input type="checkbox"/> Fuel Storage

Date:	Authorization Number:	Camera/Model:	Inspector
July 22nd, 2015	2AM-MEA0815	Sony DSC-HX50V Cyber shot	WRO Wilson
Photo No.	Lat/Long (DD.MM.SS.SS, NAD83)		
Photo 1	NA

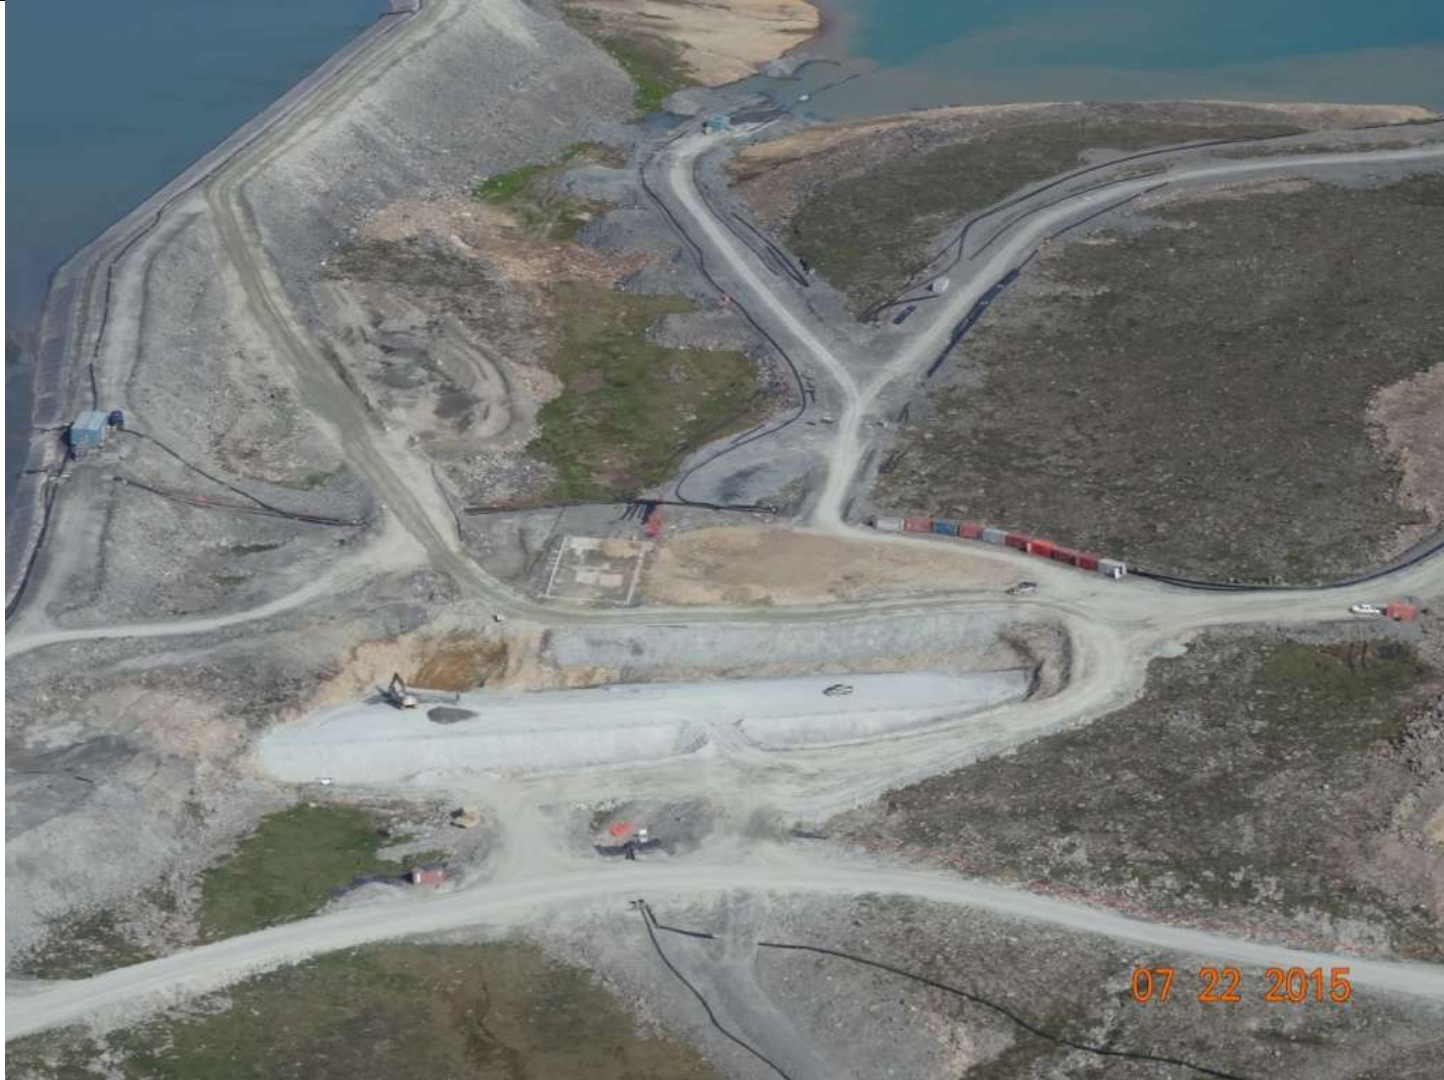
- 11. The construction of Saddle Dams 3 (photo 1), 4, and 5 have begun. Saddle Dam 3 will be brought up to an elevation of 140m this year, while the first stages of excavation are taking place for the footing of Saddle Dam 4 and 5.
- 12. Central Dyke is being raised to 137m for 2015.

**Description:**  
Saddle Dam 3

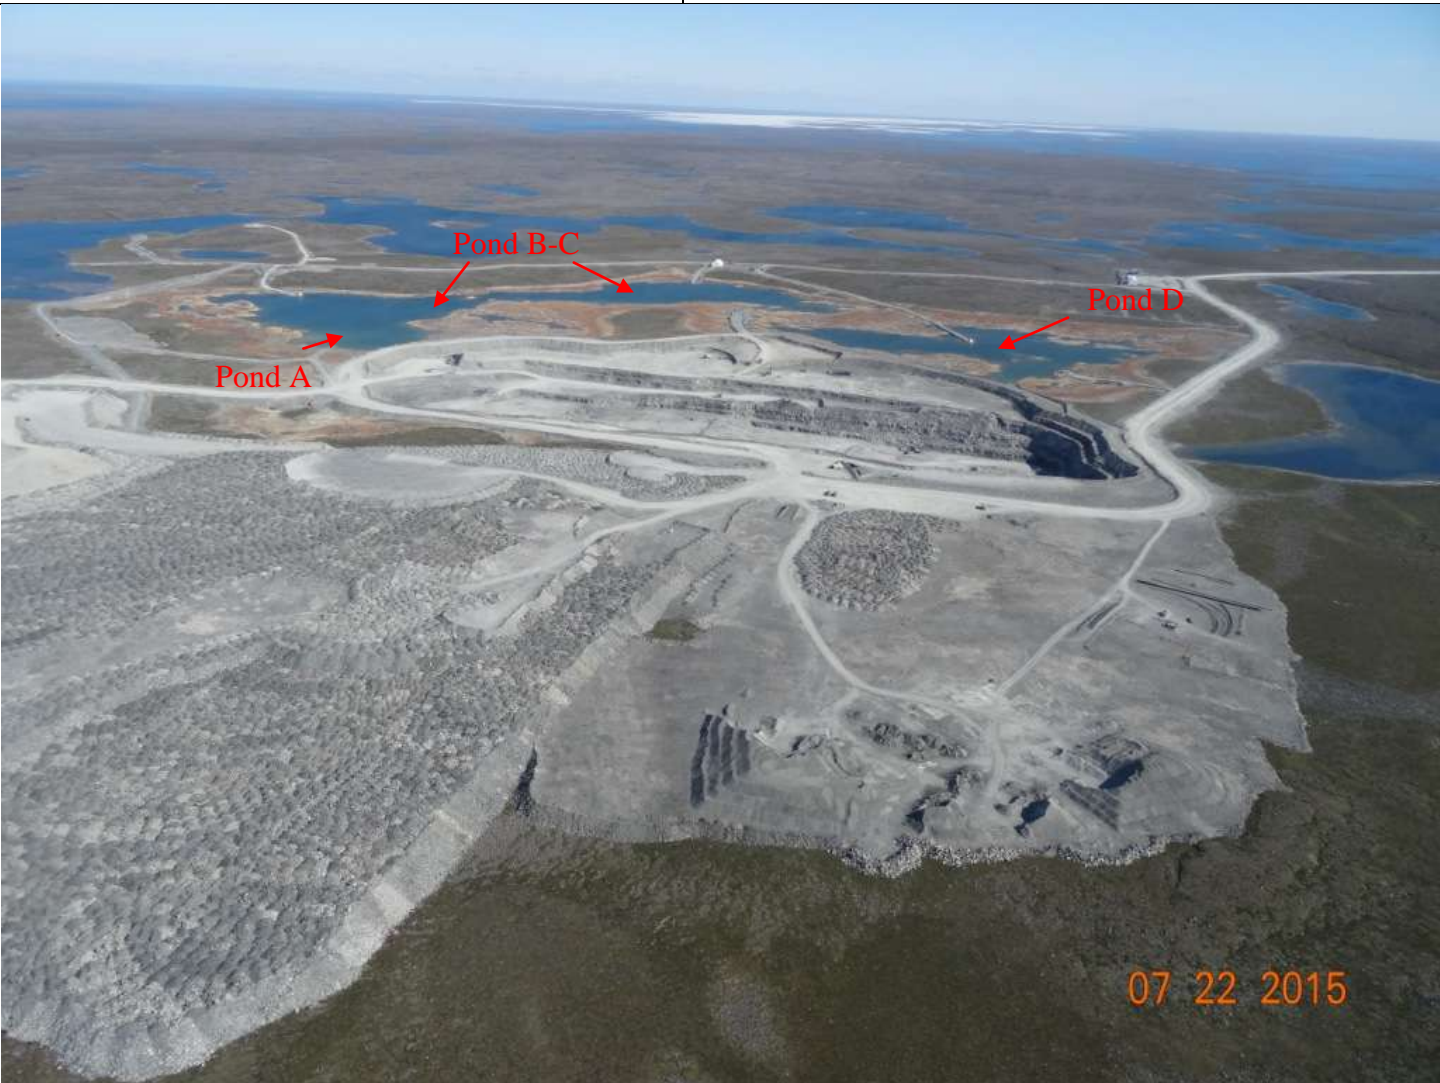
Photo No.  
Photo 4

- 7. As part of the Freshet Action Plan, snow is removed from the ST-16 area during the winter to minimize the surface run-off collected at freshet.
- 8. The Vault attenuation pond (VAP) is separated into four sections as the natural topography of the lake bottom allows. The sections are labelled by AEML as ponds “A” through “D” (photo 4). Pond D is non-connective with the other ponds, thus water is pumped from D to B-C ponds through conveyance lines. Monitoring station ST-25 is located in Pond D. A sample was collected at ST-25 by the Inspector.

Vault Waste Rock Pile, Vault Pit, Vault Attenuation Pond (Pond A,B-C and D labelled)

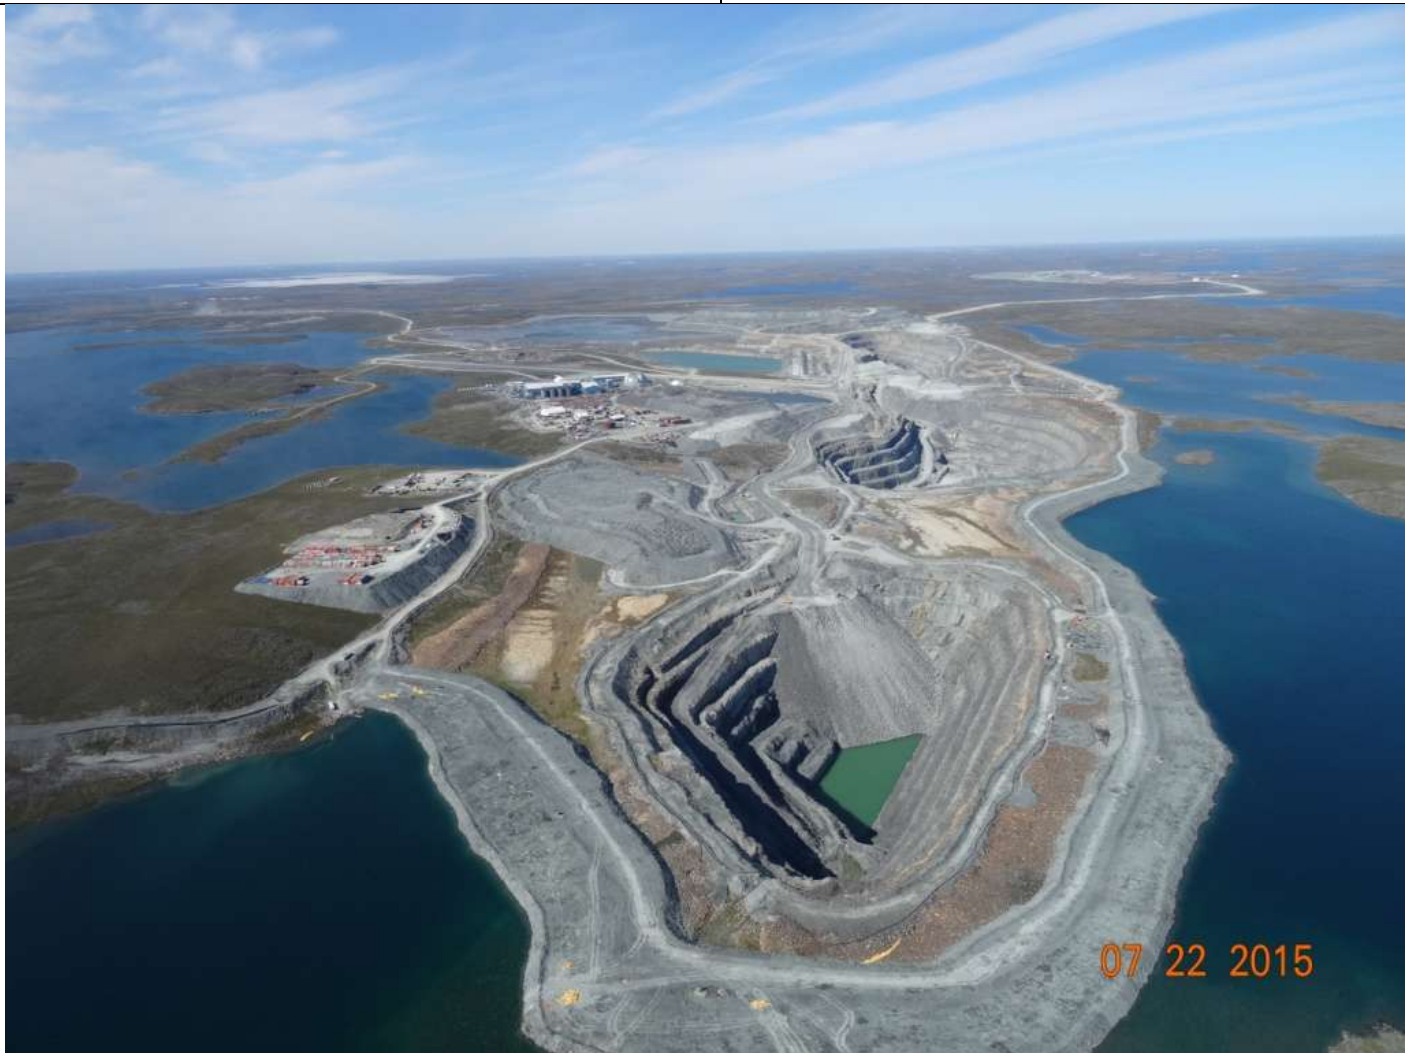
Photo No.	Lat/Long (DD.MM.SS.SS, NAD83)
Photo 5	NA

- 14. Progressive reclamation continues at Bay Goose Pit (photo 5). The pit was noted, during the July 22<sup>nd</sup>, 2015 fly over, to contain a large amount of water. AEML advised this water is surface run-off.

<b>Description:</b> Bay goose pit looking North
--

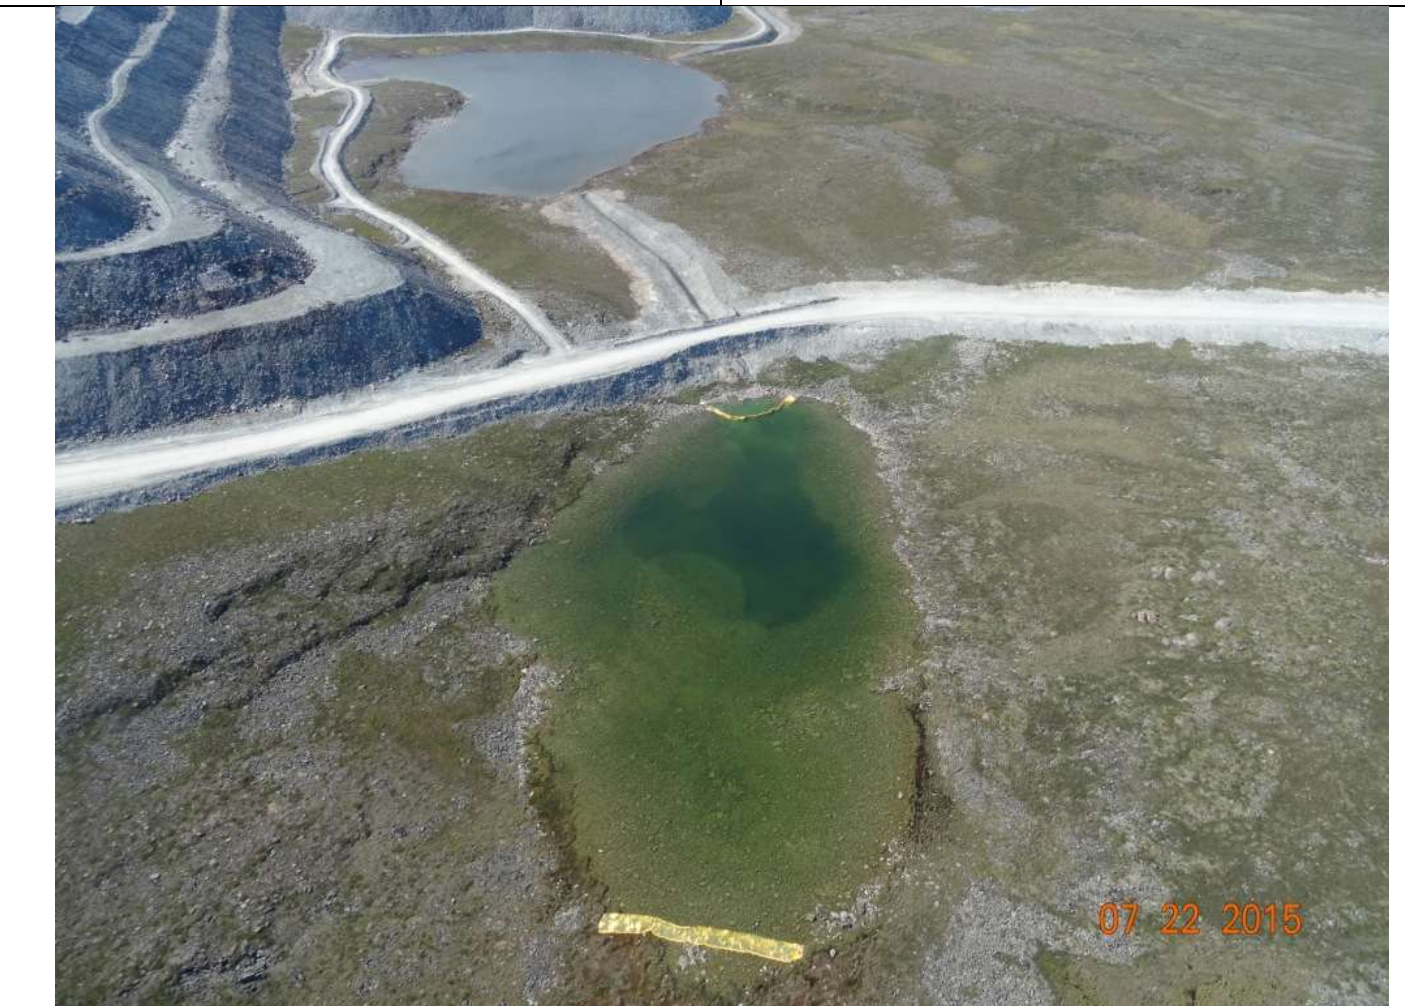
Photo No.	Lat/Long (DD.MM.SS.SS, NAD83)
Photo 6	NA

<b>Description:</b> Silt curtains in Np-1 with Vault road in the mid ground and NP-2 Lake in the background.
---
