August 25th, 2015

**Re: 2AM-MEA0815: Agnico Eagle Mines Meadowbank Gold Project response to the
AANDC Water Licence Inspection Report dated July 24th, 2015**

The following information is provided in response to comments and recommendations made in your 2AM-MEA08515 Water Licence Inspection report dated July 24th, 2015.

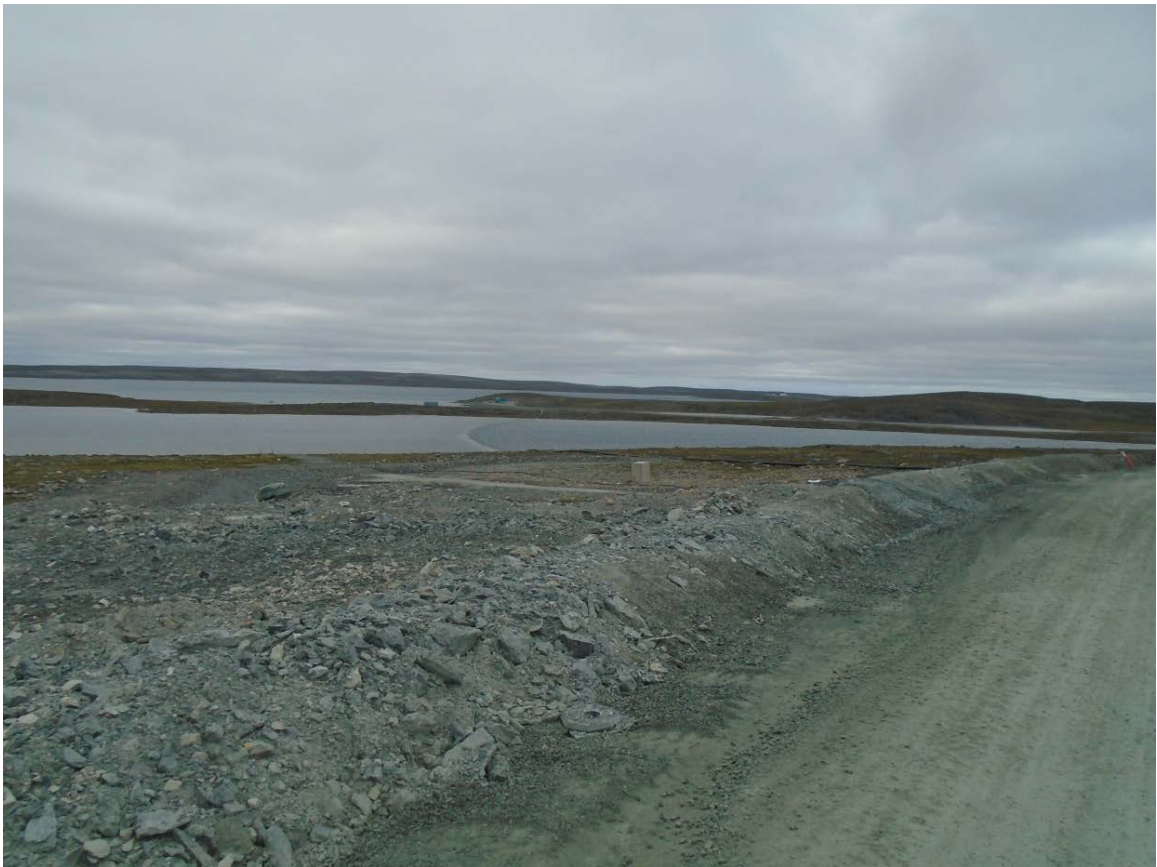
- 5- A section of the rock barrier has been removed near door A/cyanide destruction area of the Mill to allow for drainage of the road. The Inspector is concerned with possibility of contaminated water and the location of this drainage way as it is very near to Third Portage Lake.

Figure 1: Concerned section of the rock barrier berm that was refilled with material

AEM response: As of July 30, 2015, the area described by the Inspector was recapped (see Figure 1 below) and no additional sections of the rock barrier will be removed in the future. If AEM needs to remove, in the future, a section to allow for road drainage this will be done in a section where water can be collected by the Mill seepage Trench downstream (constructed as corrective measure for the Mill seepage). This will prevent any drainage water that may be contaminated from reaching Third Portage Lake.

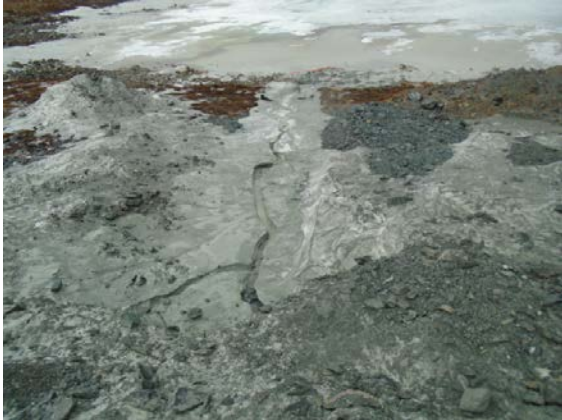
Date	Observation	Photo	
07/06/2015	More turbid due to mud, flow increased.

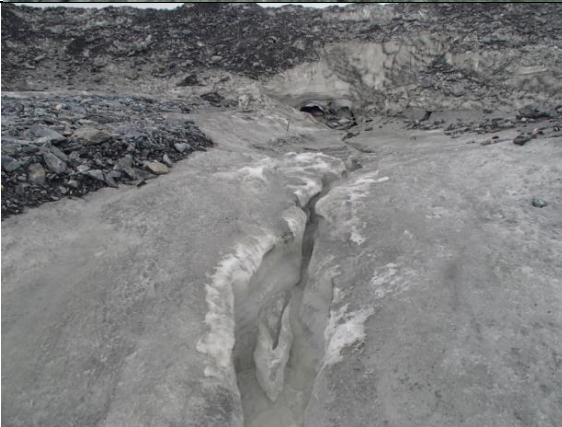
08/06/2015	Installation of Turbidity Barrier.
