WATER LICENCE INSPECTION FORM

Licensee		Licensee Representative	
Agnico Eagle Gold Mines Limited		Jeff Pratt, Environmental Coordinator	
Licence No. / Expiry		Representative Title	
2AM-MEA1525/ July 22 <sup>nd</sup> , 2025		Kevin Buck, Environment Superintendent	
Land Authorization No.		Land Authorization Expiry	
66A/8-71-2, AWPAP		66A/8-72-2 Quarrying lease	
Date of Inspection		Inspector	
October 21st, 2015		WRO Wilson	
Activities Inspected			
<input type="checkbox"/> Camp	<input checked="" type="checkbox"/> Water Management	<input checked="" type="checkbox"/> Mining	<input checked="" type="checkbox"/> Construction
<input type="checkbox"/> Roads/Hauling	<input checked="" type="checkbox"/> Other: Water Discharge	<input checked="" type="checkbox"/> Other: Spills	<input checked="" type="checkbox"/> Reclamation
<input type="checkbox"/> Fuel Storage

PHOTO LOG

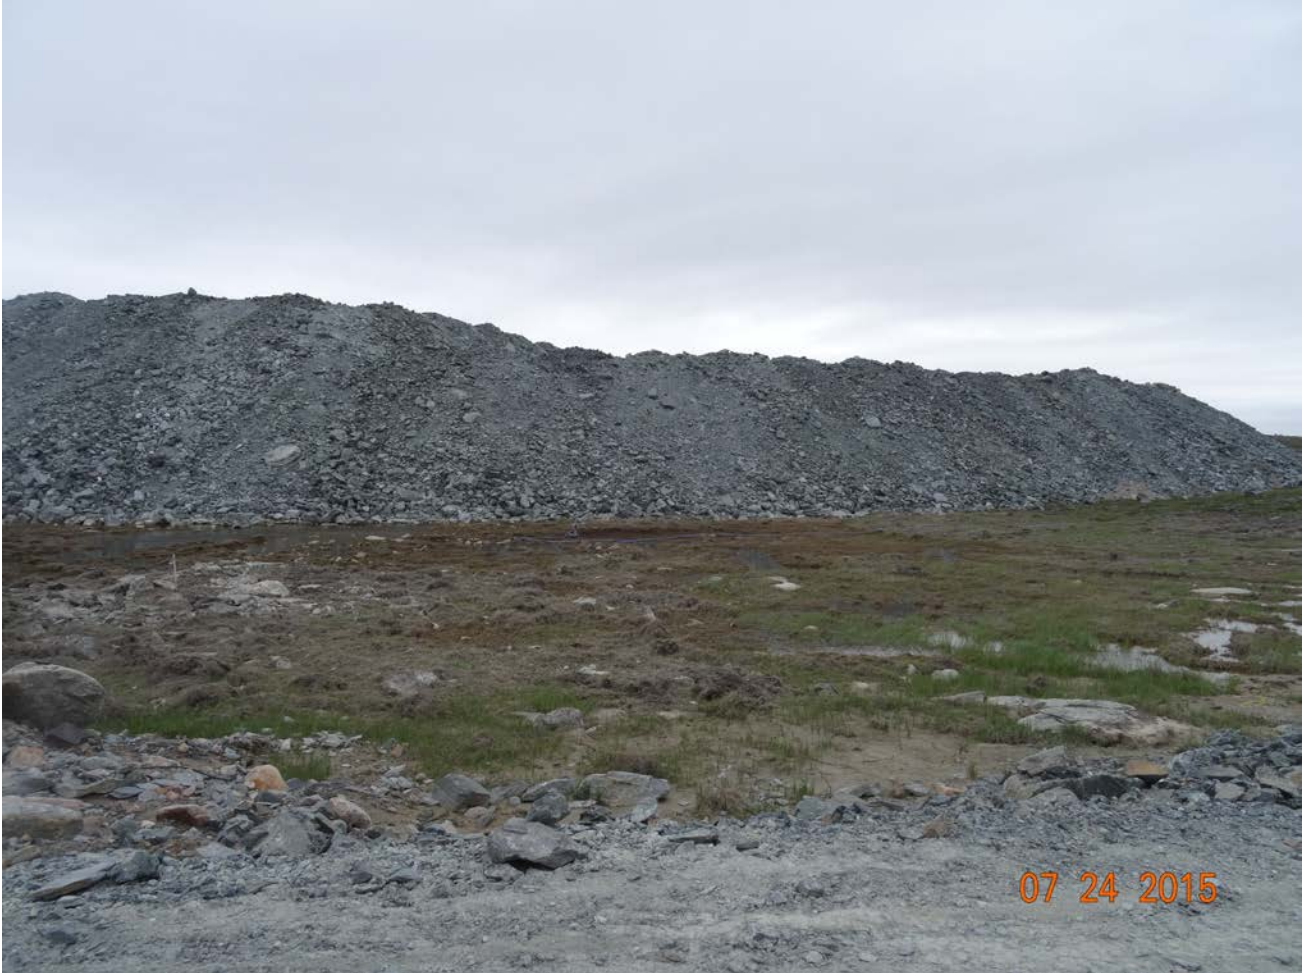
Date:	Authorization Number:	Camera/Model:	Inspector
October 21 <sup>st</sup> , 2015	2AM-MEA1525	Sony DSC-HX50V Cyber shot	WRO Wilson
Photo No.		Lat/Long (DD.MM.SS.SS, NAD83)	
Photo 1		N65° 2' 48.02", W96° 3' 37.87"

4. A small contact water collection pond (approximate location N65° 2’ 47.464”, W96° 3’ 40.342”) has been constructed at the North East side of the NPAG waste rock extension pile (WEP) of the Waste Rock Storage Facility (WRSF).

a. The inspector request more information about the WEP collection pond including the construction, samples of the waste water, quantity of waste water recovered and respective hazards ( see photo 1, 2 and 3).

**Description:**  
July 24<sup>th</sup>, 2015 Water accumulation at the NPAG Waste Rock Extention also referred to as WEP

- AEM shall provide to the inspector and the Nunavut Water Board with the information requested regarding the WEP before February 2016.

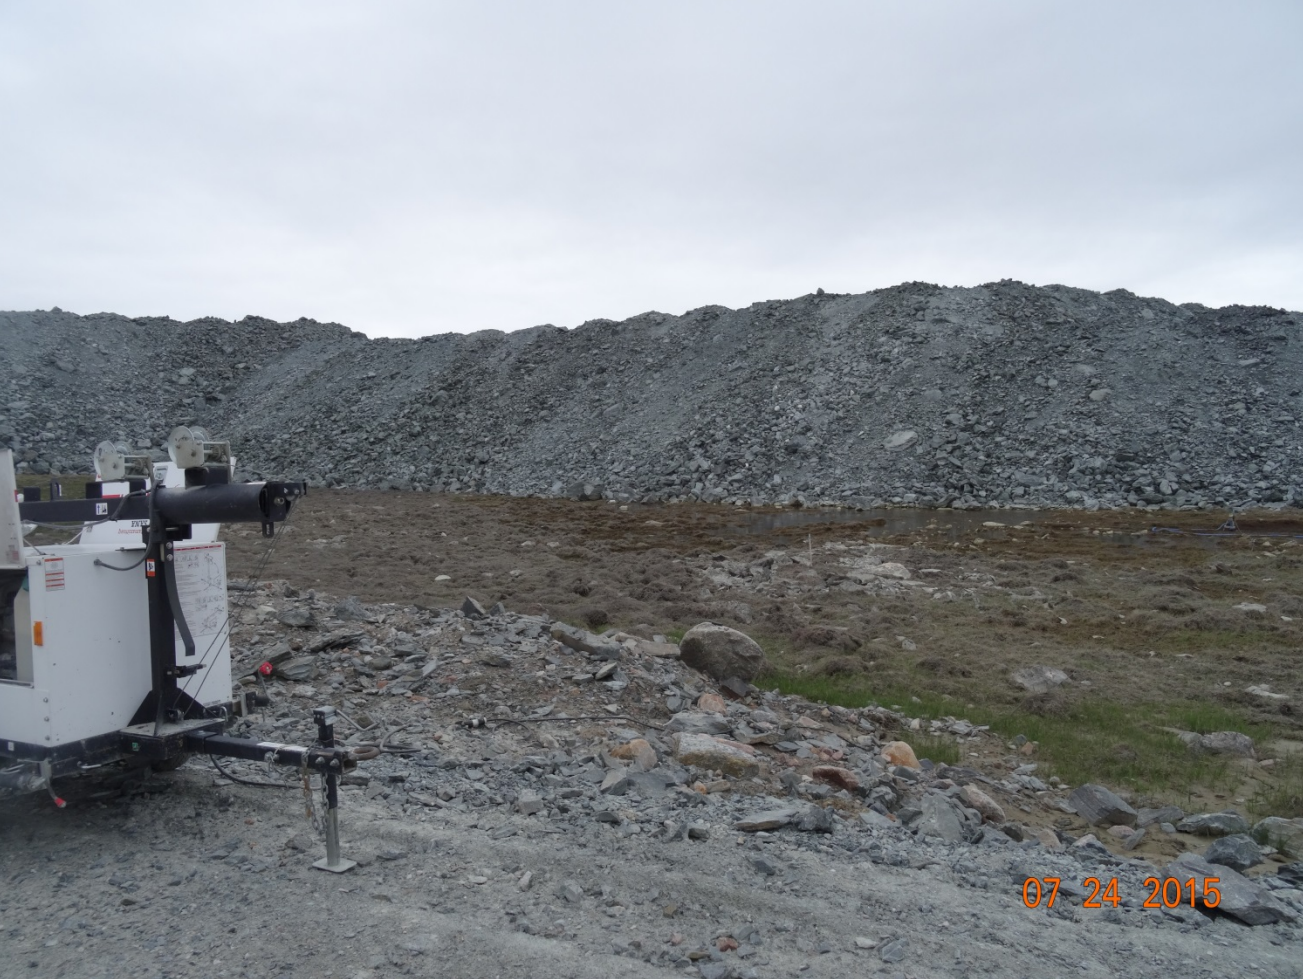
Locations name:	Lat/Long (DD.MM.SS.SS, NAD83)
Photo 2	N65° 2' 48.02", W96° 3' 37.87"

**Description:**  
July 24<sup>th</sup>, 2015 Water accumulation at the NPAG Waste Rock Extention

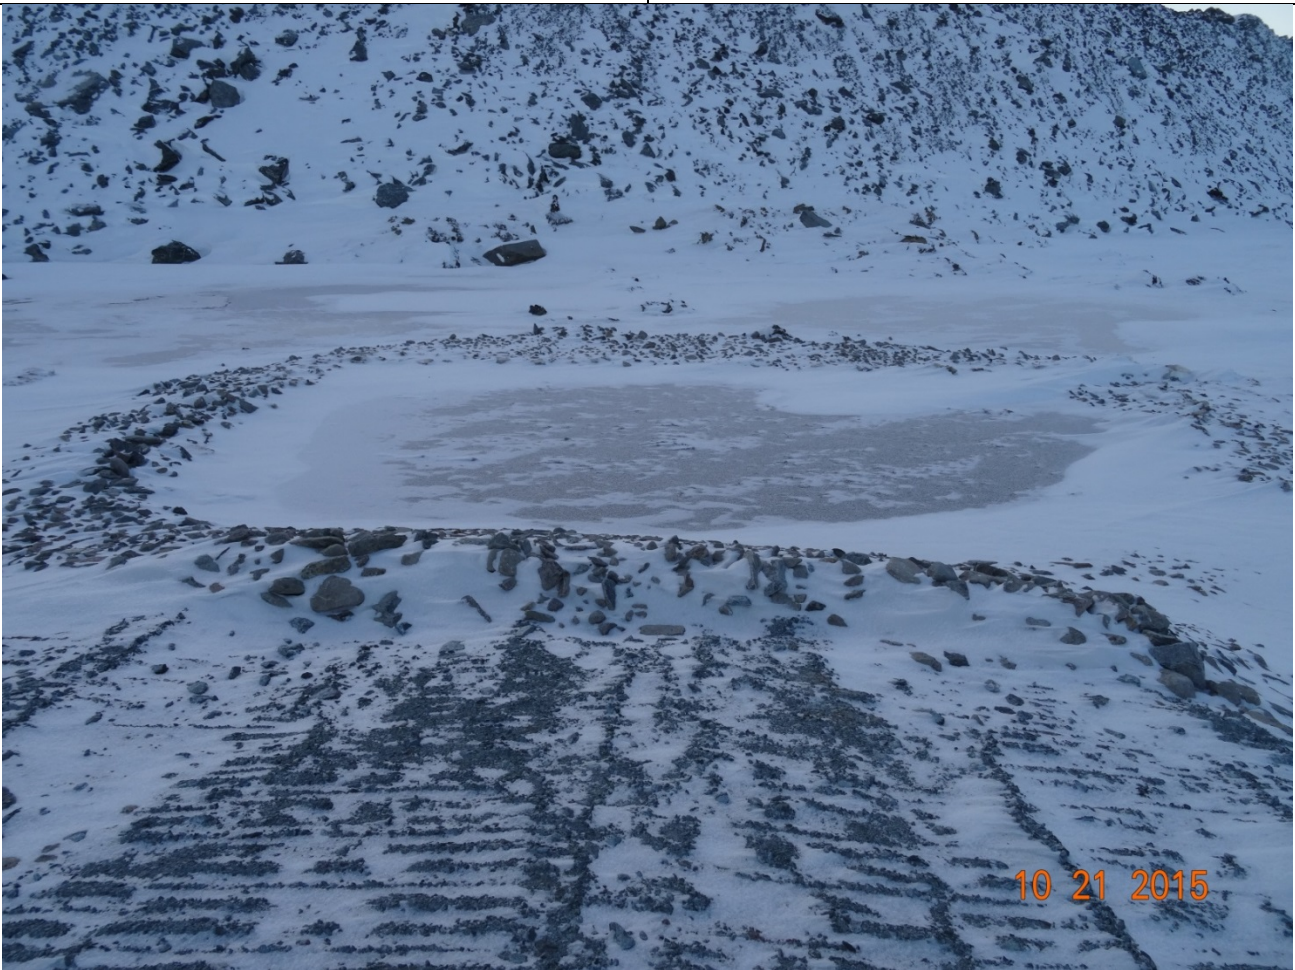
Photo No.  
Photo 3

Description:  
October 21<sup>st</sup>, 2015 Contact water retention structure

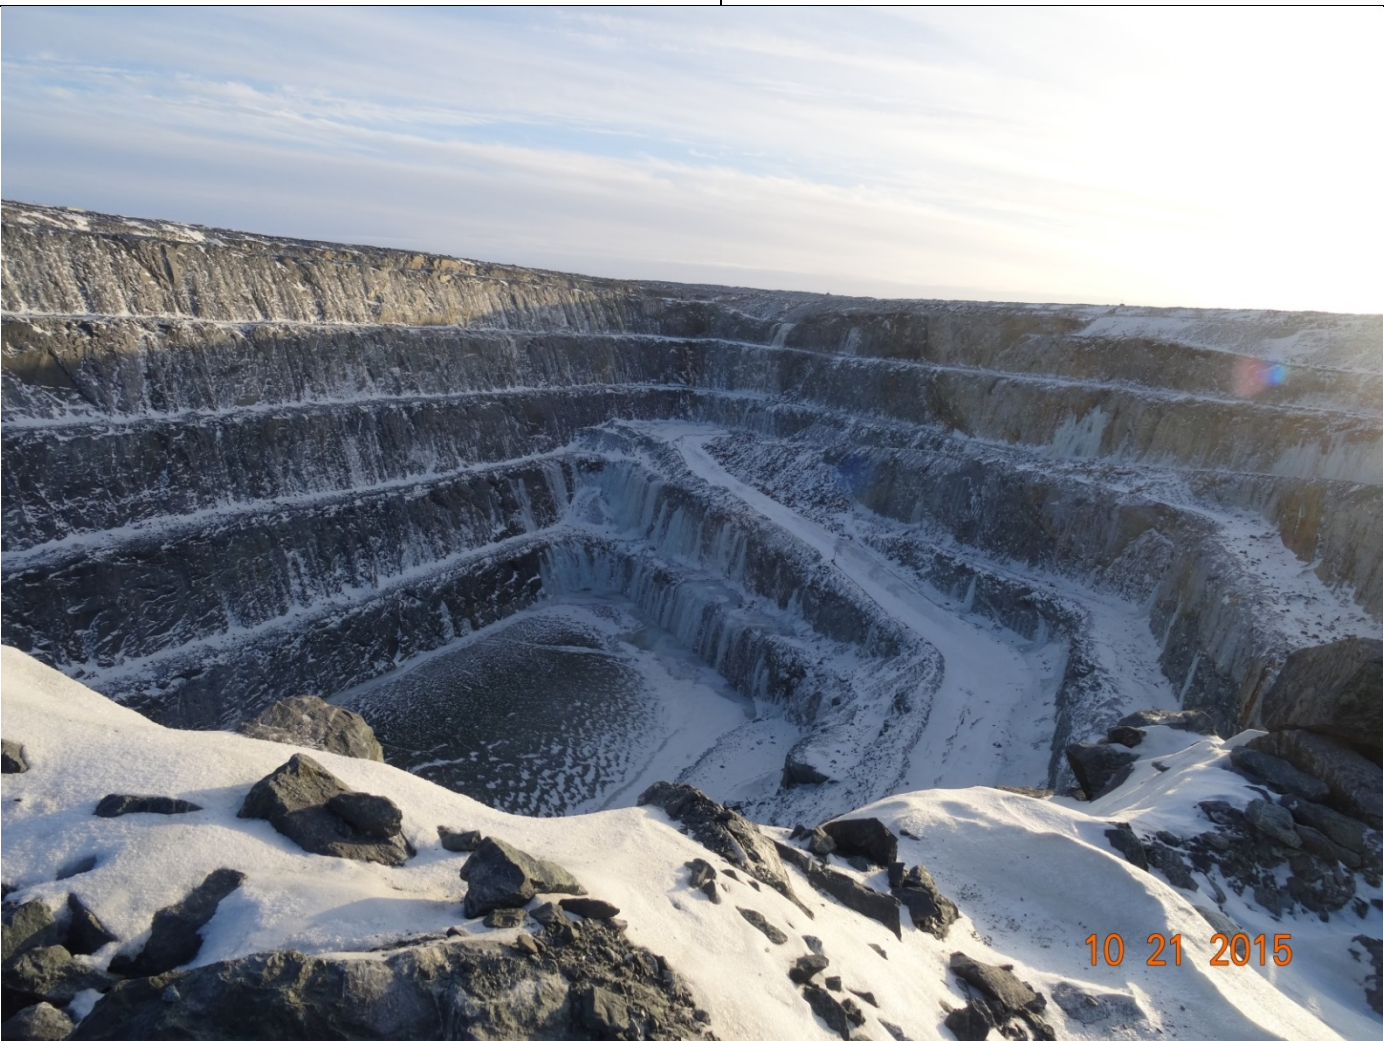
Photo No.  
Photo 4

b. The Mine Waste Rock and Tailings Management Plan, V1 (Drawing 3.4) indicates the completion of phase 1 of the North Cell TSF capping. The inspector would like to confirm the elevation of the North cell and activities occurring in the North Cell 2015/2016.
8. Goose pit re-flooding (photo 4).

a. As part of the FAP snow management program, snow will be dumped into Goose pit. This will reduce water accumulation in areas of concern and contribute to the natural re-flooding reducing the total fresh usage.

Description:  
Natural reflooding of Goose Pit
