WATER LICENCE INSPECTION FORM

Licensee	Licensee Representative
Agnico Eagle Mines Limited	Robin Allard
Licence No. / Expiry	Representative's Title
2AM-MEA1525 July 22nd, 2025	Senior Environmental Coordinator
Land Authorization No. / Purpose / Expiry	Land Authorization Expiry
66A/8-71-2, AWPAR Lease	66A/8-72-2 Quarrying Lease
Date of Inspection	Inspector
May 9-10 th , 2017	WRO Wilson
Activities Inspected	
<input type="checkbox"/> Camp <input type="checkbox"/> Drilling <input checked="" type="checkbox"/> Mining <input checked="" type="checkbox"/> Construction <input type="checkbox"/> Reclamation <input type="checkbox"/> Fuel Storage	
<input type="checkbox"/> Roads/Hauling <input type="checkbox"/> Other: <input type="checkbox"/> Other:

Attached: Photo Log 2AM-MEA1525, - May 10th, 2017

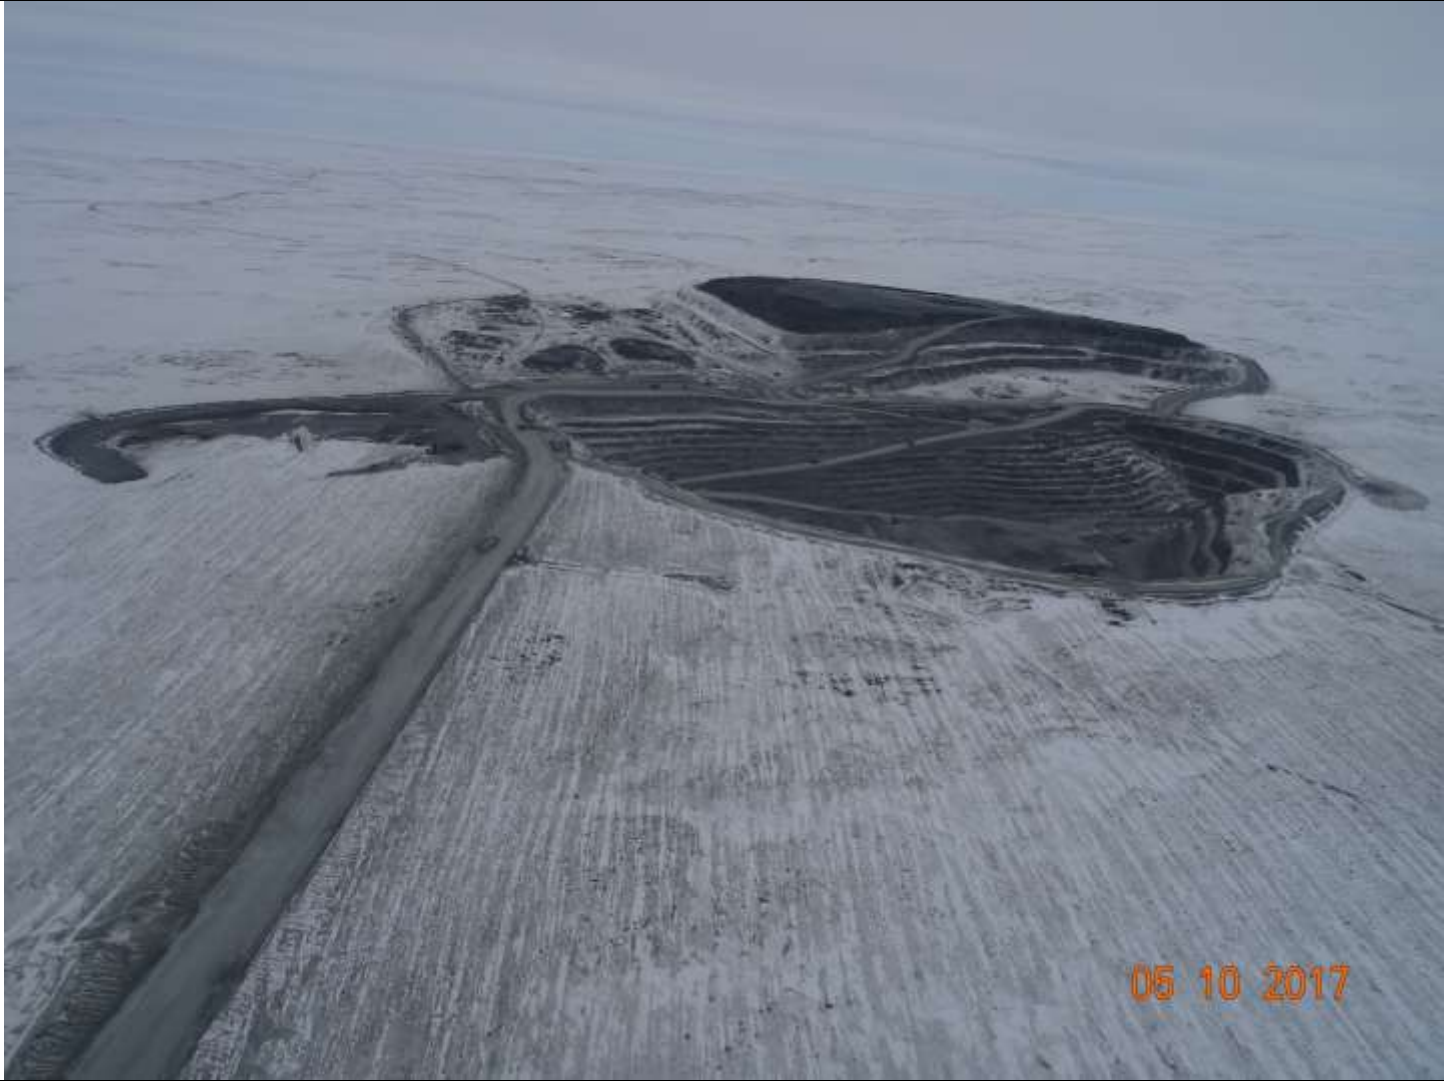
Date:	Authorization Number:	Camera/Model:	Inspector
May 9-10 th , 2017	2AM-MEA1525	Sony DSC-HX50V Cyber shot	WRO Wilson
Photo No.		Lat/Long (DD.MM.SS.SS, NAD83)	
Photo 1		N63° 1' 23.00", W 92° 11' 7.5"

Description:
Looking East: Vault area

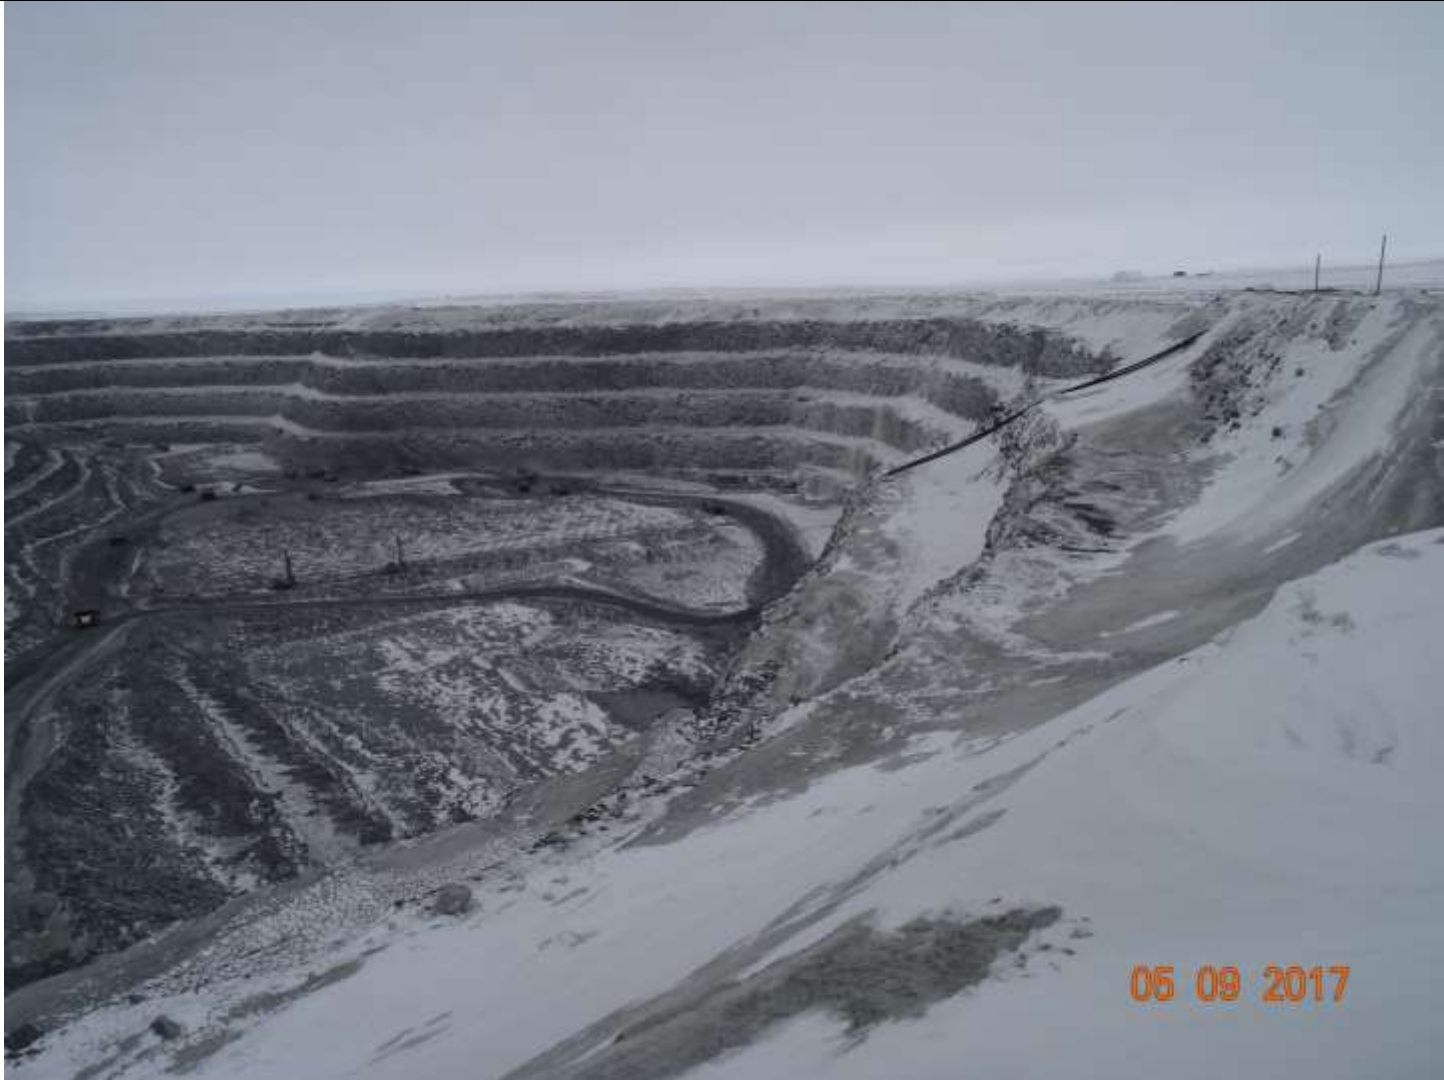
Photo 2

Vault pit sump

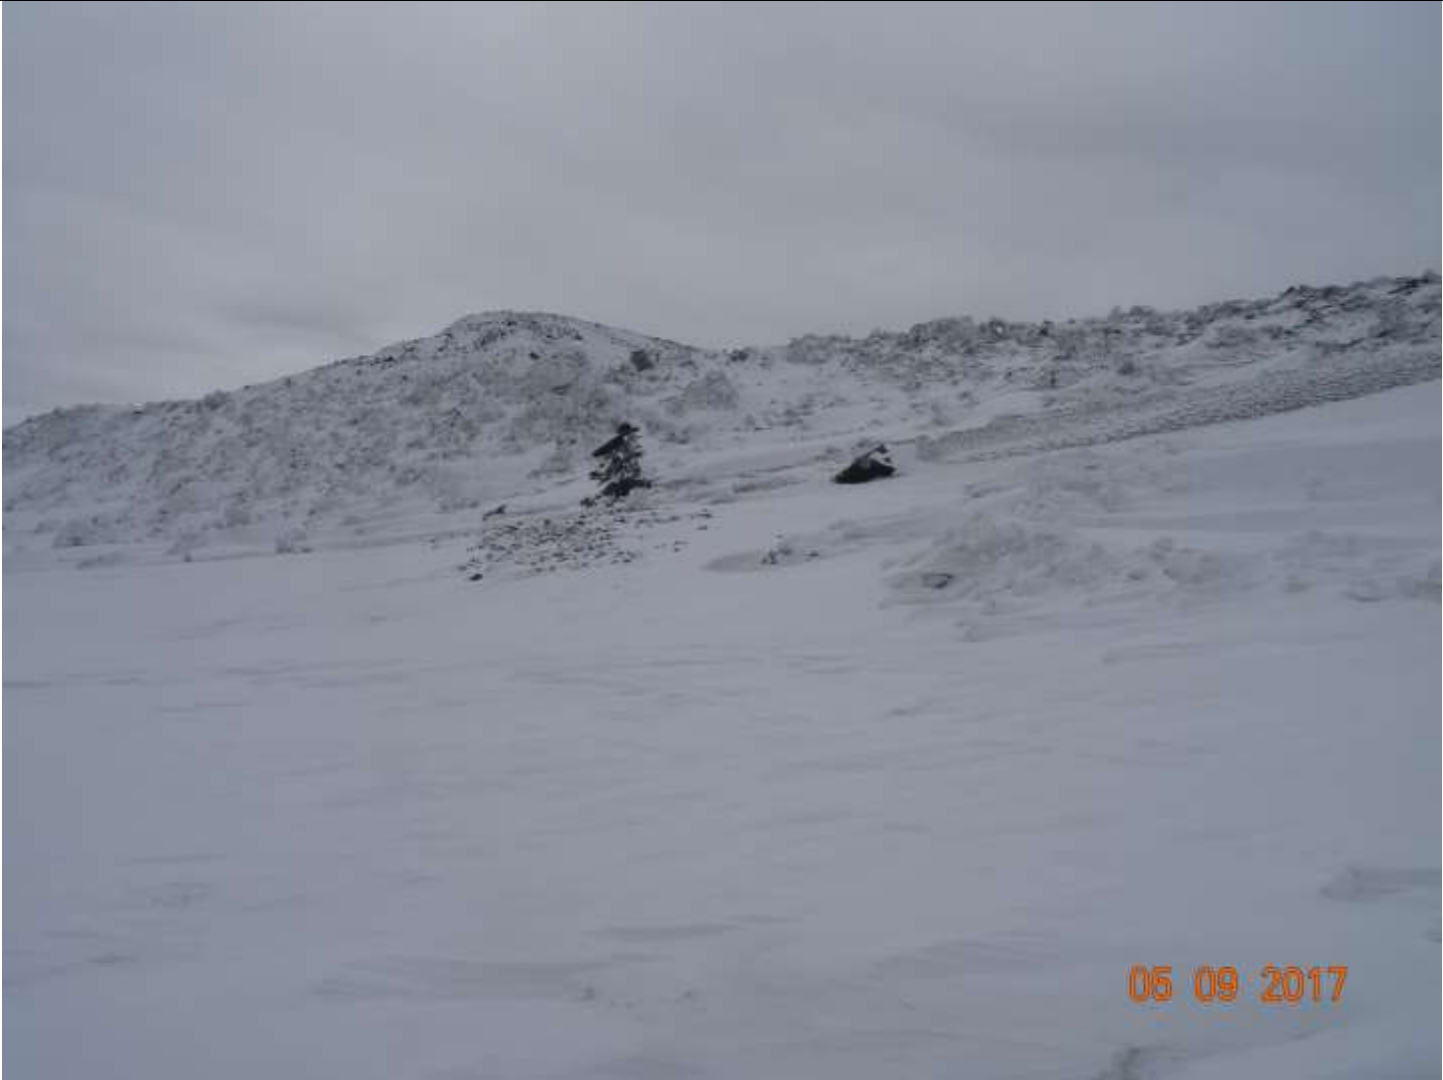
Photo 4

Vault haul Road, Sediment in snow

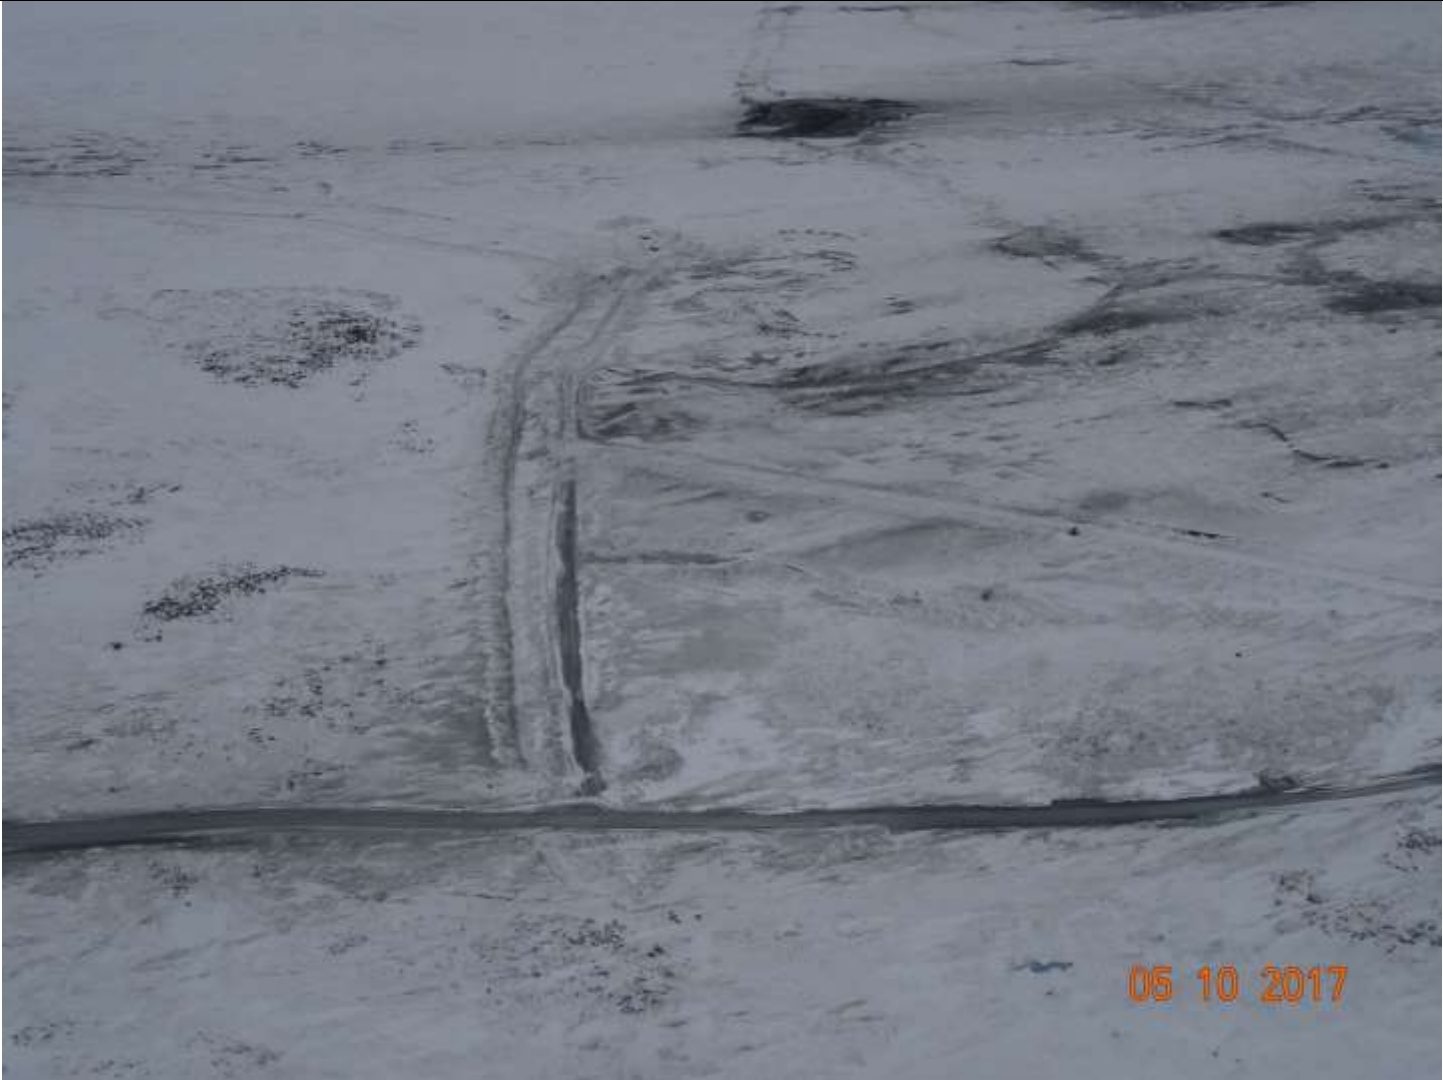
Photo 6

Tailing facility non-contact water diversion ditch

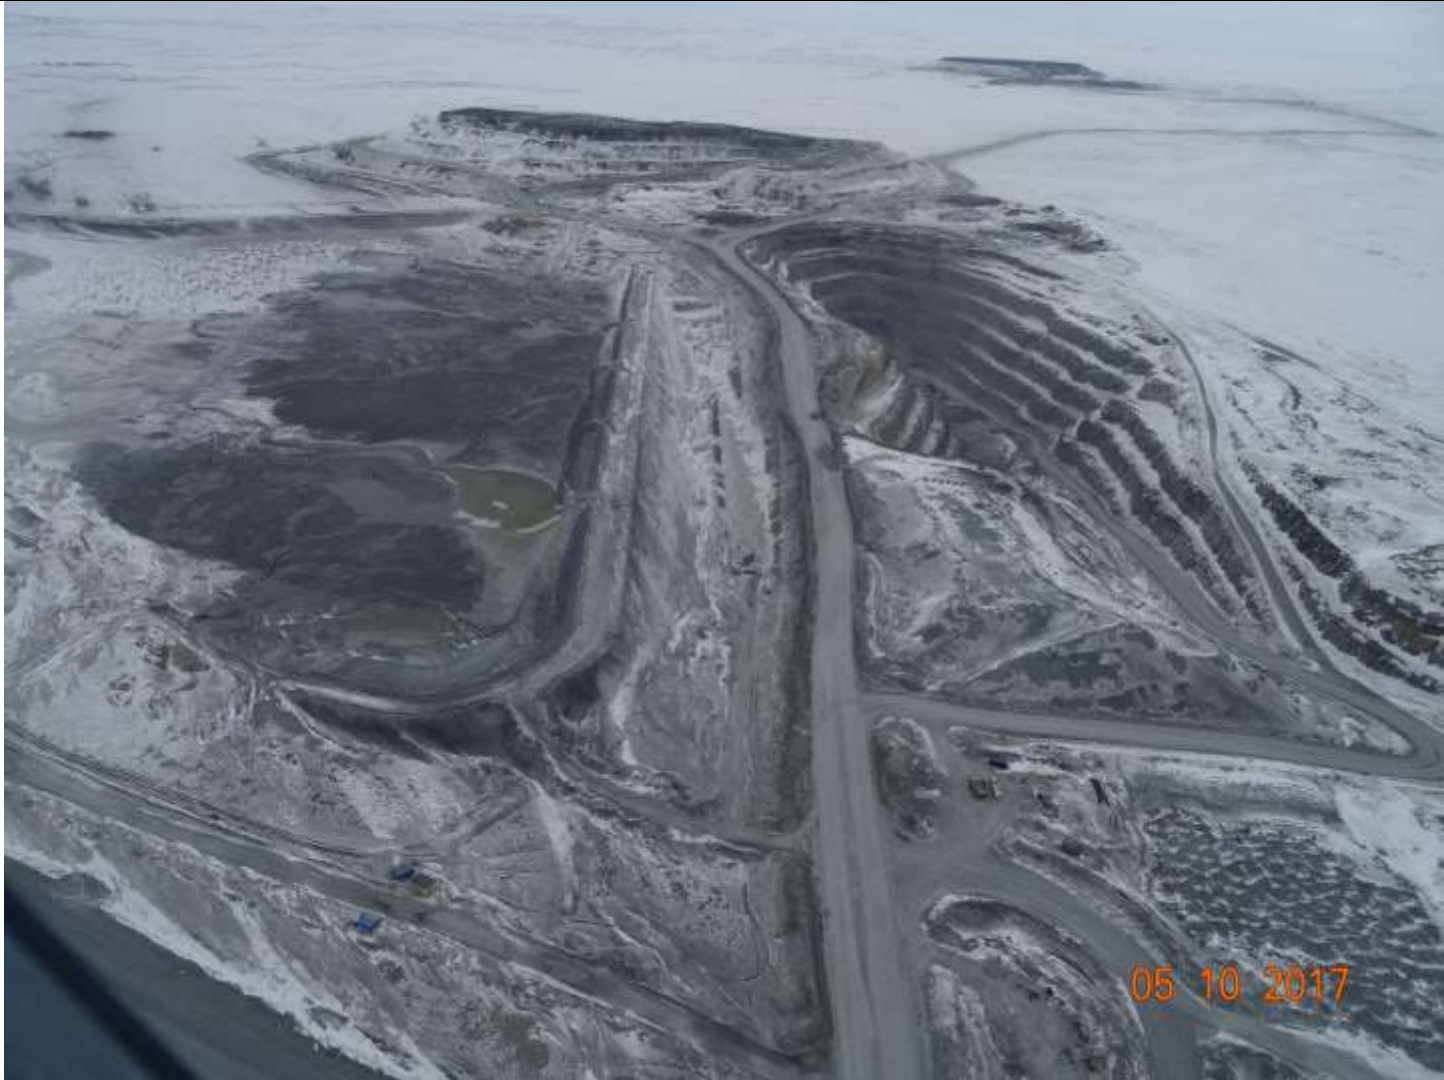
Photo 8

Central Dyke
