**WATER LICENCE INSPECTION FORM**☒ Original
☐ Follow-Up Report

Licensee	Licensee Representative
Agnico Eagle Mines Limited.	Eric HALEY
Licence No. / Expiry	Representative's Title
2AM-MEA1530, March 27 th , 2030	Interim Environmental Coordinator
Land Authorization No. / Expiry	Project Name
66A/8-71-2	Meadowbank Project
Date of Inspection	Inspector
October 1 st , 2020	RMO J.Voisey
Activities Inspected	
<input type="checkbox"/> Camp <input type="checkbox"/> Drilling <input type="checkbox"/> Mining <input type="checkbox"/> Construction <input type="checkbox"/> Reclamation <input type="checkbox"/> Fuel Storage <input checked="" type="checkbox"/> Roads/Hauling <input type="checkbox"/> Other: Airstrip <input type="checkbox"/> Other: Bulk Sample

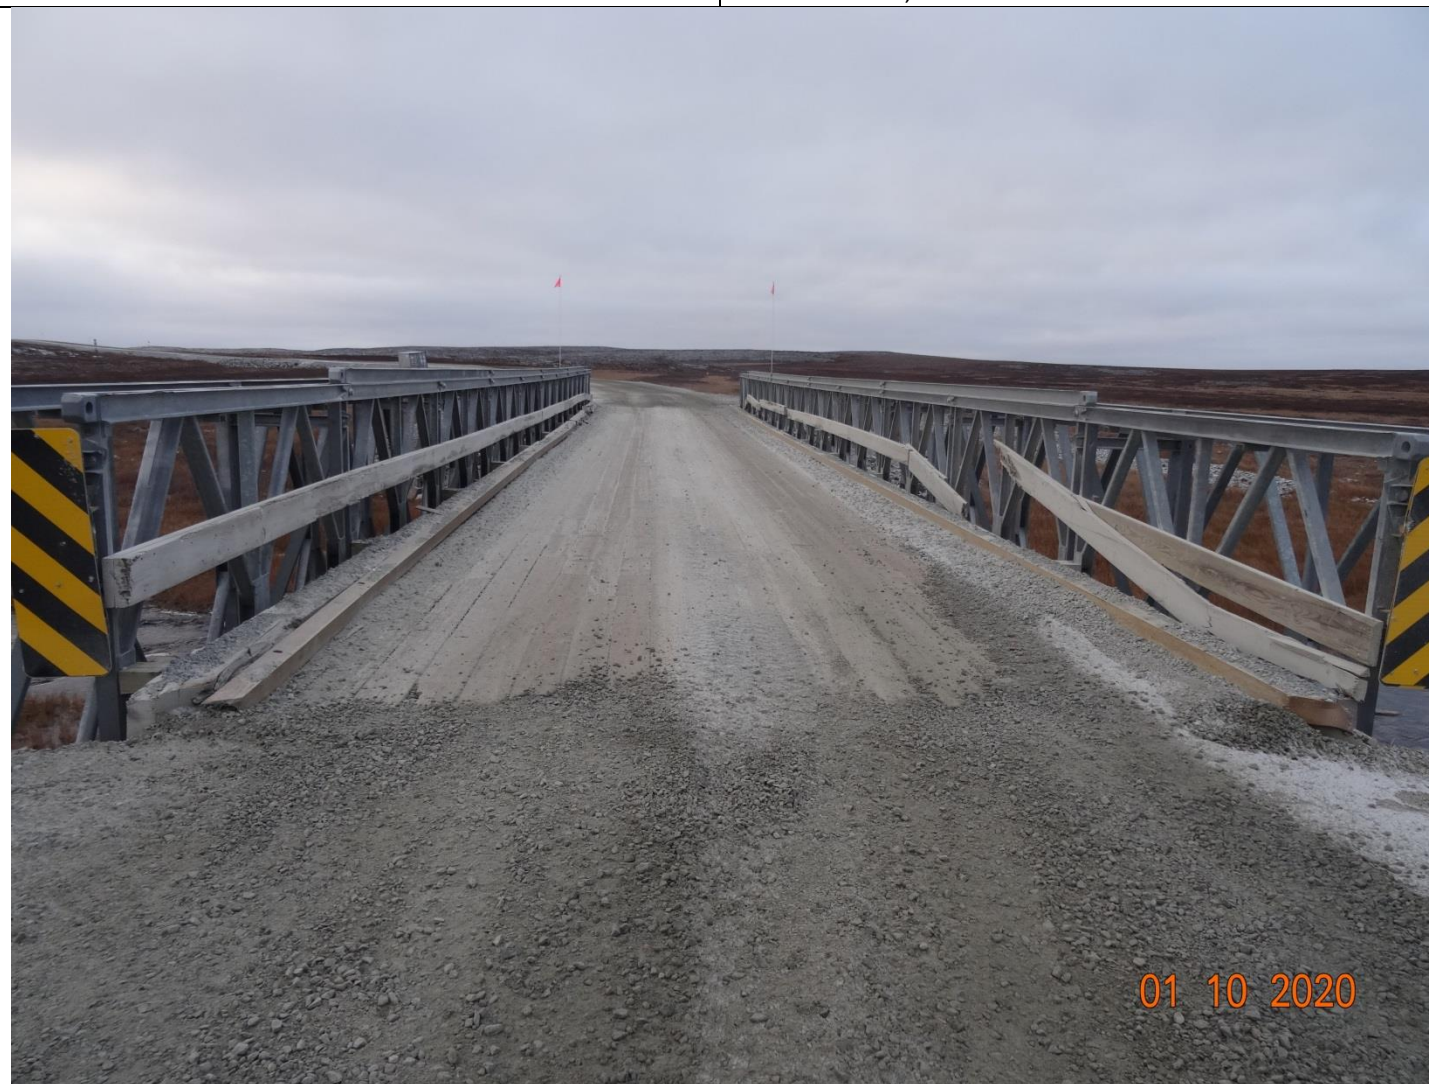
Date:	Authorization Number:	Camera/Model:	Inspector
October 1 st , 2020	2AM-MEA1530	Sony DSC-HX50V Cyber shot	RMO Voisey
Photo No.	Lat/Long (DD.MM.SS.SS, NAD83)		
Photo 1	N64° 27' 23.83", W96° 04' 55.99"

Many of the bridges use different construction methods, for example a flat top deck verses the wire grating or skirting around the deck versus no skirting (photo 1). The observation noted from the water crossings that utilized the flat top deck and the skirting show that this design indeed limits the amount of sediment in the water course.

Bridge at km 17.

The Licensee will provide the Inspector with a summary of the maintenance that will be completed this year on all the water crossings to prevent further sediment from entering the water course. This summary is due July 1st 2021.

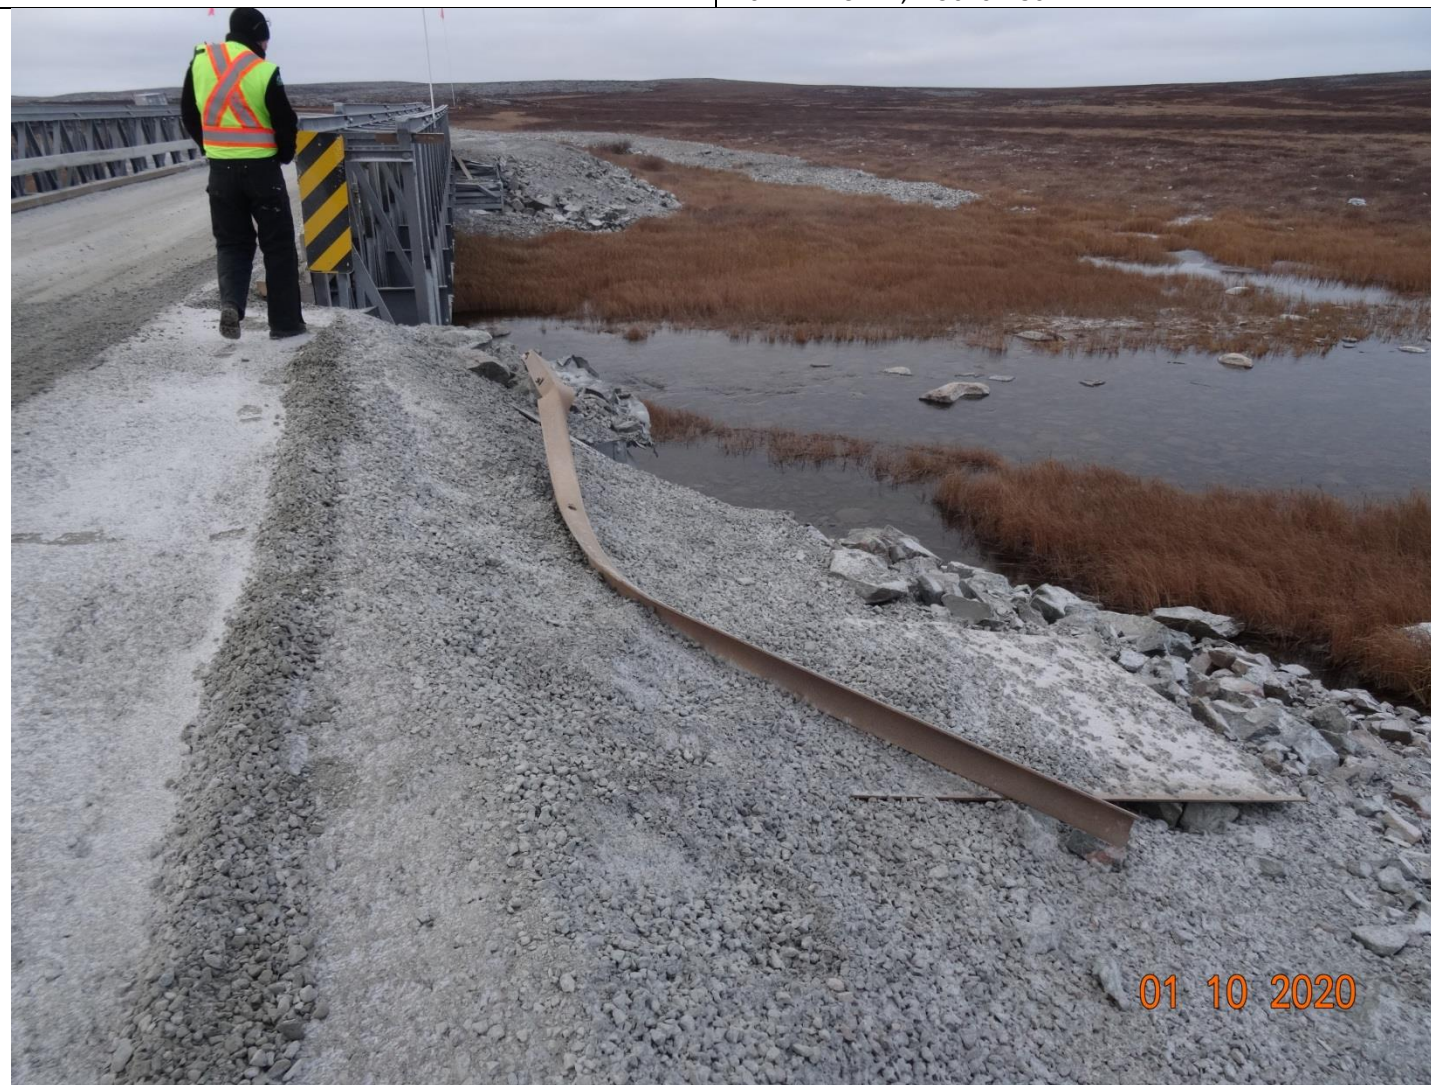
Photo 2

Bridge at km 17.

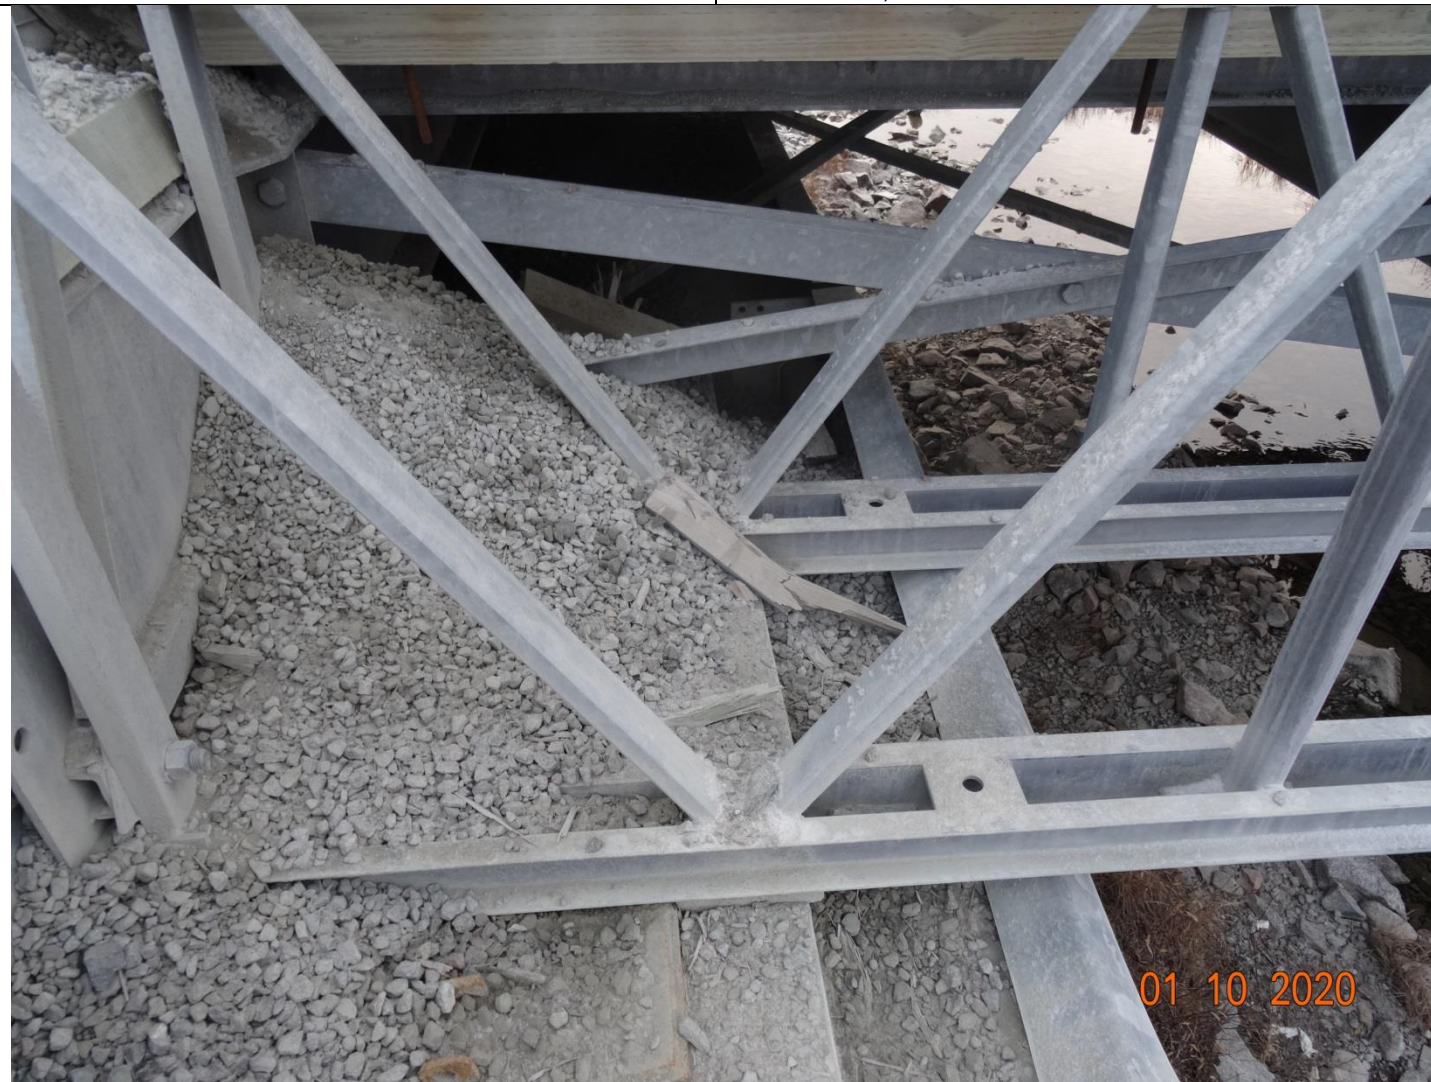
Photo 3

Bridge at KM 17.

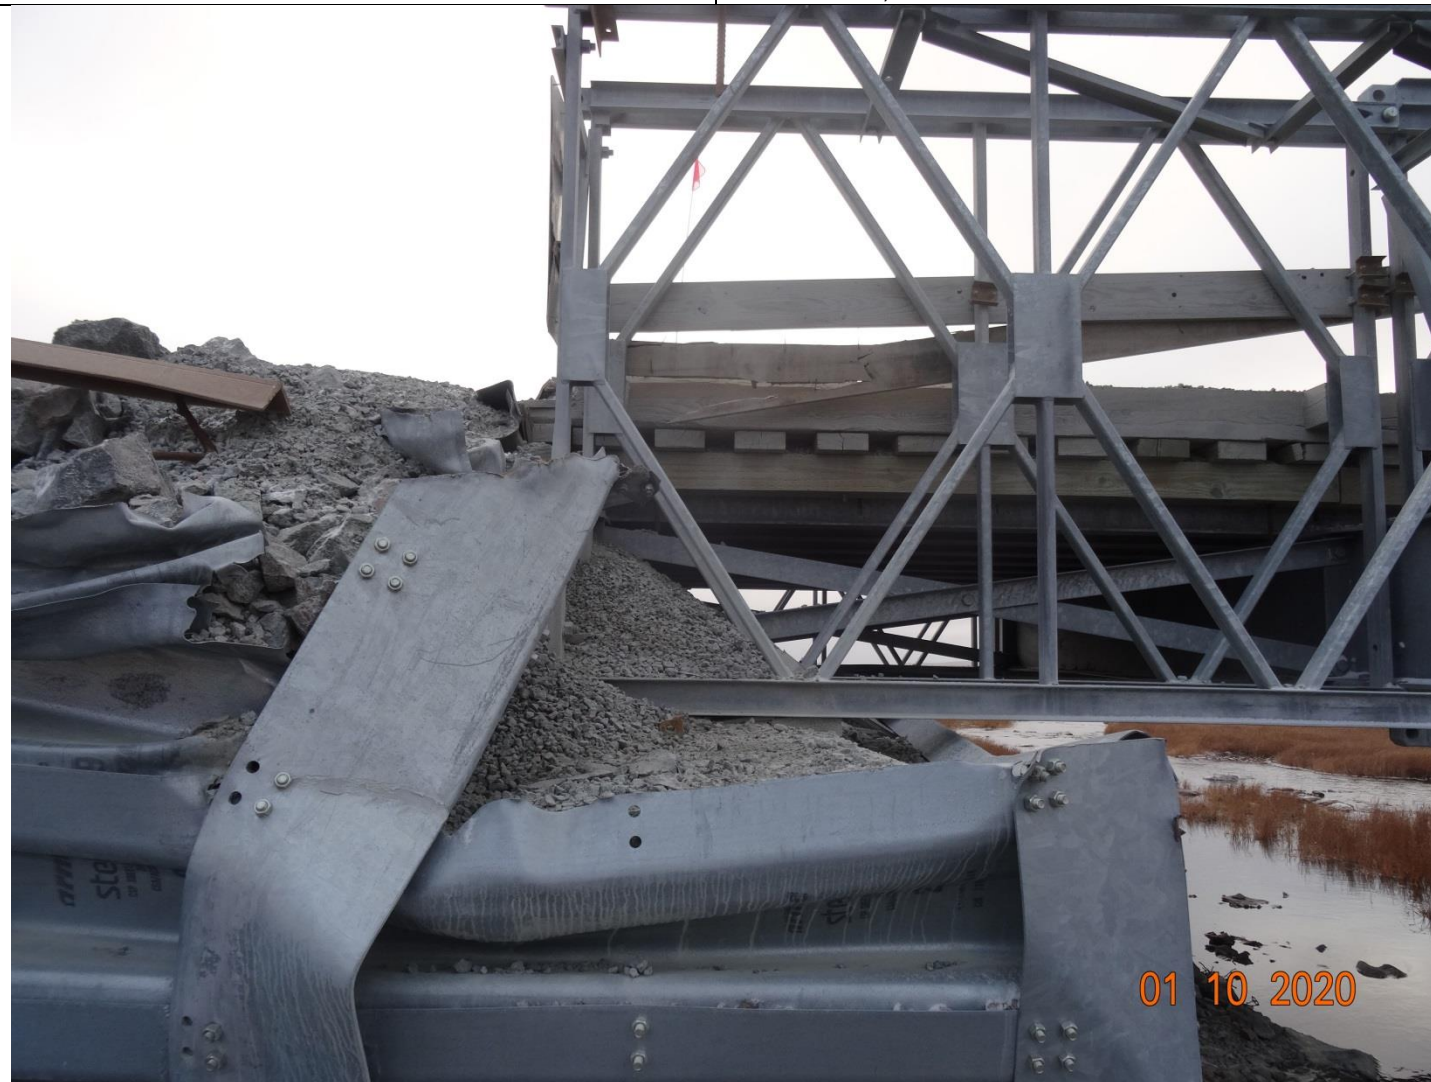
Photo 4

Bridge at KM 17.

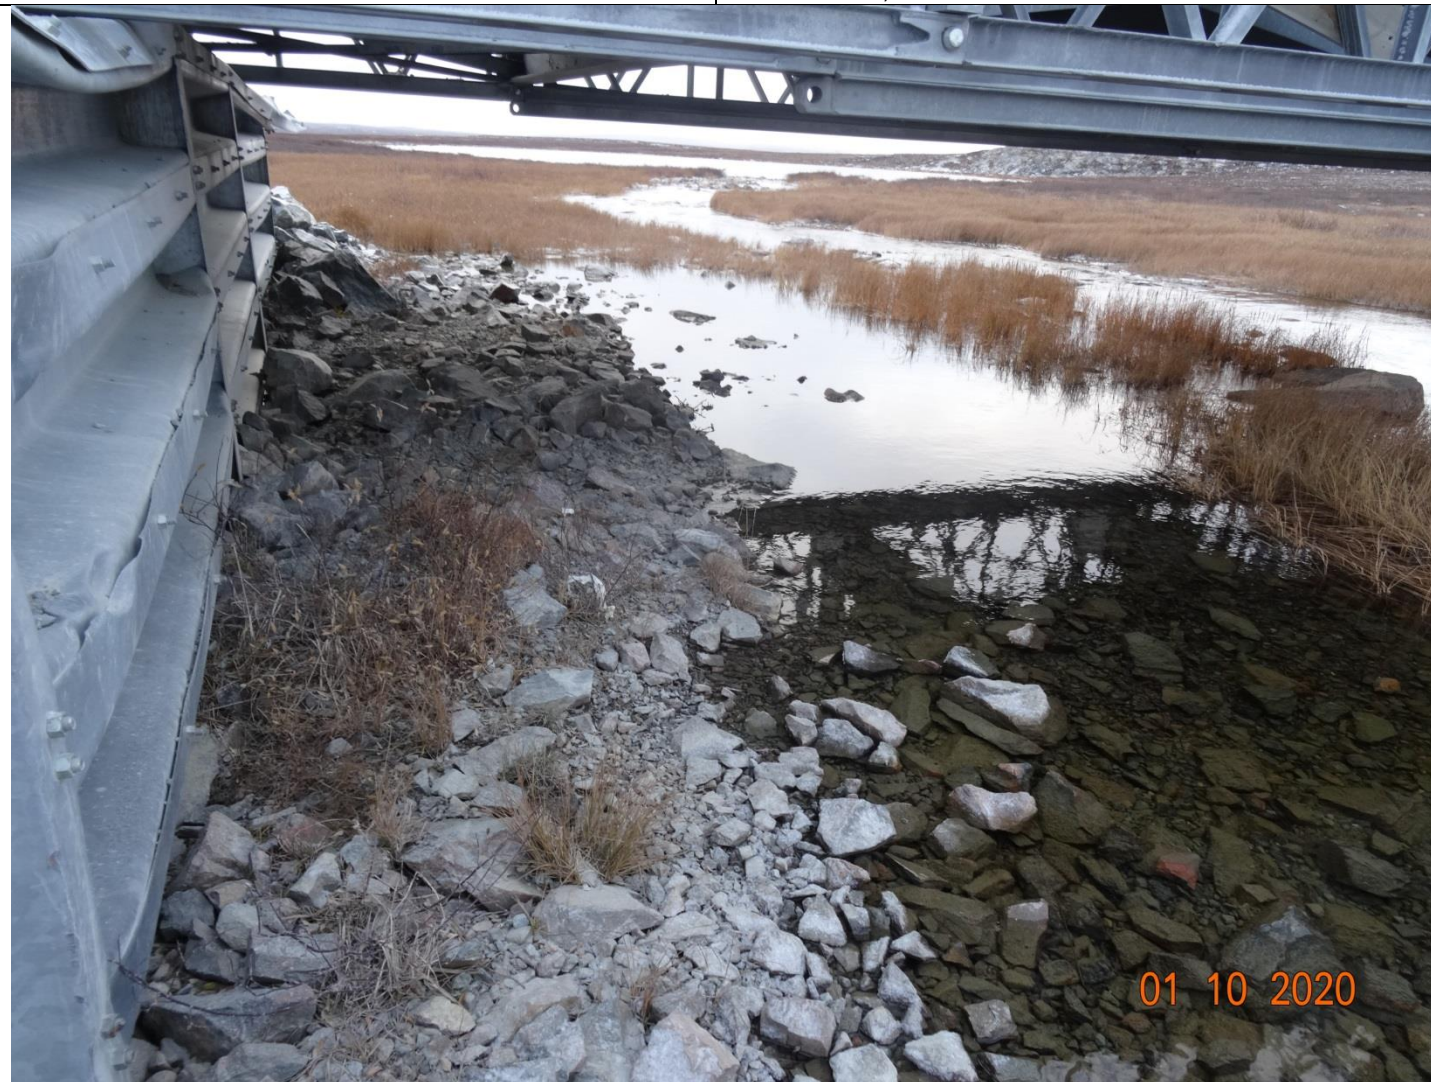
Photo 5

Bridge at KM 17.

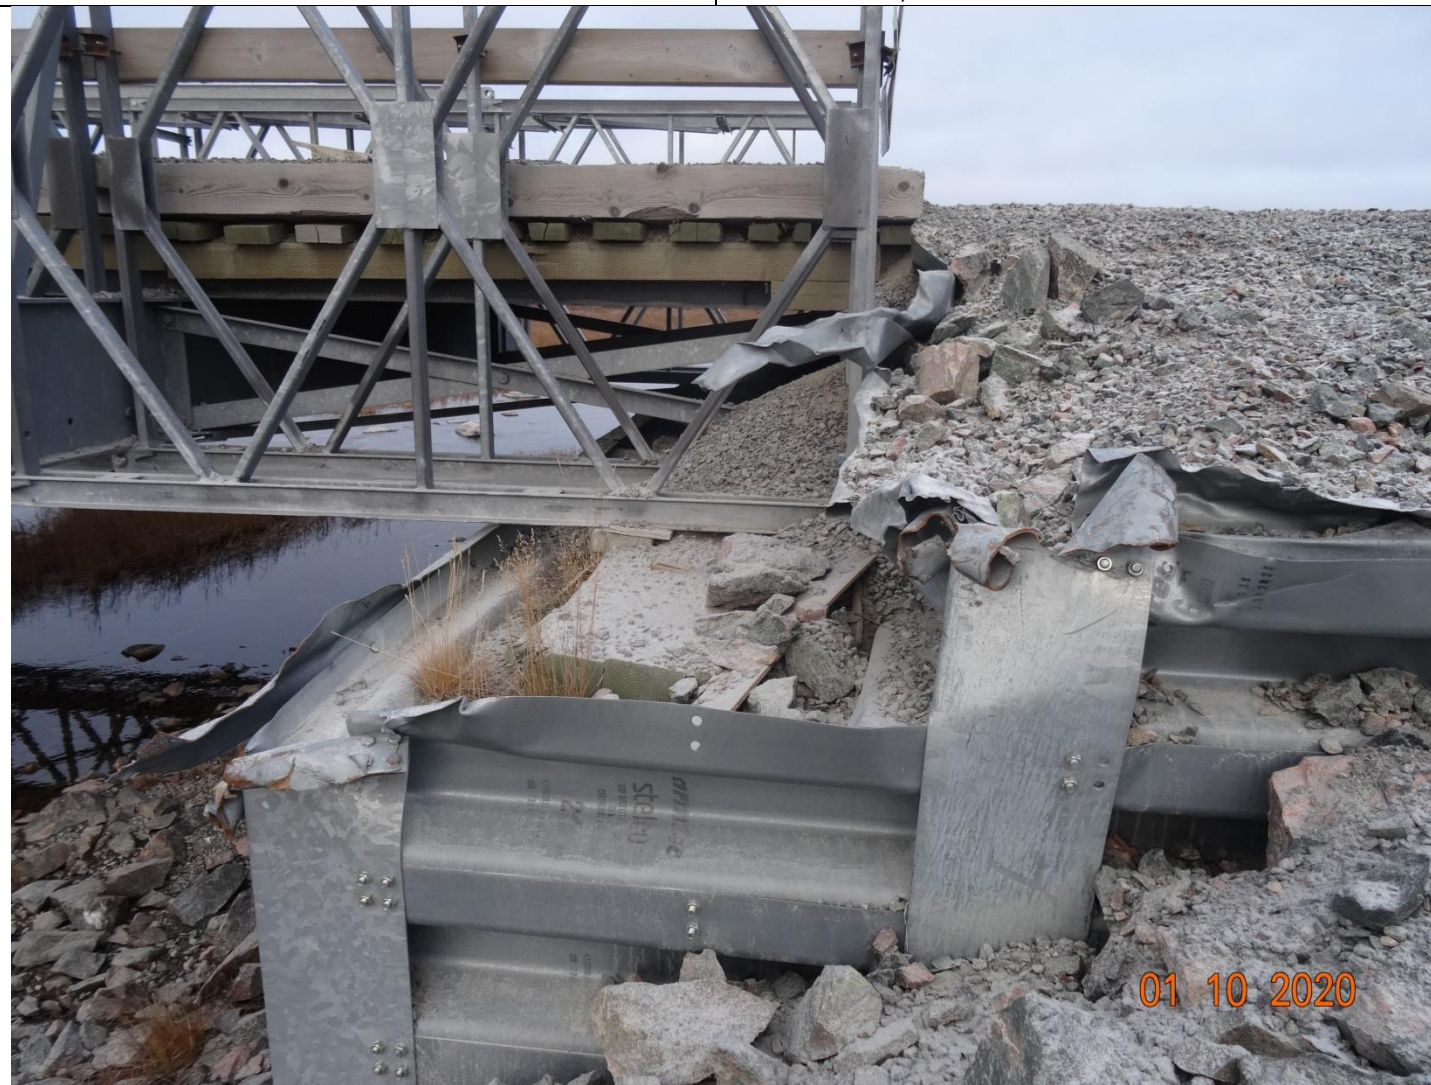
Photo 6

Bridge at KM 17.

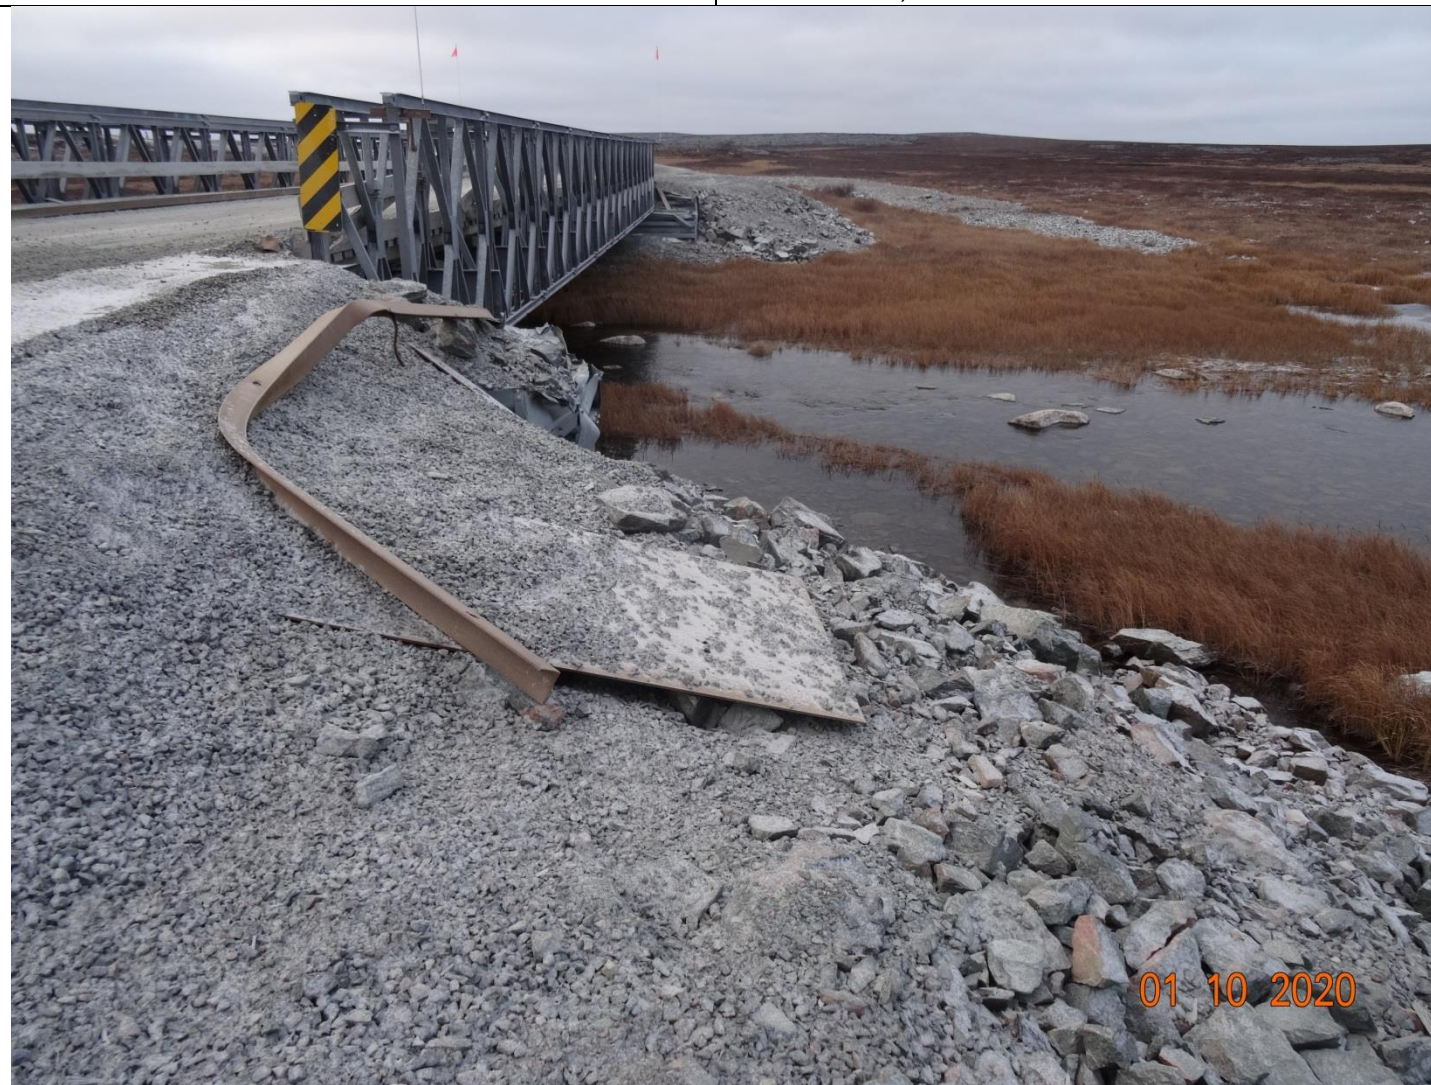
Photo 7

Bridge at KM 17.

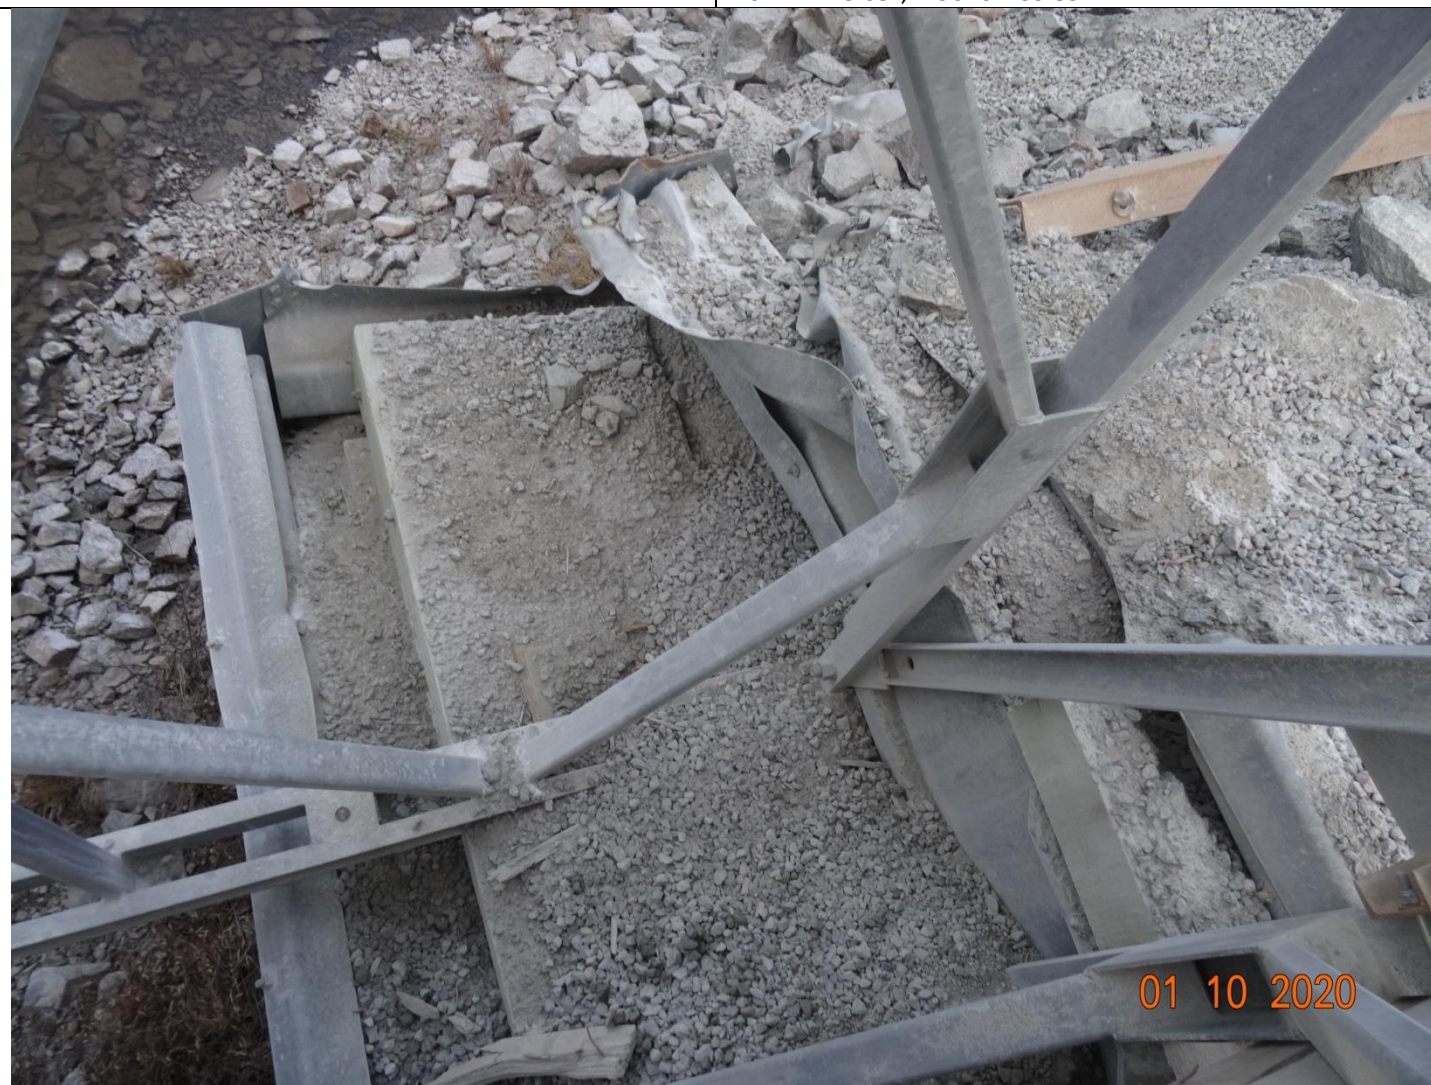
Photo 8

Bridge at km 17

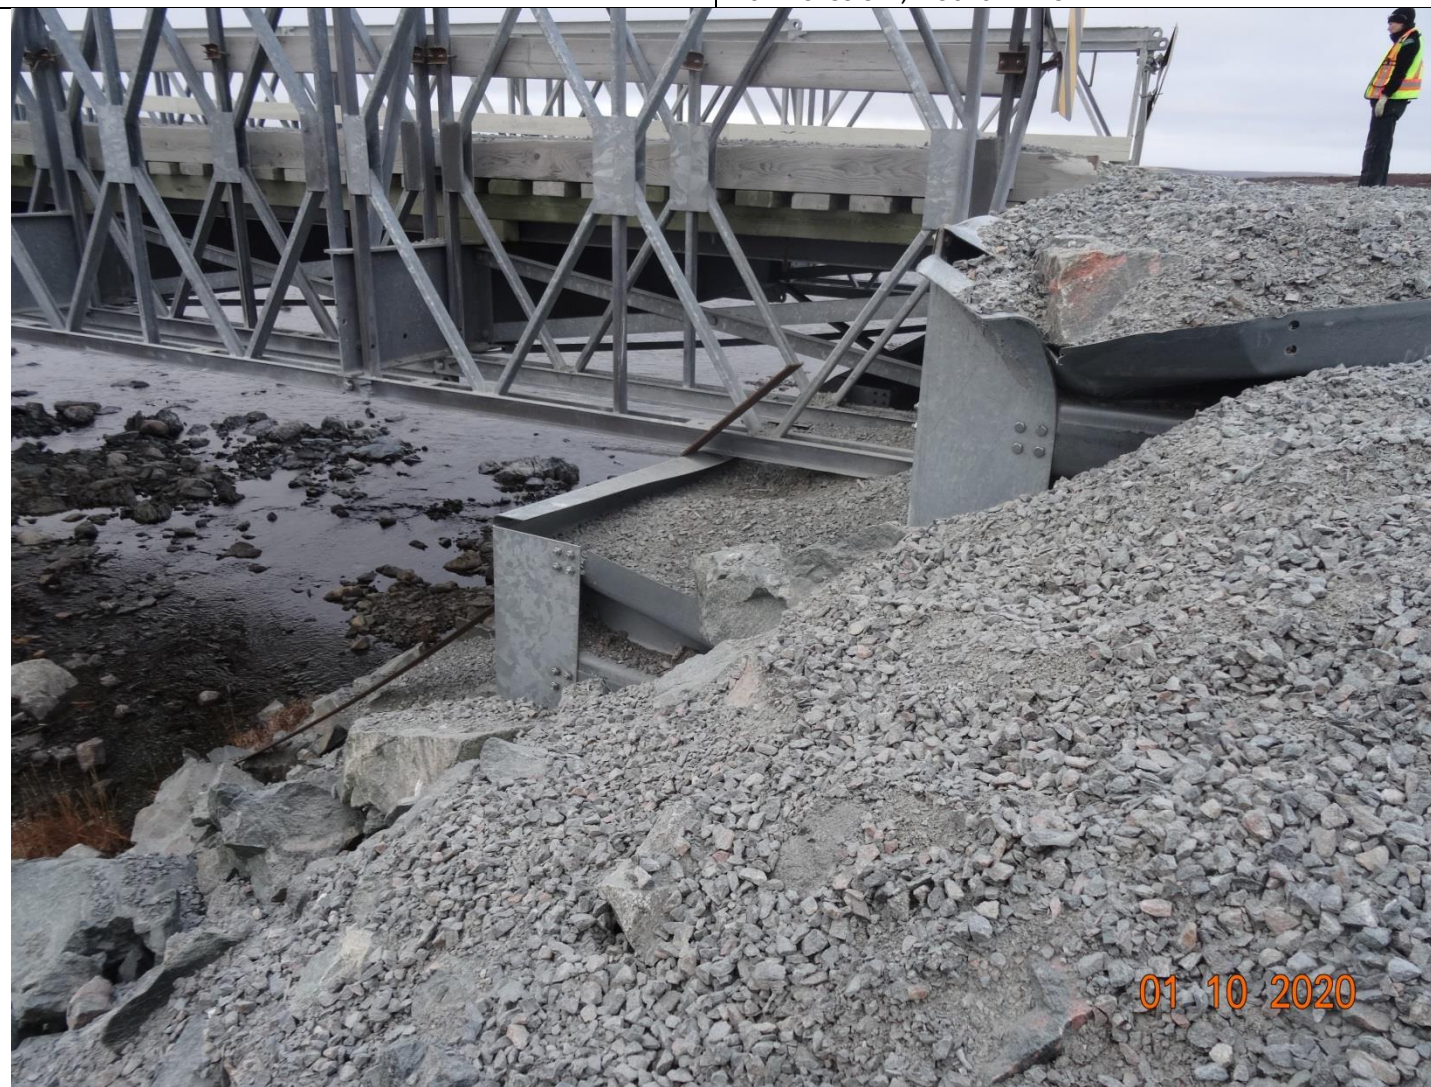
Photo 9

Bridge at KM 23.

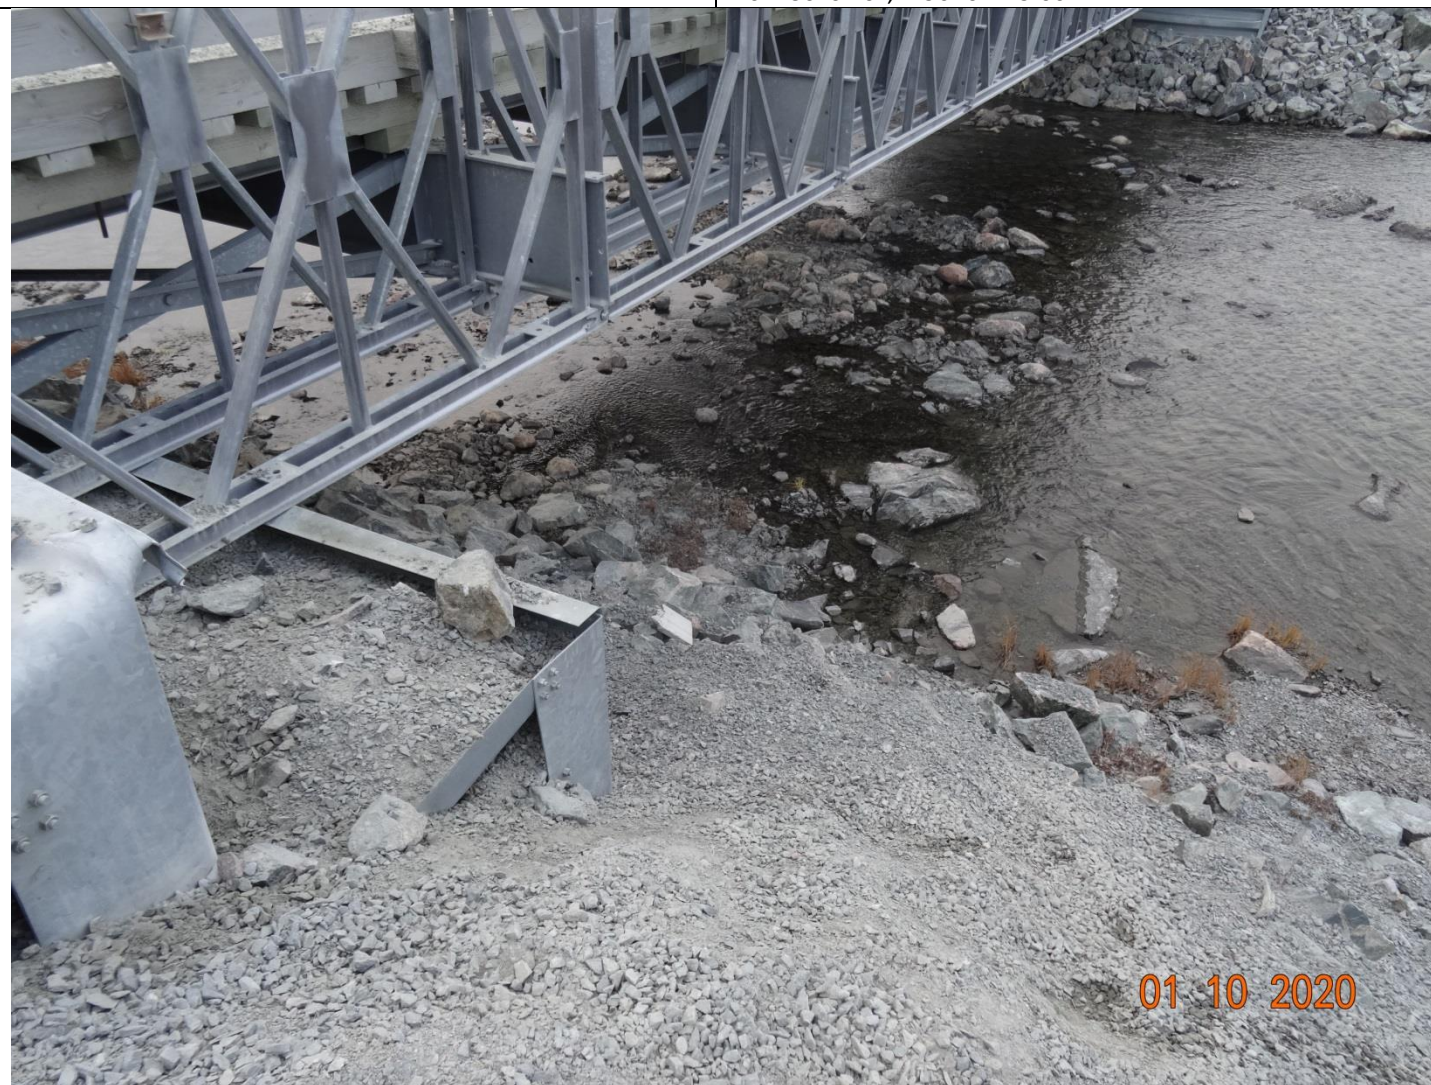
Photo 10

Bridge at KM 23.

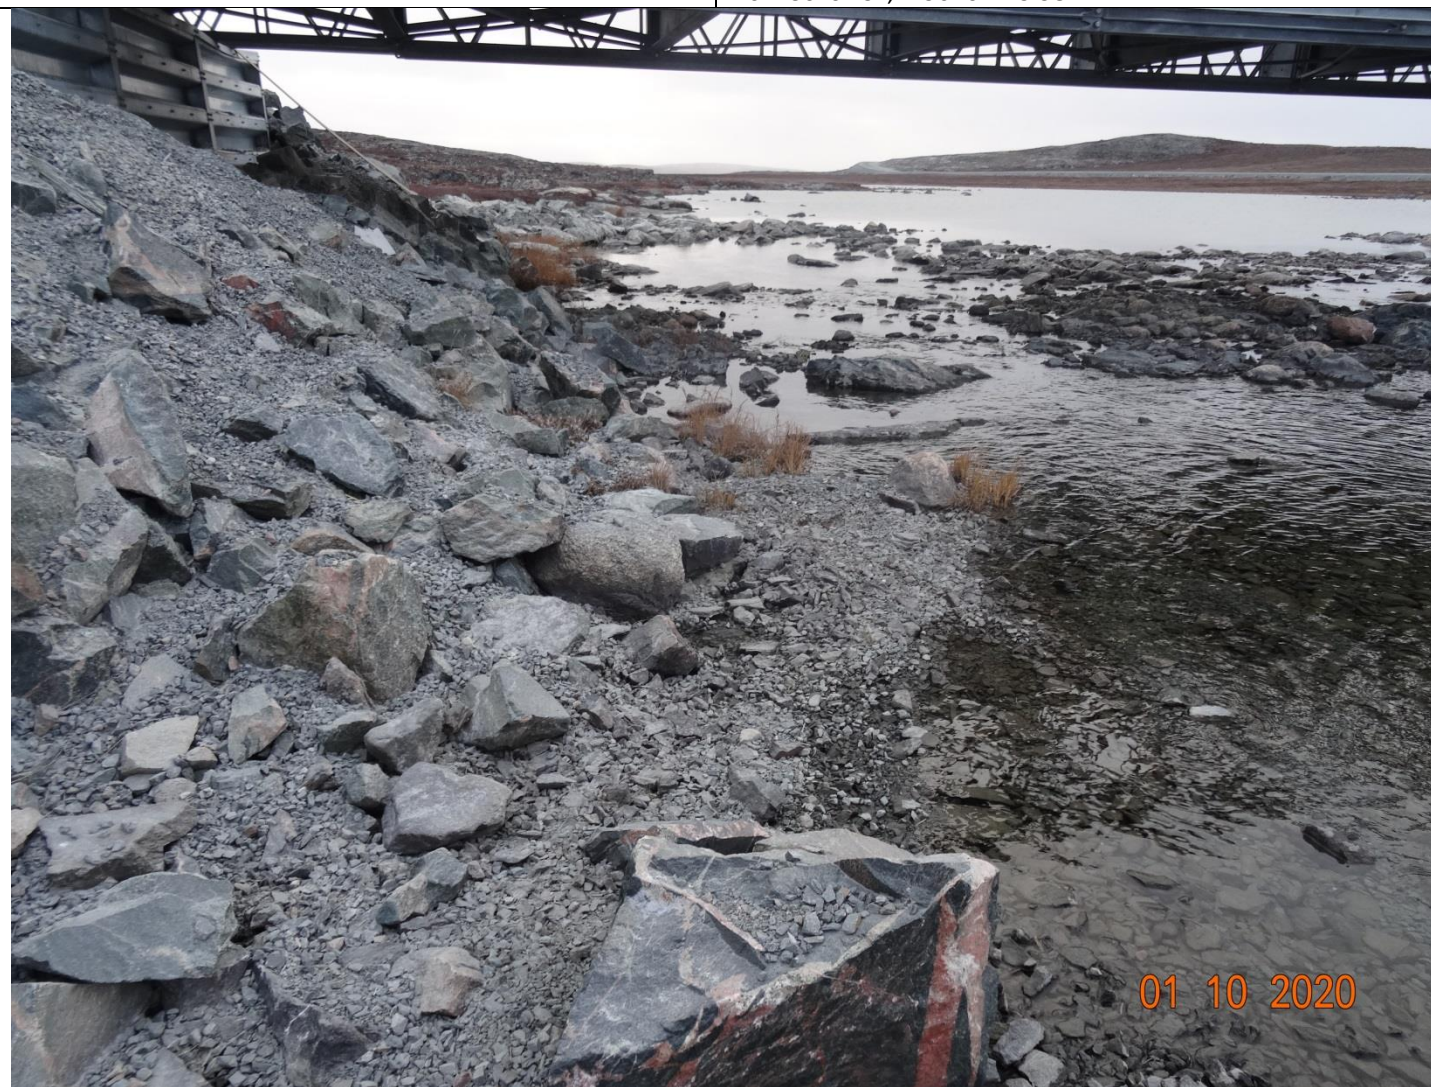
Photo 11

Bridge at KM 23.

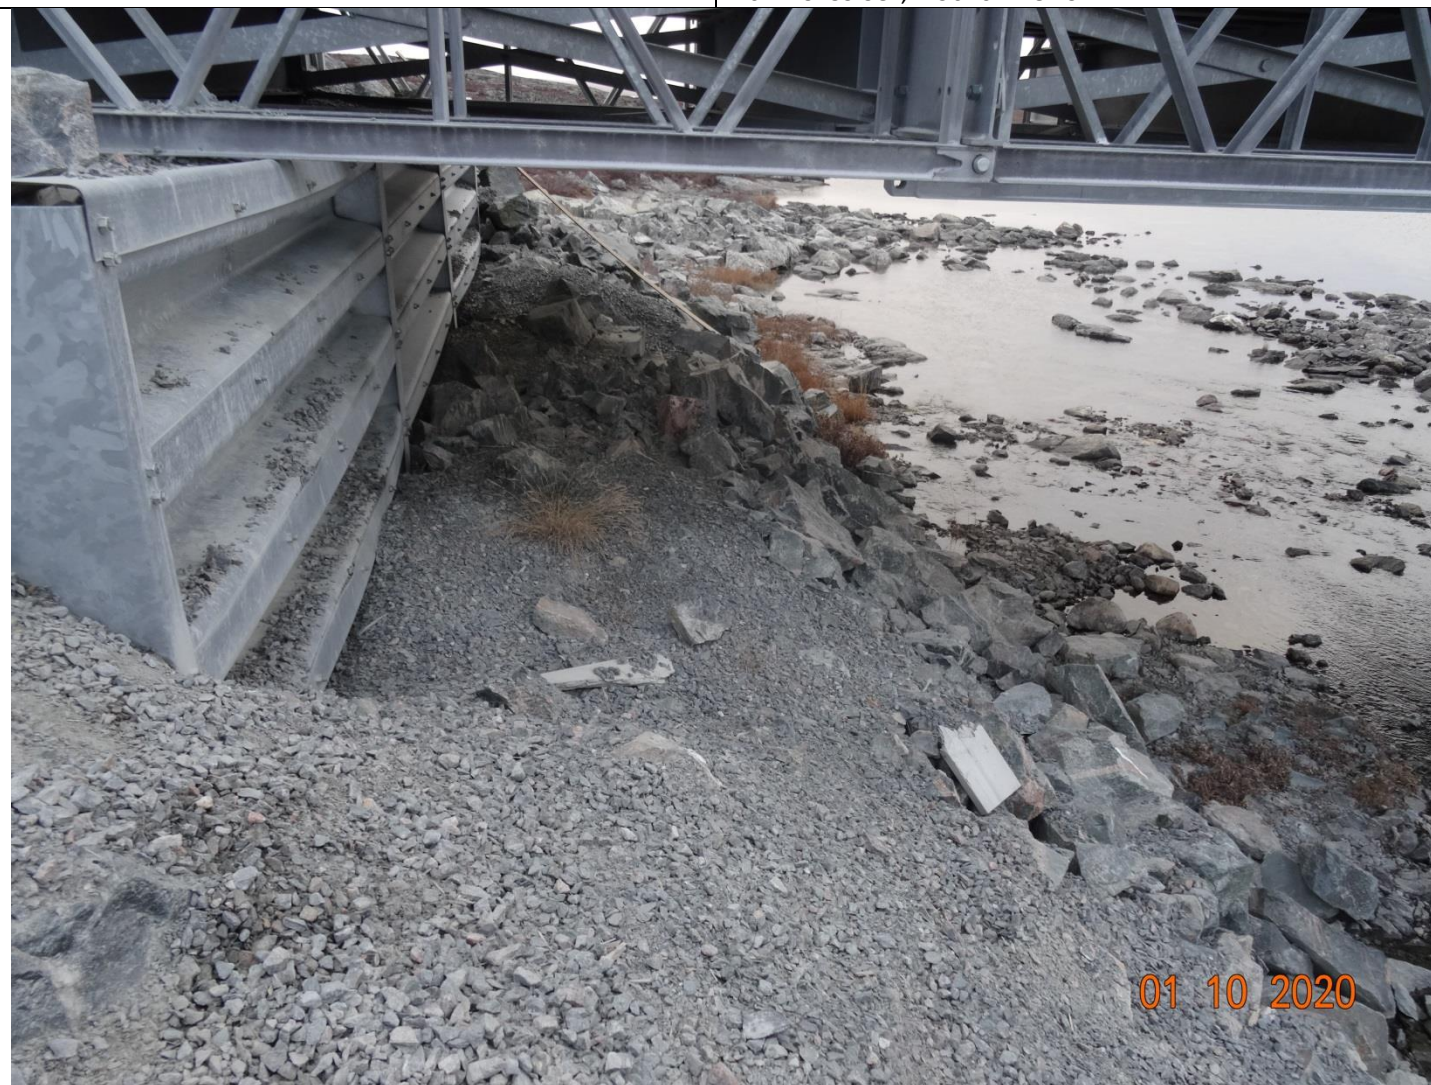
Photo 12

Bridge at KM 23.

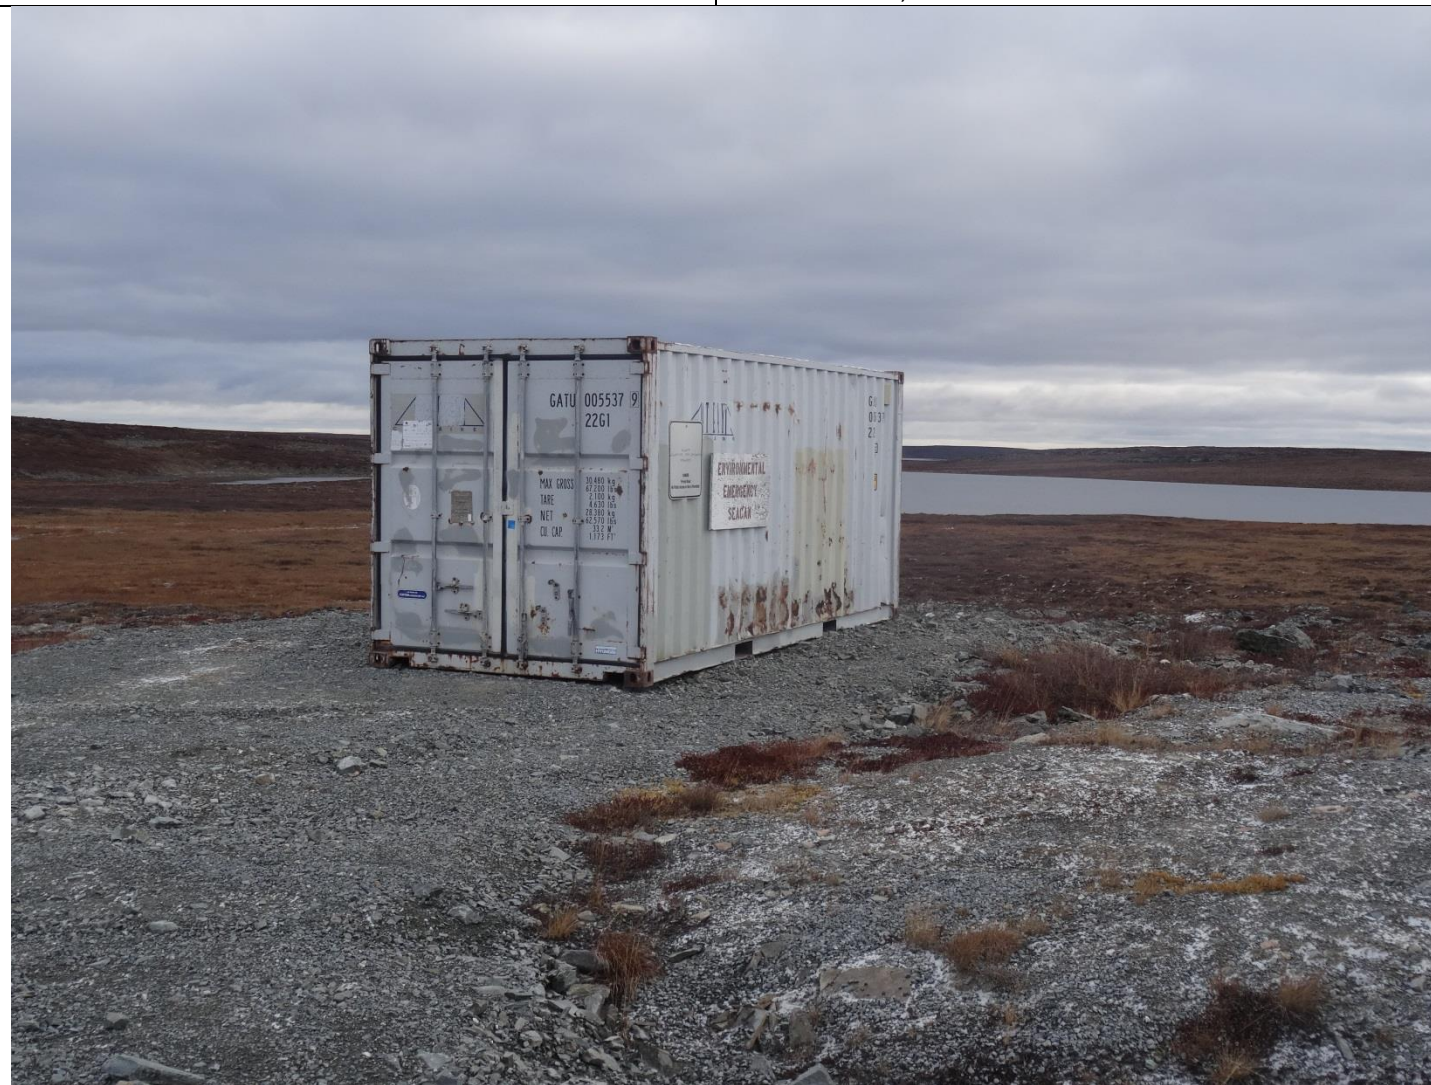
Photo 13

Emergency Response Sea-Can at KM 62 bridge.

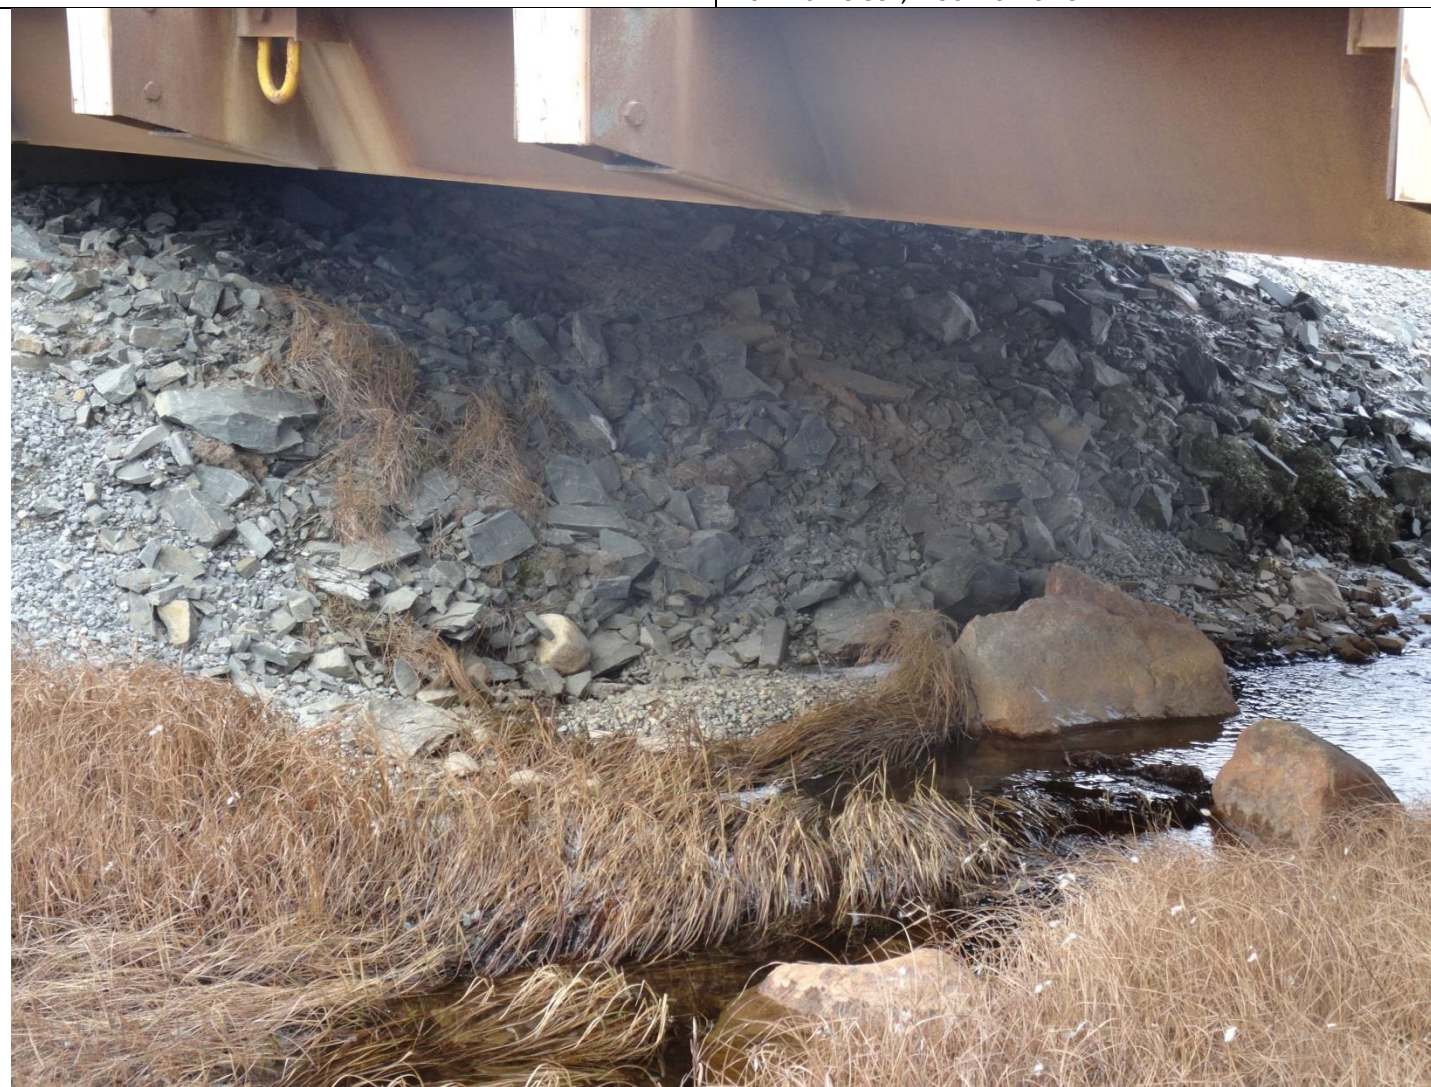
Photo 14

Bridge at KM 62.
