**WATER LICENCE INSPECTION FORM**☒ Original
☐ Follow-Up Report

Licensee	Licensee Representative
Agnico Eagle Mines Limited.	Eric HALEY
Licence No. / Expiry	Representative's Title
2AM-MEA1530, March 27 th , 2030	Interim Environmental Coordinator
Land Authorization No. / Expiry	Project Name
66A/8-71-2	Meadowbank Project
Date of Inspection	Inspector
October 1 st , 2020	RMO J.Voisey
Activities Inspected	
<input type="checkbox"/> Camp <input type="checkbox"/> Drilling <input type="checkbox"/> Mining <input type="checkbox"/> Construction <input type="checkbox"/> Reclamation <input type="checkbox"/> Fuel Storage <input checked="" type="checkbox"/> Roads/Hauling <input type="checkbox"/> Other: Airstrip <input type="checkbox"/> Other: Bulk Sample

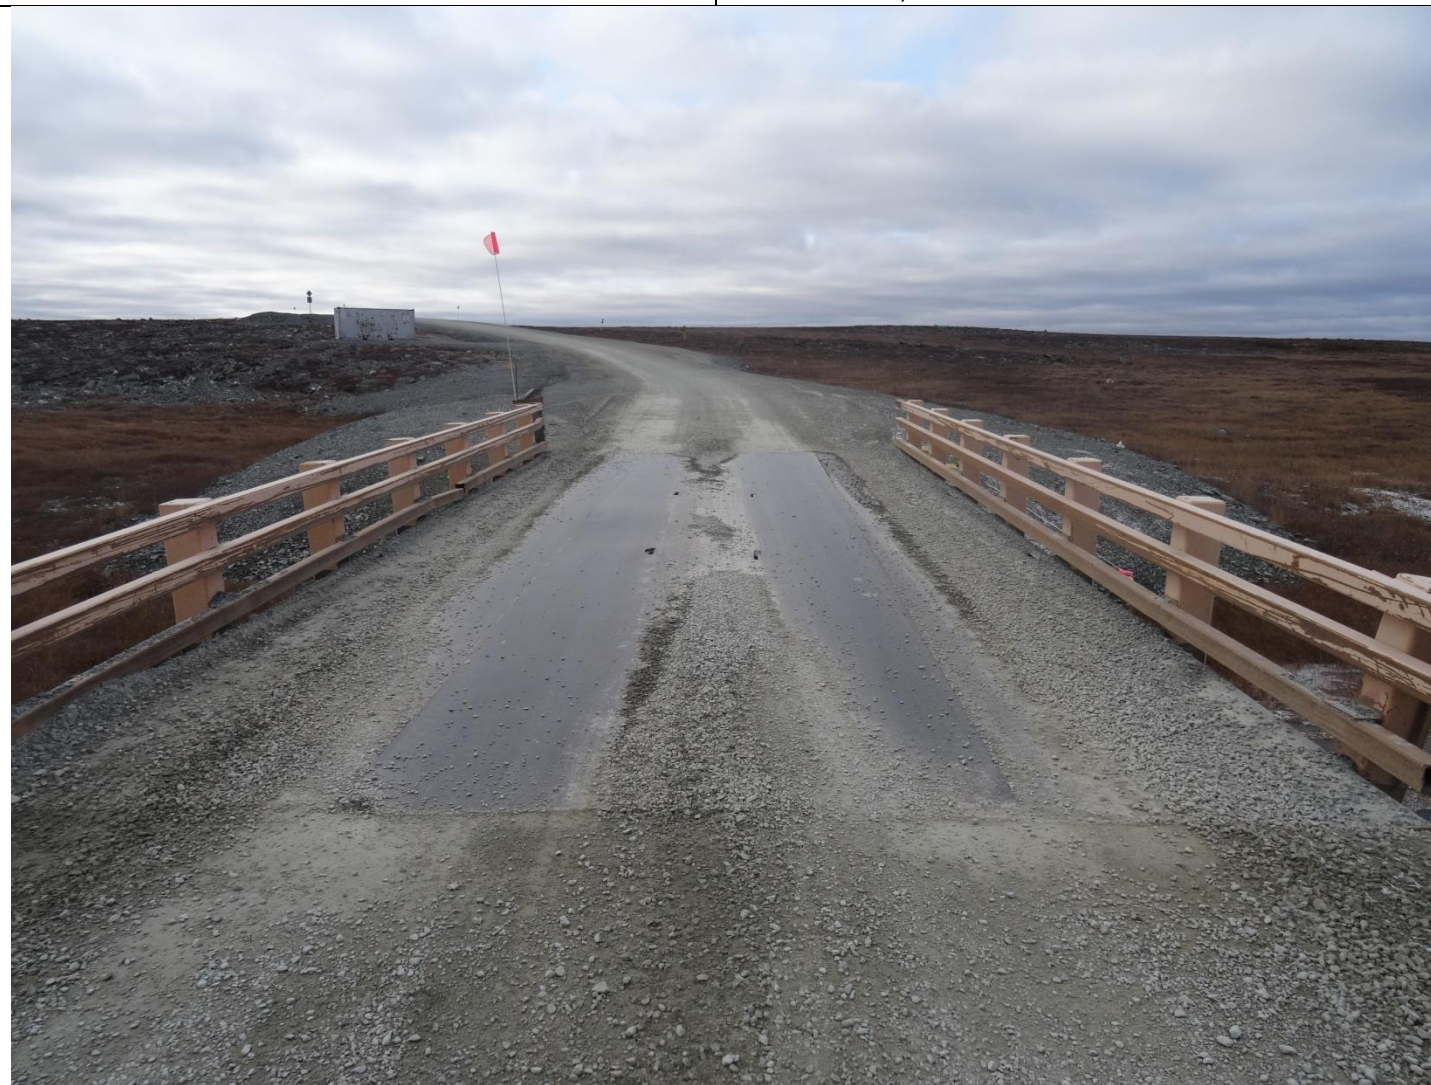
Photo 15

Bridge at KM 62.

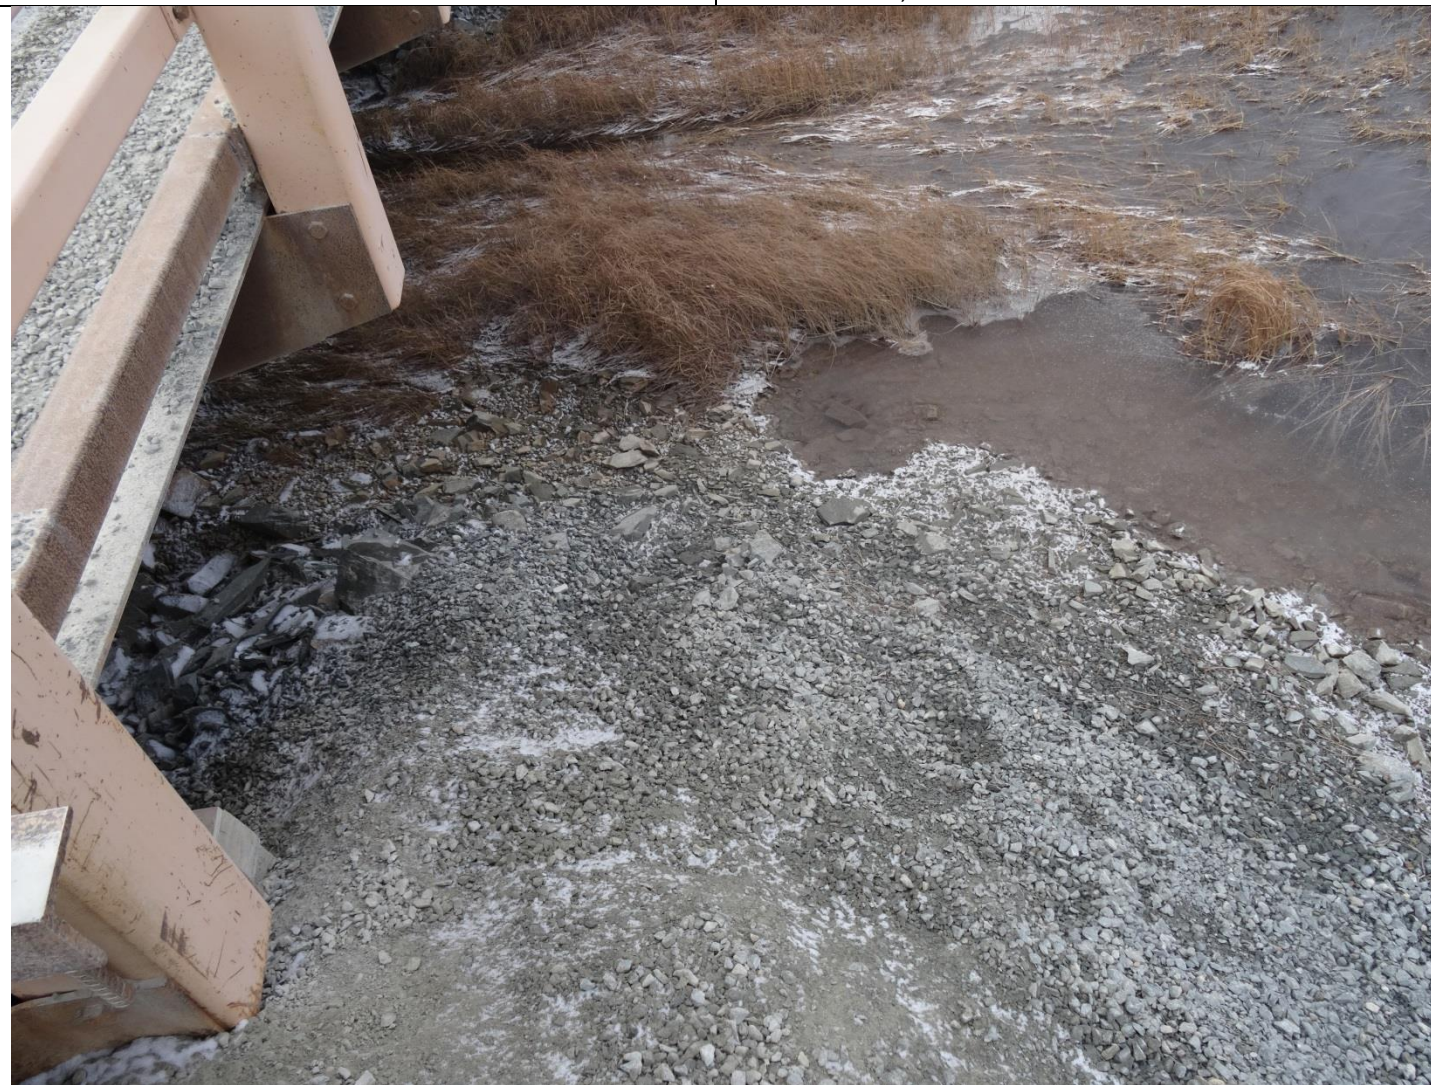
Photo 16

Bridge at KM 62.

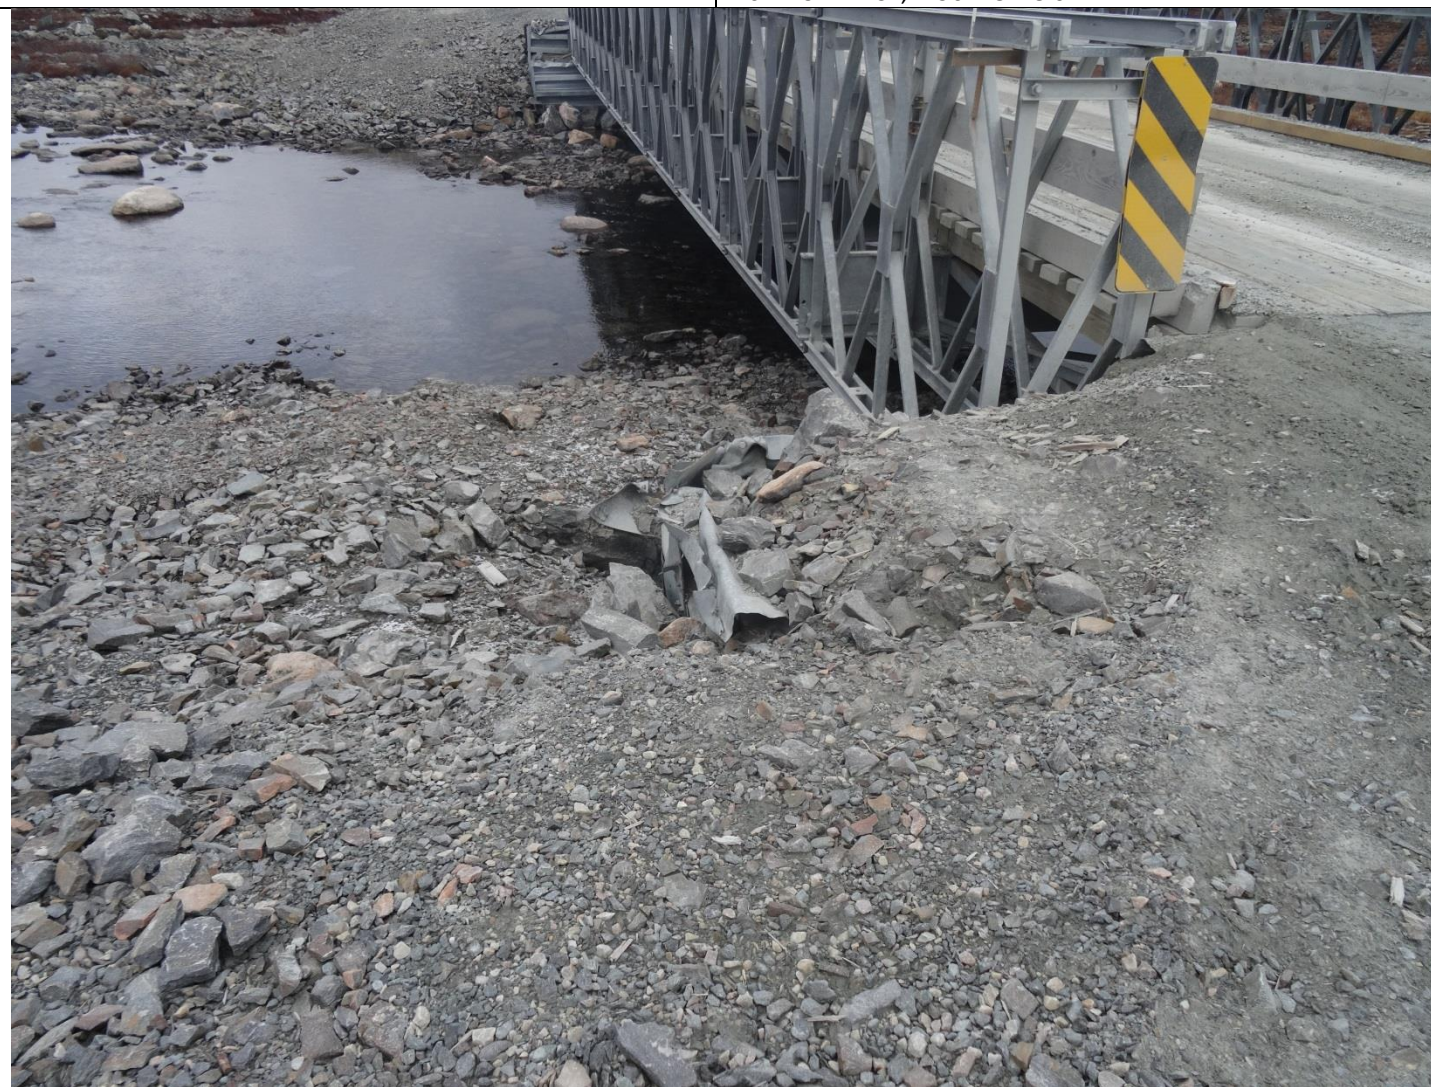
Photo 17

Bridge at km 69.

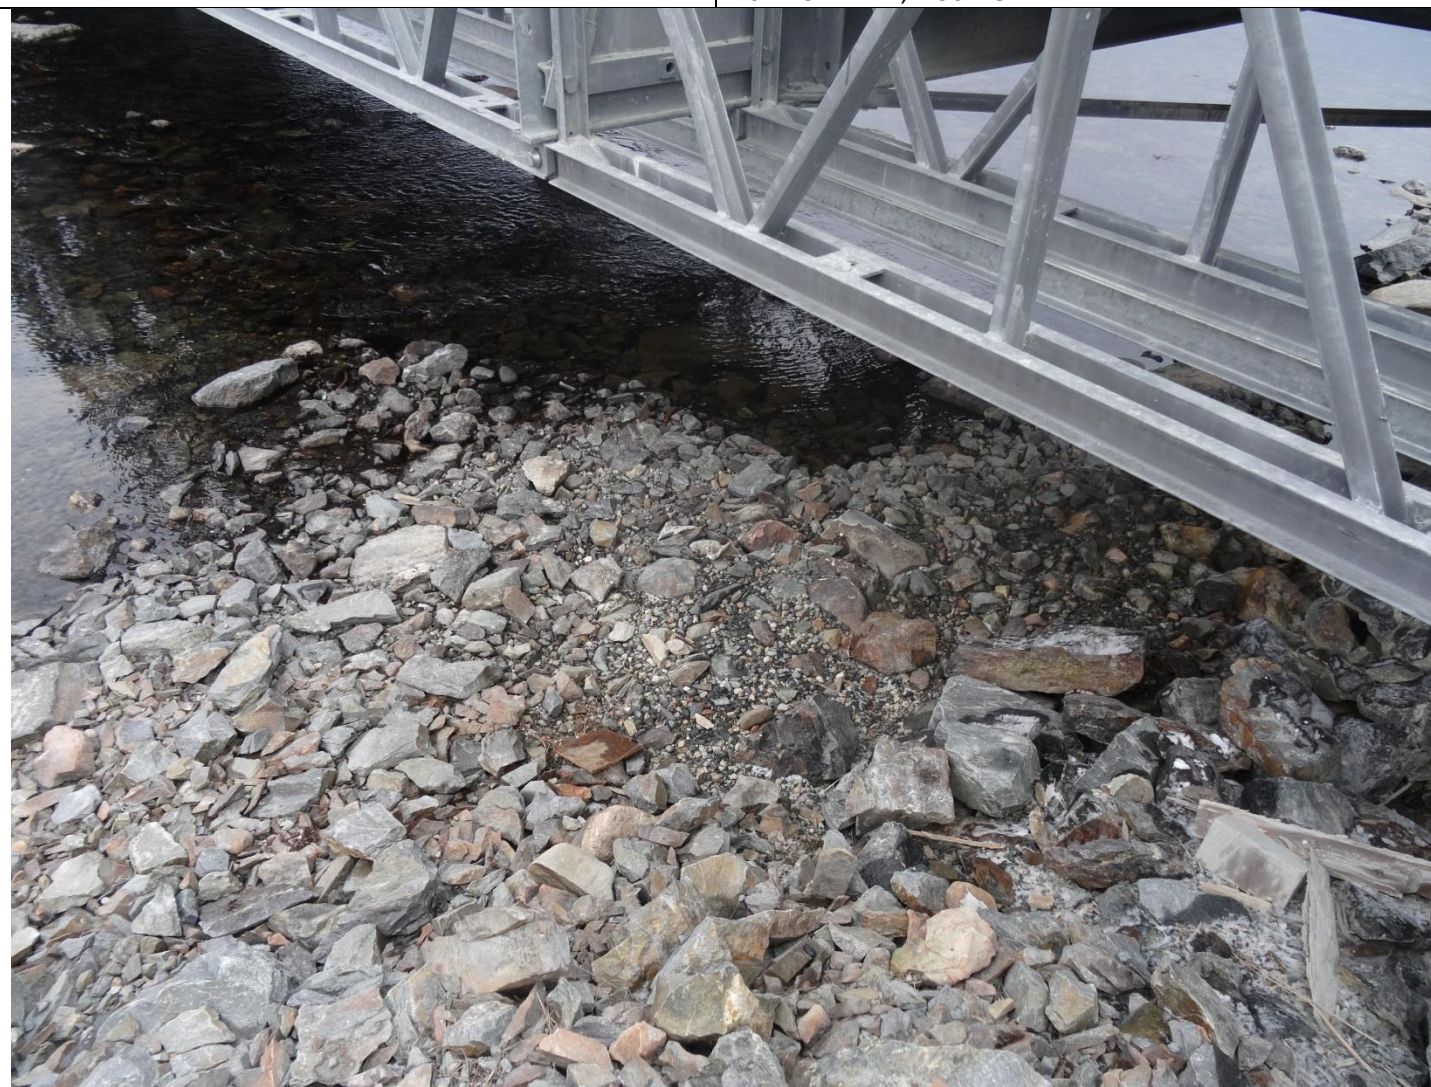
Photo 18

Bridge at KM 69.

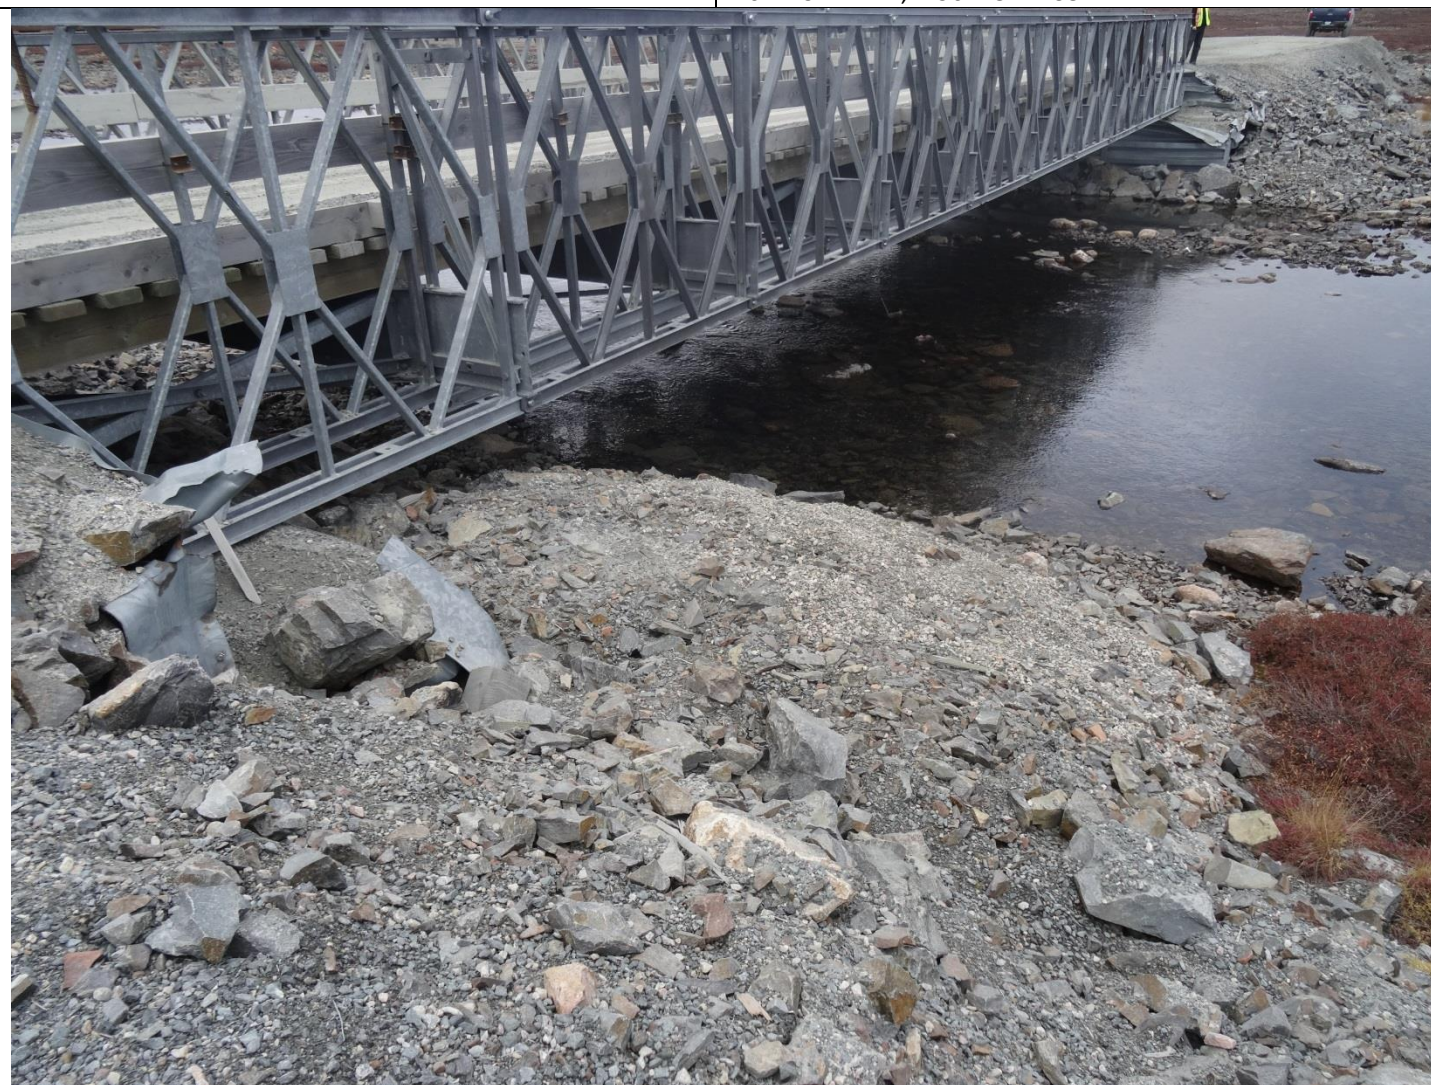
Photo 19

Bridge at KM 69.

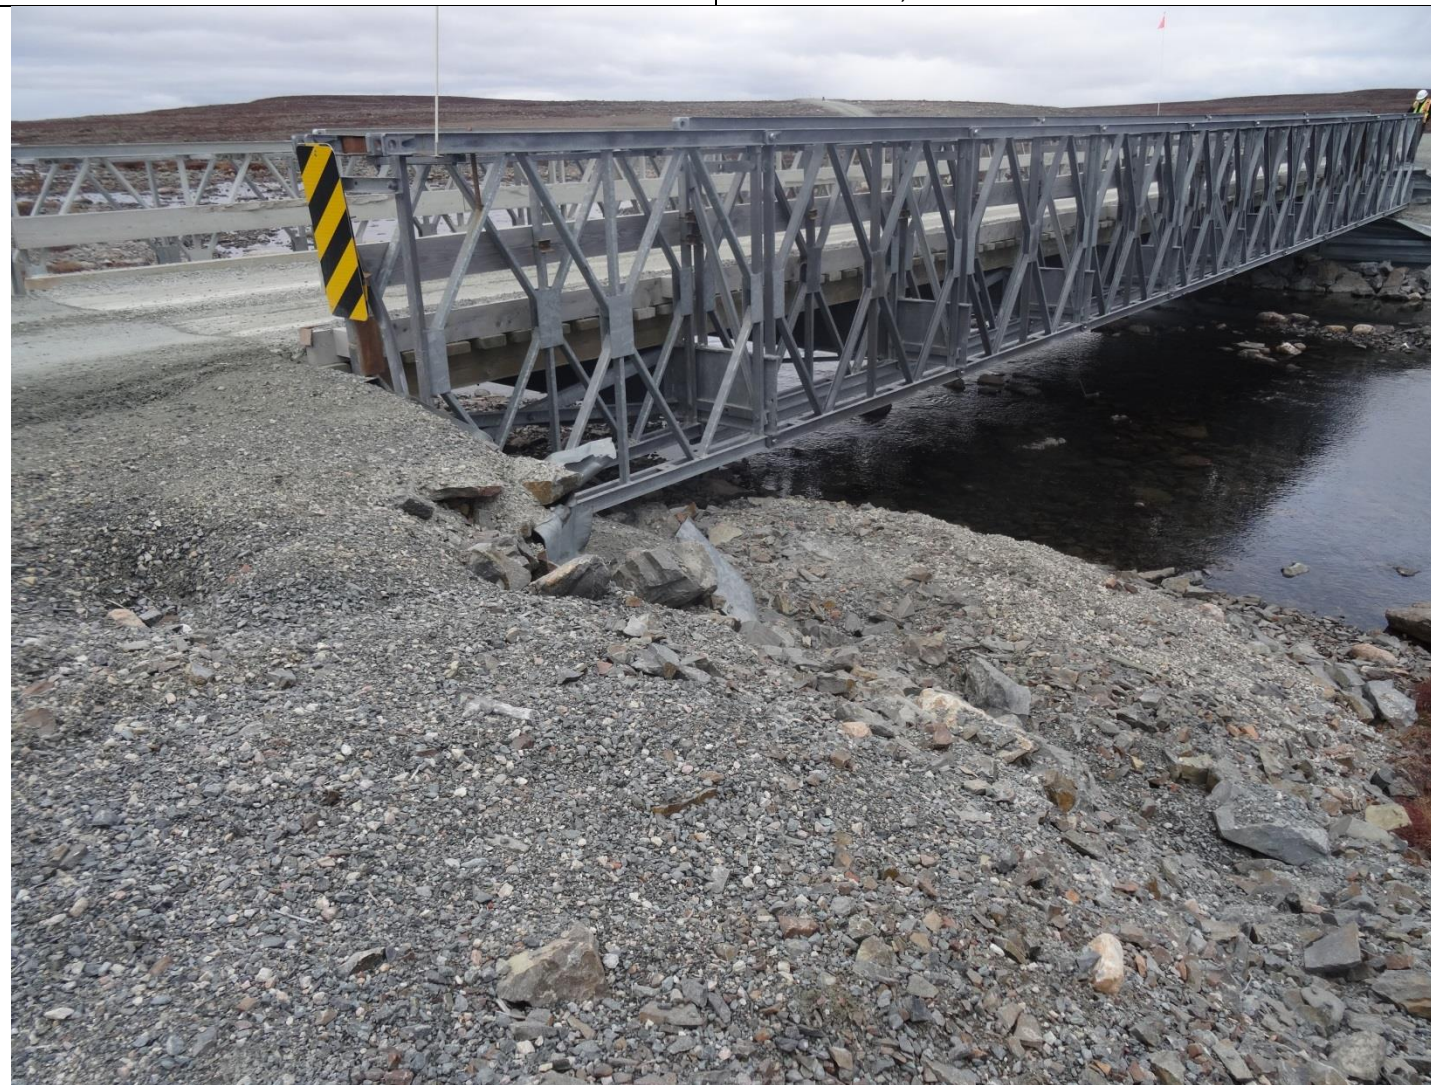
Photo 20

Bridge at KM 69.

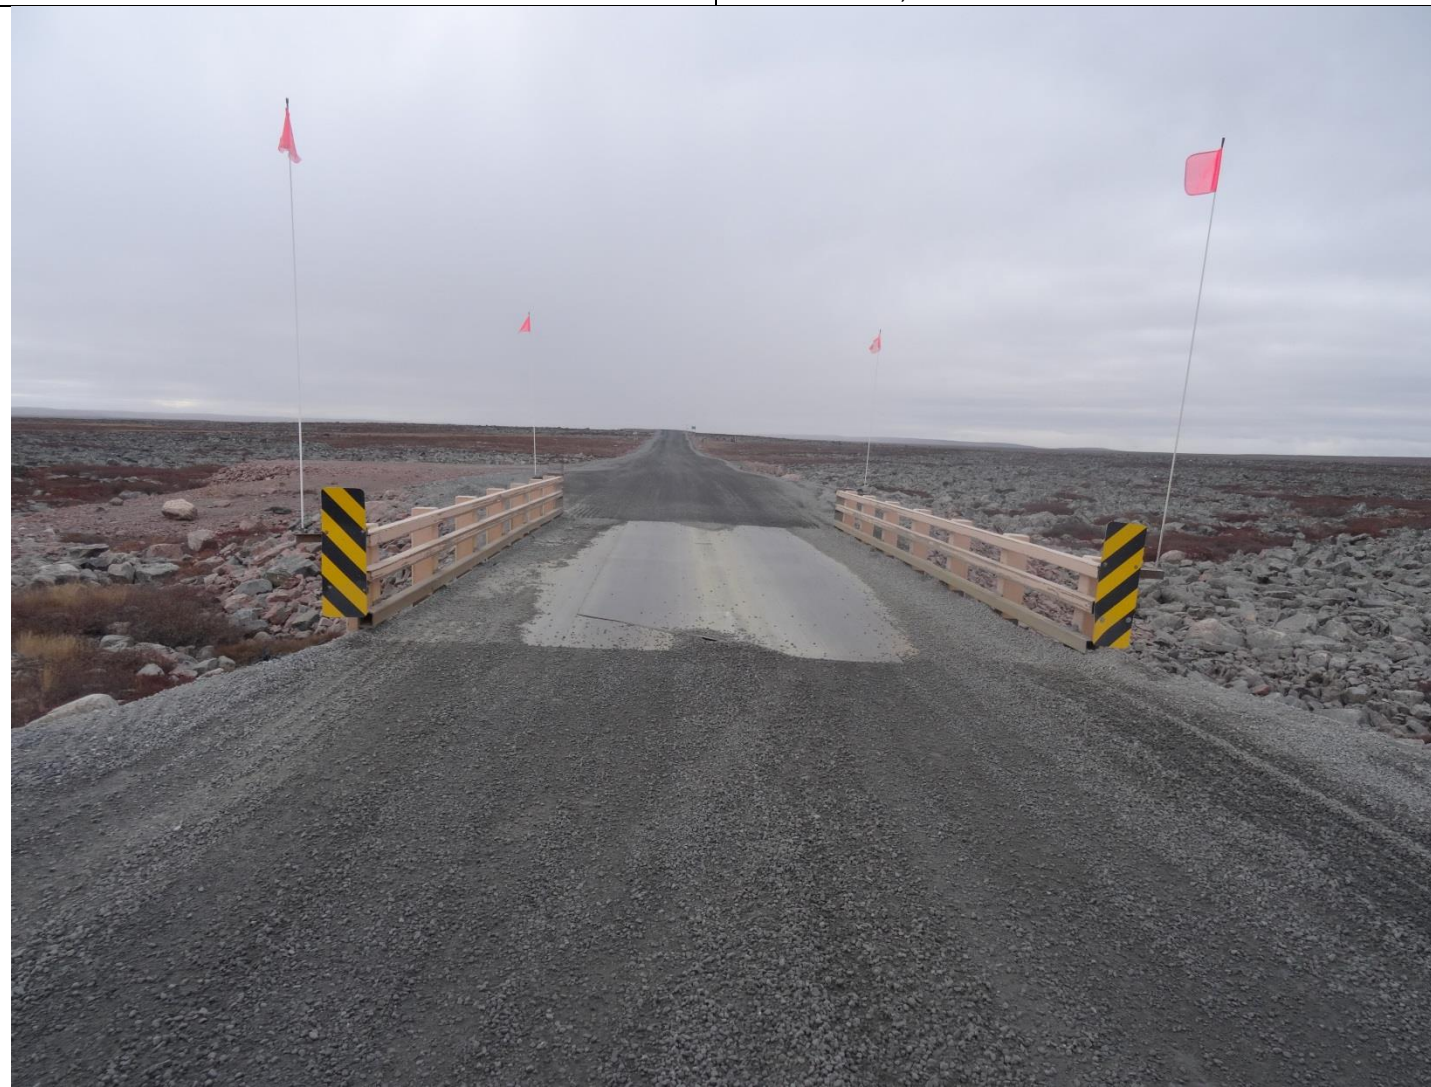
Photo 21

Bridge at KM 74.

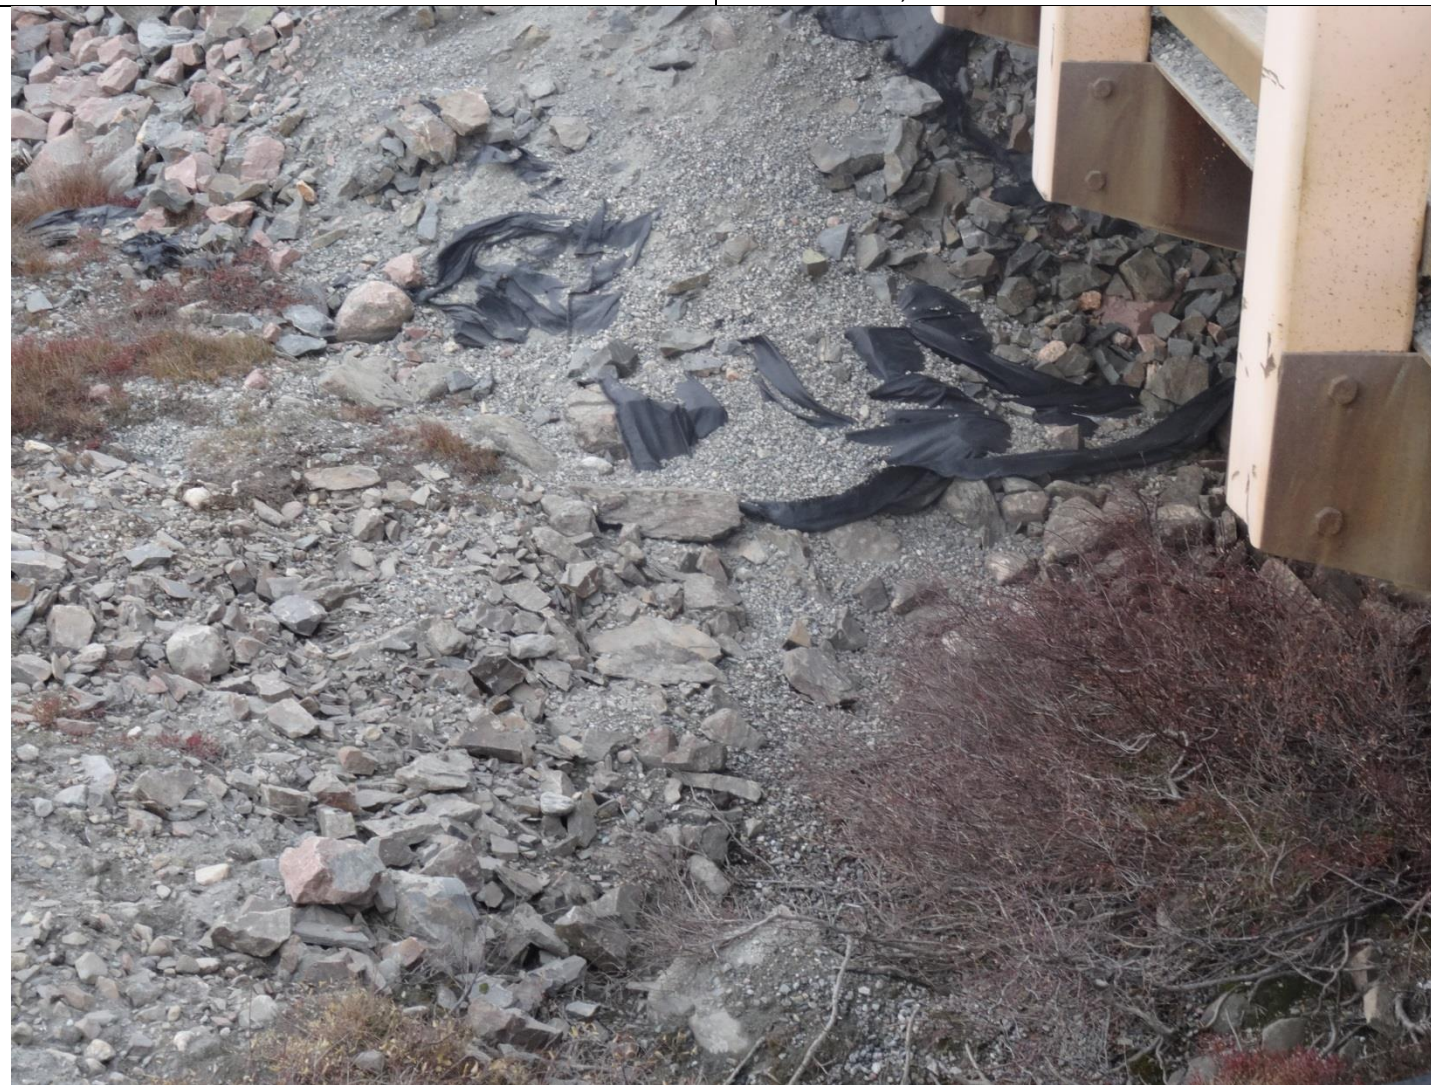
Photo 22

Bridge at KM 74.

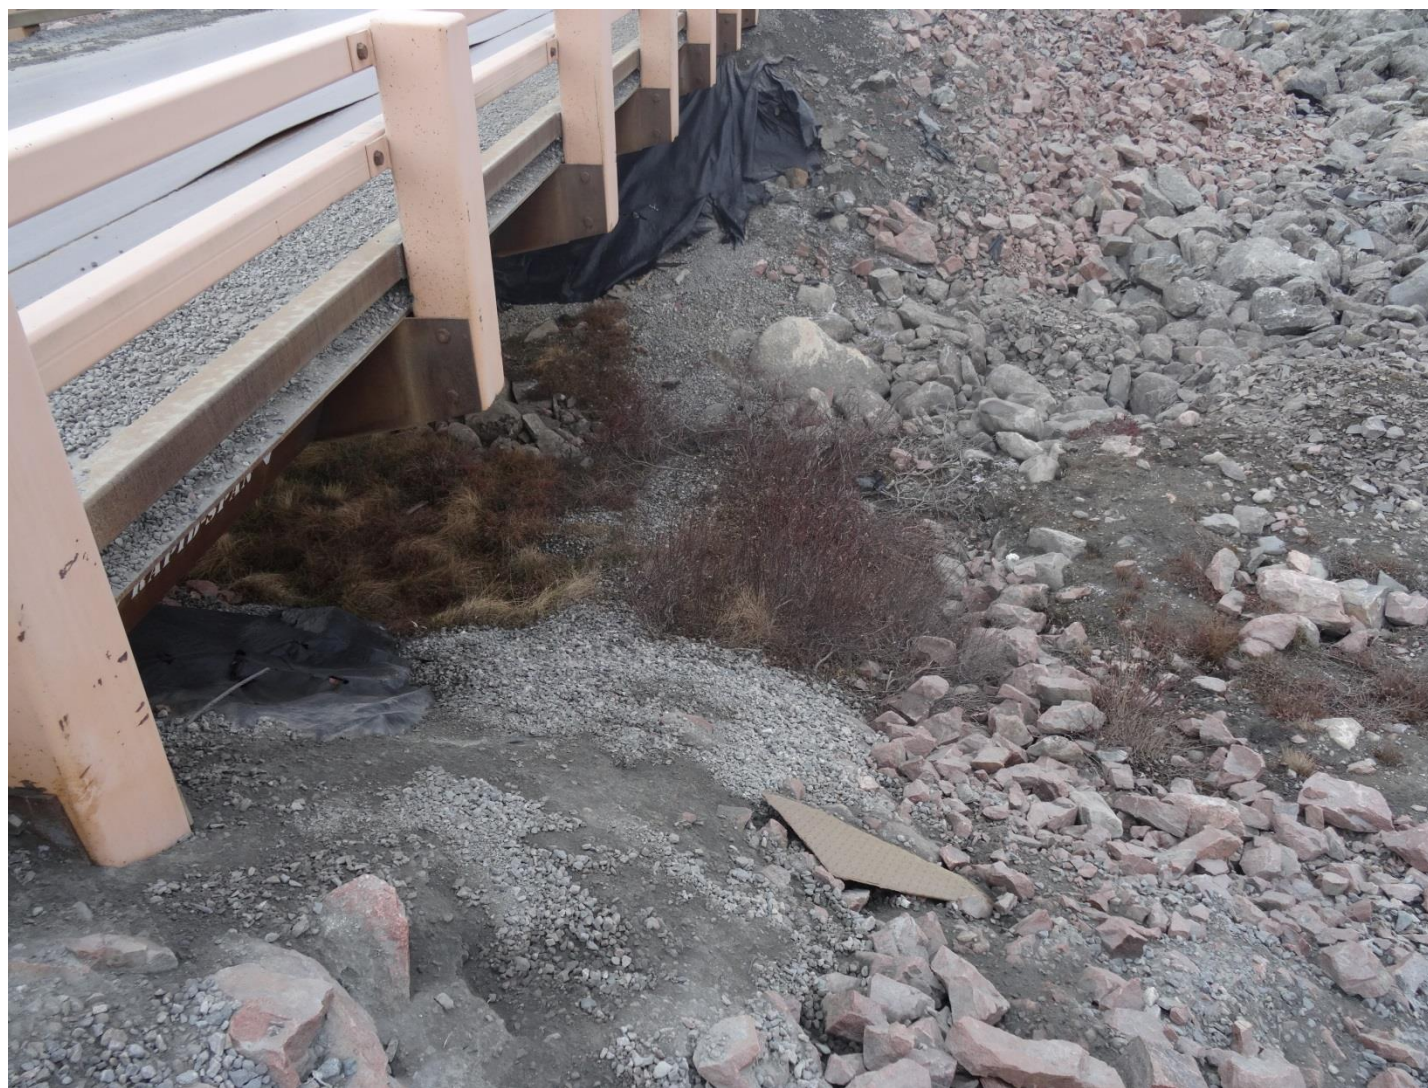
Photo 23

Bridge at KM 74.

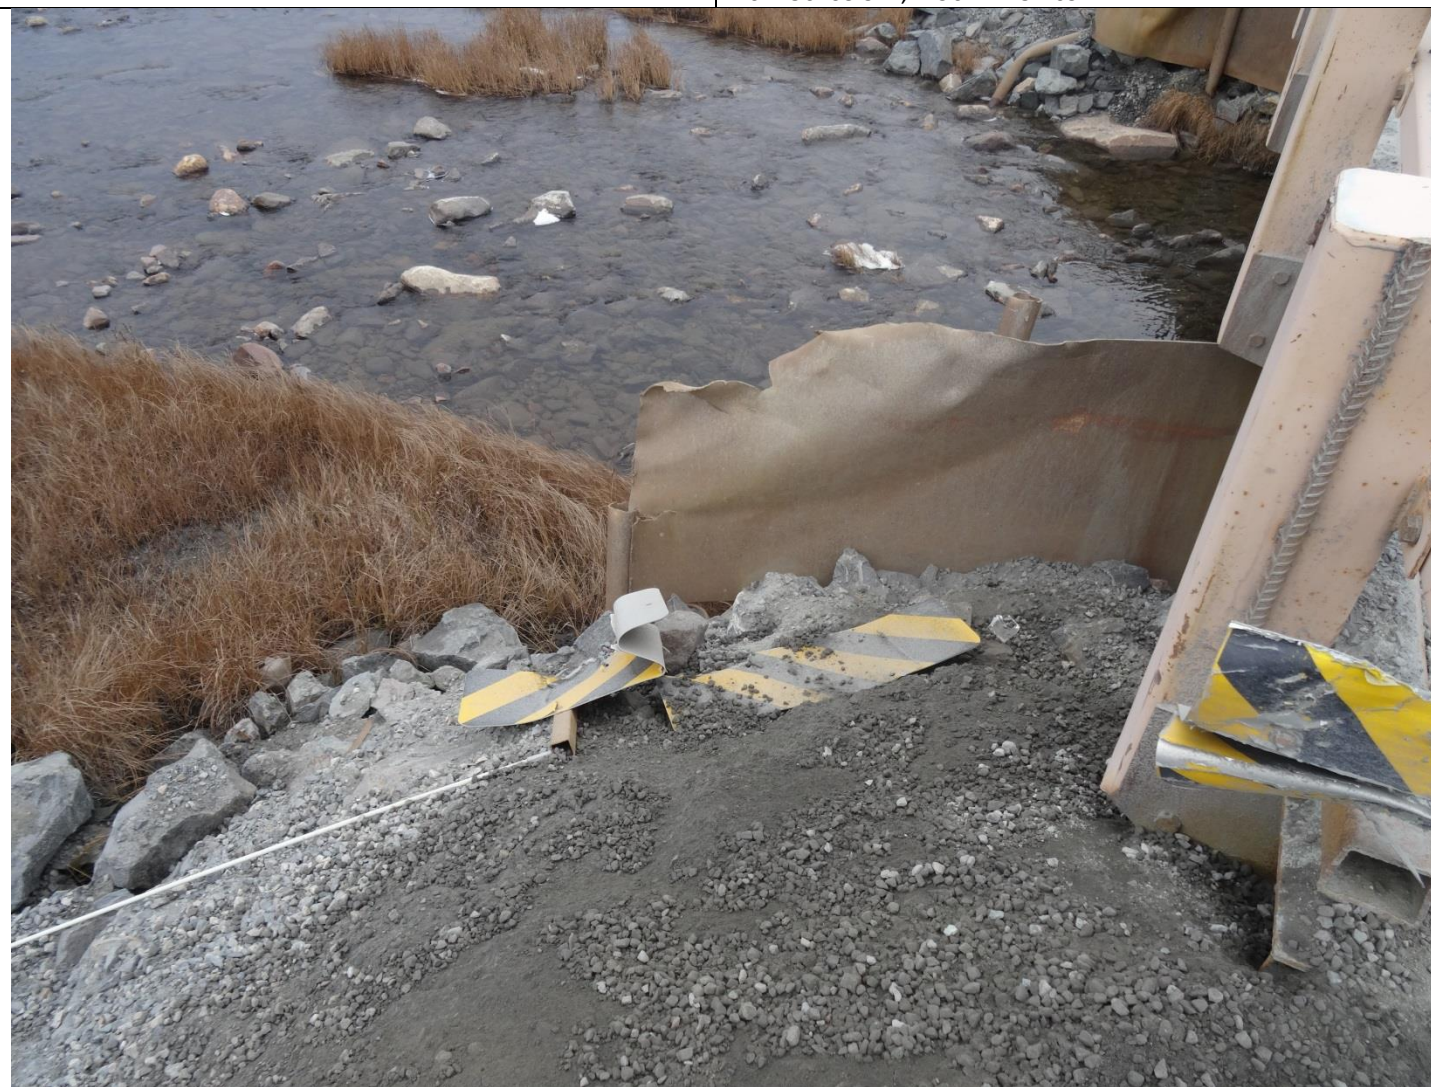
Photo 25

SECTION 1	<input checked="" type="checkbox"/> Comments (s. __)	<input type="checkbox"/> Non-Compliance with Act or Licence (s. __)	<input type="checkbox"/> Action Required (s. __)
<p>On October 1st, 2020 an inspection was conducted of the Meadowbank Water Licence 2AM-MEA1530 by Crown Indigenous Relations and Northern Affairs Canada (CIRNAC)'s Resource Management Officer (RMO), Jakob VOISEY. The inspection was conducted to ensure compliance with applicable terms and conditions of the water licence.</p> <p>PRELIMINARY NOTES</p> <ul style="list-style-type: none"> The inspection was conducted without an Agnico Eagle Mines Limited representative due to COVID-19 restrictions that were in place at the time of the inspection. RMO Christine WILSON accompanied RMO VOISEY while conducting this water licence inspection. <p>OBSERVATIONS</p> <ol style="list-style-type: none"> KM 9 Bridge, no concerns at this water crossing. Guard stone has been used to prevent erosion where appropriate. KM 17 Bridge, concerns related to erosion and deposition of sediment into the water course. The abutment appears to be damaged, allowing a small amount of sediment is being washed down into the water course (photo 1-8). Erosions prevention measures should be implemented. KM 23 Bridge, concern related to erosion and deposition of sediment into a water course. Erosion prevention measures and maintenance of these prevention measure should be implemented at this water crossing (photo 9-12). KM 62 Bridge, no concerns related to this water crossing (photo 13-16). KM 69 Bridge, concern related to erosion and deposition of sediment into the water course. The abutment appeared to be damaged. There is a pile of gravel/material found at the foot of the abutment. Erosion prevention measures and maintenance of these prevention measure should be implemented annual to prevent sediment from entering the water course (photo 17-20). KM 74 Bridge, concern related to erosion and deposition of sediment into a water course. Erosion prevention measures and maintenance of these prevention measure should be implemented at this water crossing (photo 21-23). KM 83 Bridge, concern related to erosion and deposition of sediment into a water course. Erosion prevention measures and maintenance of these prevention measure should be implemented at this water crossing (photo 24-26).

Bridge at KM 83.

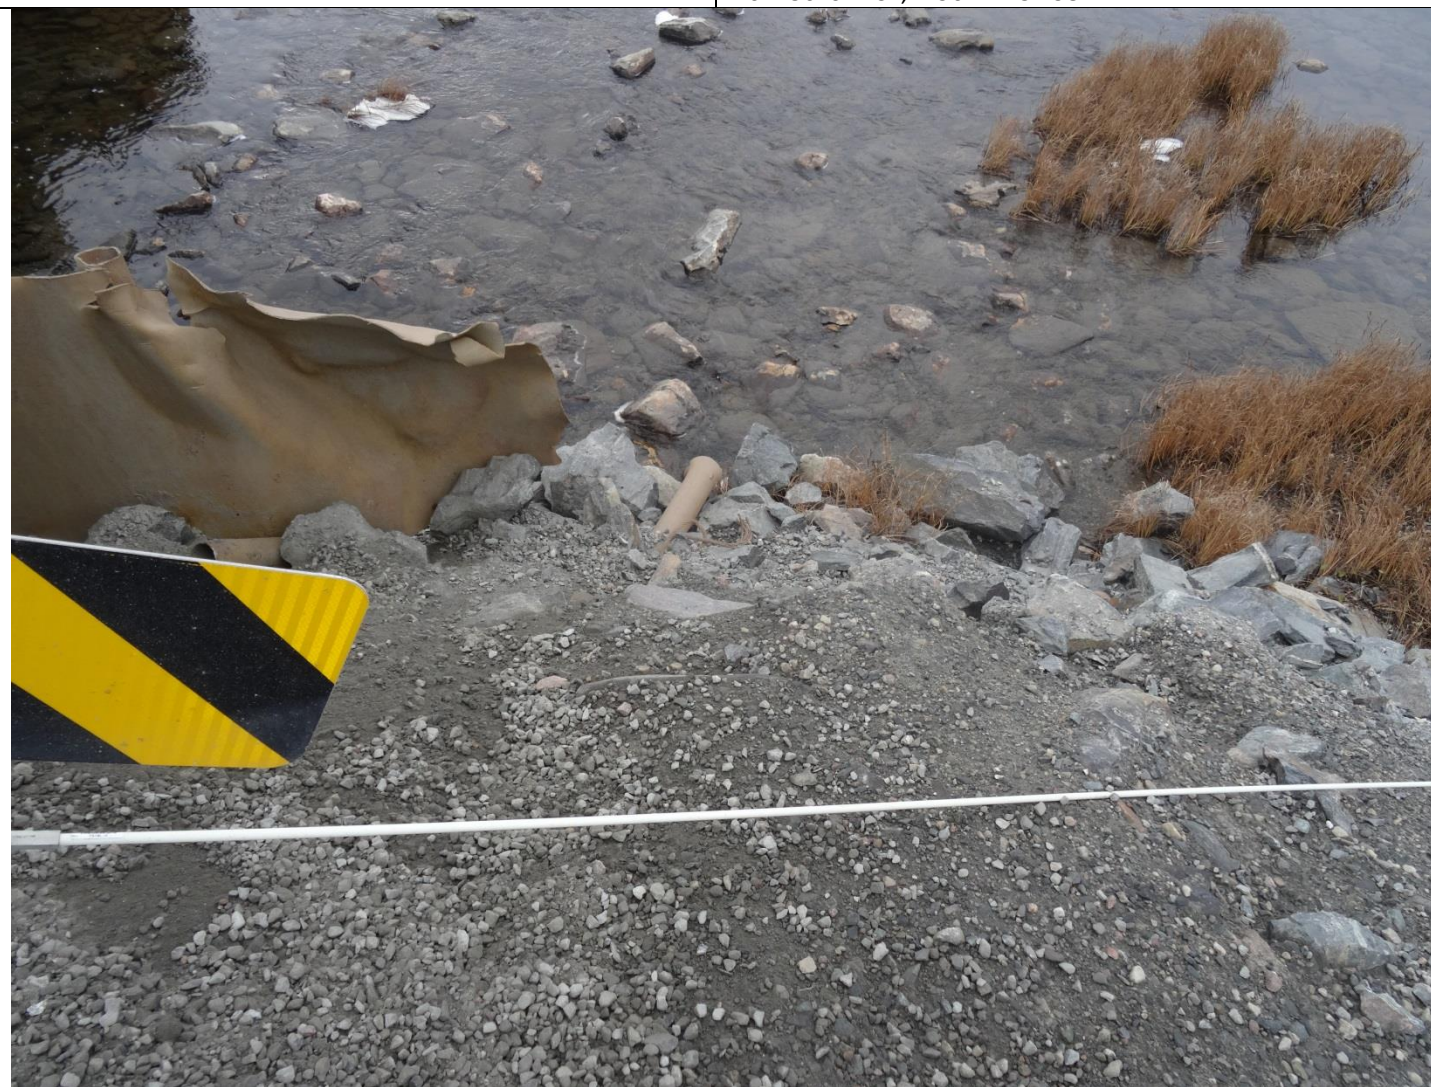
Photo 26

Bridge at KM 83.
