WATER LICENCE INSPECTION FORM

Licensee	Licensee Representative
Agnico-Eagle Mines Limited	Eric Haley
Licence No. / Expiry	Representative's Title
2AM-MEA1530 / March 27 th 2030	Environment General Supervisor
Date of Inspection	Inspector
August 10 th , 2021	Atuat SHOULDICE
Activities Inspected	
<input checked="" type="checkbox"/> Camp	<input type="checkbox"/> Drilling
<input type="checkbox"/> Roads/Hauling	<input checked="" type="checkbox"/> Mining
	<input type="checkbox"/> Construction
	<input type="checkbox"/> Reclamation
	<input type="checkbox"/> Fuel Storage
	<input type="checkbox"/> Other:

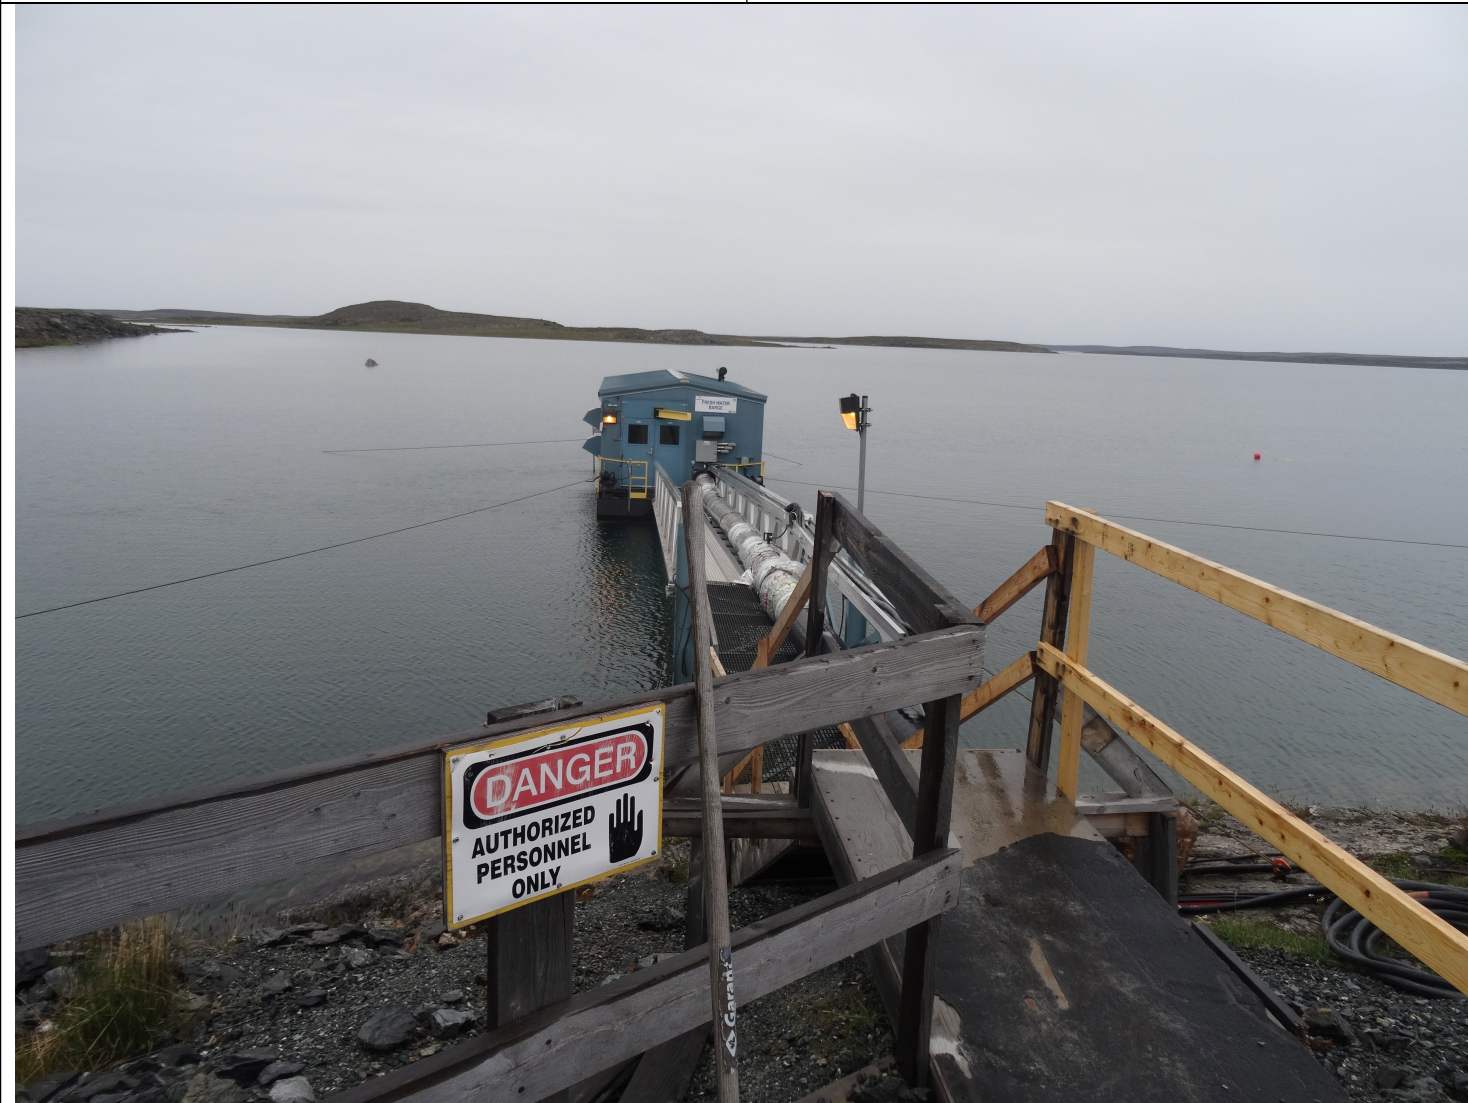
PHOTO LOG			
Date:	Authorization Number:	Camera/Model:	Inspector
August 10 th 2021	2AM-MEA1530	Sony DSCHX50V	RMO Shouldice
Photo No.	Lat/Long (DD.MM.SS.SS, NAD83)		
Photo 1	N65° 1' 9.33", W96° 5' 3.52"

Description:			
Fresh water barge.

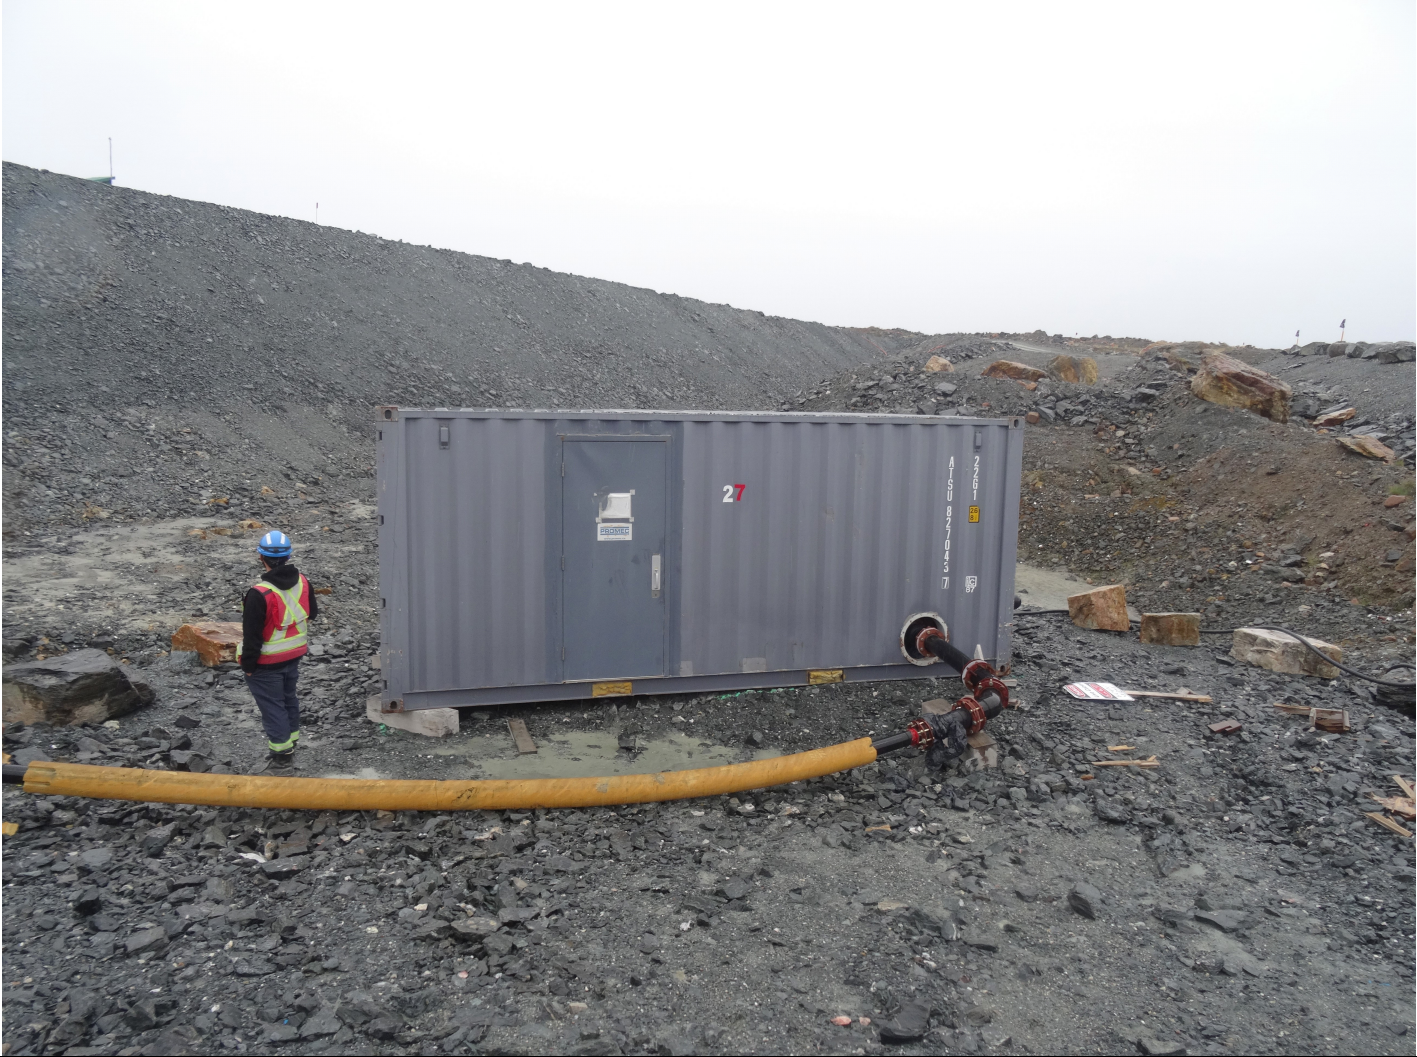
Photo 2

Saddle Dam 3.

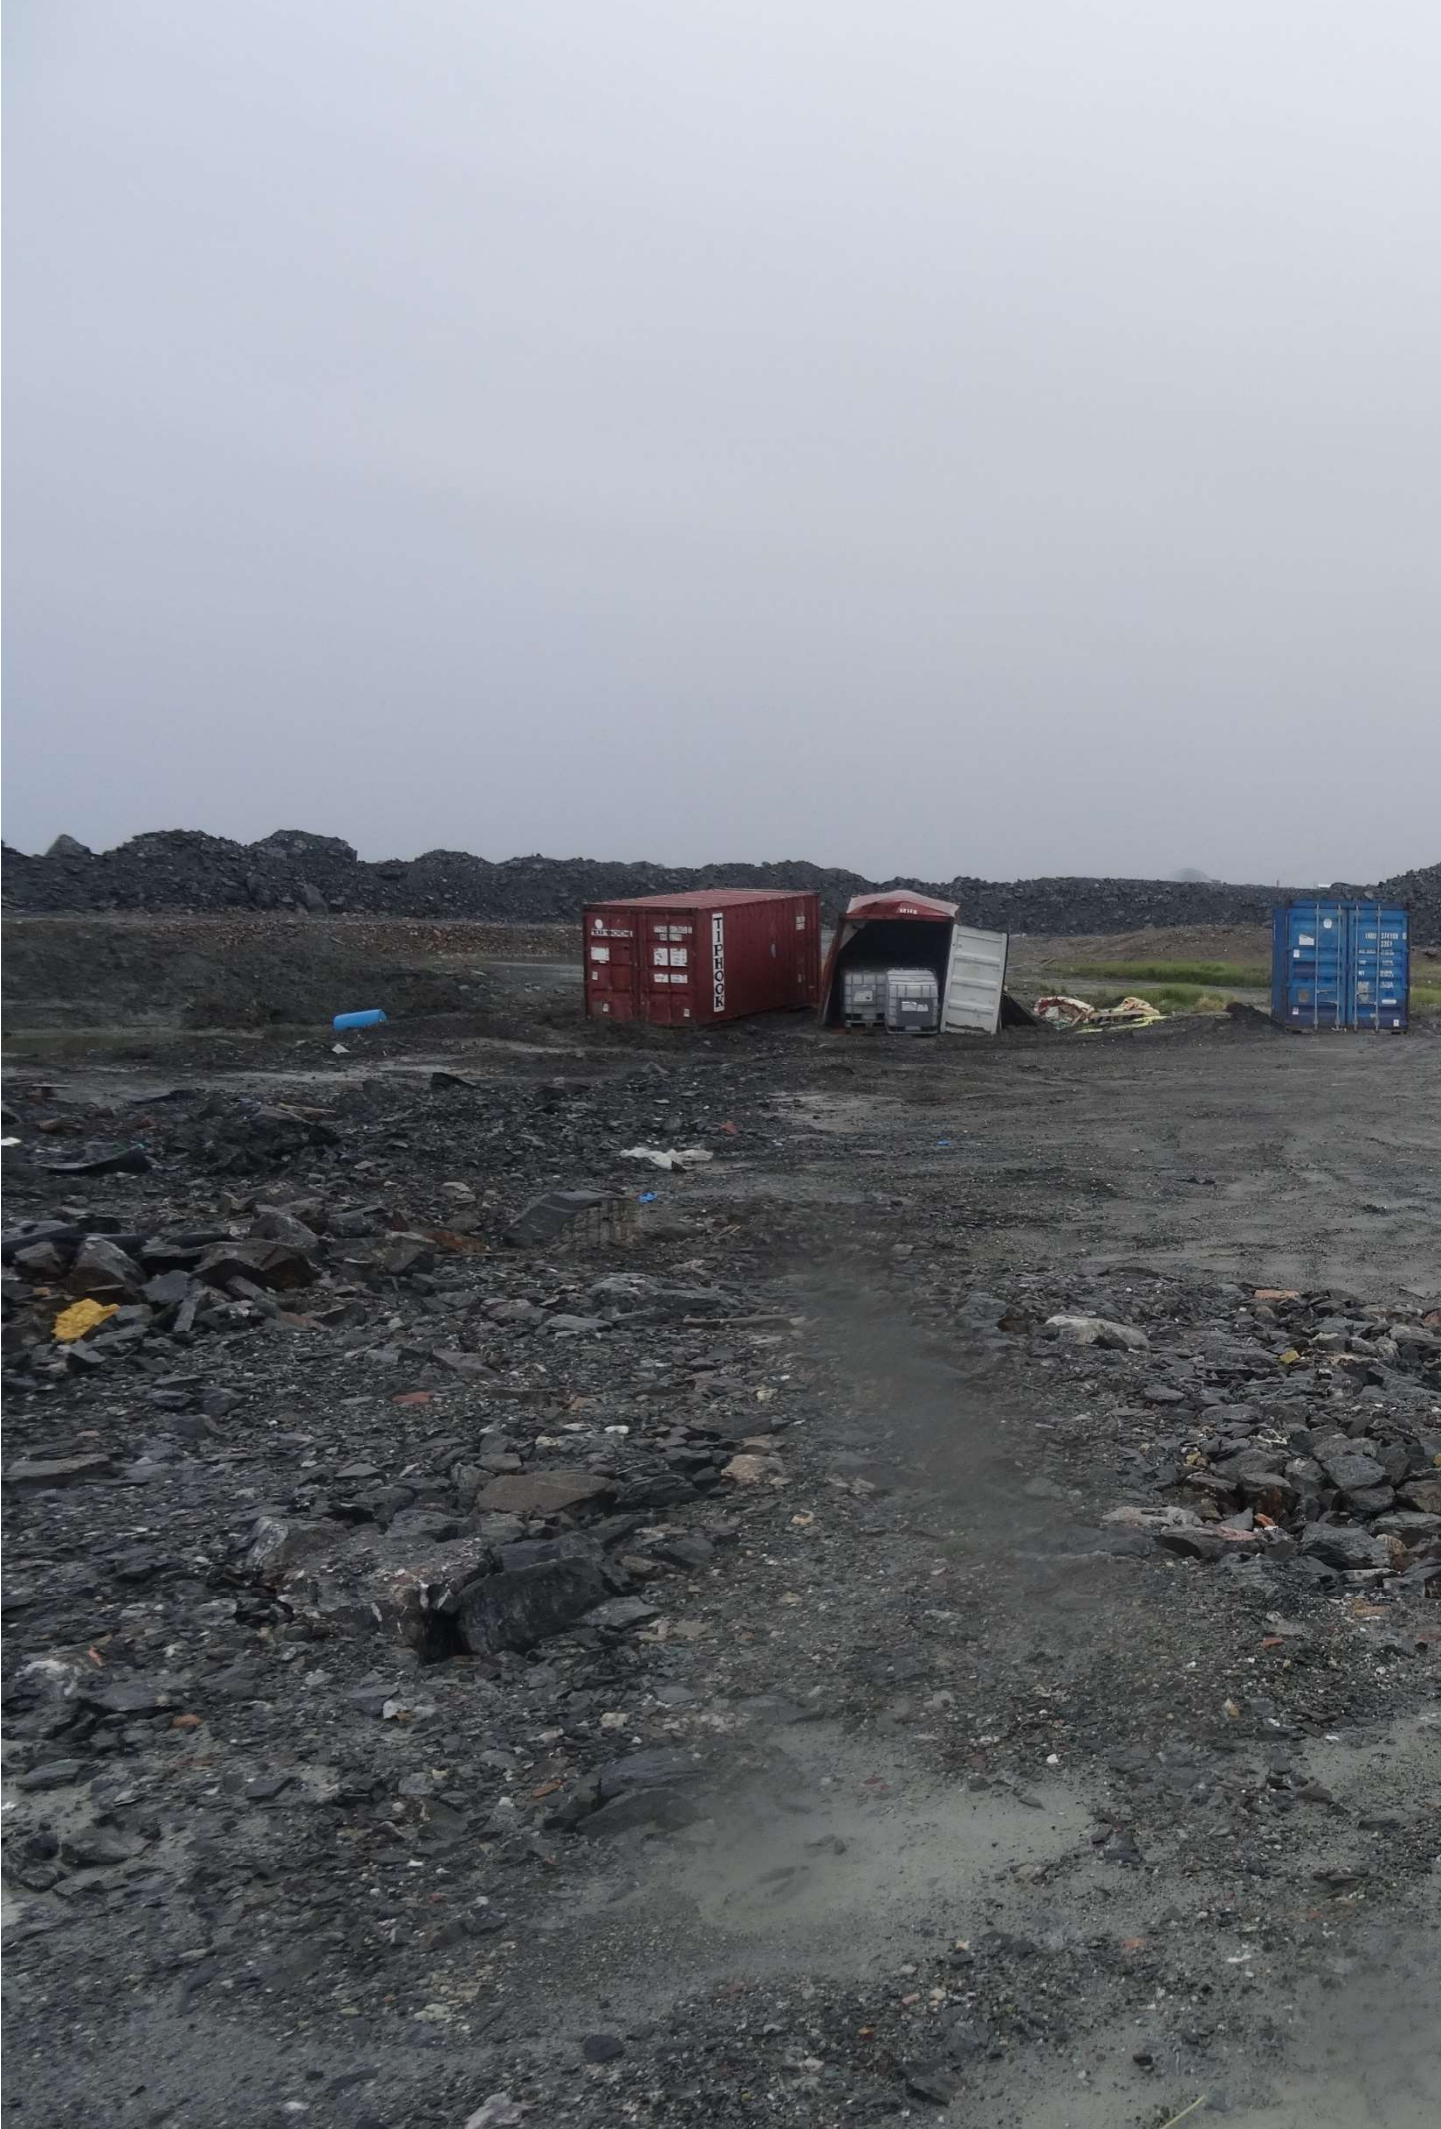
Photo No.	Lat/Long (DD.MM.SS.SS, NAD83)
Photo 3	N65° 2' 26.9", W96° 5' 2.34"

Description:
Progressive reclamation work at the North cell Tailings storage facility. Top of photo.

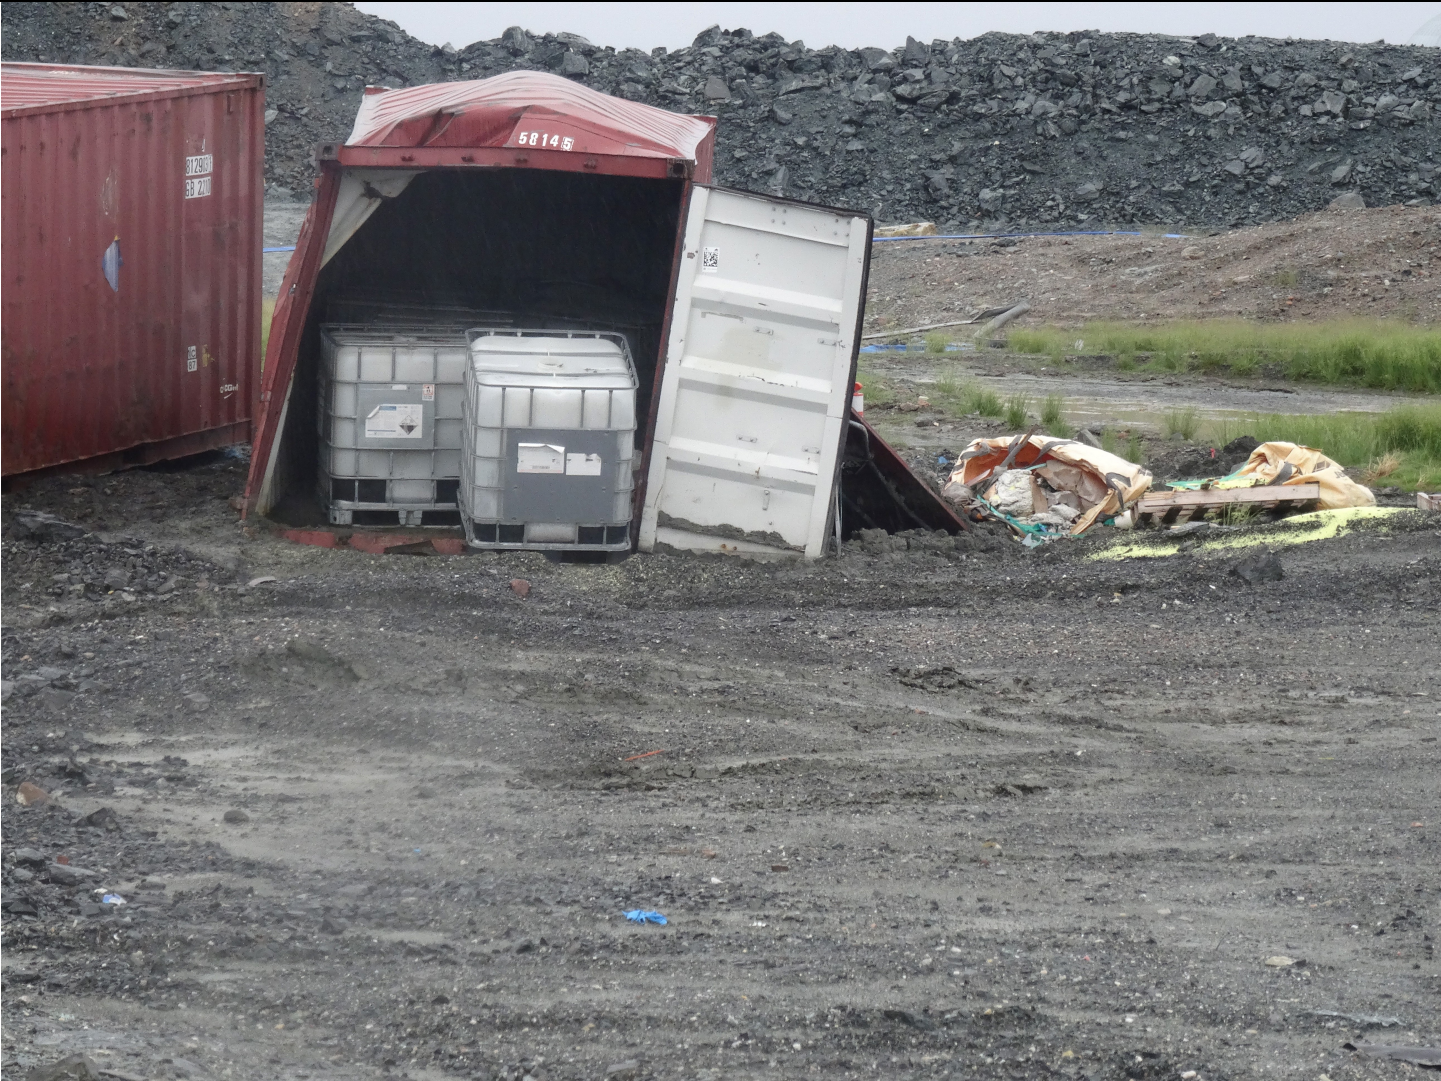
Photo 4

A yellow material is spilled onto the ground around the seacans.

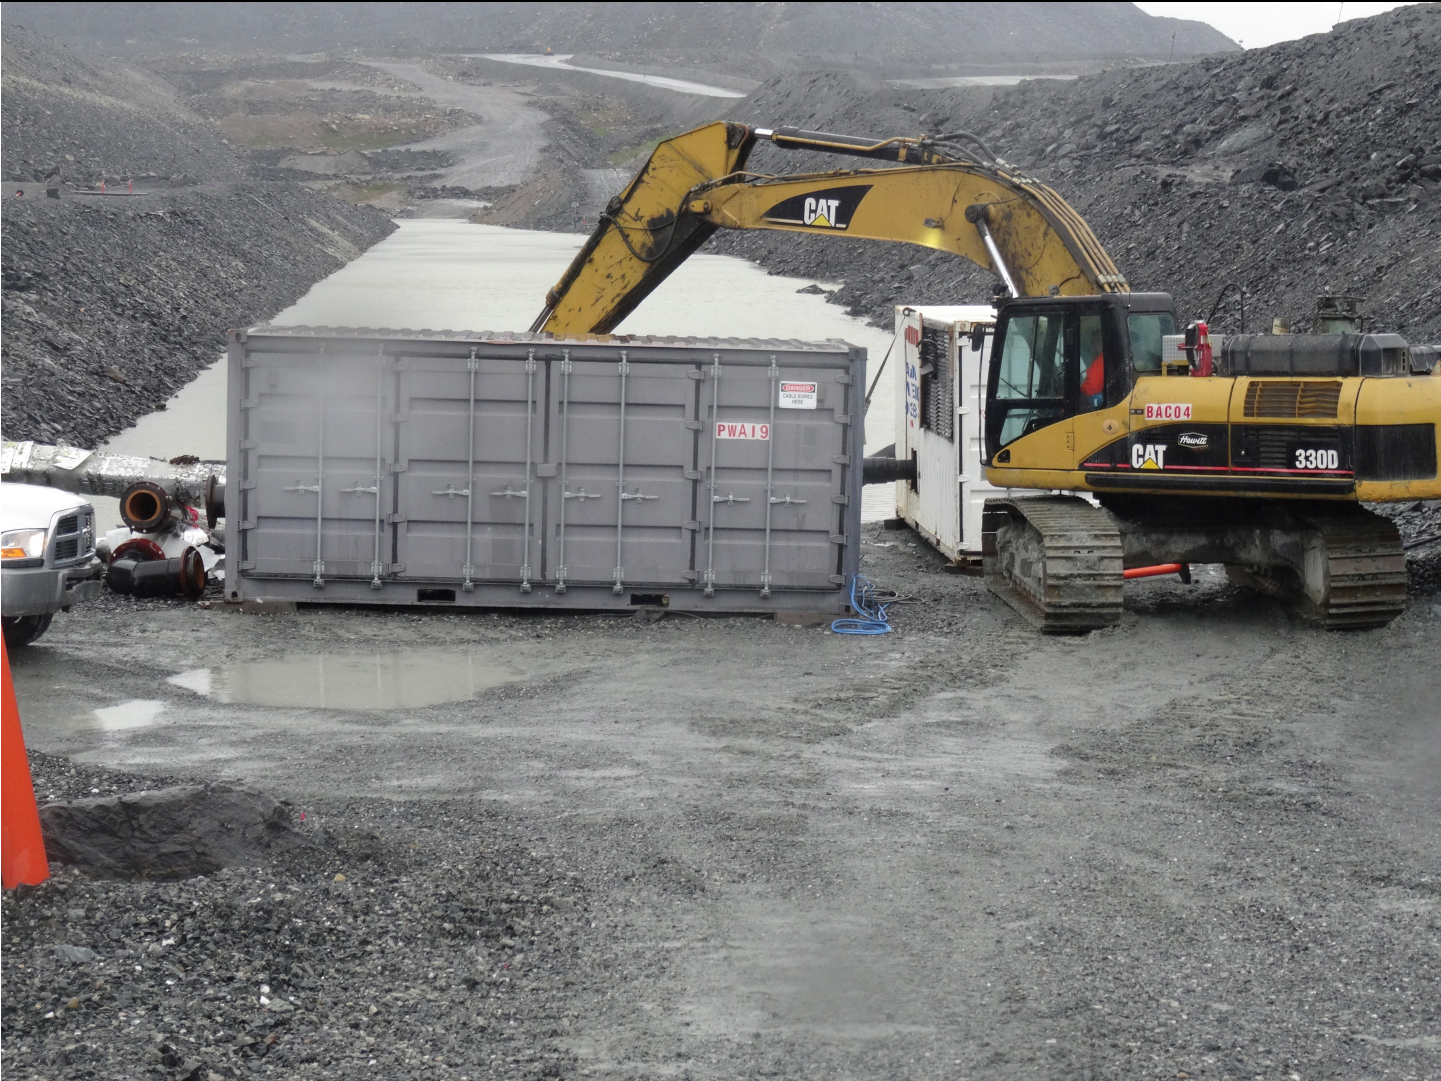
Photo 5

The Central Dike Seepage monitoring station (ST-S-5).

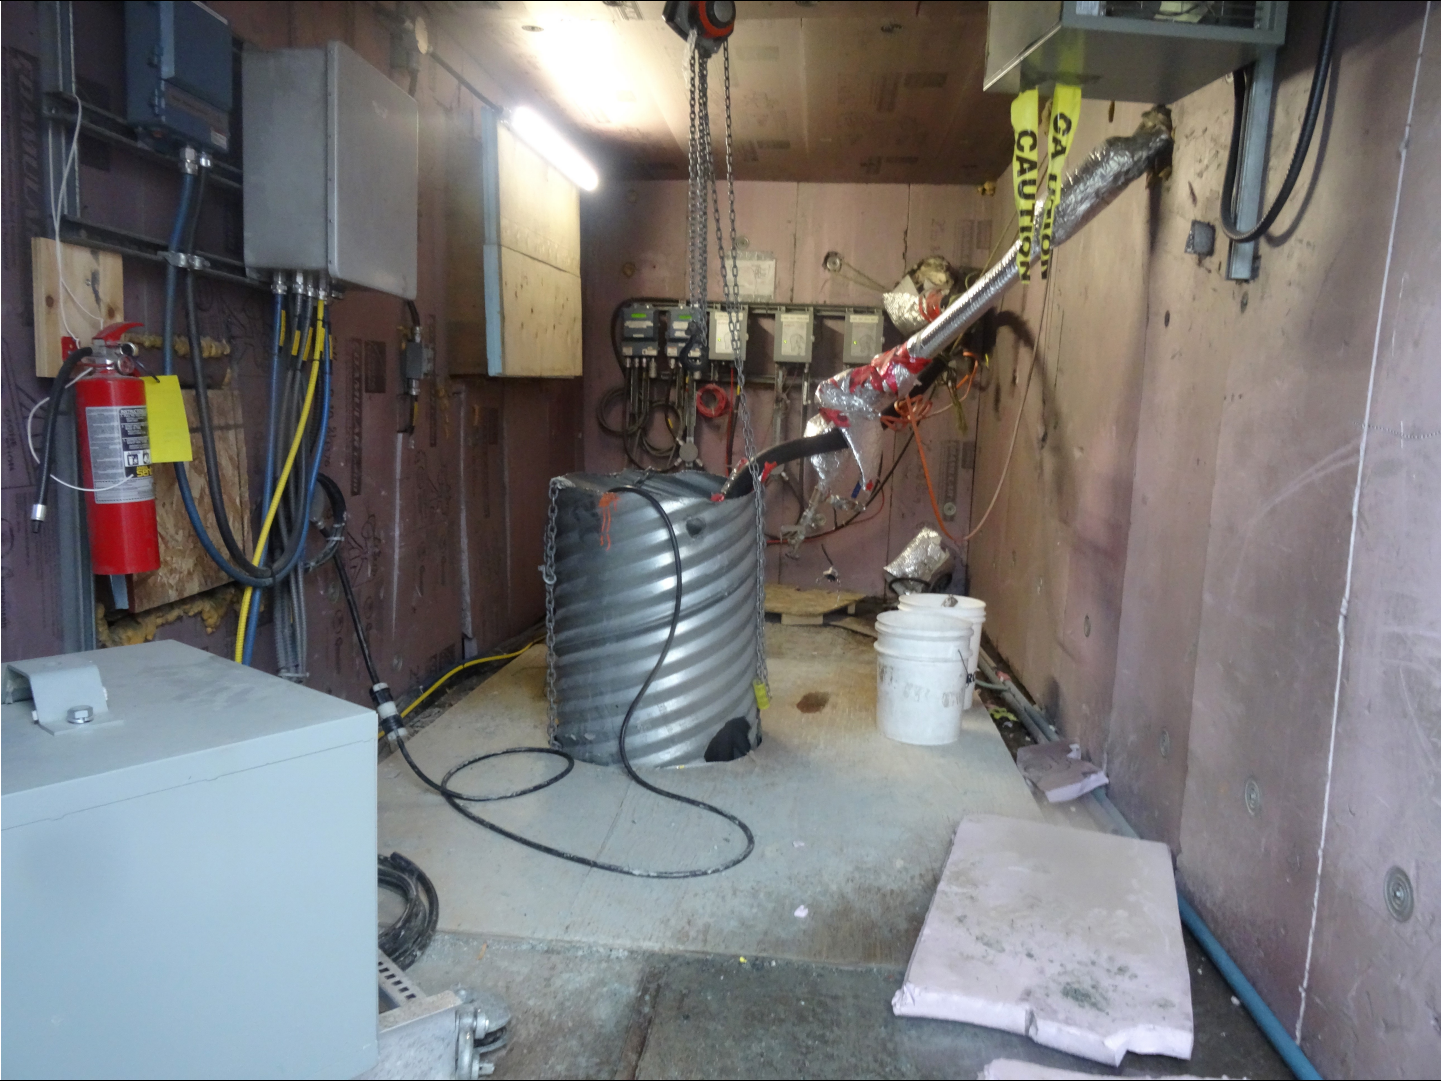
Photo 5

East Dike monitoring station.
