WATER LICENCE INSPECTION FORM

☒ Original
☐ Follow-Up Report

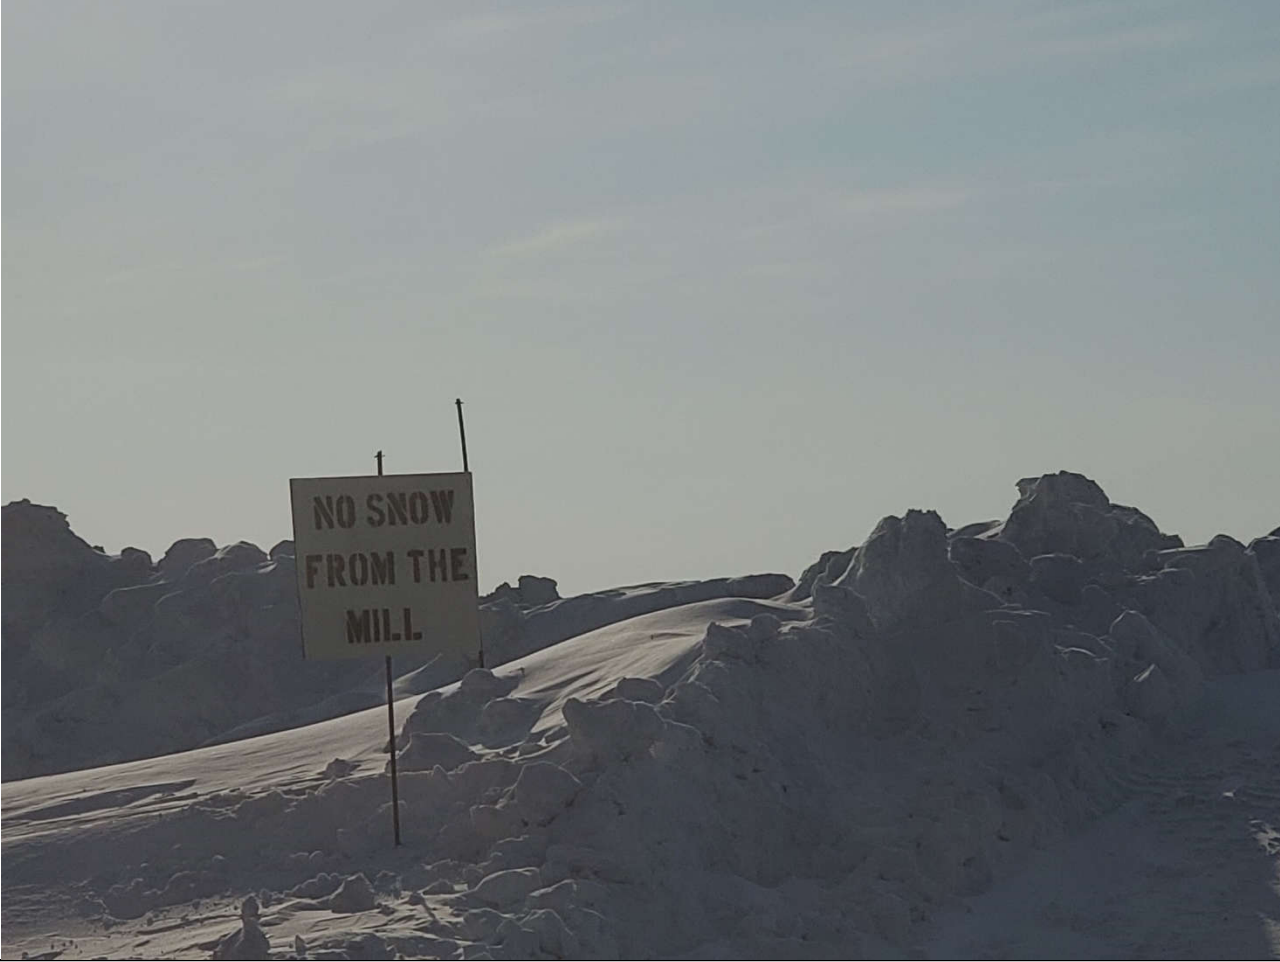
Description:			
Signage installed to inform operators snow from around Mill shall not be brought to this location.

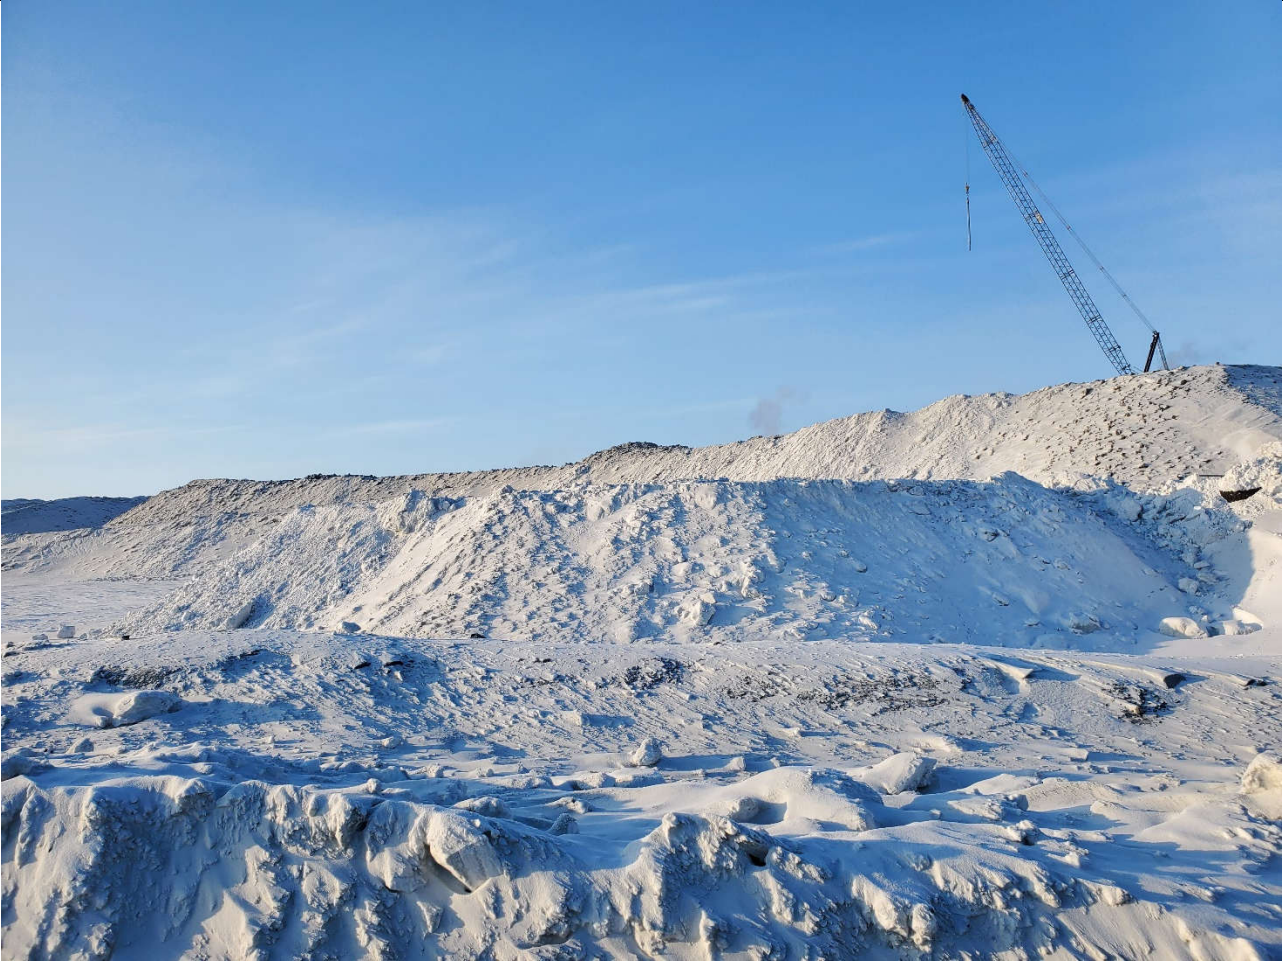
Description:			
Snowdump at Stormwater pond.

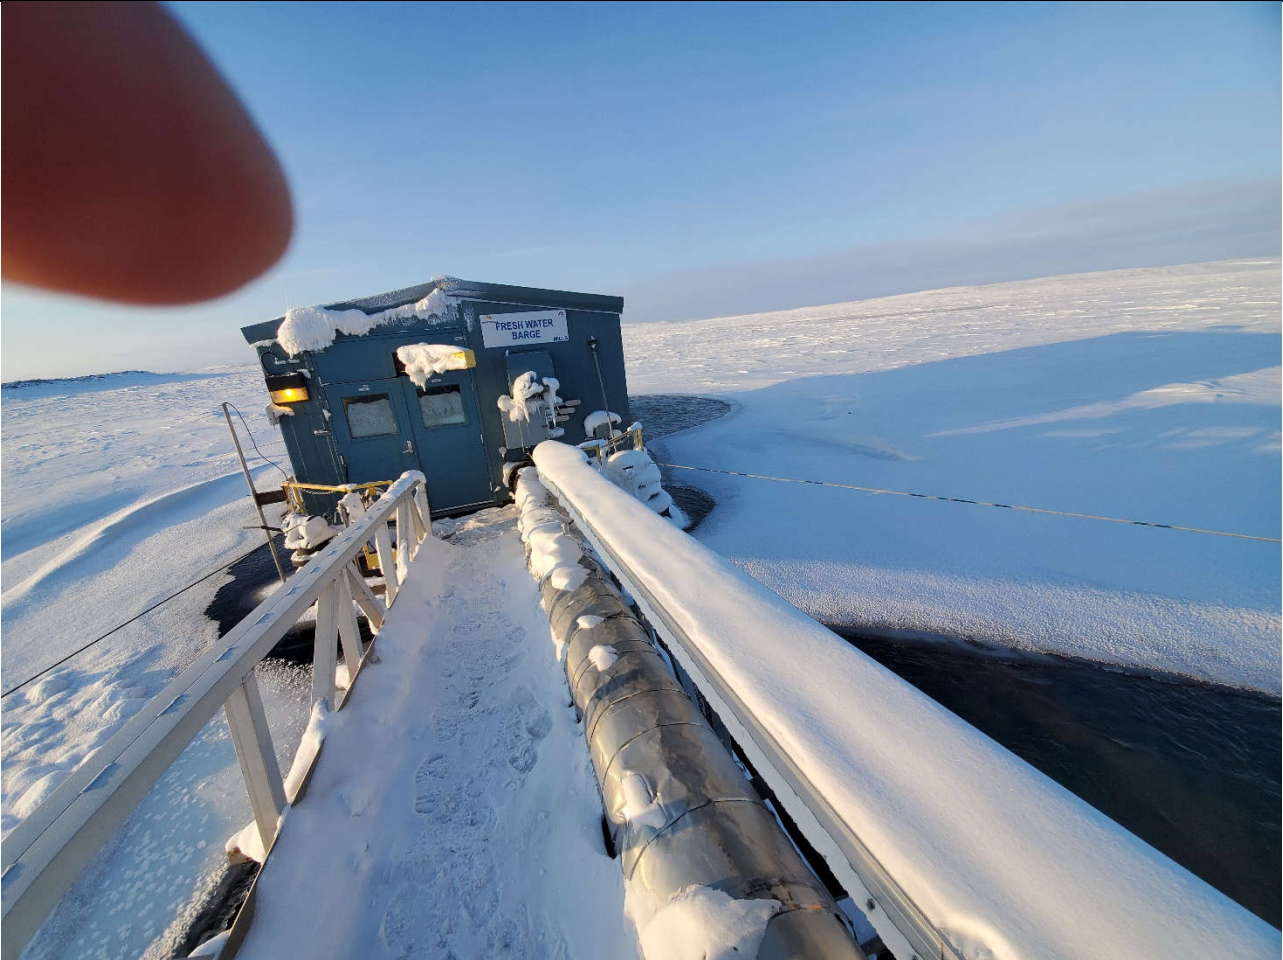
Description:			
Freshwater intake barge at Third Portage Lake ST-01
