## **Appendix A1**

### **Independent Geotechnical Expert Review Panel 2008 Reports**

**October 31, 2008 – Trip Report**

**Re: Meadowbank Dike Review Board (MDRB)**  
**Report No. 1**

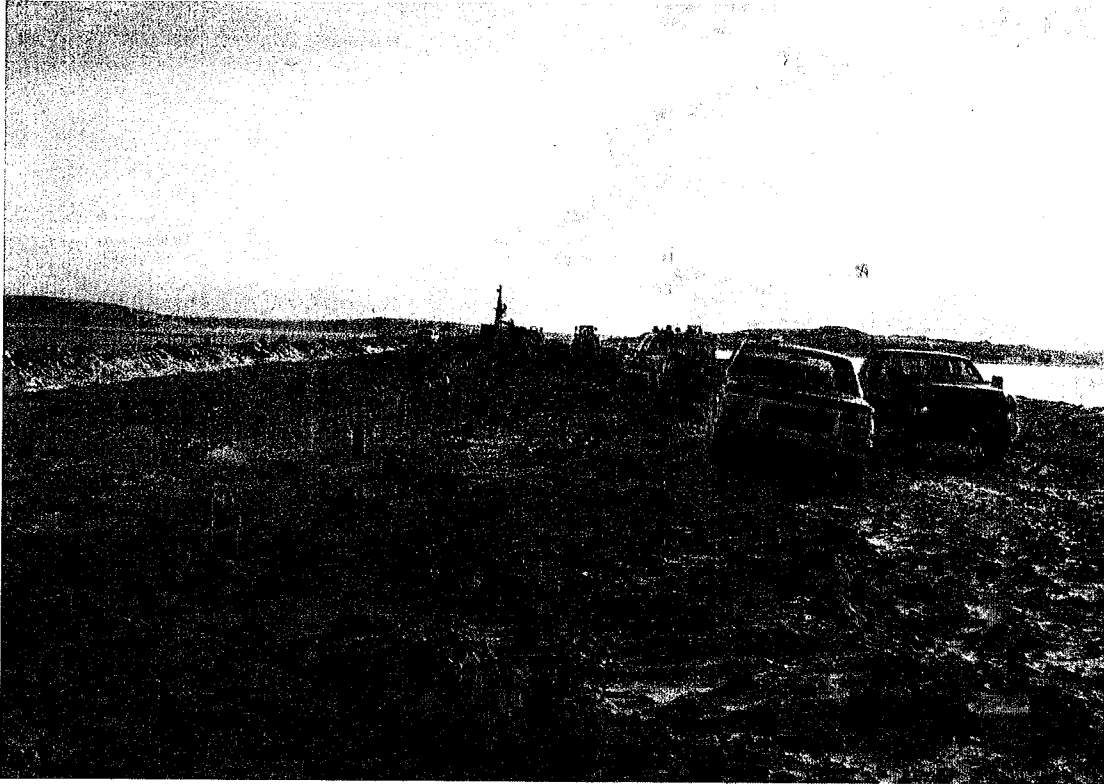
Photo 1 – East Dike crest with Primary holes grouted in casings protruding

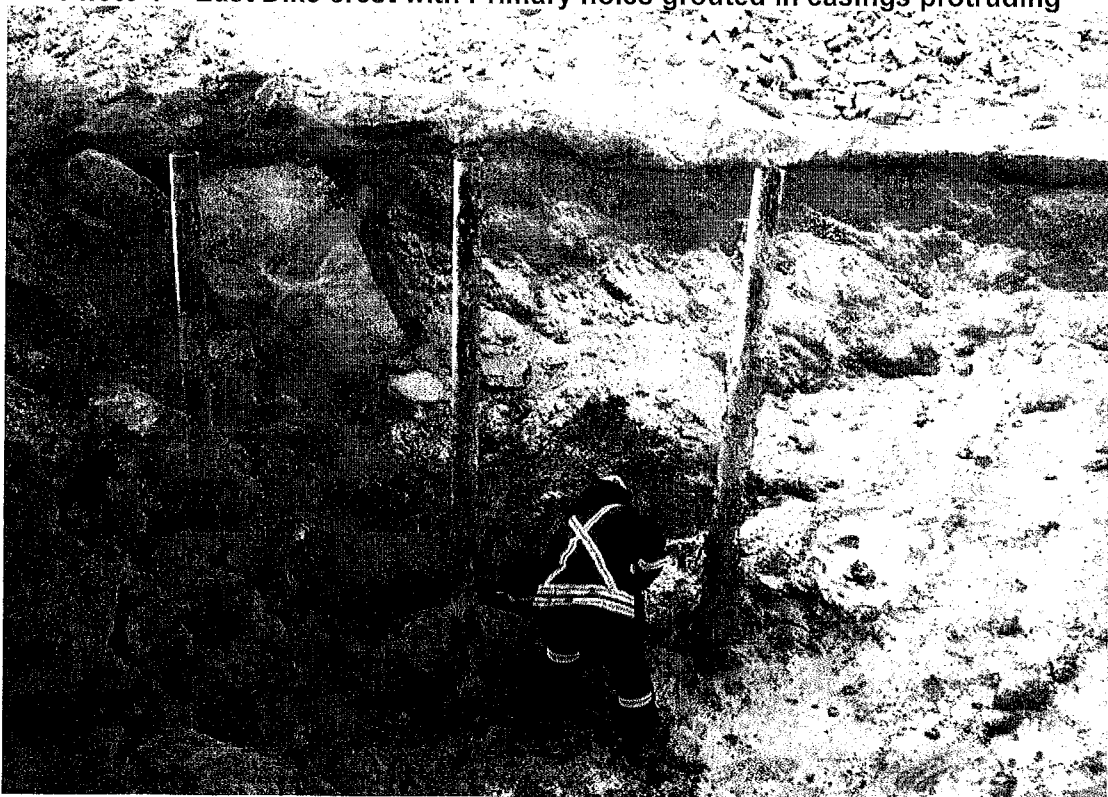
Photo 2 – Excavated grouted in casings and grout bulb at slurry wall rock contact

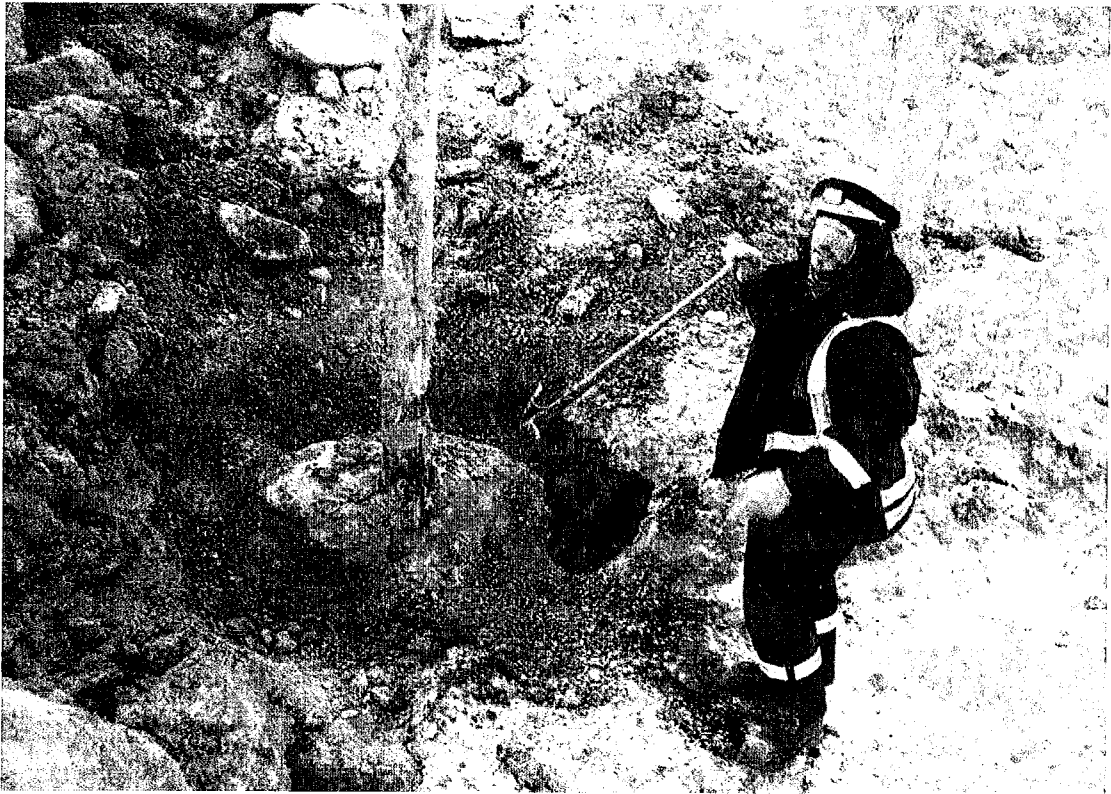
The grouting trial excavation indicated the presence of loose ungrouted 'crush' fill at the base of the cutoff wall fill material. This is apparent in the deeper 'hole' excavation seen in Photo 3. The grout bulb achieved by the GIC grouting trial clearly indicates the presence of open matrix crush prior to grouting. Reliable grouting of the toe of the cutoff wall is a necessity to prevent rapid seepage through such crush fill. Grouting of the rock below the upper surface could not be inspected.

Photo 3 – Grout bulb with excavated ungrouted 'crush' fill adjacent

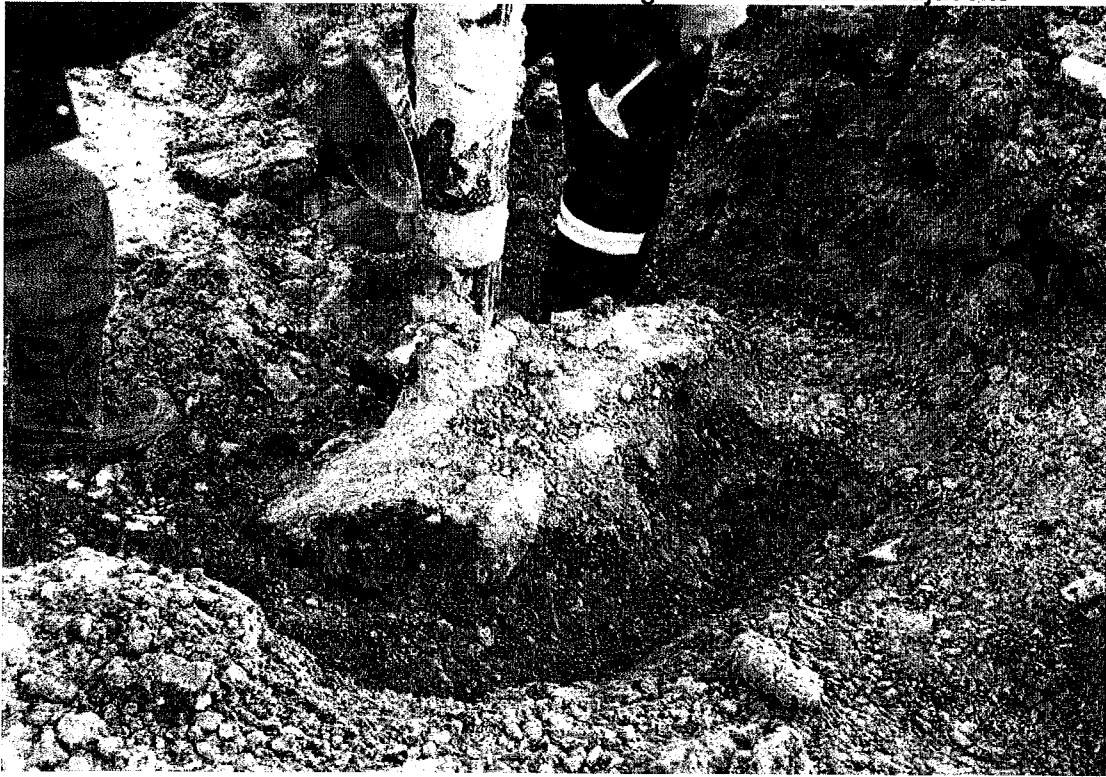
Photo 4 – Limited extent of grout bulb. Injection port sleeve at tip of spade.

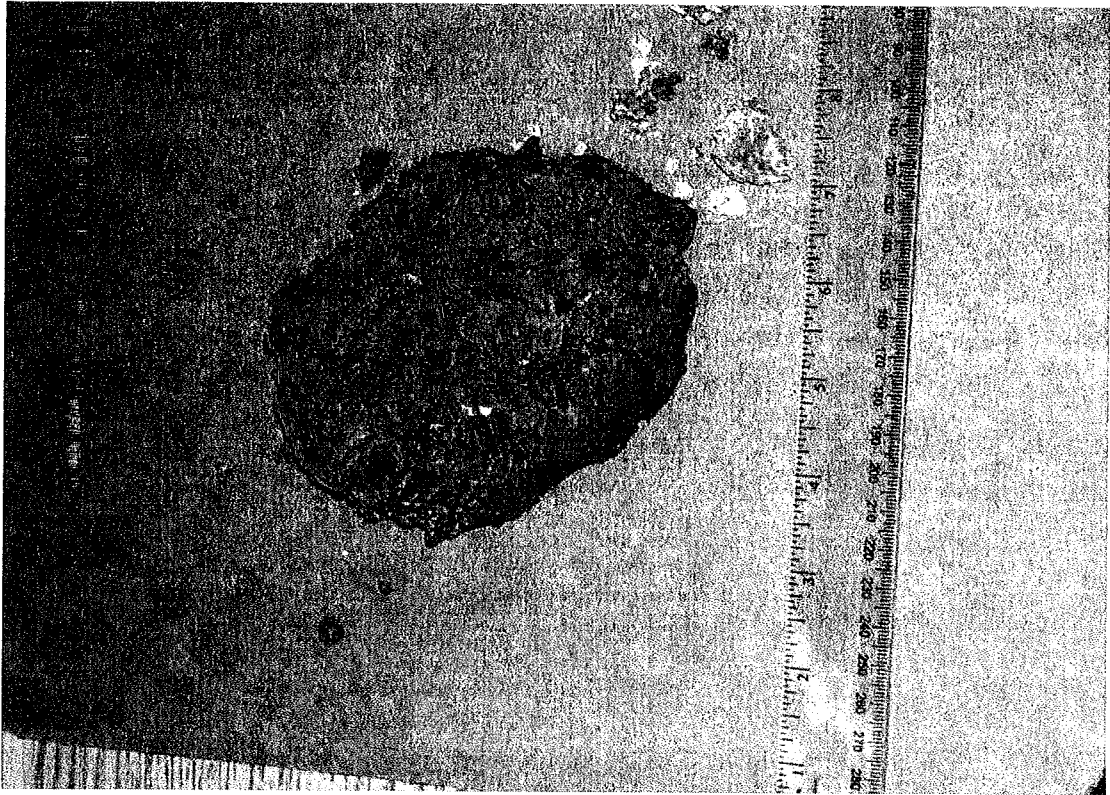
Photo 5 – Sample of grouted crush

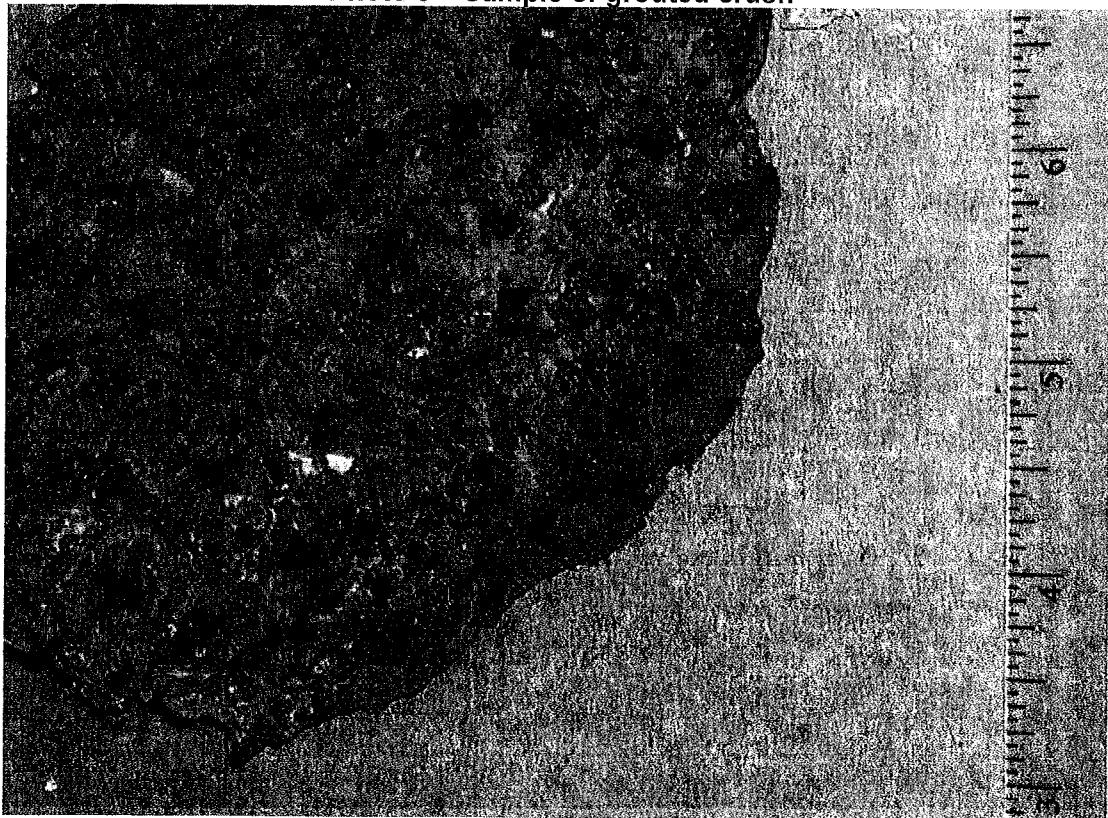
Photo 6 – Close-up of part of grouted crush sample

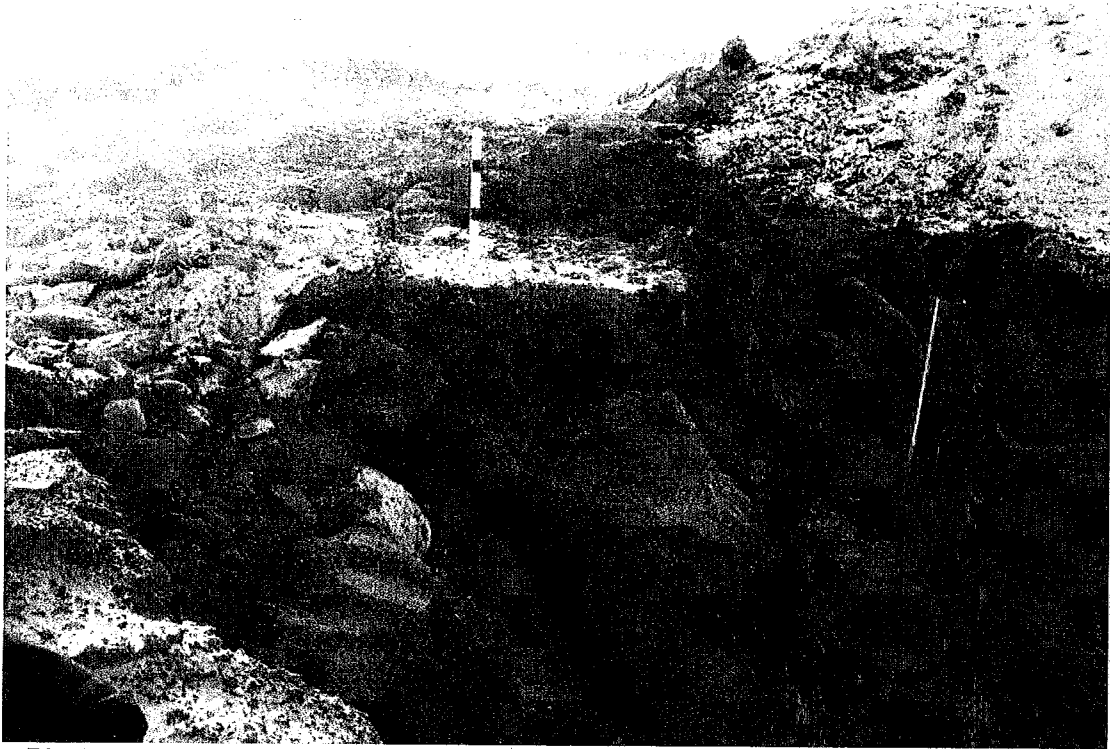
Photo 7 - "tube-a-manchette" (TAM) grouting tube (white) in test zone still to be excavated
