2009 Annual Geotechnical Inspection, Meadowbank Gold Project, Nunavut

2009 Annual Geotechnical Inspection - Meadowbank Gold Project, Nunavut

Agnico-Eagle Mines Limited
Meadowbank Division
P.O. Box 540
Baker Lake, Nunavut
X0C 0A0

Project Number: 09-1428-0018
Doc. No. 969 Ver. 0

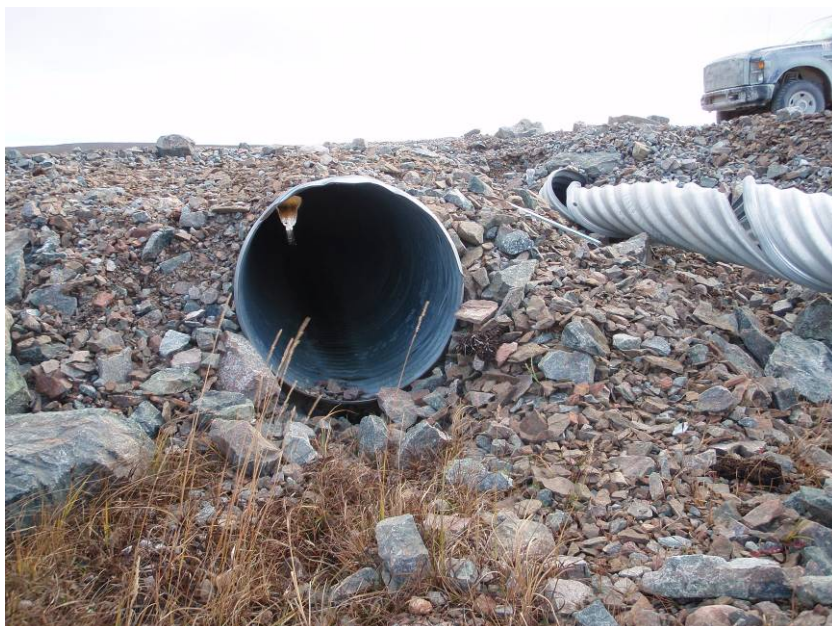
PHOTOGRAPH 12 – PC-14, km 4+260

At km 4+260, PC-14, there are two 600 mm diameter CSP culverts. The upstream end of the culvert closest to Baker Lake is damaged and would severely impede flow. The adjacent culvert is in good condition, with only minor crushing along the haunch evident. At this location, there is no apparent channel and at the time of the inspection no flow was evident through the culverts. The capacity for the single functional culvert to handle flows should continue to be monitored, especially during the spring freshet to ensure adequate drainage.

Description: Upstream view of culverts. Culvert closer to Baker Lake is damaged on upstream side. Other culvert has minimal crushing on haunch of culvert near the center of the road. Uniform grade, no obstructions.

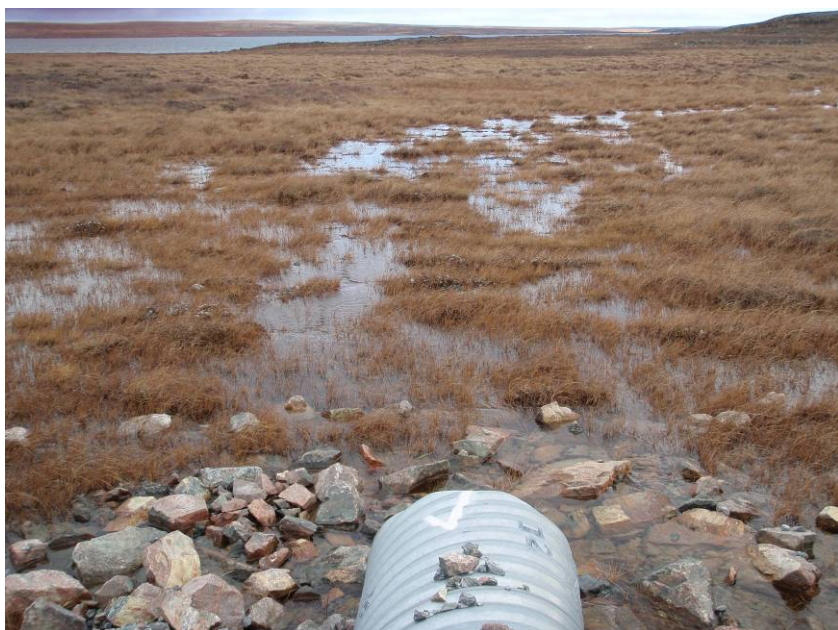
PHOTOGRAPH 20 – R-03, km 10+580

Description: Upstream view of culvert. Culvert is in good condition, uniform grade, and no obstructions. Water flowing through culvert is orange, oxidized.

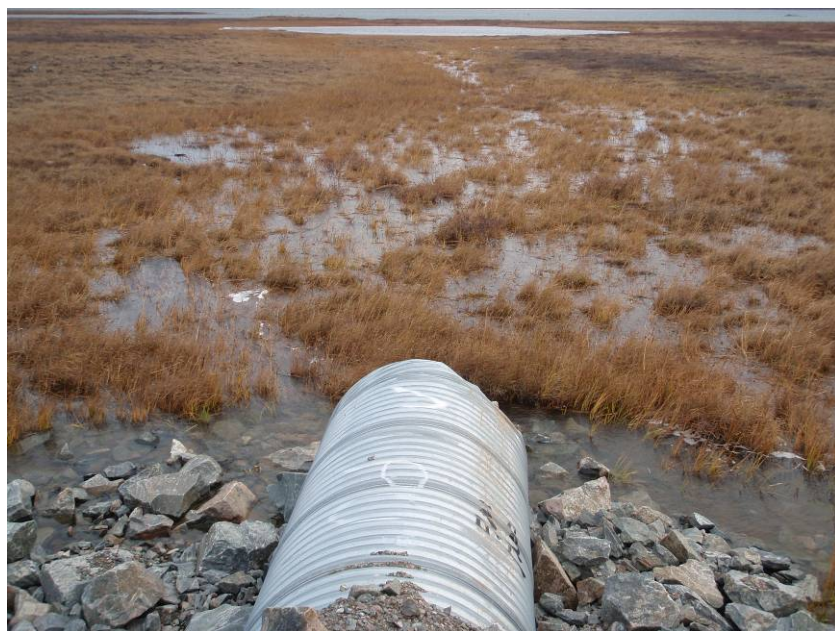
PHOTOGRAPH 22 – R-04, km 12+050

Description: Upstream view of culvert. Culvert is in good condition, very minor deflection in haunch of culvert, uniform grade, and no obstructions. Stream bed consists of cobbles, boulders and grass. Very broad drainage area, no definitive channel.

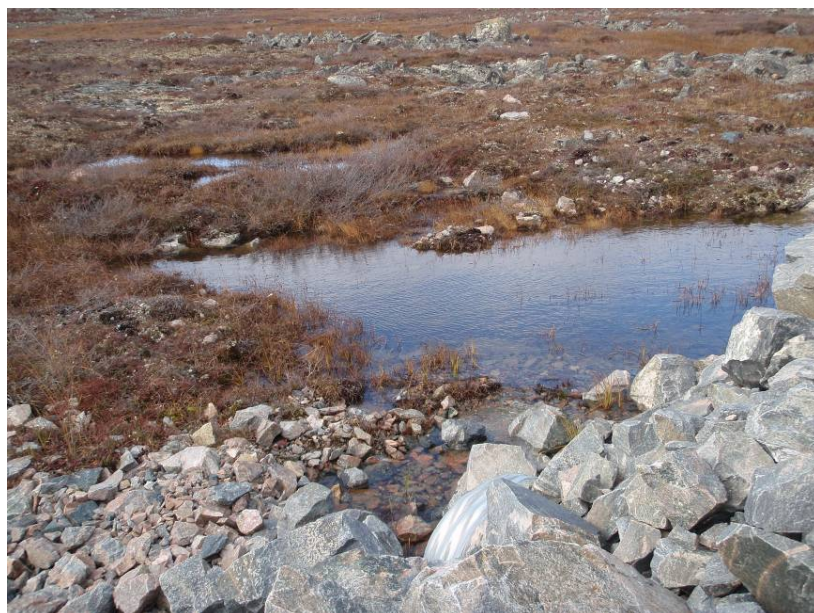
PHOTOGRAPH 26 – PC-2, km 13+405

Description: View through culvert from upstream to downstream. Crushing and dent on side and haunch near upstream end of culvert. Likely damaged during installation, continue to monitor as road bed consists of gravel and some larger cobbles (angular), potential for condition to worsen. Uniform grade, no blockage evident.

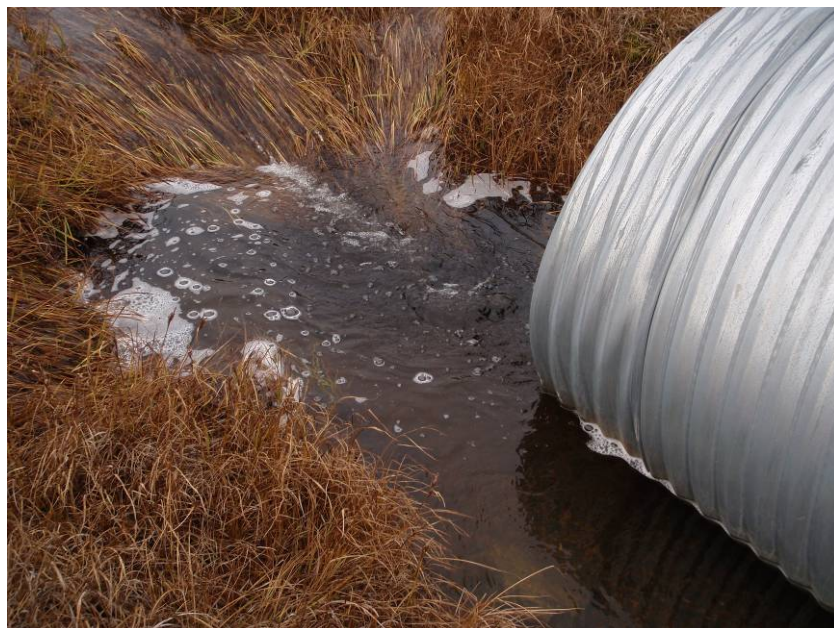
PHOTOGRAPH 34 – R-05A, km 15+645

Description: Upstream view of culvert. Culvert is in good condition, uniform grade, and no obstructions. Upstream end of culvert is set above bottom of stream or concentrated flow has eroded some material under the culvert. Stream bed consists of soil and grass. High flow was evident at the time of the inspection.

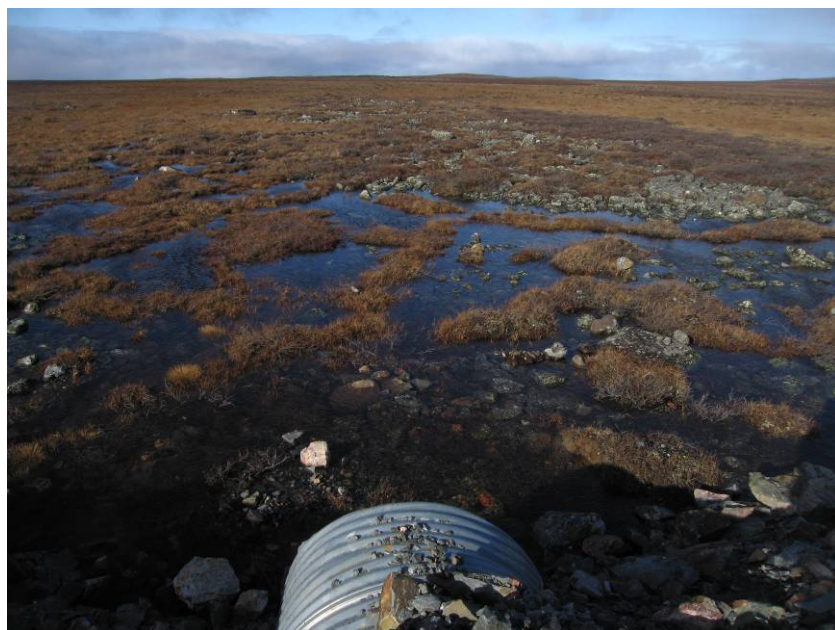
PHOTOGRAPH 64 – R-17, km 77+440

Description: View through central culverts from downstream to upstream. Culvert damaged on side and top, crushing is evident.

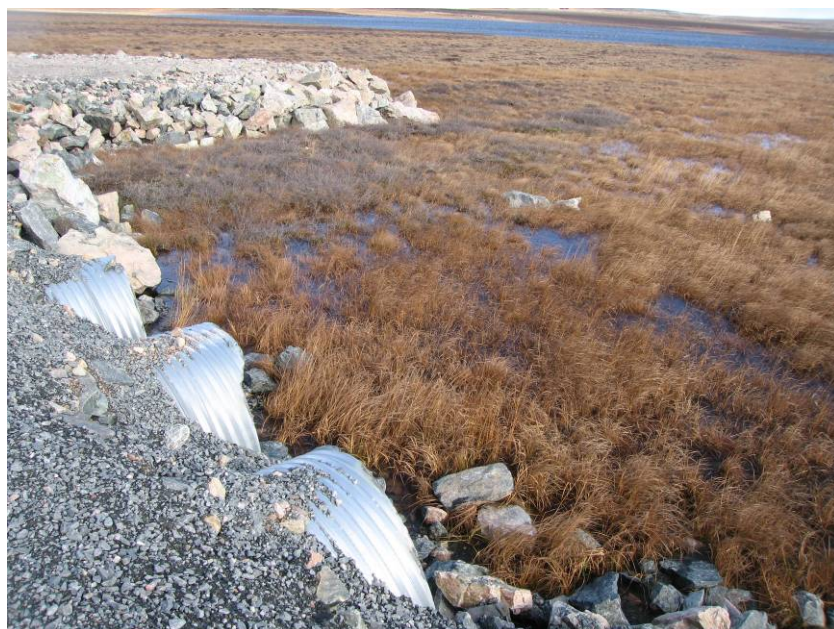
PHOTOGRAPH 68 – R-18A, km 81+045

Description: Upstream side view of culverts. Northern most culvert (closest to Meadowbank) observed to have some minor crushing along haunch. Central culvert shows minor crushing of top and dents in base and sides likely damaged during construction. Southern most culvert (closest to Baker Lake) is in the best condition. There is minimal road cover over culverts. All culverts observed to have a constant grade and no obstructions. Grass in stream base, no turbidity observed.

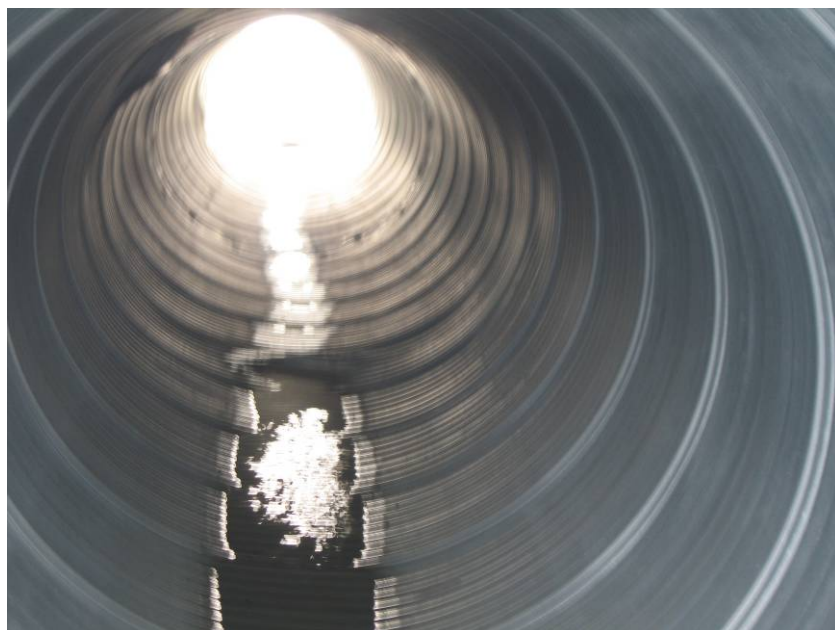
PHOTOGRAPH 74 – R-21, km 87+500

- R-21, km 87+500 – both of the culverts at this location have dents on the base and side and minor deflection along the haunch;
- R-23, km 93+600 – moderate damage;

Description: View from upstream to downstream through eastern culvert (closest to Meadowbank) damage on base and sides evident. Grade is generally uniform and no blockages observed within culvert.

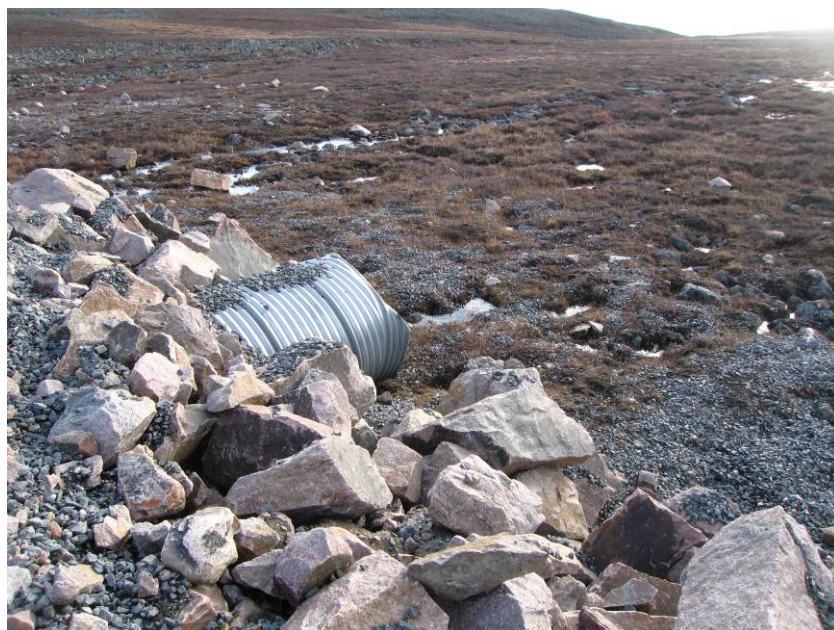
PHOTOGRAPH 80 – R-23, km 93+600

Description: Upstream to downstream view through culvert. Moderate crushing along haunch of culvert centerline, uniform grade, no blockages, and no sign of erosion observed.

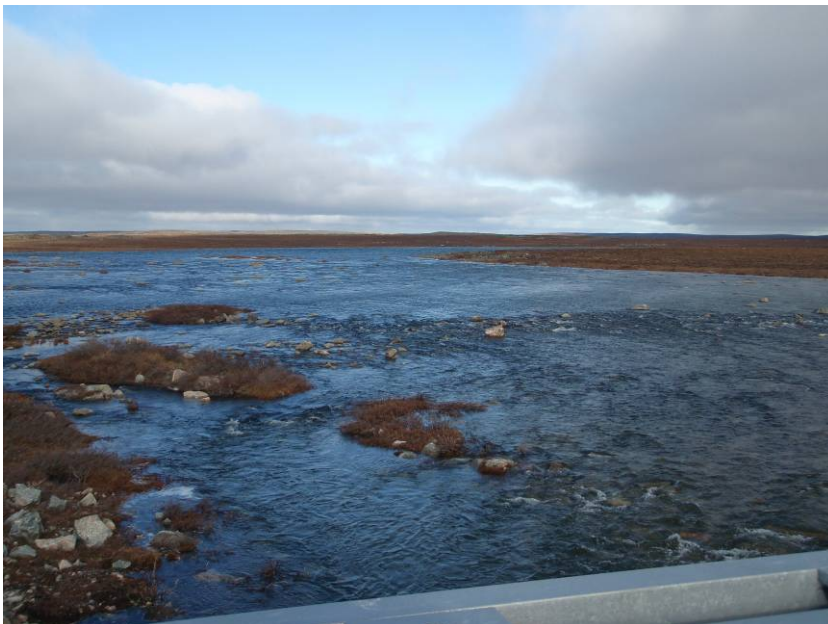
PHOTOGRAPH 2 – Bridge 1 - R02, km 8+750

Description: View of bridge looking across deck looking south west. Abutment supports slightly damaged, likely during construction.

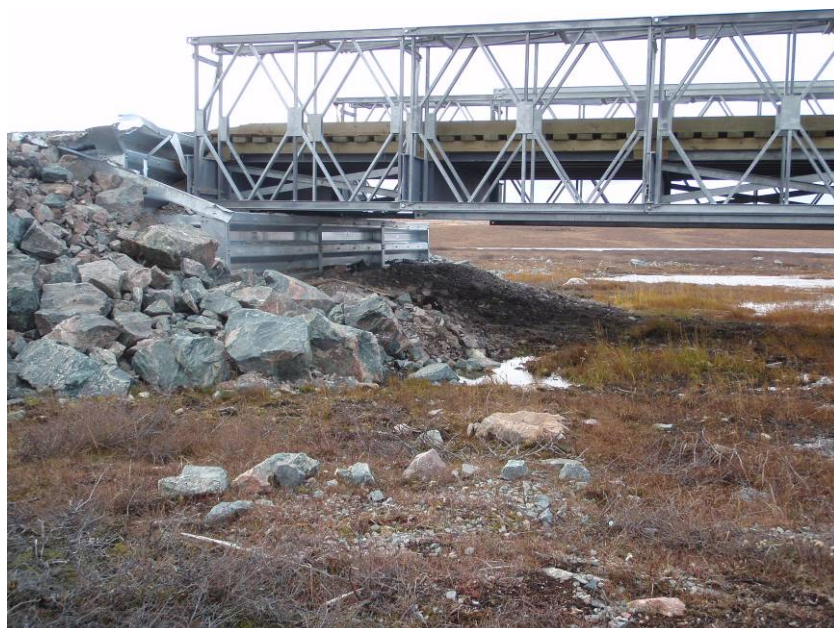
PHOTOGRAPH 14 – Bridge 2 - R05, km 17+600

Description: Upstream view of abutment on south side. Minor damage to abutment box, likely damaged during construction.

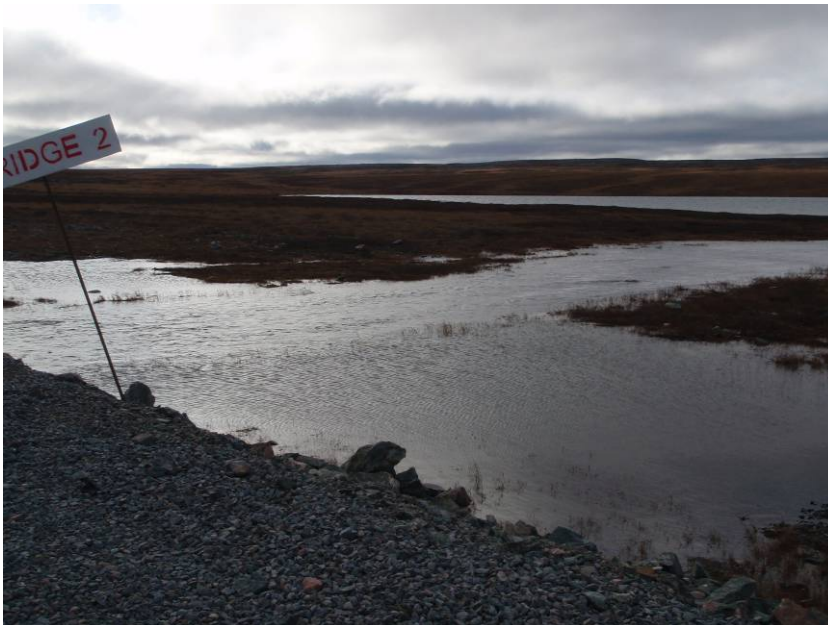
PHOTOGRAPH 16 – Bridge 2 - R05, km 17+600

Description: Upstream view of abutment on north side. Minor damage on deck, likely damaged when grading.

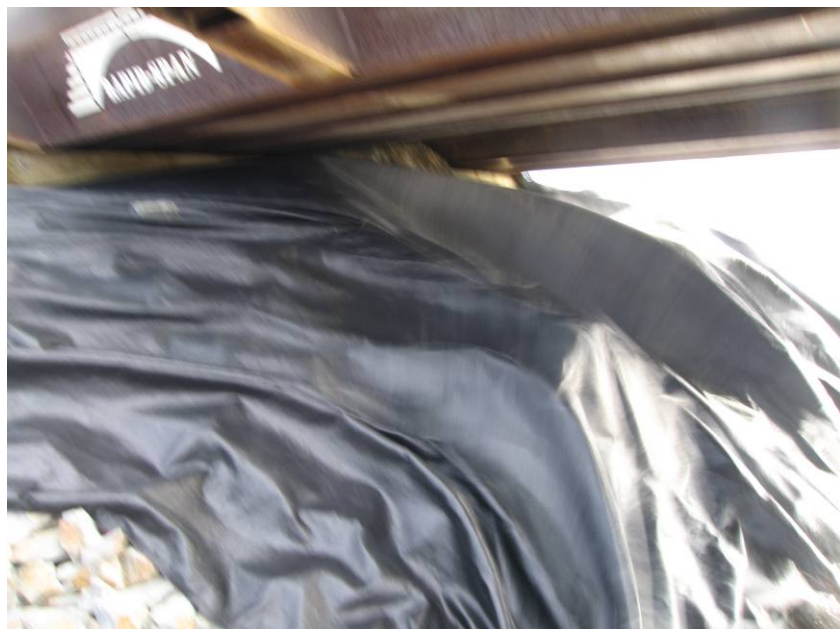
PHOTOGRAPH 43 – Bridge 7 - R16, km 73+800

Description: View beneath deck from upstream to downstream. Grass and cobbles in stream bed. Geotextile on abutments is damaged, some granular road bed falling below deck.

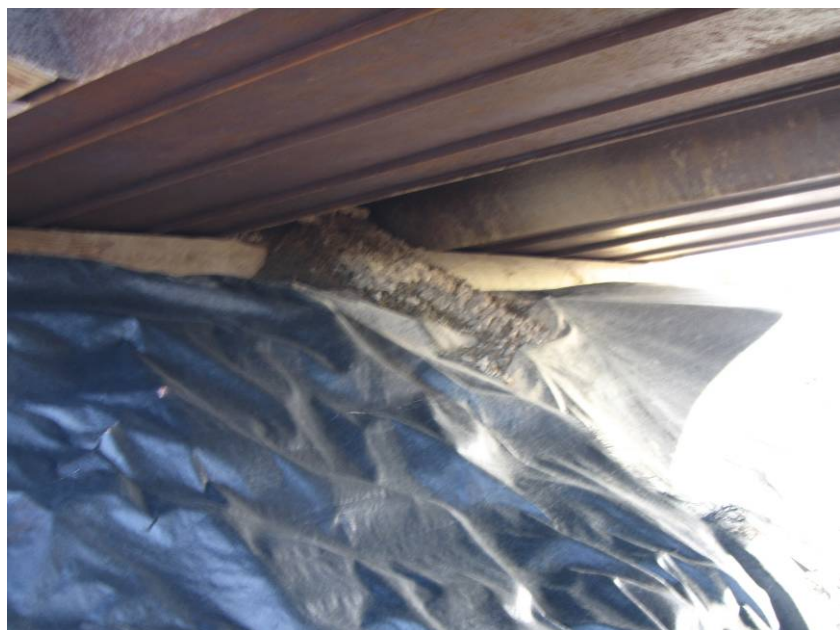
PHOTOGRAPH 48 – Bridge 8 - R18, km 79+500

Description: View of left abutment from upstream to downstream. Geotextile beneath abutment, small amount of road base observed to have fallen below the bridge deck.

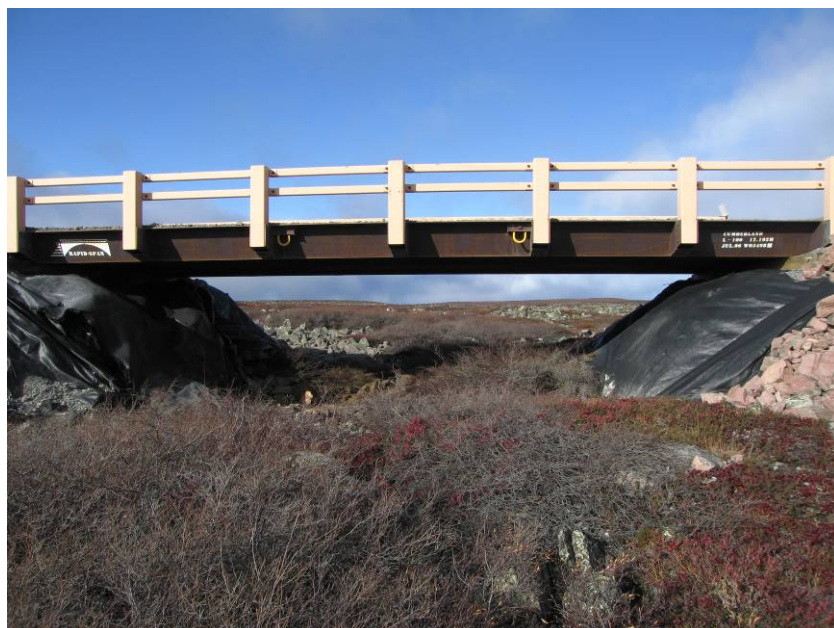
PHOTOGRAPH 50 – Bridge 8 - R18, km 79+500

Description: View of right abutment from upstream to downstream. Damaged geotextile beneath abutment, blowing in the wind.

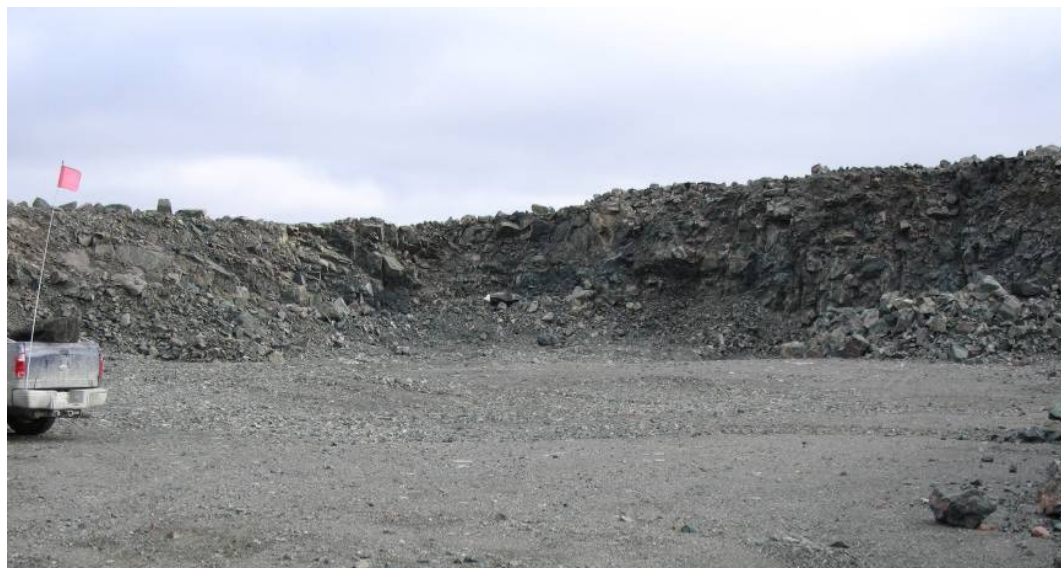
PHOTOGRAPH 8 – Quarry 3

Description: View of west wall. High cut wall, jointed and fractured, ravelling.

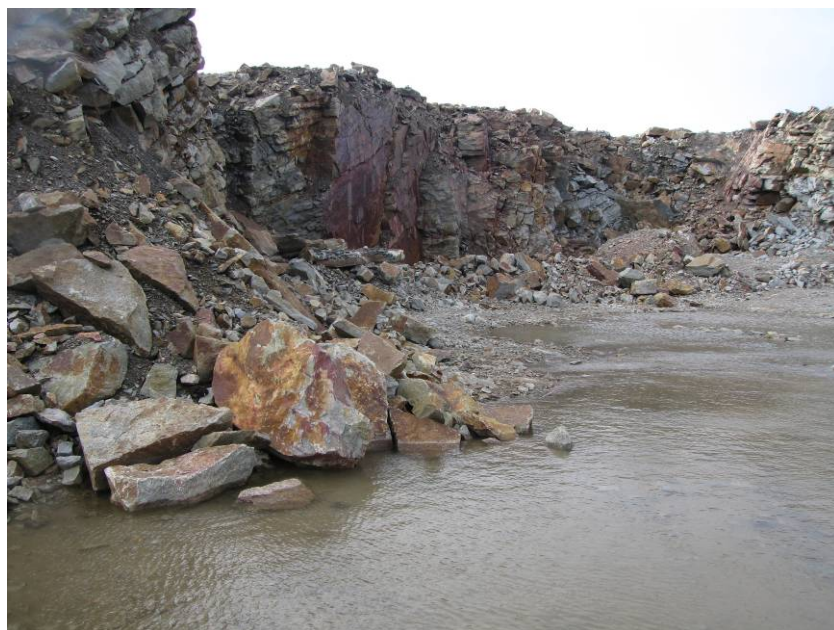
PHOTOGRAPH 20 – Quarry 7

Description: View of west wall. Near vertical wall, about 10 m high, majority fractured and jointed, block size pieces (0.2 to 0.5 m) and smaller ravelling. Some ponded water, less than 20 cm deep.

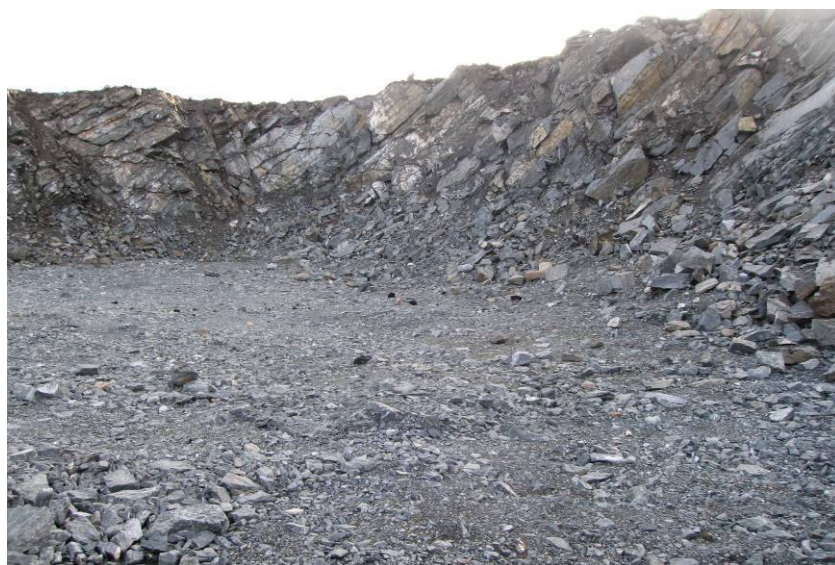
PHOTOGRAPH 24 – Quarry 8

Description: View of north wall, looking northwest. Wall about 8 to 10 m high, lightly fractured and jointed, raveling prevalent.

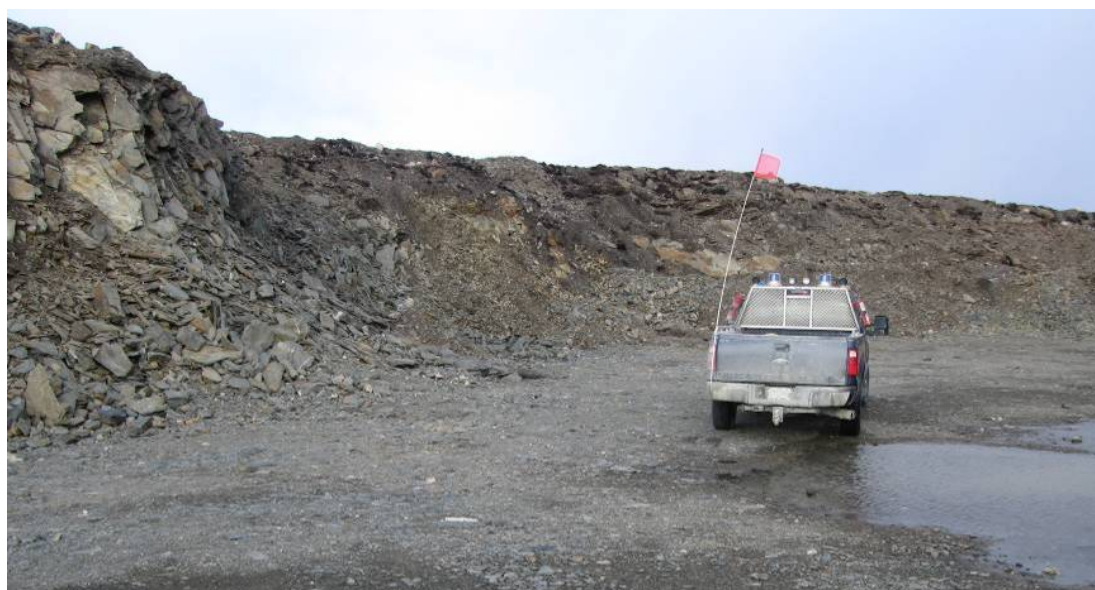
PHOTOGRAPH 32 – Quarry 10

Description: View of west wall. Wall highly fractured and ravelling.

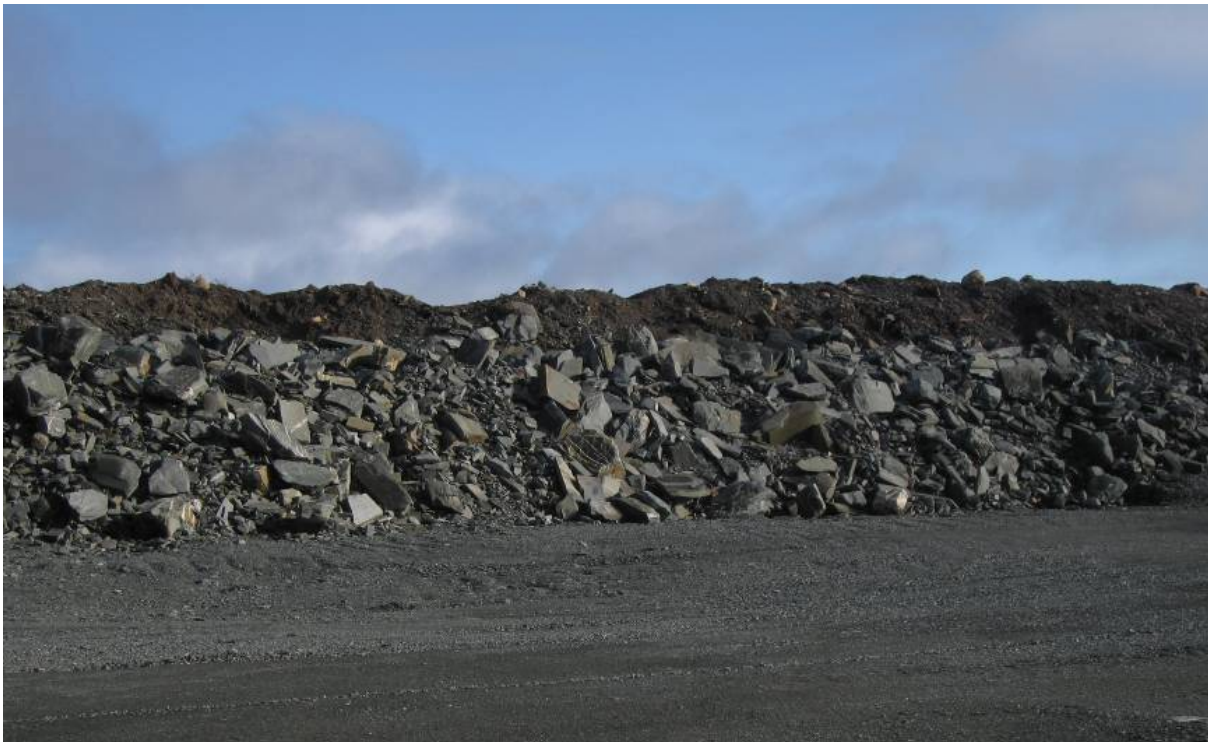
PHOTOGRAPH 36 – Quarry 11

Description: View of southern portion of the eastern wall. Stockpile of rock and crush in front of quarry wall. Vertical wall highly fractured, thin planar surfaces, ravelling.

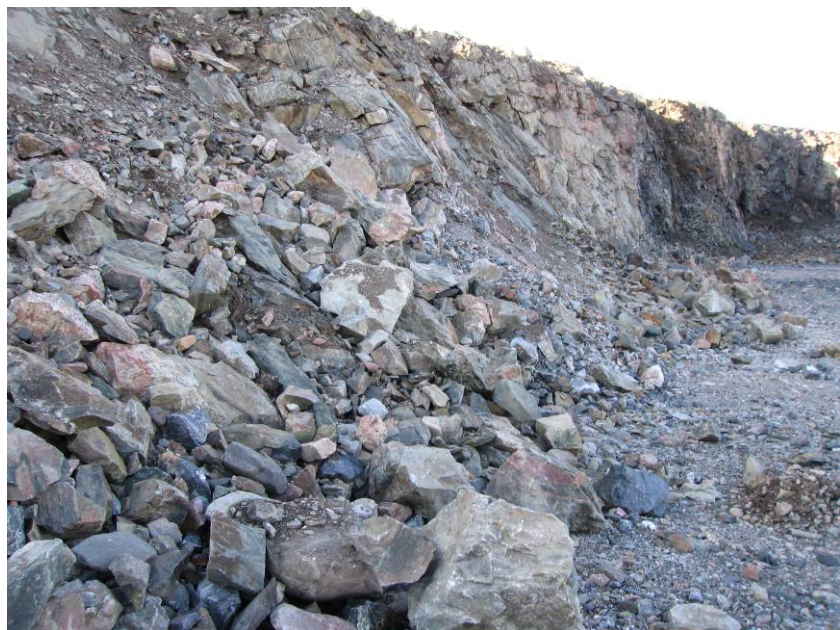
PHOTOGRAPH 63 – Quarry 18

Description: View of frost heave and thaw settlement at entrance of quarry, looking northeast.

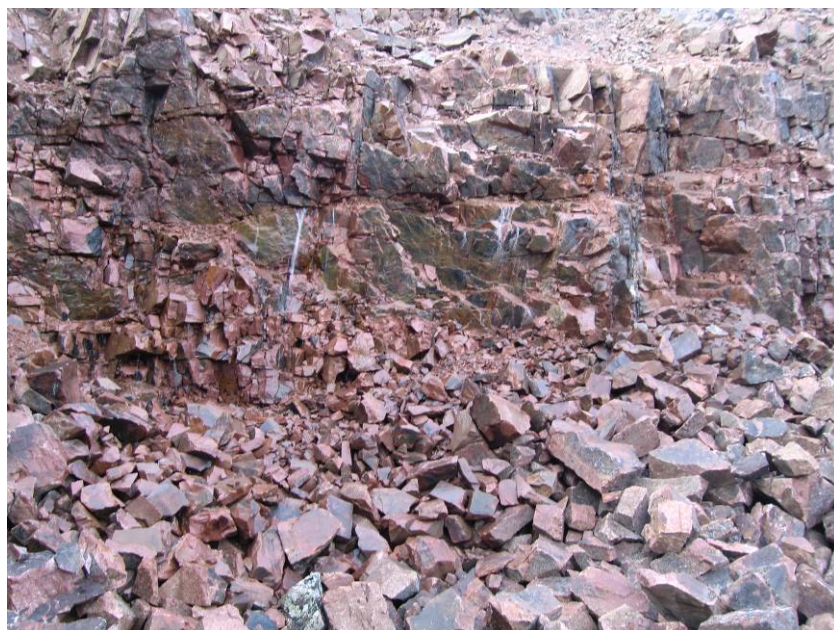
PHOTOGRAPH 71 – Quarry 21

Description: Looking south. Vertical walls 6 to 8 m high decreasing towards the AWPAP. Some ravelling of small blocks. Small inflow / seepage observed but no ponded water.
