## **Appendix A3**

### **Independent Geotechnical Expert Review Panel 2009 Reports**

February 10, 2009

**Re: Meadowbank Dike Review Board (MDRB)**  
**Report No. 2**

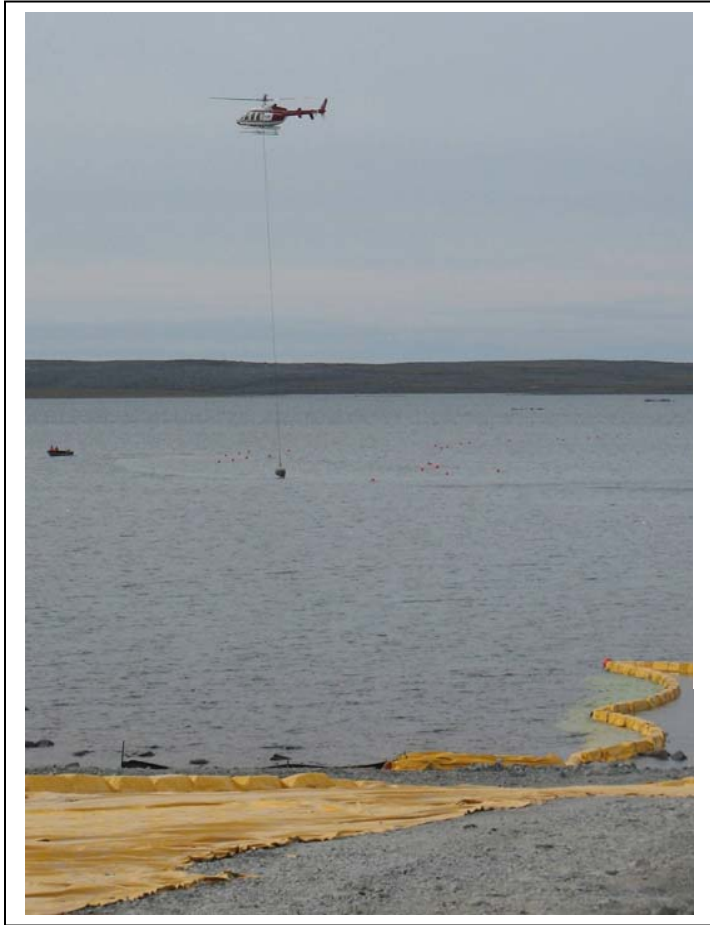
Silt curtain mobilization for Bay-Goose is underway. The anchors, in the form of selected blocks of rock, are being set by means of a helicopter (See photo #1). Given that no large barge is available, this is an efficient and apparently cost effective way of carrying out this component of the work. In parallel, the assembly of sections of curtain on land will accelerate the installation. It is noted that the curtains will be full depth to lake bed as compared to the open bottomed installation used last year. This should be more effective with respect to the lateral translation of the sediment plume but the curtain will need to resist current forces. The Board considers that all practical efforts to make effective use of silt curtains are being implemented.

Photo # 1      Silt curtain anchor placement

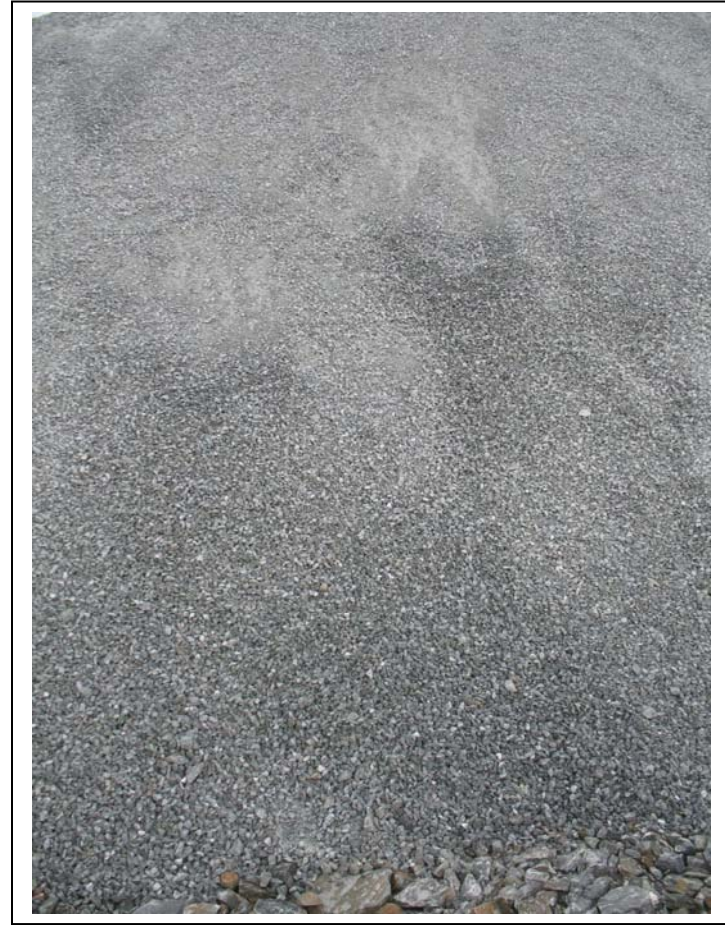
a) A stockpile of 0-20 mm material has been built near the abutment from which the Bay-Goose embankment will be launched. Some segregation was noted as shown in photo #2. Although material with a maximum size such as 20 mm is not particularly prone to segregation, care is still required when handling the material in a dry state. Lifts in the pile should not exceed 2 m in height. The pile should be stepped and material should not be allowed to spill down the full length of side slopes.

Photo # 2      Stockpile of 0-20 mm material

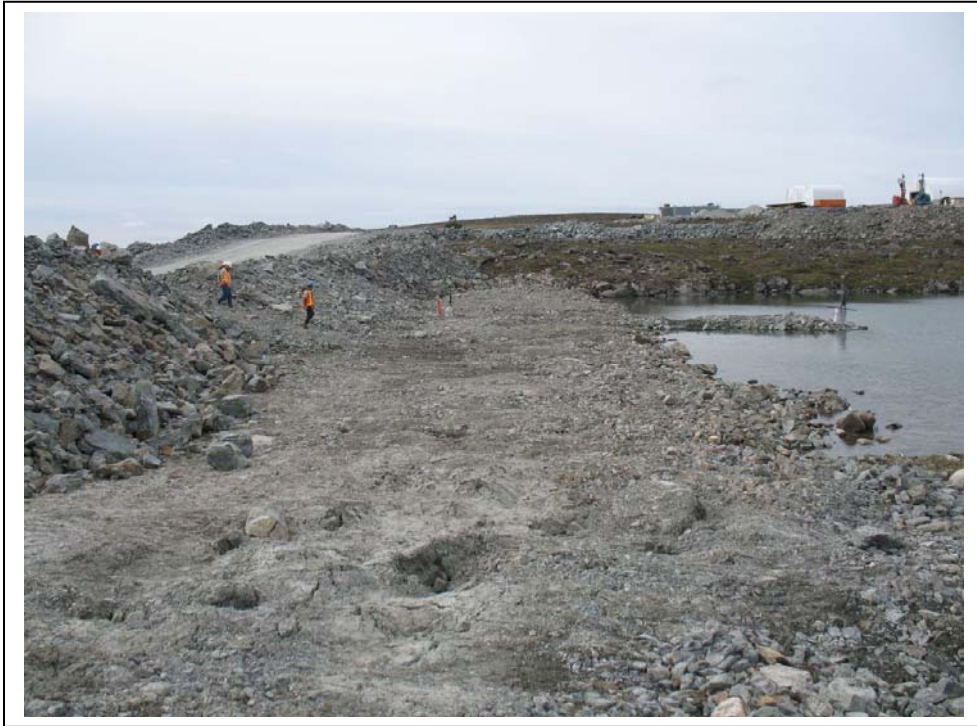
The Board made a brief inspection of this completed structure. Construction was carried out in winter which permitted the excavation of a 4.5 m deep cut-off trench in the dry, due to permafrost and grounded lake ice, which removed the need for a cofferdam. Maintenance of frozen conditions was desirable given the 25 m depth of till below the dike foundation. The foundation conditions are monitored by two sets of thermistors that can be seen in photo # 3.

Photo # 3 South Camp dike, upstream toe

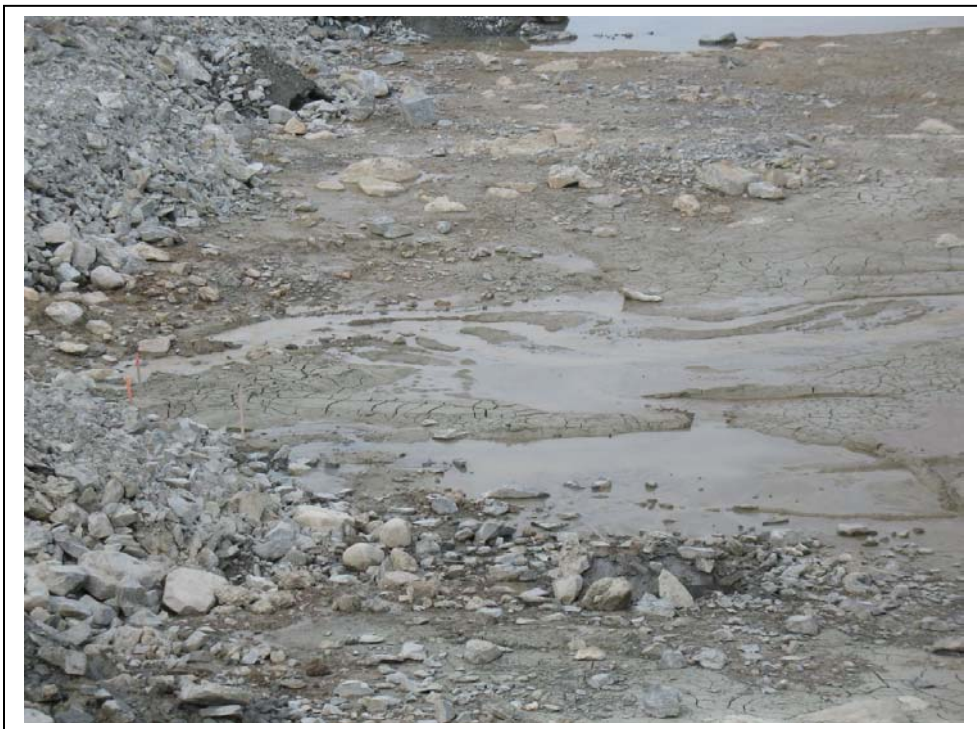
This was the first visit since completion of the dike. The final configuration with an increased width of haul road was noted. An inspection was made of the area at the toe downstream of the remedial grouting work carried out in March of this year. Seepage emanates from the toe in the area between Stn. 6+450 and 6+490 but the precise location of the source has yet to be determined due in part to the presence of fill material from a ramp used to install the dewatering pumps. The ramp was being excavated at the time of the visit. Consequently, the water turbidity was at least in part due to this disturbance. The seepage exited from the east side of the fill (photo # 4) until a channel was excavated on the west side. The majority of the flow is now seen to originate on the west side (photos # 5 and 6). Monitoring by way of weirs or flow pipes is required at both locations, and visual description of changes in suspended fines is necessary.

Photo # 4 East Dike, seepage to east of ramp
