## **Appendix H1**

### **Inspection Reports and Response**

**AEM Response to 2009 Inspection Report, September 18,  
2009**

### **Action Plan for Gray Water at Exploration Camp**

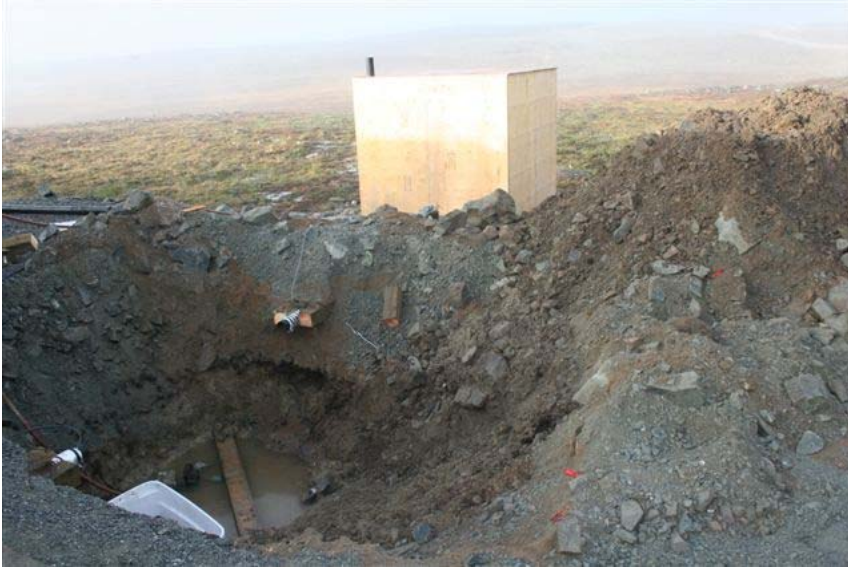
1. Construction of the new grease trap.

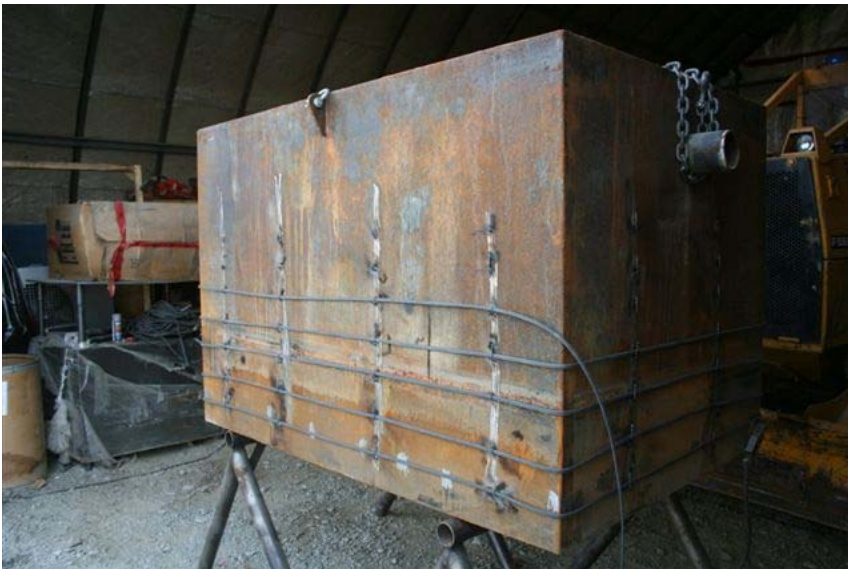
2. Grease trap with heat trace.

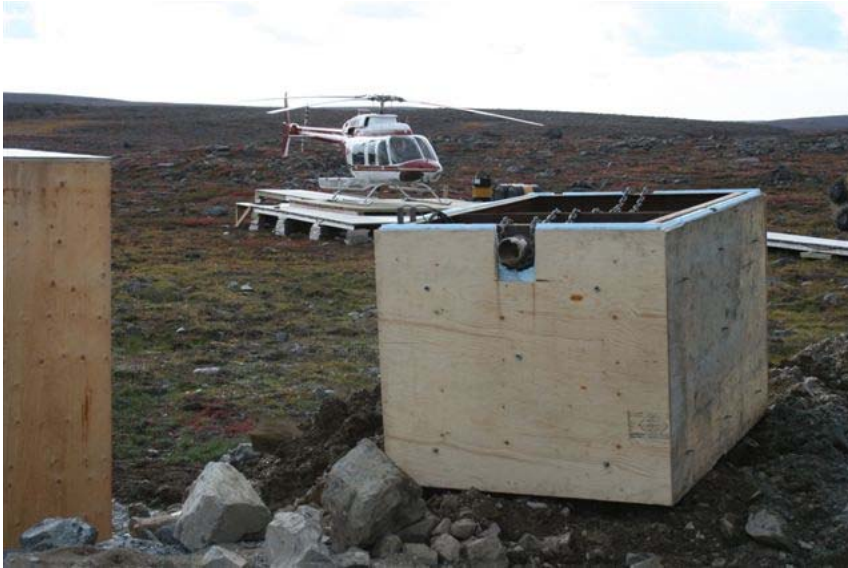
3. Grease trap before the installation ; isolated 4' x 4' x 6'.

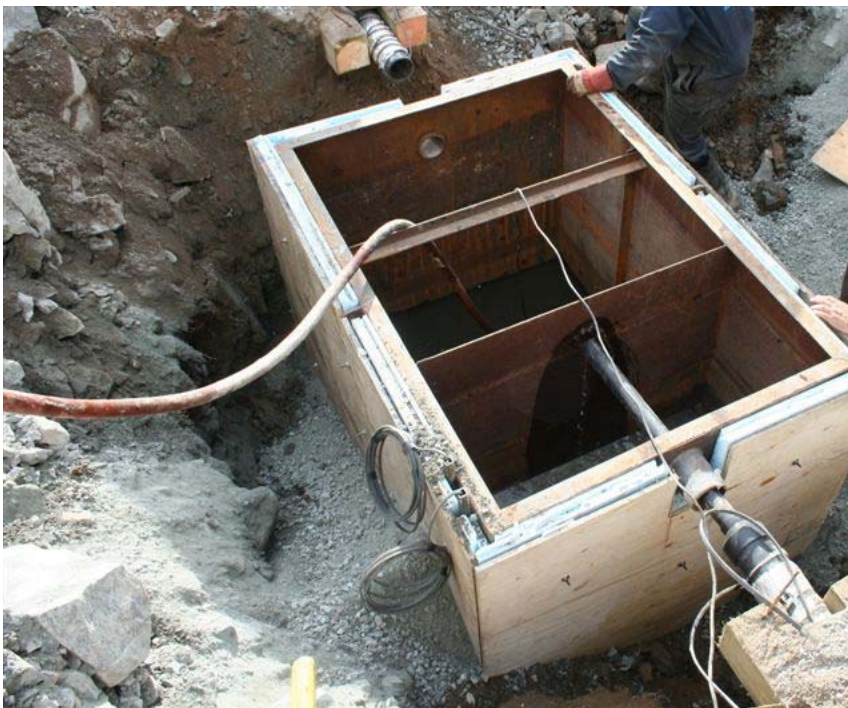
4. excavation and installation of the grease trap

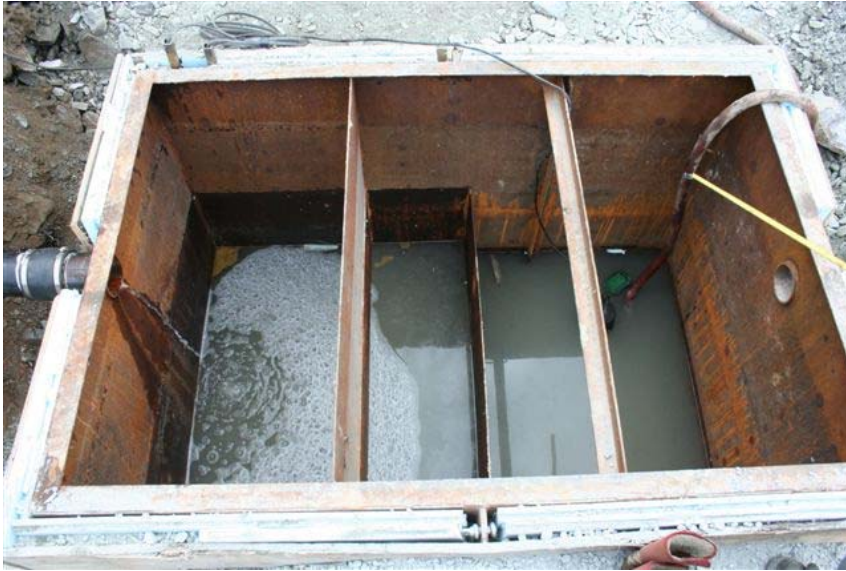
5. It's work ; in the left corner we can see the grease.

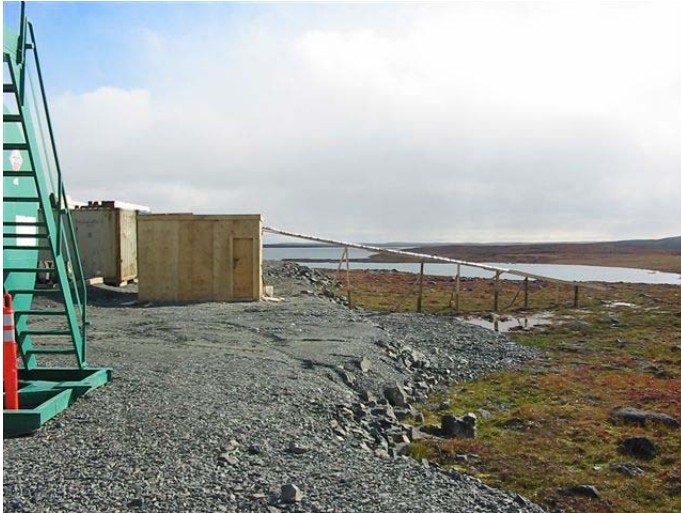
9. Final installation of the grease Station.

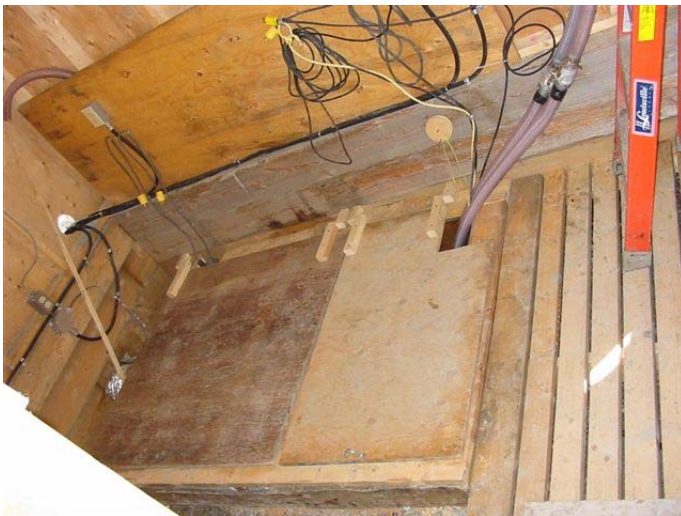
10. Inside of the Grease Station with panel over the trap.

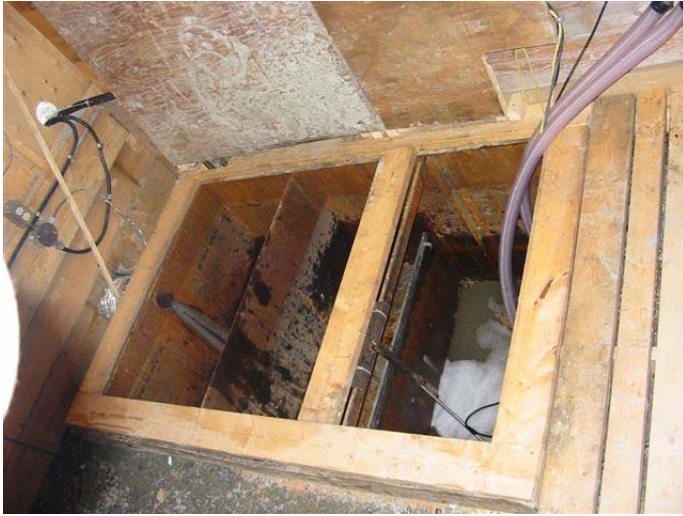
11. Easy access to the pump truck in the Grease Station.

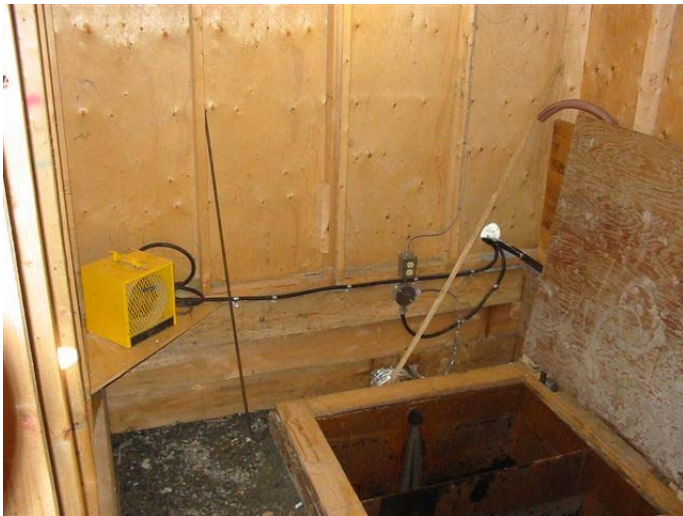
12. Heater inside of the station

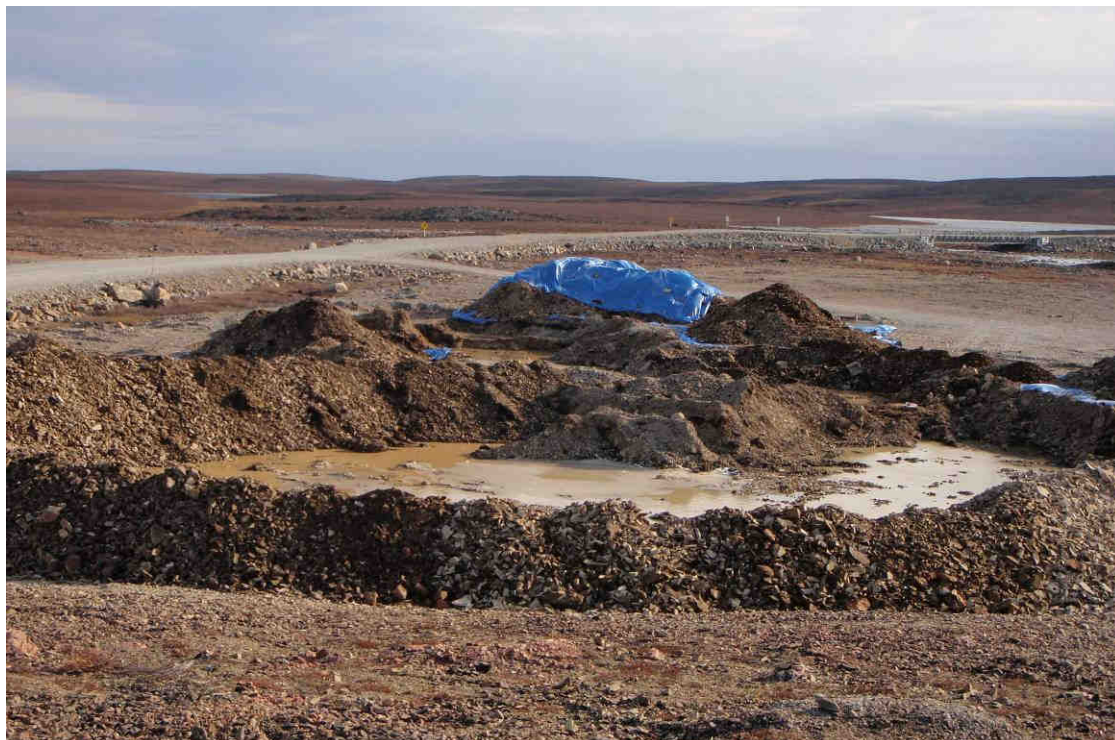
**Photo 01:** After completion of the contaminated soil exhumation last falls, banks on each side of the holes have been created to avoid any incident. – September 23<sup>rd</sup> 2008

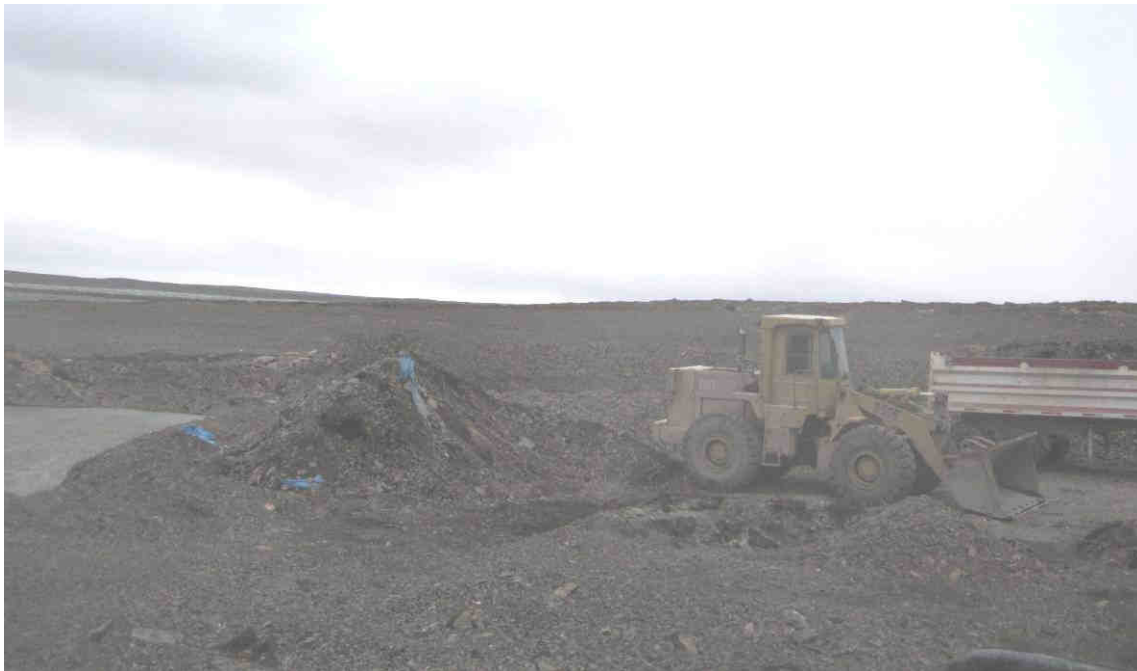
**Photo 03:** During the works; the soil was on tarps and both the soil and the tarps have been brought to the Quarry #22 – September 1<sup>st</sup> 2009.

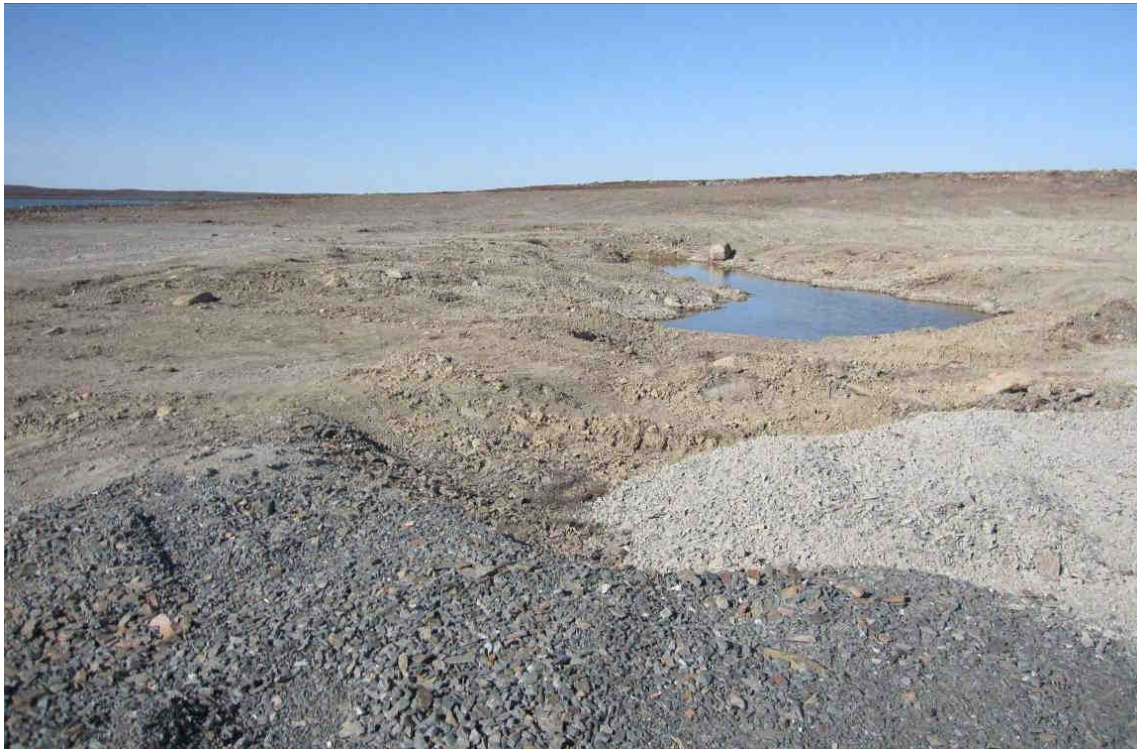
**Photo 04:** After completion of the haulage the area have been levelled with the loader. The banks (non-contaminated material) were pushed to make sure there are no steep slopes – September 4<sup>th</sup> 2009.
