Appendix A2

Independent Geotechnical Expert Review Panel Reports

**Report No 5
Meadowbank Mine Dike Review Board
Meeting December 17-18, 2009**

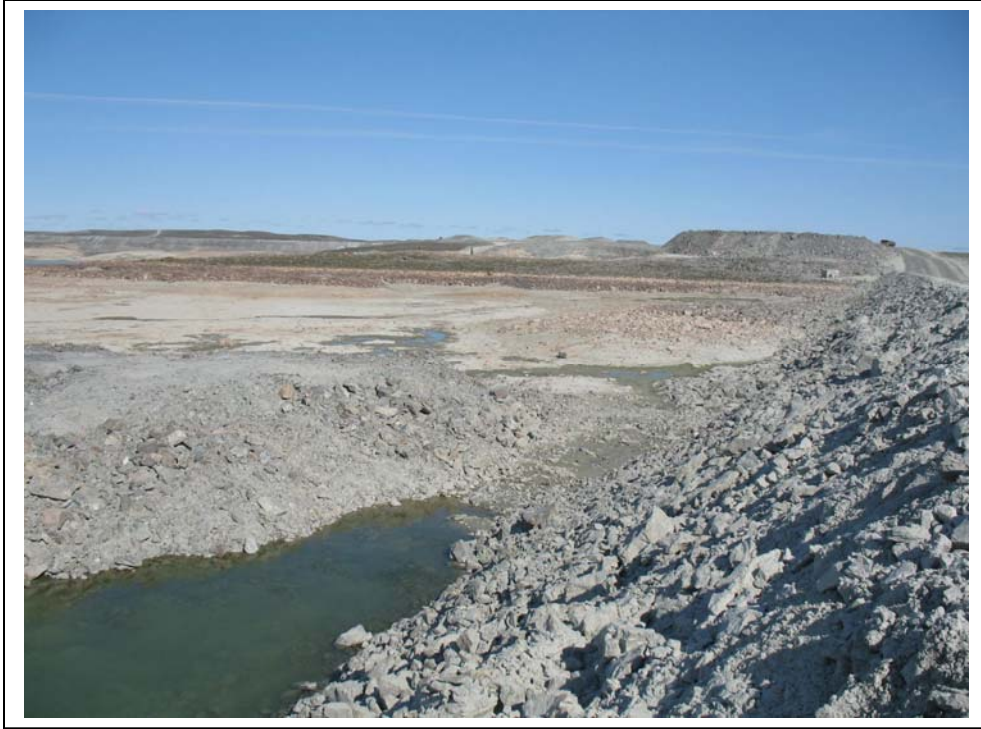
Photo # 1 East dike, seepage areas in North Channel

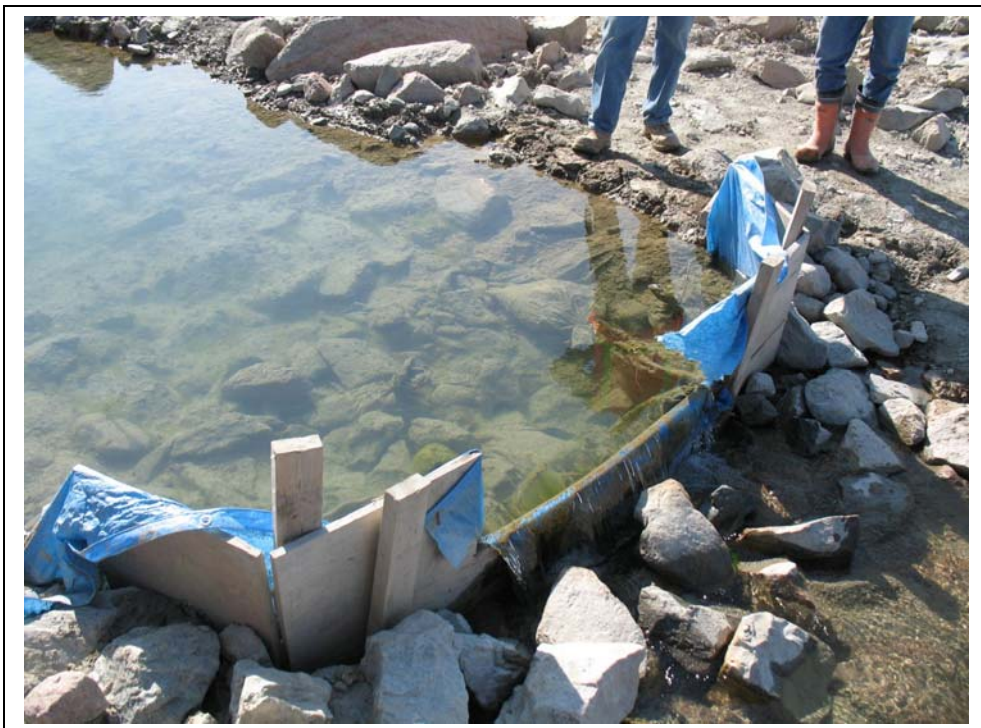
Photo # 4 East dike, weir circa Stn. 60+490

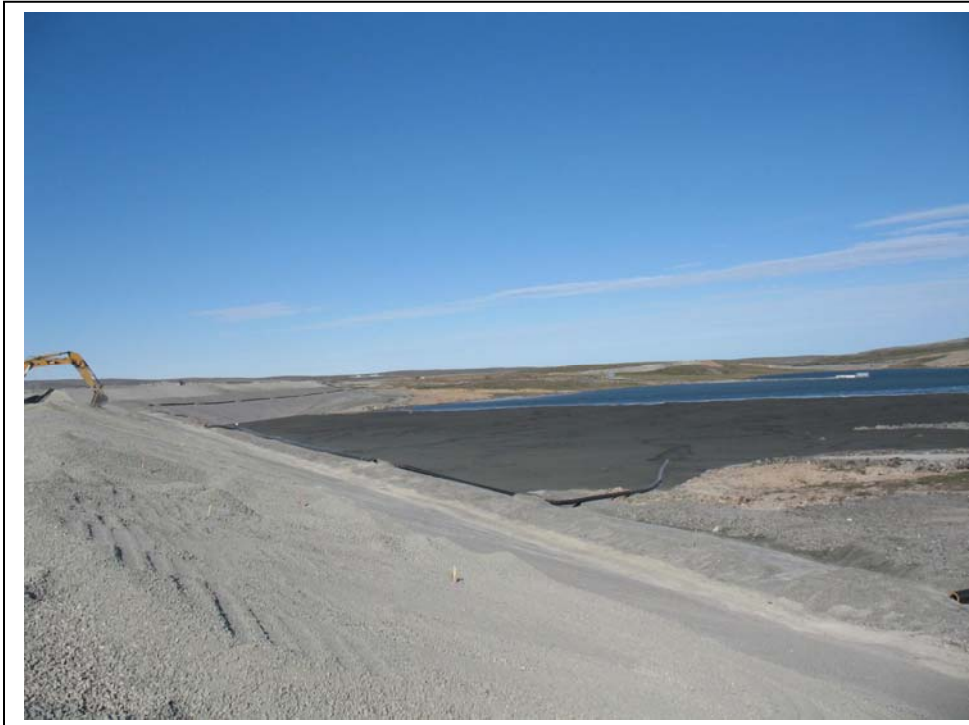
Photo # 14 Stormwater dike, tailings beach and decant water pond

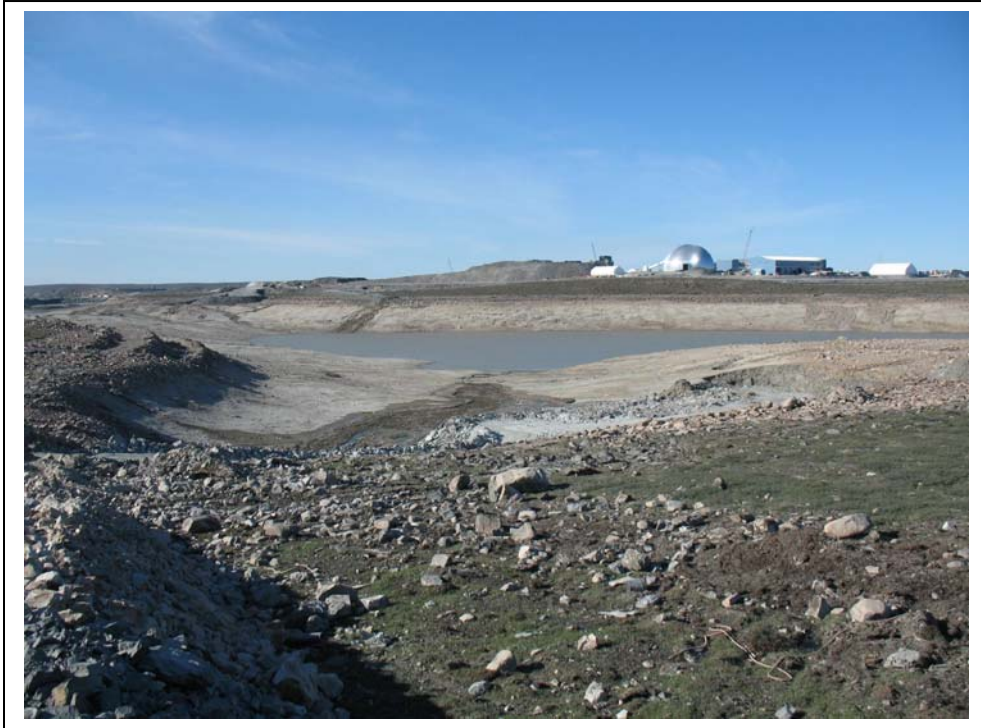
Photo # 19 Central dike axis, view from North abutment to South

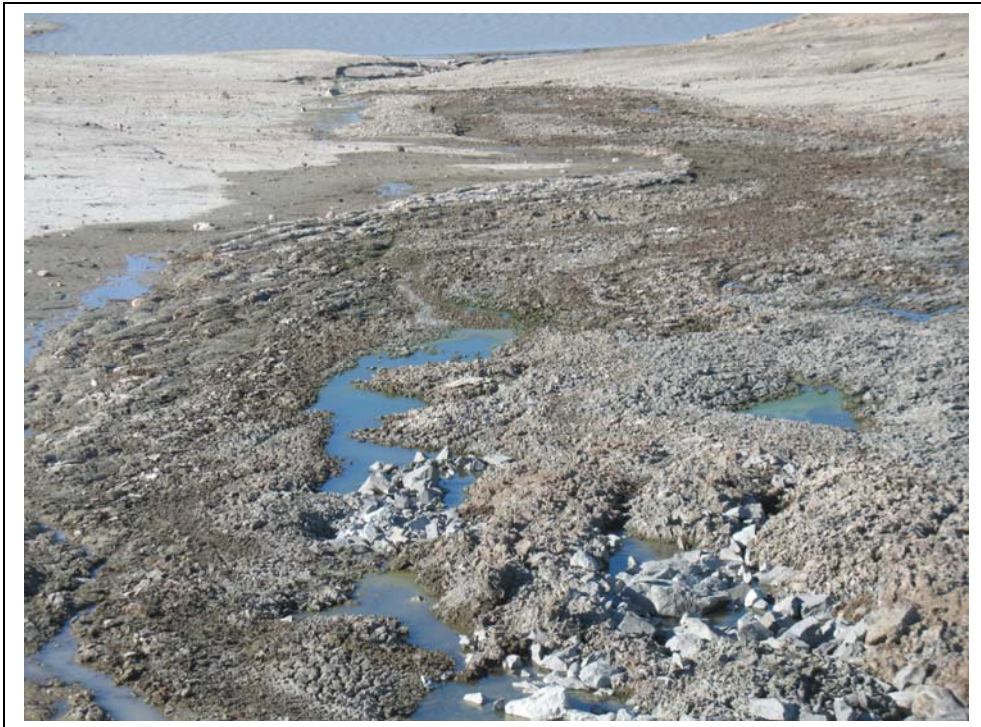
Photo # 20 Central dike axis, flow slide in lakebed sediments
