Appendix E1

Document: *2010 Spill Reports*

SUBJECT: January 16th Fuel Tanker Accident

SUBJECT: October 6th Fuel Tanker Accident

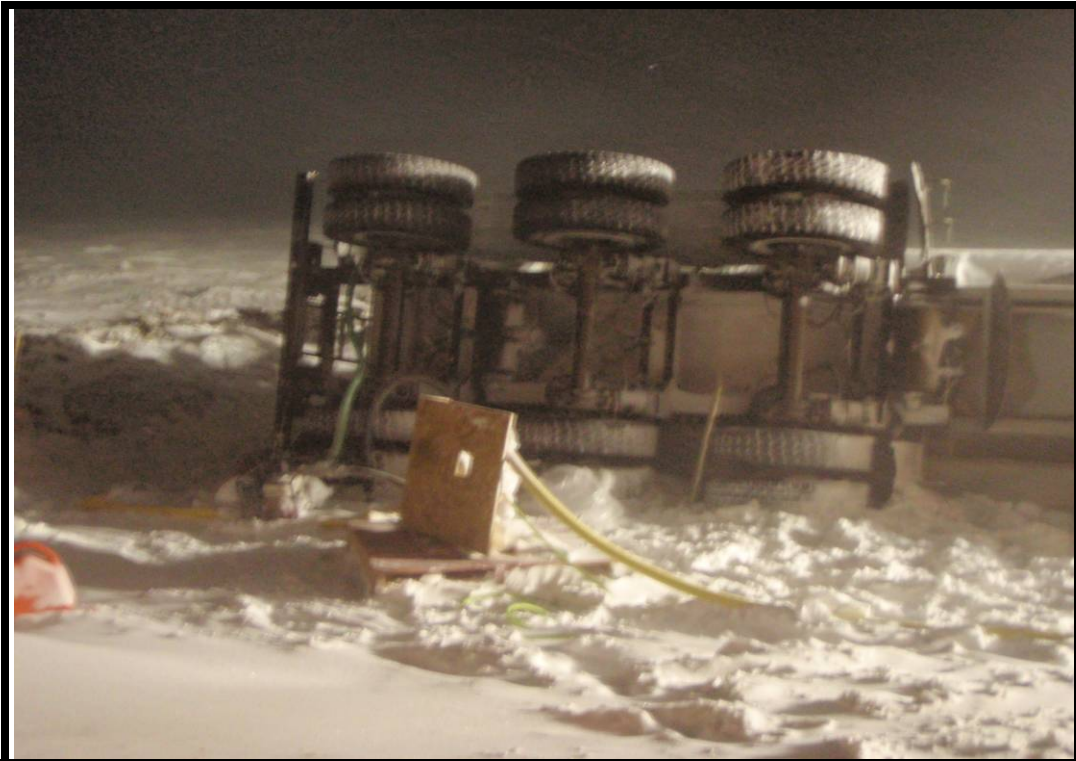
Due to blizzard and poor road conditions, a 40,000L tanker truck slipped off the road and rolled onto its side between the emulsion plant and the Meadowbank mine site (km 103). A code-one was called on the radio and immediately two AEM surface operation employees rushed to the scene and assisted the Arctic Fuel Inc driver. The trailer of the tanker had rolled off the road and onto its' side at the base of a hill. Due to the pressure of the roll-over, the top refueling hatches were released and fuel was spilling out. The AEM first responders quickly sealed the hatches. The emergency response team and environmental staff were mobilized. The integrity of the tanker remained intact with a small continuous leak near a release valve. This was determined to be the only active hydrocarbon spill source.

Photo No 1: 40,027L fuel truck flipped on its side; fuel transfer pumps in foreground; note poor visibility

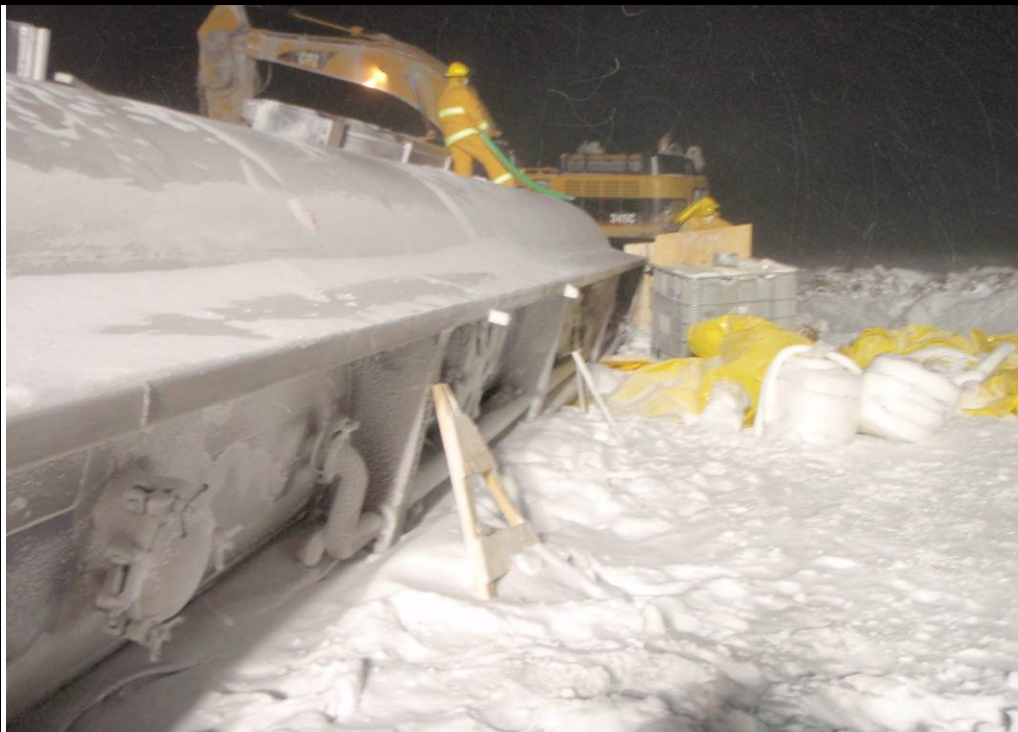
Photo No 2 : Top hatches that were immediately secured

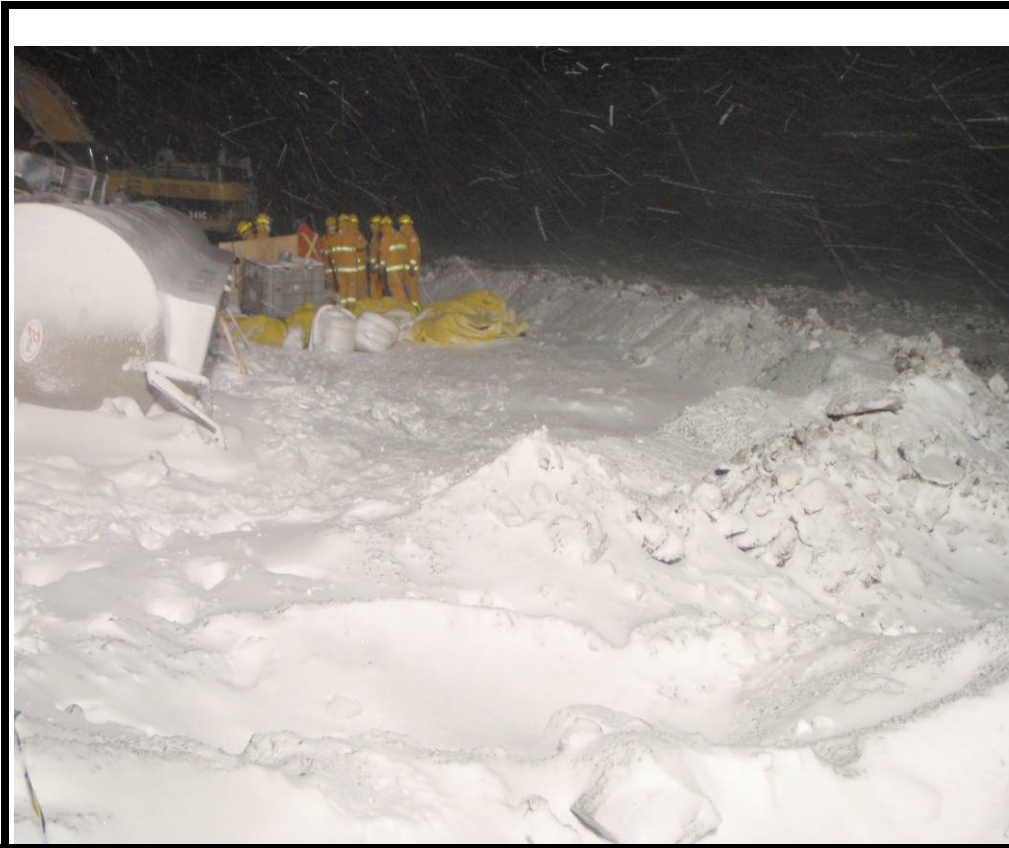
Photo No 3 : Secondary berm constructed with the large excavators

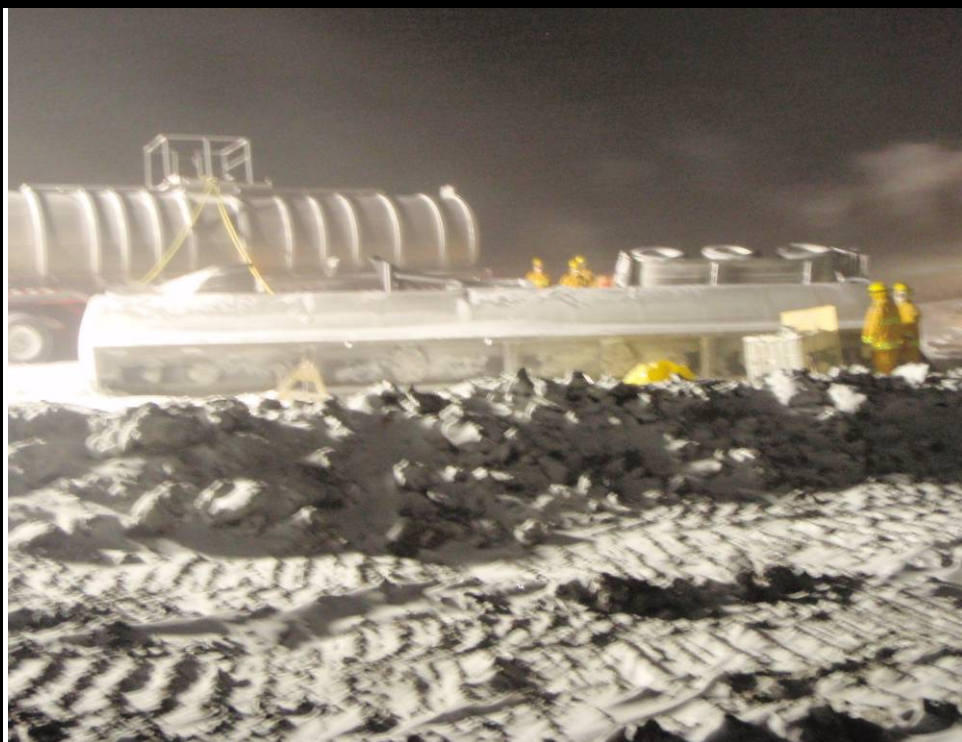
Photo No 4 : ERT organizing pumps to transfer to another tanker; berm in foreground constructed of local muck and lined with $\frac{3}{4}$ inch gravel on the inside

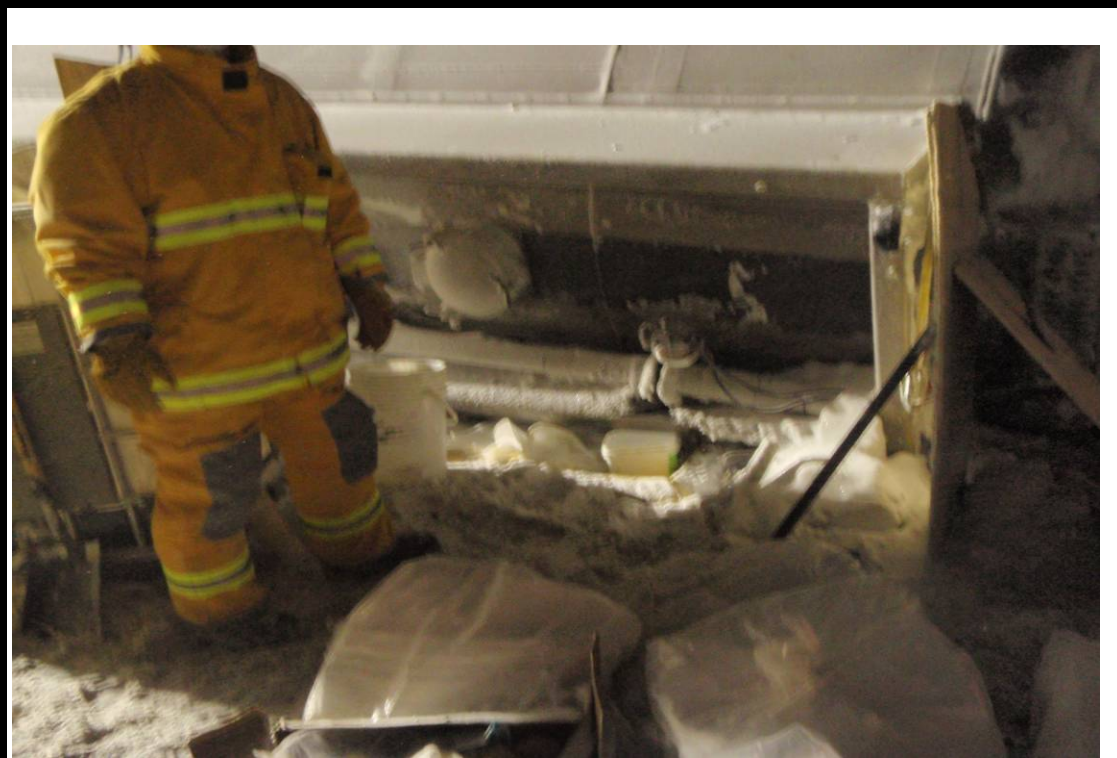
AEM environmental staff contained the area near the release valve with emergency containment berms (see photos) and recovered most of the fuel with absorbent pads or buckets which were transferred to a large cube ~100 gallon storage containers. At this time, the scene was controlled and the ERT leaders coordinated the involvement of the operations staff to bring an excavator and crushed gravel to the scene to construct a secondary containment berm. There was an attempt to pump fuel from the rear release valve, but this was not successful. Instead, two 4 inch holes were cut on the side of the tanker (given that the truck was on its' side, this was the *top* of the tanker) and pumps were set-up with the help of the construction group. During this time, a secondary containment berm was constructed as a contingency (see photos) incase the integrity of the tank did not remain intact. Suction pumps were used to remove the fuel inside the rolled-over tanker and placed in another tanker truck that was parked on the road nearest to the accident site. The fuel pumping and transfer process took nearly 8 hours to complete. Most of the fuel from the truck was transferred to another tanker truck. A total of 38,850 L was recovered.

Photo No 5 : Yellow insta-berm, absorbent pads and buckets used to contain and recover leaking release valve. No other apparent spills.

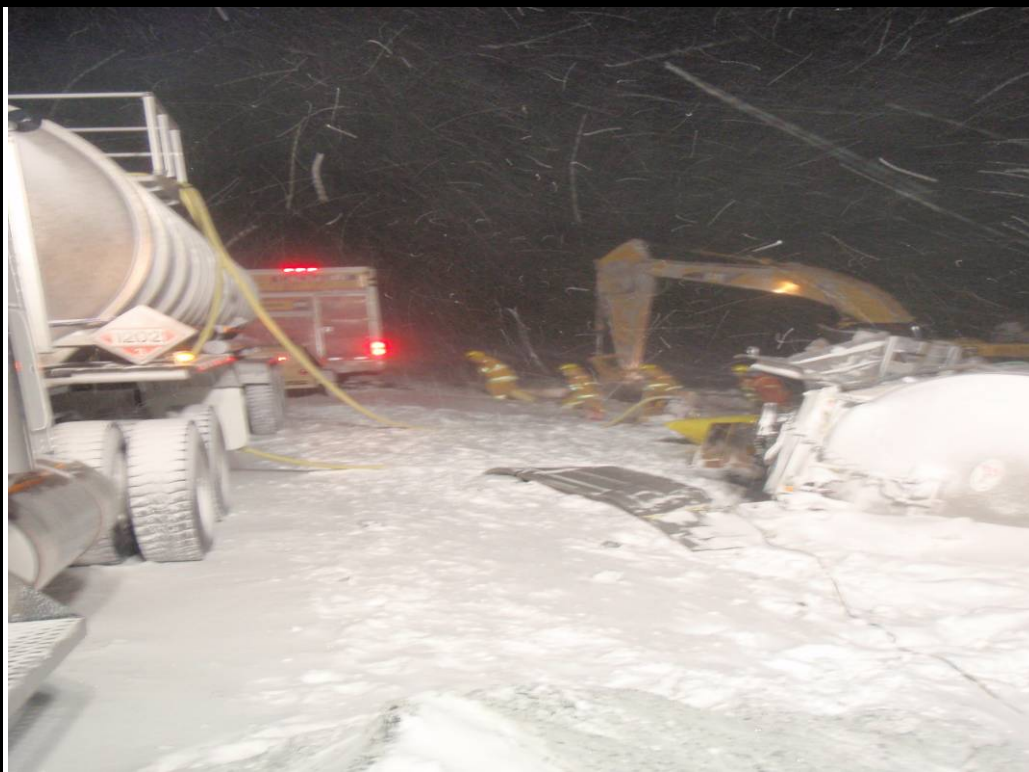
Photo No 6 : ERT setting up pumps; note the difficult weather conditions

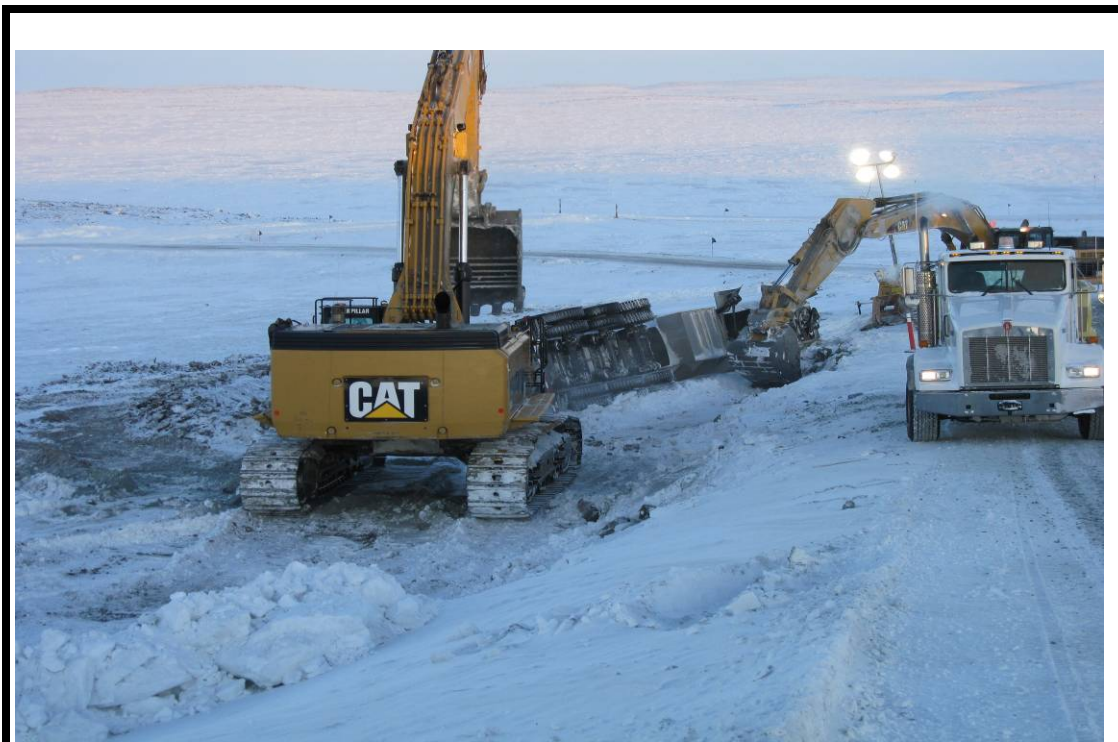
The following day (January 17th), the tanker was lifted with cranes and set upright on the road (see photos). It was evident that the tanker was not punctured or penetrated from the impact of the roll-over and thus confirmed that the identified source of contamination was limited to the release valve (and initially, from the hatches). The snow inside of the secondary containment berm was excavated and placed in containment cells at the Meadowbank mine site (see photos). Surface soil inside the secondary containment berm was also excavated and sends to the quarry 22.

Photo No 7 : January 17th tanker recovery

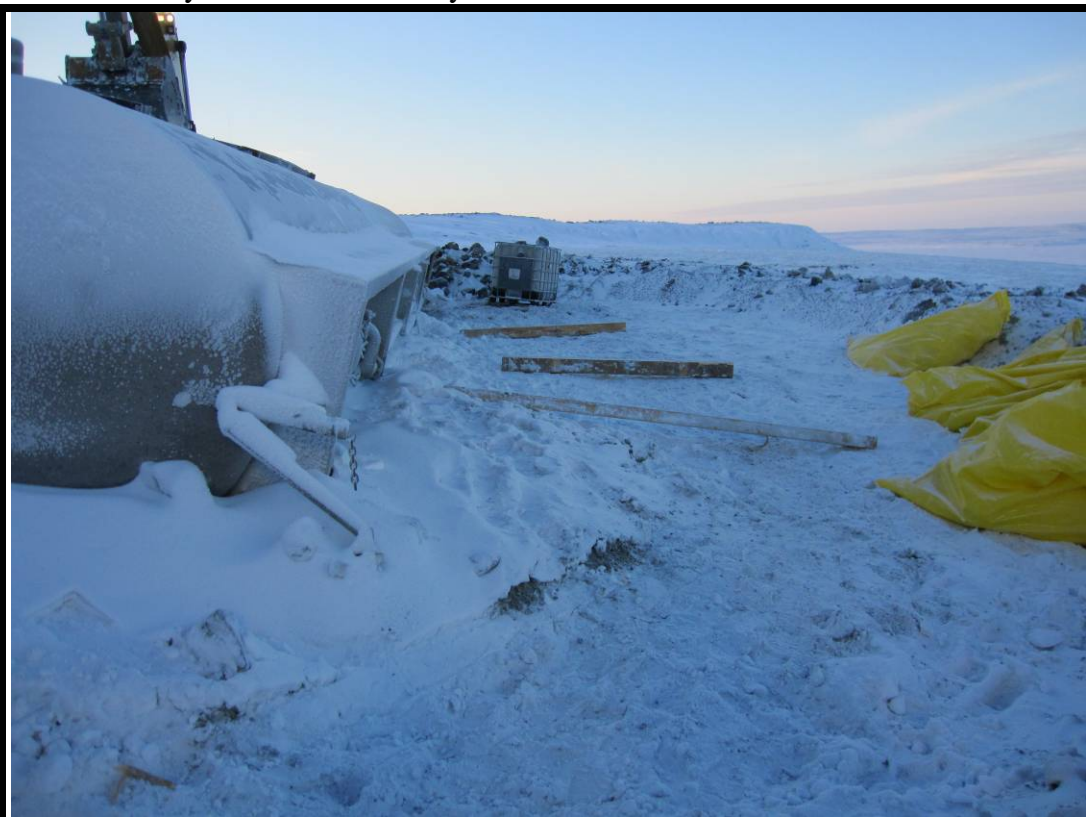
Photo No 8: Secondary containment berm and HDPE hazardous spill bags

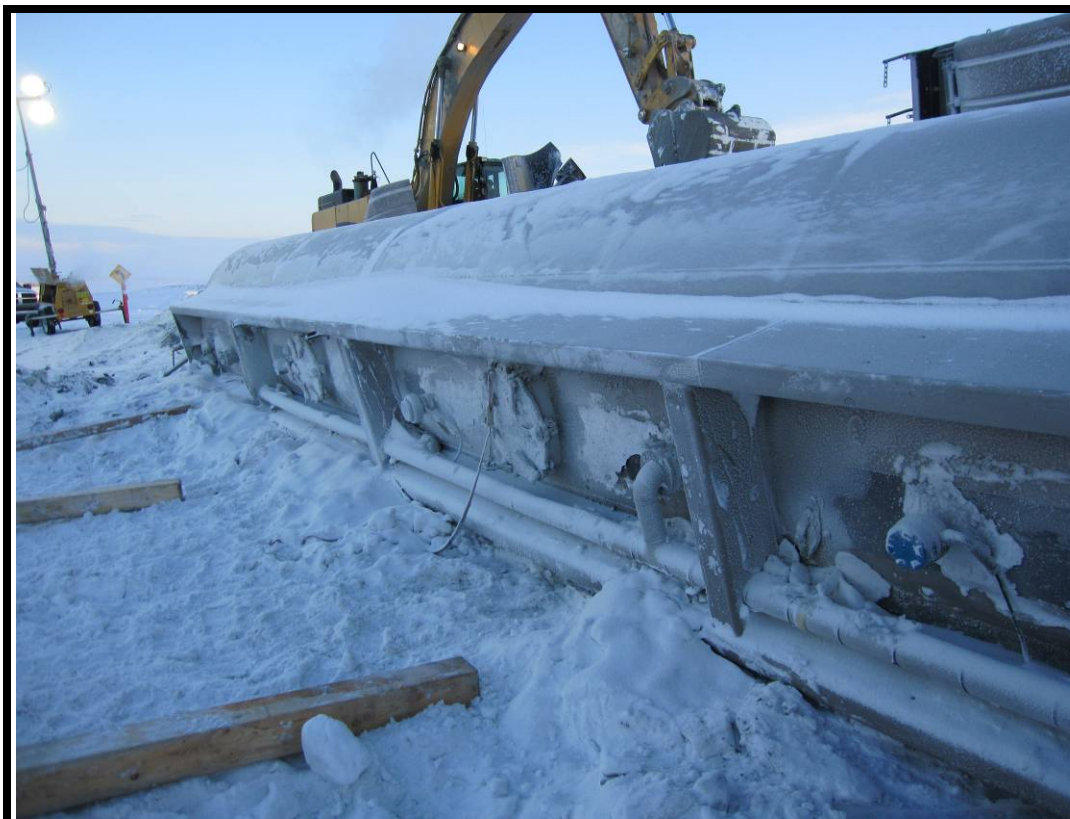
Due to the quick response of the first responders, ERT and environmental staff, it is conservatively estimated that approximately three quarters (~800L) of the 1127 L were spilled into the nearby snow from the released top hatches (see photos). Much of the remaining fuel was collected by environmental staff, and the only persistent leak was contained with the use of HDPE yellow emergency spill berms. Most of the release valve spillage was collected in buckets inside the yellow emergency berm and placed in an ~100 gallon cube containers. The remainder was collected in spill rags and placed in yellow hazmat HDPE bags. Much of the snow around the release valve was also cleaned up by hand and placed in HDPE bags. The spill was called into the GN spill reporting hotline at about 9am by AEM. A complete report was submitted shortly thereafter at 11:00am. Although the spill report volume was 1127L, it was unlikely that this was the actual spill volume, as most of this quantity was collected with buckets or absorbed with spill rags.

Photo No 9 : Top hatches

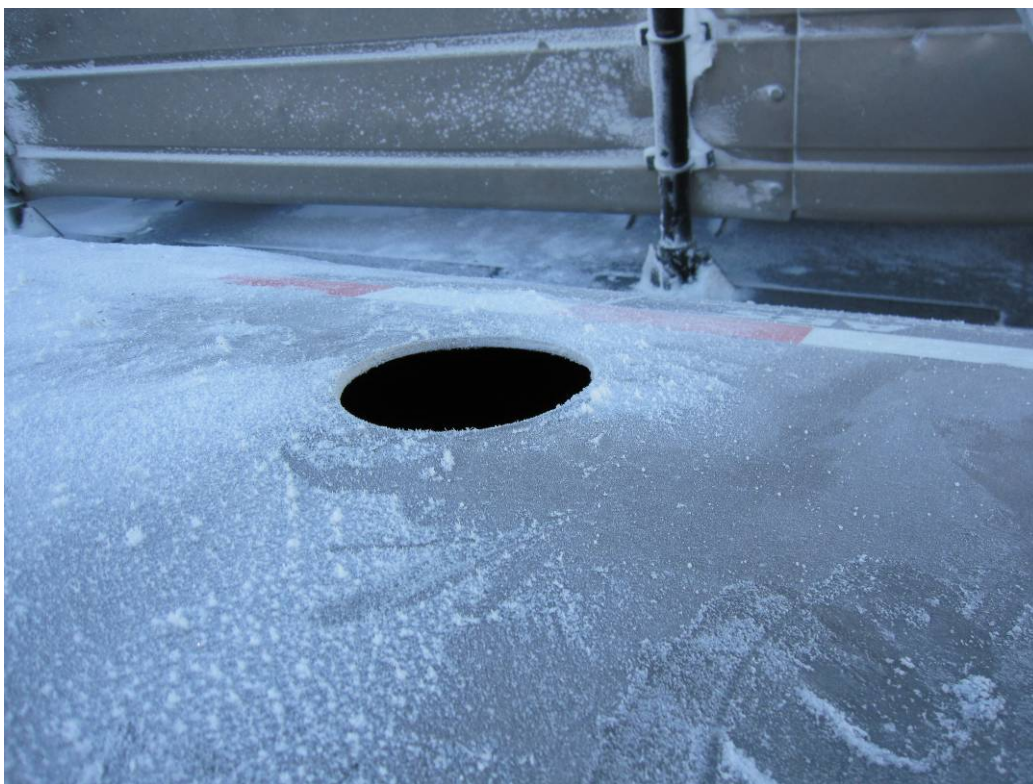
Photo No 10 : Drilled hole on the side of the tanker

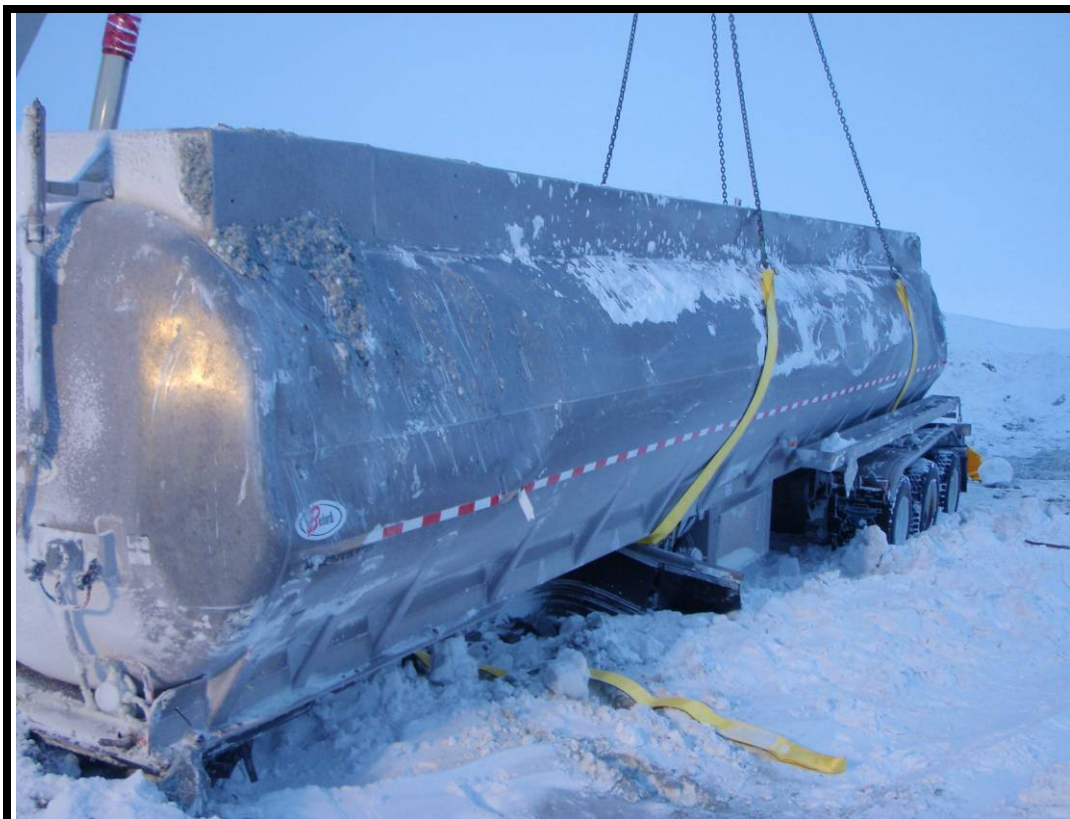
Photo No 11 : Dents at front of tanker

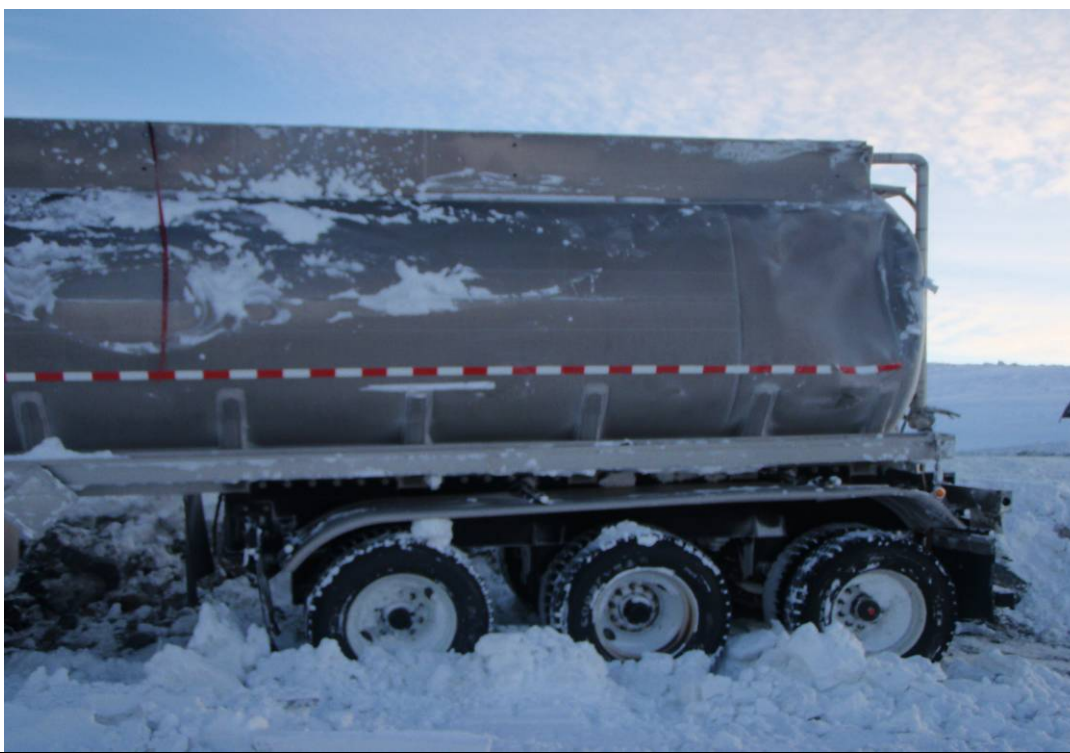
Photo No 12 : Dents at rear of the tanker; no punctures

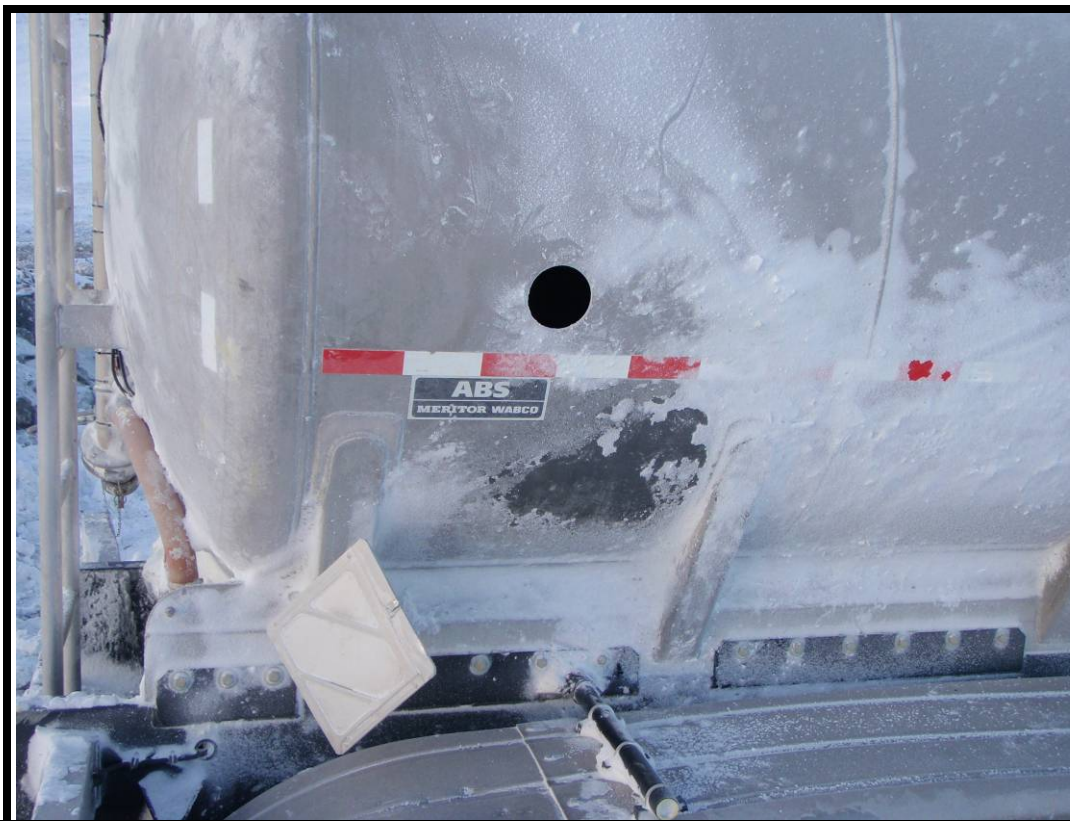
Photo No 13 : Drilled hole used to pump and recover fuel.

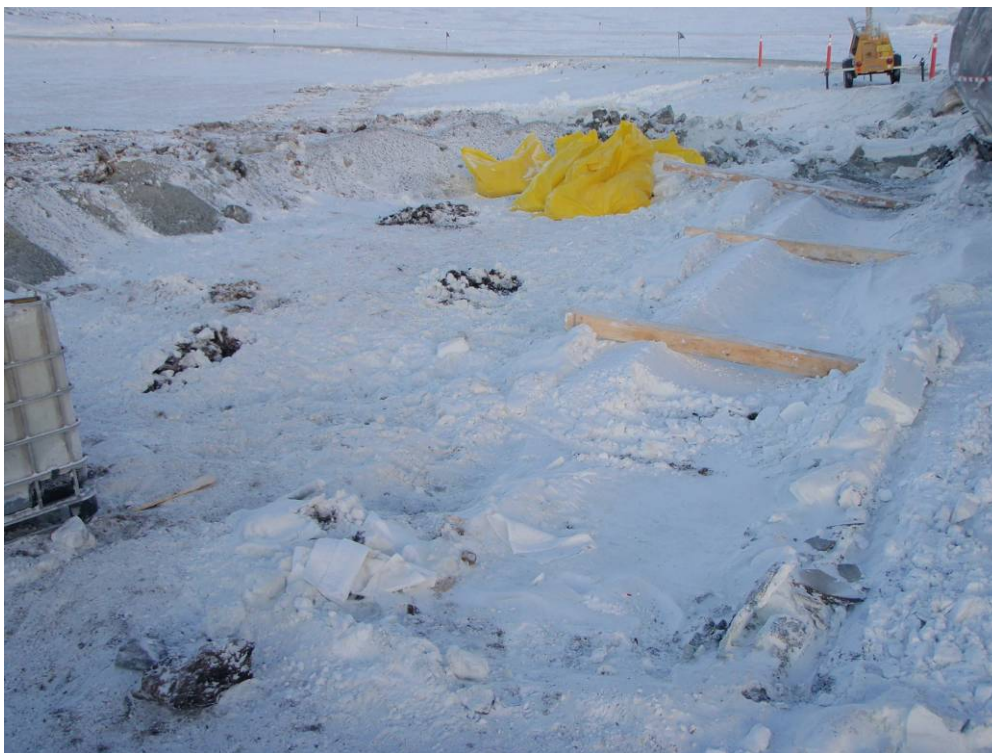
Photo No 14 : Site after the removal of the tanker

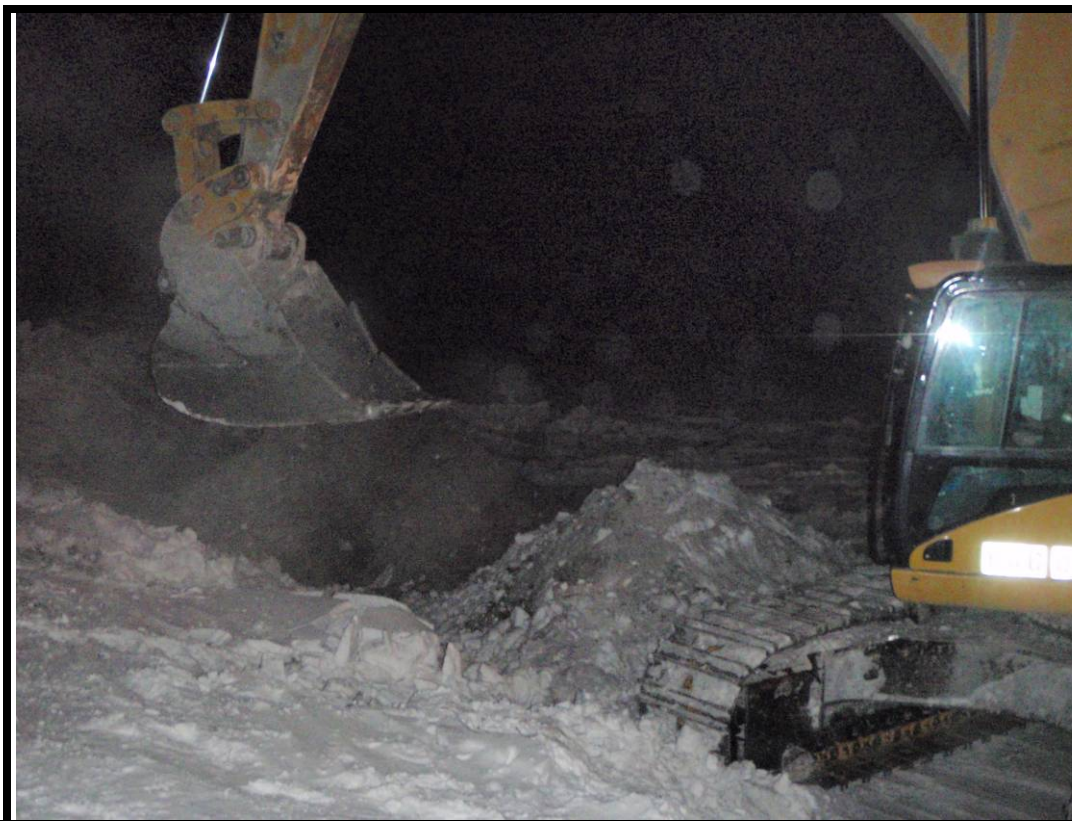
Photo No 15 : Snow and soil excavation in the evening of January 17th

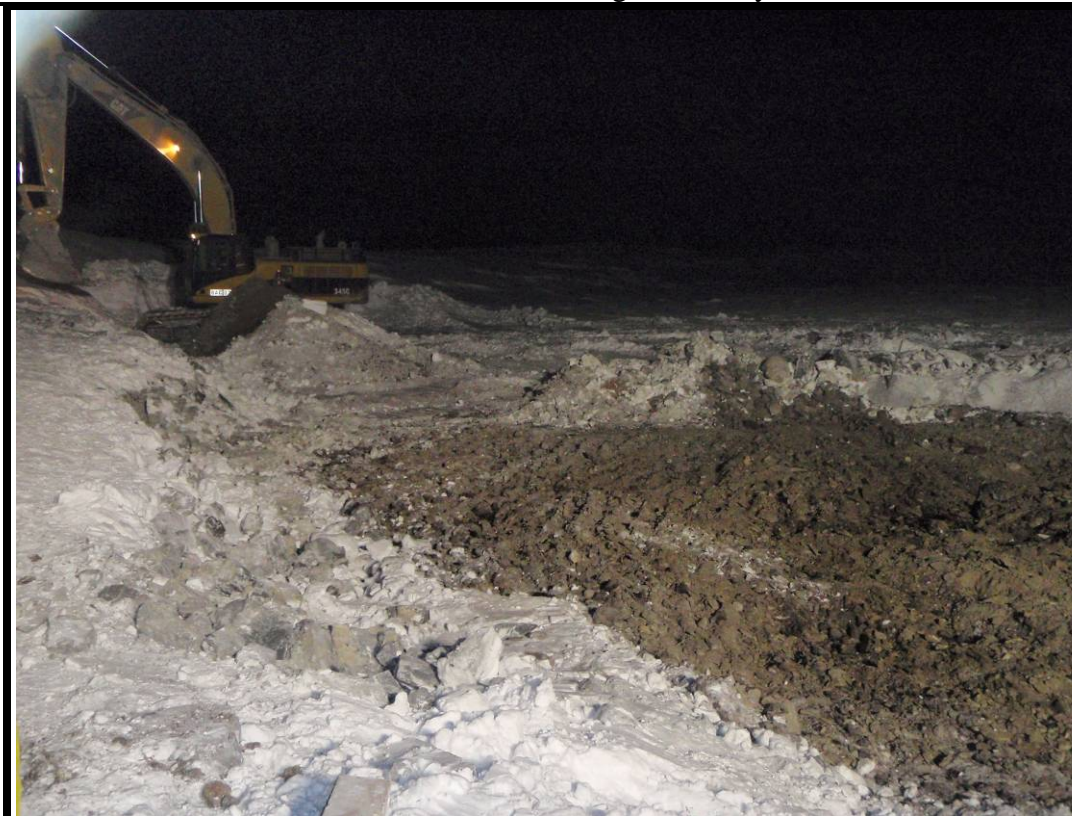
Photo No 16 : Snow and soil clean-up

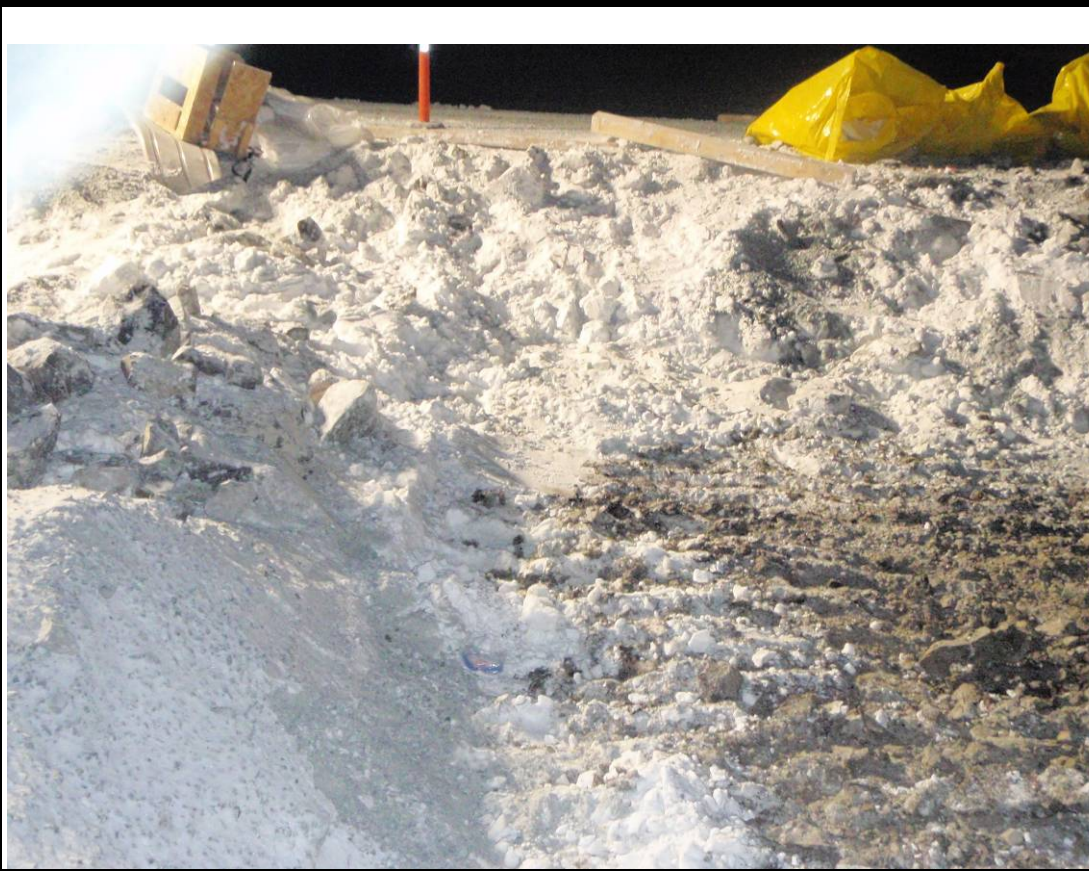
Photo No 17 : Snow and soil clean-up

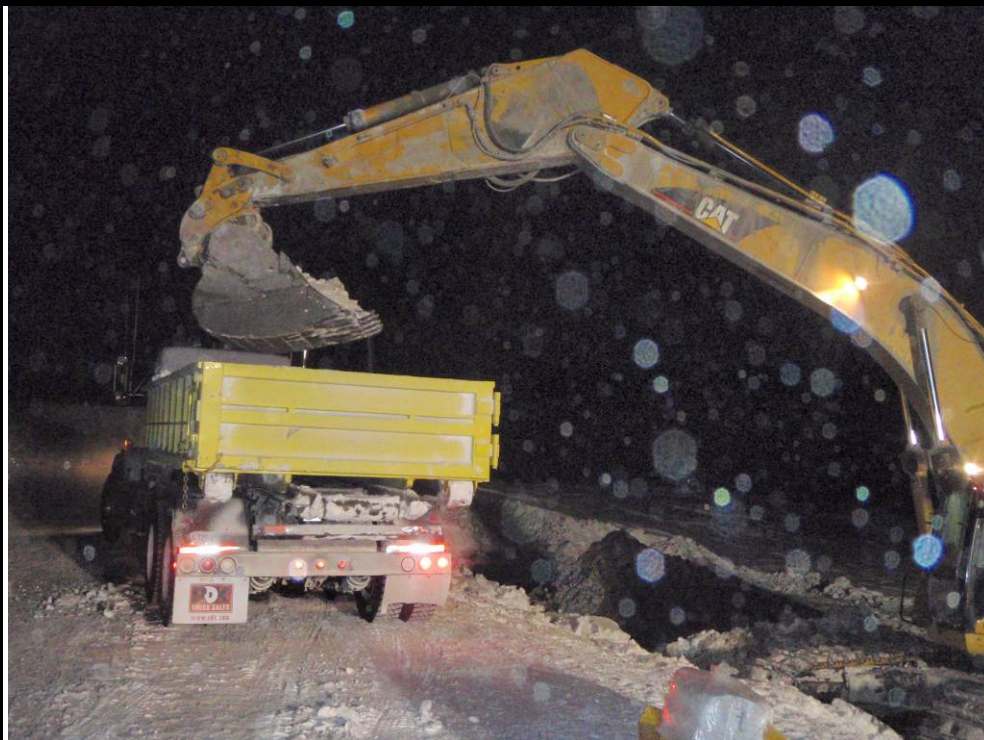
Photo No 18 : Material removed from the site of the accident.

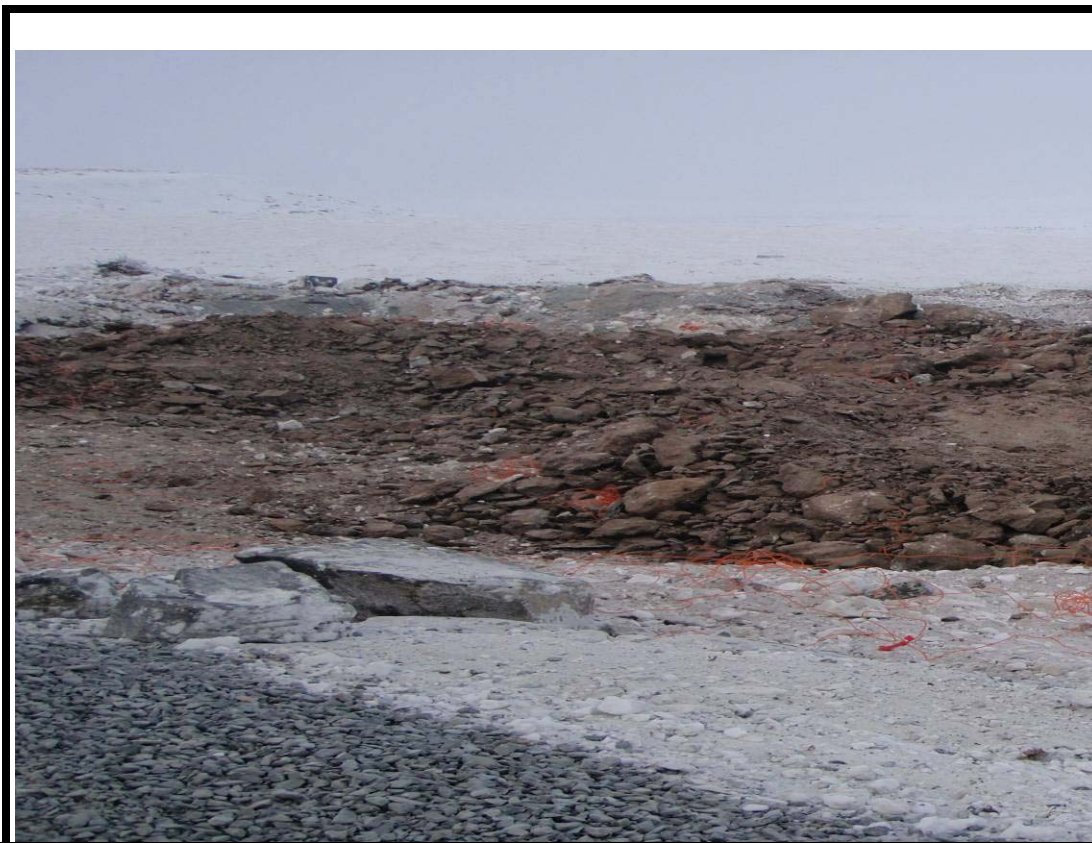
Once this was done, diesel odor was still perceptible. After some try to remove the rest of the contamination with the mechanical shovel, we realize, it was impossible to dig deeper to make a good recovery, because the ground is frozen. It was decided to blast the bottom of the excavation to take out the remaining contaminated soil. The blast took place on February the 13th and went six feet under the previous excavation. The blasted soil was excavated and sends to the quarry 22. No more contamination and diesel odor was detected. Composite samples were taken in the bottom of the excavation as well as on the side and will be analyzed.

Photo No 19 : Spill site right after the blast, February 13th 2010

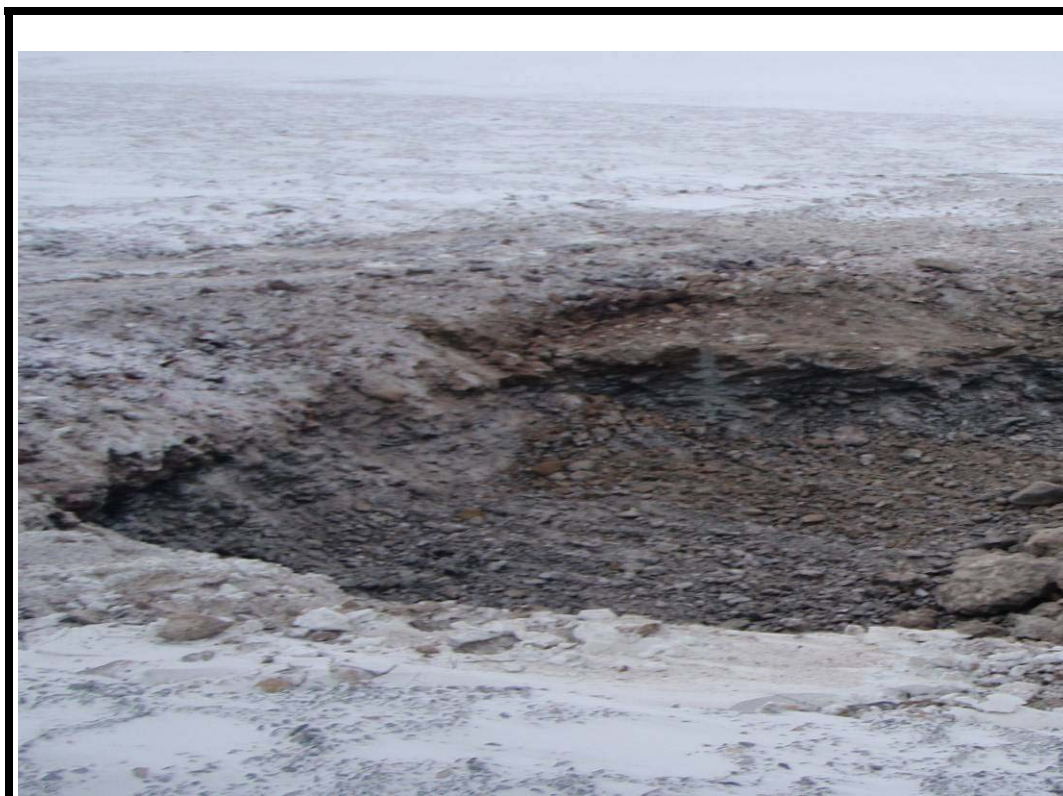
Photo No 20 : Excavation after blast and clean up February 13th, 2010

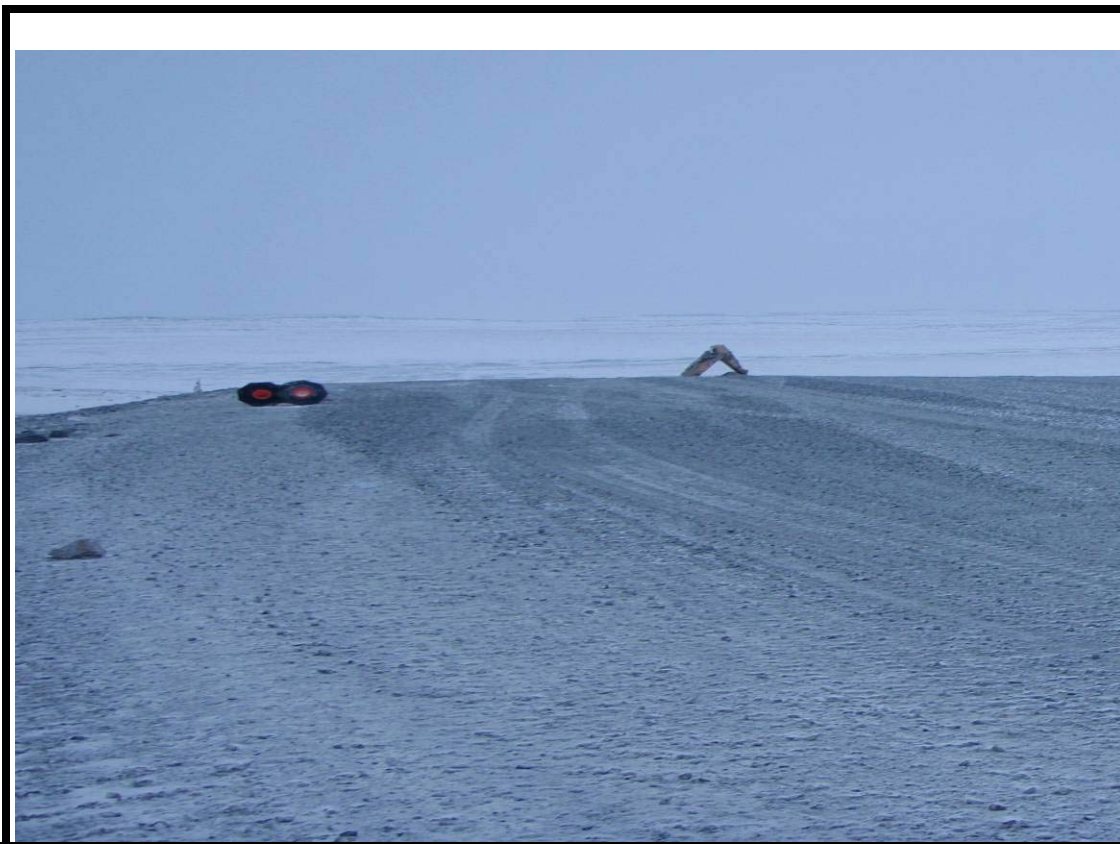
Photo No 19 : Road enlargement February 13, 2010

To avoid another accident at this emplacement, AEM enlarged the road at the top off the hill (photo No19). Truck driver will have more space and it will allow them to take more speed going into the hill.

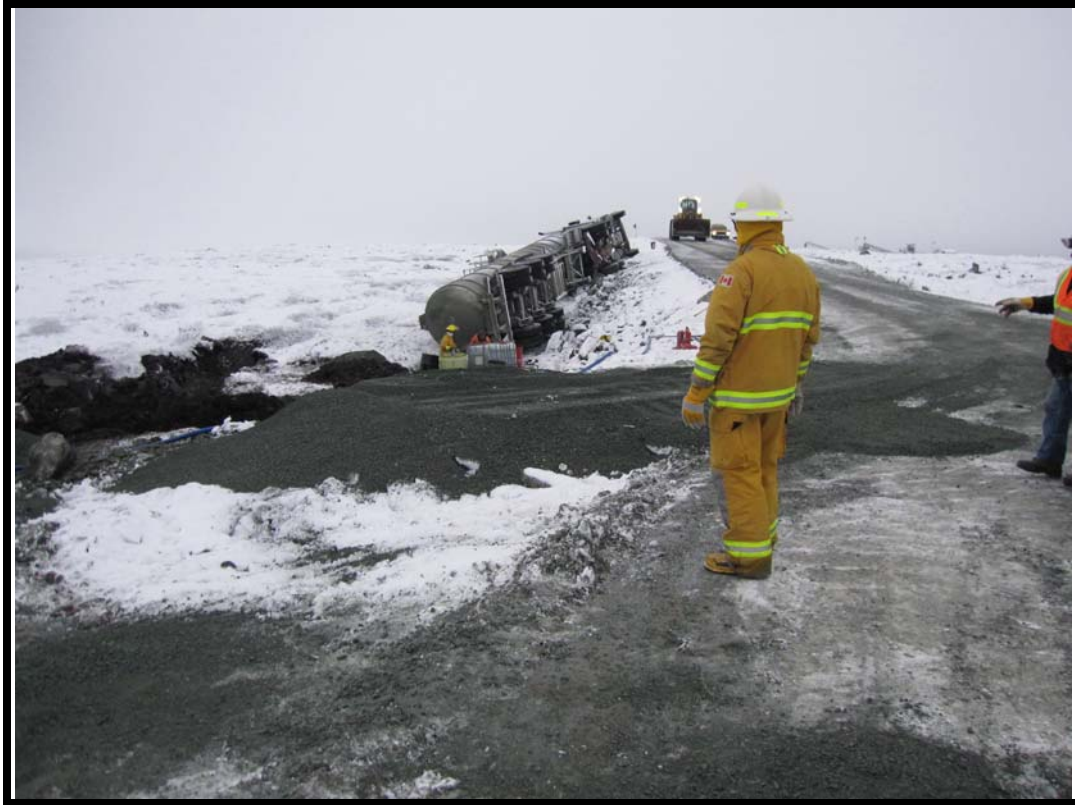
Wednesday, October 16 at 4:45 AM, due to slippery condition on the road, a tanker truck hauling fuel from Baker Lake to Meadowbank mine site rolled over off the road (Photo No 1) just after bridge #3 and just before Quarry 3 at KM 22 (N 64 30 019, W 096 07 451, IOL land parcel BL 18). The tanker truck was hauling 40,000L of diesel fuel to site. The vehicle is owned by AEM however the drivers are under contract with Arctic Fuels in Baker Lake. The tank was damaged on a rock and the fuel was leaking on the ground.

Photo No 1: Accident of a tanker truck of 40,000L of fuel. The truck rolled over on the road's side.

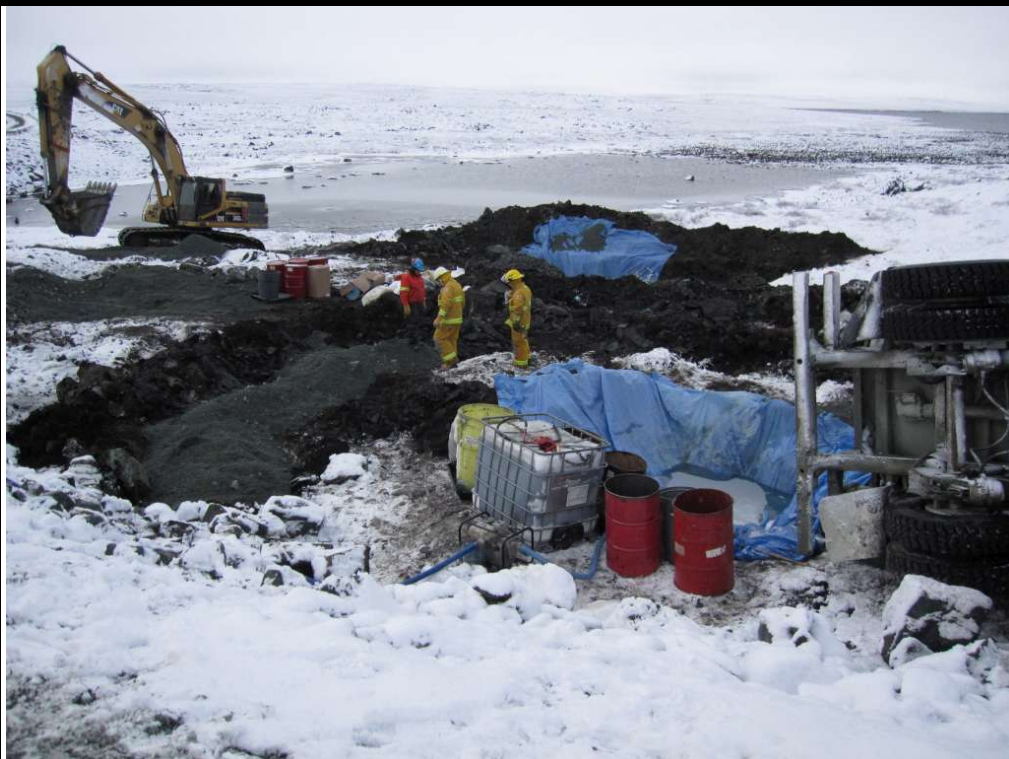
Photo No 2 : General view of the first intervention. We can see the two ponds.

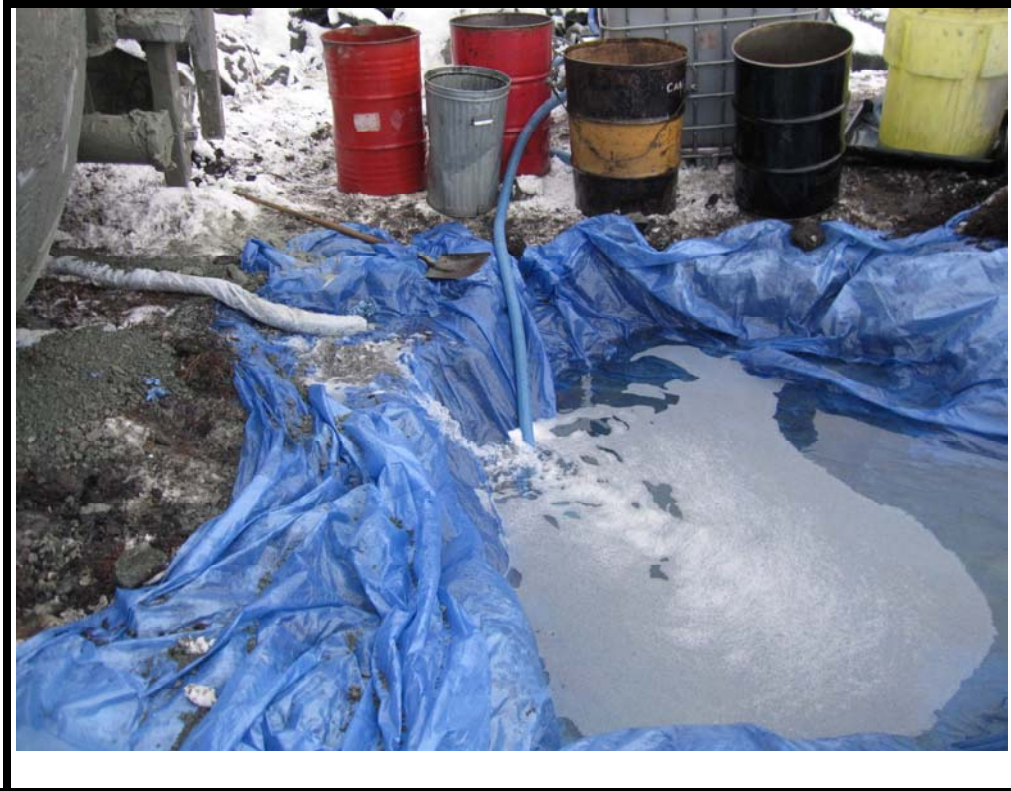
Photo No 3 : View of the first pond where the fuel leaching from the tanker was pumped directly in another 40,000 L tanker truck.

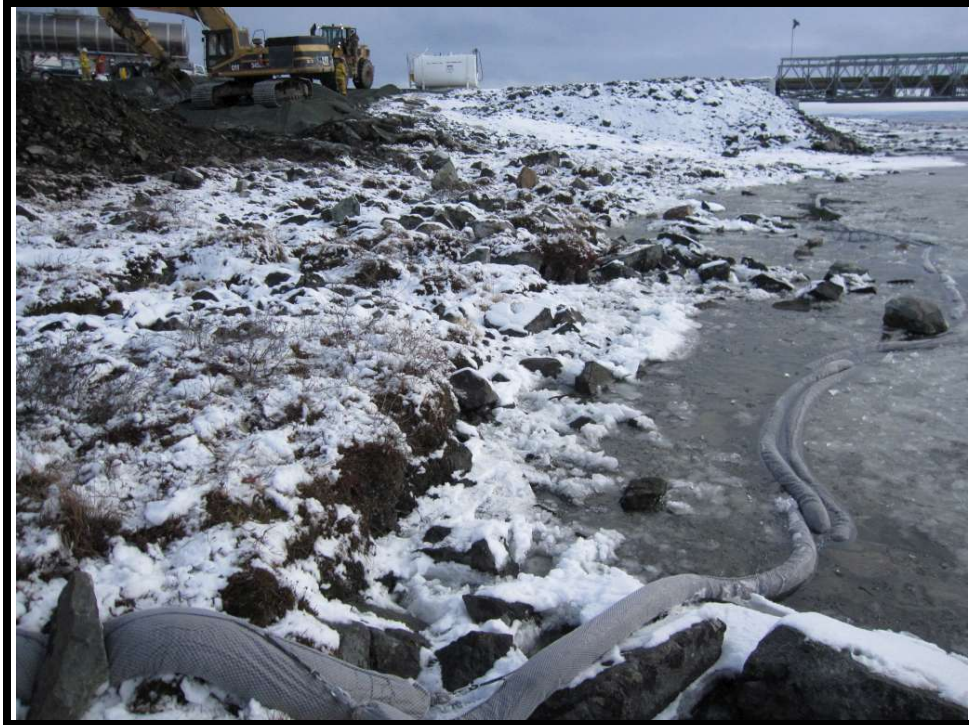
slope from the leak before it can reach the water in the river. Booms were installed in the river, five meters from the shore by prevention (photo No 4). We installed two pumps, one in each pond. The liquid pumped from both ponds was transfer directly in another tanker truck of 40,000 L (photo No 3). With this method, we estimate that 37,000 L of fuel was recovered. Therefore approximately 3,000 L were spill in the environment. We begun to excavate the contaminated soil during the afternoon and 210 tons of material was removed and store in the quarry #6. We observed then we have around 30 to 60 centimetres of overburden and the contamination run directly under the soil to infiltrate the fractured bedrock. A fault caught the majority of the product. The second pond was made to stop the progression of the fuel in that fault. In total 48,000 litres of fuel and water has been pumped during that first day of intervention (photo No 6). The tanker was moved from the accident site around 18:00.

Photo No 4 : Booms installed in the river to prevent the river contamination.
