Appendix E1

Document: *2010 Spill Reports*

SUBJECT: January 16th Fuel Tanker Accident

SUBJECT: October 6th Fuel Tanker Accident

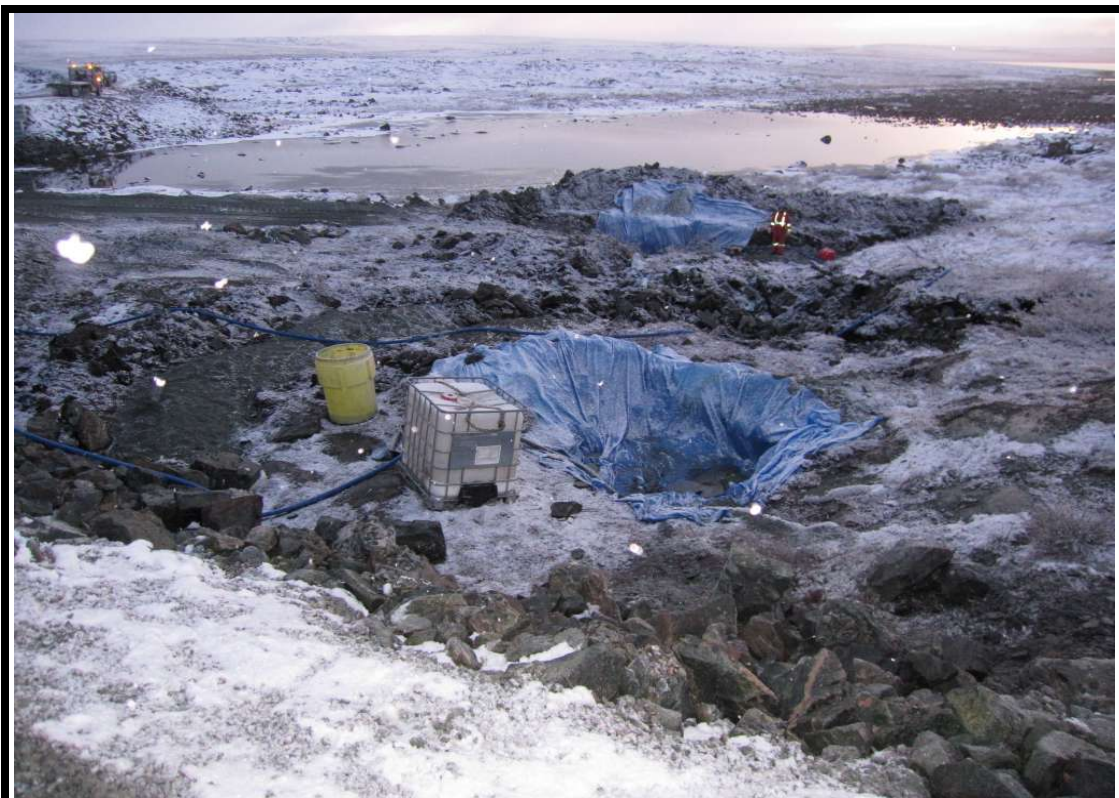
Photo No 5 : General view at the end of the first day of the intervention. The area of the spill was secured.

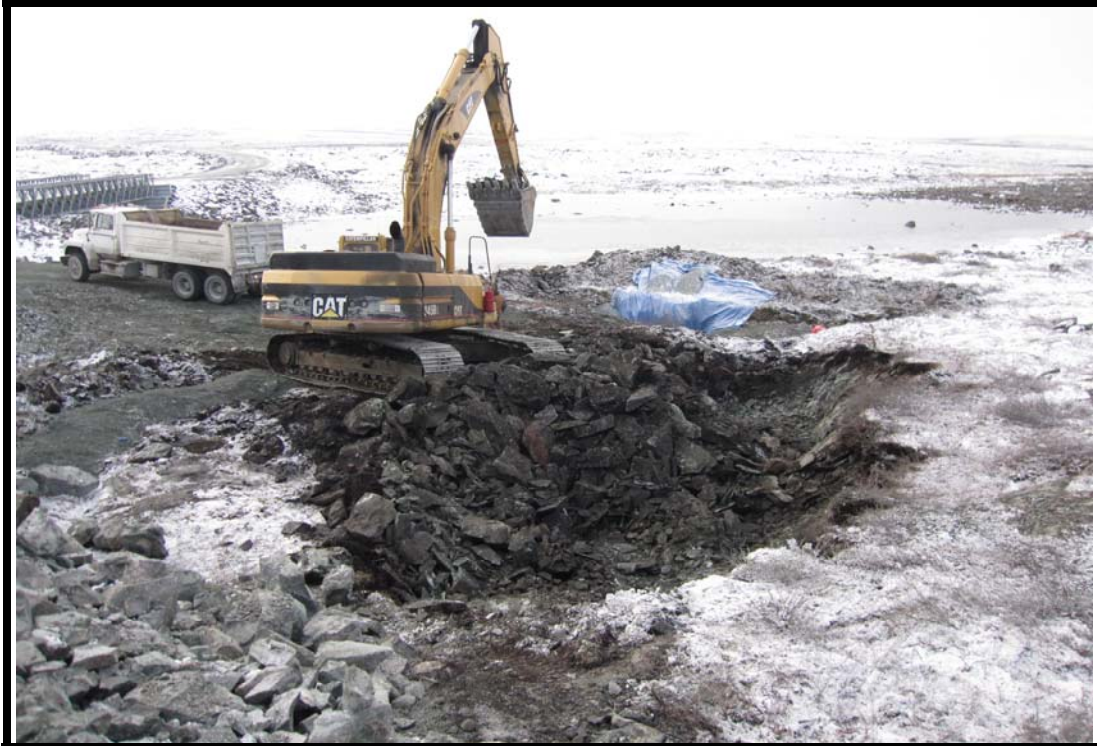
Photo No 6 : Excavation during October 7.

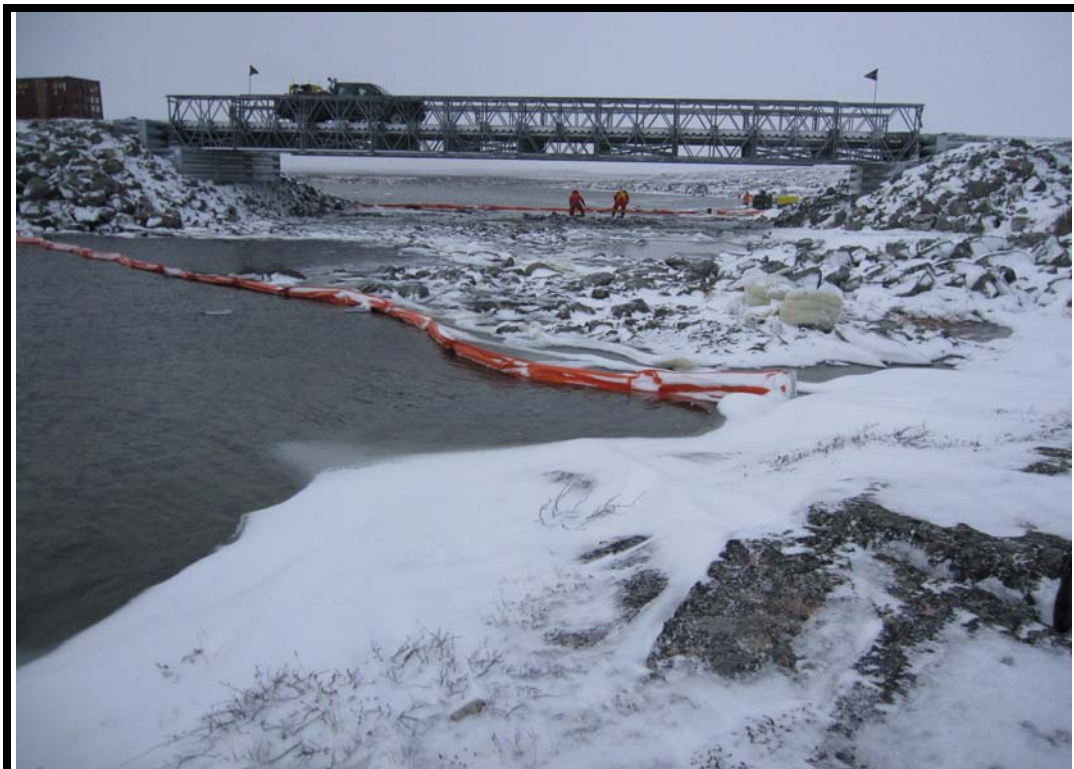
Photo No 7 : Maritime barriers were installed under the bridge.

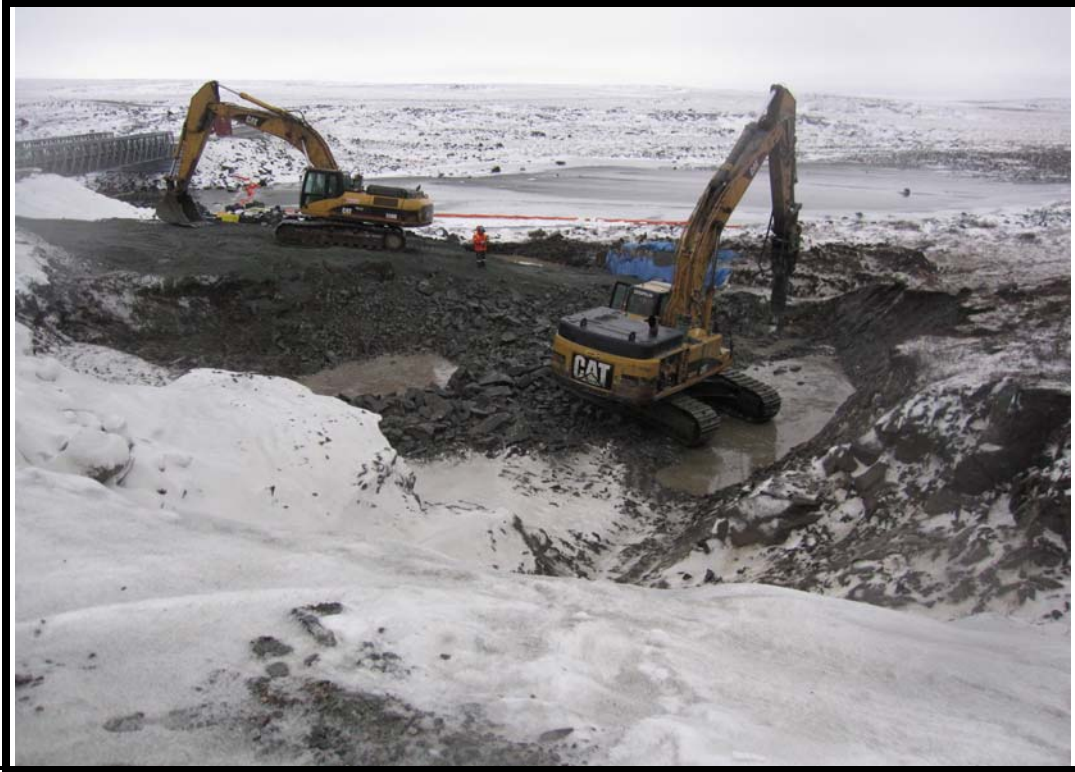
Monday October 11, The excavation area is defined following the contamination external limit (Photo No 8). We cannot go deeper (deepest place is 21 feet). We still have sheen in the water in the bottom of the excavation. 895 tons of rock was excavated.

Photo No 8 : Reach the bottom of the excavation .

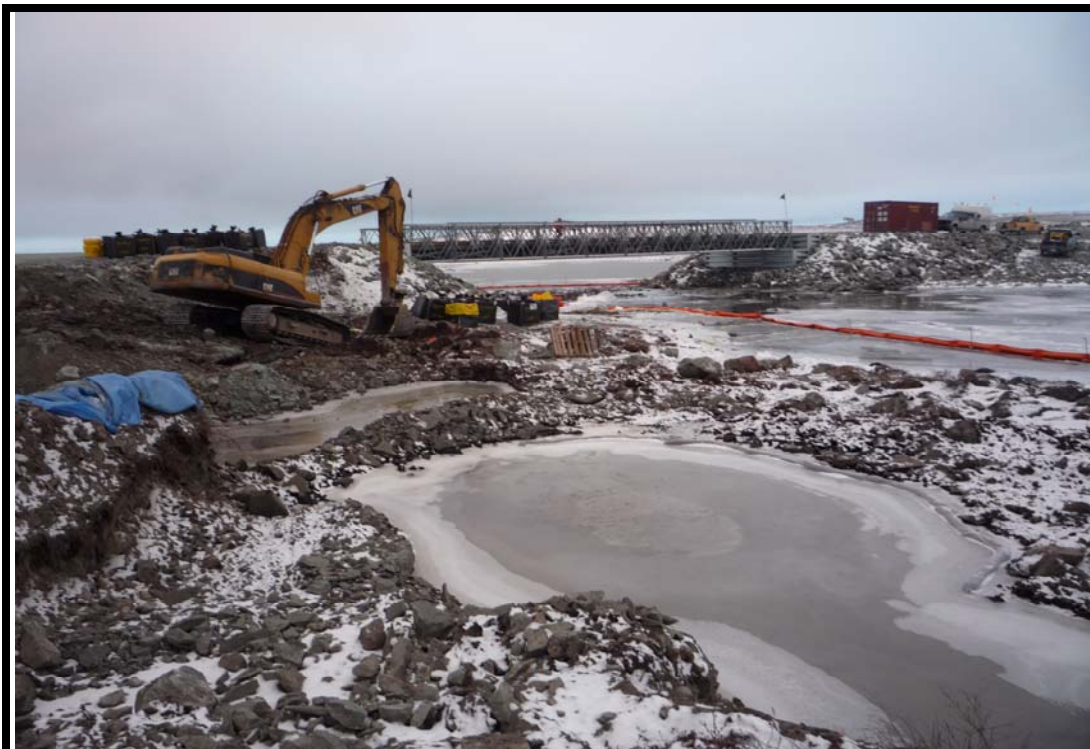
Thursday October 14, we began to remove the material in the area near the abutment of the Bridge 1 (Photo No 9). The material not contaminated was put back into the Northeast wall of the large excavation. A ditch was done between the abutment of the bridge and the first ditch. We began to excavate and reach the water, odours of fuel are noted. A small sheen is noted under the bridge, recuperated with booms.

Photo No 9 : Beginning of the excavation between the bridge abutment and the first ditch.

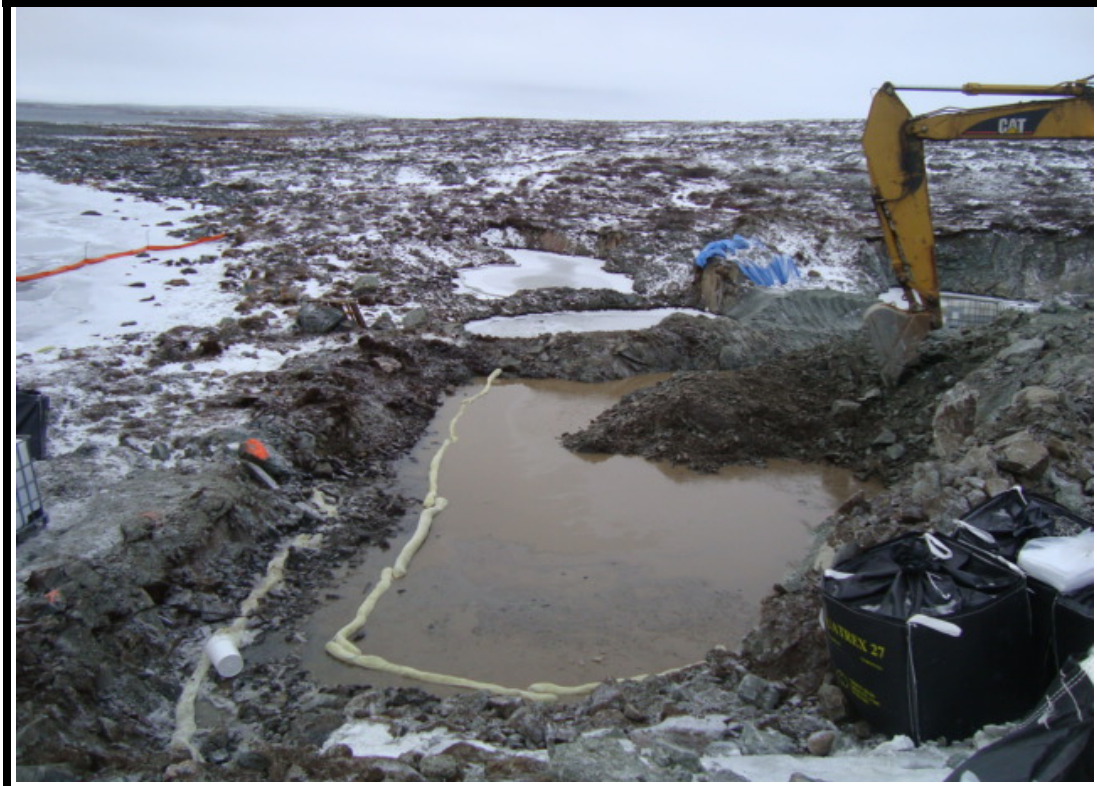
Friday October 15, we continued the excavation of the contaminated soil (75 tons was removed) (Photo No 10). Odours of fuel are still noted. A small sheen was observed under the bridge, recuperated with booms. Visit of the KIA (Simeon Miggunkwak).

Photo No 10 : Excavation between the abutment of the bridge and the first ditch.

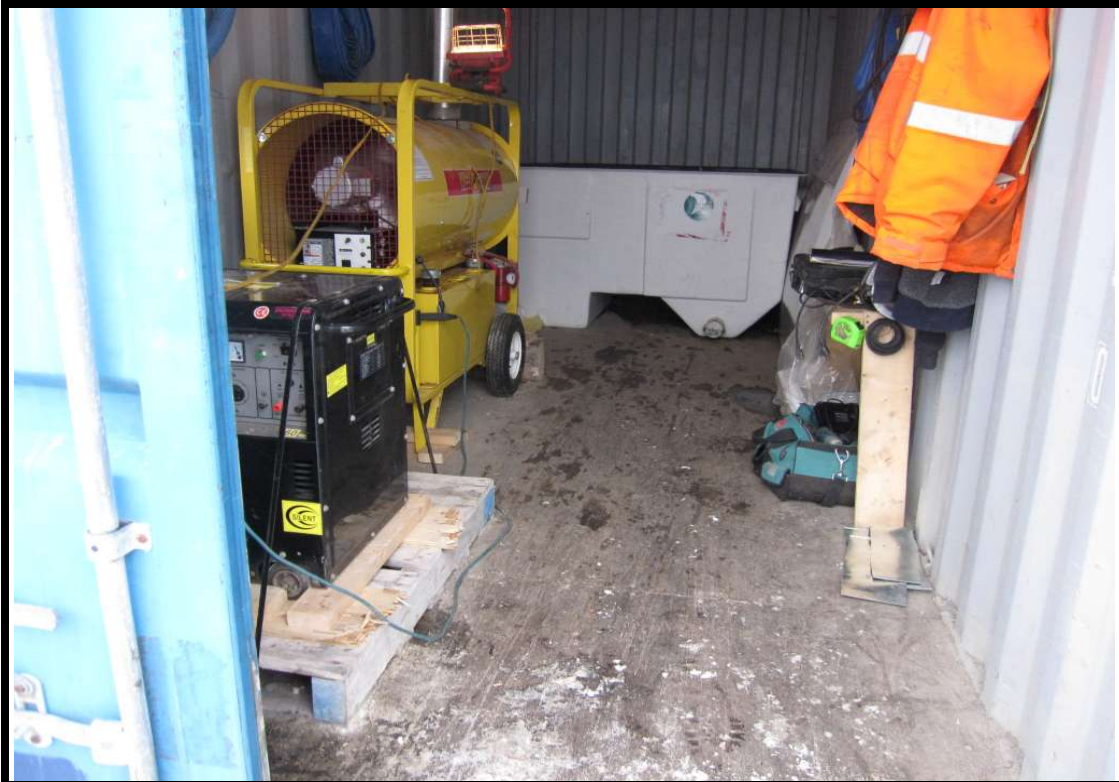
Thursday October 21 to Monday 25, AEM work to build a water treatment. An oil separator installed inside a heated seacan will recover the contamination (photo No 11). To avoid having an effluent, the water needs to be conserving inside the excavation done. The water will be pump in recirculation, passing through the oil separator and returning inside the ponds.

Photo No 11 : Inside the heated seacan where the oil separator is installed.

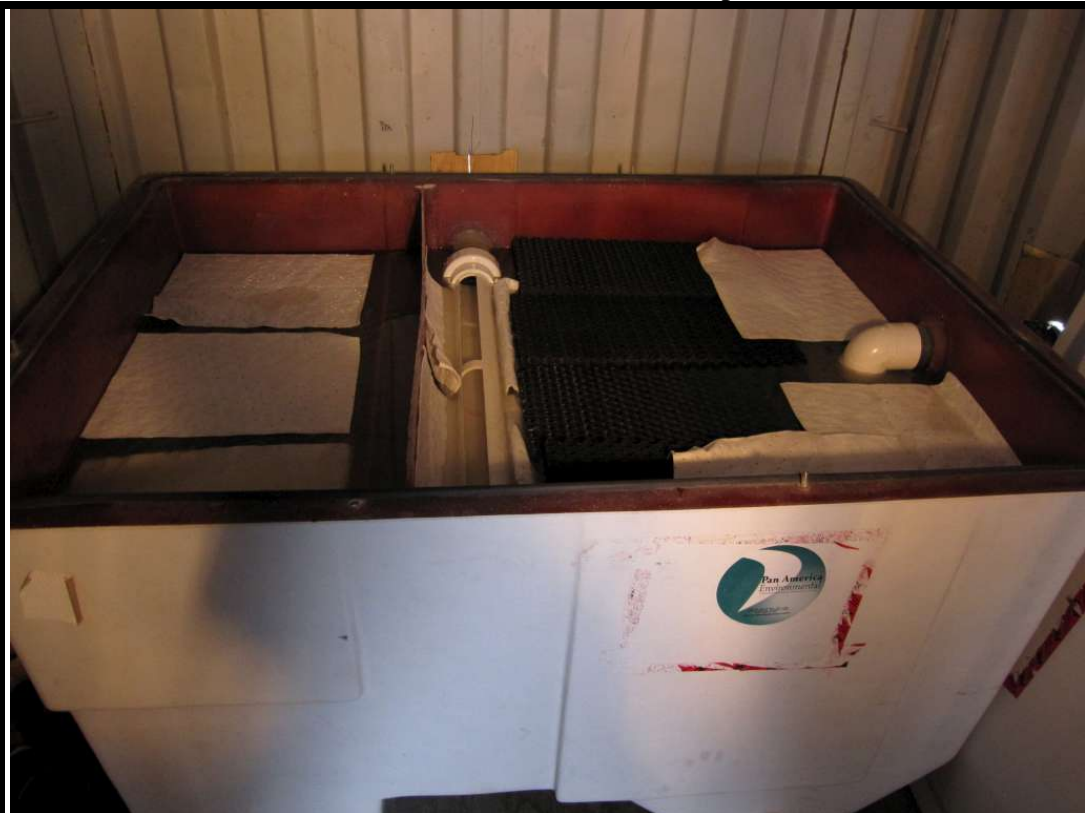
On Monday we observed that the treatment of the water is slow but efficient. We apply absorbents pads inside the oil separator and in the ponds inside the excavation to accelerate the recovery (photo No12 and No 13).

Photo No 12: Absorbents pads placed in the oil separator to help the contamination recovery.

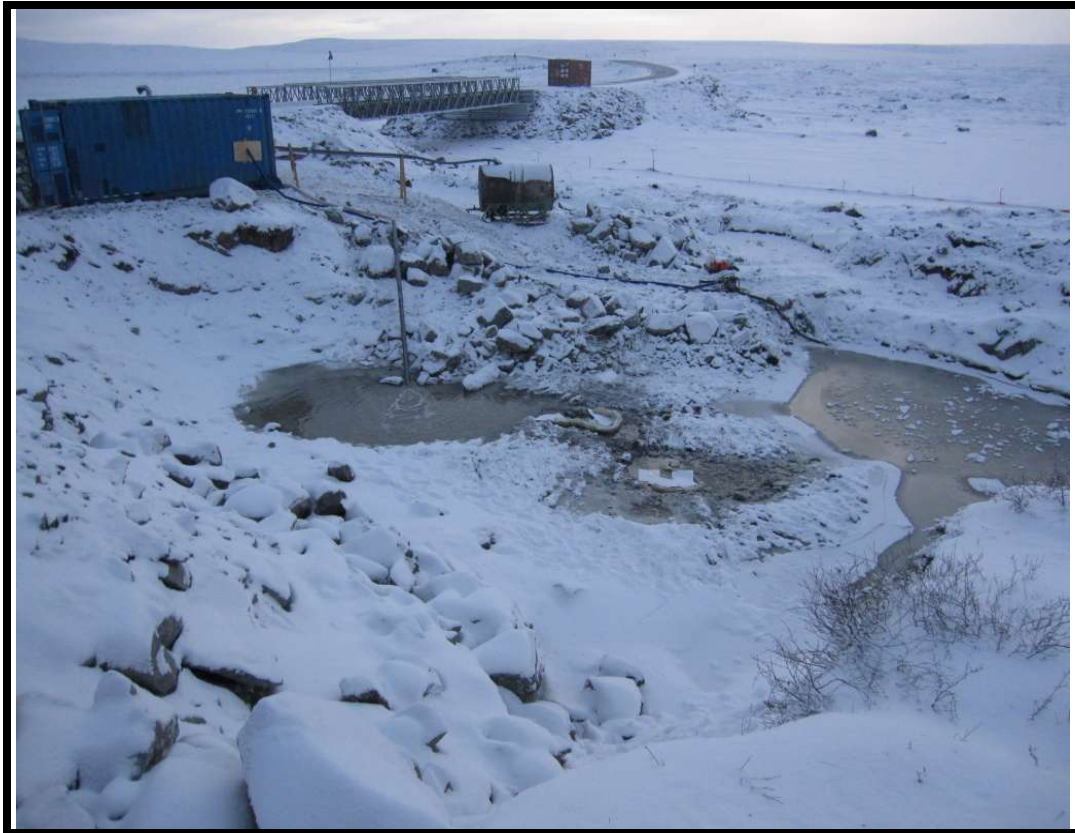
Photo No 13 : Spill area on October 25. Water is treating in recirculation.
