Appendix A2

Independent Geotechnical Expert Review Panel Reports

Report 8: *Meeting April 26-27, 2011*

**Report No 8
Meadowbank Mine Dike Review Board
Meeting April 26-27, 2011**

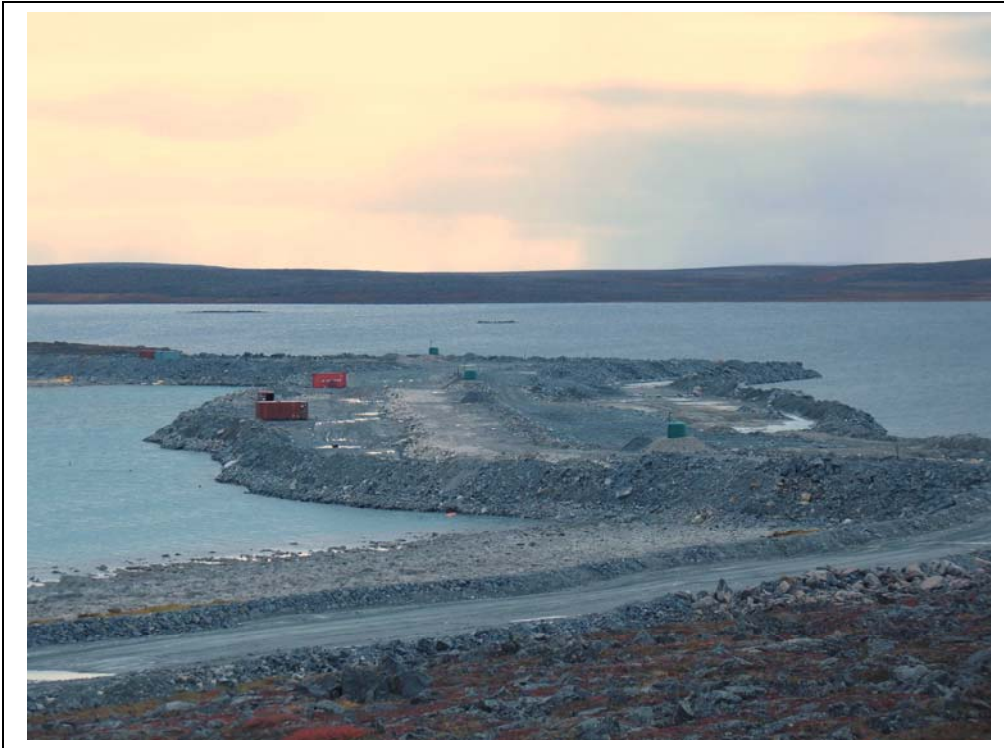
Photo #1 Southern extremity of
Bay-Goose dike

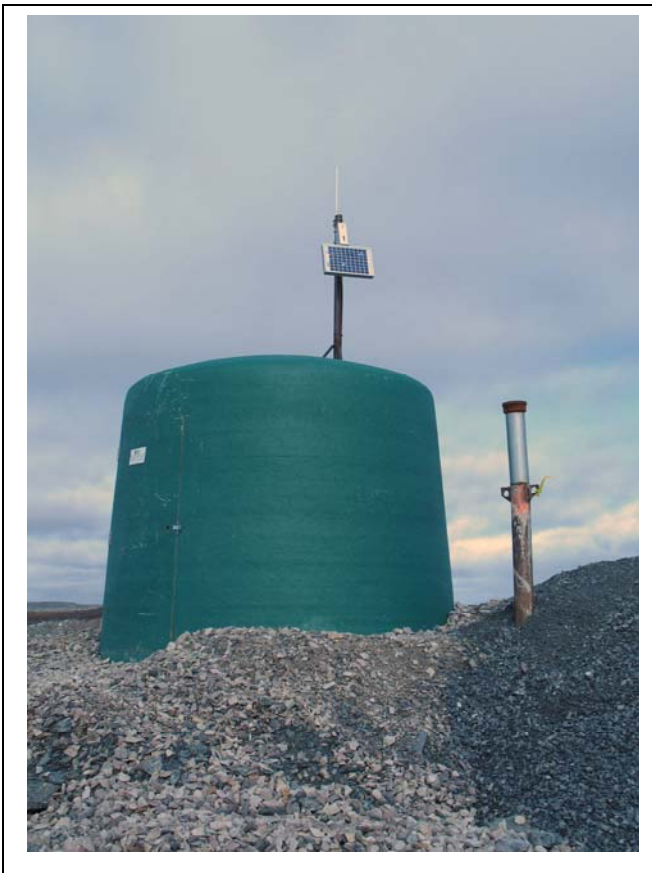
Photo #2 Instrument shelter on Bay
Goose dike to house data acquisition
equipment

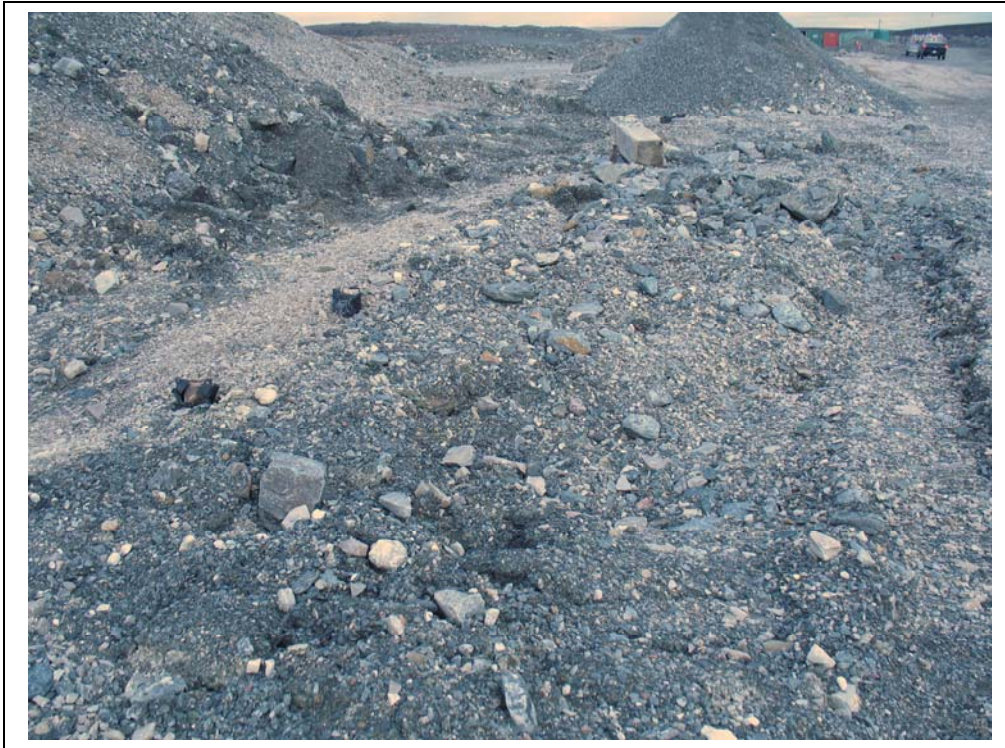
From the outward appearance, no adverse conditions were noted. The Board is pleased that work will be undertaken shortly to add the thermal topping and re-grade the dike crest, as the uneven nature of the actual platform is not conducive to the visual identification of any phenomena such as settlement and cracking (photos #3 and #4). It was noted that, so far, the pond water has remained clear which not only reduces the need for treatment, but facilitates the visual identification of any material transport along the edge of the dike.

Photo #3 Rough surface of dike crest
which may prevent identification of movement

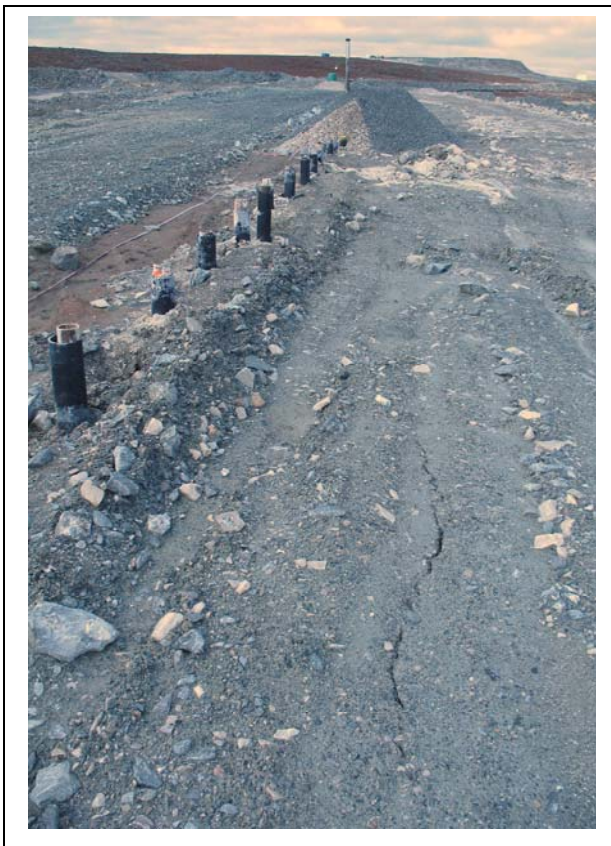
Photo #4 Cracking on crest visible
because surface is more even at this point

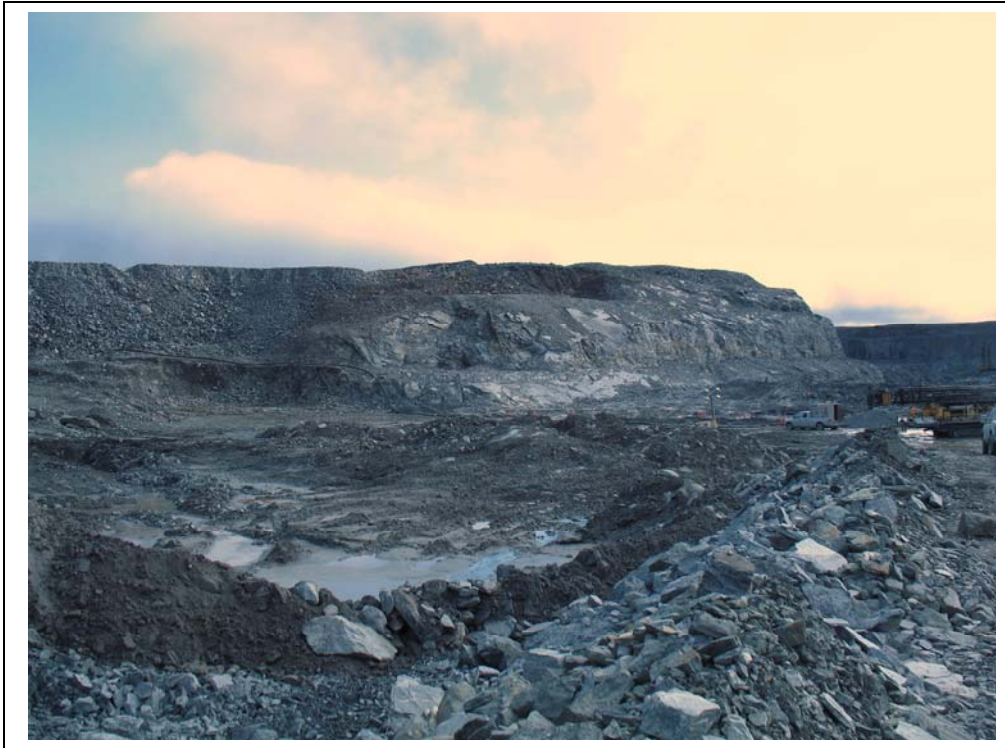
From the visit into the pit, the Board was able to better appreciate the bedrock topography and presence of uniform sands in a buried channel downstream of the dike area (photos #5 and #6). The Board recommends that the extent of this channel and the significance of potential erosion of the sands on the dike integrity be evaluated. Note that the central cut-off for the dike was taken to rock but that the overburden foundation of the downstream shell could be adversely affected by erosion or mass movement.

Photo #5 Portage Pit wall situated downstream of East Dike. Note contrast between overburden on left and rock on right

Comment *The Board recommends that the extent of a buried channel and the significance of potential erosion of the sands on the dike integrity be evaluated. Note that the central cut-off for the dike was taken to rock but that the overburden foundation of the downstream shell could be adversely affected by erosion or mass movement.*

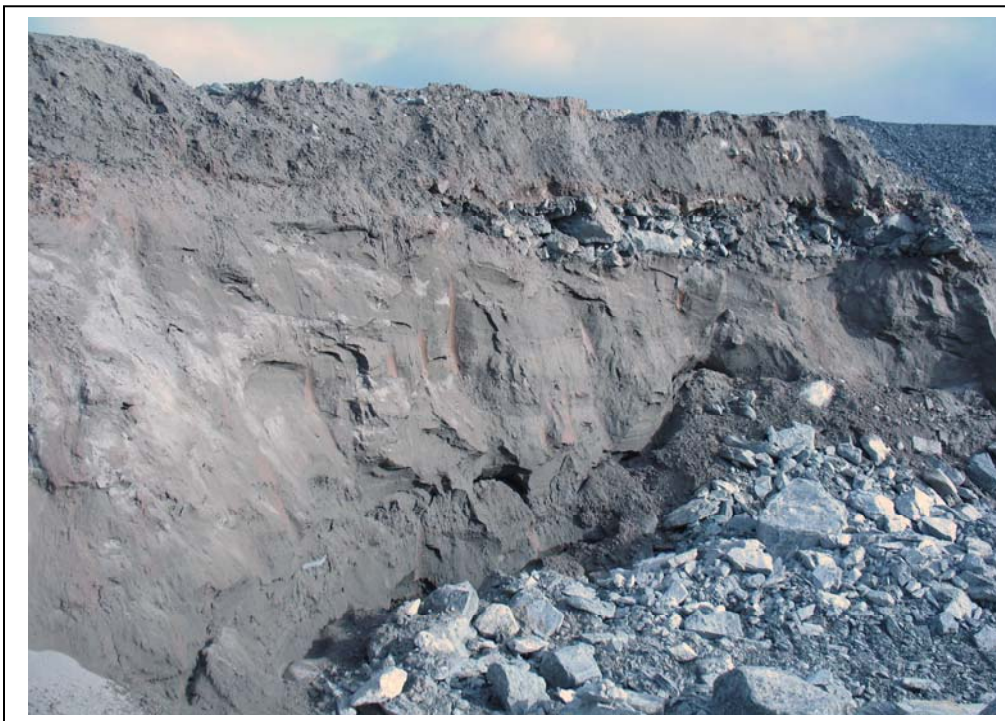
Photo #6 Uniform sand deposit in floor of Portage pit

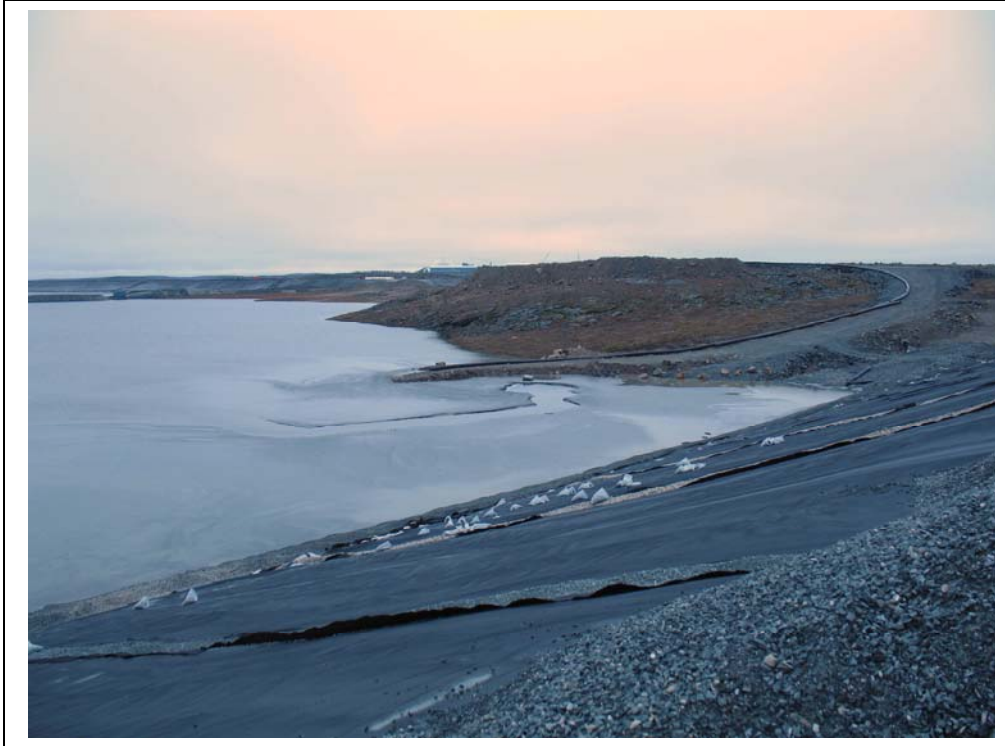
Saddle Dam No. 1 has been completed to elevation 150 m. Only a partial beach has been formed to protect the liner against ice damage and additional spigotting is required in this area before the onset of winter (photos #7 and #8).

Photo #7 Saddle Dam No.1. Tailings deposit at left abutment

1. Additional spigotting was initiated on October 19. An acceptable beach has been created to prevent damage on the liner from the ice.
2. A permanent system will be installed in summer 2012. This one will minimize the fluctuation from the run-off and maintain a stable water table inside the structure.
3. The design of the Central Dike includes zoned fills and drainage elements to provide proper drainage of the downstream foundation and shell. Consideration of inflows in the anchor trench is also being evaluated.

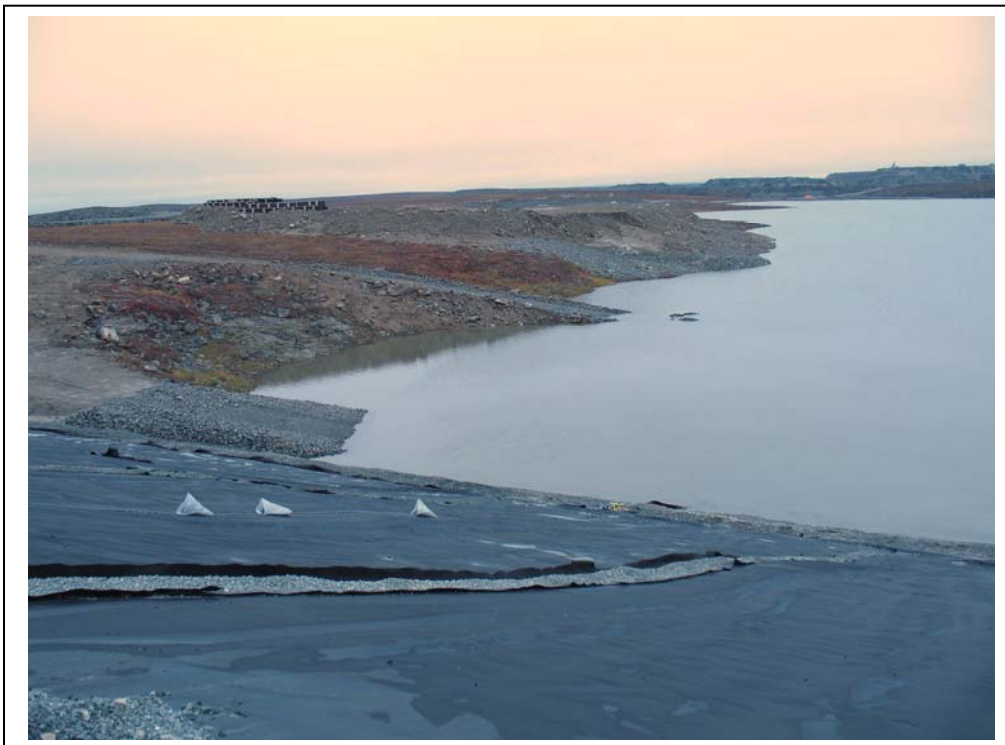
Photo #8 Saddle Dam No.1. Tailings deposit at right abutment not visible above water

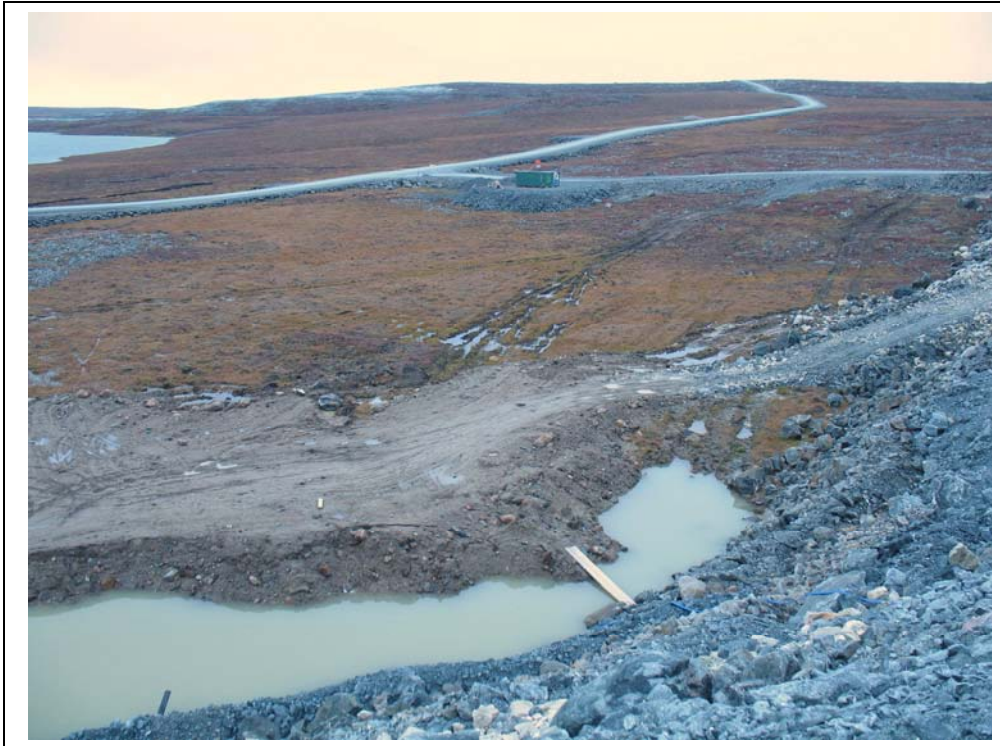
Work is underway to supply power to the downstream toe area to permit the installation of a pumping system to prevent the accumulation of run-off water which could create a heat source and provoke permafrost degradation beneath the dike (photo #9). The pump controls should be set to maintain a stable water elevation in the embankment with minimal fluctuation.

Photo #9 Saddle Dam No.1. Ponded water at downstream toe

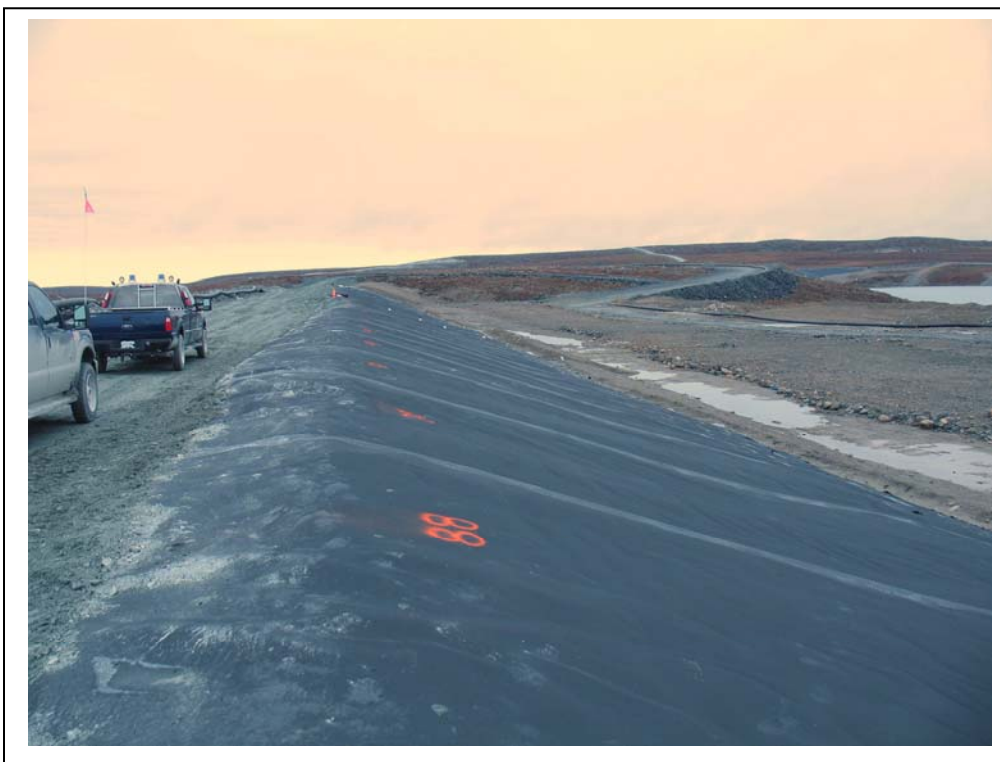
Photo #10 Saddle dam No. 2. LLDPE liner

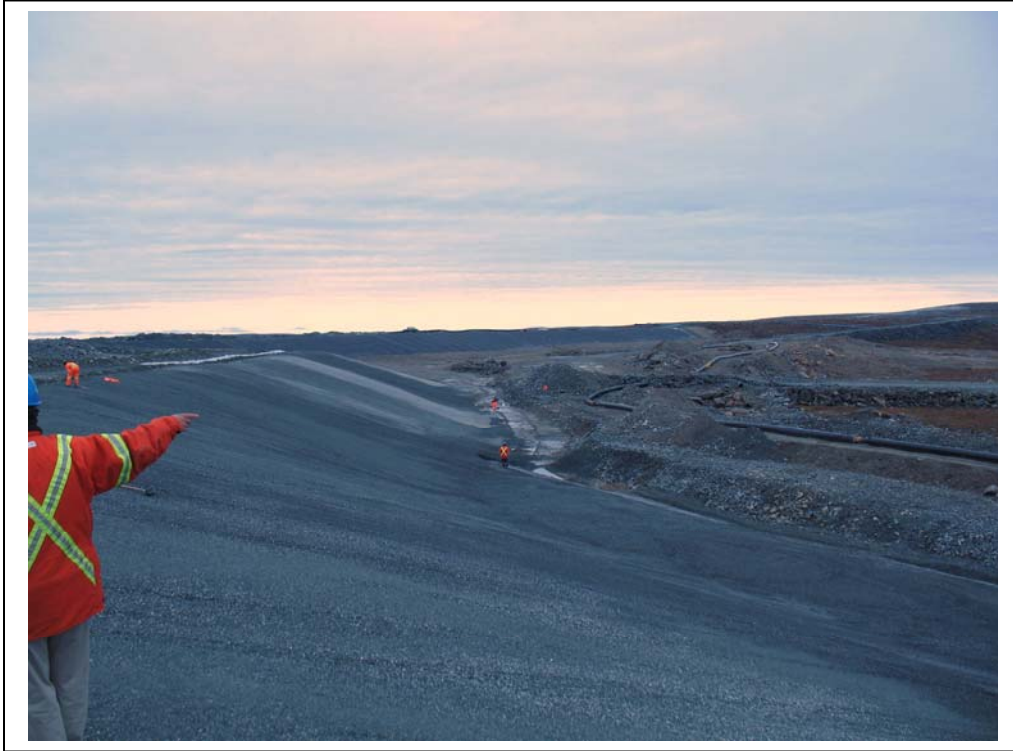
Photo #11 Stormwater Dike. Preparation of upstream slope to receive Coletanche liner

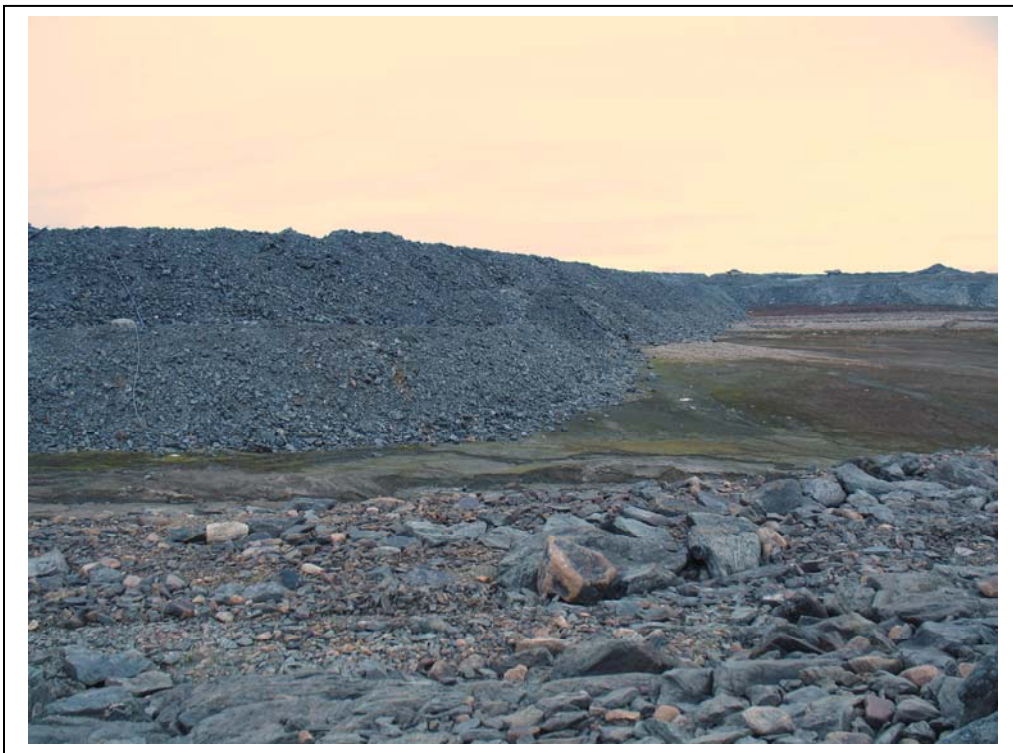
Photo #12 Downstream toe of Stormwater Dike

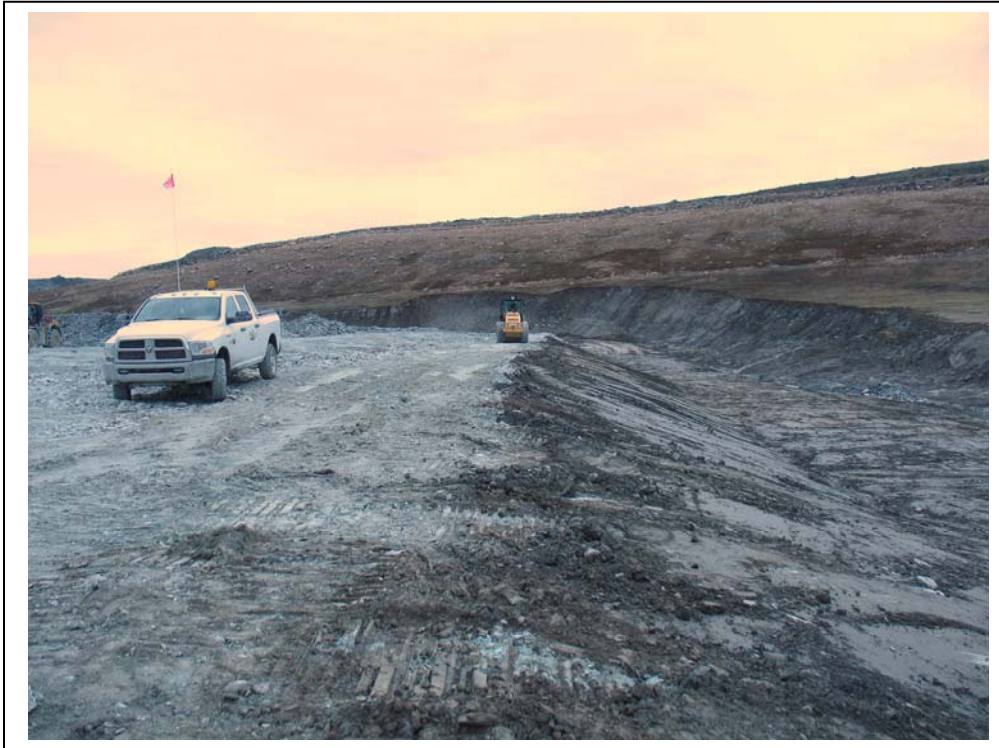
Construction of the cofferdam in the bed of the dewatered Second Portage Lake is underway and proceeding as planned (photo #13). Considerable inflow was observed to be emanating from what was described as un-grouted investigation boreholes (photos #14 and #15). Sumps within the rockfill of the cofferdam (photo #16) are required to take care of some of this inflow as well as run-off from the foundation downstream of the cofferdam which slopes to the upstream. The significance of these aspects on the design and construction of the central dike should be evaluated.

Photo #13 Cofferdam. Start of placement of impervious till zone

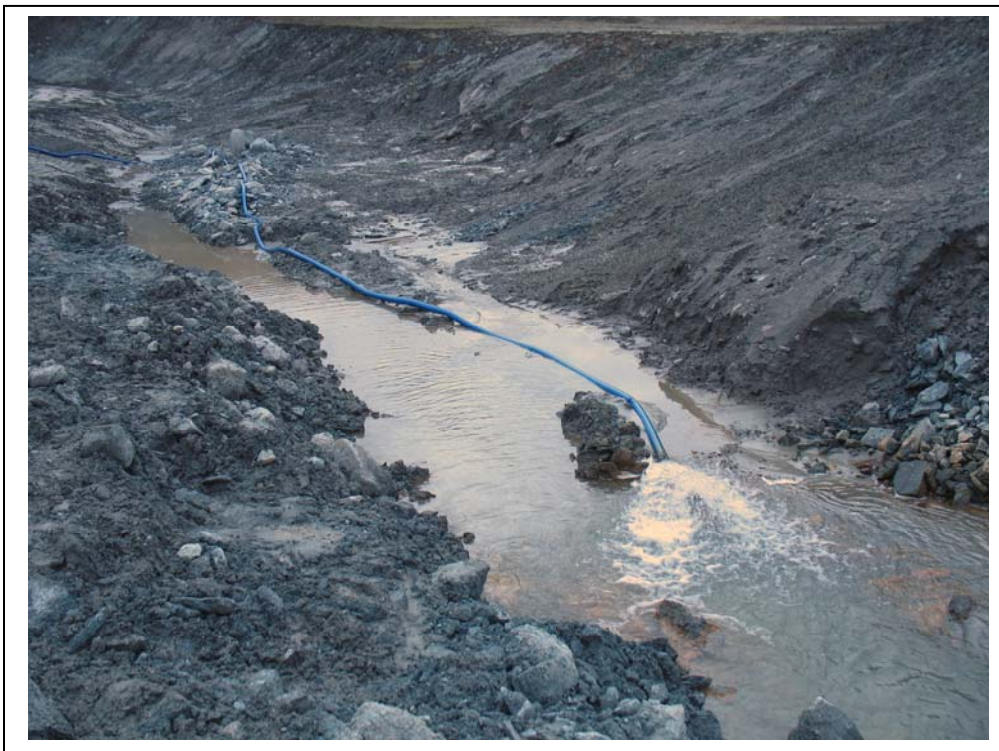
Photo #14 Cofferdam. Water pumped from sump inside rockfill.

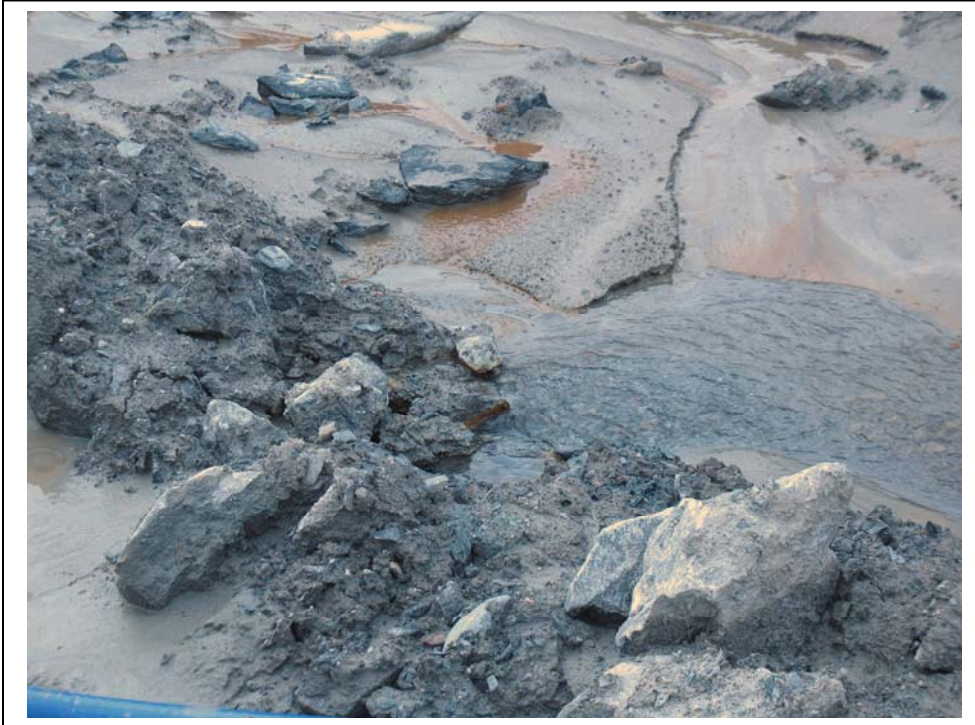
Photo #15 Cofferdam. Water welling up from un-grouted investigation borehole

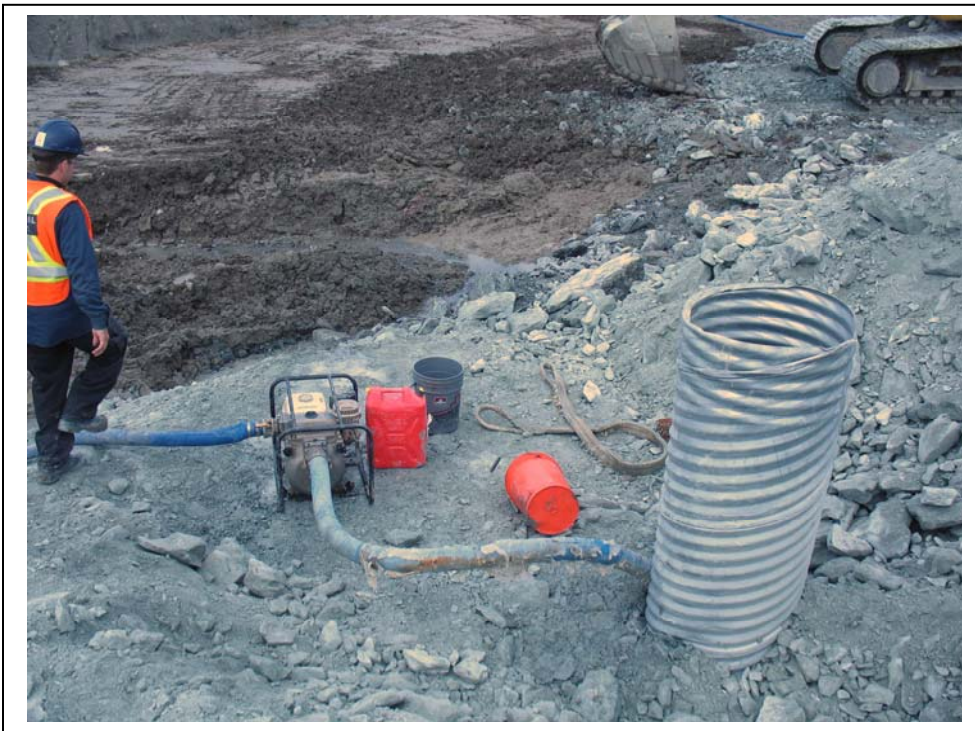
Photo #16 Cofferdam. Second sump in rockfill under construction.
