Report: *2012 Annual Review of Portage and Goose Pit Slope Performance*

2012 Annual Geotechnical Inspection Meadowbank Gold Mine, Nunavut

Agnico-Eagle Mines Limited
Meadowbank Division
PO Box 540
Baker Lake, Nunavut
X0C 0A0

Report Number: Doc 1394 1212210073 0115_13

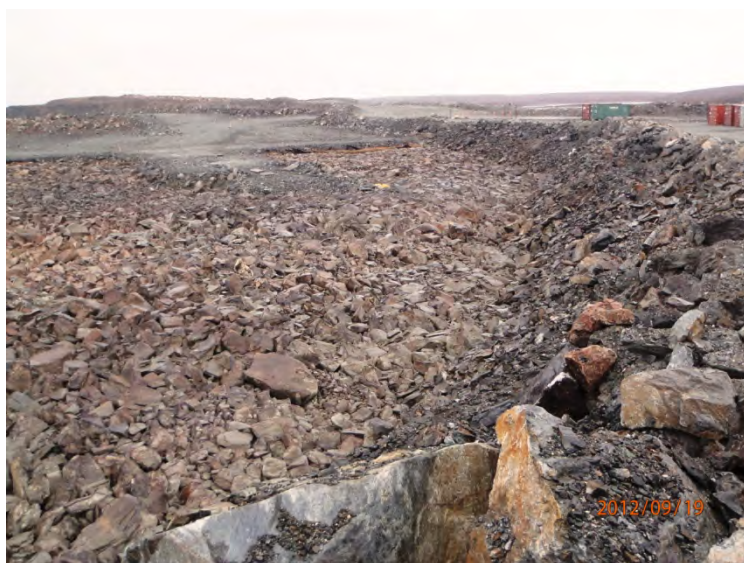
Photograph A3-4 Bay Goose Dike

In 2012, tension cracks were observed within the jet grouting sludge and trench area within the North Seepage Channel from Sta. 30+282 to Sta. 30+400. The tension cracks were equipped with rebars and after two months of monitoring, no change in the opening was recorded. The tension cracks mostly disappeared during the thawing. It is recommended to continue monitoring the evolution of those tension cracks.

Description: From Sta.30+338 to 30+370 (north channel), looking southwest along crest centreline at a zone of tension cracks on the crest. The cracks are receding and are hard to see. Note the rebars used to monitor the evolution of the cracks.

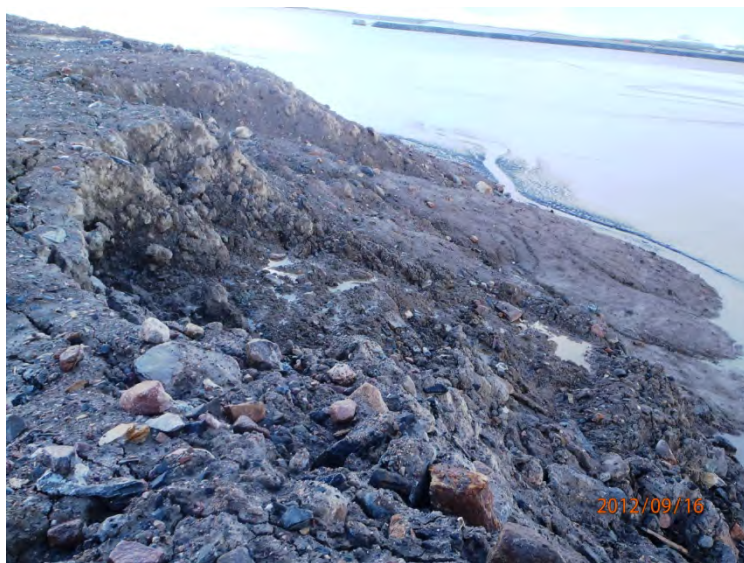
Photograph B1-2 Tailings Storage Facility

Description: From Saddle Dam 1 looking east toward the North Cell of the Tailings Storage Facility. Notice the unstable pad from SD1 foundation stripping having slope failure at coordinate 637205E/7216044N.

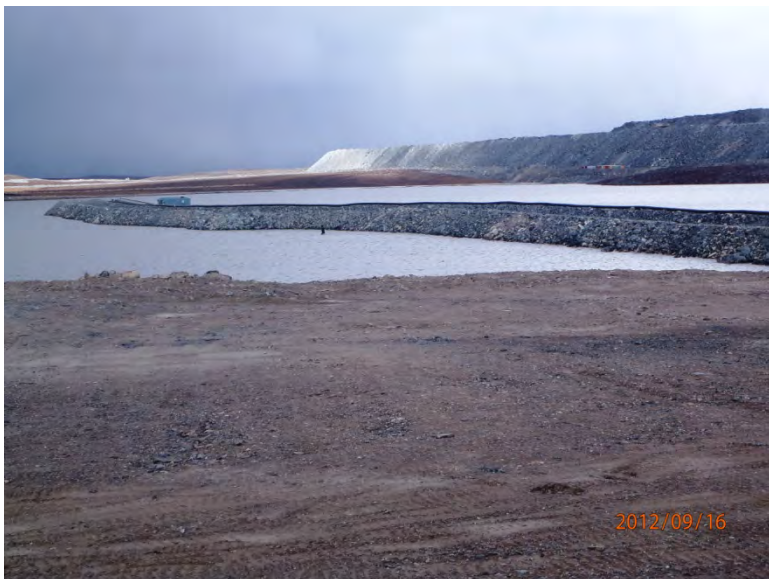
Photograph B1-4 Tailings Storage Facility

Description: From unstable pad at coordinate 637205E/7216044N looking east toward the North Cell of the Tailings Storage Facility. Notice the slope failure and the presence of tension cracks (10 to 15 mm opening).

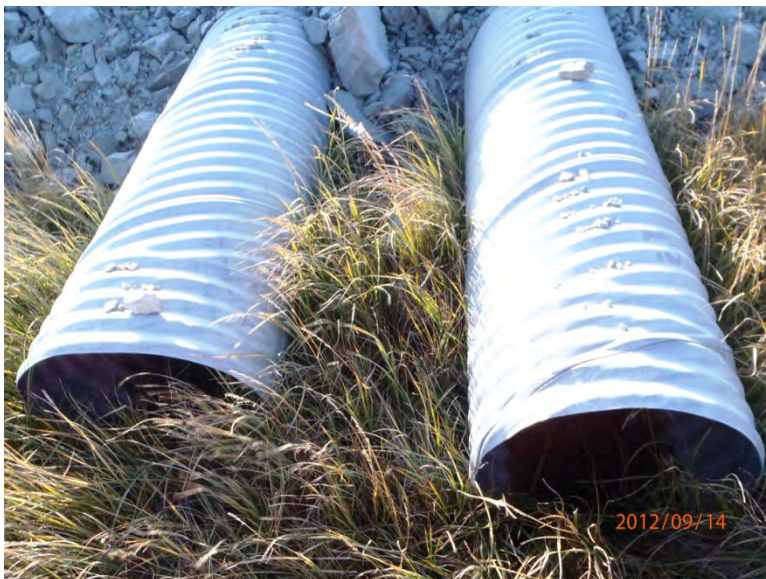
Photograph D1-10 : PC-14 km 4+260

Description: Upstream view of the culverts. Culvert on the right is filled with gravel, crushed and damaged. Culvert on the left is slightly damaged but still functioning. Notice the too thin road bed cover.

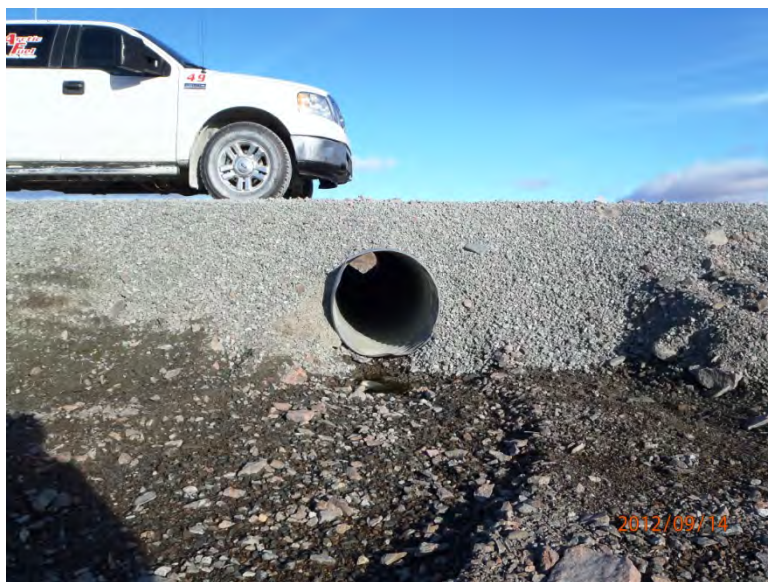
Photograph D1-12 : unnamed km 5+700

Description: Upstream view of the culvert. Good condition, inlet slightly obstructed.

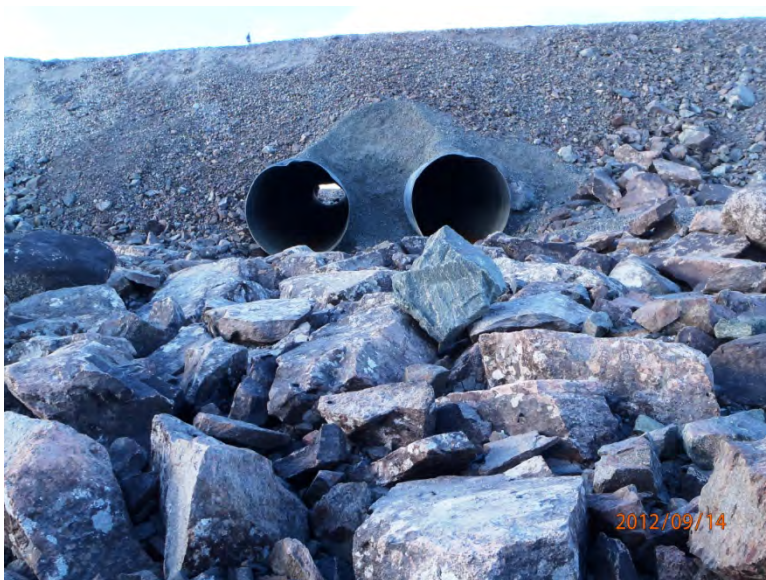
Photograph D1-16 : PC-17 km 8+850

Description: Upstream view of the culverts. Good condition other than slight damages observed at the inlet.

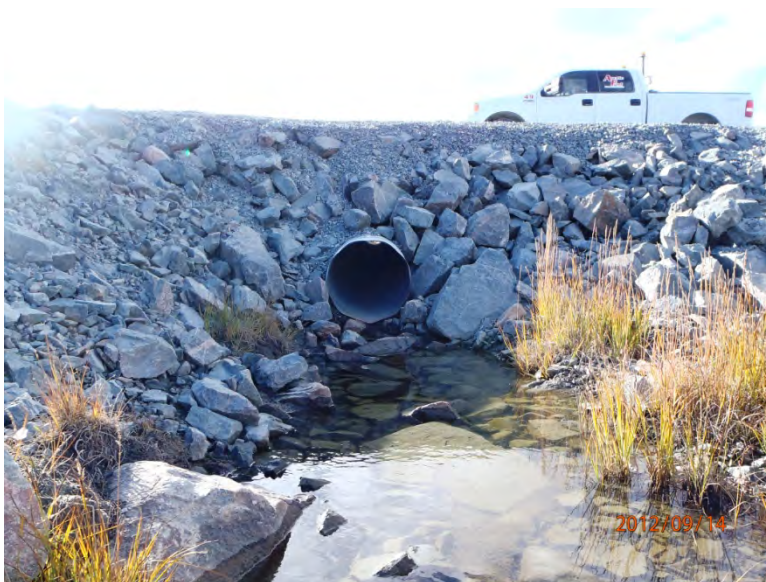
Photograph D1-36 : PC-5 km 18+280

Description: Upstream view of the culvert. The inlet is a little bit damaged and shows small signs of erosion.

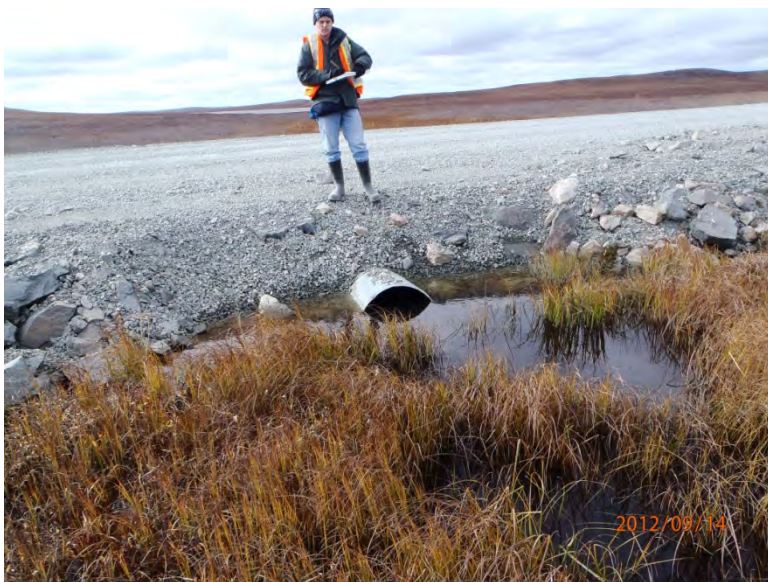
Photograph D1-54 : PC-12 km 41+300

Description: Upstream view of the culvert. Good condition. Culvert practically submerged.

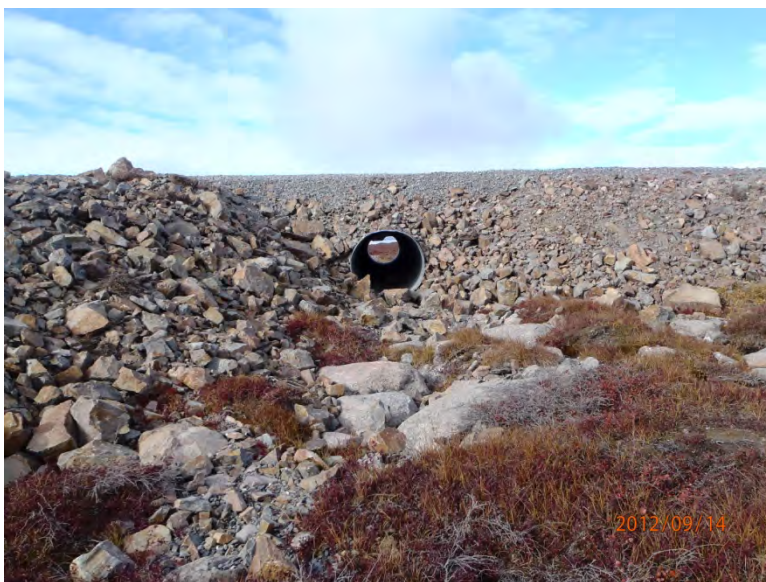
Photograph D1-62 : R-14 km 67+840

Description: Upstream view of the southern culvert (out of three). Good condition. Minor damage to the inlet.

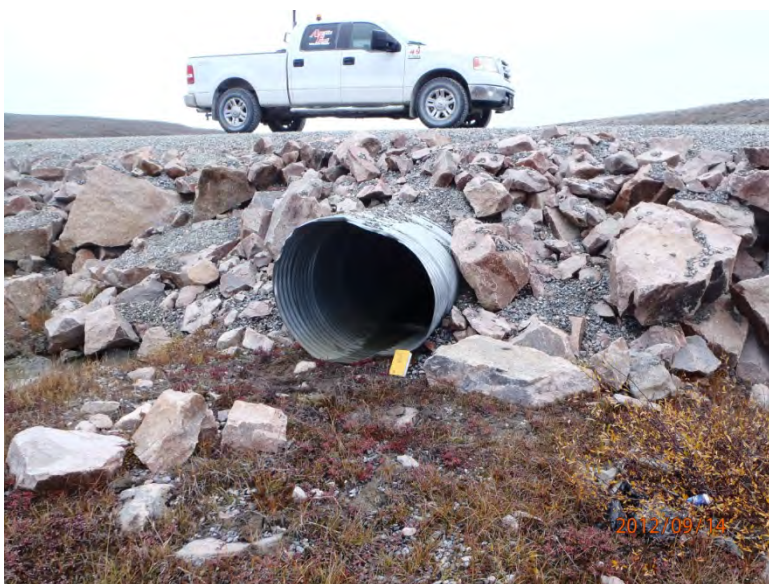
Photograph D1-72 : R-23 km 93+600

Station	Name	Structure Description	Comments
89+550	Quarry 20		
93+400	Quarry 21		
93+600	R-23	1x1200 mm CSP	Minor damage near the top, but still in good condition.
98+100	R-24	2x1200 mm CSP	The outlet of the southern culvert shows minor erosion.
99+200	Quarry 22		
101+950	R-25	2x600 mm CSP	
104+400	R-26	3x1200 mm CSP

Description: Upstream view of the culvert. Inlet has minor damage near the top, but is in good condition.

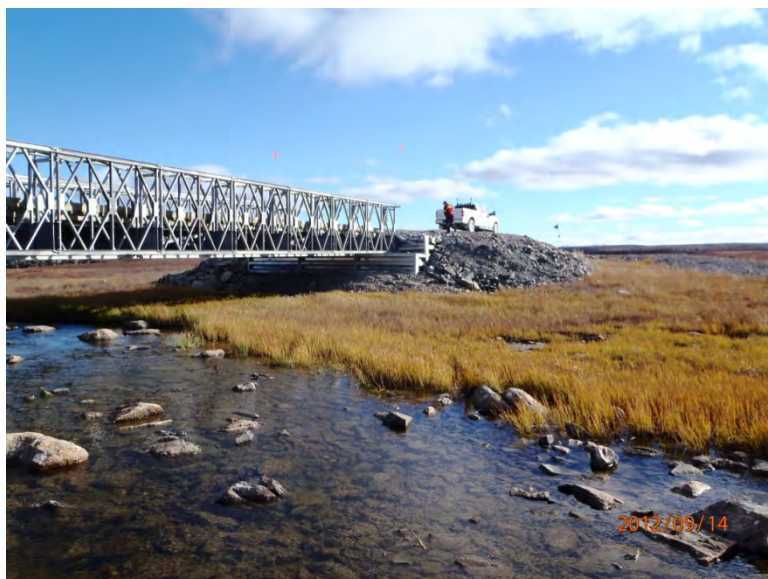
Photograph D2-6 Bridges 2 – R05 km 17+600

Description: Looking at the north abutment from upstream. Damage of the bin wall likely caused during snow removal activities.

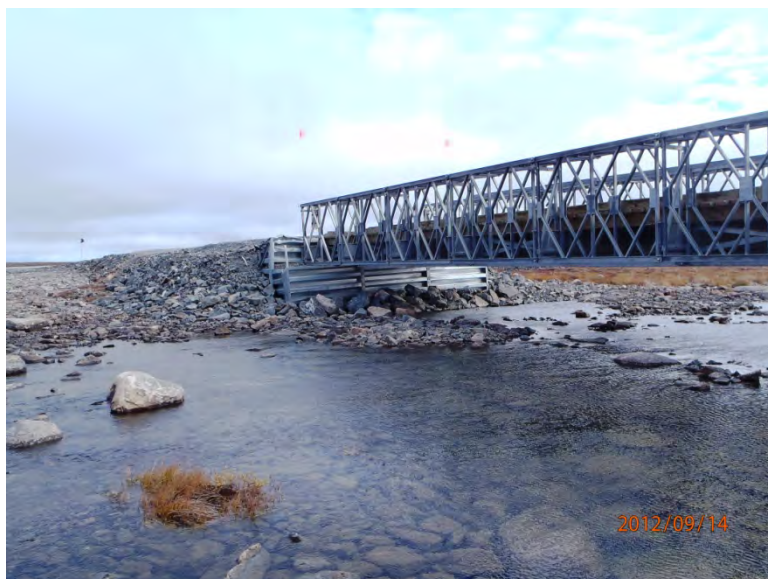
Photograph D2-22 Bridges 6 – R15 km 69+200

Description: Looking at the south abutment from downstream. Damage of the bin wall likely caused during snow removal activities.

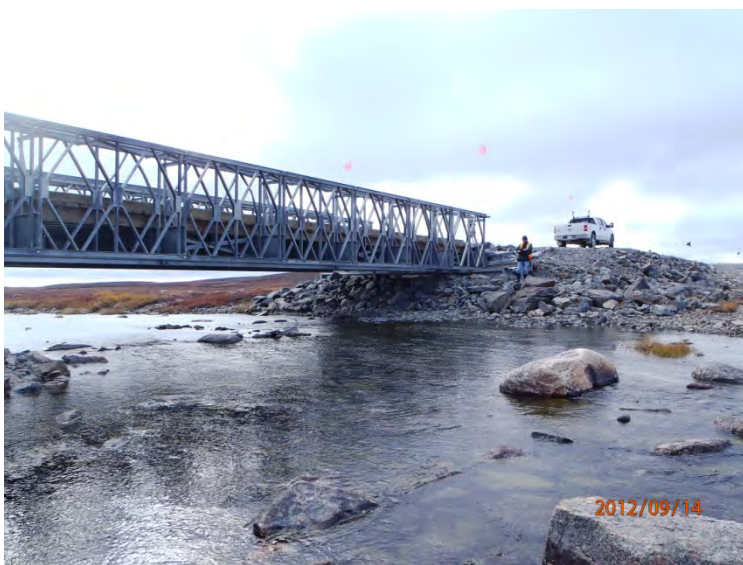
Photograph D2-24 Bridges 6 – R15 km 69+200

Description: Looking at the north abutment from downstream. Damage of the bin wall likely caused during snow removal activities.

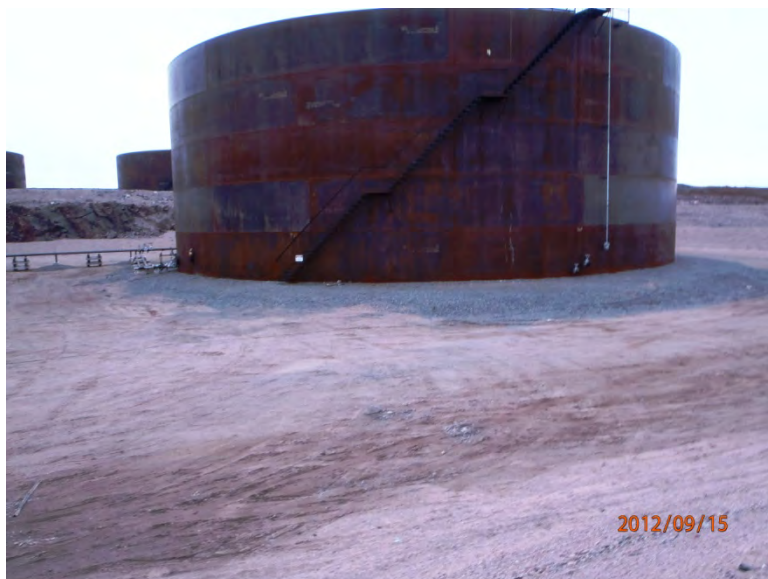
Photograph F1-16 Baker Lake Tank Farm

Description: Looking northwest at tanks 3 and 4. Notice the accumulation of water in the corner and the sign of high elevation of water that probably submerged the tank foundation fill at freshet.

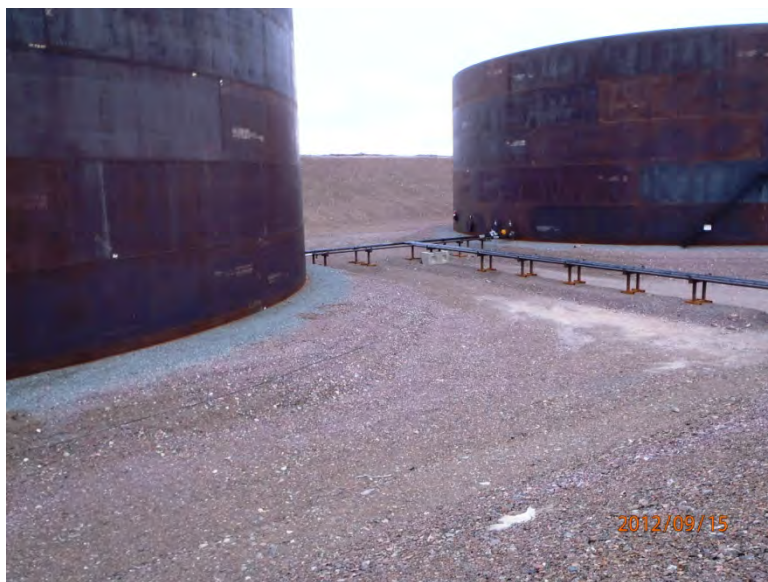
Photograph F1-20 Baker Lake Tank Farm

Description: Presence of longitudinal tension crack (10 mm open) on the upper bench north of tanks 3 and 4.

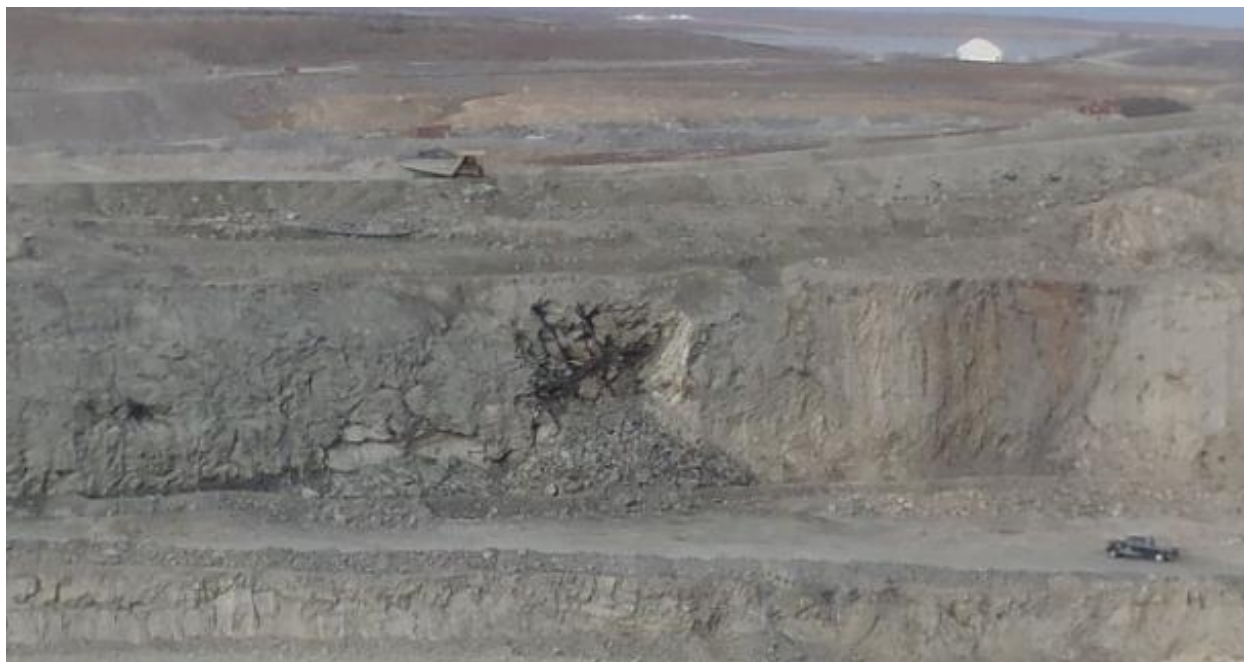
A local bench scale rock fall observed on the west wall was inspected during a traverse along the 5109 platform. The location of the rock fall is identified as Stop 2 in Figure 5. A photograph of the rock fall area is shown below.

Photograph 3: Rock fall on west wall of Pit A on 5109/5123 bench, Stop 2 in Figure 5 (pickup truck in foreground is at 5,109 RL)

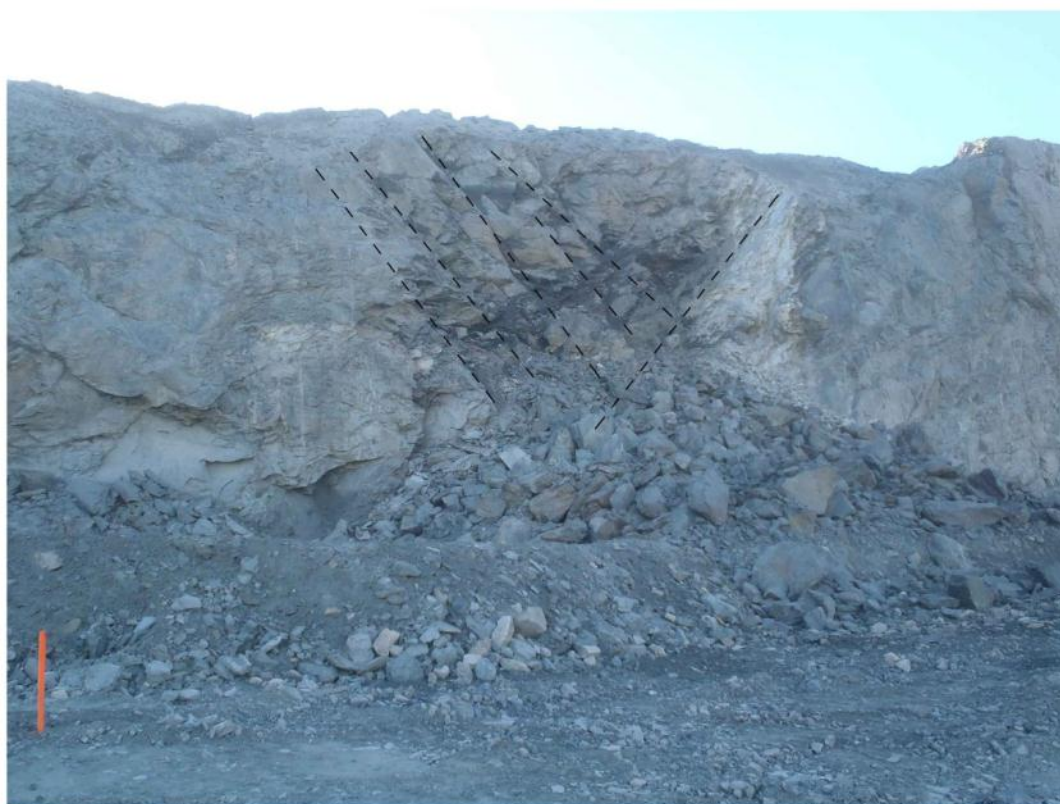
The stratigraphy in this area is very tightly folded, and strikes into the wall. The interaction of the steeply south dipping stratigraphy and closely spaced north dipping joints results in ravelling of material from the formation of wedge structures in the blocky ground. Ongoing ravelling of the material has resulted in filling behind the containment berm, and some over-topping. This is shown in the following photograph.

Photograph 4: Overtopping of deflection berm by rock fall on west wall of Pit A on 5109 bench, Stop 2 in Figure 5

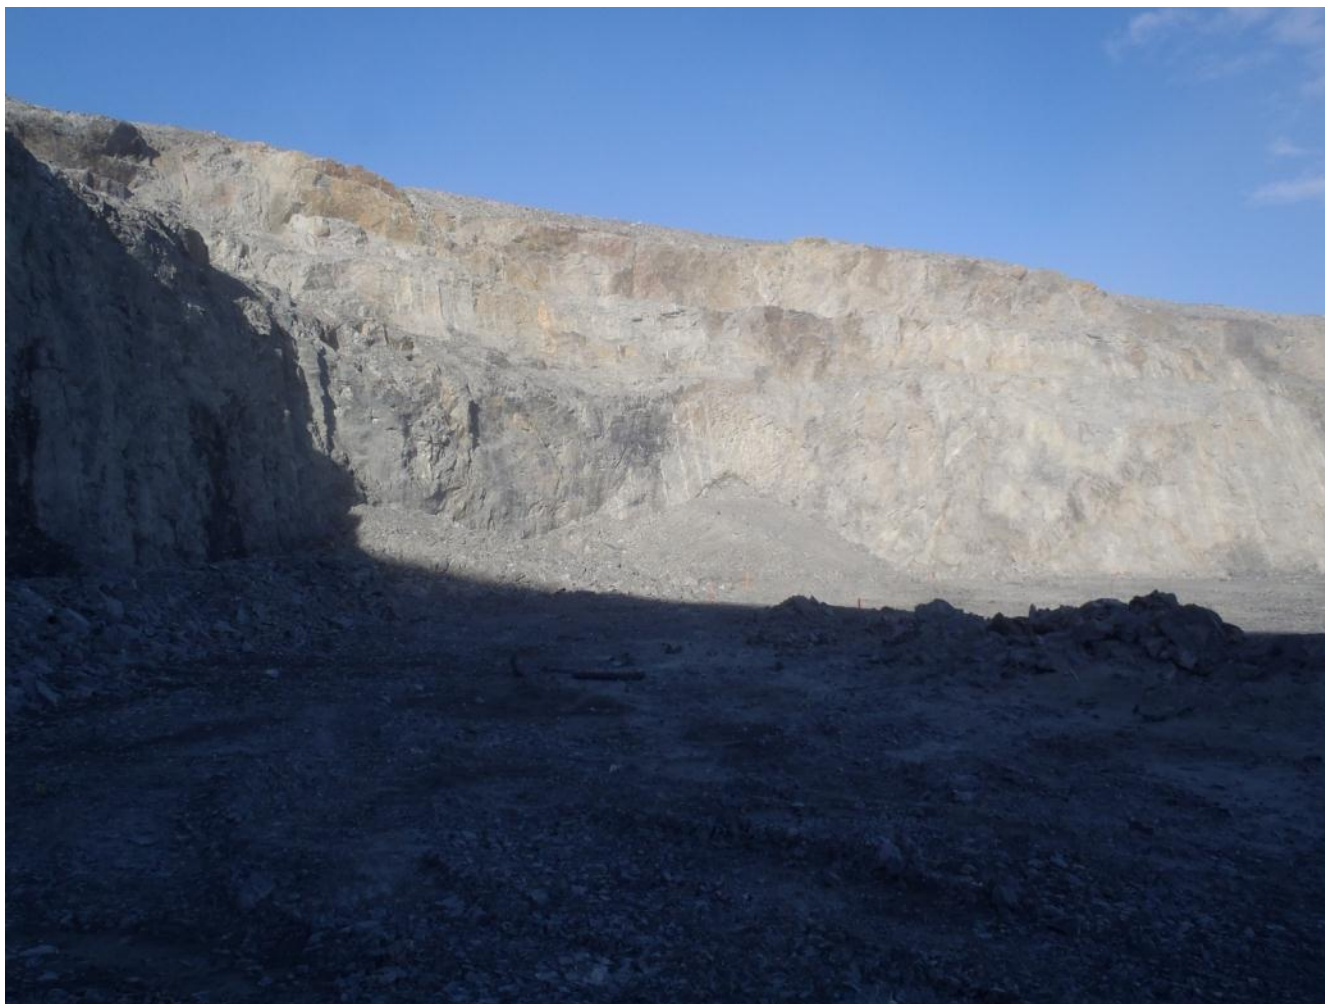
The rock exposed in the north wall of the pit appears more fractured than the west and east pit walls. Jump ramps have been constructed to allow scaling of the walls, as shown in the following figure.

Photograph 5: The north wall of Pit A, showing jump ramps for scaling of the wall (Stop 3, Figure 5)

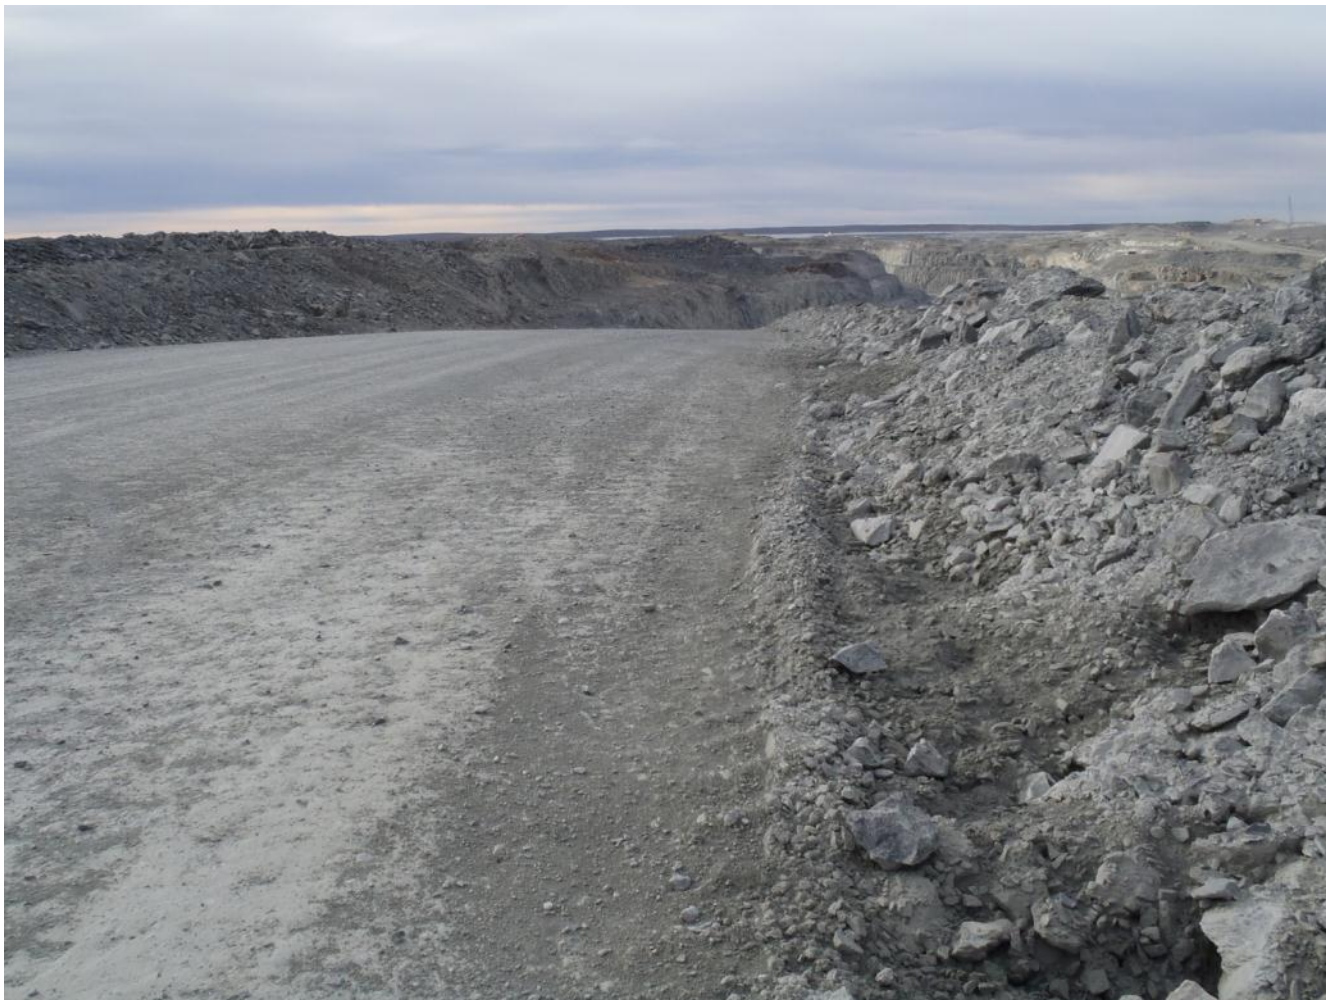
In 2011 AEM observed tension cracks at the crest of the east wall ramp (Stop 1 in Figure 5). The area was inspected as part of the 2011 pit slope performance review. Based on observations made during that site visit the tension cracks did not appear to be indicative of a larger scale failure. Recommendations were made that the area be monitored and the ramp be graded to redirect water away from the tension crack area. The area was re-inspected during the 2012 site visit and no tension cracks were observed.

Photograph 7: Pit A east ramp showing area of ramp where tension cracks were observed in 2011 (Stop 1, Figure 5)

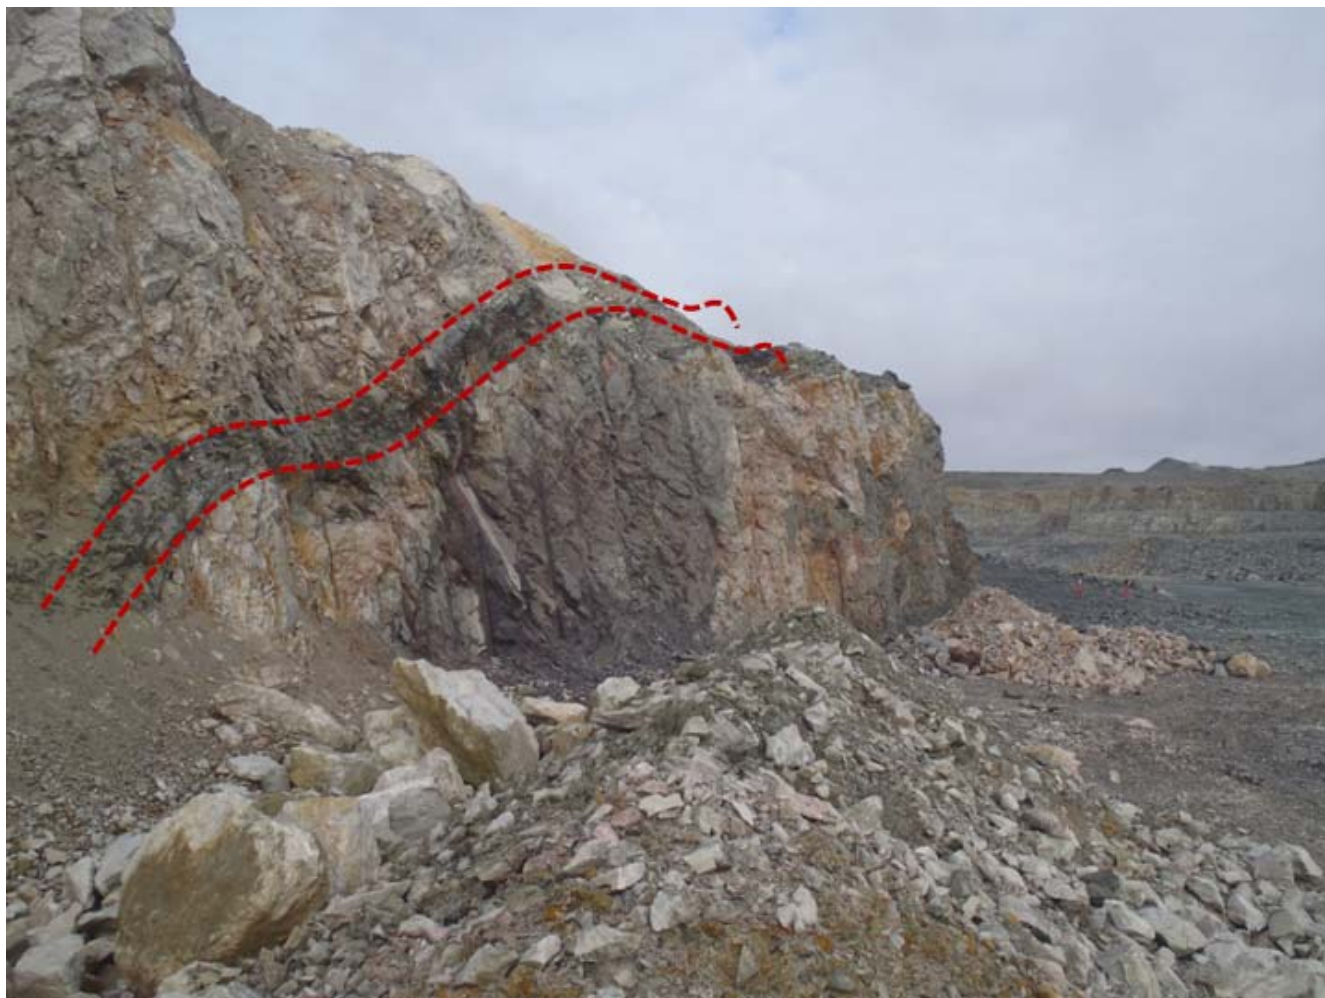
During the 2011 pit slope inspection, a fault was identified at the transition between Pits A and B in the west wall behind the 5130 bench crest. The fault trends in a northwest to southeast direction, dips steeply into the wall and is approximately 1 to 1.5 m wide. The orientation, measured from the 5116 platform during the 2011 site visit, is 60/220 (dip and dip direction, without correction for magnetic declination). The footwall is characterized by tightly folded intermediate volcanic rocks and quartzite. The fault as observed in 2011 from the 5116 platform is shown in the following figure.

Photograph 8: Pit B west wall fault exposed in the 5116 bench face in 2011

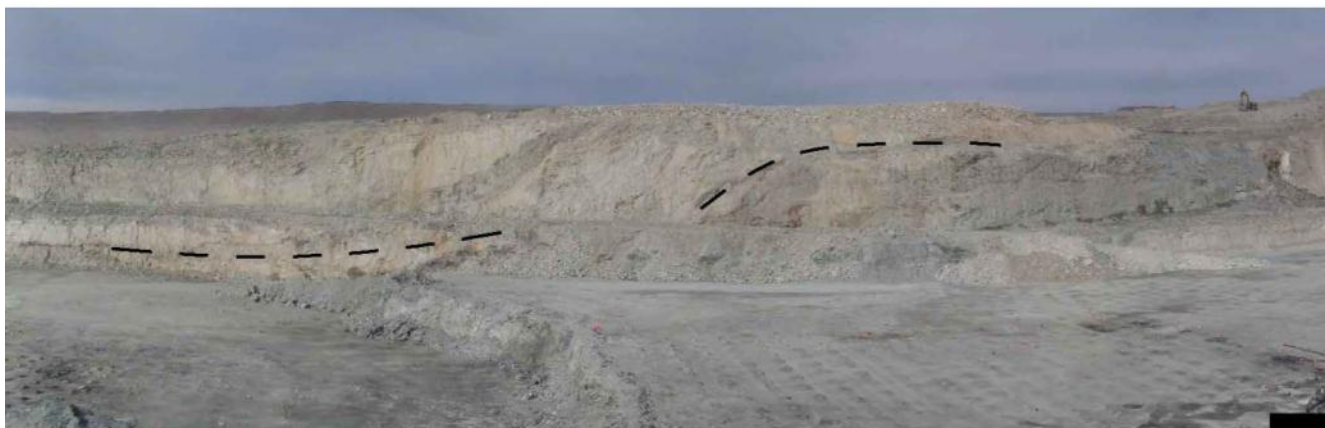
Since the site visit in 2011, the west wall of Pit B has been excavated further, exposing more of the fault. The trace of the fault extends southward from its observed location on the 5116 bench in 2011, and can be traced in the face of the 5088/5095 bench as it trends approximately sub-parallel to the wall. It is possible that this fault is the northern projection of the Bay Fault, or a splay of that fault, which has not clearly been identified to this point.

Photograph 9: Pit B west wall showing the exposure of the fault in the lower bench

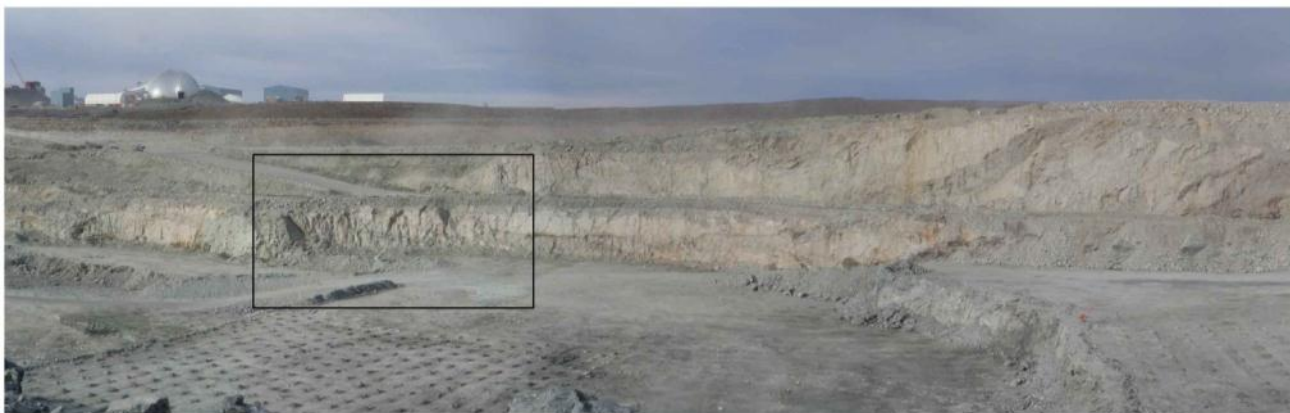
A series of small wedge structures were noted in the west wall of Pit B. This area is shown in the following photograph.

Photograph 10: Area of west wall of Pit B with wedge structures noted (viewed from Stop 4 in Figure 5)

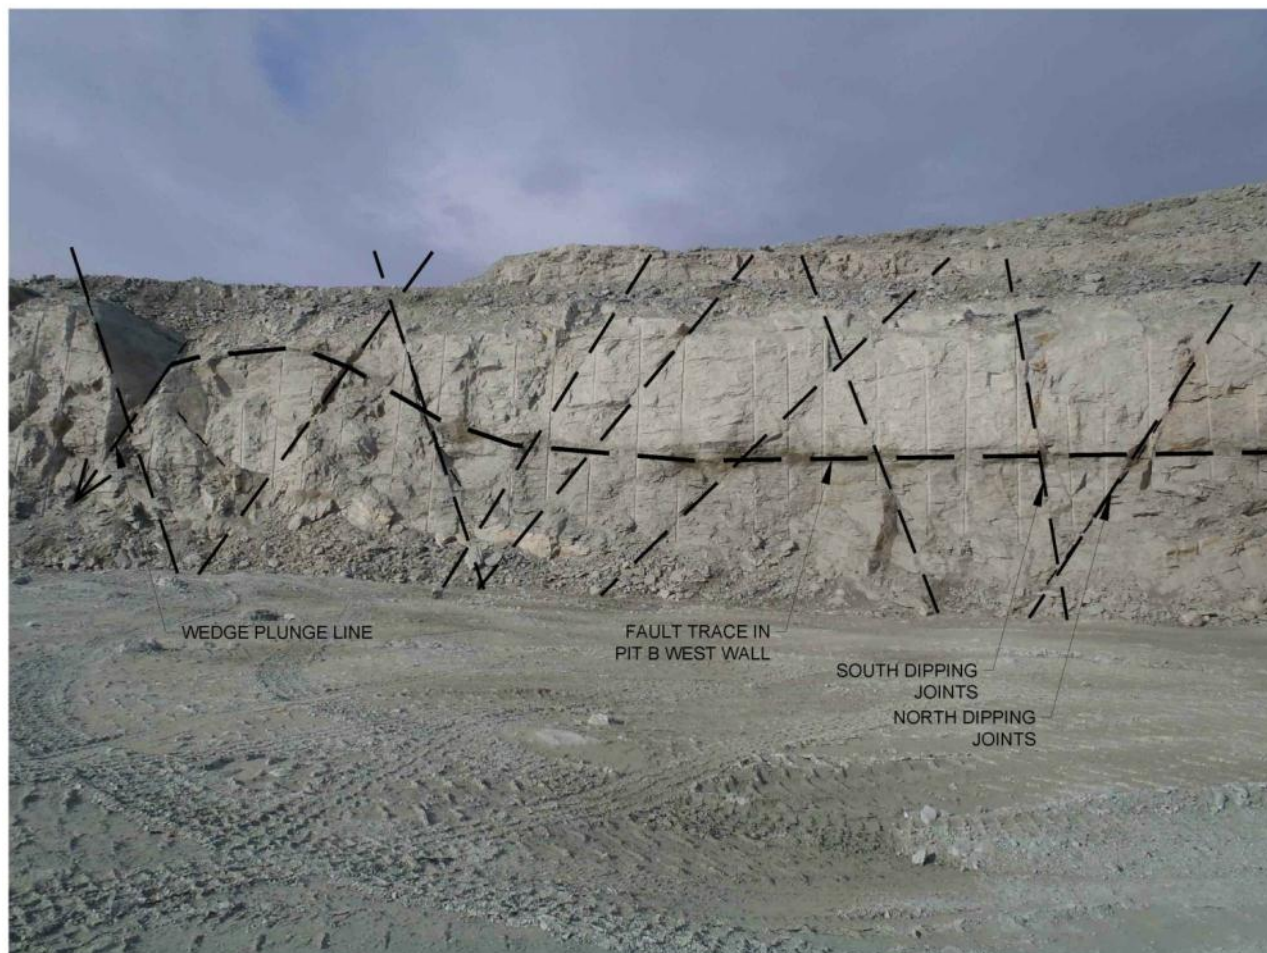
Some of the material accumulated at the toe of the bench is a result of small-scale wedge failures. These are shown in the next photograph.

Photograph 11: Small-scale wedge structure noted in west wall of Pit B (viewed from Stop 5 in Figure 5)

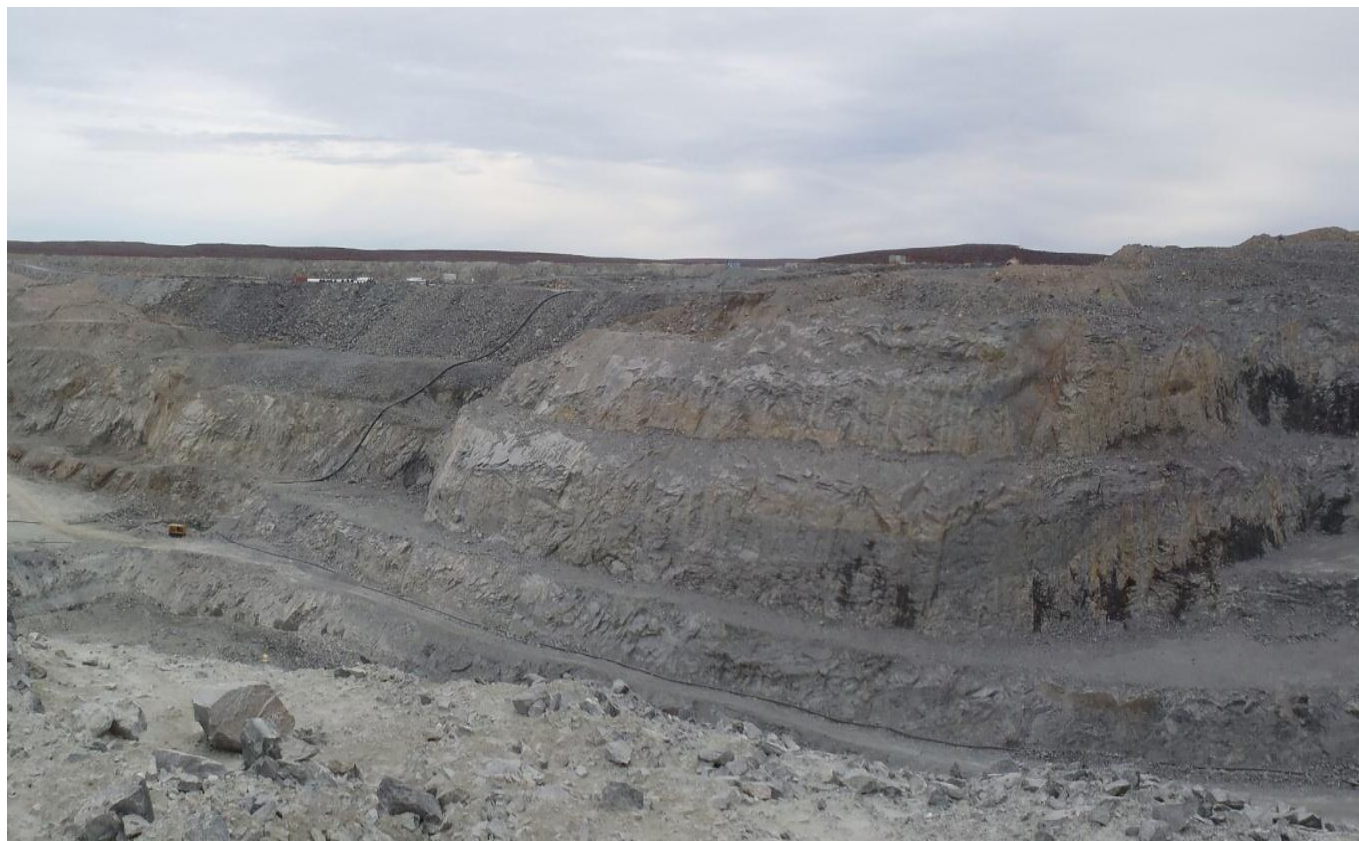
Photograph 19: North end of Pit D east wall showing undercut foliation and area of catchment loss, looking northeast (from Stops 7 and 8 in Figure 5)

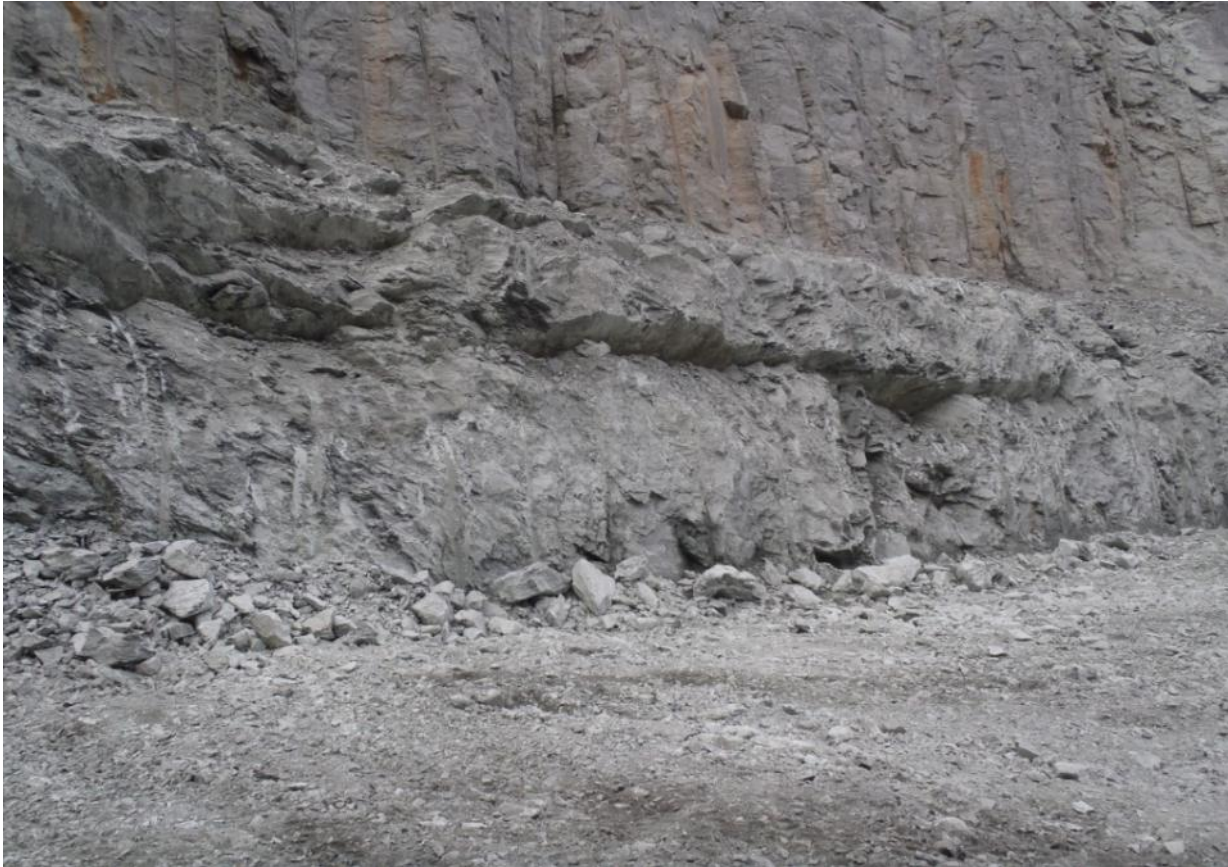
Photograph 23: Over-digging of ultramafic rock leading to overhangs (Stop 12 in Figure 5)

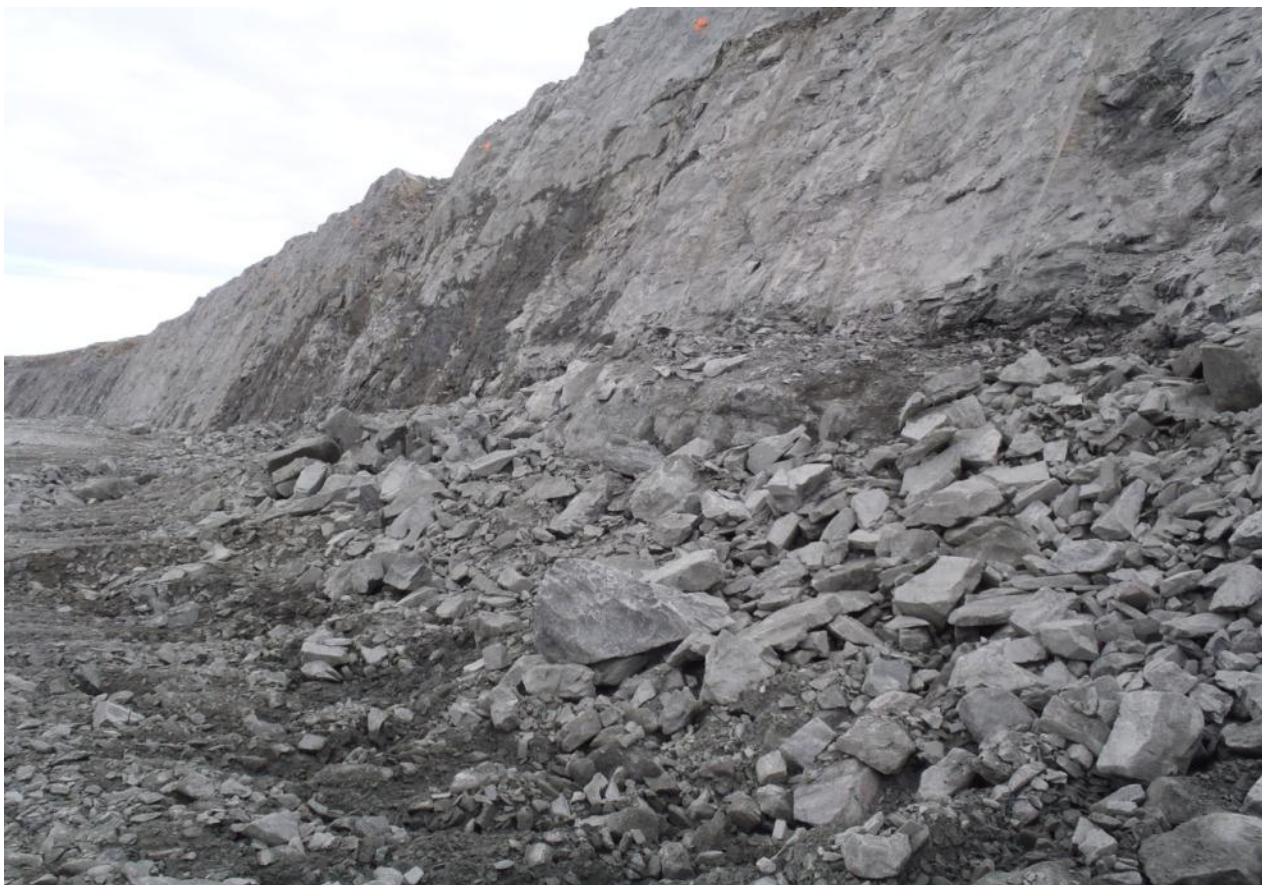
Photograph 31: Hard toes at 5,116 RL, Goose Pit east wall

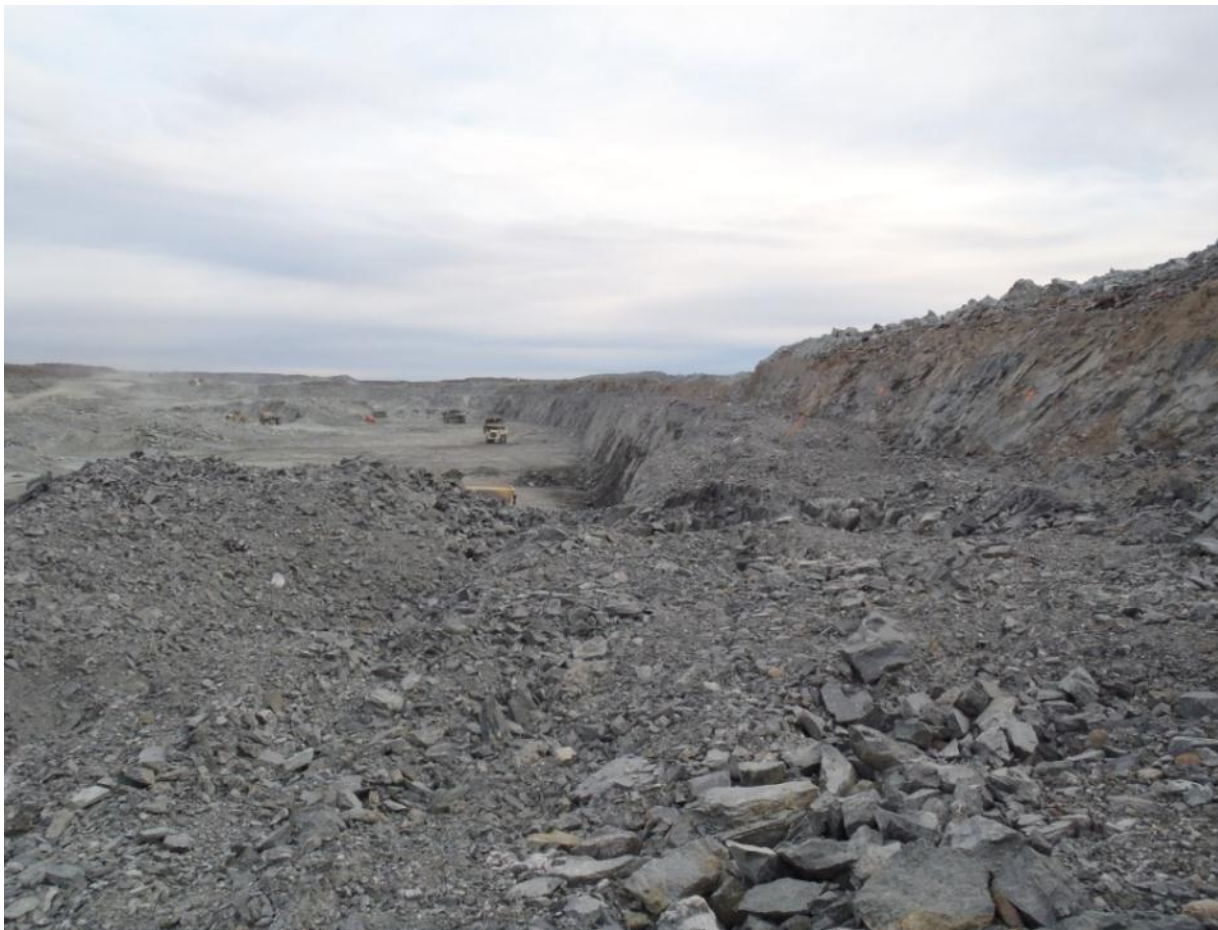
Photograph 35: The 5130 bench of the Goose Pit, showing hummocky appearance and poor cleaning in areas
