Appendix B2

Independent Geotechnical Expert Review Panel Reports

Report 12: *Meeting September 10-12, 2012*

**Report No 11
Meadowbank Mine Dike Review Board
Meeting April 11-12, 2012**

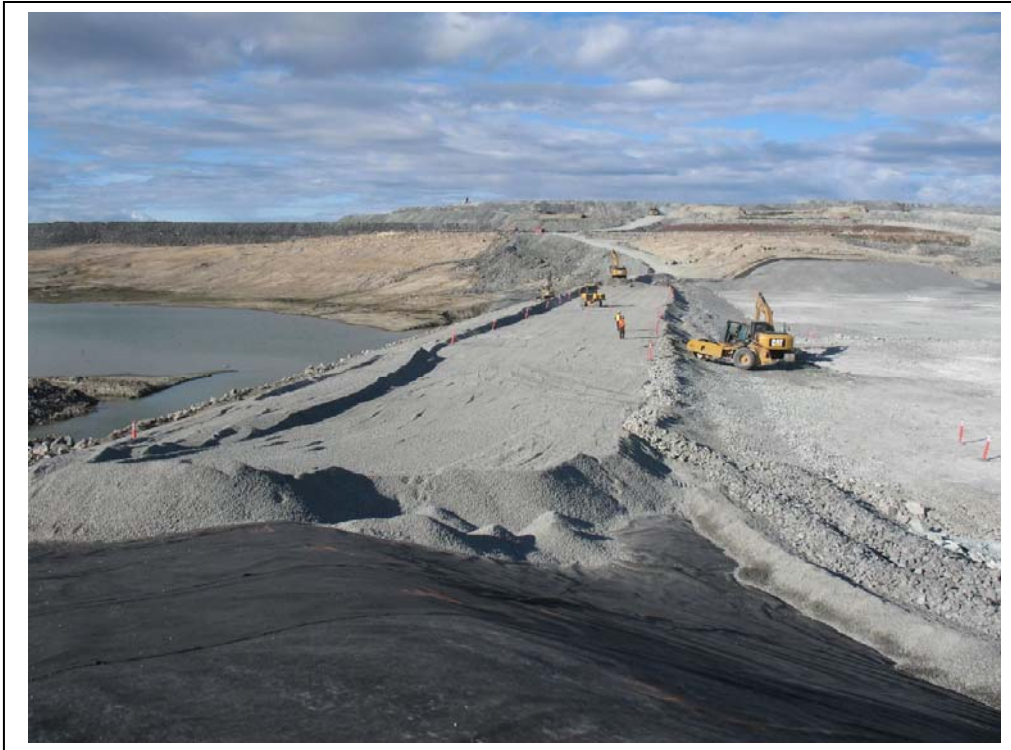
Photo #1 Central Dike, fill over U/S cofferdam

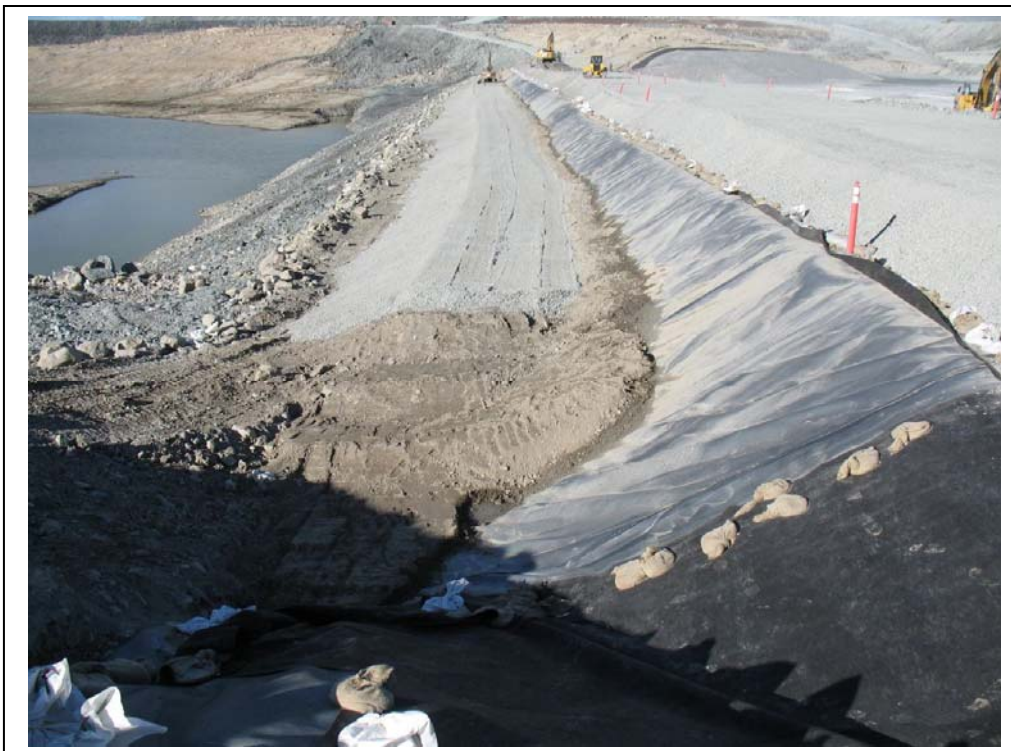
Photo #2 Central Dike, liner extension tied into cofferdam fill

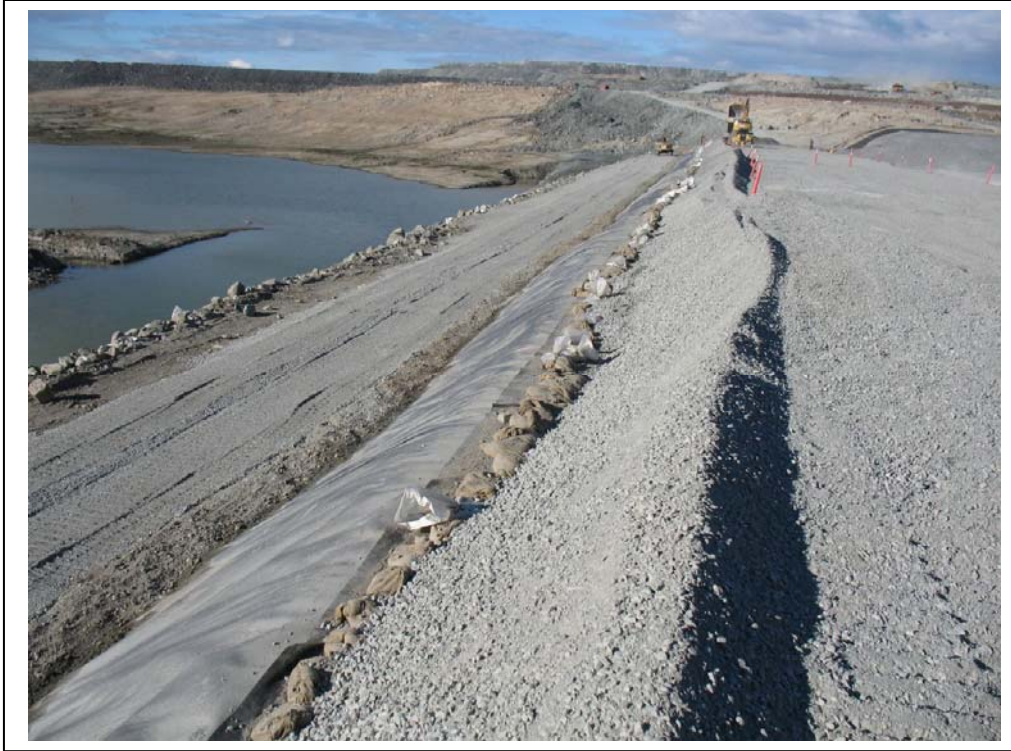
Photo #3 Bench to tie in U/S face liner. Too narrow.

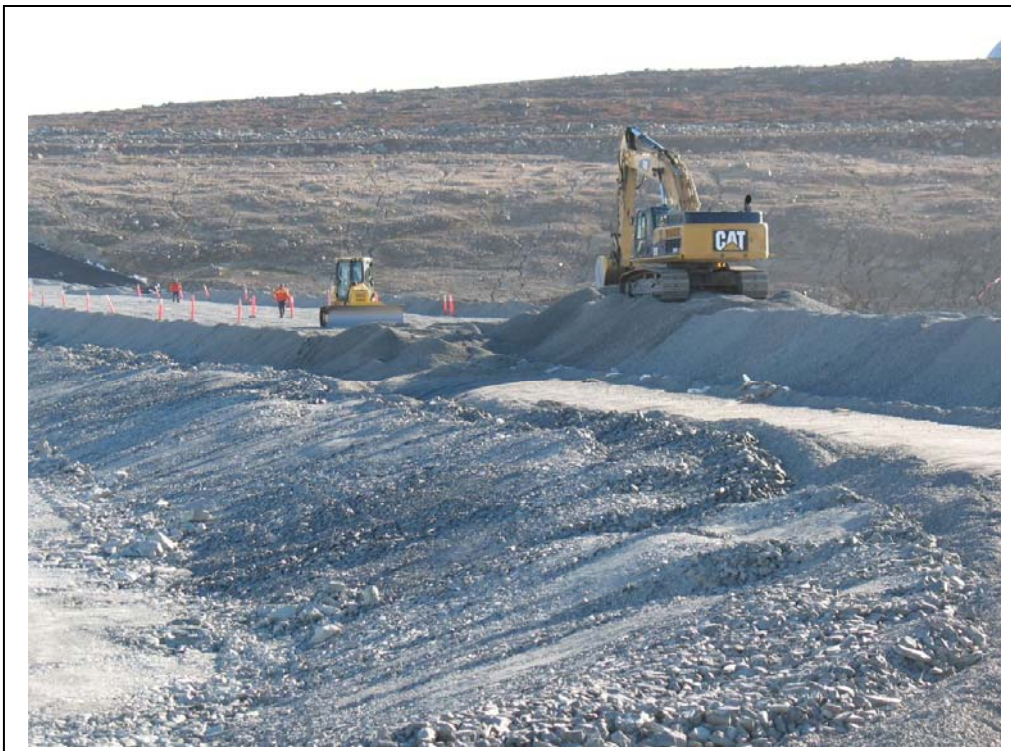
Photo #4 Redistribution of filter layer from thick layer designed to protect liner

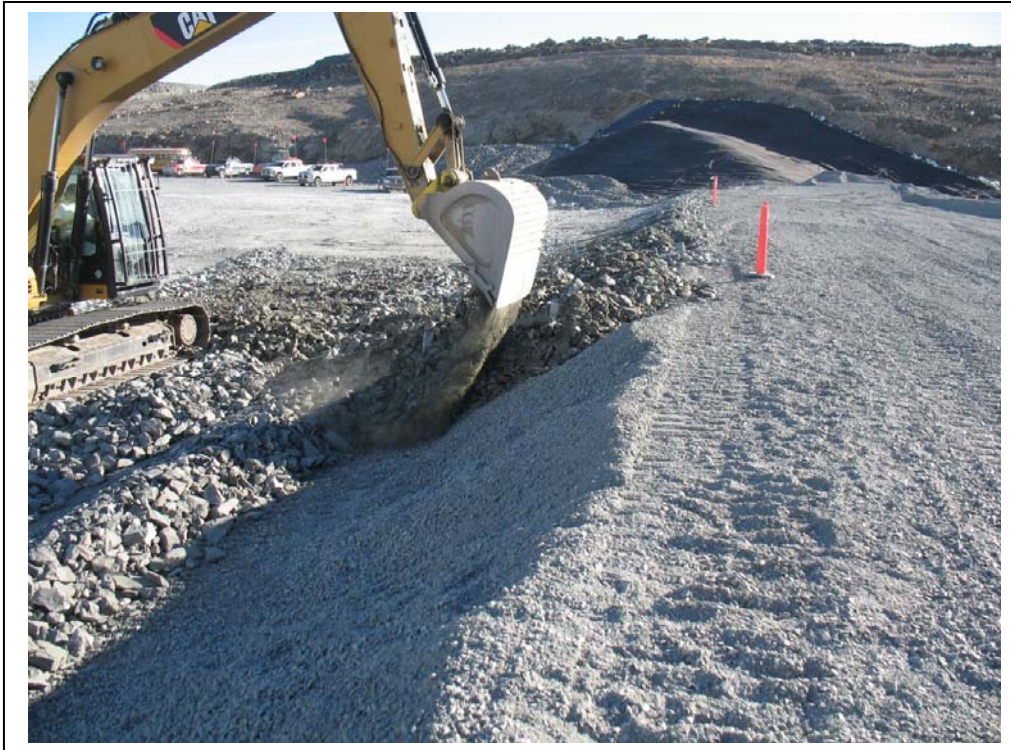
The coarse transition zone (Photo #5) was generally devoid of any significant pockets of segregation, though local examples could be noted.

Photo #5 Placing of coarse filter

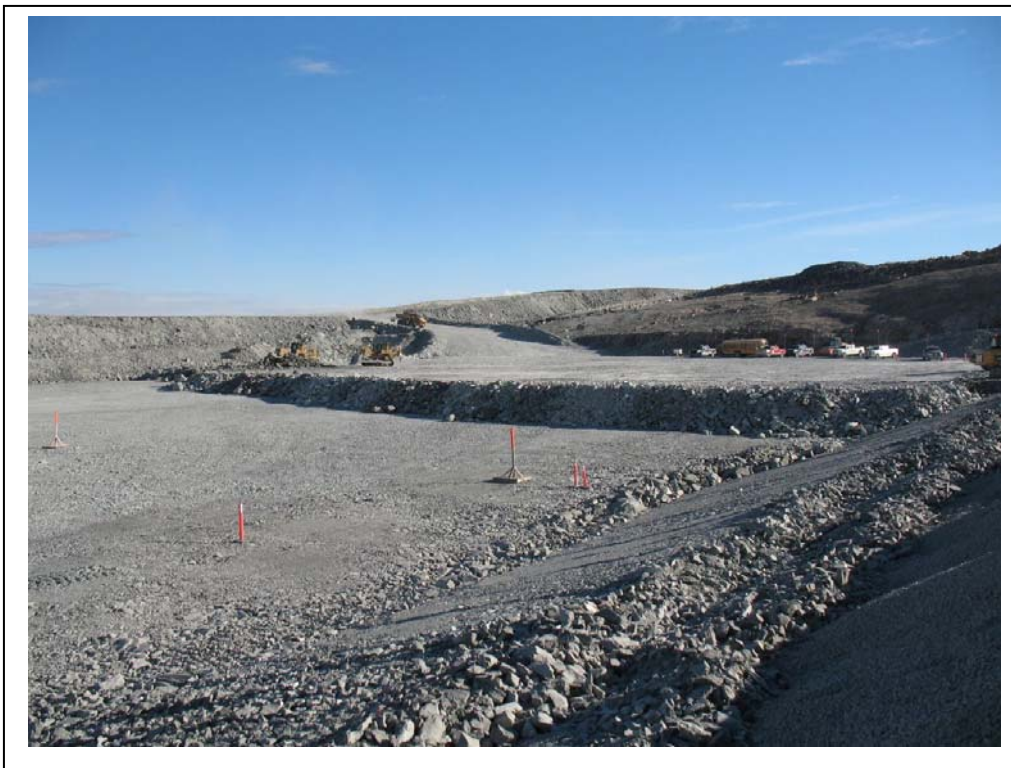
Photo #6 General view of advancing face

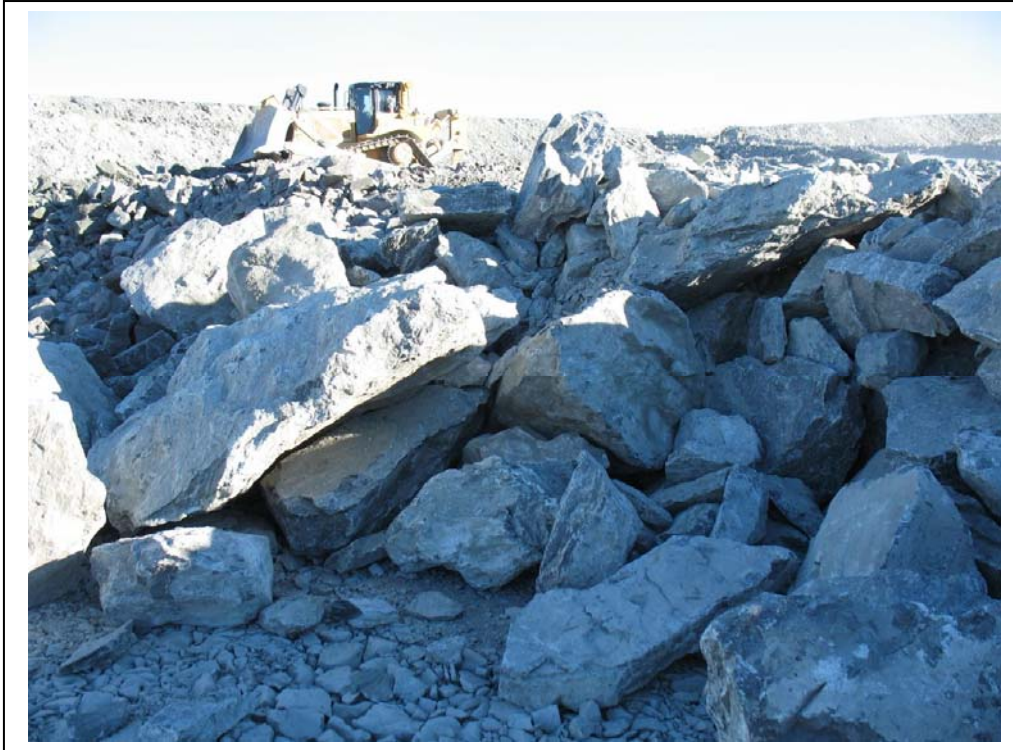
Photo #7 Local area of large size rock fragments

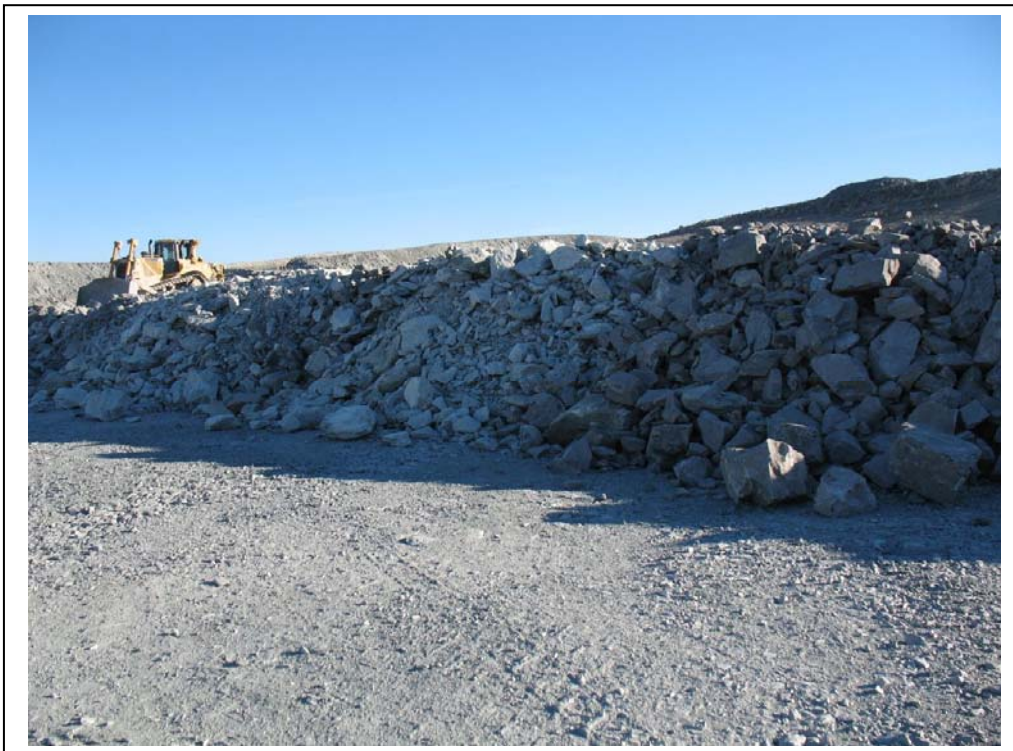
Photo #8 Typical rockfill gradation

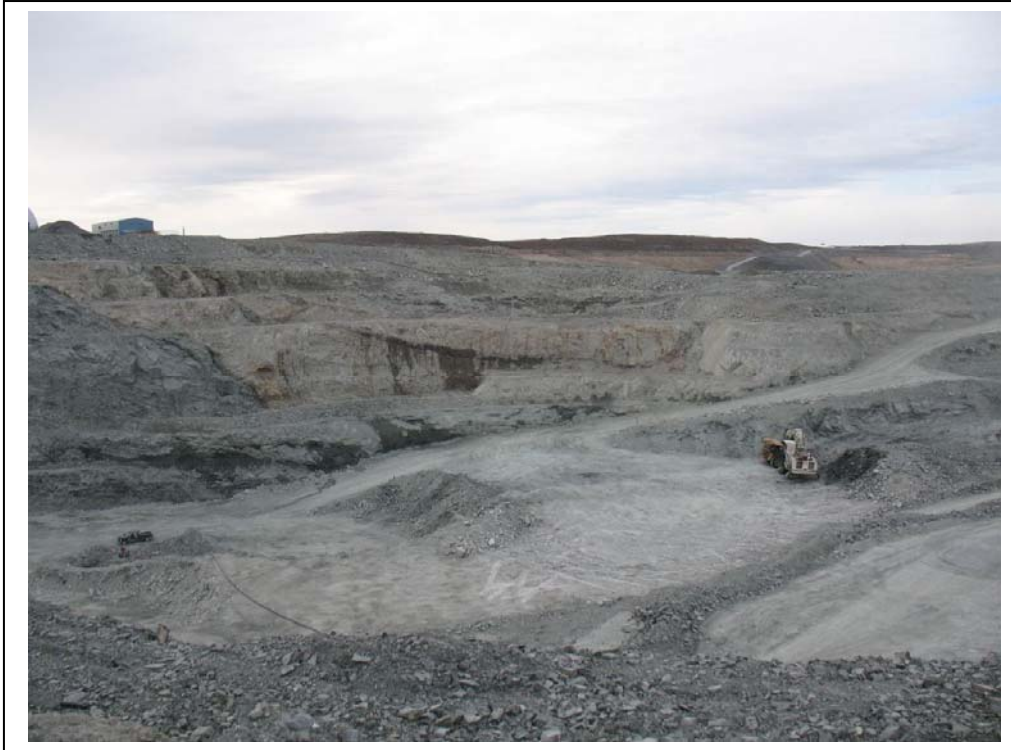
Photo #9 Portage pit wall D/S of Central Dike

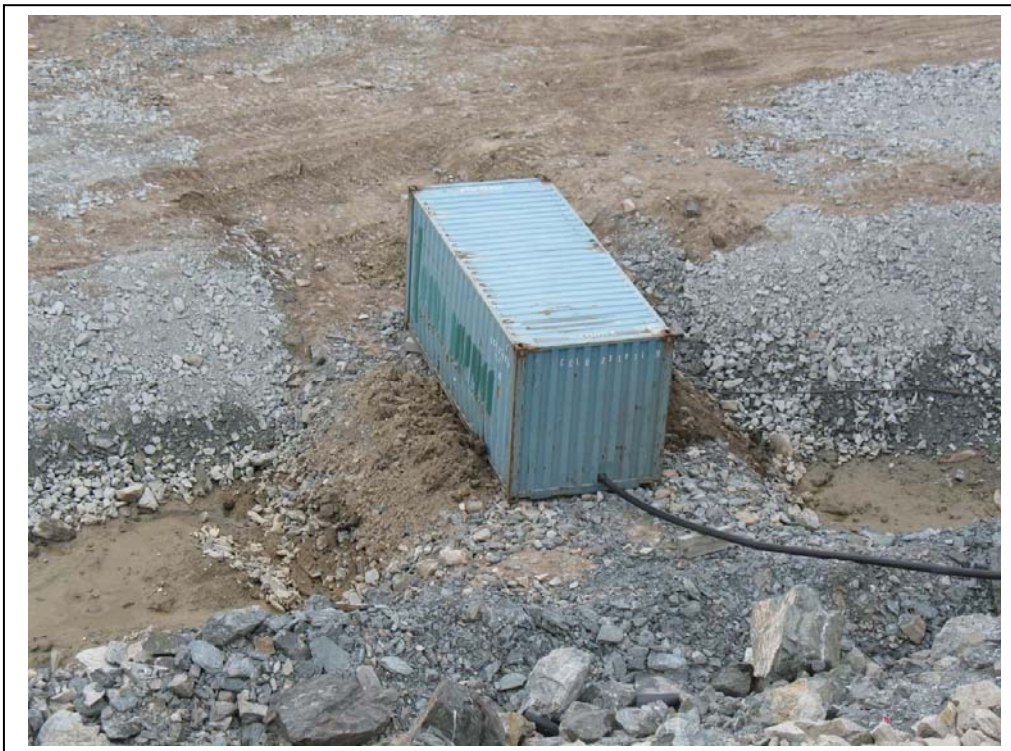
At Saddle dam #1, the pump station installation was noted (Photo #10). A check should be made of the potential for freezing of the fill surrounding the sump as this may require the temporary installation of a portable submersible pump in the spring.

Photo #10 Saddle Dam #1, downstream pump station

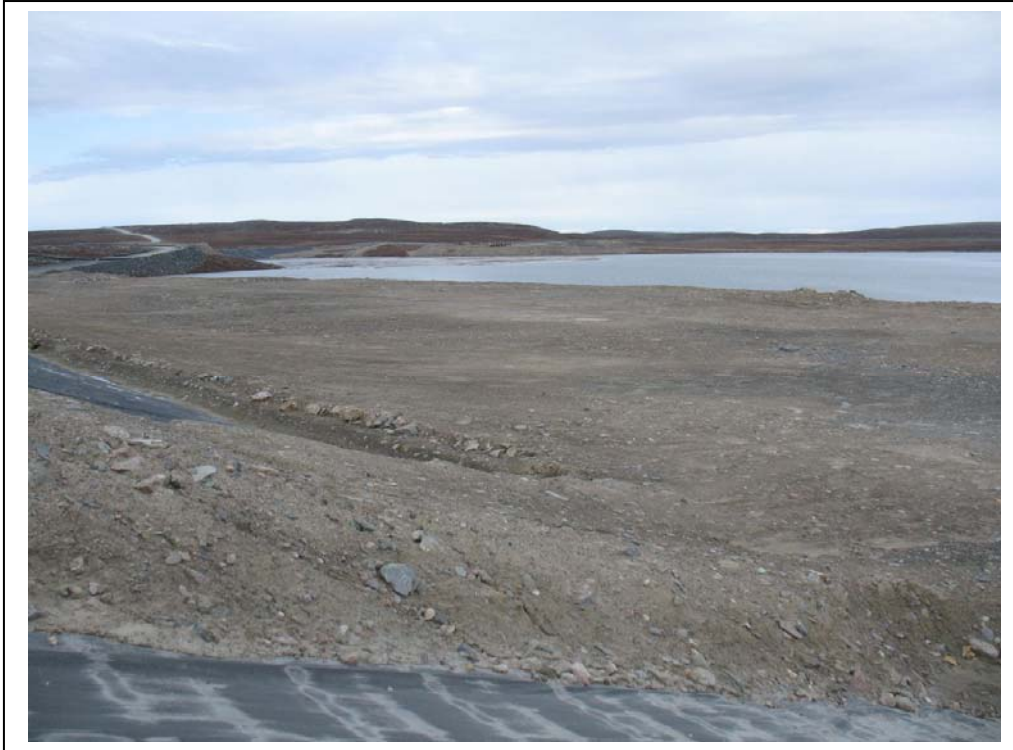
At Saddle Dam #2, the upstream toe had been covered with till to create a “beach” in advance of tailings deposition and temperatures are below zero in the foundation. Note that the foundation of this structure was above the pre-construction lake level and permafrost was already established.

Photo #11 Saddle Dam #2, till placed as beach

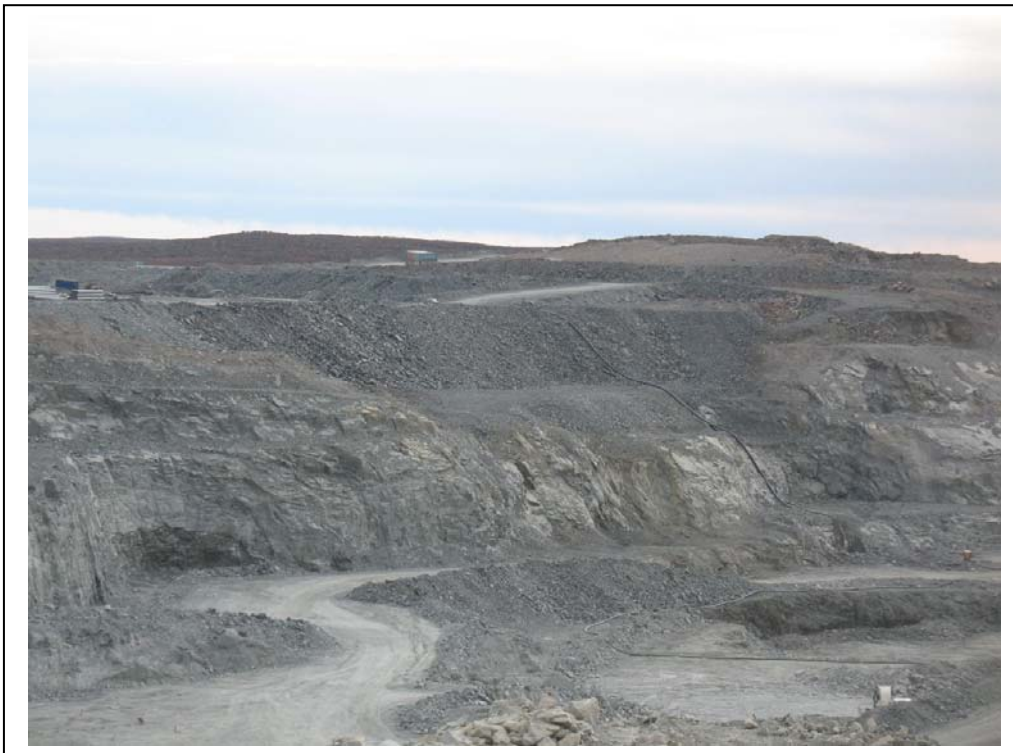
Photo #12 Protection on overburden face D/S of East Dike

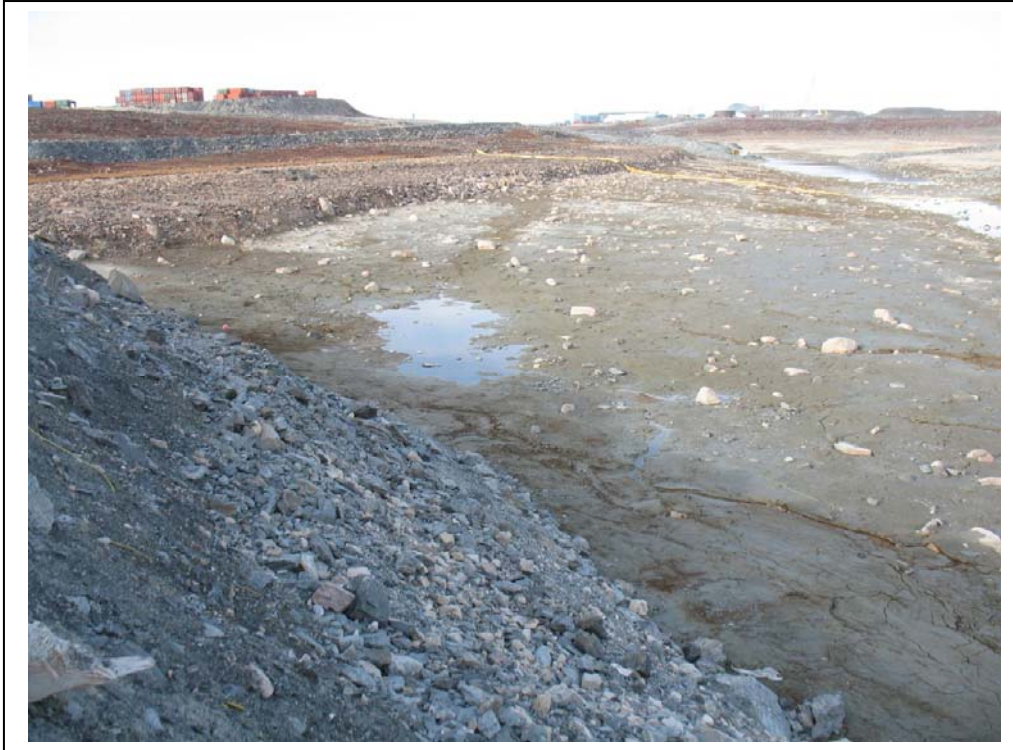
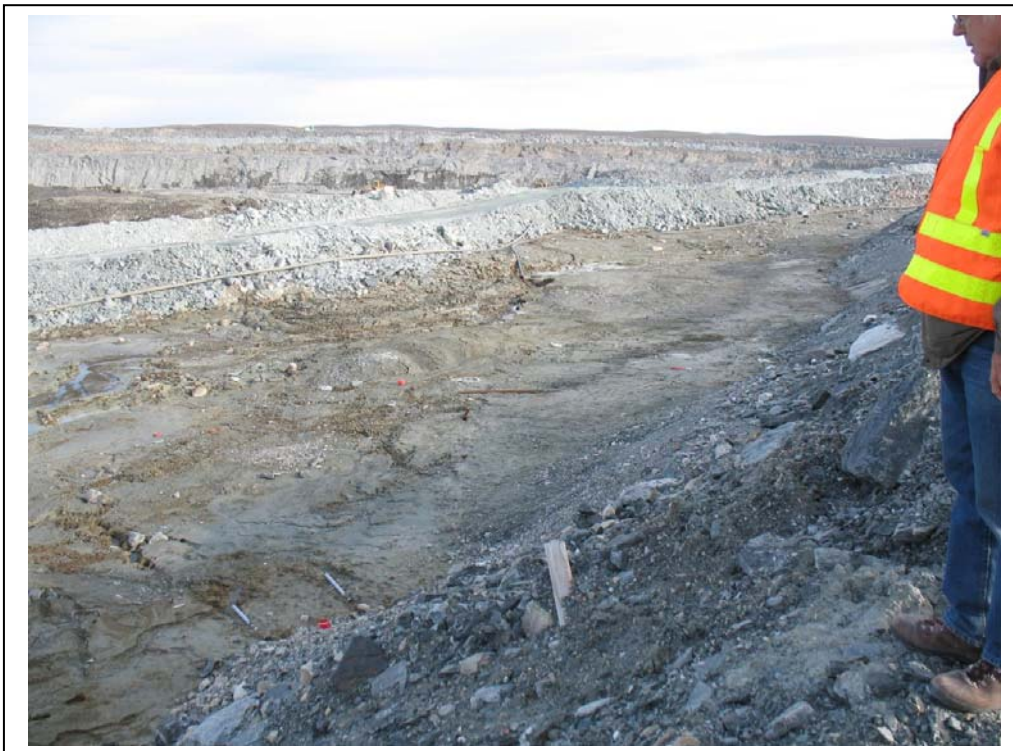
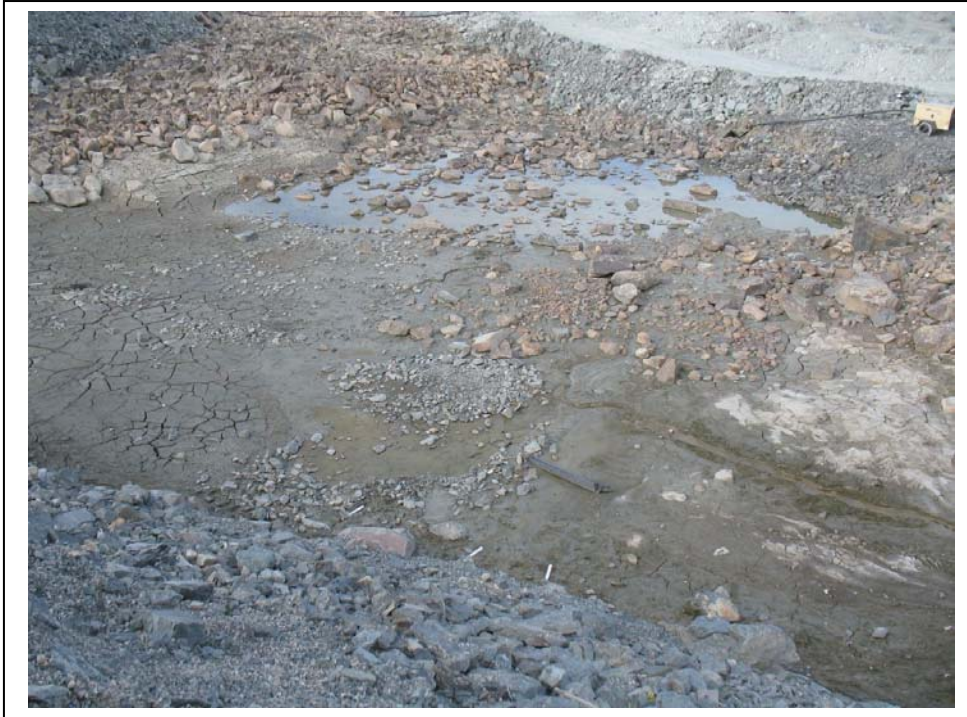
At the Bay-Goose dike, the downstream toe areas can now be examined and the conditions in the channels 1, 2 and 3 are shown respectively in photos #13 to 15. Seepage was observed to be minor.

Photo #13 Bay-Goose Dike, channel #1

Photo #14 Bay-Goose Dike, channel #2

Photo #15
Bay-Goose Dike
channel #3

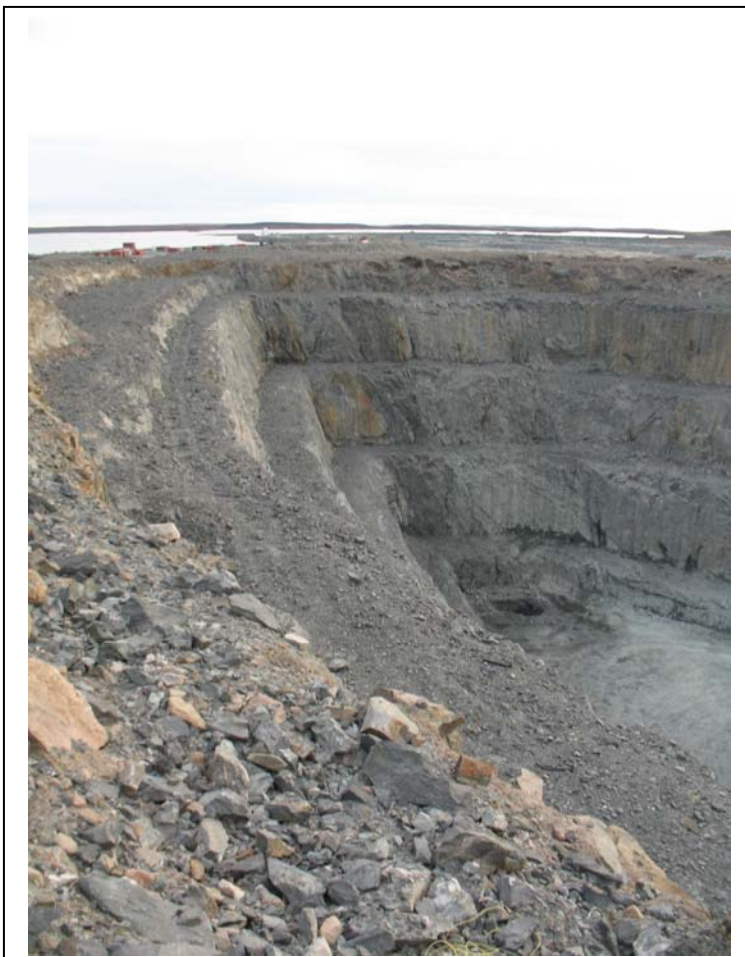
Photo #16
Southern extremity
of Portage Pit

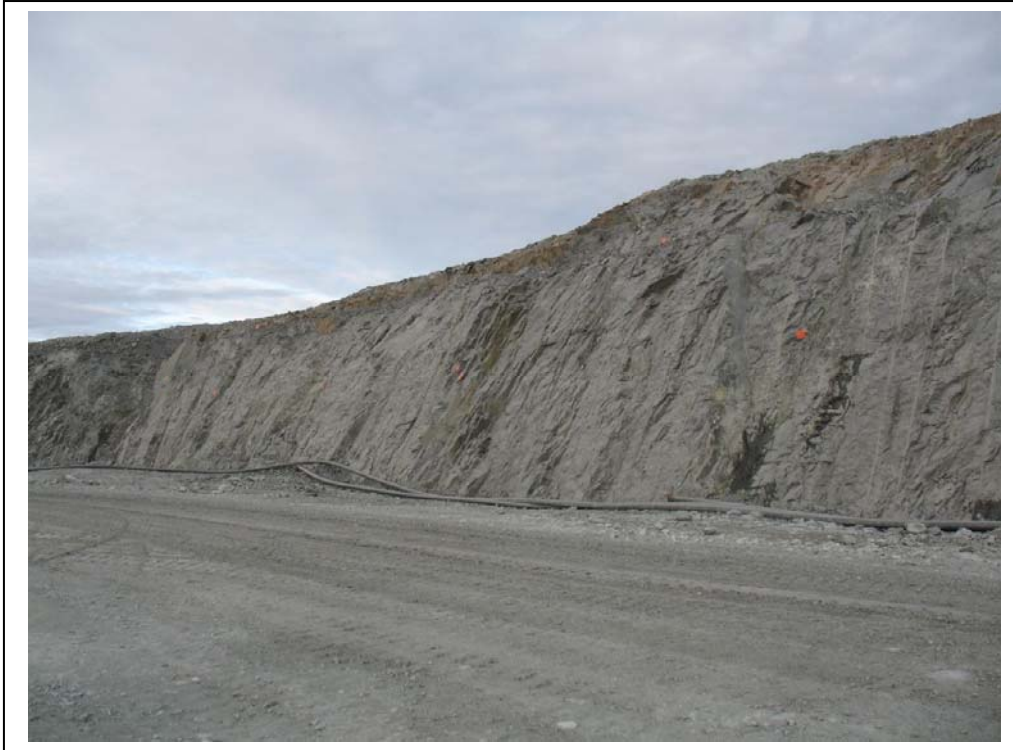
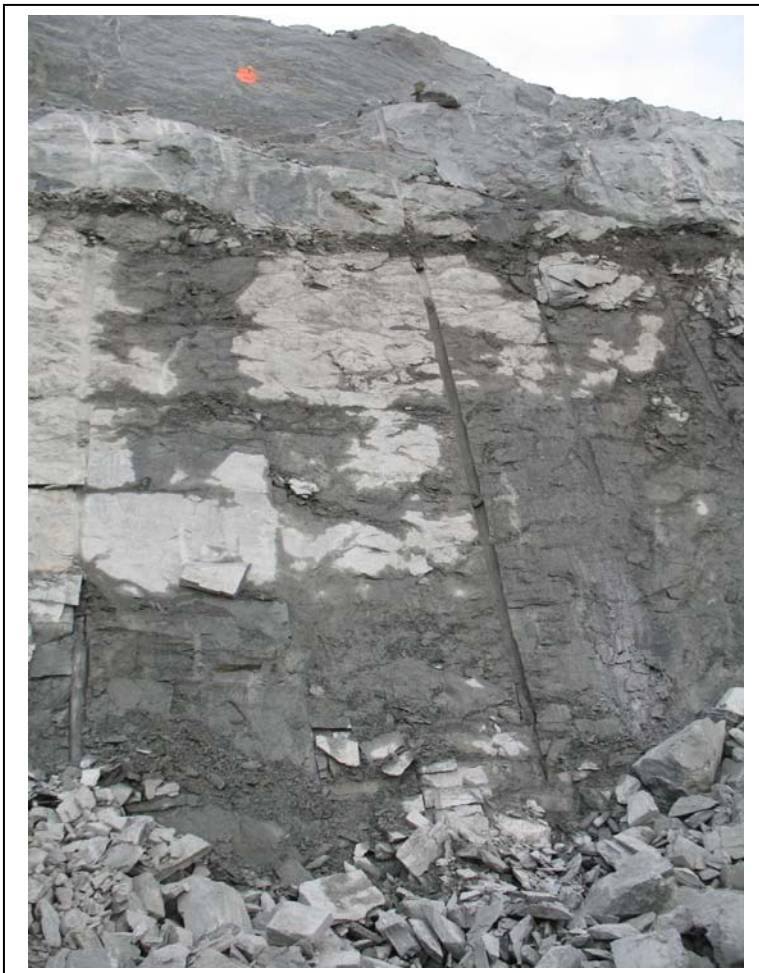
Photo #17
East wall of Bay-Goose pit

Photo #18
East wall of Bay-Goose Pit
