Appendix B2

Report: *Meadowbank Dike Review Board Reports #14*

**Report No 14
Meadowbank Mine Dike Review Board
Meeting September 9-11, 2013**

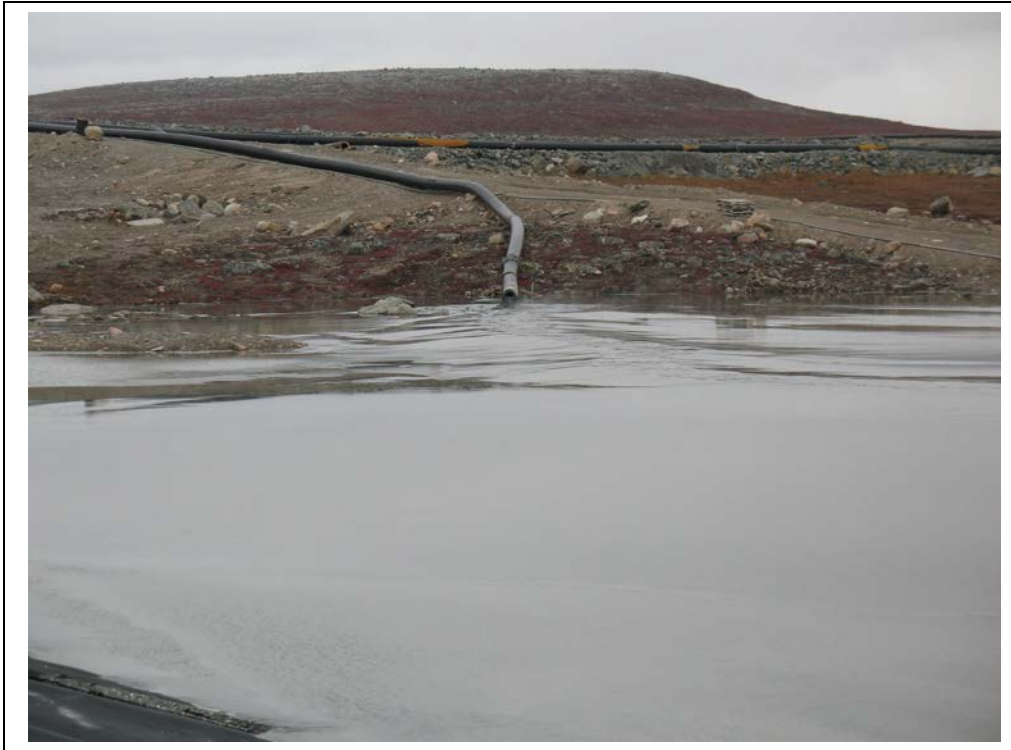
Photo #1 Saddle Dam No. 1 Note single large diameter tailings outfall

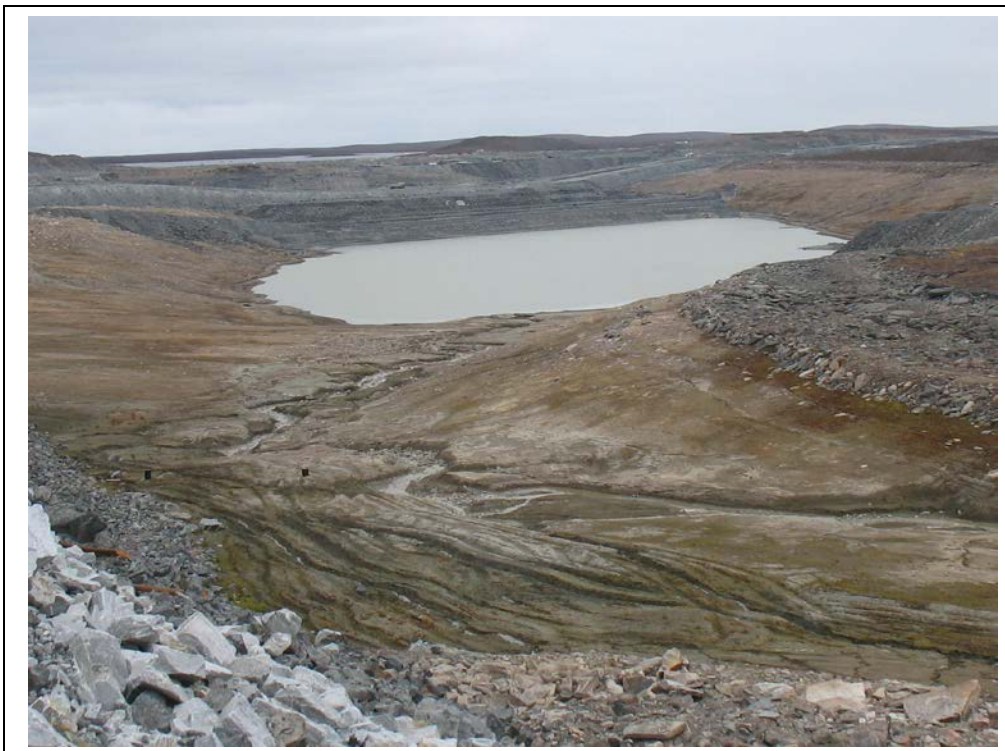
Photo #2 Central Dike, as viewed from Stormwater Dike. South Cell used for water storage only

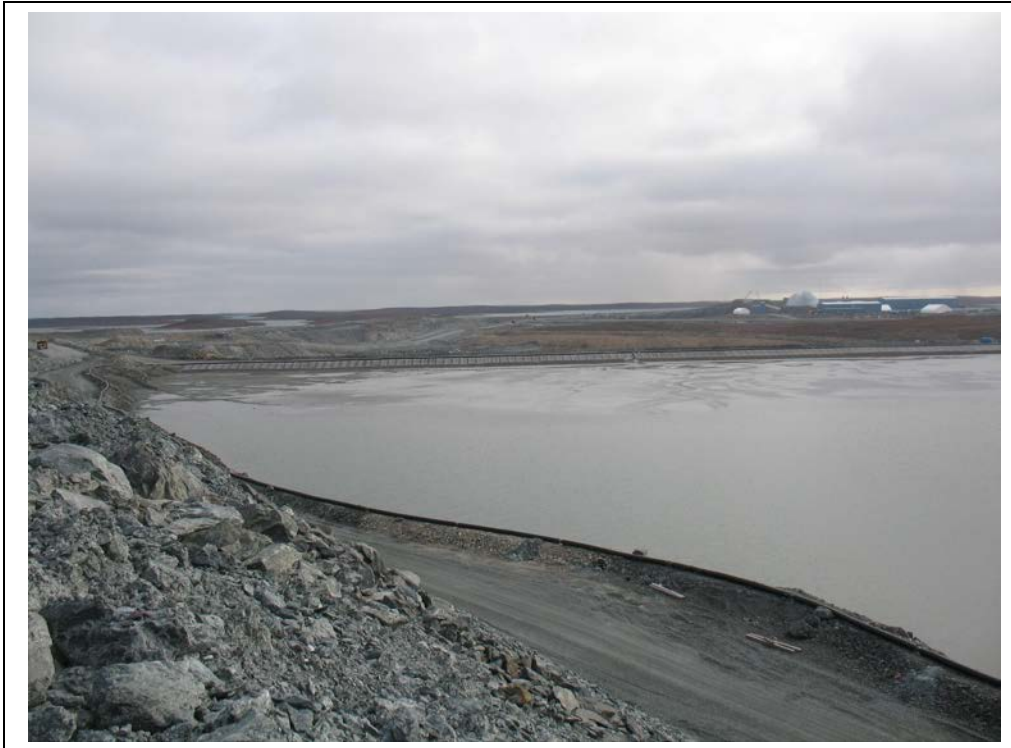
to minimize run-off towards the TSF, a series of ditches have been excavated from the high end of the catchment area to the north, leading water away from the TSF to the west and to the east of the latter. One such series of ditches passes through RP-2 and connects with ponds which ultimately drain to the Second Portage Lake at a point to the south of the Portage Pit. These works thus have the consequence of directing any seepage water that enters RP-2 to the outside of the Lease Boundary. This potential flow path was identified and mentioned in a Technical Memorandum from GAL dated March 24, 2011. It was hypothesized that the tailings beach and long term ingress of freezing would minimize the amount of water reporting to the RSF. The current situation has arisen in part due to the lack of a beach on the eastern shore of the TSF as shown in photograph #3.

The Board does not agree that this is an adequate approach and wishes to draw attention to the possibility of tailings piping through the coarse run-of-mine rock that comprises both the Rockfill Roads RF-1 and RF-2, as well as the RSF. Such a loss of tailings could release water from the decant pond towards RP-2 and overwhelm a seepage collection facility. The Board recommends proper evaluation made of cut-off alternatives, one of which could be a freeze wall created by a row of passive thermosyphons which would function very efficiently in a location such as Meadowbank.

Photo #3 Toe of waste rock storage facility and Rockfill Road RF-1 to east of the TSF

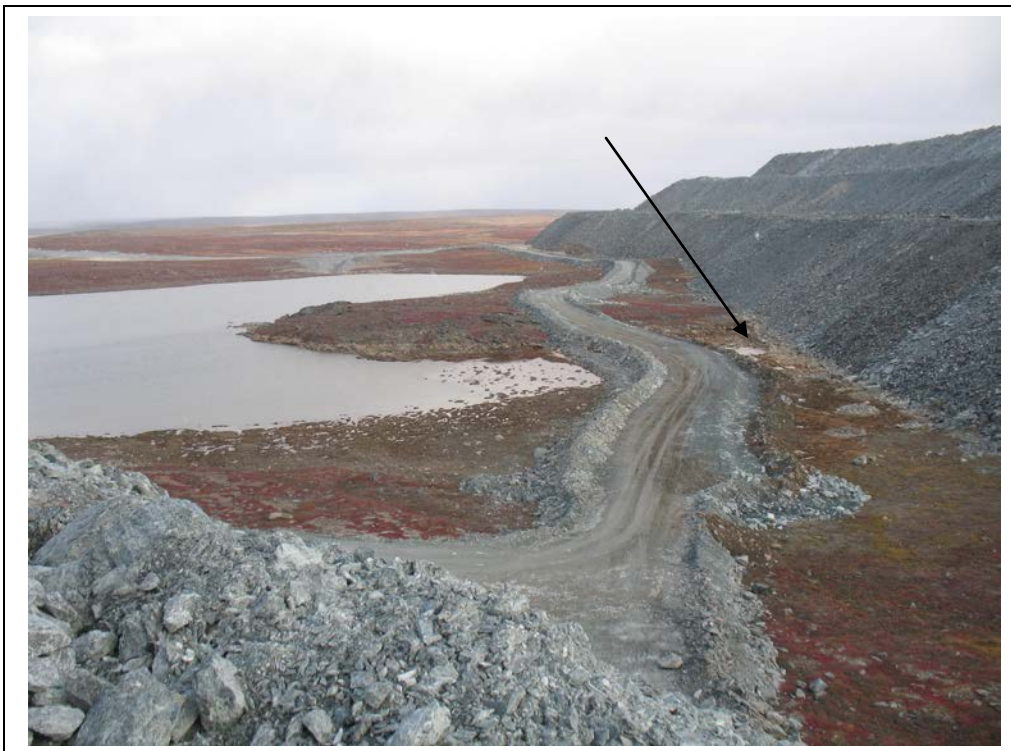
The Board was informed of the situation regarding seepage from the TSF through the Rock Storage Facility (RSF). A good summary of the sequence of observations and of the water chemistry was provided. The diagnostic studies are ongoing. The Board accepts the view that there has been a tailings water communication which, with other contaminants from the rock pile, has reached the perimeter of pond NP-2 situated to the north of the RSF. In the pre-mine natural conditions, pond RP-2 drained to Second Portage Lake through what is now the TSF. The outlet to the lake is at around elevation 141 m and with the TSF pond now at elevation 143 m, a hydraulic gradient in the reverse direction has now been created. As part of the plan

Photo #4 Site of seepage observations at waste rock pile. Pond RP-2

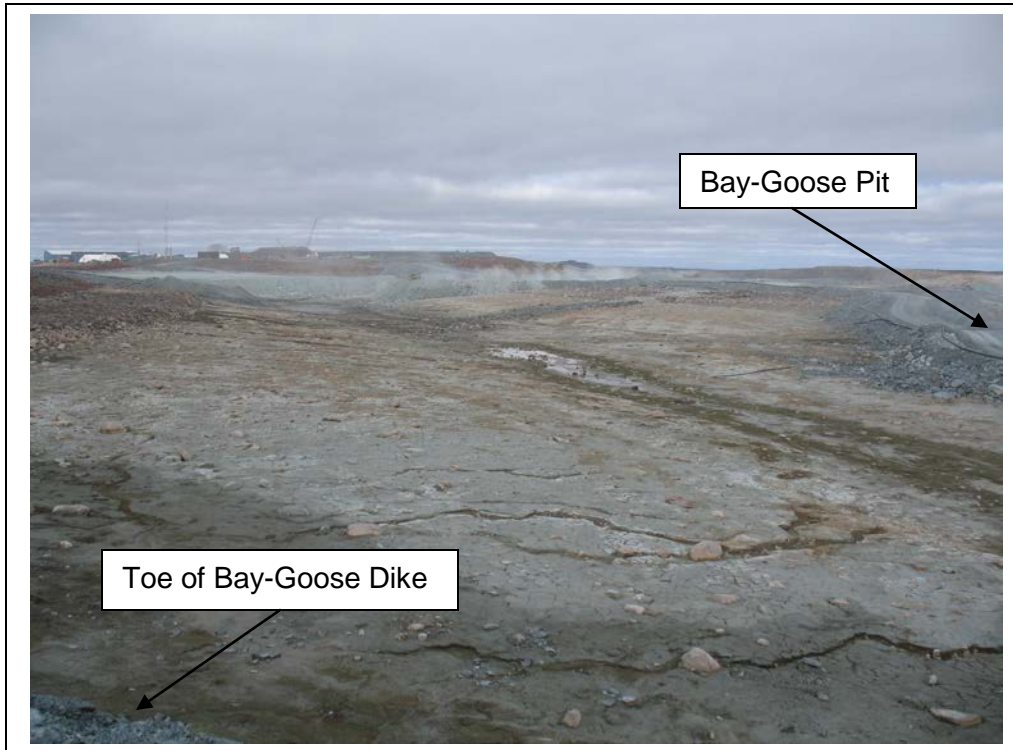
The Board was given a summary of the performance of the dewatering dikes as determined from the instrument monitoring and visual inspections. No new issues have been identified. The Board is content with the management of the dikes and the pertinent observations such as the accumulation of water during freshet between the Bay-Goose Dike (Channel #1) and the pit wall (see photo #5). Measures will be taken to avoid a recurrence in subsequent years as water ponding above the pit wall is undesirable.

Photo #5 Bay-Goose in-field area downstream of Channel 1. Water ponded here during freshet

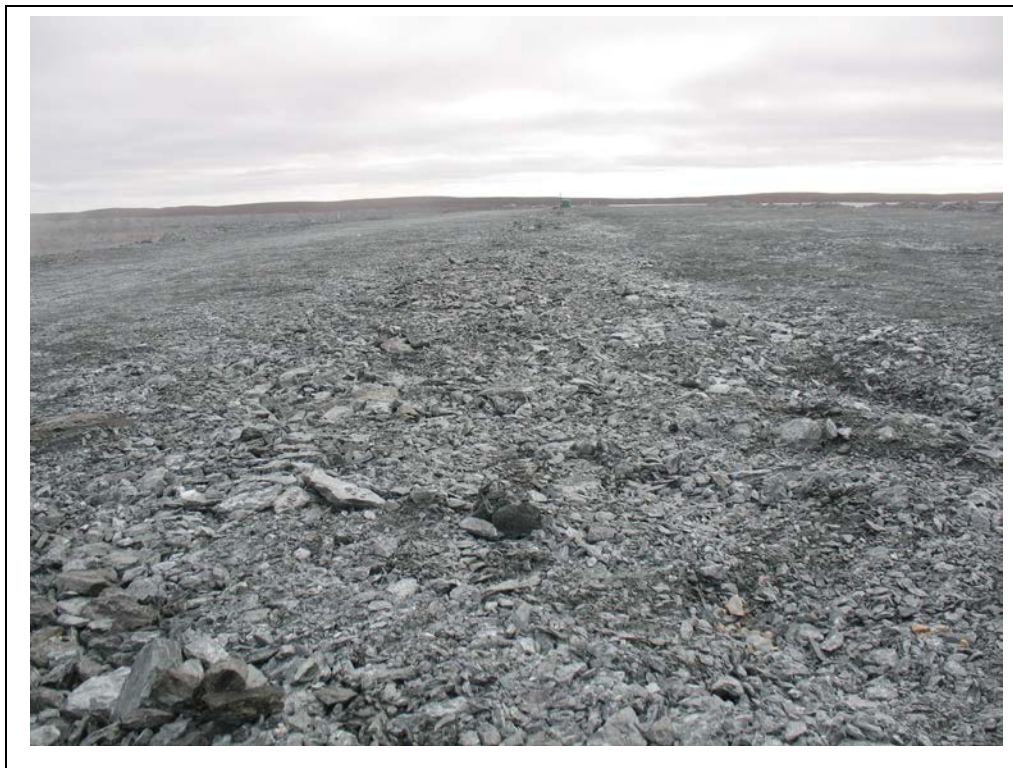
While it is clear that other maintenance items are being addressed, the results may leave something to be desired. During the site tour, the Board observed the capping that had been placed on the Bay-Goose Dike during the preceding winter. This rockfill capping enhances thermal protection of the core but as it was placed during winter, ice and snow were incorporated in the fill. Moreover, no compaction was carried out. As a result, the surface is irregular and several cracks were noted (photos #6 and #7). This hampers the identification of any settlement or cracking related to the performance of the body of the dike. Compaction and grading of the surface is recommended.

Photo #6 Crest of Bay-Goose Dike, view along cut-off axis

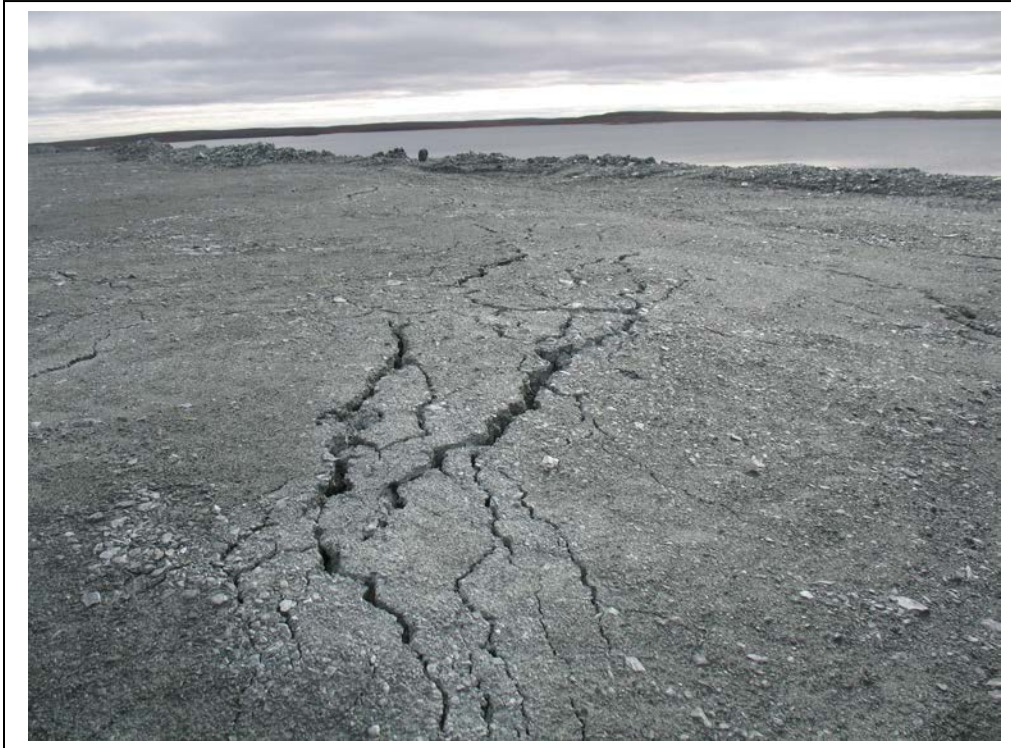
Photo #7 Crest of Bay-Goose Dike, upstream shell

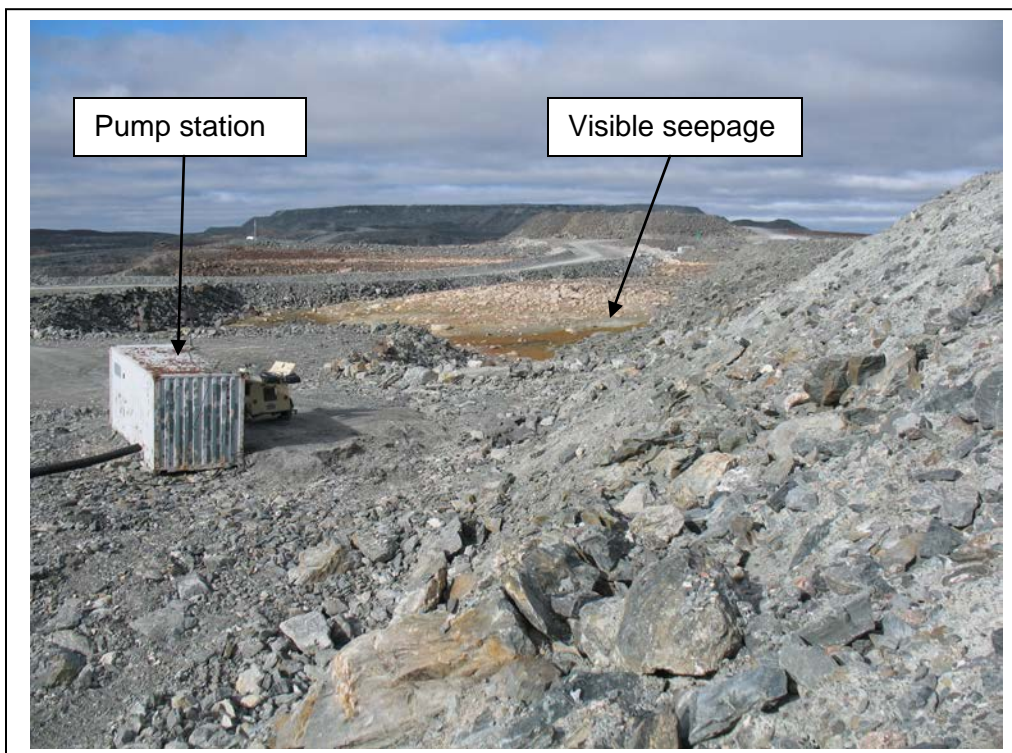
Seepage emanating from the toe of East Dike appears to have stabilized or even diminished. However, seepage in the foundation bedrock may be reporting directly to the Portage Pit.

Photo #8 Toe of East Dike

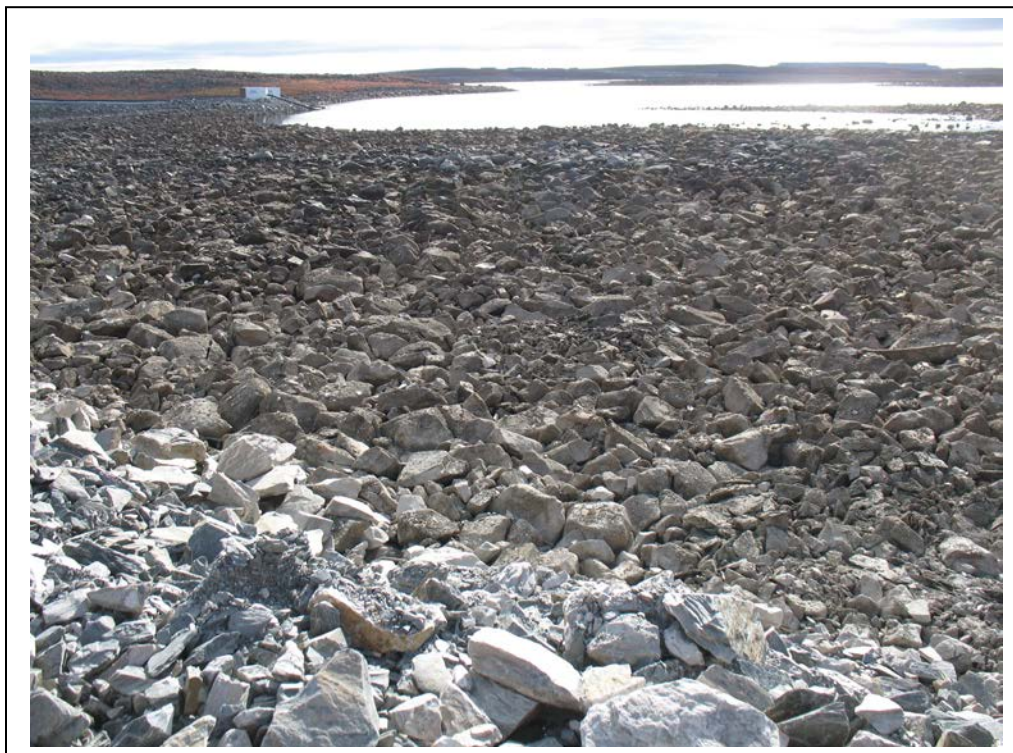
No issues were brought to light during the dewatering. It was noted during the site visit that the lakebed downstream of the dike is covered with a thick layer of ice jacked and broken rock which does not facilitate the observation of any seepage (Photo #10). However, this low head structure is founded on permafrost which provides an impervious barrier. Thermistors have been installed to permit detection of any change in this situation.

Photo #10 Lakebed downstream of Vault Dike

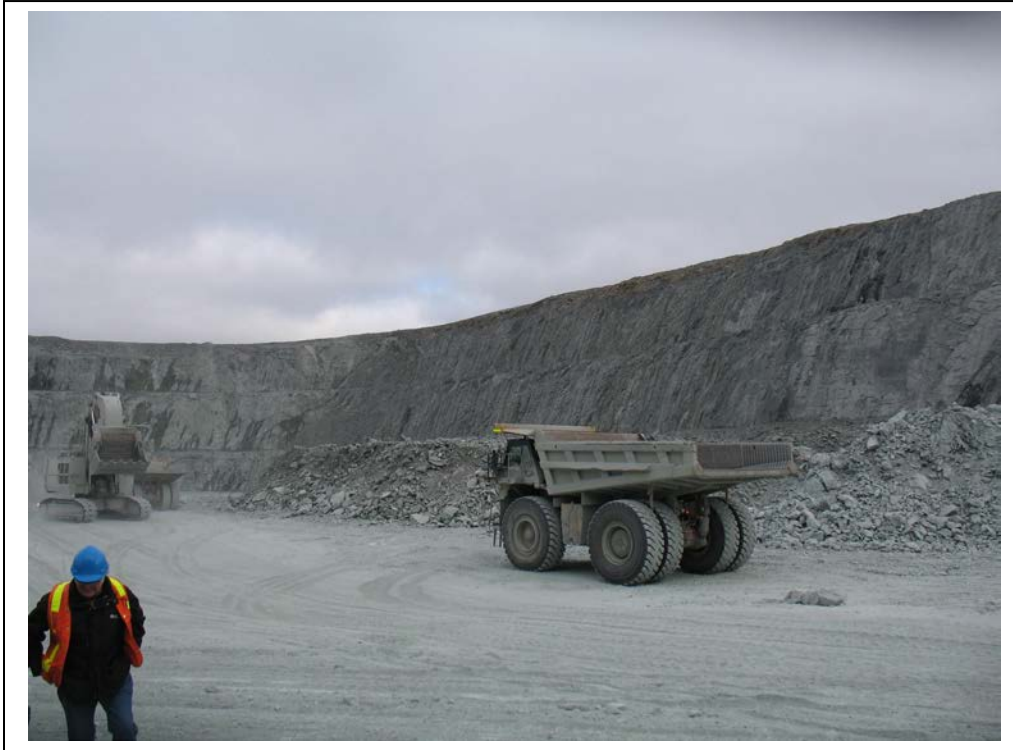
Photo #11 Bay-Goose Pit, east wall
