Appendix F1

Report: GN Spill Report

NT-NU SPILL REPORT

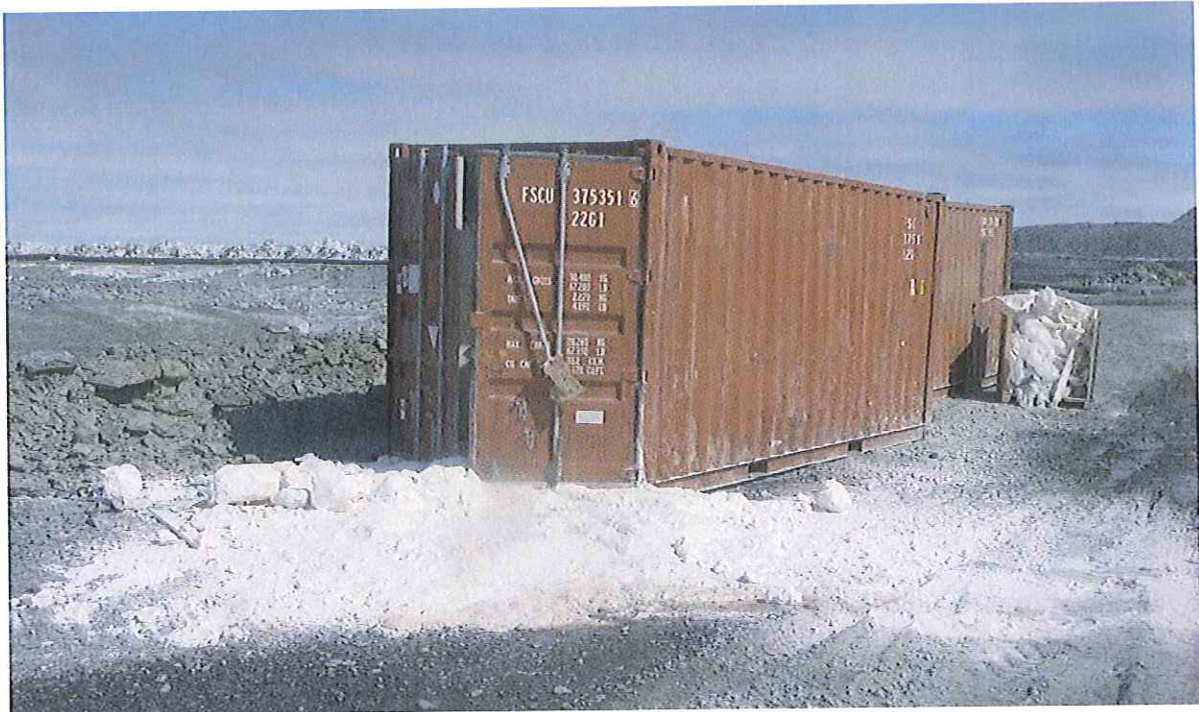
A sea-can containing unusable bag of quick lime, due to their condition, was stored near the tailings pond for disposition into the tailings pond. The zoom boom operator picked up a bag to move it to the disposition point. The bottom of the bag had rotted out and when the bag was lifted out of the seacan the product spilled on the ground. Approximately 500 Kg of quick lime was spilled on the ground. See photo below.

Photo of spill above; Below spill cleaned up, Lime Seacan Removed, and new seacan for Dewatering supplies in place

Site Services cleaned-up contaminated material and soil with the loader and disposed of into the tailings pond.

In the future, Seacan's full of outdated lime will only be unloaded in a location that prevents any contaminants from reaching the environment. i.e from inside the TSF boundary or on a ramp into the TSF, this way if there is a spill, the material spilt is with the TSF, also any water run off or rain will carry the chemical into the TSF and not the surrounding environment.

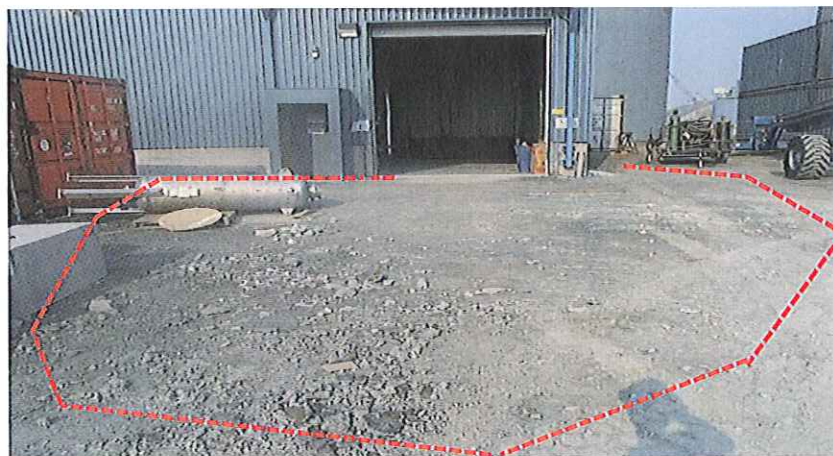
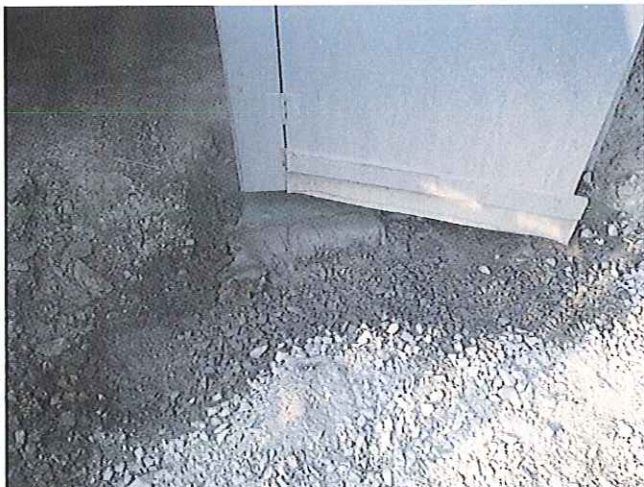
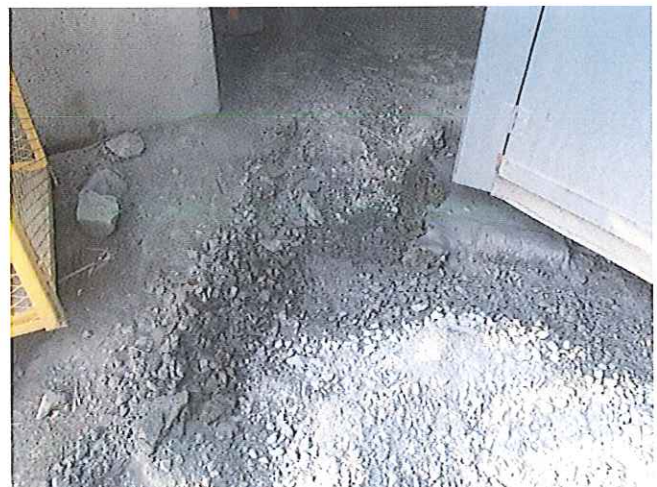
Spill:

H	PRODUCT SPILLED Tailings Slurry	QUANTITY IN LITRES, KILOGRAMS OR CUBIC METRES ~1 m3	U.N. NUMBER		
	SECOND PRODUCT SPILLED (IF APPLICABLE)	QUANTITY IN LITRES, KILOGRAMS OR CUBIC METRES	U.N. NUMBER		
I	SPILL SOURCE Pipeline	SPILL CAUSE Broken pipeline	AREA OF CONTAMINATION IN SQUARE METRES 10		
J	FACTORS AFFECTING SPILL OR RECOVERY	DESCRIBE ANY ASSISTANCE REQUIRED	HAZARDS TO PERSONS, PROPERTY OR EQUIPMENT		
K	ADDITIONAL INFORMATION, COMMENTS, ACTIONS PROPOSED OR TAKEN TO CONTAIN, RECOVER OR DISPOSE OF SPILLED PRODUCT AND CONTAMINATED MATERIALS Inside the mill, while mill was operating, the tailings line became disconnected. Before being able to completely stop the mill operation the tailings continued to come out of the pipe. The vast majority of the tailings slurry stayed inside the mill. However, the level became high enough that some leaked outside the door of the mill. Site services department immediately commenced clean up of the slurry. Back hoes were used to mix slurry with rock fill. This material was excavated taken to the Tailings Storage Facility. Photos of clean up and GPS Coordinates will be sent as a follow up. JEFF PRATT - (867)759-3555 EXTENSION 6728 / RYAN VANENGEN - (867) 763-4610 EXTENSION 6838

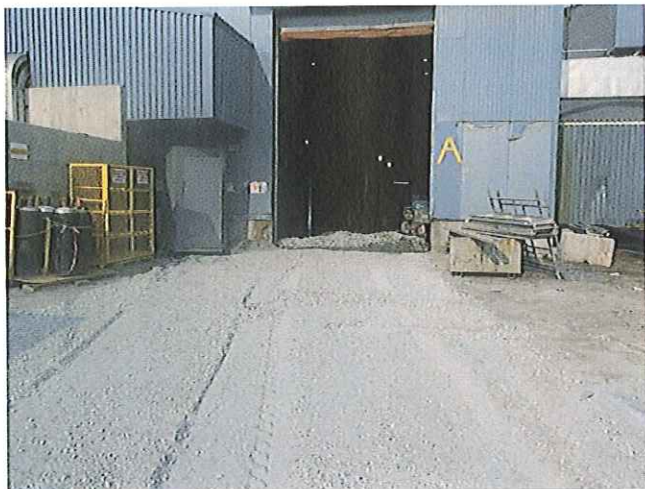
During Clean up:

Spill area mixed with rock material to absorb

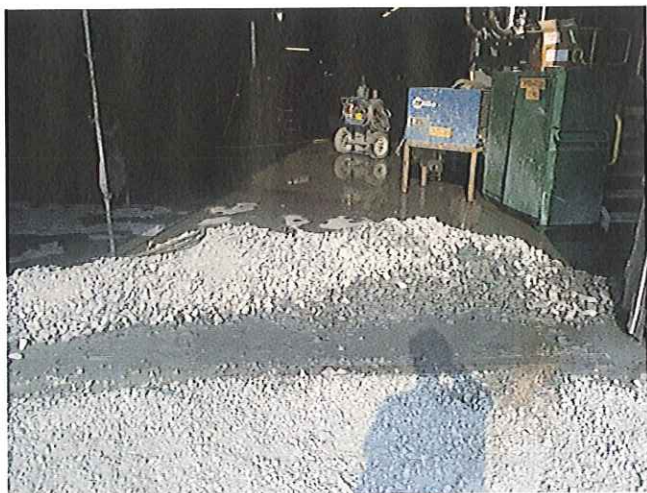
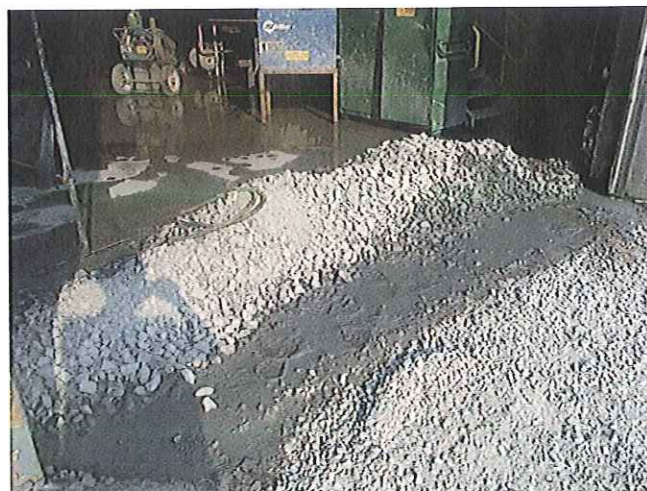
Berm put in place to stop further

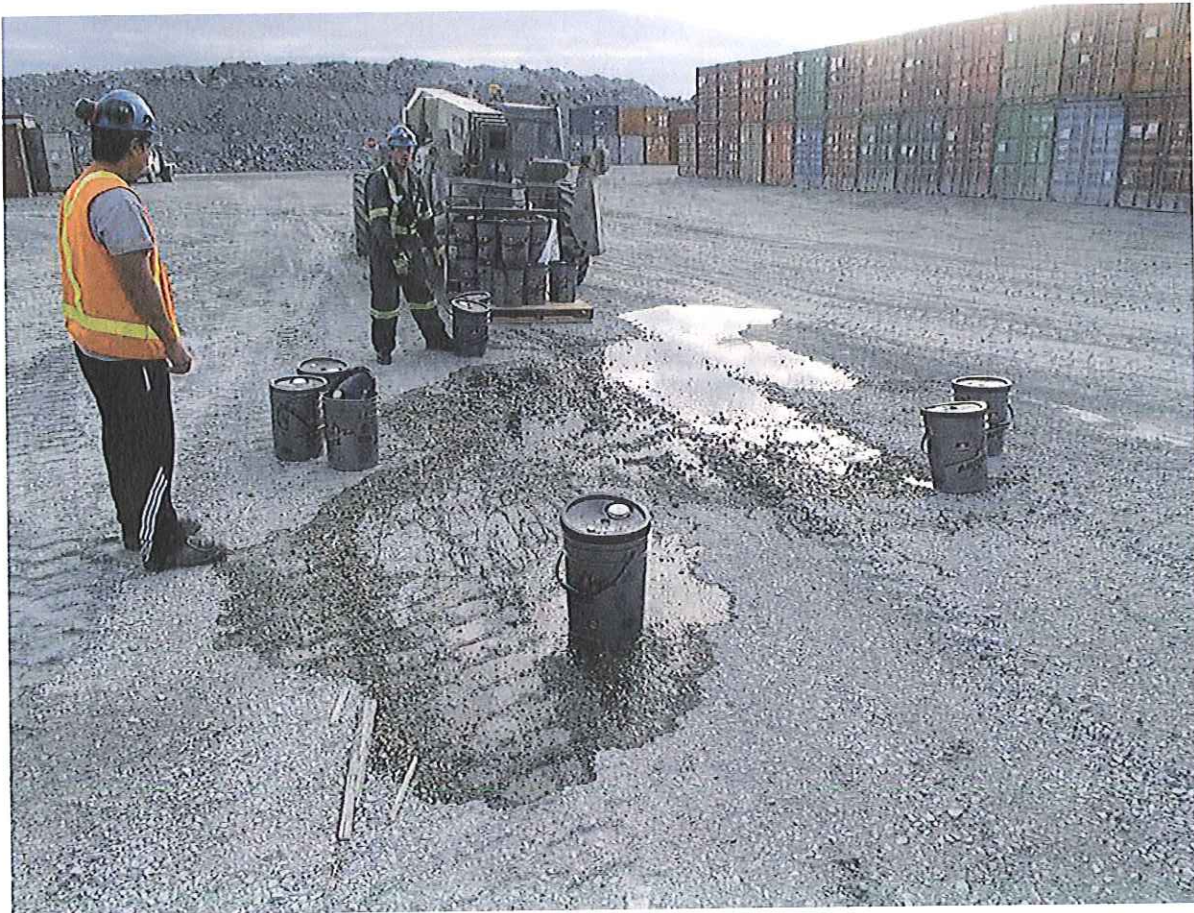
Before Clean-up

SECOND PRODUCT SPILLED (IF APPLICABLE)	QUANTITY IN LITRES, KILOGRAMS OR CUBIC METRES	U.N. NUMBER		
I	SPILL SOURCE PALLET OF DRILL OIL PAILS	SPILL CAUSE PAIL TIPPED during transport		AREA OF CONTAMINATION IN SQUARE METRES 6	
J	FACTORS AFFECTING SPILL OR RECOVERY	DESCRIBE ANY ASSISTANCE REQUIRED		HAZARDS TO PERSONS, PROPERTY OR EQUIPMENT	
K	ADDITIONAL INFORMATION, COMMENTS, ACTIONS PROPOSED OR TAKEN TO CONTAIN, RECOVER OR DISPOSE OF SPILLED PRODUCT AND CONTAMINATED MATERIALS The zoom boom operator was delivering a pallet of drill oil pails with the zoom boom when he hit a bump and 9 pails fell off the pallet. All the contaminated material was cleaned-up and sent to contaminated soil landfarm.				
L	REPORTED TO SPILL LINE BY Marie-Pier Marcil	POSITION Sr. Compliance Tech	EMPLOYER AGNICO EAGLE	LOCATION CALLING FROM MEADOWBANK	TELEPHONE 8197633700
M	ANY ALTERNATE CONTACT Ryan Vanengen	POSITION Env. Superintendent	EMPLOYER AGNICO EAGLE	ALTERNATE CONTACT MEADOWBANK LOCATION	ALTERNATE TELEPHONE 8677634610

Please find the following photos before and after clean-up as a follow up to the Spill report submitted August 12th, 2014 by Agnico Eagle Meadowbank division. All the contaminated material was clean-up and disposed appropriately in the contaminated soil container.

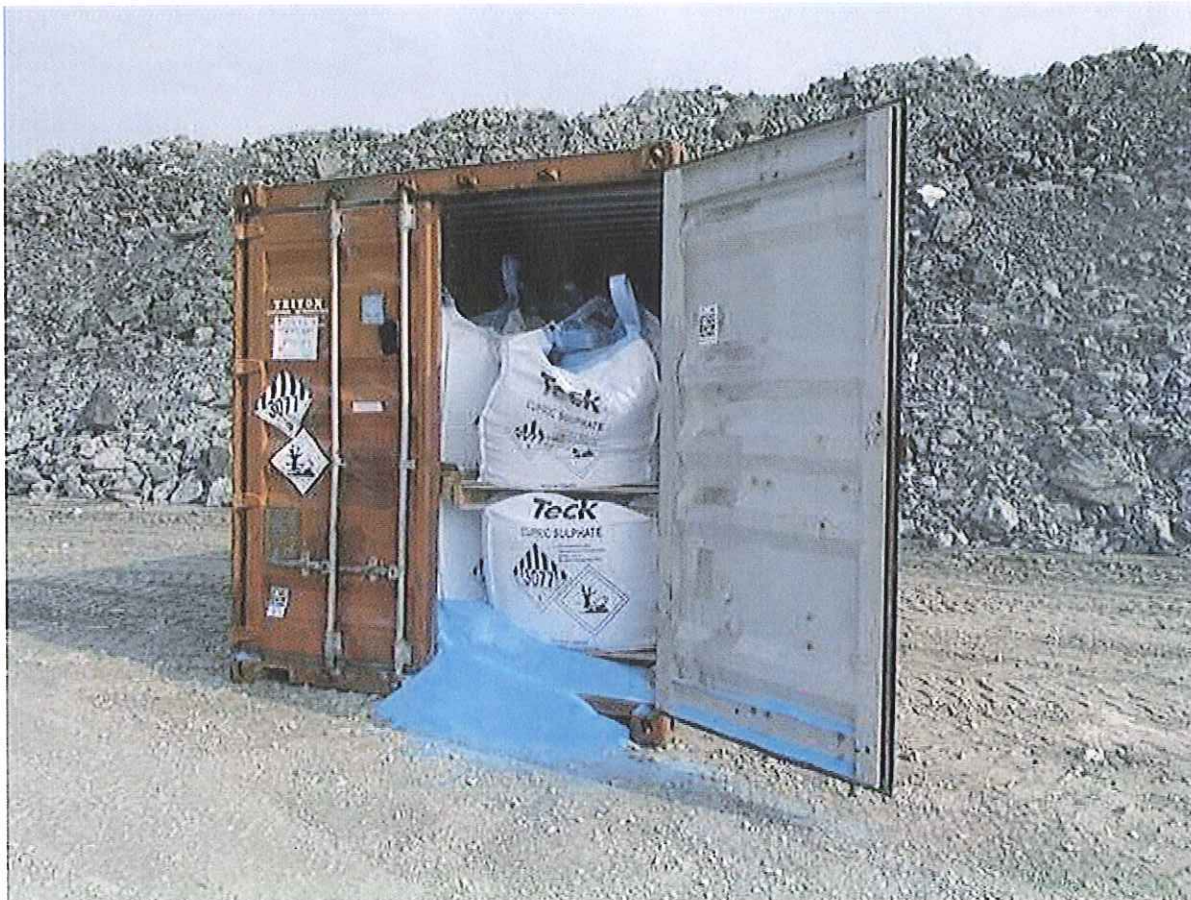
Before Clean-up

H	PRODUCT SPILLED Copper Sulfate		QUANTITY IN LITRES, KILOGRAMS OR CUBIC METRES 5 Kg		U.N. NUMBER 3077	
	SECOND PRODUCT SPILLED (IF APPLICABLE)		QUANTITY IN LITRES, KILOGRAMS OR CUBIC METRES		U.N. NUMBER	
I	SPILL SOURCE 1000 Kg Bag		SPILL CAUSE Damaged bag		AREA OF CONTAMINATION IN SQUARE METRES 1	
J	FACTORS AFFECTING SPILL OR RECOVERY		DESCRIBE ANY ASSISTANCE REQUIRED		HAZARDS TO PERSONS, PROPERTY OR EQUIPMENT	
ADDITIONAL INFORMATION, COMMENTS, ACTIONS PROPOSED OR TAKEN TO CONTAIN, RECOVER OR DISPOSE OF SPILLED PRODUCT AND CONTAMINATED MATERIALS A sea can containing large bags of copper sulfate was opened in the lay down area, resulting in a spill due to a previously damaged bag. A small amount of copper sulfate in solid form spilled out of the sea can and a small amount spilled onto the ground. A follow-up document including photos before and after clean-up will be send soon. K All the contaminated material was cleaned-up and disposed of in the Tailings Storage Facility.

Please find the following photos before and after clean-up as a follow up to the Spill report submitted August 26th, 2014 by Agnico Eagle Meadowbank division. All the contaminated material was clean-up and disposed appropriately at the tailings storage facility.
