Report: 2015 Annual Geotechnical Inspection

2015 Annual Geotechnical Inspection Meadowbank Gold Mine, Nunavut

Agnico-Eagle Mines Limited
Meadowbank Division
PO Box 540
Baker Lake, Nunavut
X0C 0A0

Document Number: Doc1533 1535715-Rev0

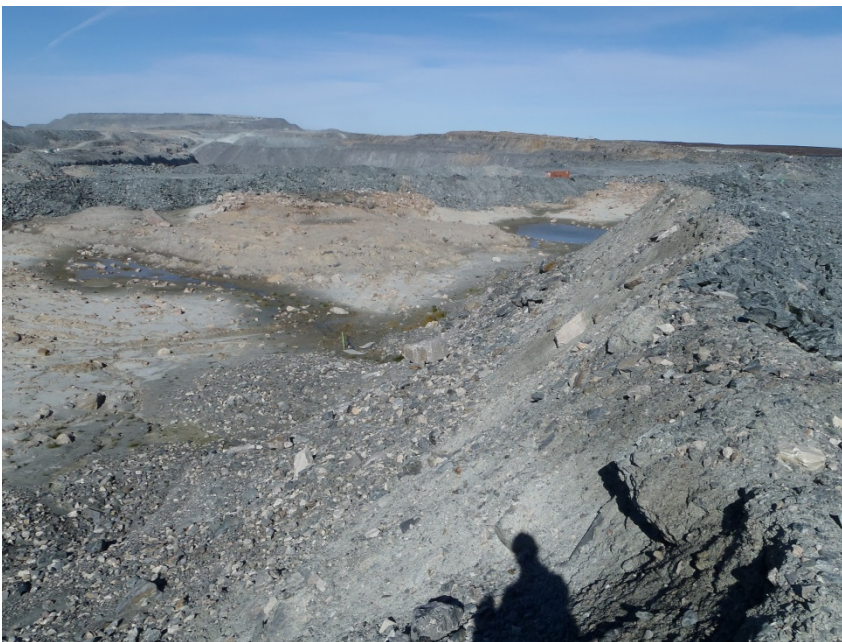
Photograph A3-6 Bay Goose Dike

Description: Close-up of seepage monitoring station 8 to monitor the flow at the North Channel (around Sta.30+420). Strong flow was observed during the inspection.

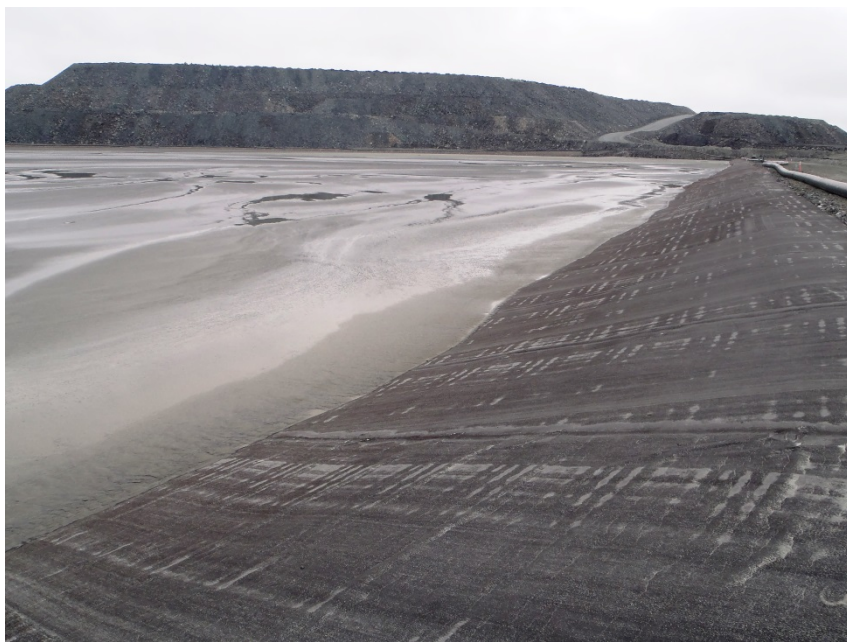
Photograph B1-6 Tailings Storage Facility

Description: From Sta. 10+650 on Stormwater Dike looking west. Inadequate tailings beach against portion of Stormwater Dike.

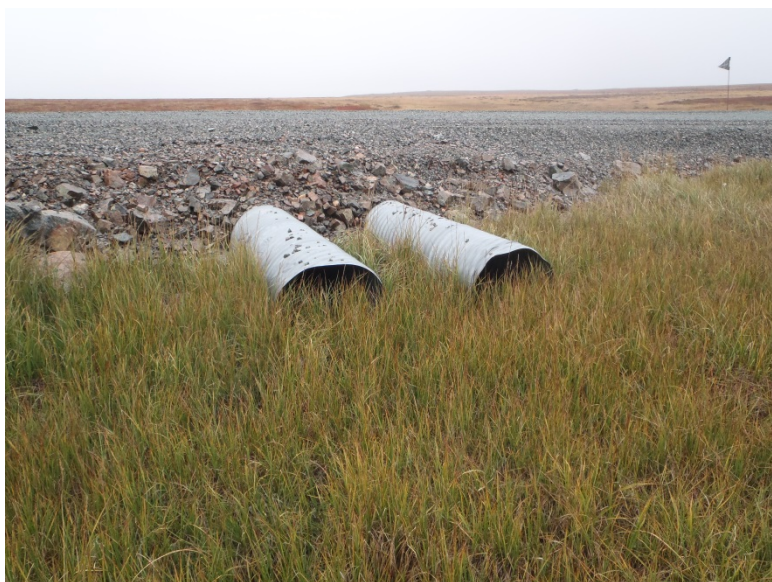
Saddle Dam 1 Photographic Log and Record of Inspection

Description: View of the culverts inlet. Culvert on the right is filled with gravel, crushed and damaged. Culvert on the left is slightly damaged but still functional.

No geotechnical issues were identified with the bridges, culverts and quarries along the AWPR. It is recommended to pay particular attention to culverts R-00A, 5+700, PC-14 and PC-16. If insufficient capacity to handle the flows is observed at freshet, or water is circulating under the road at these locations, then it is recommended to clear the obstructions or repair the culverts. It is recommended to add protection to the fine granular material placed around culverts PC-17 and PC-17A. It is also recommended to monitor the progression of the erosion of culverts at freshet at R14, R18-B, R20, R23, R24. If the erosion condition continues to deteriorate at these culverts it is recommended to repair them.

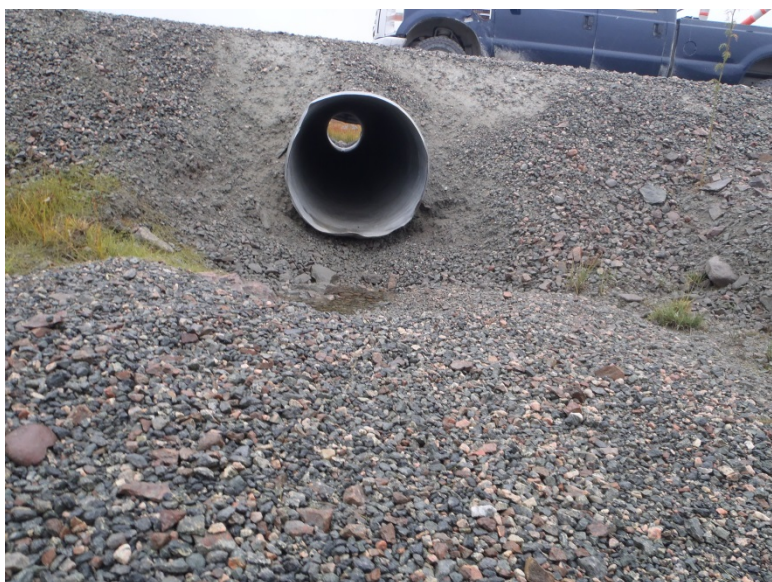
Photograph D1-12: unnamed km 5+700

Description: View of the culvert inlet. Good condition, inlet is short in length as the road rolling surface is at the edge of the inlet.

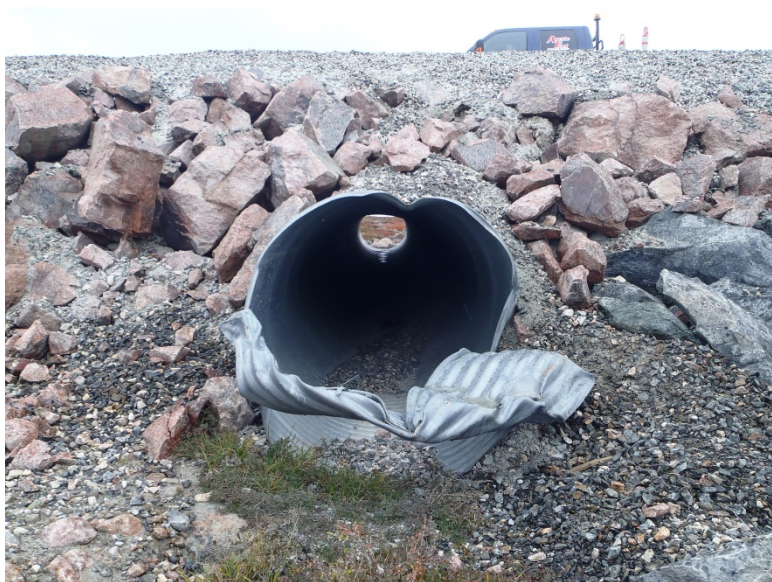
Photograph D1-64: R-20 km 85+490

Description: View of the culvert inlet. The middle of the culvert is slightly collapsed. The inlet is installed above the ground surface and water flows beneath the culvert. The culvert is in stable condition.

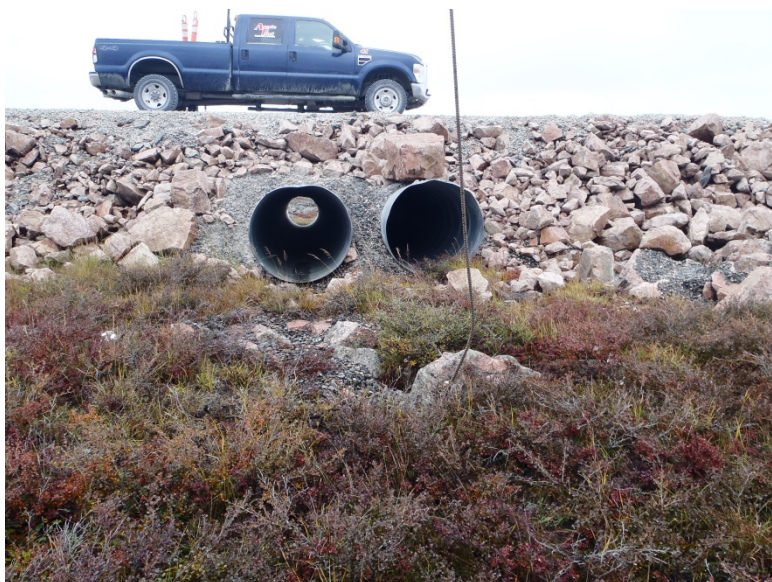
Photograph D1-66: R-21 km 87+300

Description: View of the culverts inlet. Both culverts are slightly collapsed in the middle. In stable condition, but should have been installed lower to avoid erosion issue.

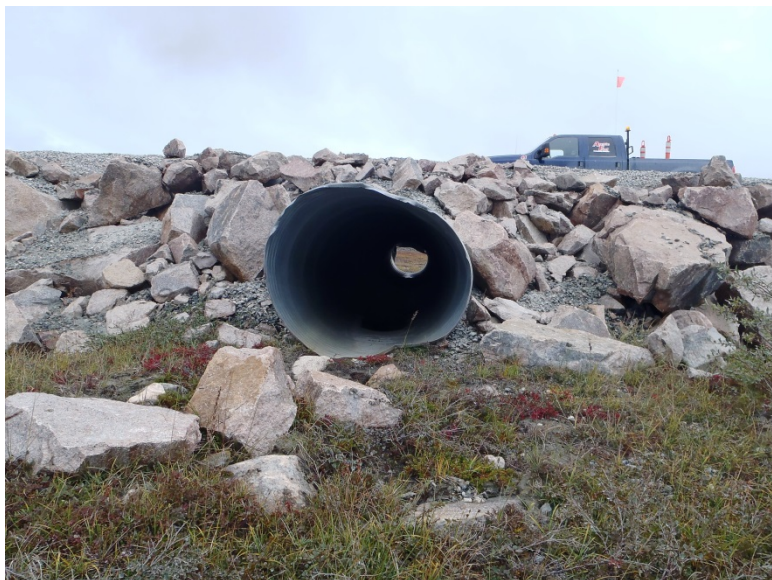
Photograph D1-68: R-23 km 93+600

Description: View of the culvert inlet. The culvert is installed too high and there is a low flow of water through the road rockfill. In good condition.

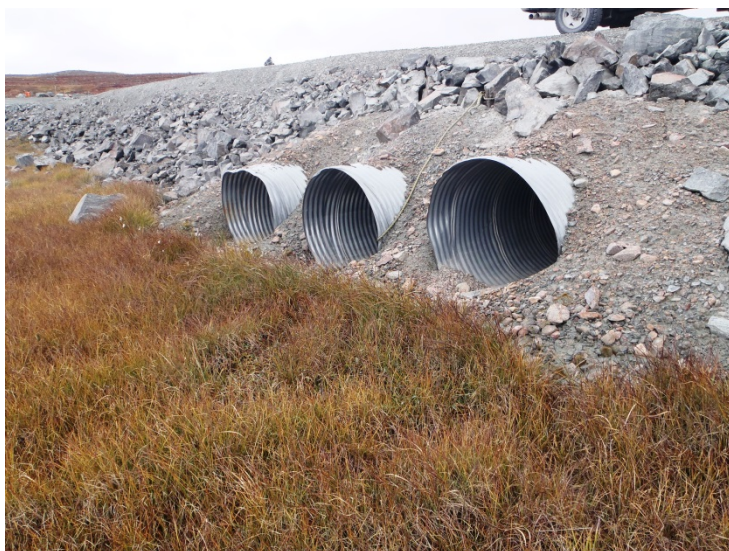
Photograph D1-76: R-26 km 104+400

Description: View of the culverts inlet. Presence of a 0.4 m boulder in front of the west inlet. In good condition.

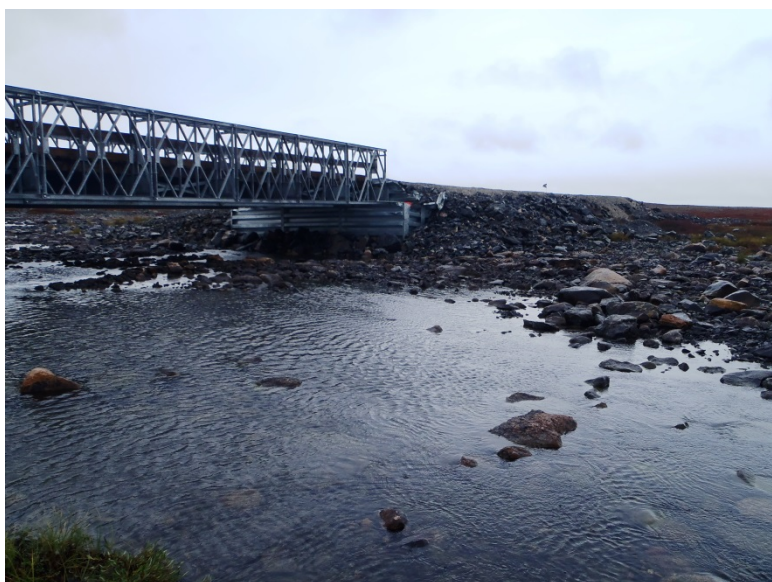
Photograph D2-18 Bridges 6 – R15 km 69+200

Description: Looking at the south abutment from downstream. Damage to the bin wall likely caused during snow removal activities.

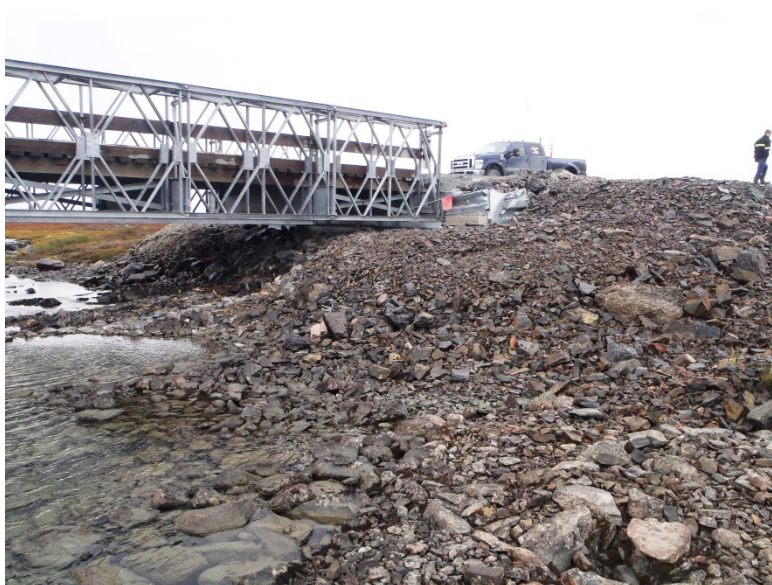
Photograph D2-20 Bridges 6 – R15 km 69+200

Description: Looking at the north abutment from upstream. Damage to the bin wall likely caused during snow removal activities.

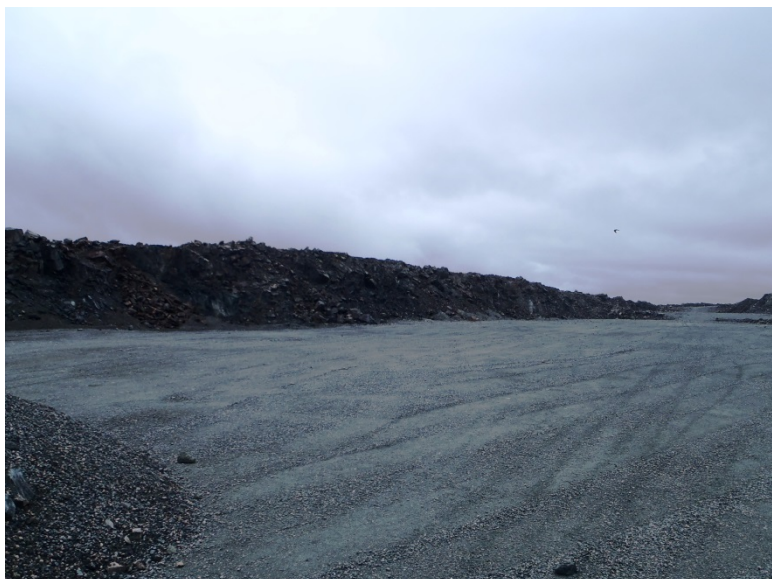
Photograph E1-6: Quarry 3 – km 23+700

Description: View of west wall. Presence of loose rock along steep wall.

Presence of unstable blocks and loose rocks along steep walls were also observed in most of the quarries but especially in Quarries 3, 7, 9, 16, 19 and 23. These unstable blocks and loose rocks should be cleaned if operation of these quarries resumes. It is recommended that workers be cautious in these quarries and be made aware of the potential hazard.

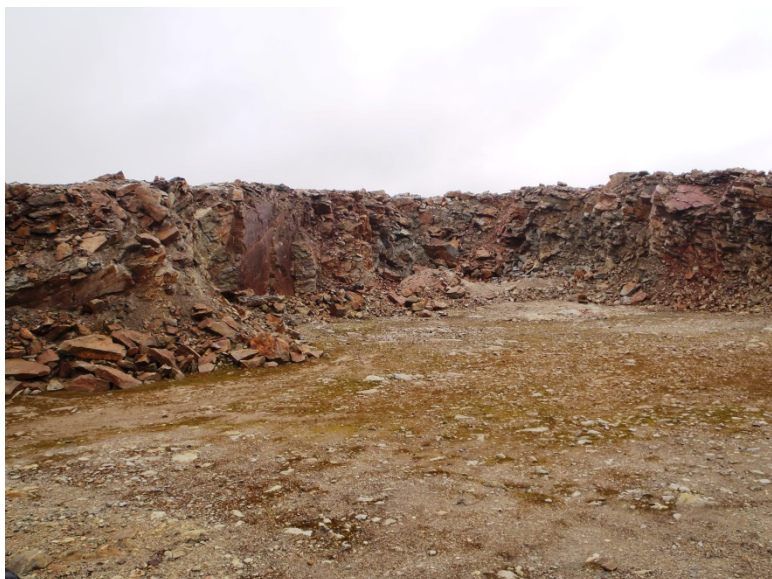
Photograph E1-14: Quarry 7 – km 39+800

Description: View of west wall. Presence of loose blocks.

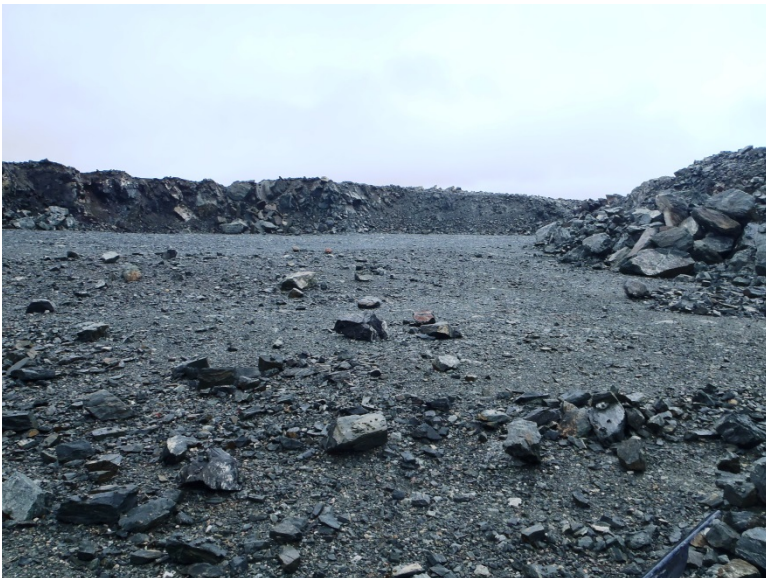
Photograph E1-18: Quarry 9 – km 44+600

Description: View of west and south walls. Presence of loose blocks.

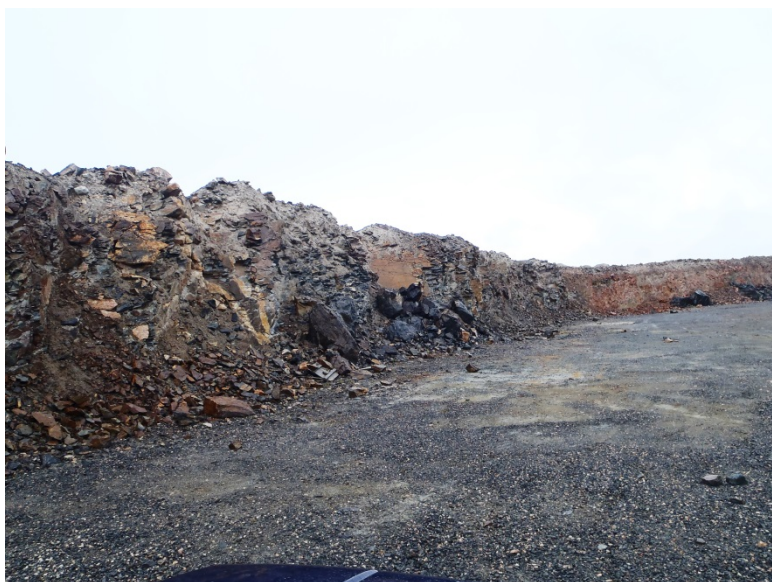
Photograph E1-32: Quarry 16 – km 70+400

Description: View of the south and west walls. Presence of loose rocks on steep wall.

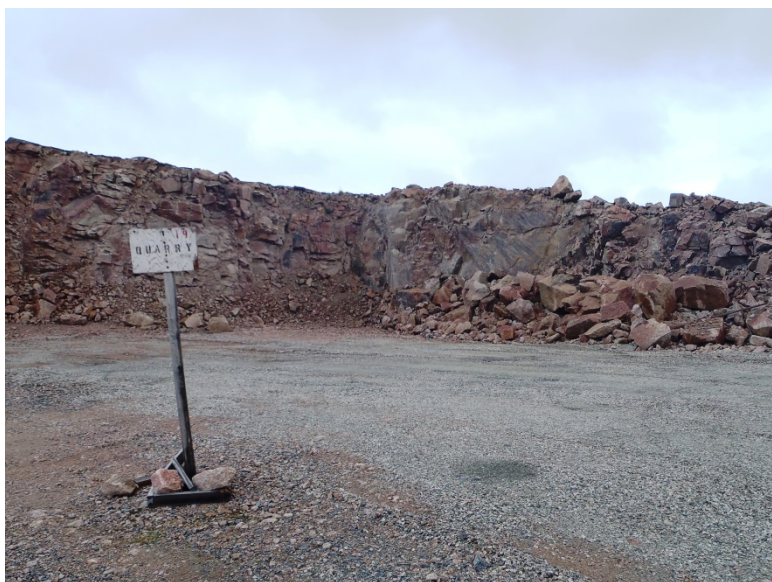
Photograph E1-38: Quarry 19 – km 84+300

Description: Looking at the north and west walls. Presence of loose rocks on top of steep wall.

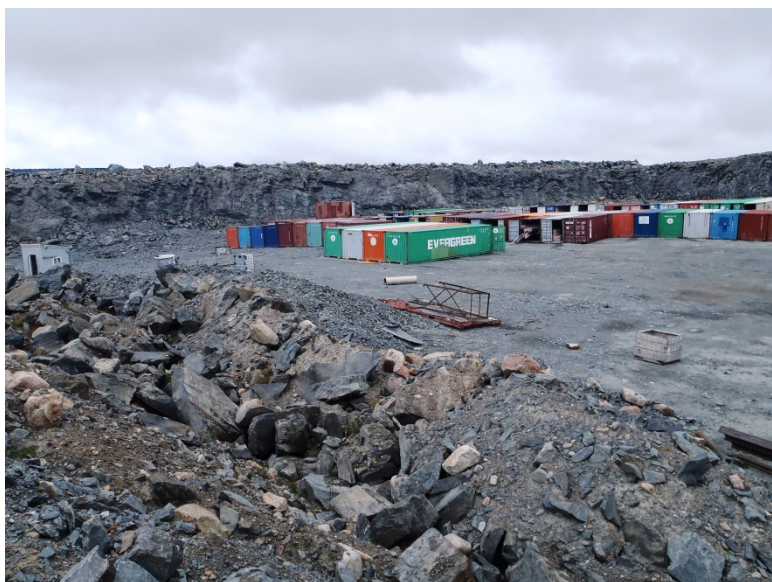
Photograph E1-48: Quarry 23 (Airstrip Quarry)

Description: Looking at the east and the south walls. Presence of loose rocks along steep wall.
