Annual Review of Slope Performance

MEADOWBANK MINE

ANNUAL REVIEW OF PIT SLOPE PERFORMANCE (2015)

CJ Clayton Mine Geotechnical Services Ltd.
North Vancouver, BC

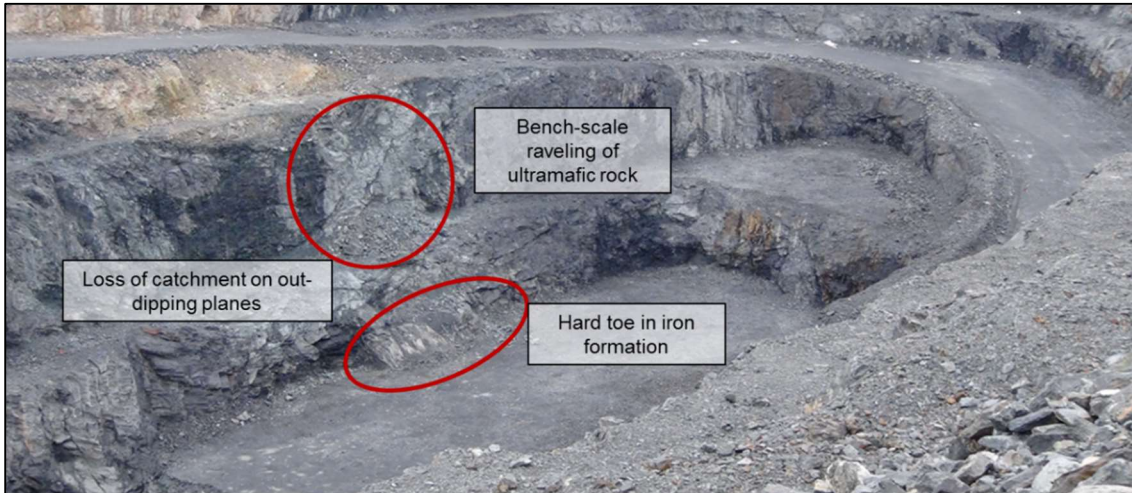
base of the slope, exposing out-dipping planes. Poor quality ultramafic rock exposed in the bench above continues to ravel with exposure to air and moisture, along adversely oriented joint structure. This has resulted in loss of catchment. This is a localized occurrence and not indicative of larger scale instability, hence can be managed through mucking as necessary. AEM plan to mine the Pit A pushback beginning with the upper benches, and progressing downwards. Consequently, no personnel or machinery will be working beneath this area.

Photograph 4-5: Pit A lower west wall raveling

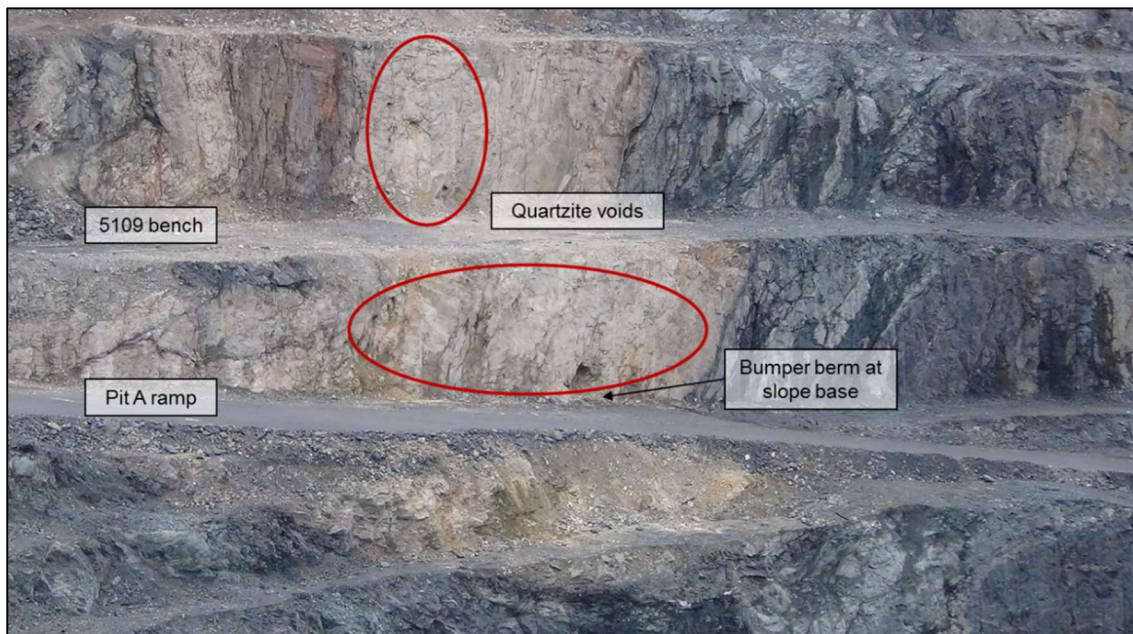
The quartzite stratigraphy observed in the Pit A west wall along the ramp contains several large voids identified during previous inspections. Previous recommendations for managing local instability associated with the voids have been implemented, including the construction of a bumper berm to contain material that may continue to ravel.

Photograph 4-7: Voids in quartzite above Pit A west ramp

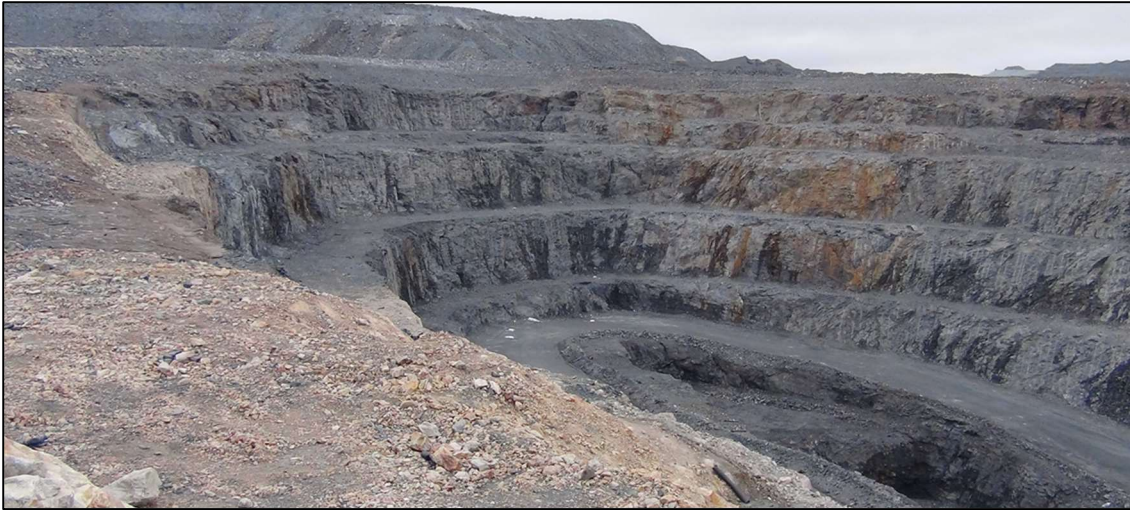
The north through northeast walls of Pit A continue to perform adequately. Very little accumulation of loose or raveling material on the catch benches was noted during the site visit.

Photograph 4-8: Pit A north to northeast wall

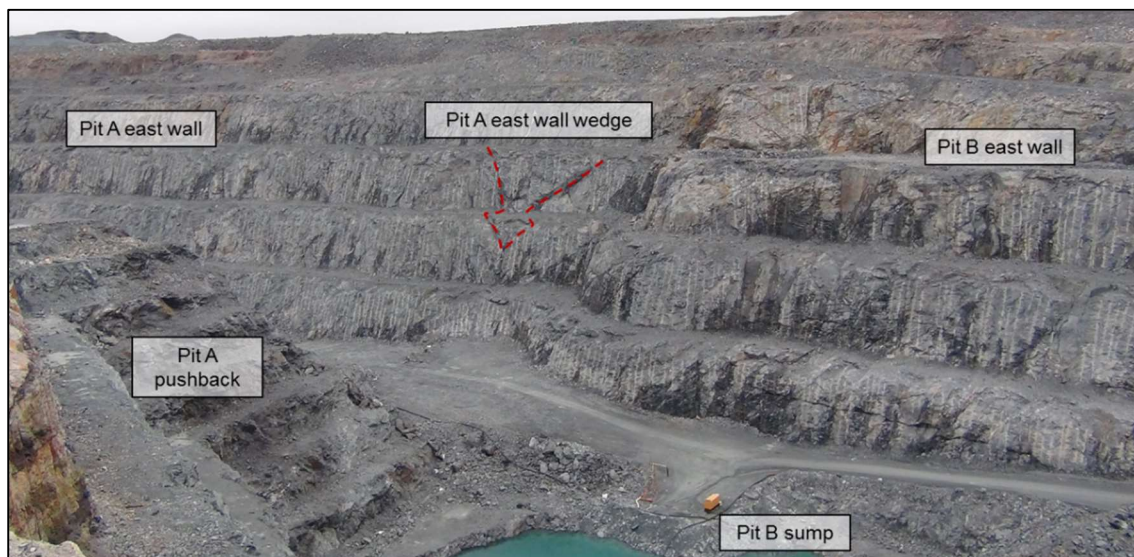
During the 2014 site visit a large wedge was identified on the east wall of Pit A, shown in the following Photograph 4-10.

Photograph 4-10: Pit A east wall wedge

Recommendations made following the 2014 site visit included completing a Lidar scan of the wedge followed by a kinematic assessment of the potential for sliding of the wedge. AEM have completed this analysis, and the results are presented in the figure below.

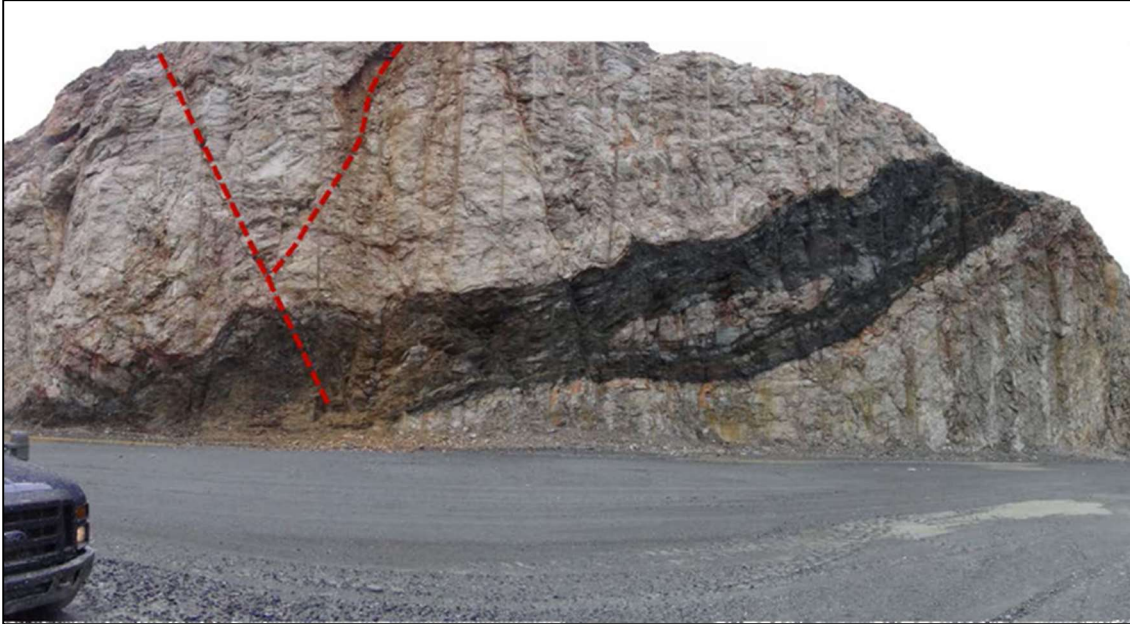
During the 2014 inspection a wedge immediately above the west ramp access to the pit was identified, and is shown in Photograph 4-12, and in Photograph 4-13 below from the 2014 inspection.

Photograph 4-13: Pit B west ramp wedge (Reference: Golder 2014)

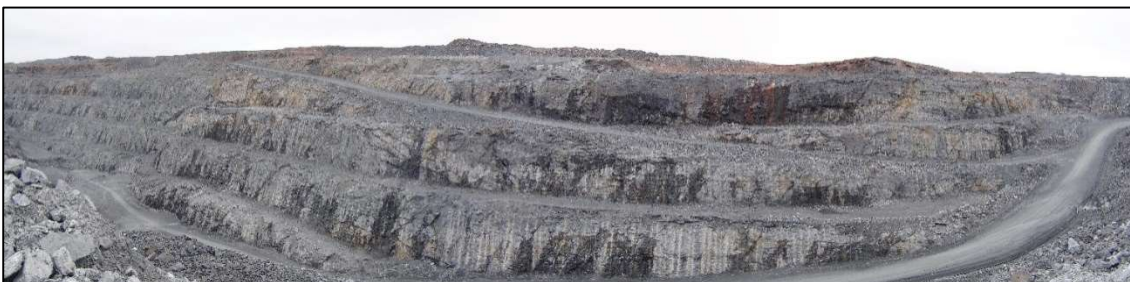
The east wall of Pit B was inspected from several viewpoints as well as from within the pit. The wall continues to perform satisfactorily. Benches are generally clean with little accumulation of material.

Photograph 4-14: Pit B east wall performance

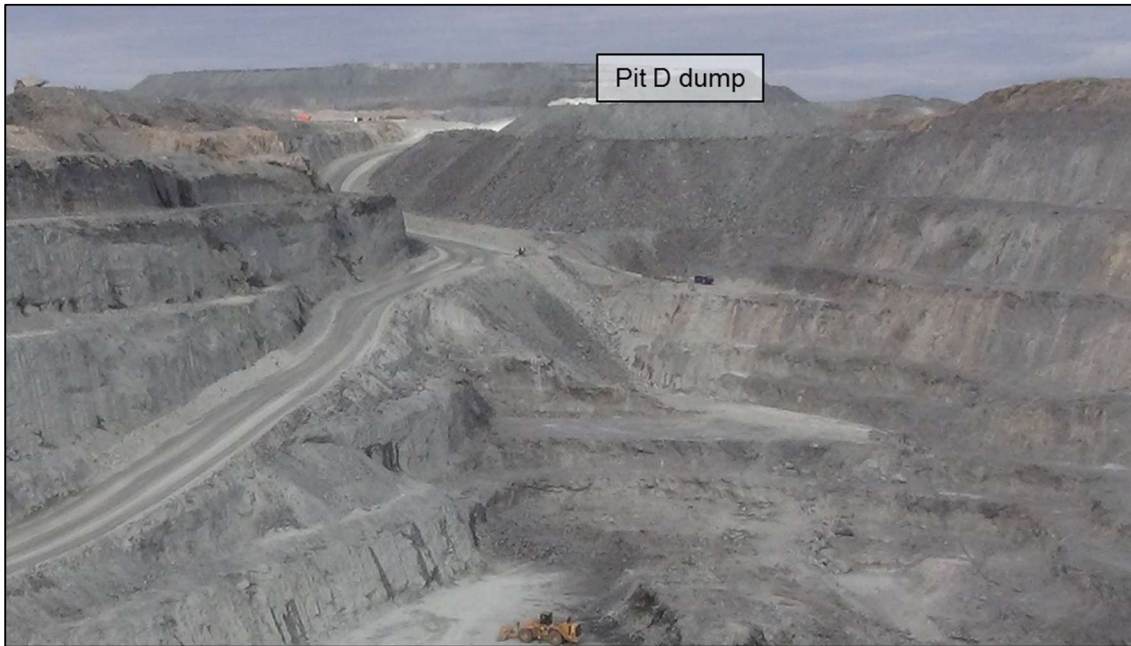
The west and east pit walls of Pit C are buttressed by waste rock and no longer present any significant geotechnical hazard. The main dump platform for Pit C is used for storing stockpiles of stemming material. The Pit C dump is performing adequately. There were no tension cracks observed in the crest area, and no bulging of the face or toe areas was noted at the time of the inspection.

Photograph 5-2: Pit D waste rock dump, looking north from Pit E3

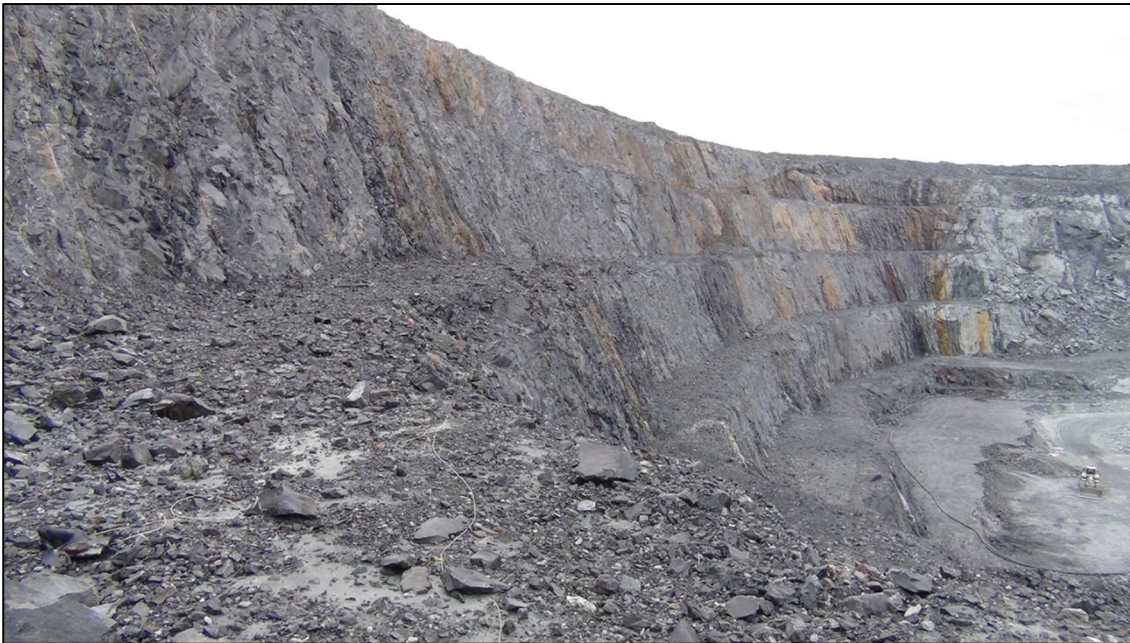
The Pit E3 east wall is excavated in good quality intermediate volcanic. The main structural control for the east wall is a steeply west dipping foliation plane. Bench face angles have been excavated generally parallel to this dominant structure, and the bench and overall wall performance continues to be satisfactory. Final benches have been cleaned and scaled appropriately. Occasional bench-scale rock falls have occurred in association with local undercutting of wedge and plane geometries; however the material from these local failures has been retained on the catchment benches.

Figure 6-1: East wall showing good bench and wall performance

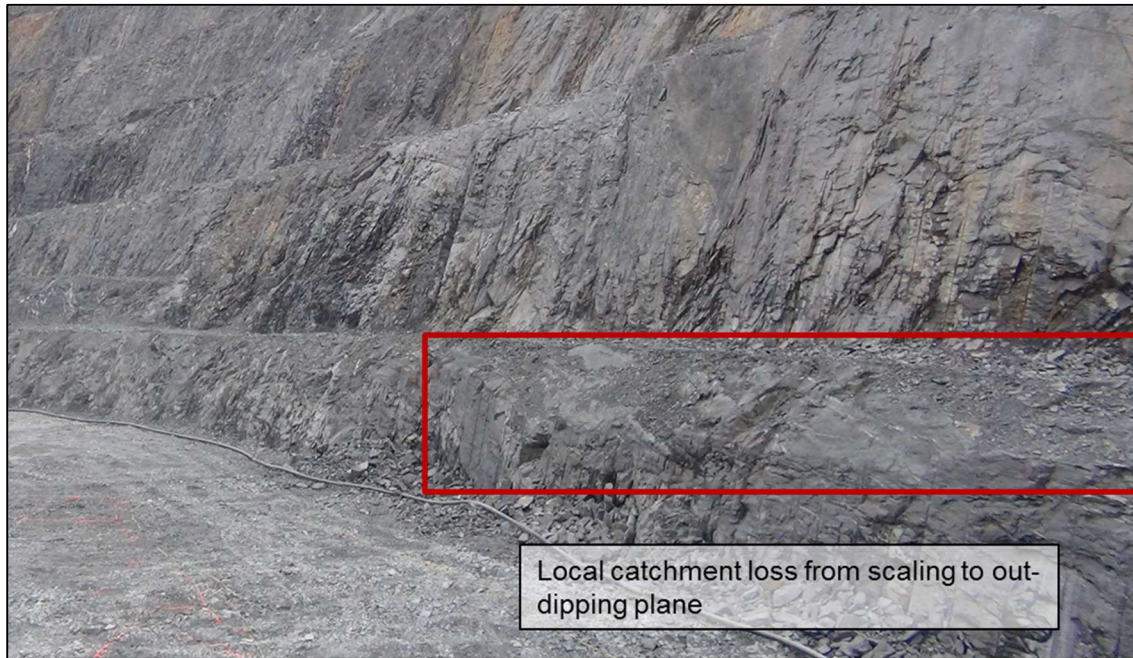
Local areas of out-dipping planes have been encountered in the lower benches, and where identified have been scaled back resulting in some crest loss and associated loss of catchment. However, this action is appropriate locally as it results in a more stable bench face by removing the risk of adverse structure failing at a later time.

Figure 6-2: Example of catchment loss from scaling to out-dipping plane

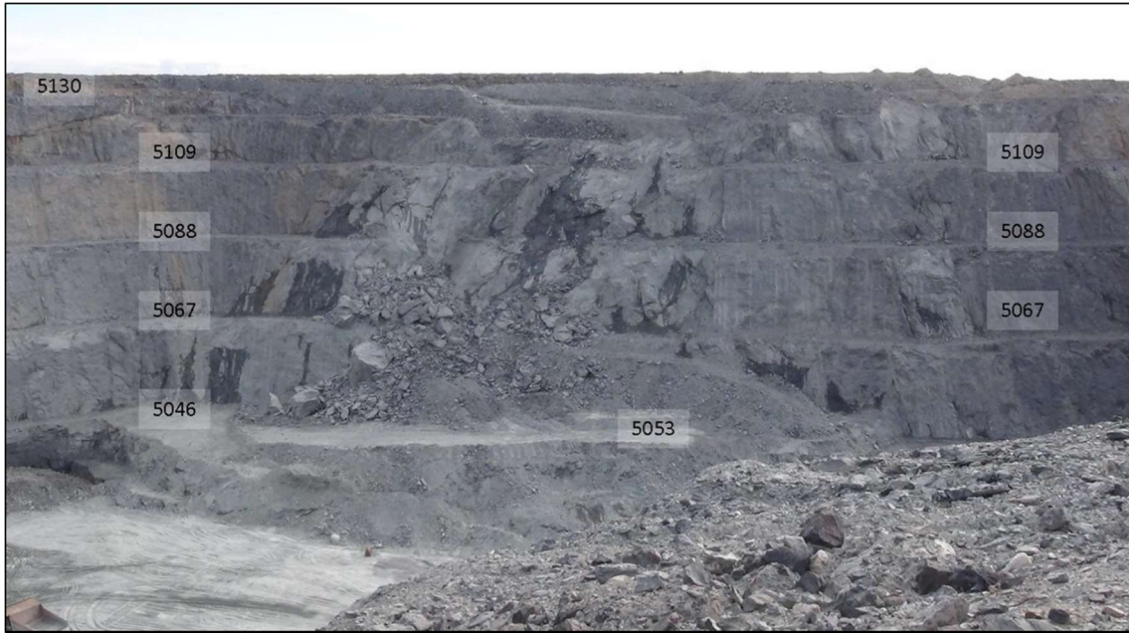
The Pit E3 south wall has experienced significant instability, and AEM are currently developing a plan to mitigate the instability and manage risk. The area has been designated no entry until remedial measures are undertaken to stabilize and monitor the wall, including slope depressurization, crest unloading, and installation of additional slope monitoring installation. The mechanism of failure is well understood, and the contributing factors are the complex geology and structure, the absence of permafrost and the presence of groundwater. The engineering geology model and stability analyses indicate the failure behind the crest will be limited to the depth of the ultramafic rock and will not extend back to the dewatering dike. AEM are in the process of designing a program to stabilize the slope, and to install additional instrumentation such as piezometers, TDR cables, and thermistors. Monitoring of the slope using the GroundProbe radar is currently the most effective method for managing risk. Monitoring should continue with diligence, and vigilance.

Photograph 6-1: Pit E3 south wall

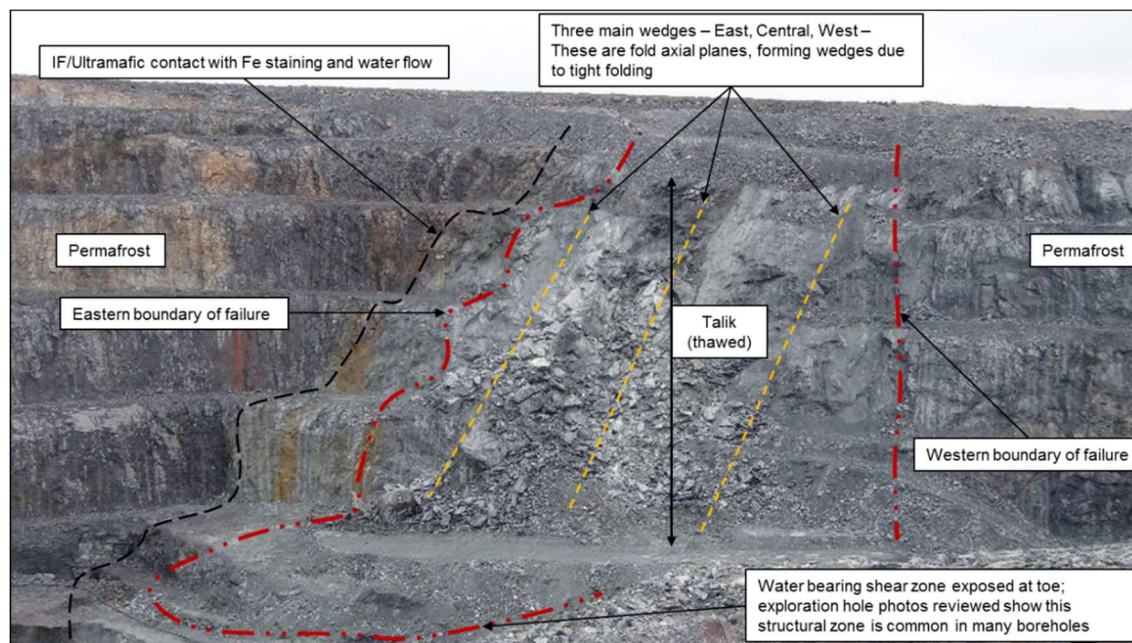
Photograph 6-2: Pit E3 south wall controls governing instability

The orientation of the main stratigraphic boundaries, and the layer-parallel foliation developed as part of the major fold events, are the primary controls on bench-scale and overall slope stability, and so an understanding of the fold patterns relative to the south wall is of primary importance in assessing the slope stability. Previous studies (2007) identified that the foliation and stratigraphy at the south end of the Portage Pit is reoriented to an east-west direction, dipping to the north.

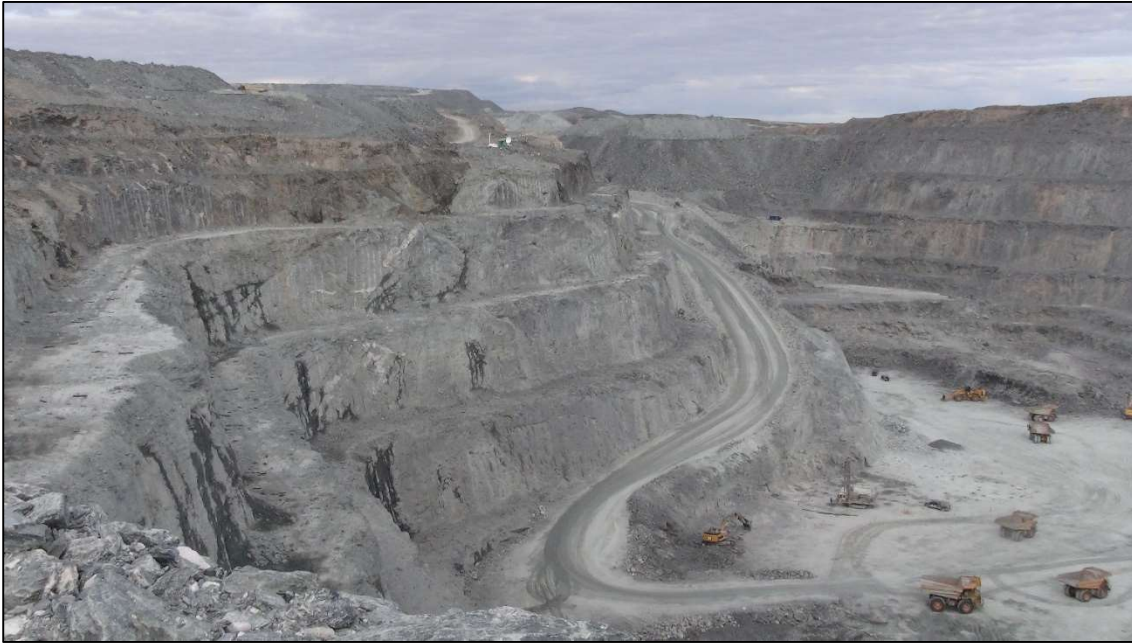
Currently the performance of the west wall benches is satisfactory, particularly in the upper benches excavated in the stronger rock types. The bench face angles are steep, with wide catch benches, and these are adequate for retaining small material that has failed.

Photograph 6-3: Pit E3 west wall upper benches

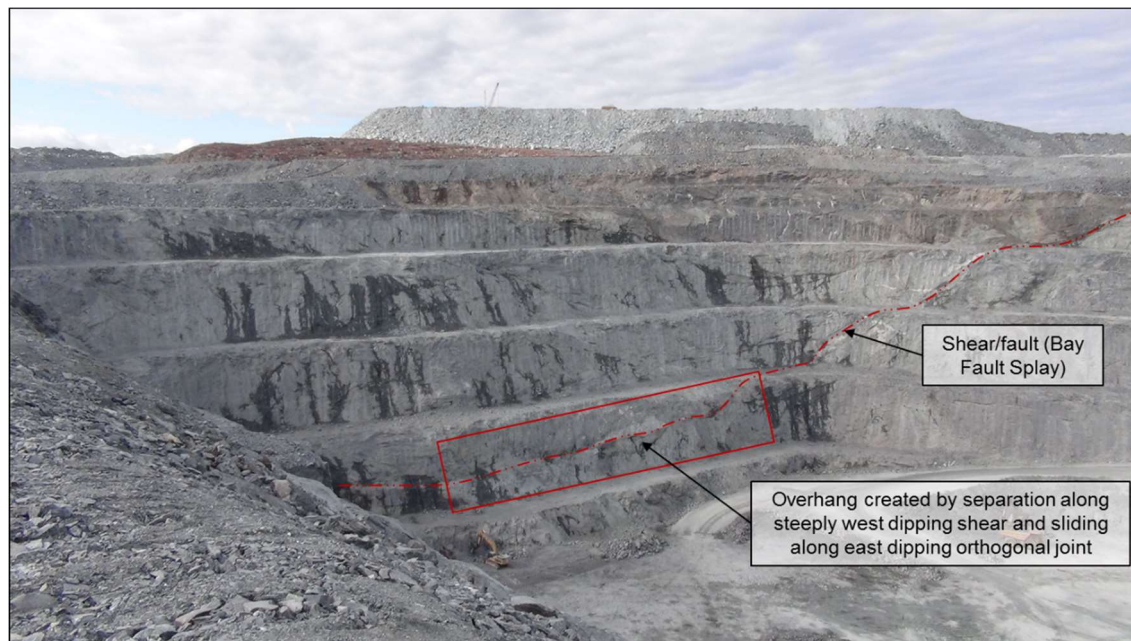
At the south end of the west wall, the contact of the ultramafic rock and overlying intermediate volcanic rock is inclined into the wall, which is beneficial for overall slope stability, but results in bench-scale instability of the underlying ultramafic rock. Local rock falls have occurred as the ultramafic rock separates from the overlying volcanic contact, followed by sliding along the steeply east dipping orthogonal joint set. This instability is exacerbated by the presence of shear zones within the ultramafic rock, which are inclined steeply into the west wall. The area of the overhang has been cleaned well, as has the bench beneath it. As this area of the pit continues to be mined down, continuing raveling of ultramafic rock can be expected. However, this material is expected to collect on the catch benches.

Photograph 6-4: Pit E3 west wall lower benches

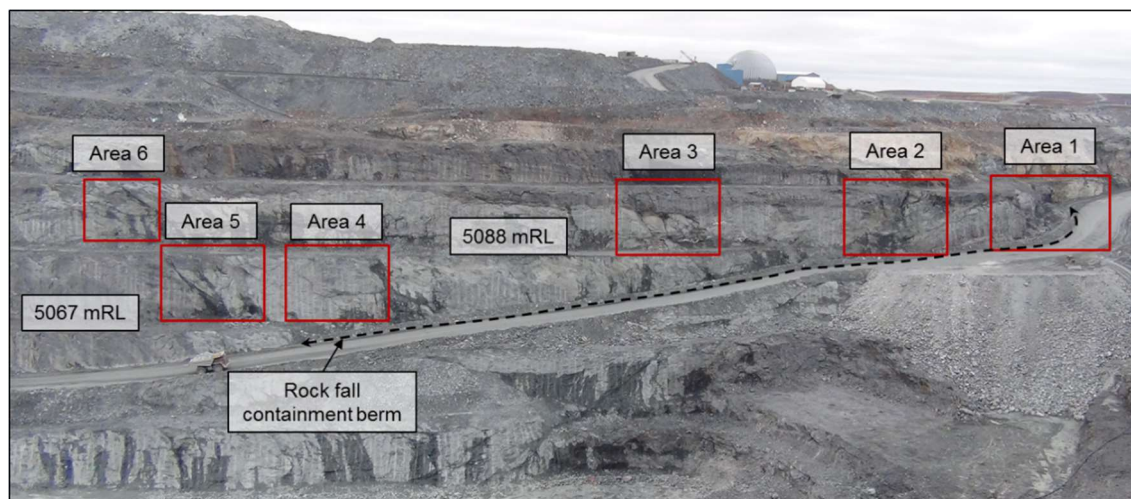
The Pit E3 ramp is situated on the west wall of the pit, and descends to the south into the pit. Several areas of potential instability were noted in the benches of the ramp. These are shown in the following photograph.

Photograph 6-5: Pit E3 west wall ramp areas of potential instability

The Pit E3 ramp is situated on the west wall of the pit, and descends to the south into the pit. Several areas of potential instability were noted in the benches of the ramp. A rock fall containment berm along the west side of the ramp is being used to effectively manage the risk of rock falls from the areas of potential instability. The ultramafic rock below the ramp is strongly sheared, but is currently performing well. The rock fall containment berm should be maintained along the ramp. The ultramafic rock should continue to be scaled carefully, and operators instructed to avoid over-excavating which could lead to instability.

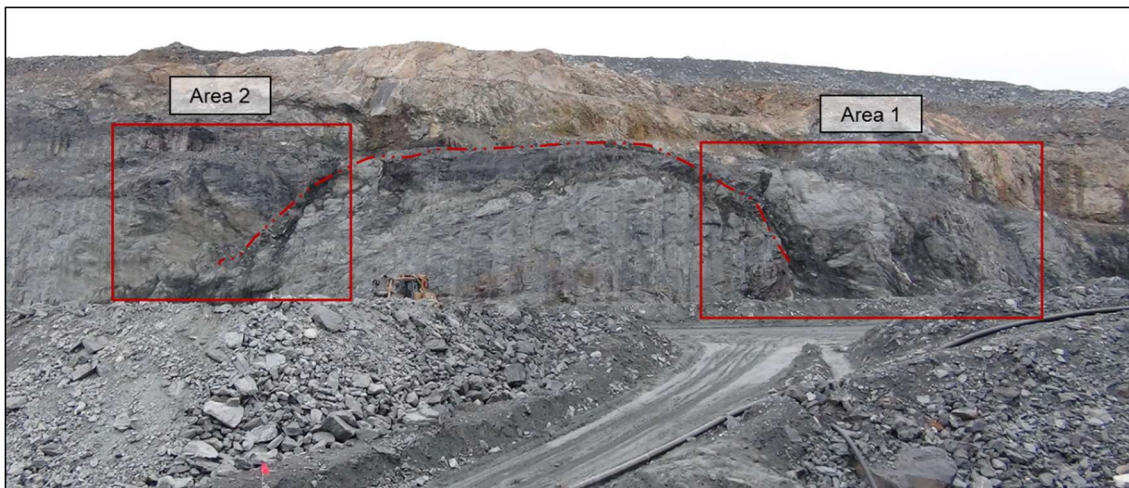
Photograph 6-7: Pit E3 Ramp Areas 1 and 2 - Bay Fault or splay

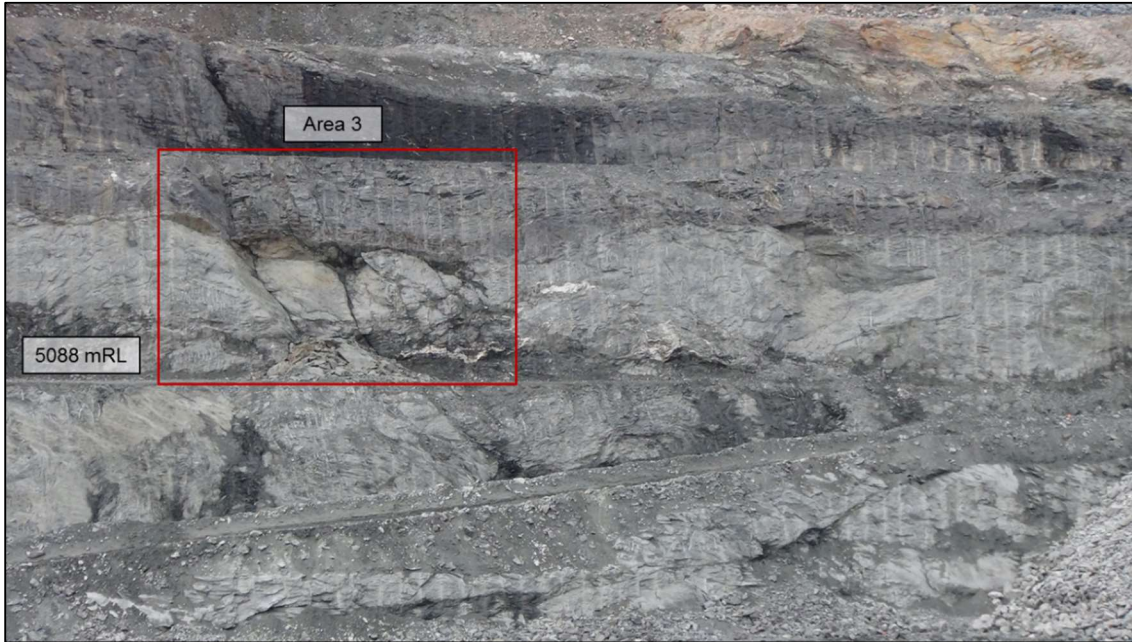
bench at the toe of the wedge, having raveled from the contact area. The combination of the 5088 mRL bench, and the containment berm on the ramp is adequately managing the potential for rock fall in this area.

Photograph 6-8: Pit E3 Ramp Area 3 wedge

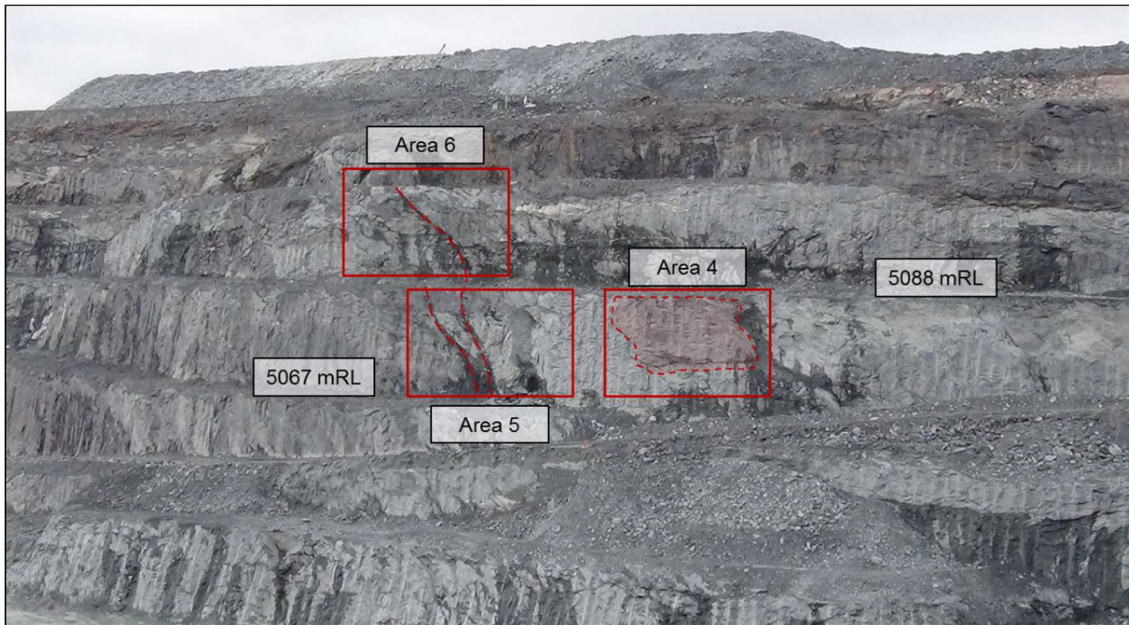
Area 6 is located above the 5088 mRL bench, and is a vertical extension of the closely spaced jointing of Area 5. These are steeply north dipping shear joints, which intersect the volcanic rock. The close spacing and continuous nature of these joints may result in increased raveling of material particularly during freshet and spring thaw. The 5088 and 5067 mRL benches should provide sufficient catchment for material that ravel from these areas.

Photograph 6-11: Pit E3 Ramp Area 6

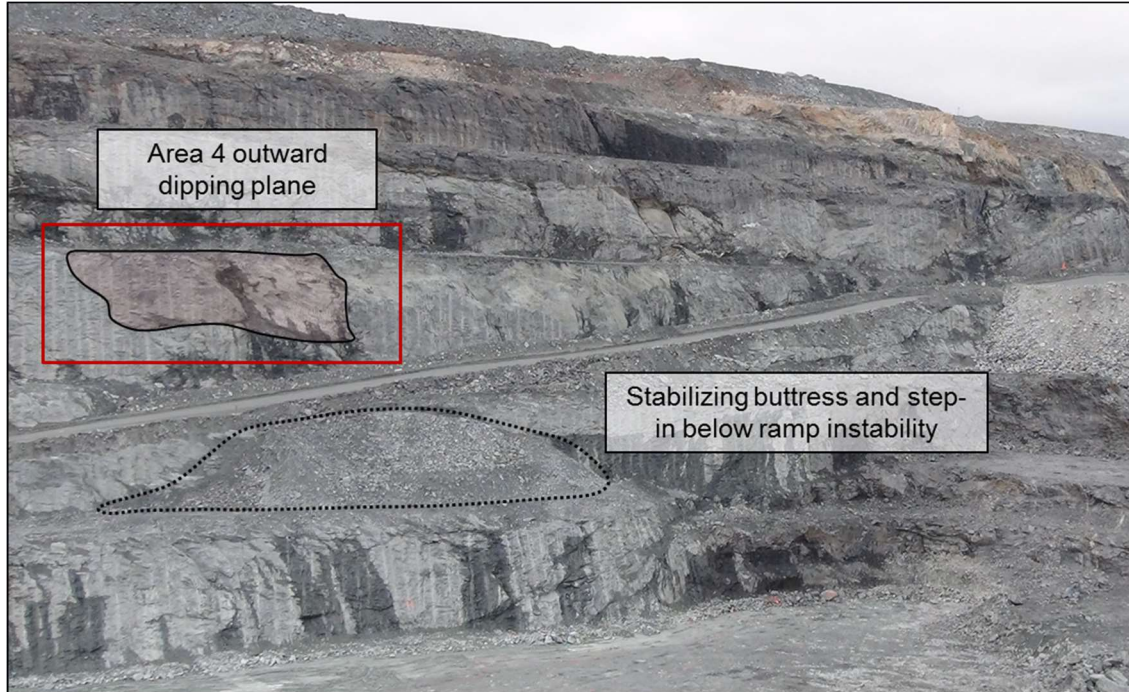
Sheared foliation is observed which dips into the wall at shallow angles, and it should be expected that this structure will create a top release surface for material to separate from and ravel as the pit is deepened. The ultramafic rock should be carefully scaled, and the operators instructed not to over-excavate in this material.

Photograph 6-13: Pit E3 west wall ramp buttress and step-in

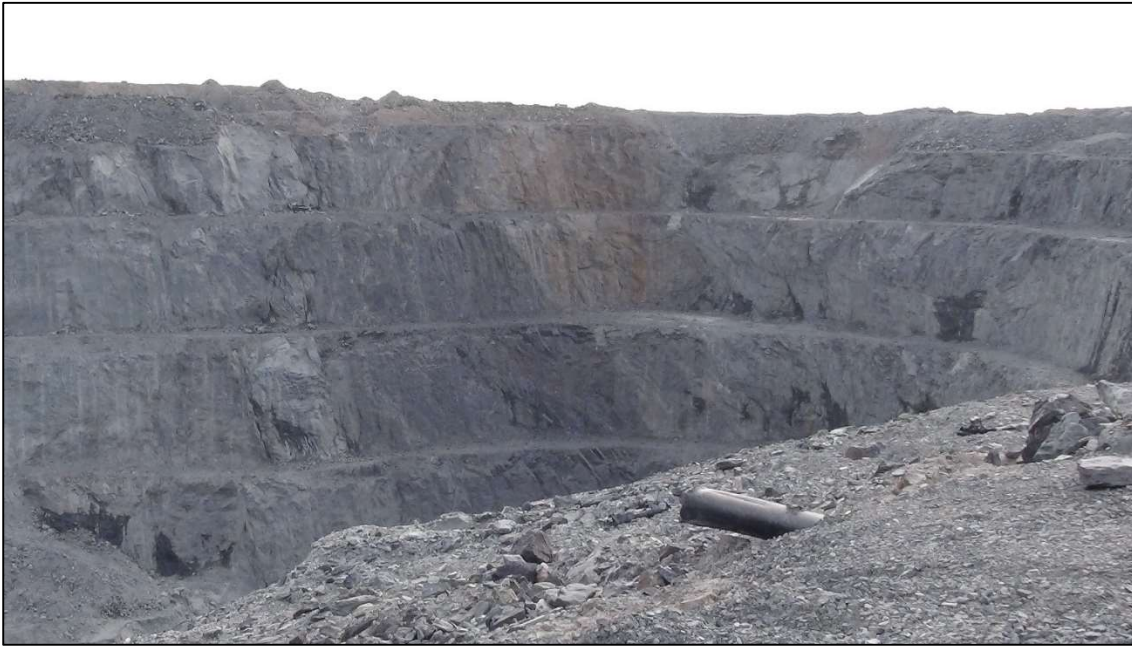
The topmost bench of the south wall of the slot reveals an adversely oriented, continuous planar structure dipping to the northeast at a moderate angle which was scaled out during mining. As the east wall of the pushback transitions into the Pit E3 south wall, continuous north dipping joint planes result in catchment loss where these have been undercut by bench face angles. This was noted during the 2014 inspection. These areas have been scaled during mining, and appear to be performing well despite the loss of catchment.

Photograph 6-14: Pit E3 south slot pushback looking south

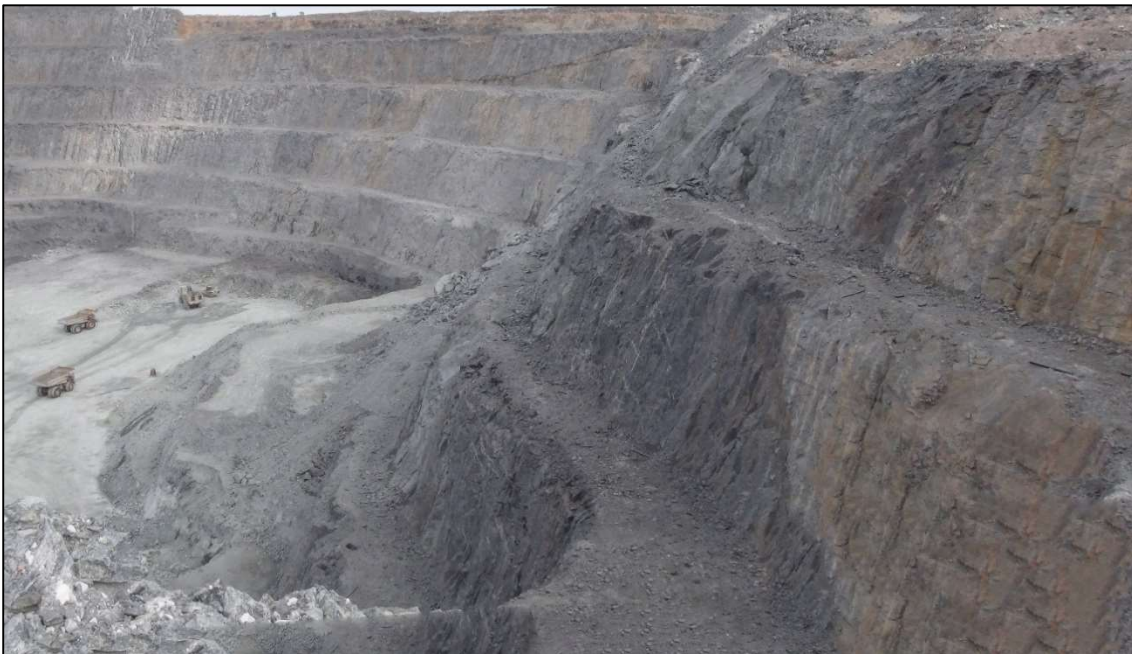
Photograph 6-15: Pit E3 pushback east wall showing local planar failure along continuous north dipping surfaces

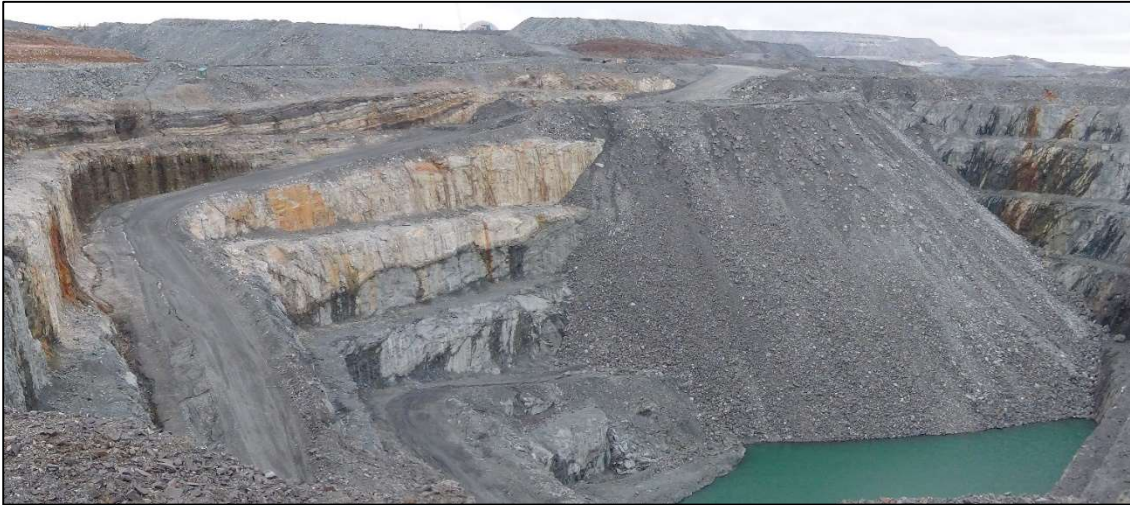
Much of the west wall of the pit is now covered by a waste rock dump which conceals or partially conceals many of the instabilities noted during the 2014 inspection, and now acts to buttress those instabilities. As such, there is no evidence of additional instability since the 2014 inspection.

Photograph 7-3: Goose Pit west wall performance

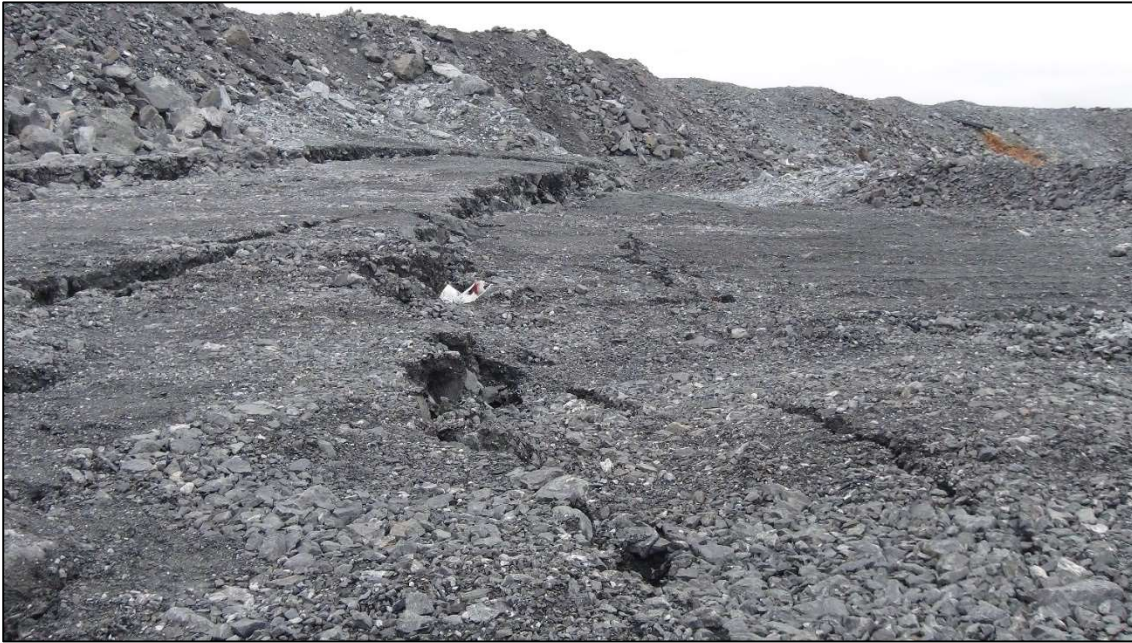
A series of large tension cracks were noted on the dump platform, between 10 m and 20 m back from the dump crest. The tension cracks are curvilinear and extend the full width of the dump platform. There is up to approximately 30 cm of vertical displacement across the cracks and lateral separation, or opening.

Photograph 7-6: Goose Pit dump tension cracks

Mining has been completed at Goose pit to a final floor elevation of 4997 mRL. The Goose pit slopes continue to perform adequately. Waste rock has been end-dumped into the northwest corner of the pit near the access ramp entry, using the pit as a short-haul dump. A pit lake has formed, and is at an elevation of 5031.18 mRL (15 October 2015). During the inspection a series of tension cracks were identified on the waste rock dump platform. This area is now classified as no entry, and a rock fill berm has been placed to prevent access. The dump may be reactivated in the future. Prior to reactivation an inspection of the dump should be carried out, and an appropriate action plan developed.

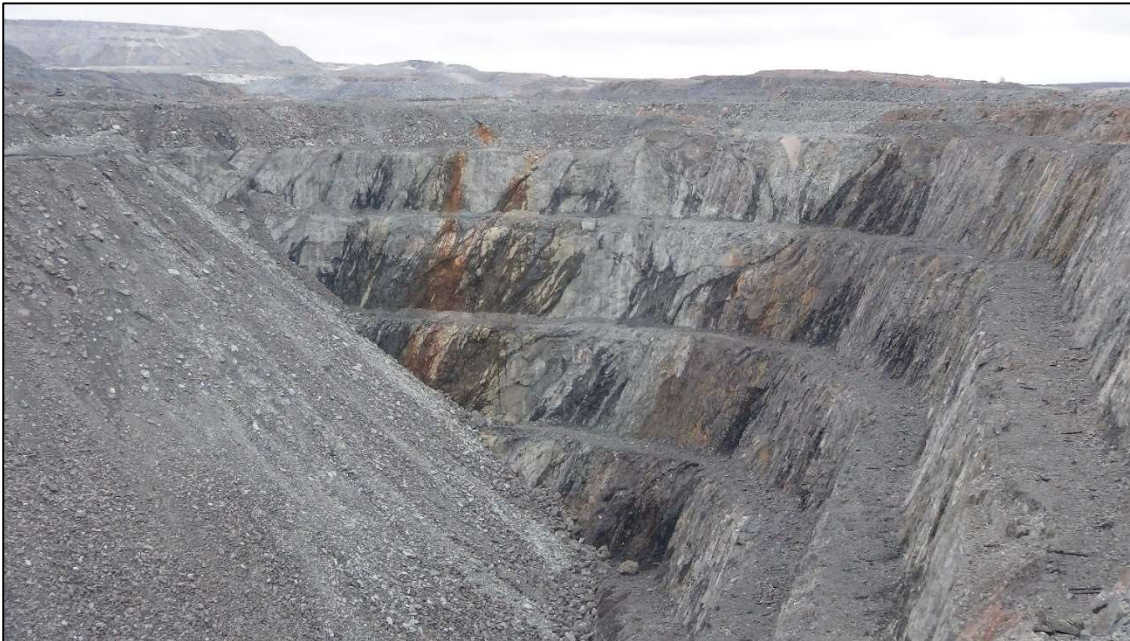
The following photograph illustrates the geology and seepage daylighting in the north end-wall face.

Photograph 7-7: Goose Pit north end wall

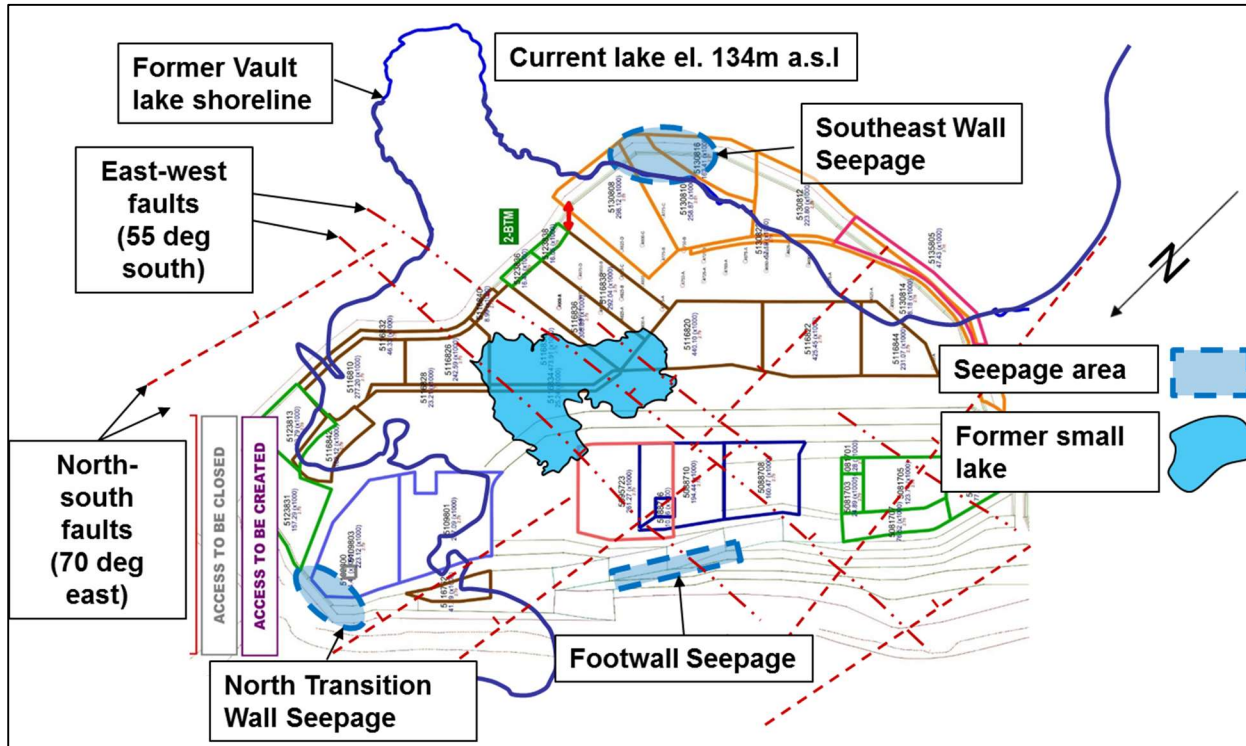
An inflow along the east wall was in response to the wall pushback into a talik beneath the former Vault Lake, and to the lake area being managed with a relatively high water surface at 5134.1 mRL. As noted in the 2014 inspection report, any push back of the east-southeast high wall should include a re-evaluation of the slope stability as the optimized design (2013) assumed the wall would remain frozen (with the exception of the upper bench). A push-back of the east high wall will place it in the unfrozen talik beneath Vault Lake, and may change the conditions for the stability of the slope.

Water inflows and seepage were noted in a number of areas of the pit. The locations are shown on the figure below. These are generally related to the dewatering of Vault Lake, and to the current lake level. These are discussed in relevant sections below.

Figure 8-3: Vault Pit seepage and pit inflows

- Lower the water level in Vault Lake to reduce inflows through the ring road.
- If settlement of the ring road is noted, use road rock fill material to bring back to grade. Monitor for the development of tension cracks within the road surface. Restrict access on the downstream side of the ring road in the immediate area of the seepage.

- If significant inflows continue to be observed during 2016 summer thaw period, install piezometers and thermistor behind the wall, record observed conditions, and compare with predicted conditions.

- If observed conditions are not consistent with the predicted conditions it may be necessary to review the optimized slope stability in the context of new data.

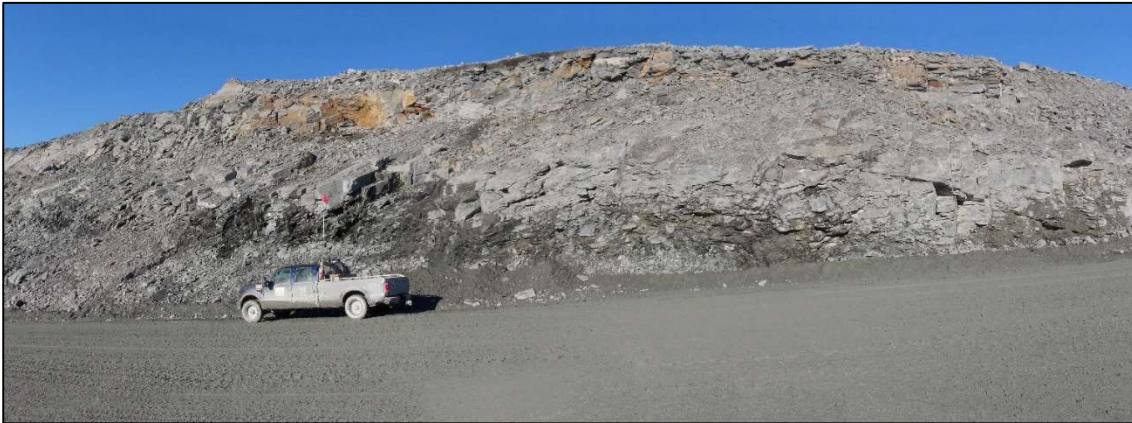
An area of seepage adjacent to the ramp may be derived from a hydraulic connection to east-west and north-south structures connecting with the talik beneath the dewatered Vault Lake. If increased raveling is noted, it may be necessary to construct bumper berms in this area

Photograph 8-4: Vault Pit grid west wall seepage

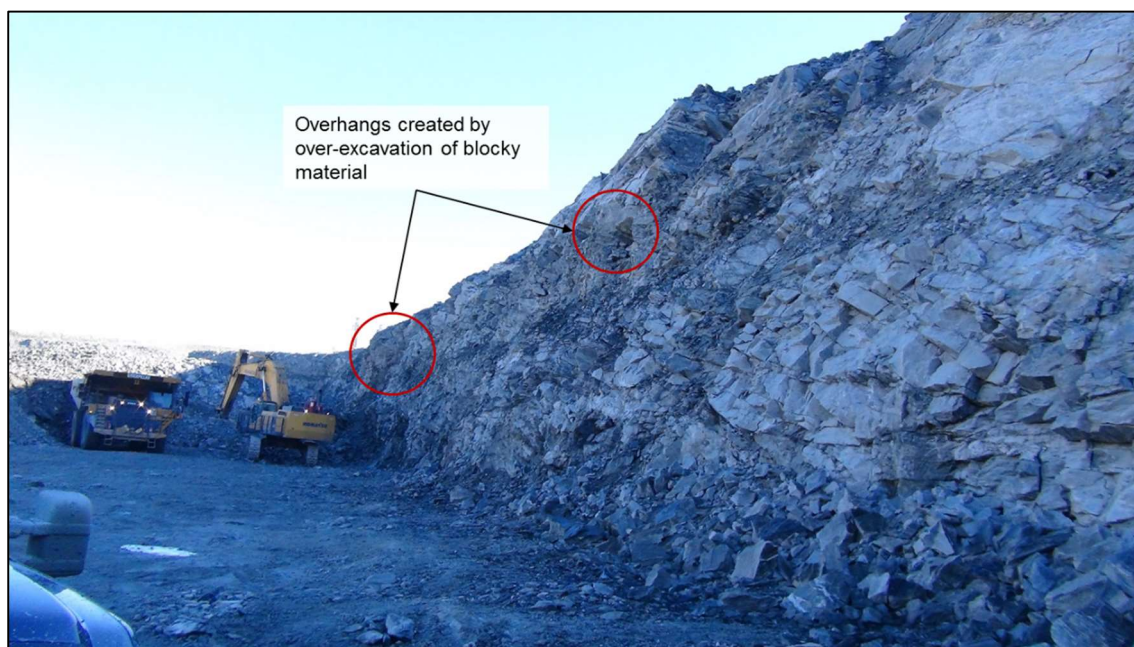
Photograph 8-10: Vault Pit Phase 1 east wall overhangs

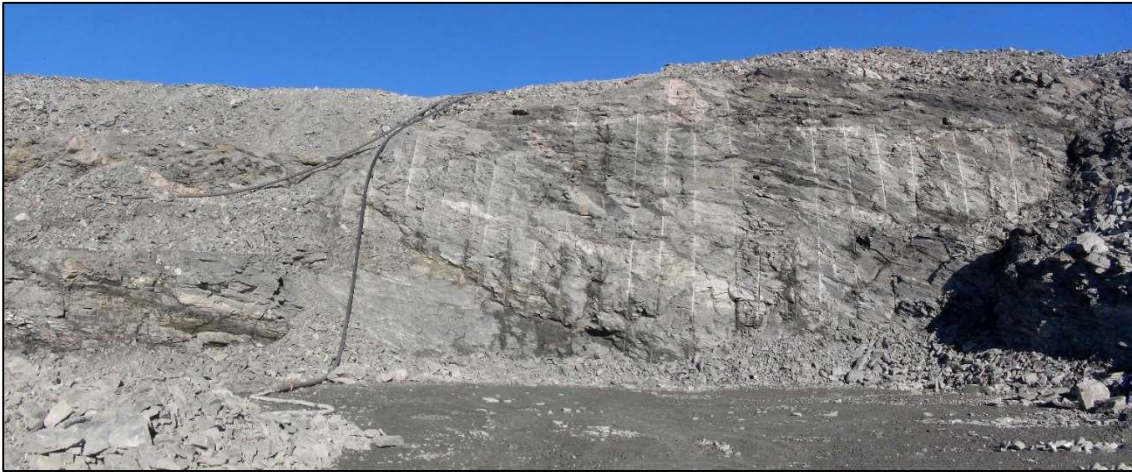
Photograph 8-16: Vault Pit north transition wall seepage near sump

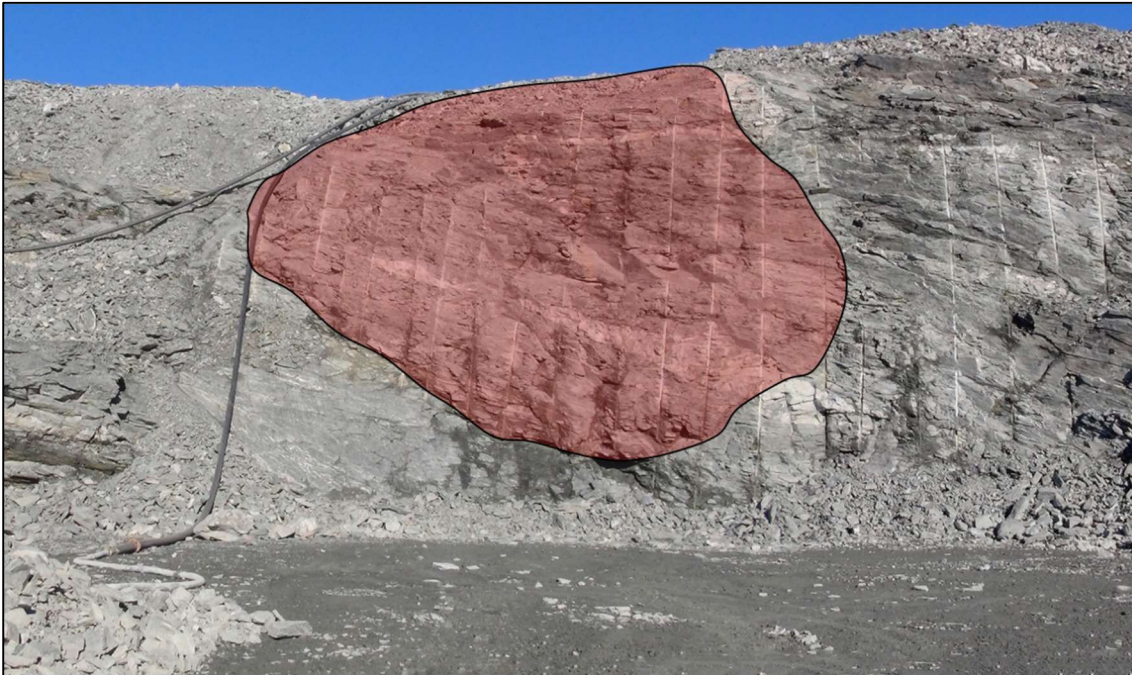
The Vault north wall (grid north) transitions from the west wall to the east wall. There is a sump near the base of the wall at the northwest corner. A wedge in the northwest corner is associated with seepage along its base. If the wedge were to fail, it could compromise the haul road at the crest. A stability assessment should be made, and bolting of the wedge should be considered. Light vehicle traffic and personnel should maintain a safe setback distance from the temporary bench faces. The water lines crossing the wedge should be moved. Continue visual monitoring as part of regular site geotechnical inspections.

Photograph 8-18: Vault Pit north transition wall wedge
