Meadowbank Dike Review Board Reports

MDRB REPORT MEETING NO.17

Report No 17
Meadowbank Mine Dike Review Board
Meeting July 27-30, 2015

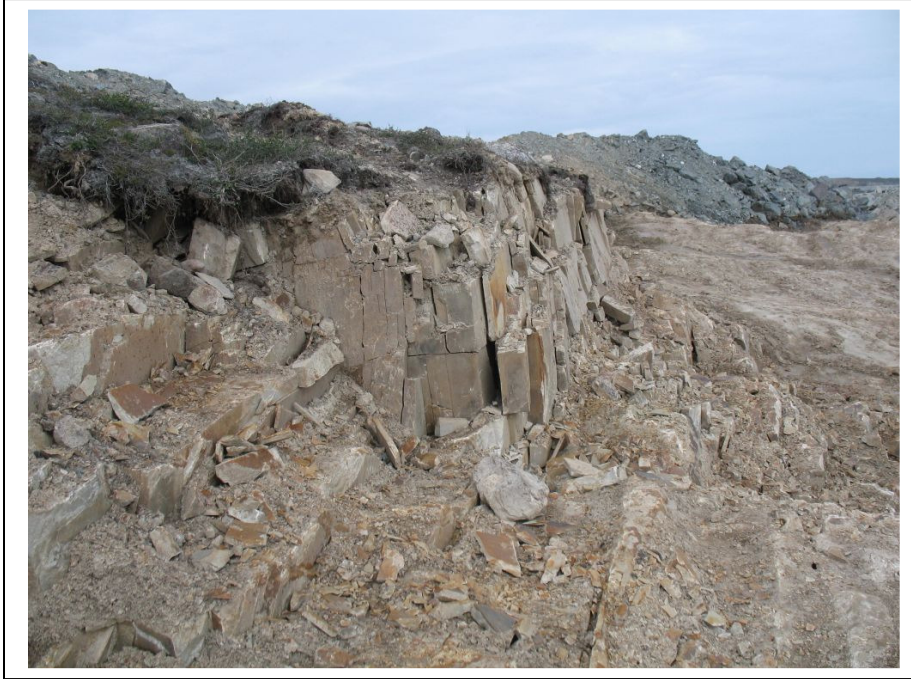
Photo #1 Saddle Dam 3, fractured rock of right abutment

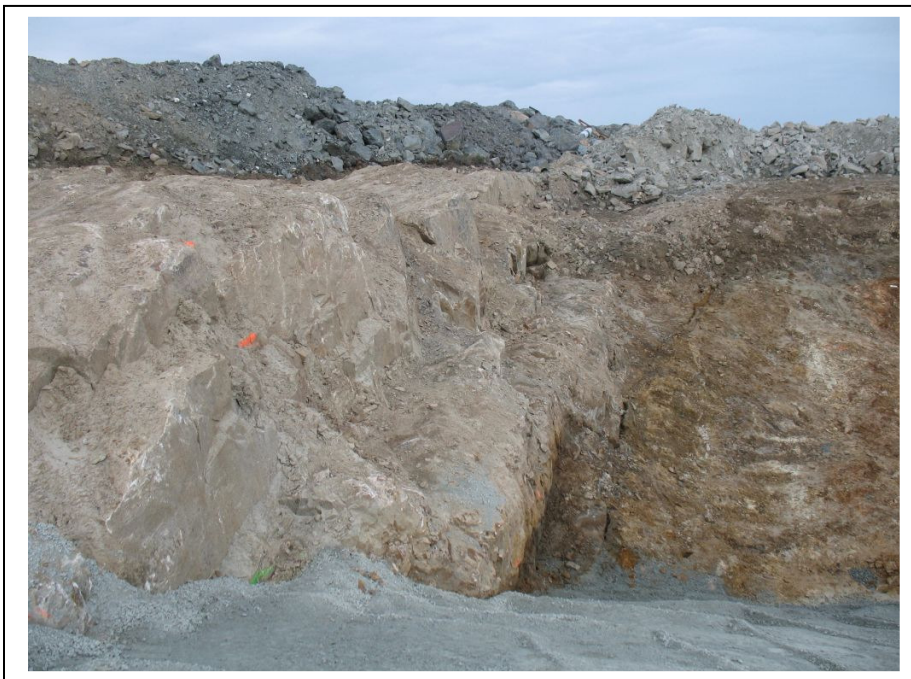
Photo #2 SD3, steep rock face adjacent to fault zone

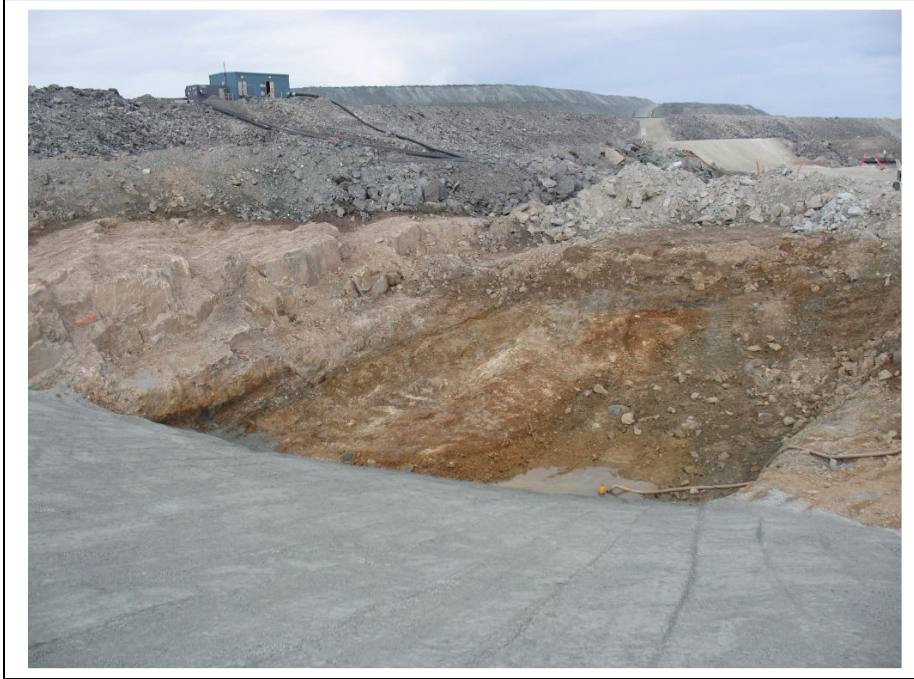
Photo #3 SD3, fault zone

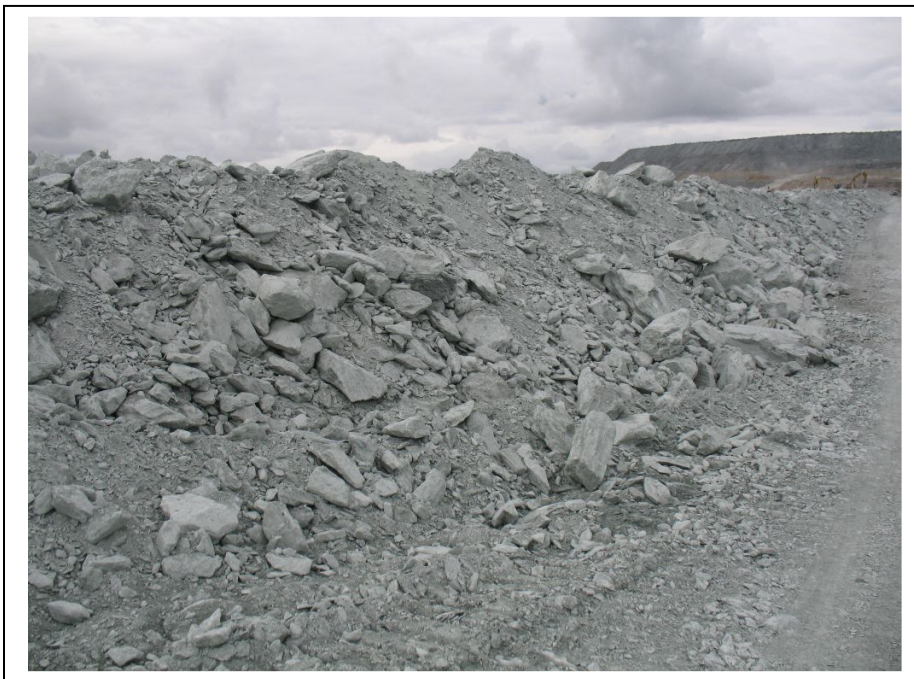
The Board made note of the behaviour of the Non Potentially Acid Generating (NPAG) soapstone rockfill being placed in the Central Dike embankment (Photo #4). While the interest in using this material is understood due to the overall shortage of NPAG material there are limitations as to what can be done with the ultramafic soapstone. A high degree of crushing and/or grinding when exposed to vehicular traffic is evident. The GAL recommendation to place and compact the material in 1 m lifts rather than 2 m may not be appropriate, particularly if the

Photo #4 Central Dike, ultramafic soapstone rockfill

During the site visit, the Board observed that the use of soapstone in the embankment is currently limited to a zone of a few meters width on the upstream side, confined by the crushed stone bedding layers of the liner on one side and by more durable rockfill on the other. The sections used in the stability analyses presented in the memorandum indicate that substantial portions of the embankment of central dike may be constructed of the soapstone which would be exposed on the downstream face.

number of passes of the vibrating roller are not reduced. Placing in a 2 m lift, but with adequate watering and moderate compaction should be evaluated. The Board recommends the excavation of test pits, to a depth of at least 2 m, to verify the fabric and density of the compacted rockfill. At the current embankment elevation, the NPAG rockfill is confined on the upstream side by the bedding/transition zones for the liner (Photo #5) and on the downstream side by PAG rockfill. However, GAL has submitted the results of a study on the expanded use of soapstone in the upper part of the Central Dike embankment and it may be exposed on the outer face. The Board has reservations about this use given the paucity of information regarding material behaviour, physical characteristics and the lack of precedent. The Board provided additional commentary on the use of soapstone by way of a memo transmitted to AEM on August 4th, a copy of which is included in Appendix E.

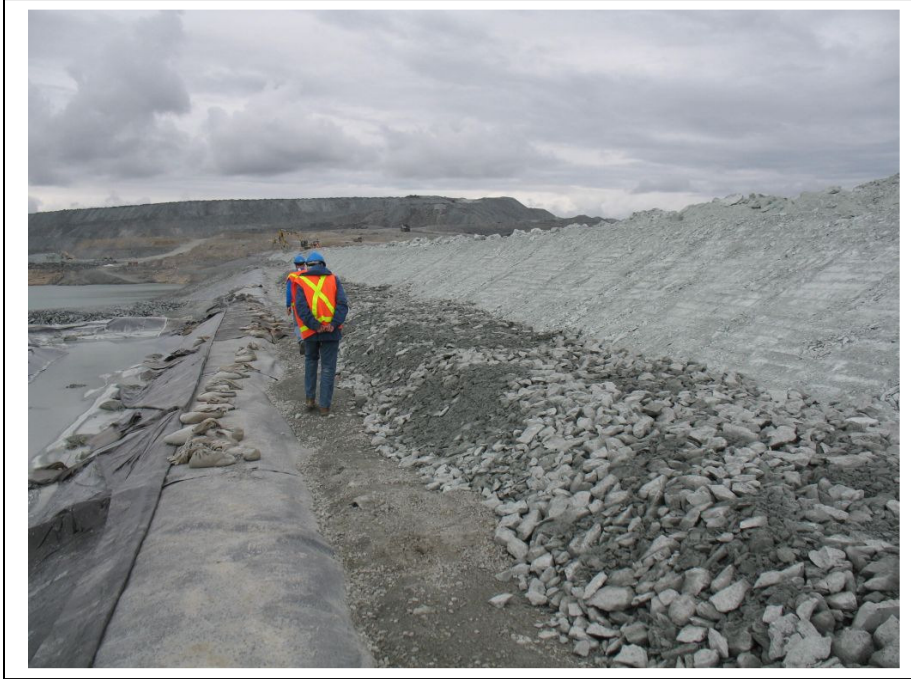
Photo #5 Central Dike, bedding and transition zones that confine the soapstone fill

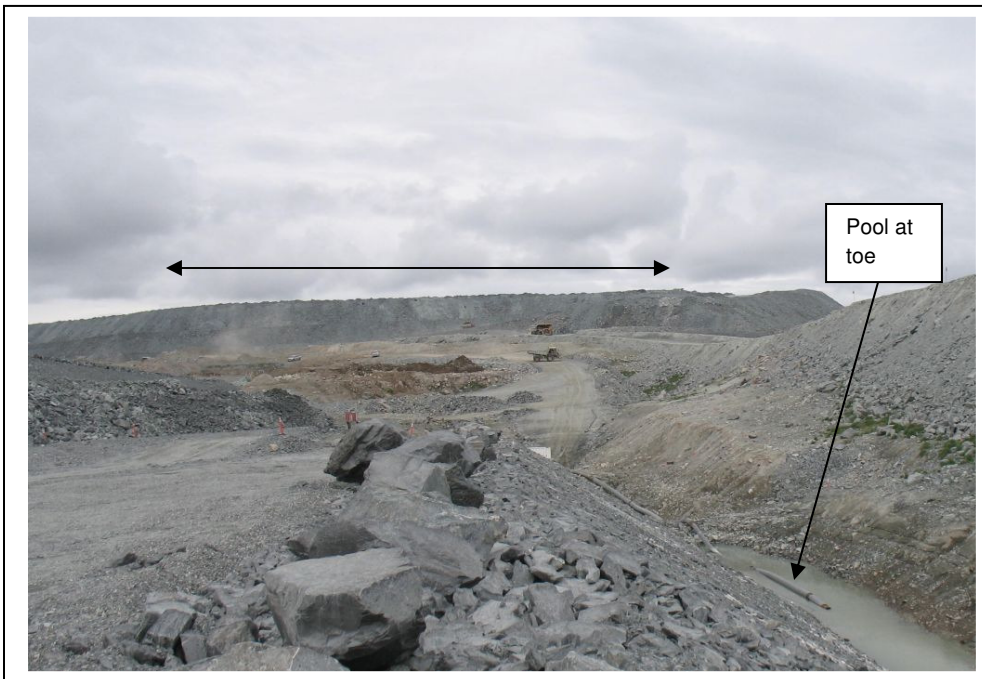
- Water ponding downstream of Central Dike was observed in October 2014. At the time the water level in the South Cell was at elevation 108.5 m.
- Tailings deposition started on November 20th, 2014.
- Leakage increased substantially and proportionately with tailings deposition.
- The downstream water level rose during the winter until pumping was initiated on April 14th, 2015. At that time, the South cell was at el. 115.8 m and the downstream pond at el. 115.5 m
- The capacity of the installation was increased and put into service on May 24th, 2015.
- Substantial quantities of water are being captured and transferred back into the South cell.
- There is a general consensus that the leakage contains tailings water though the accumulated volume is likely predominantly a result of the freshet as the catchment extends onto the abutments (Photos #6 and #7).

Photo #6 Central Dike, downstream toe, north catchment area extending to rock dump

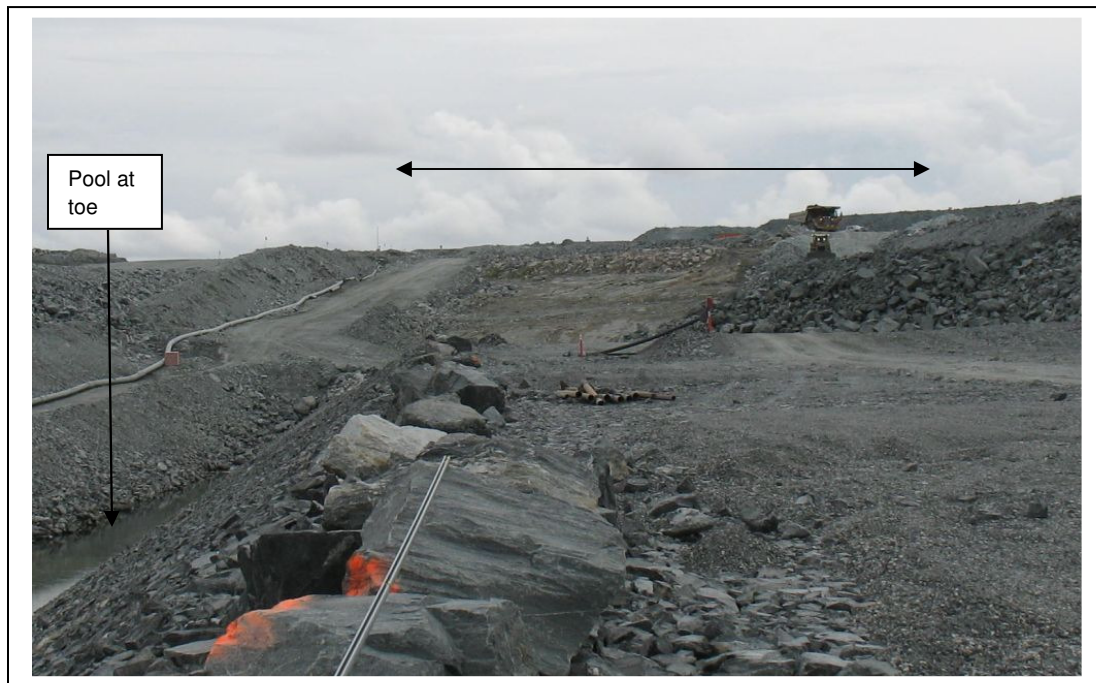
Photo #7 Central Dike, downstream toe, south catchment area extending to haul roads

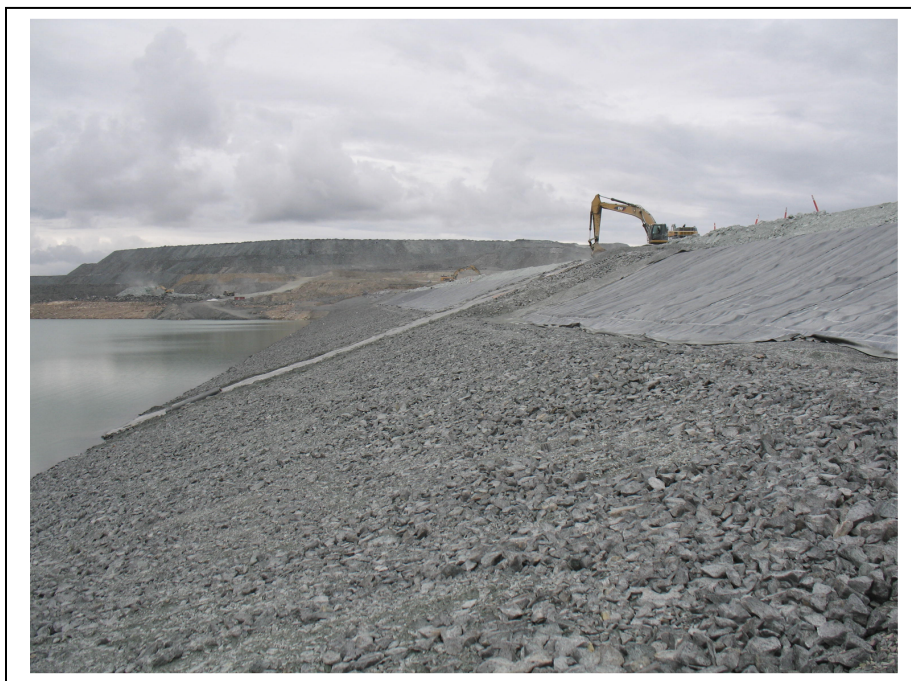
- Failure of the till liner over the cofferdam;
- Seepage delivered through the crushed stone protective layer (Photo #8) that was placed on the LLDPE liner (See MDRB report #16);
- Defects in the LLDPE liner;
- Communication through preferential pathways in the till and bedrock foundation (note that the model uses average conductivity and that no upper more pervious bedrock layer is included in the latest model).

Photo #8 Central Dike, rockfill protection layer on LLPDE liner
