Appendix F1

GN Spill Report

NT-NU SPILL REPORT

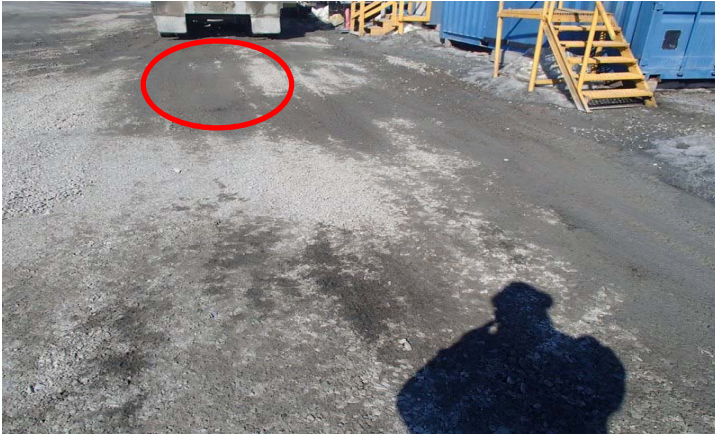
1. May 22nd – 16:30pm - Area after initial clean-up

The actions taken ensured that that the spilled material did not migrate from the immediate area and that the use of absorbent pads along with the excavation was effective in limiting the affected area to a small zone. Due to the spill at the Baker Lake Tank farm, approximately 1.0 m³ of contaminated soil have been brought on May 26th, 2015 to the Meadowbank site to be placed in the landfarm. The contaminated absorbent pads will be disposed in the Meadowbank incinerator.

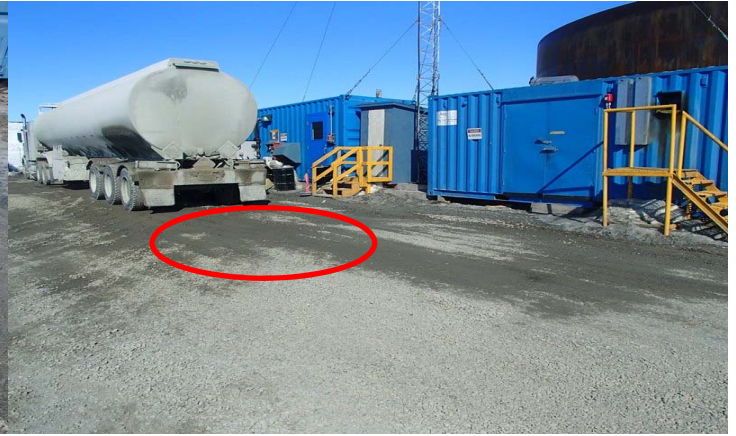
2. May 22nd – Area after initial clean-up

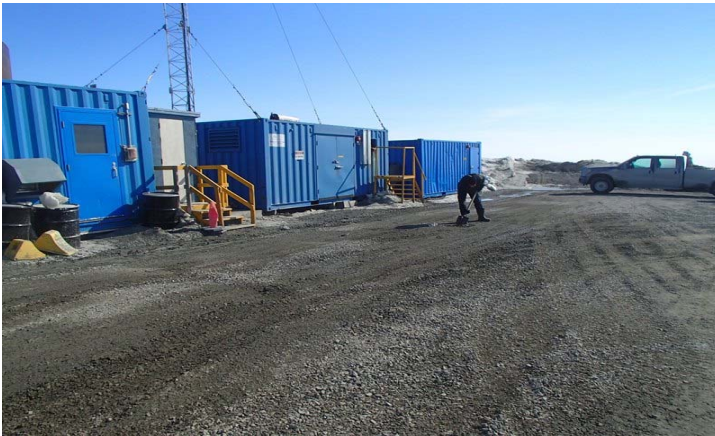
3. May 22nd – Soil Sampling

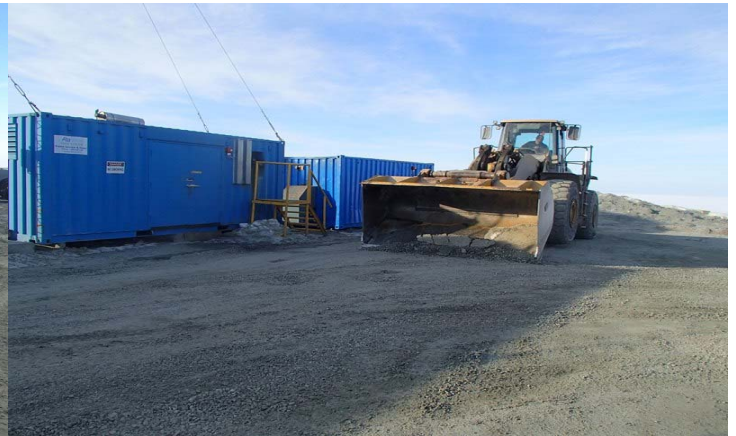
4. May 23rd – 0-20 mm granular material removal

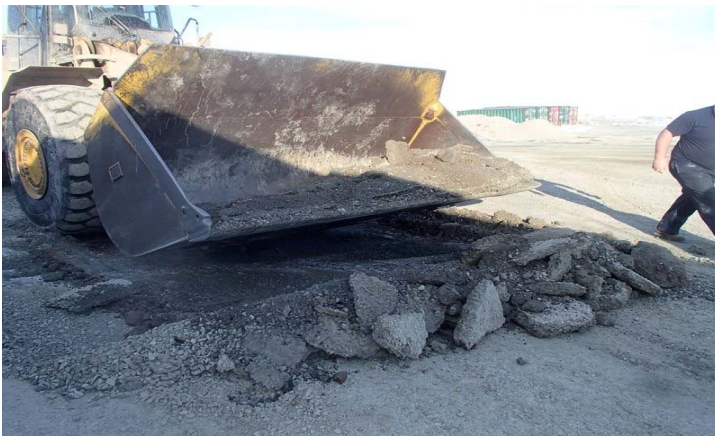
5. May 23rd – 0-20 mm granular material removal

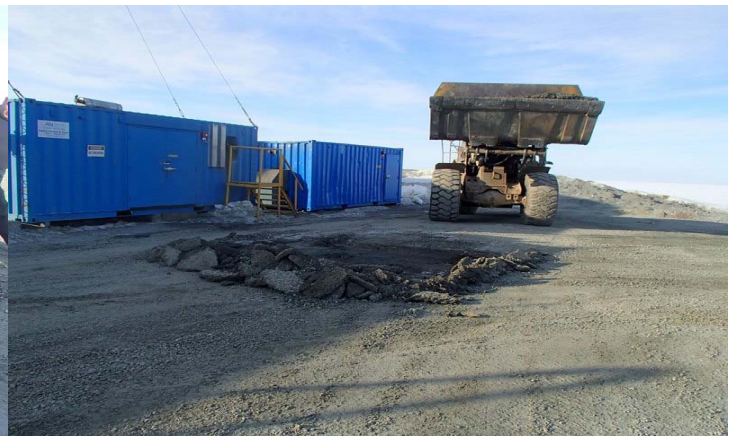
6. May 23rd – 0-20 mm granular material removal

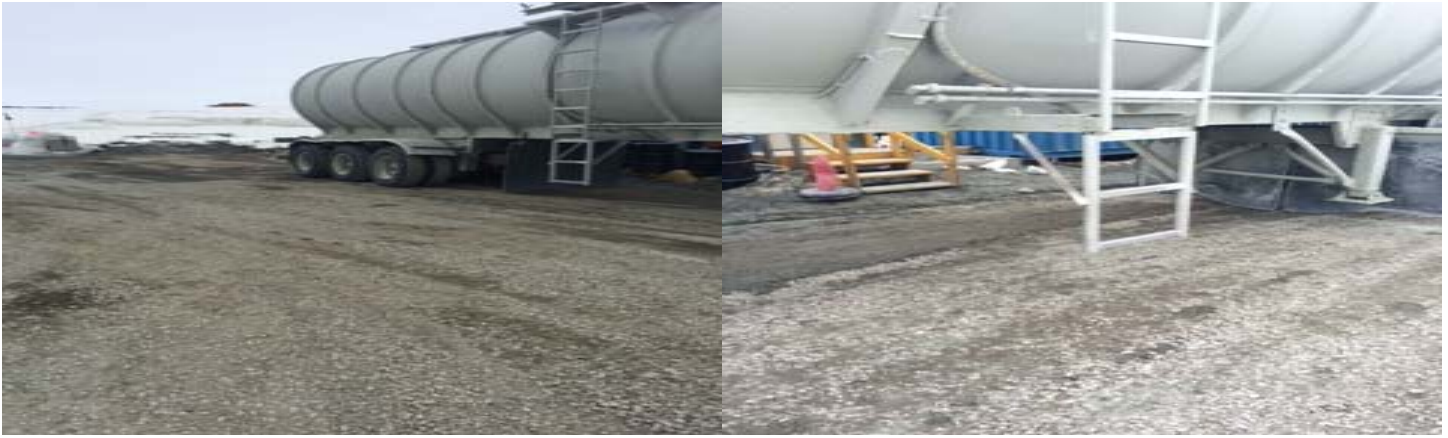
7. May 23rd – Area after new clean 0-20 mm granular material

8. May 23rd – Area after new clean 0-20 mm granular material

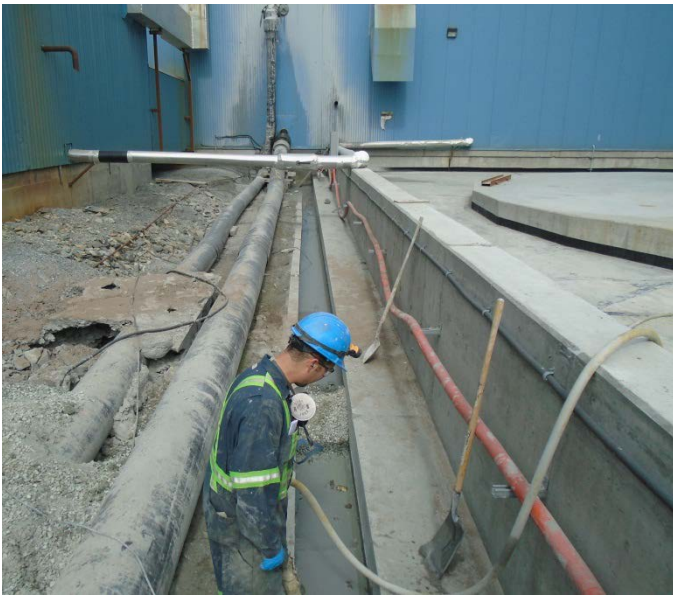
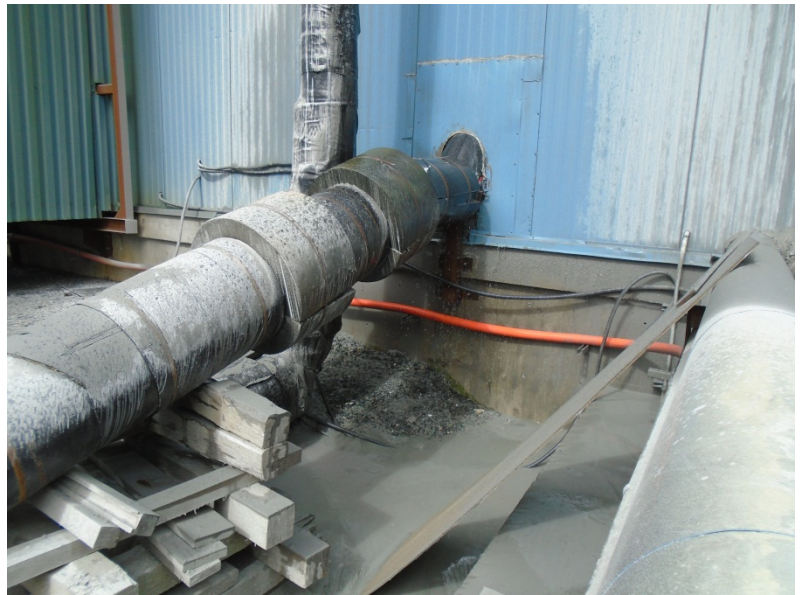
After investigation it was found that the weld of the plastic “Y” broke. No significant wear was noted on the piping outside the mill. Movement of the pipe attributed to the failing of the weld.

Clean up was immediately initiated by shovelling and pumping the slurry back into the leach pad containment. The “Y” that broke was replaced, and tailings deposition recommenced.

The Mill maintenance group has added a better support to the location in which the “Y” is located. In addition, as part of the preventative maintenance program, the “Y” will be inspected annually and changed if any irregularities are noted.

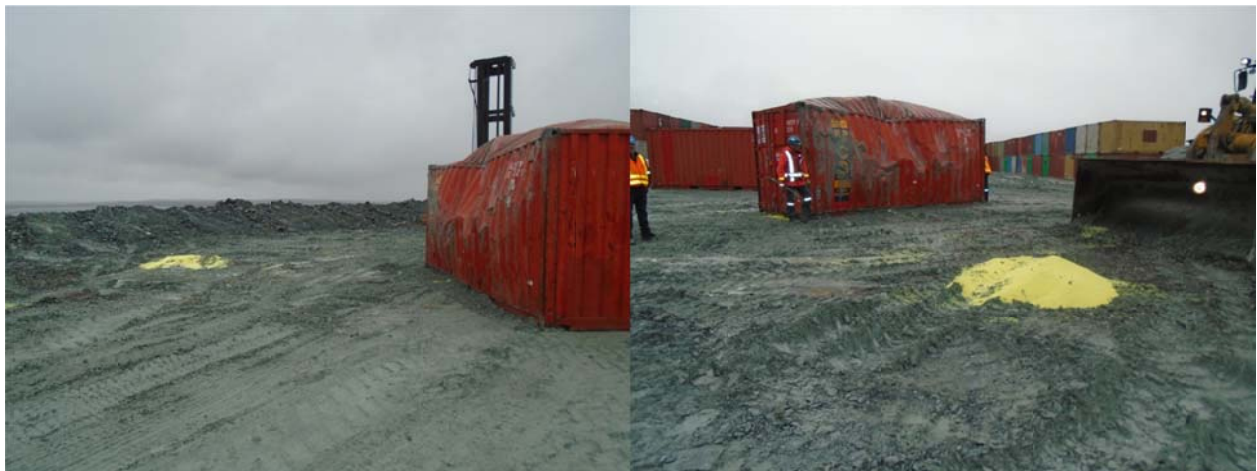
After investigation it was found that the bottom of the container was rusted and could not withstand the weight of the load during transfer. It was also found to be slippery because of ice accumulation underneath. Because of the aforementioned factors, the container handler could not hold it upright and it fell on its side. Spillage occurred when the container was put back upright, exposing gaps and openings.

A complete investigation is underway to assess sources of this incident. All concerned department are involved in this process. First conclusion noted that it was not caused by an operator error but rather by the state of the container. This was most probably created by snow and ice accumulation underneath which then led to corrosion and affected the integrity of the container.

Short term : containers that are stored at ground level over winter will be inspected before handling. This includes also an assessment of the bottom portion for any signs of damage and/or rust.

Mid/long term : storage/placement of containers on site, especially related to chemicals, will be re-evaluated to see if minimizing the possibility of corrosion is possible. This could include, for example and not necessarily : storing selected containers on second/third row, putting block under them so they are not in contact with the ground, and so forth.

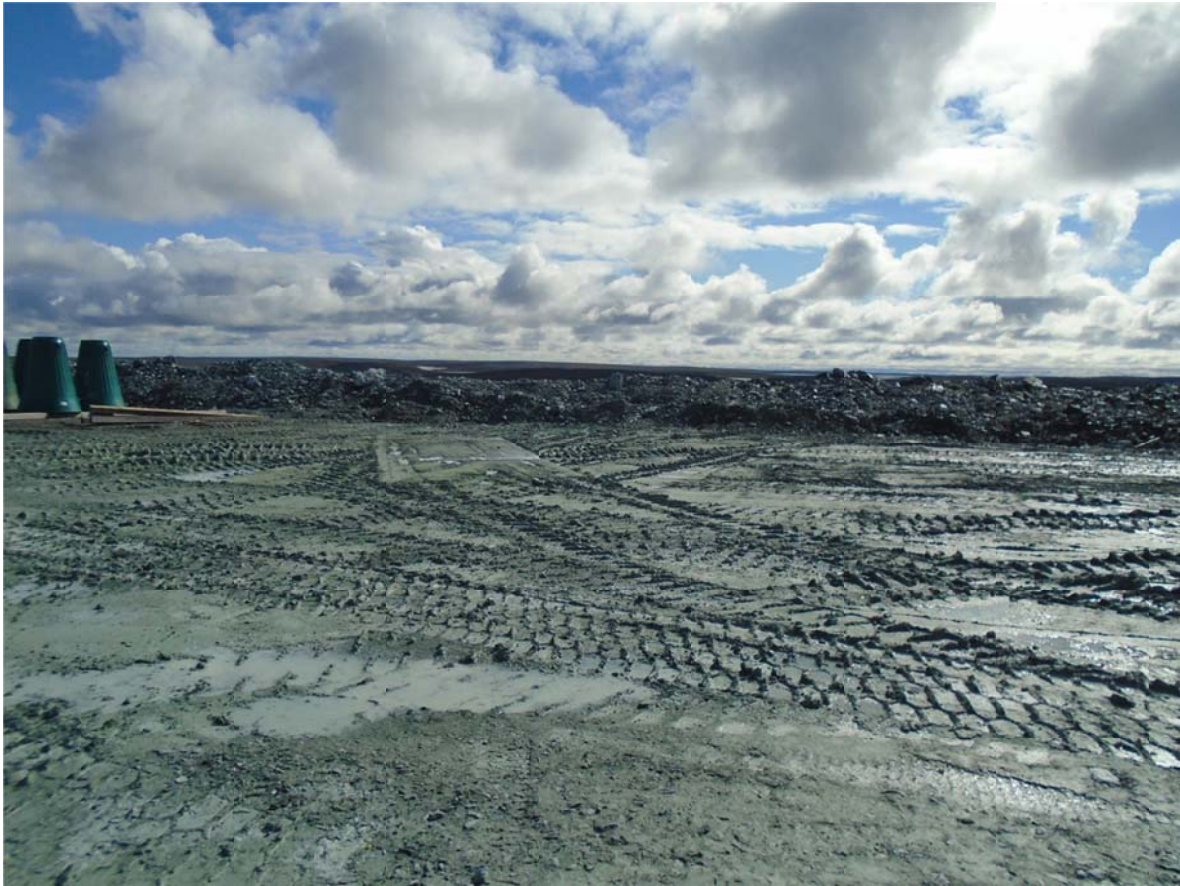
Photo of area after clean-up was completed.

All products lost in the process of removing bags and the original spilled material was then put in a roll-off to be disposed of at the landfill. Soil was added on top of the material to ensure that nothing gets windblown during transport. Roll-off was cleaned once emptied at disposal location. Everything was then covered with NPAG material to prevent further exposure to the product. The damaged container was brushed clean and also brought to the landfill.

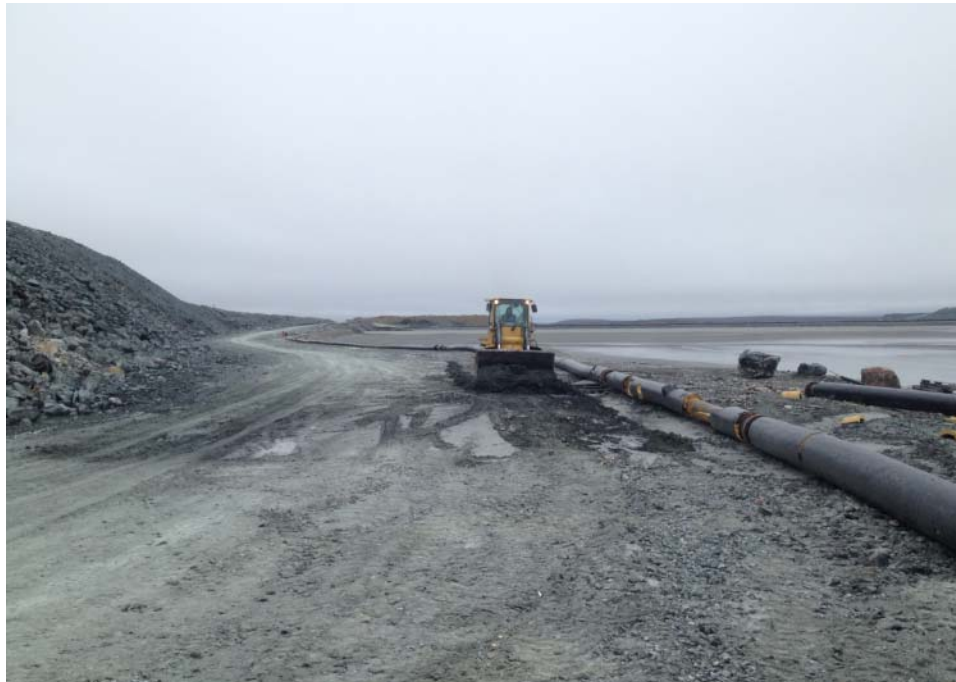
Photo 2 – Cleaning of the RF1 contaminated surface with the loader

Clean up was started on the morning of July 25th, 2015. As presented on Photo 2, the loader scraped the contaminated surface of RF1 to remove all the tailings slurry and contaminated soil. The contaminated material was then disposed in the Tailings storage facility impoundment by the loader, as presented on Photo 3. Clean aggregates were then placed on the surface of the road. Photo 4 shows the surface of the RF1 after the cleanup was completed.

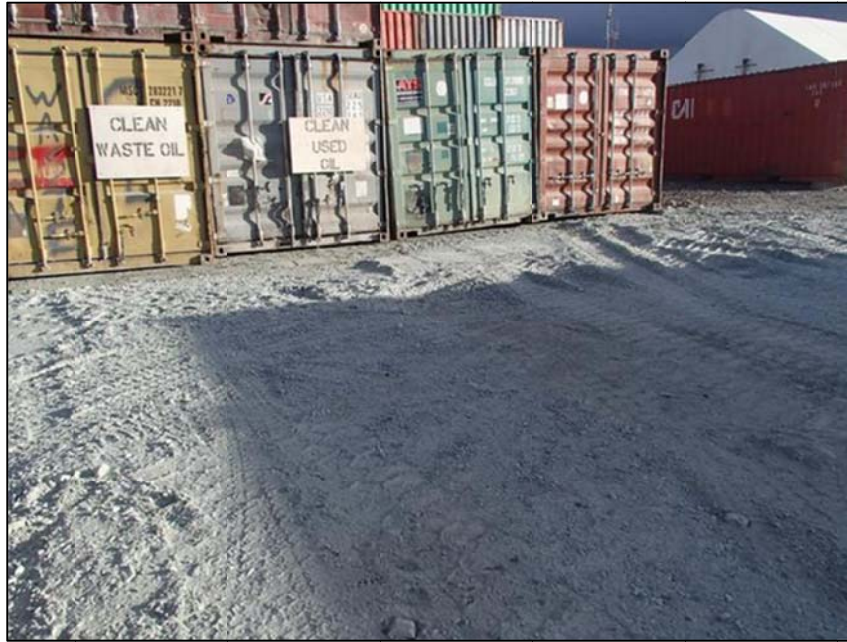
Photo 1 – Area after clean-up action

The waste oil left in the broken tote was pumped into another empty container. The contaminated soil in the area was quickly collected with a loader and put in a roll-off bin to be brought at our landfarm area at Meadowbank. The Photo 1 shows the area after the clean-up was completed.

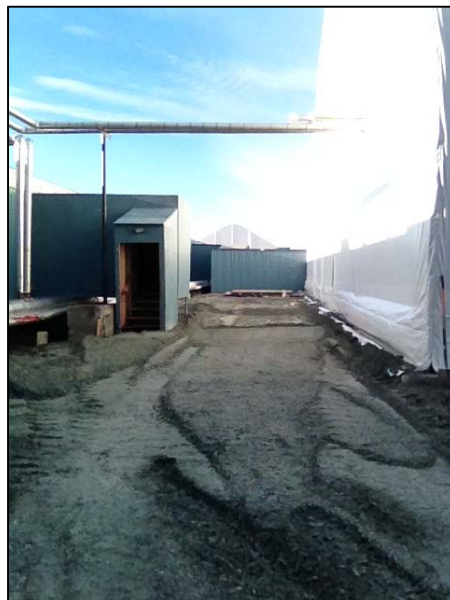
Photo 5 - Area after clean-up action, September 19th 2015

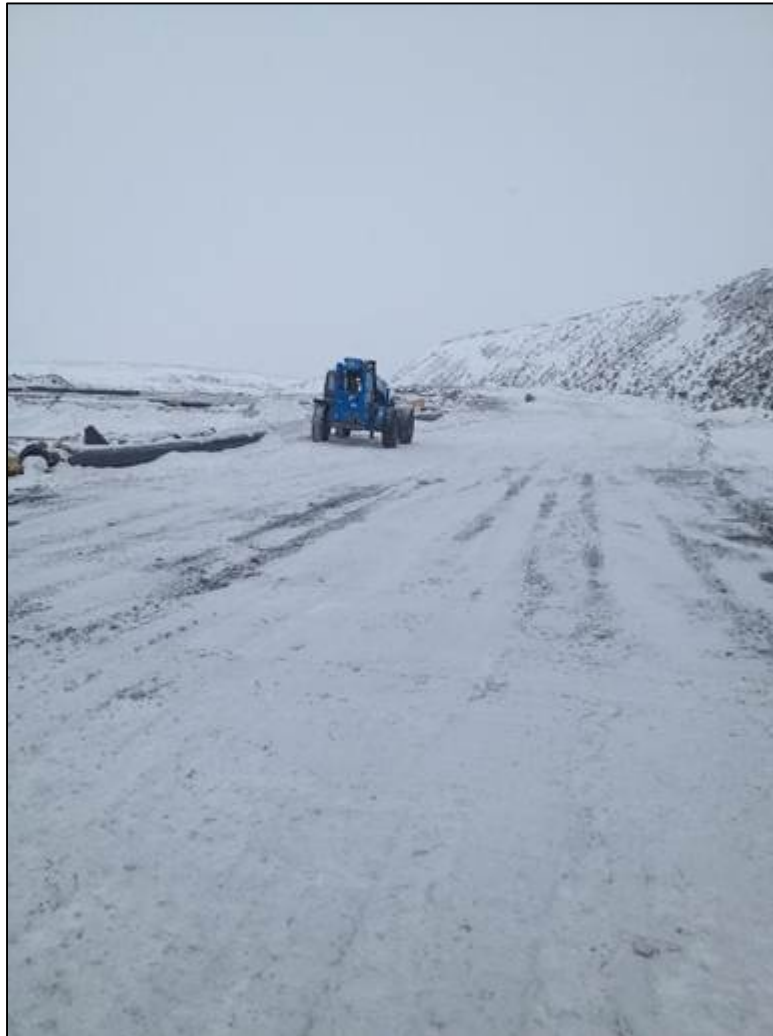
Photo 1 – RF2 surface after cleanup activities, October 11th 2015

The slurry was confined over the RF2 structure and within the tailings facility area. An area of approximately 10 m² was contaminated by the tailings slurry. Immediately after the spill occurred on October 11th, 2015, the slurry and the contaminated material were collected with a loader. The loader scraped the contaminated surface of RF2 to remove all the tailings slurry and contaminated soil. The contaminated material was then disposed in the Tailings storage facility impoundment by the loader. Photo 1 shows the area after the completion of the clean-up.

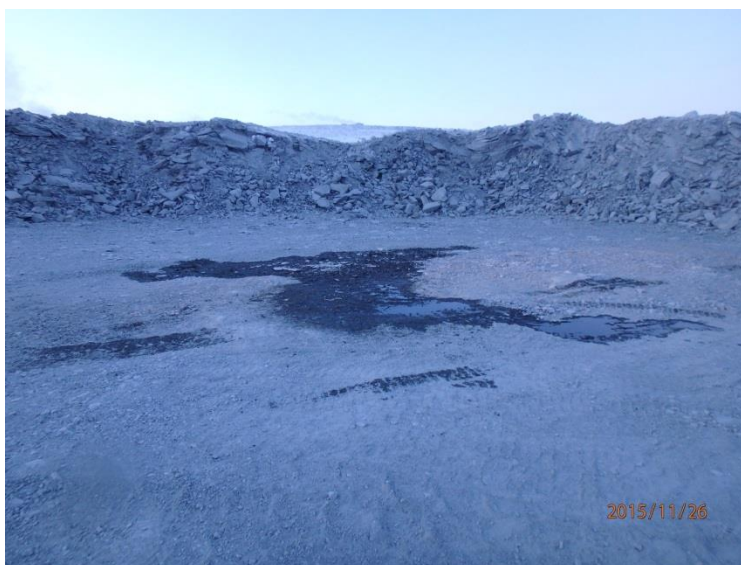
Upon closure of the valve, the mechanic notified his supervisor. The loader was removed from the area and the spill contained on location. An estimated amount of 300 liters of oil was calculated to be spilled, using the volume added to the equipment after it was moved.

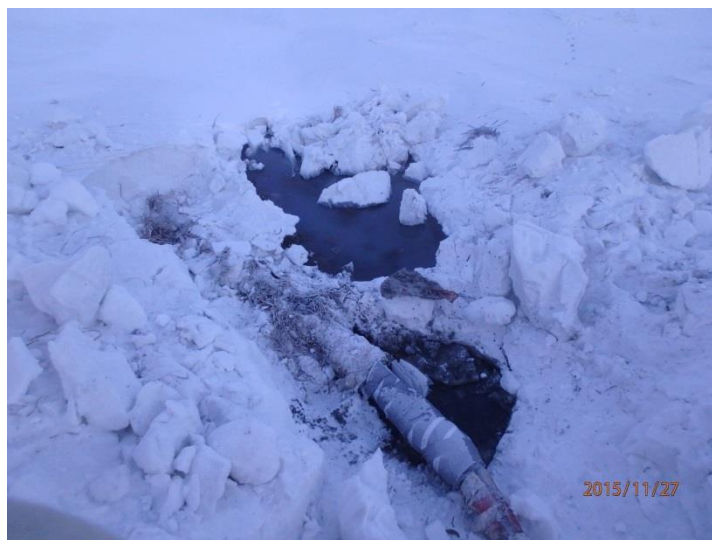
Upon being noticed, the pump was stopped at Nova. It is level controlled (floats) and thus is not pumping continuously. An estimated amount of 900 liters of sewage was calculated to be spilled, using the volume collected with the vacuum truck in the clean-up.

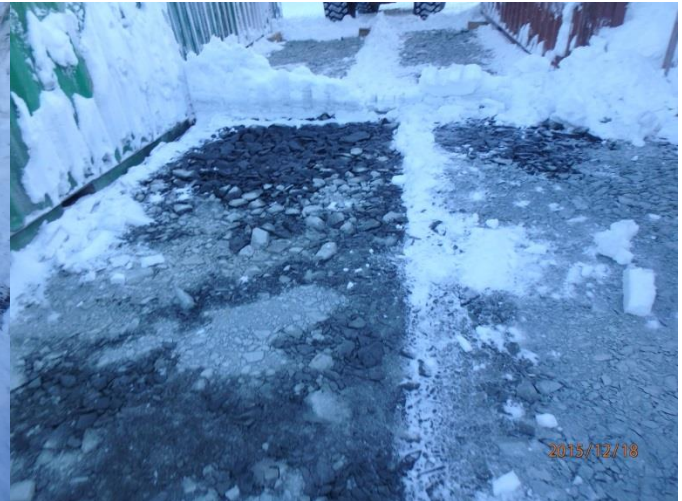
Upon noticing the drums, warehouse proceeded to empty the c-can to assess if any oil spilled outside. Upon being emptied and moved to the side, some oil was observed on the ground. From the 205 liters capacity of the drums an estimated 150 liters went on the ground with the remaining 55 liters staying inside the c-can.

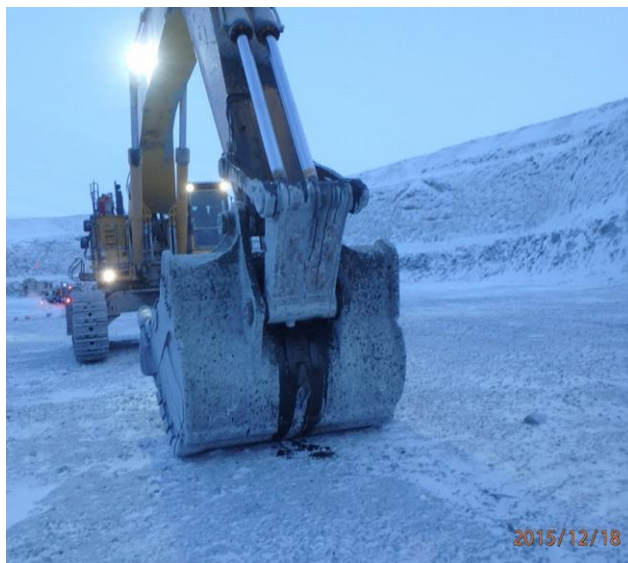
On December 18th, 2015, the hydraulic hose on the boom of backhoe #11, working in Vault pit, busted and resulted in hydraulic oil being spilled on the ground. The quantity of hydraulic oil spilled is 175 liters, and the area of contamination measured 15 m². The spill was contained with surrounding material and the hose was repaired on location. There were no off site impact or discharge to any receiving watercourses. Photo 1 shows the spill and the equipment.

Photo 1 – Hydraulic Oil Spill from Backhoe #11, Vault Pit, December 18th 2015,

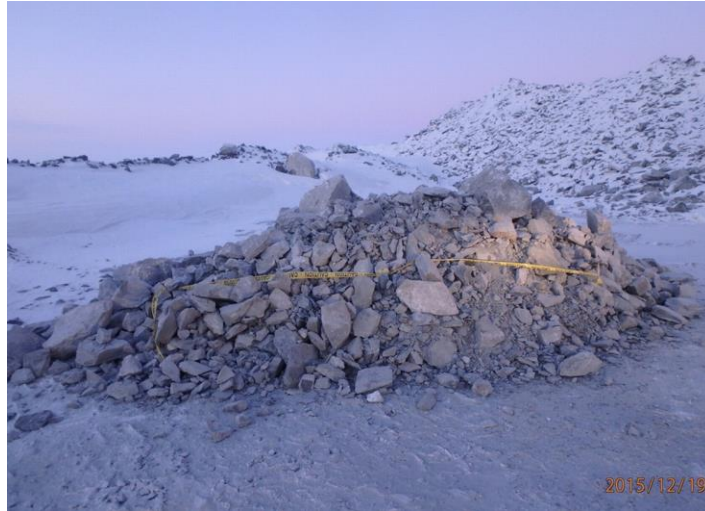
Photo 2 – Contaminated material excavated and put in pile, Vault Pit, December 19th 2015,

The area was cleaned and contaminated soil was collected and brought to the Meadowbank landfarm. An estimated volume of 8 m³ of contaminated material was excavated, put in pile and then transported to the landfarm. Photo 2 shows the excavated material.

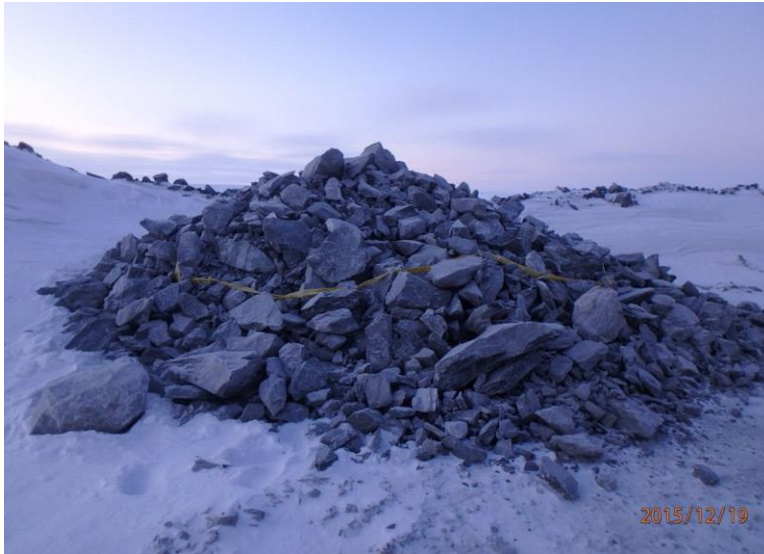
Photo 1 – Contaminated material excavated and put in pile, Vault Pit, December 19th 2015,

The area was cleaned and contaminated soil was collected and brought to the Meadowbank landfarm. An estimated volume of 12 m³ of contaminated material was excavated, put in pile and then transported to the landfarm. Photo 1 shows the excavated material.
