Report: 2017 Annual Geotechnical Inspection

February 2018

2017 Annual Geotechnical Inspection Meadowbank Gold Mine, Nunavut

Report Number: 1784282-1574-RPT-Rev0

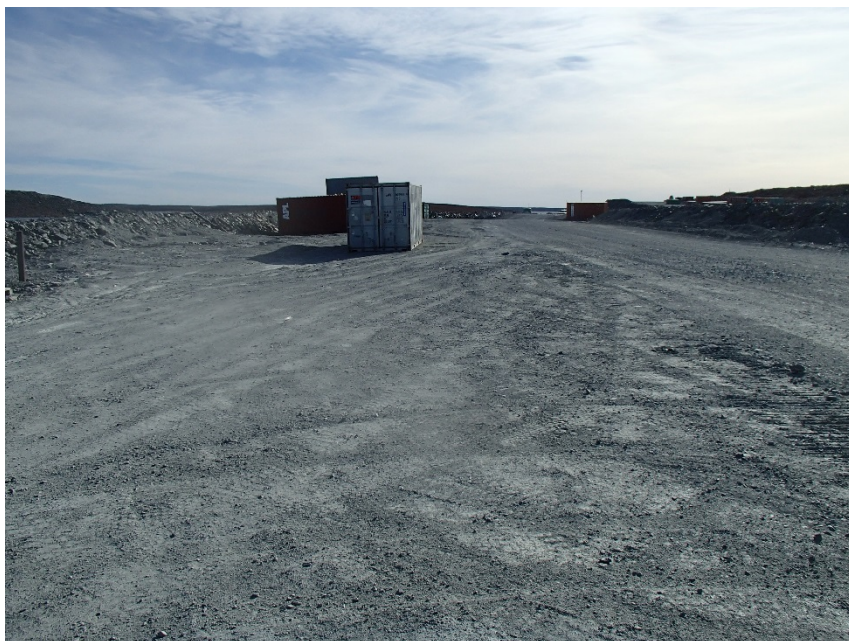
Photograph A1-1 East Dike

Description: From approximately Sta. 60+375, looking south at the crest.

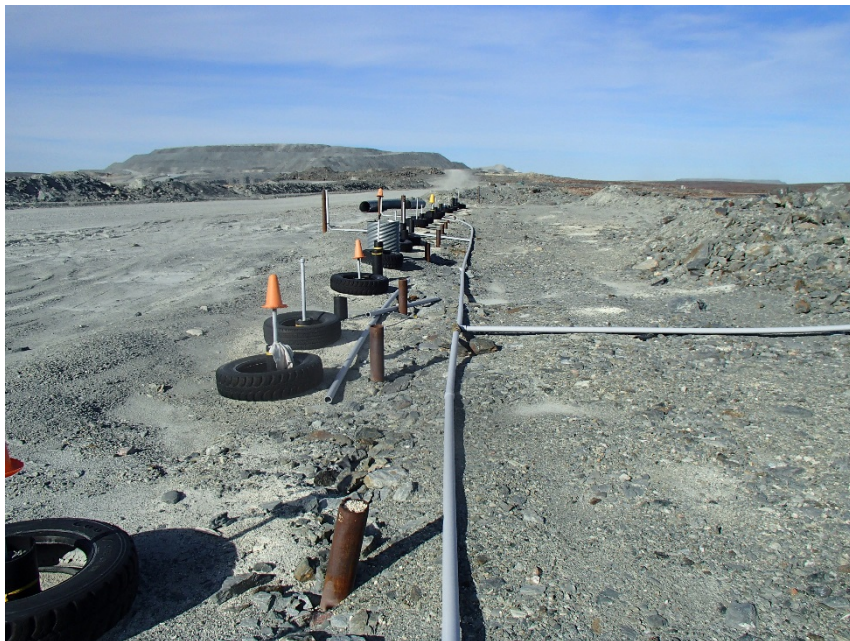
Photograph A1-3 East Dike

Description: From approximately Sta. 60+560, looking north at the crest.

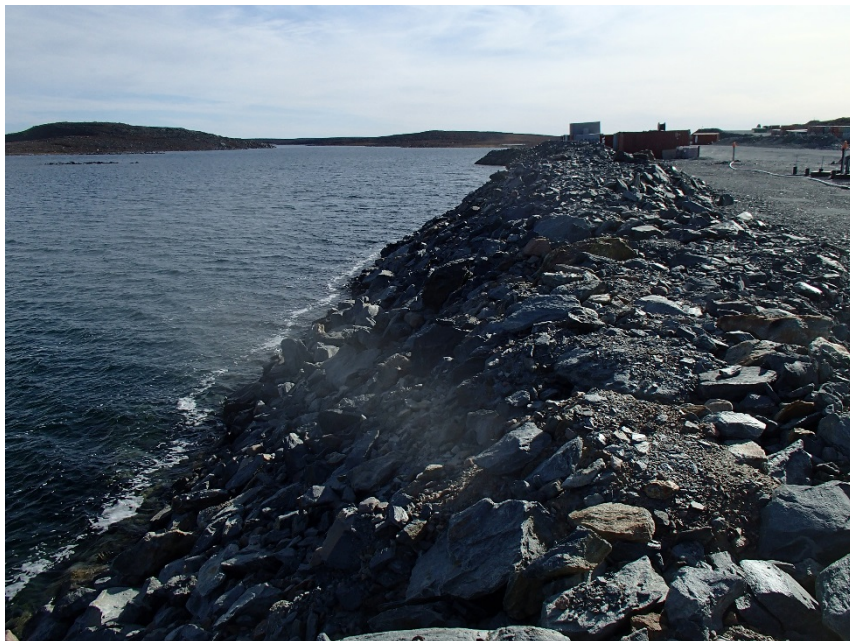
Photograph A1-5 East Dike

Description: From approximately Sta. 60+540 upstream, looking south at the crest and the upstream slope.

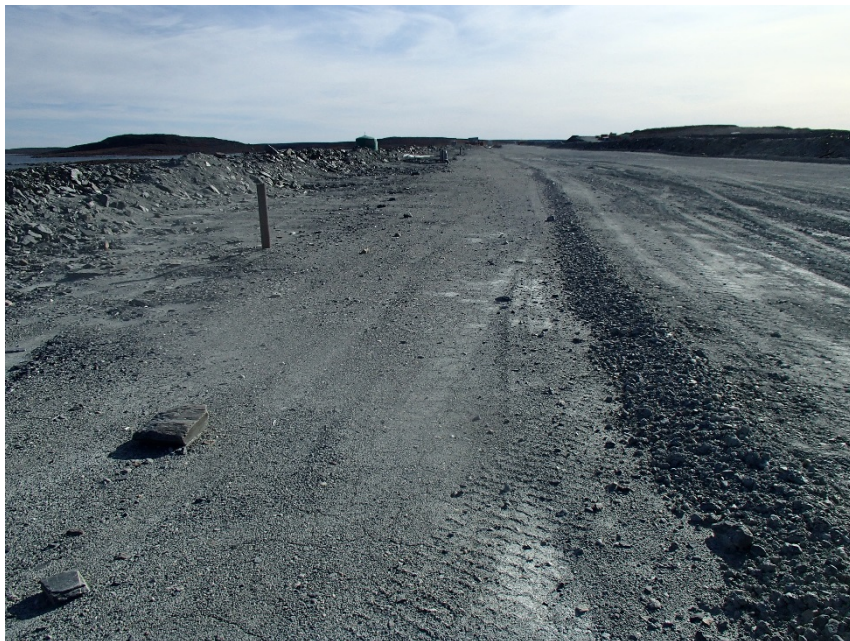
Photograph A1-7 East Dike

Description: From approximately Sta. 60+810, looking south at the crest.

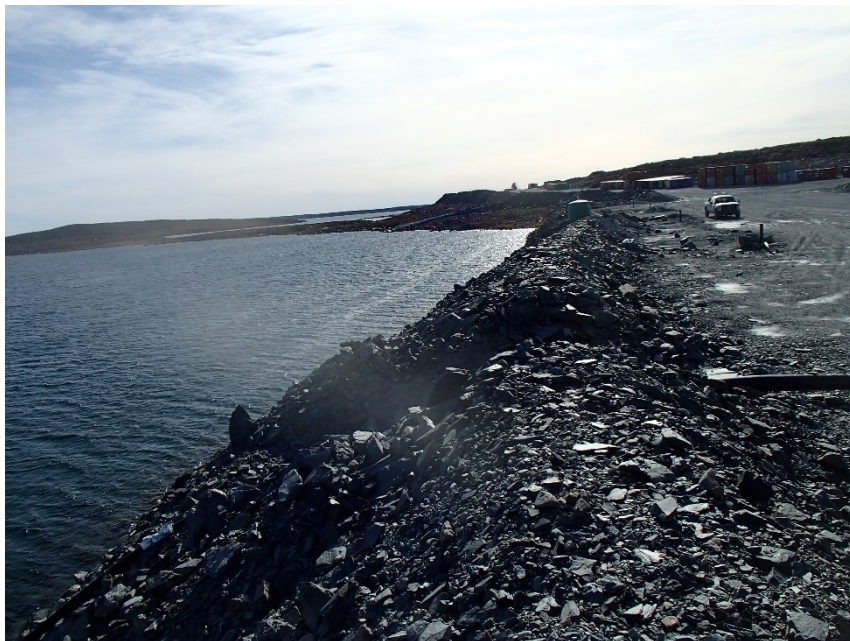
Photograph A1-9 East Dike

Description: From approximately Sta. 60+250 upstream, looking south at the crest and the upstream slope.

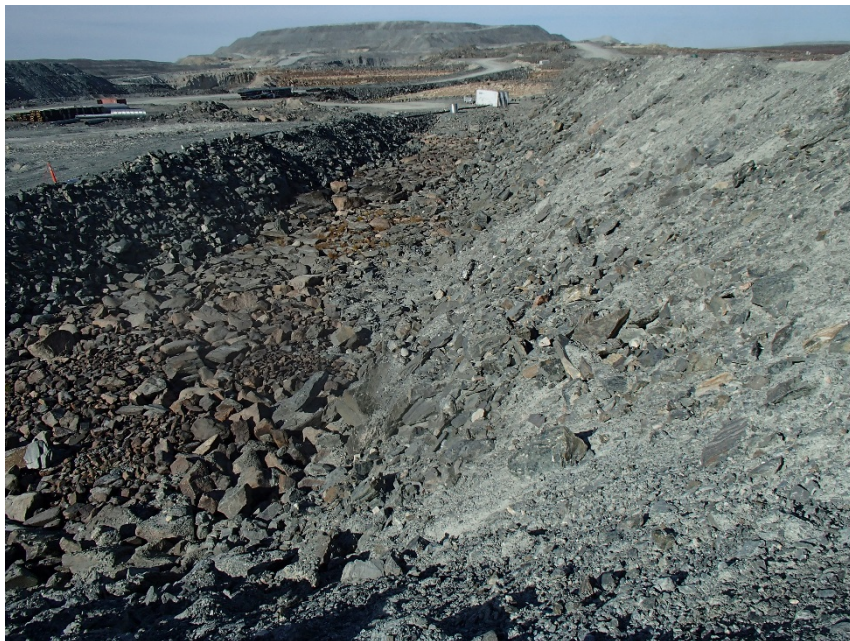
Photograph A1-11 East Dike

Description: From approximately Sta. 60+380, looking north at the downstream side.

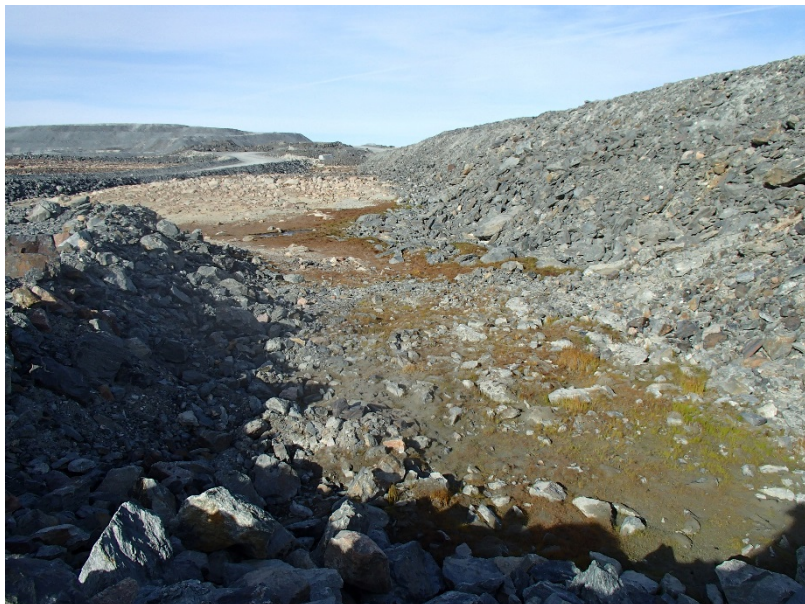
Photograph A1-13 East Dike

Description: From approximately Sta. 60+570 downstream, looking north at the downstream toe.

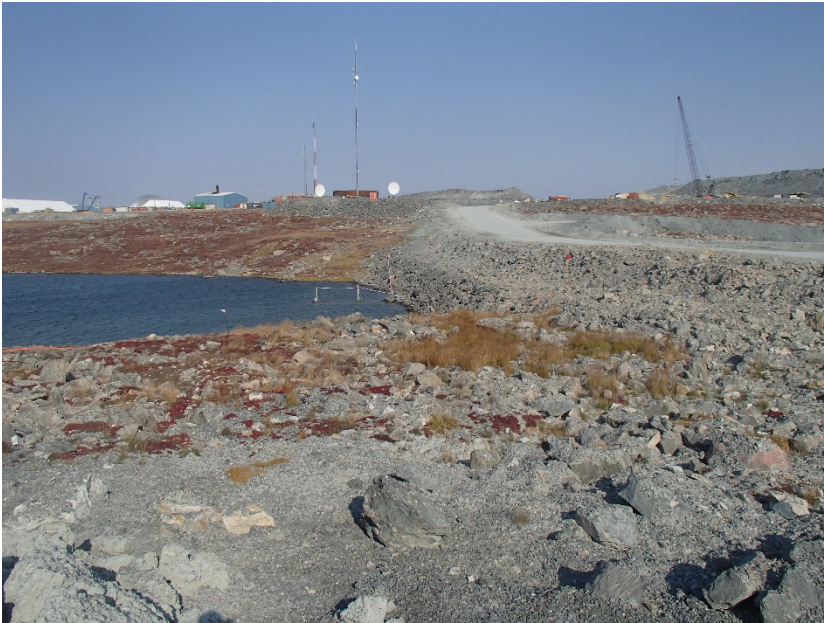
Photograph A2-1 South Camp Dike

Description: From the south abutment, looking north at the upstream slope and the thermistors instrumentation set-up.

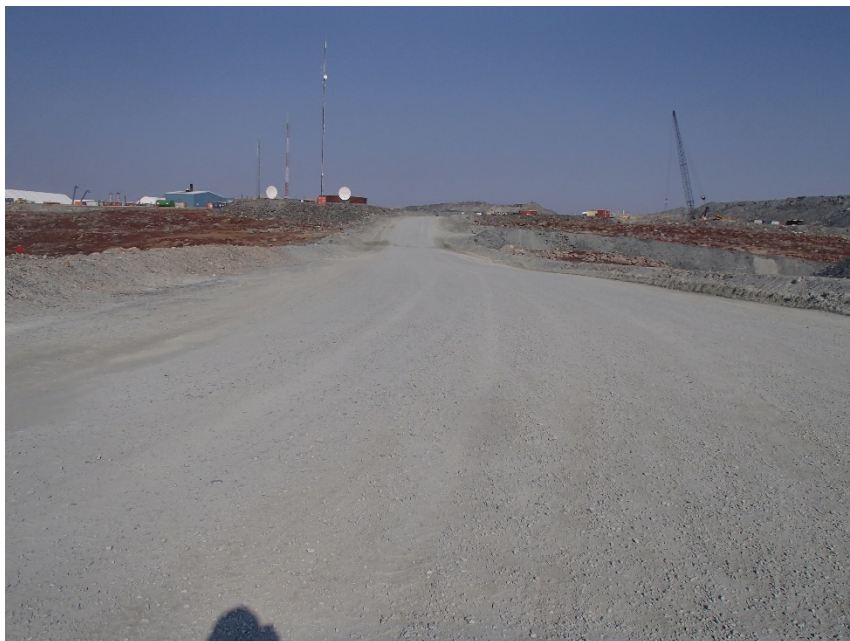
Photograph A2-3 South Camp Dike

Description: From the south abutment, looking north at the crest.
