## APPENDIX D1 CULVERTS ALONG AWPR PHOTOGRAPHIC LOG

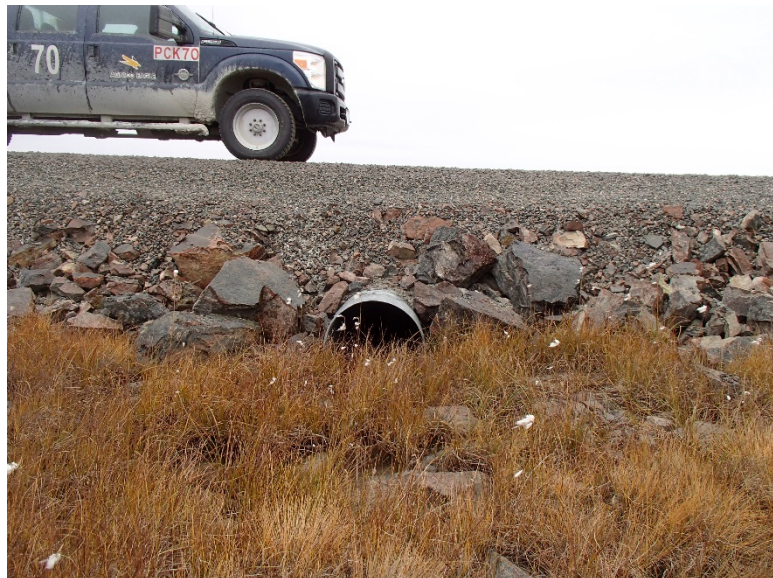
*Photograph D1-17: R-03 km 10+580*

**Description:** View of the culvert inlet. In good condition.

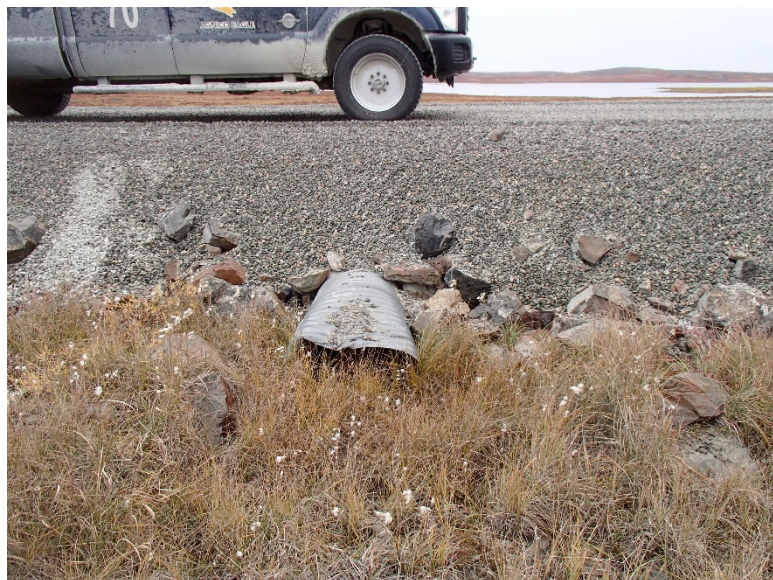
*Photograph D1-21: PC-13 km 12+745*

**Description:** View of the culvert inlet. In good condition.

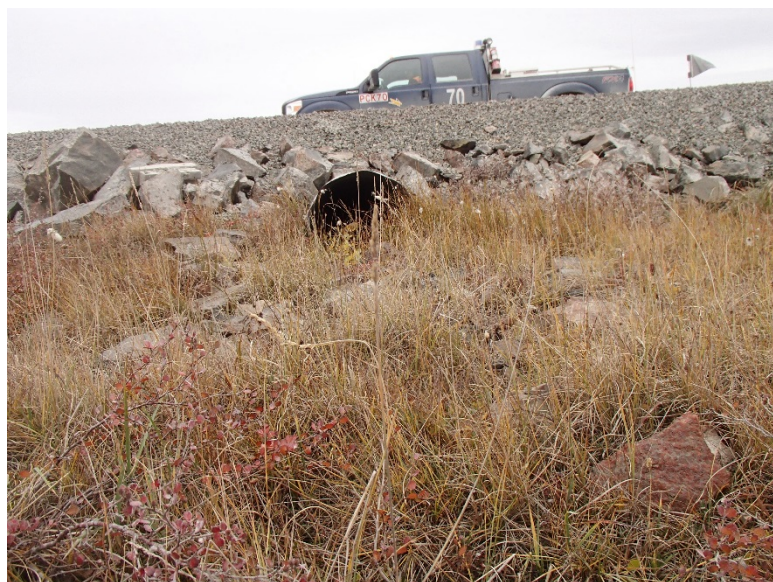
*Photograph D1-22: PC-13 km 12+745*

**Description:** View of the culvert outlet. In good condition.

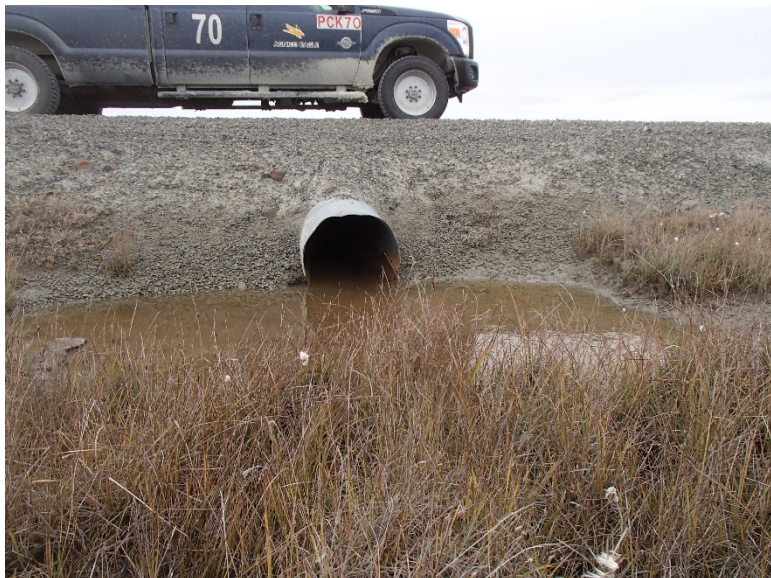
*Photograph D1-27: unnamed km 13+950*

**Description:** View of the culvert inlet. In good condition.

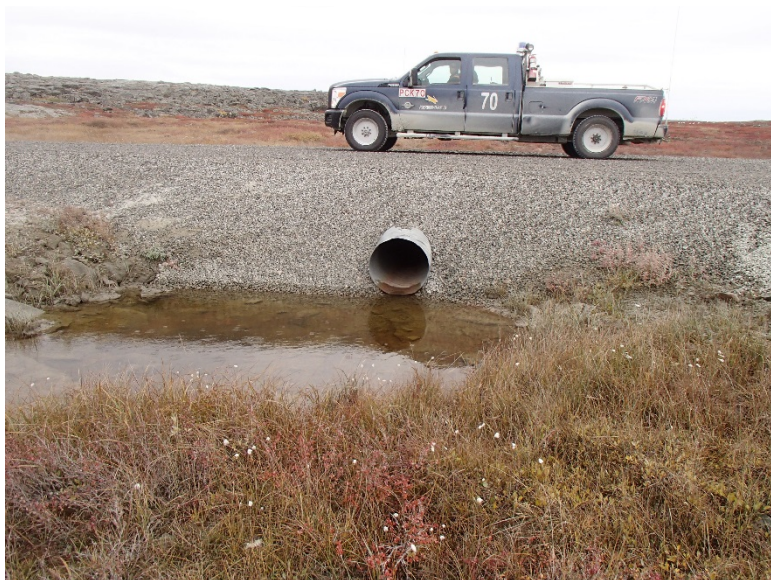
*Photograph D1-28: unnamed km 13+950*

**Description:** View of the culvert outlet. The outlet is in good condition.

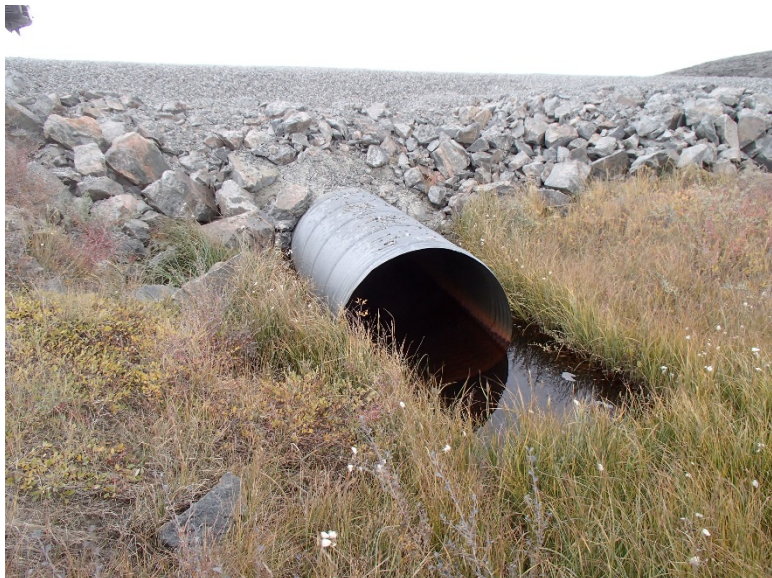
*Photograph D1-31: R-05A km 15+745*

**Description:** View of the culvert inlet. In good condition.

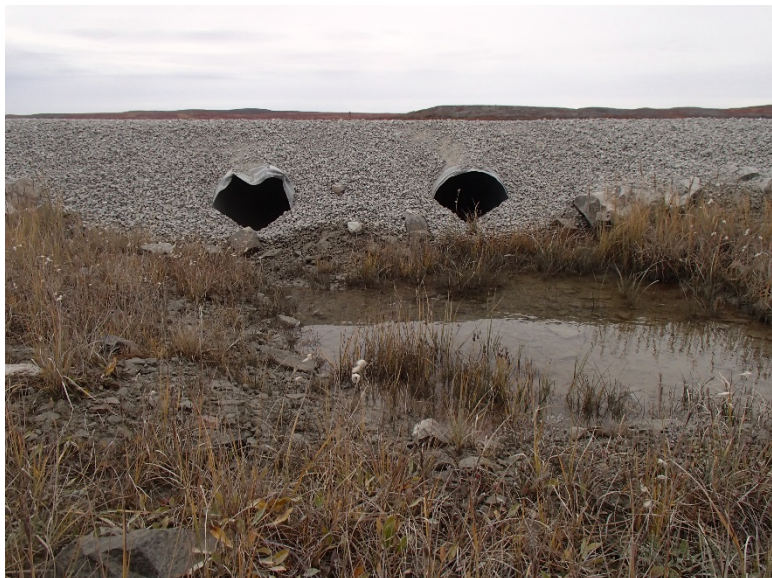
*Photograph D1-37: PC-7A km 20+240*

**Description:** View of culverts inlet. In general good condition.

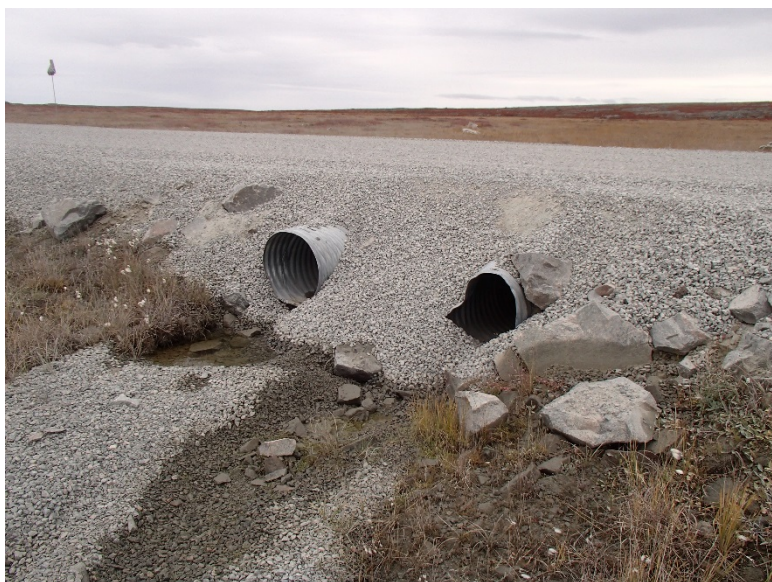
*Photograph D1-38: PC-7A km 20+240*

**Description:** View of culverts outlet. In good general condition.

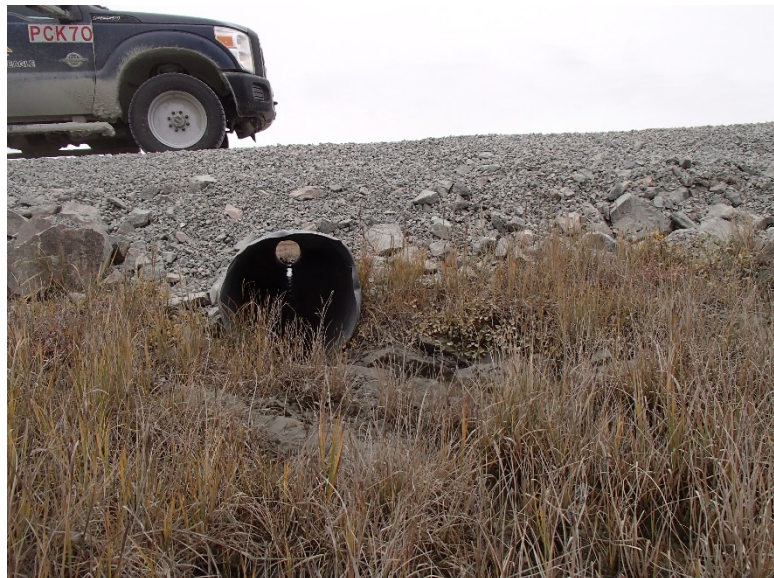
*Photograph D1-39: PC-7 km 20+250*

**Description:** View of the culvert inlet. In good condition.
