APPENDIX D2 BRIDGES ALONG AWPR PHOTOGRAPHIC LOG

APPENDIX E

Amaruq Road Photographic Log

Culverts along Amaruq Road Photographic Log

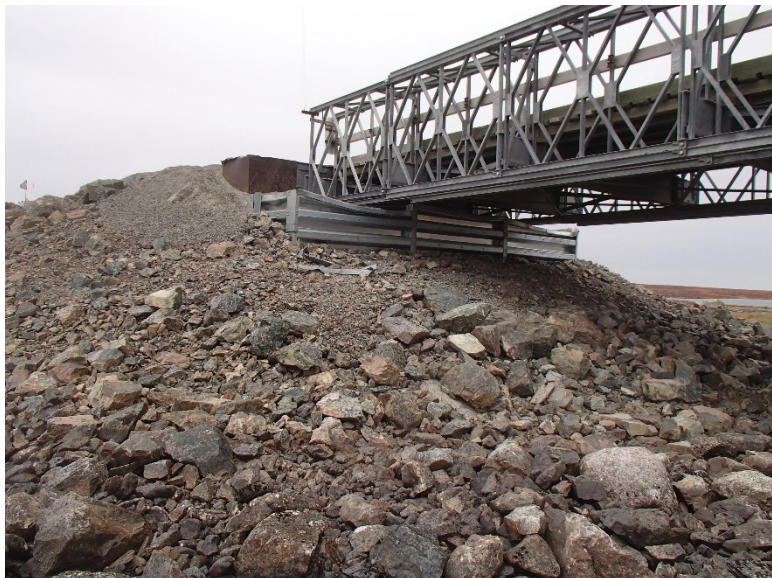
Photograph D2-3 Bridges 1 – R02 km 8+750

Description: Looking at the north abutment from upstream.

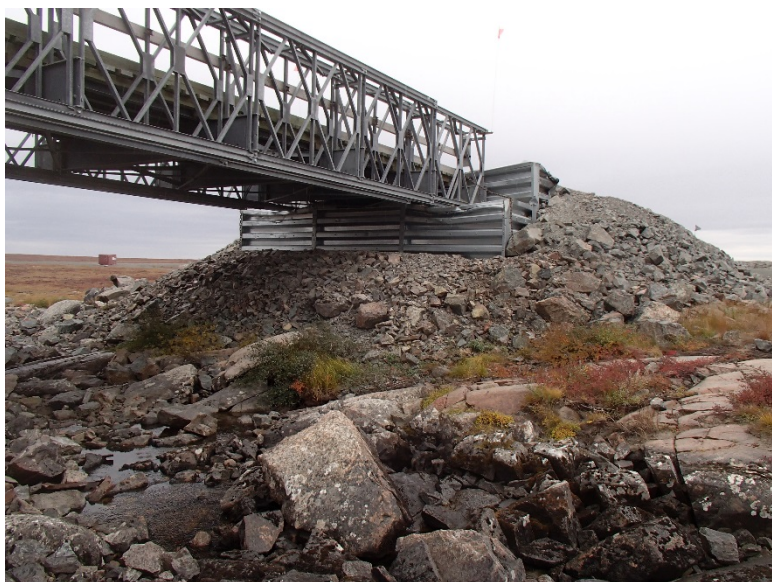
Photograph D2-4 Bridges 1 – R02 km 8+750

Description: Looking at the south abutment from upstream.

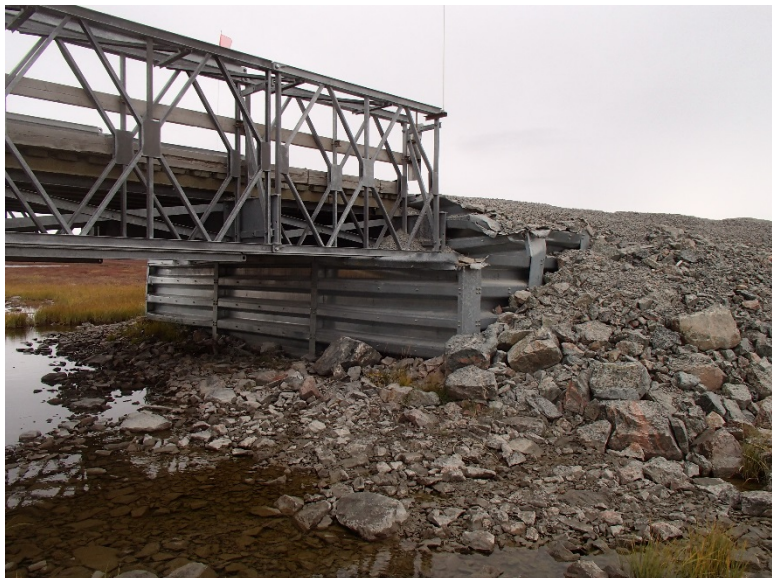
Photograph D2-5 Bridges 2 – R05 km 17+600

Description: Looking at the north abutment from downstream.

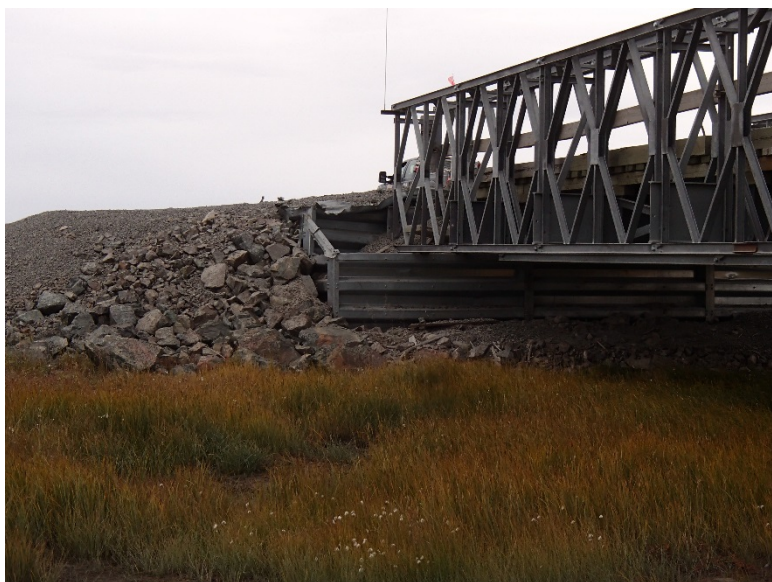
Photograph D2-6 Bridges 2 – R05 km 17+600

Description: Looking at the south abutment from downstream. Minor damage to the bin wall.

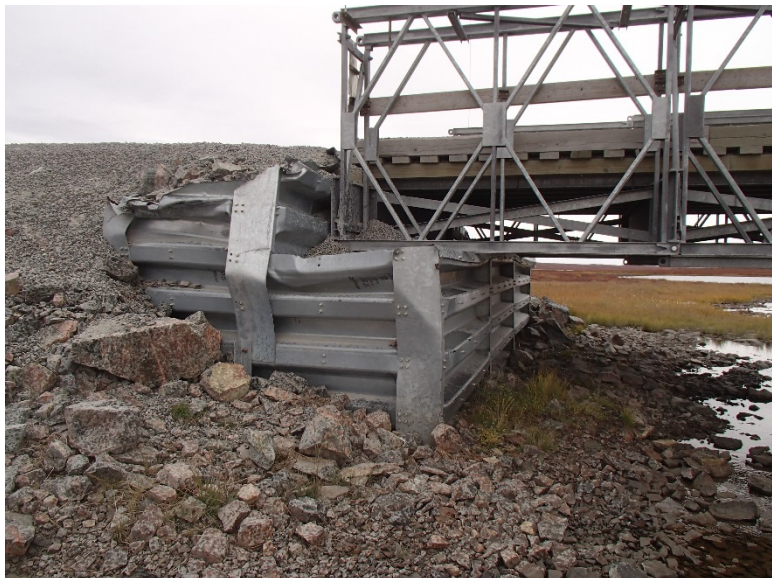
Photograph D2-7 Bridges 2 – R05 km 17+600

Description: Looking at the north abutment from upstream.

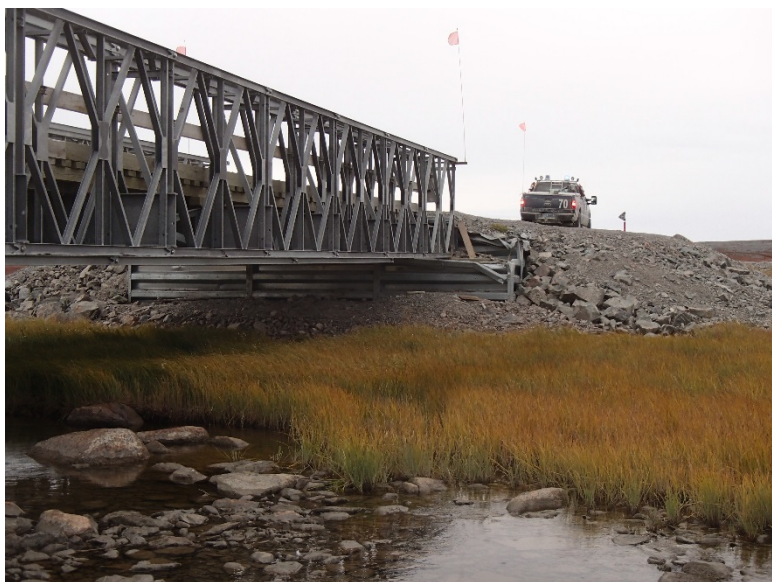
Photograph D2-8 Bridges 2 – R05 km 17+600

Description: Looking at the south abutment from upstream. Minor damage to the bin wall.

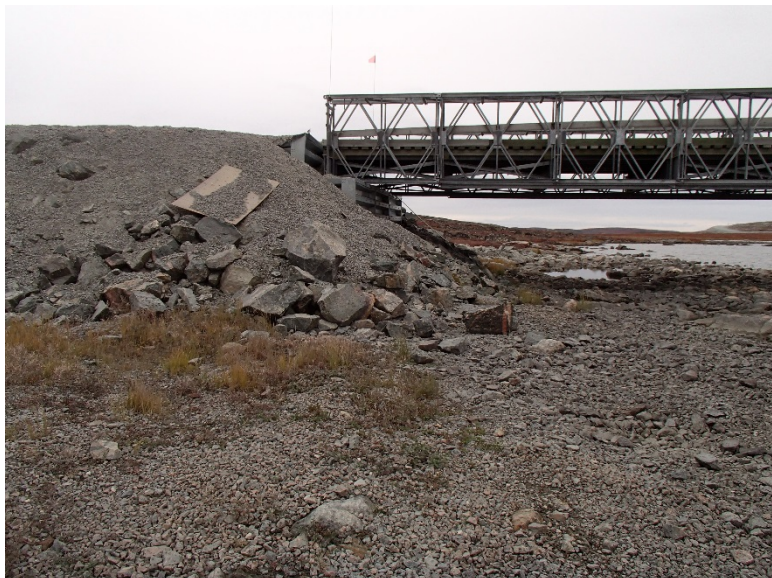
Photograph D2-9 Bridges 3 – R06 km 23+100

Description: Looking at the north abutment from upstream.

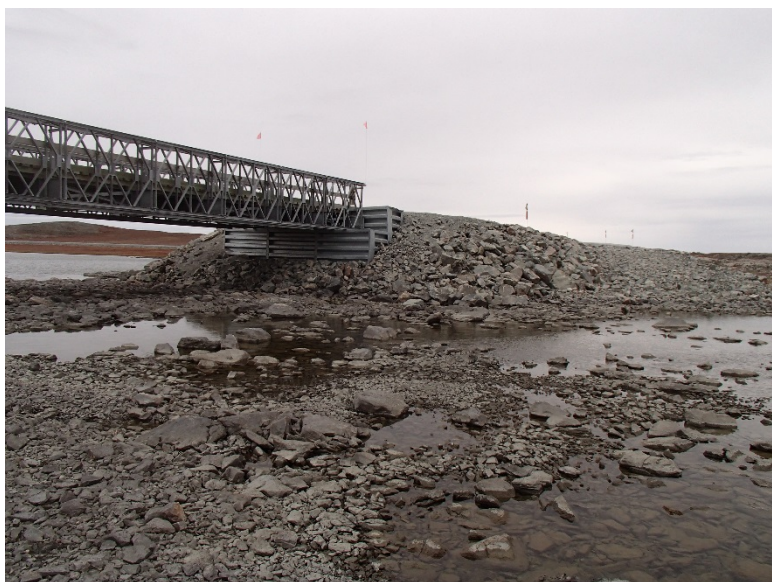
Photograph D2-10 Bridges 3 – R06 km 23+100

Description: Looking at the south abutment from upstream.

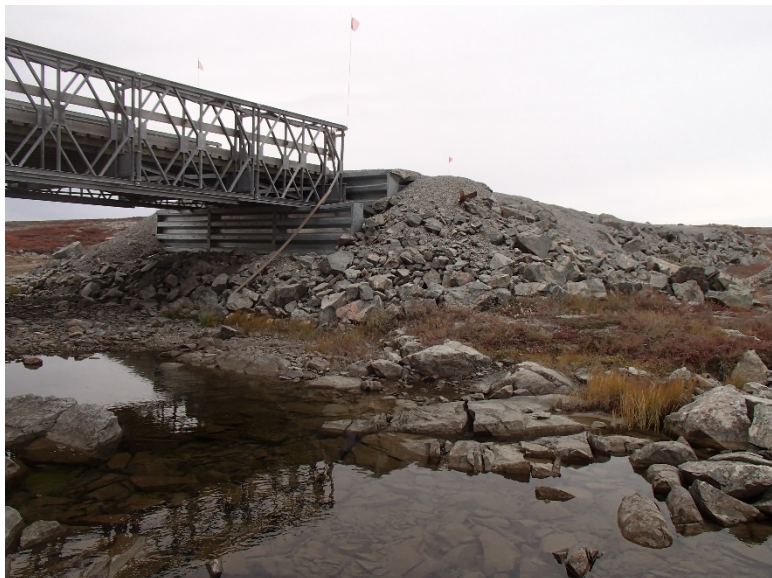
Photograph D2-11 Bridges 3 – R06 km 23+100

Description: Looking at the north abutment from downstream.

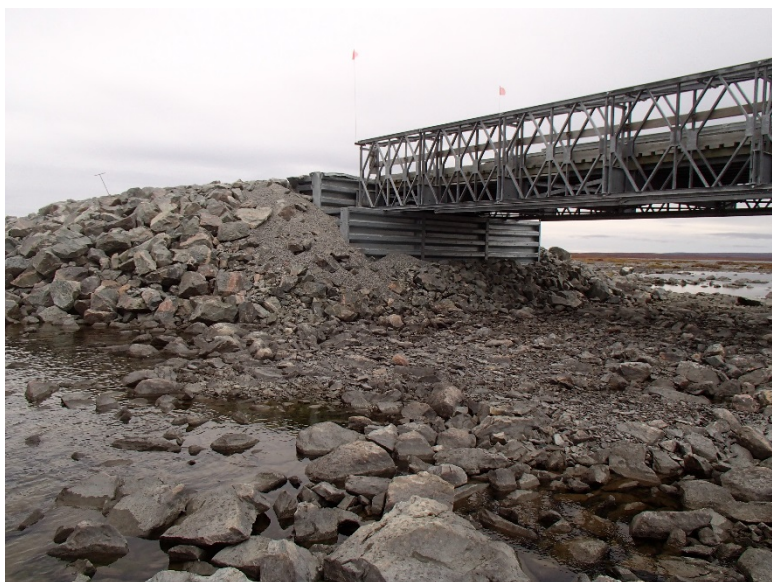
Photograph D2-12 Bridges 3 – R06 km 23+100

Description: Looking at the south abutment from downstream.

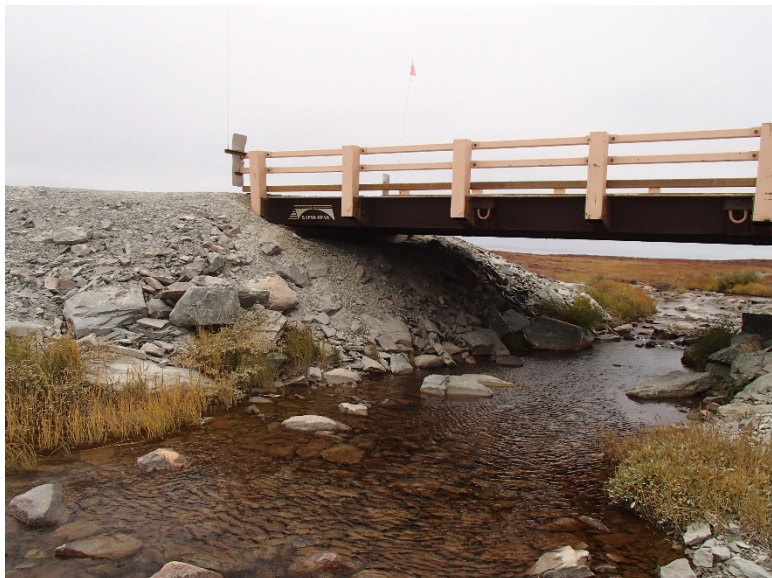
Photograph D2-13 Bridges 4 – R09 km 48+500

Description: Looking at the south abutment from downstream.

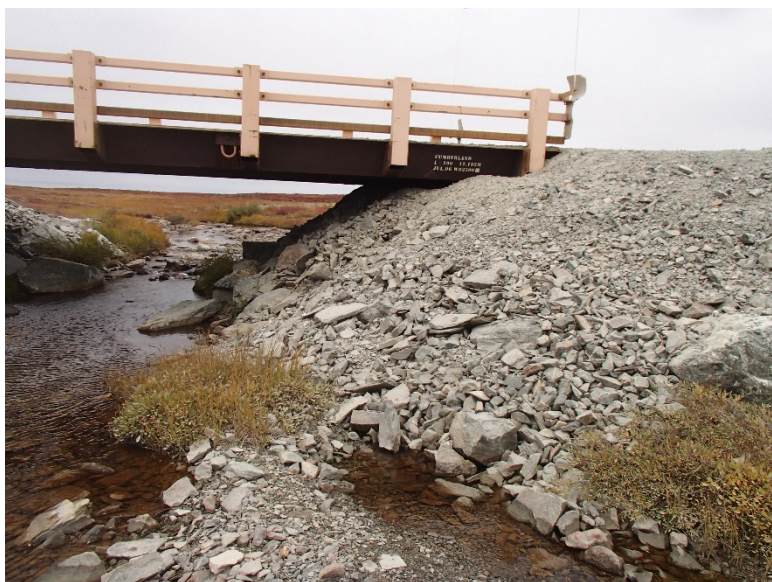
Photograph D2-14 Bridges 4 – R09 km 48+500

Description: Looking at the north abutment from downstream.

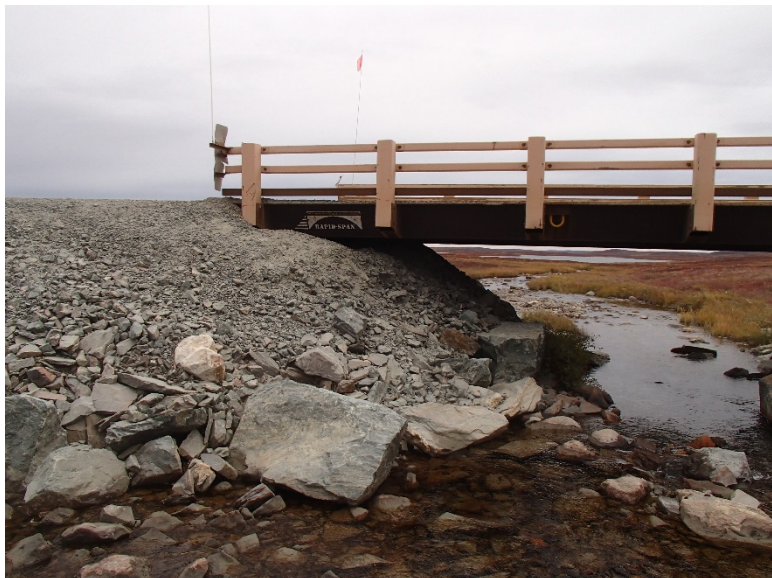
Photograph D2-15 Bridges 4 – R09 km 48+500

Description: Looking at the north abutment from upstream.

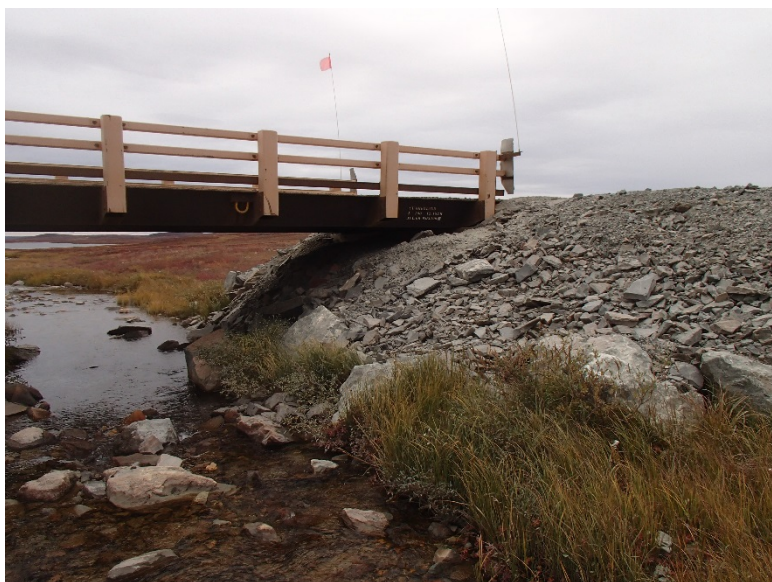
Photograph D2-16 Bridges 4 – R09 km 48+500

Description: Looking at the south abutment from upstream.

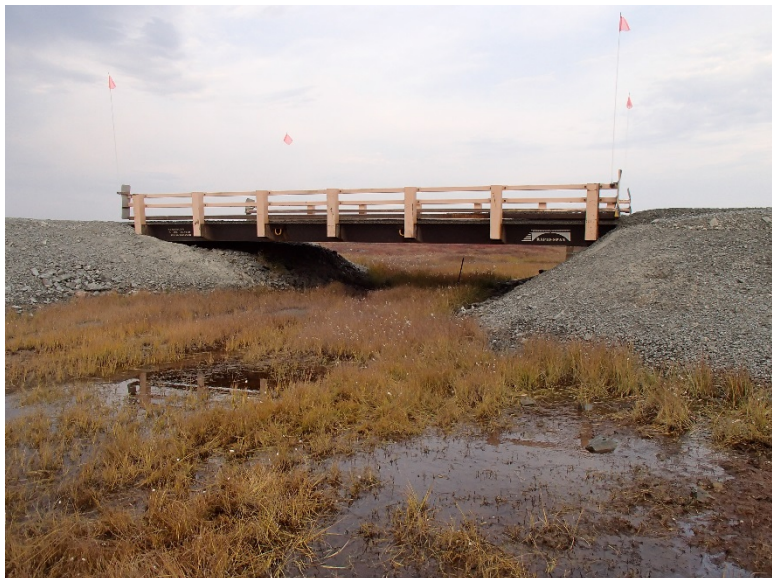
Photograph D2-17 Bridges 5 – R13 km 62+060

Description: Looking at the bridge from the downstream side.

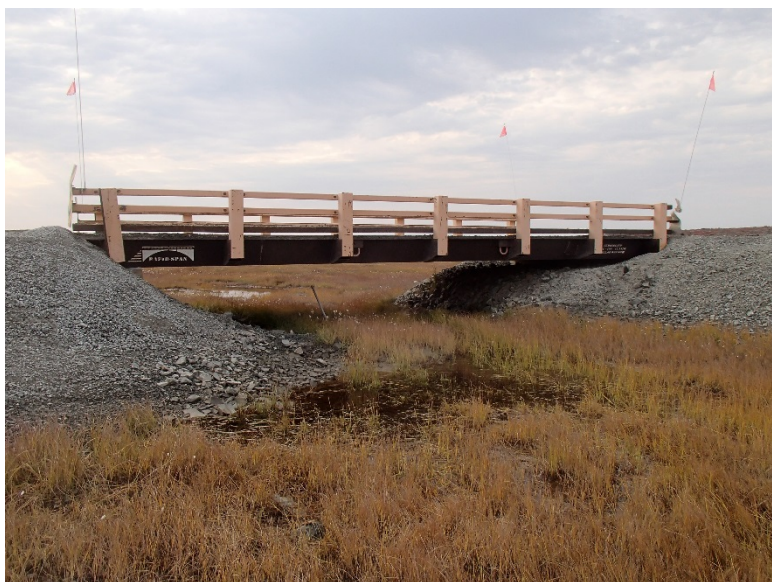
Photograph D2-18 Bridges 5 – R13 km 62+060

Description: Looking at the bridge from the upstream side.

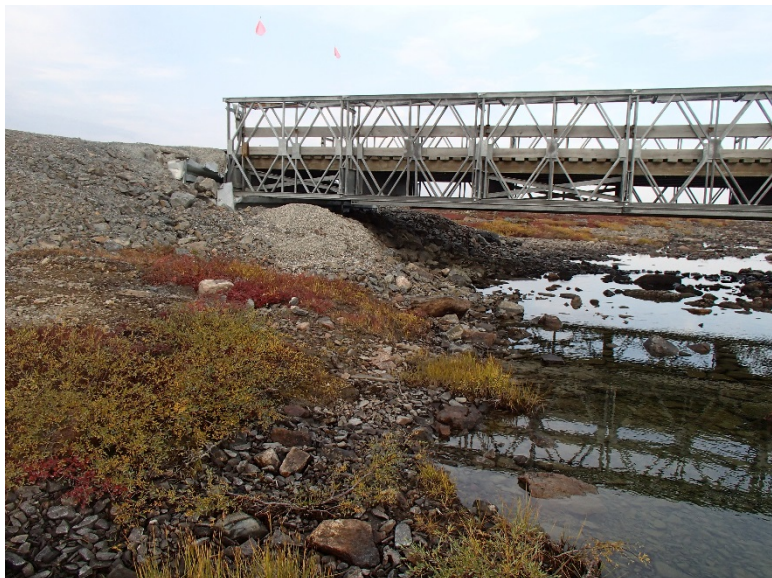
Photograph D2-19 Bridges 6 – R15 km 69+200

Description: Looking at the south abutment from downstream. Damage to the bin wall likely caused during snow removal activities. Bridge is tipping toward the west side on the abutment.

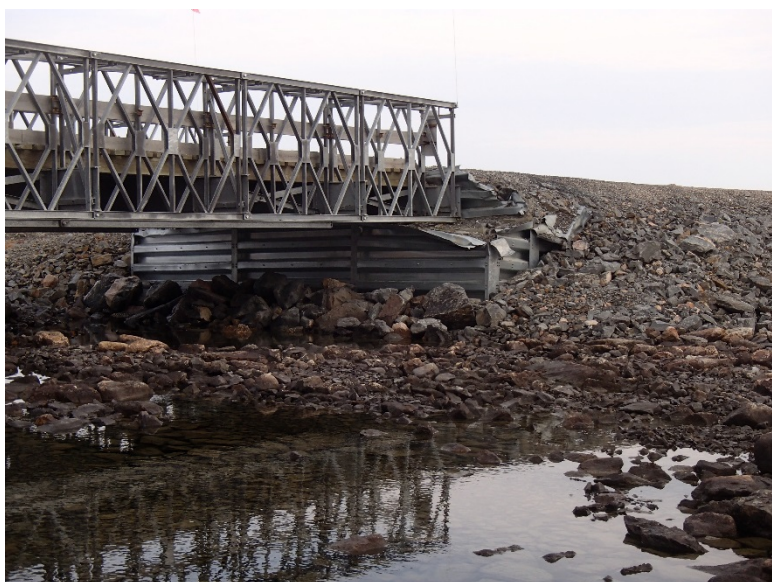
Photograph D2-20 Bridges 6 – R15 km 69+200

Description: Looking at the north abutment from downstream. Damage to the bin wall likely caused during snow removal activities. Bridge is tipping toward the west side on the abutment.

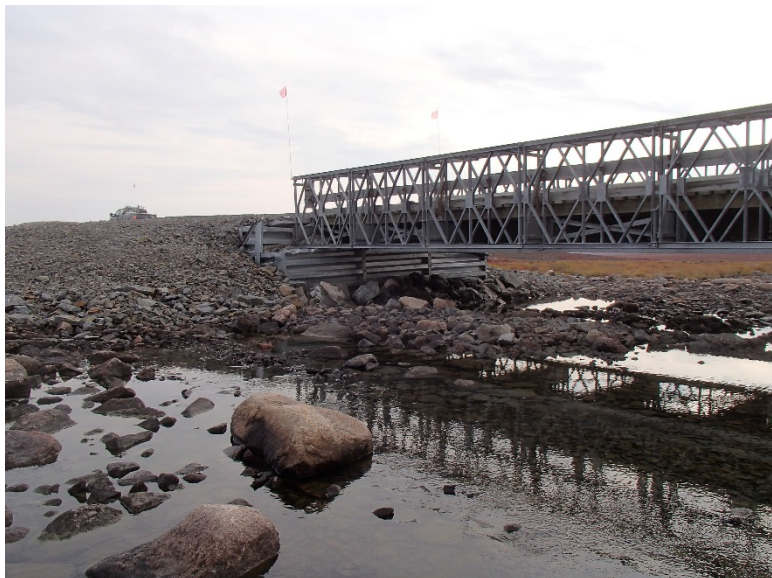
Photograph D2-21 Bridges 6 – R15 km 69+200

Description: Looking at the north abutment from upstream. Damage to the bin wall likely caused during snow removal activities. Bridge is tipping toward the west side on the abutment.

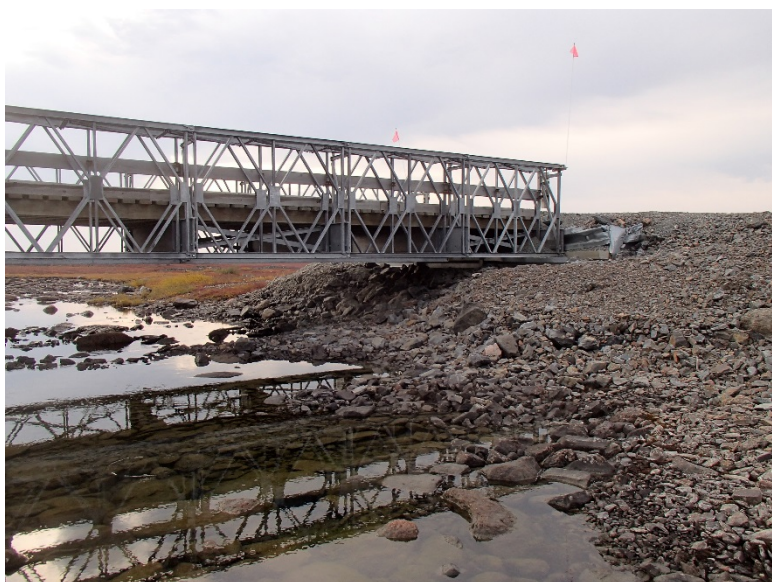
Photograph D2-22 Bridges 6 – R15 km 69+200

Description: Looking at the south abutment from upstream. Damage to the bin wall likely caused during snow removal activities. Bridge is tipping toward the west side on the abutment.

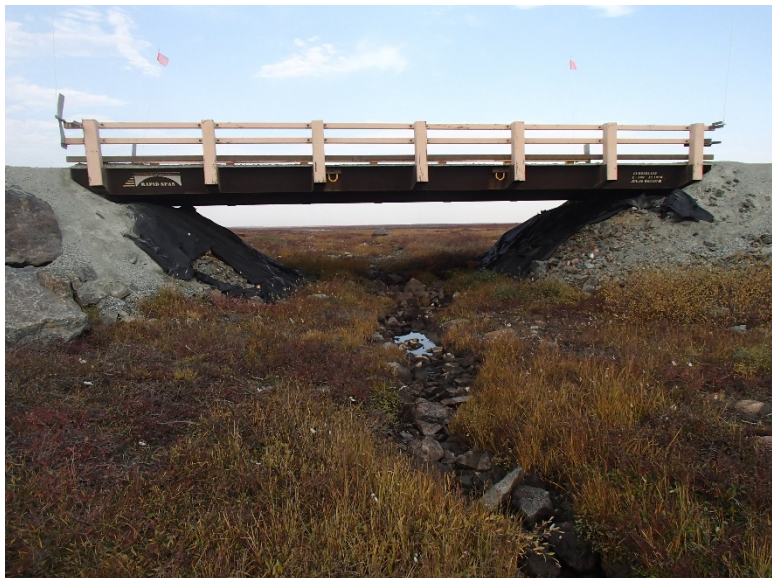
Photograph D2-23 Bridges 7 – R16 km 73+800

Description: Looking at the bridge from the downstream side.

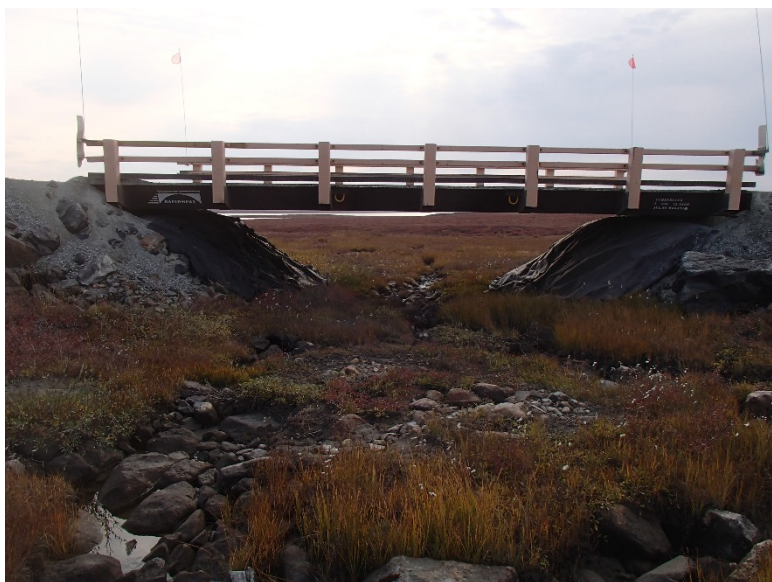
Photograph D2-24 Bridges 7 – R16 km 73+800

Description: Looking at the bridge from the upstream side.

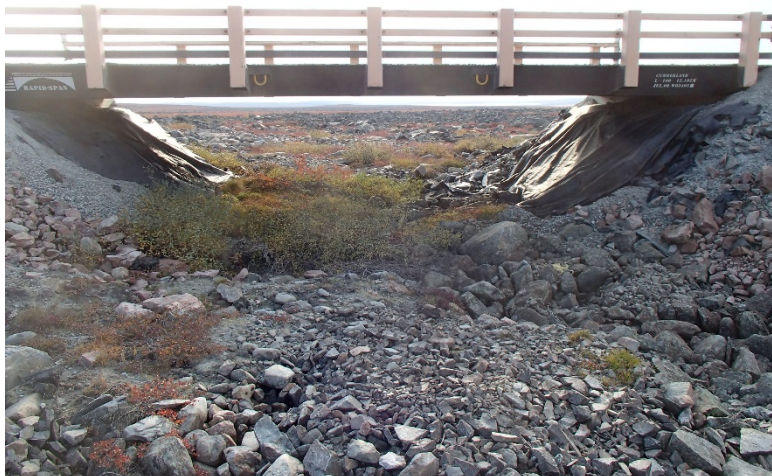
Photograph D2-25 Bridges 8 – R18 km 79+500

Description: Looking at the bridge from the upstream side.

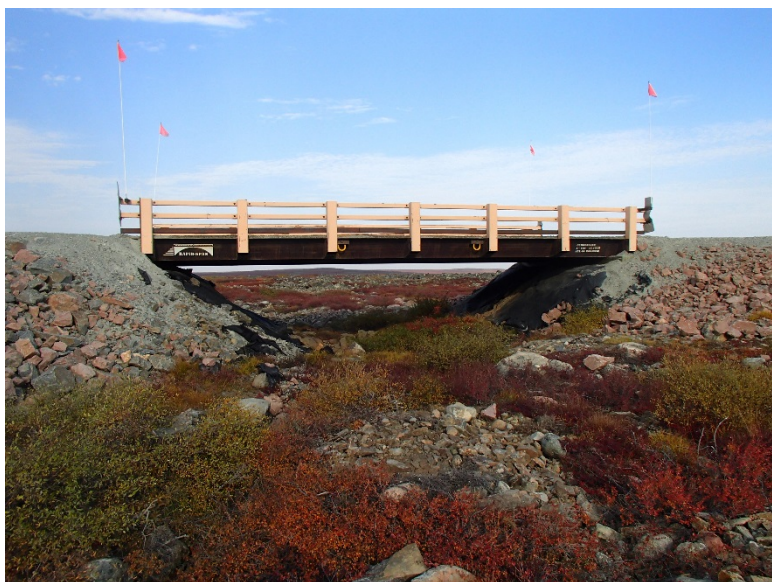
Photograph D2-26 Bridges 8 – R18 km 79+500

Description: Looking at the bridge from the downstream side.

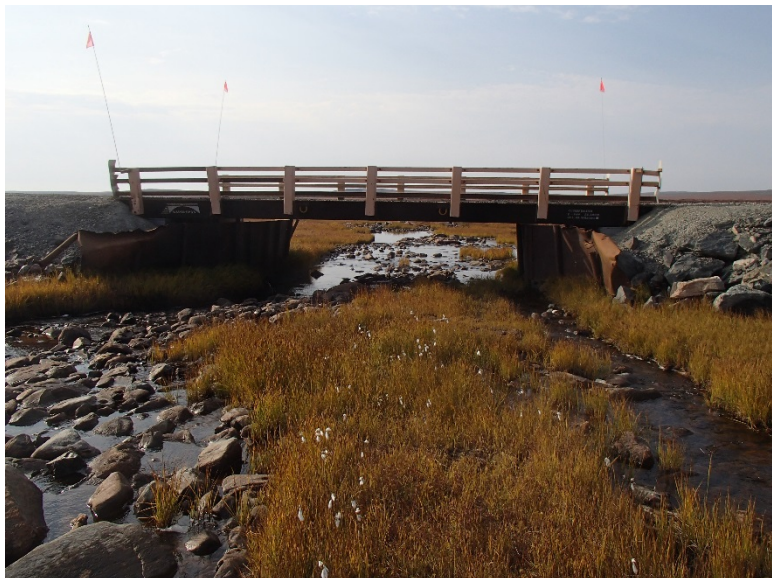
Photograph D2-27 Bridges 9 – R19 km 83+150

Description: Looking at the bridge from the upstream side.

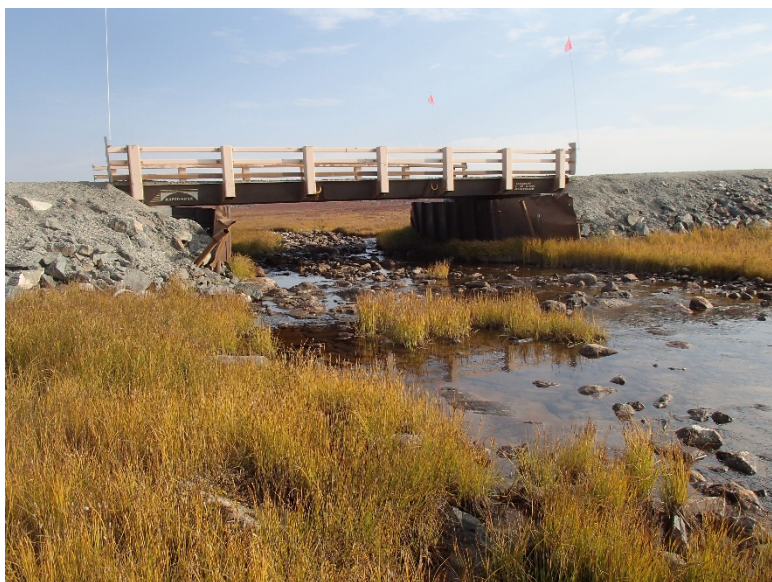
Photograph D2-28 Bridges 9 – R19 km 83+150

Description: Looking at the bridge from the downstream side.

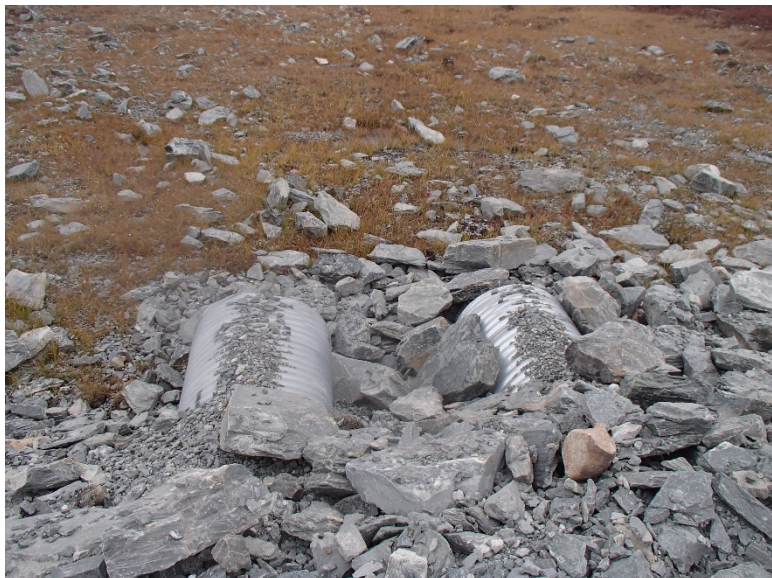
Photograph E1-1: Culvert #39 km 9+193

Description: View of culvert inlet, damaged in the middle.

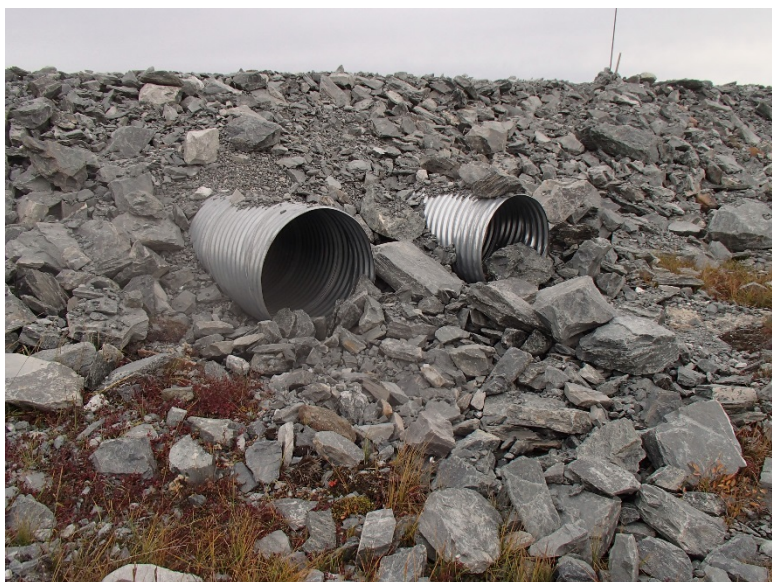
Photograph E1-2: Culvert #39 km 9+193

Description: View of culvert outlet, damaged in the middle.

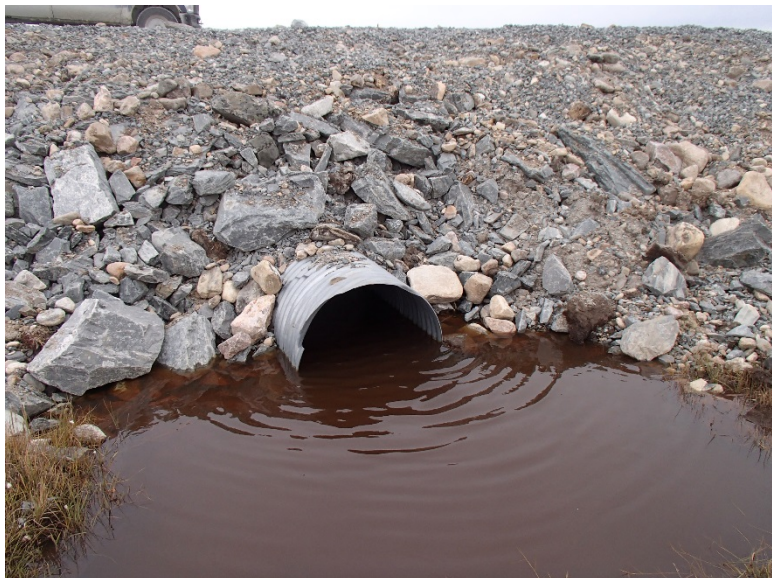
Photograph E1-3: Culvert #60 km 12+775

Description: View of culvert outlet, in good condition.

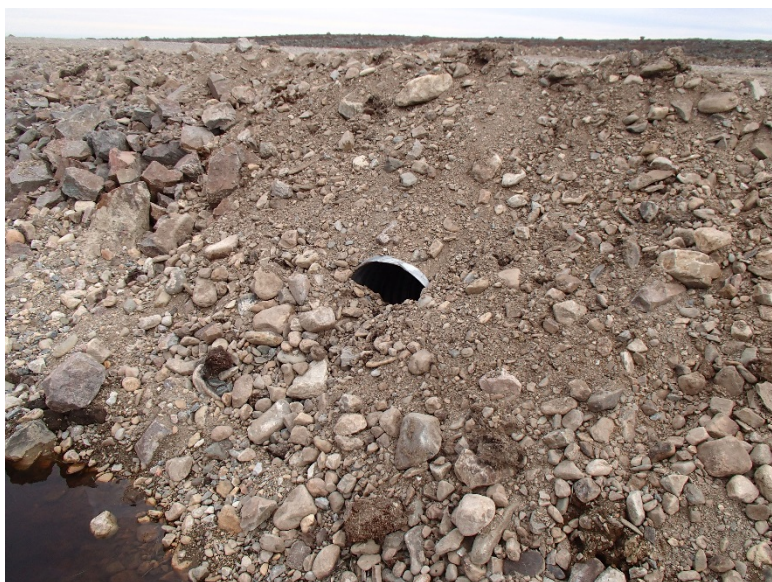
Photograph E1-4: Culvert #86 km 20+740

Description: View of culvert outlet, buried.

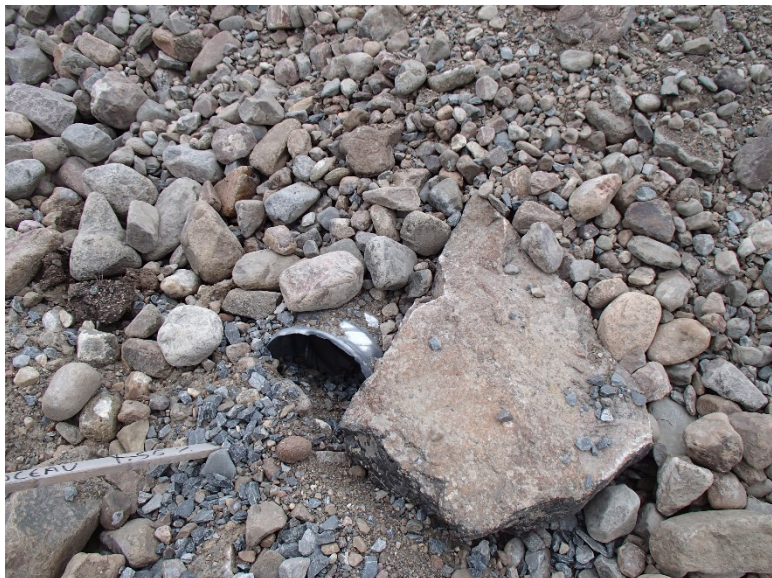
Photograph E1-5: Culvert #115 km 26+865

Description: View of culvert outlet, partially buried.

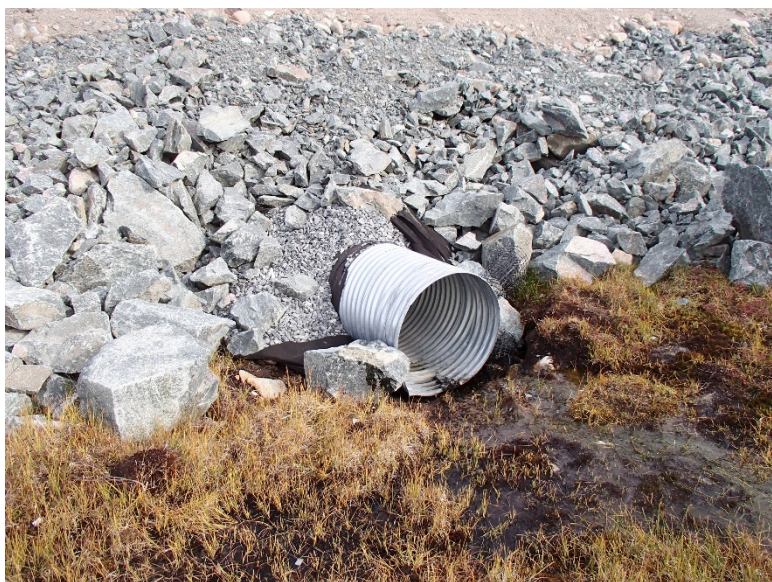
Photograph E1-6: Culvert #167 km 41+843

Description: View of culvert inlet, water is flowing underneath.

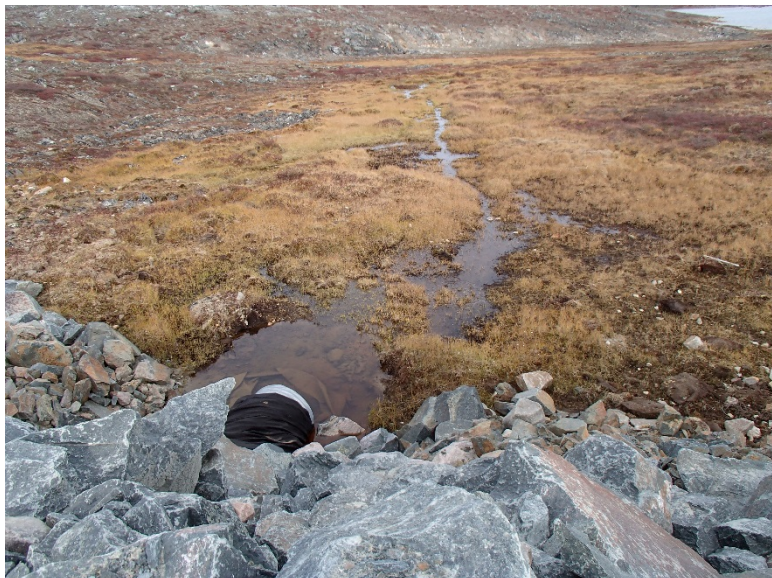
Photograph E1-7: Culvert #167 km 41+843

Description: View of culvert outlet, in good condition.

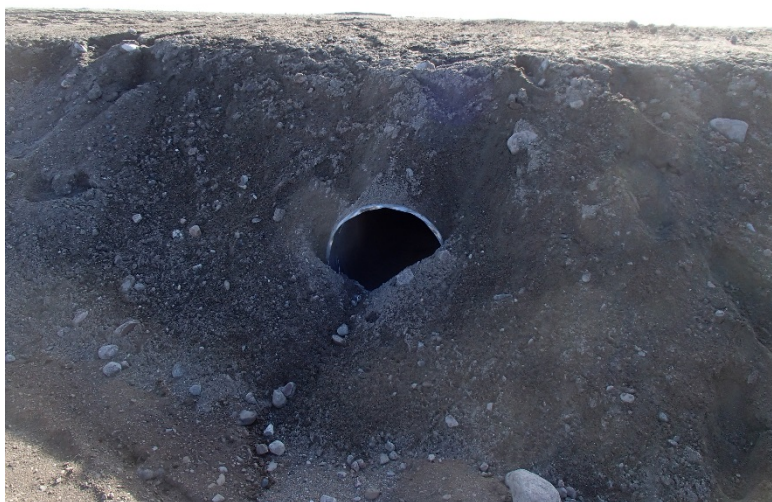
Photograph E1-8: Culvert #203 km 48+800

Description: View of culvert outlet, partially buried.
