APPENDIX G2 MEADOWBANK TANK FARM PHOTOGRAPHIC LOG

2017 ANNUAL GEOTECHNICAL INSPECTION
MEADOWBANK GOLD MINE, NUNAVUT

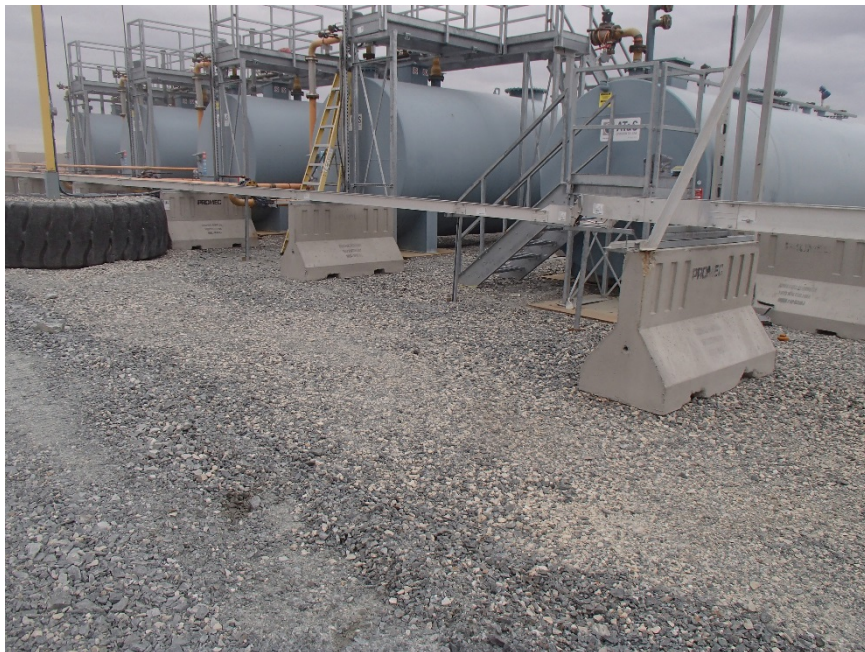
Photograph G3-1 Vault Tank Farm

Description: From the southeast corner of the Tanks looking northwest toward the Vault Tank Farm.

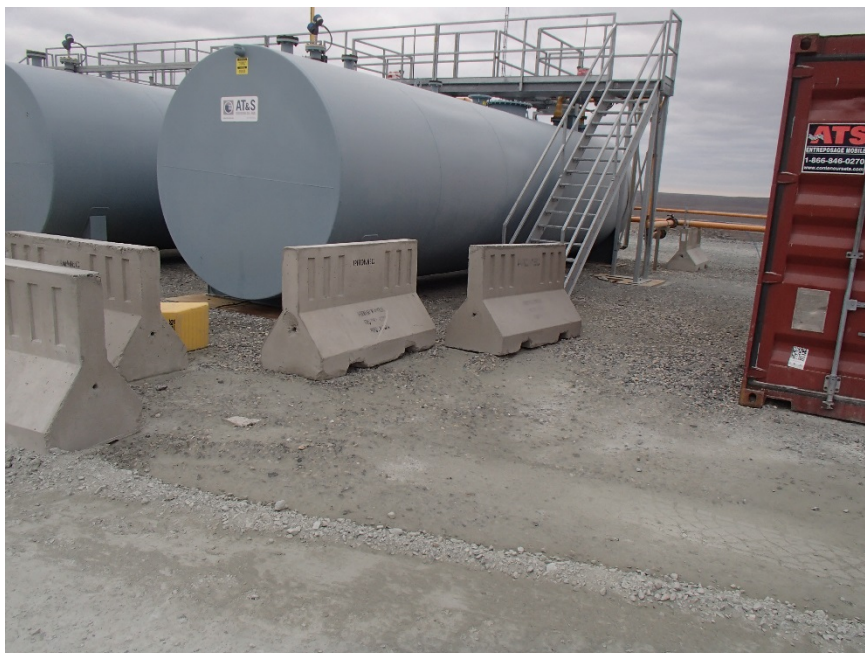
Photograph G3-2 Vault Tank Farm

Description: From the northwest corner of the Tanks Looking northeast toward the Vault Tank Farm.

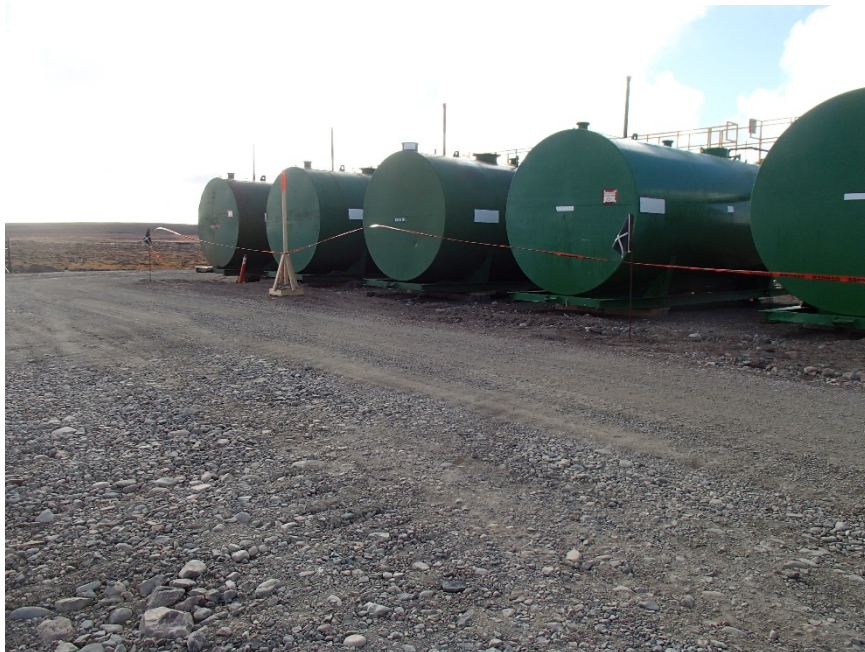
Photograph G4-1 Amaruq Tank Farm

Description: From the northeast side of the Tanks looking south toward the Amaruq Tank Farm.

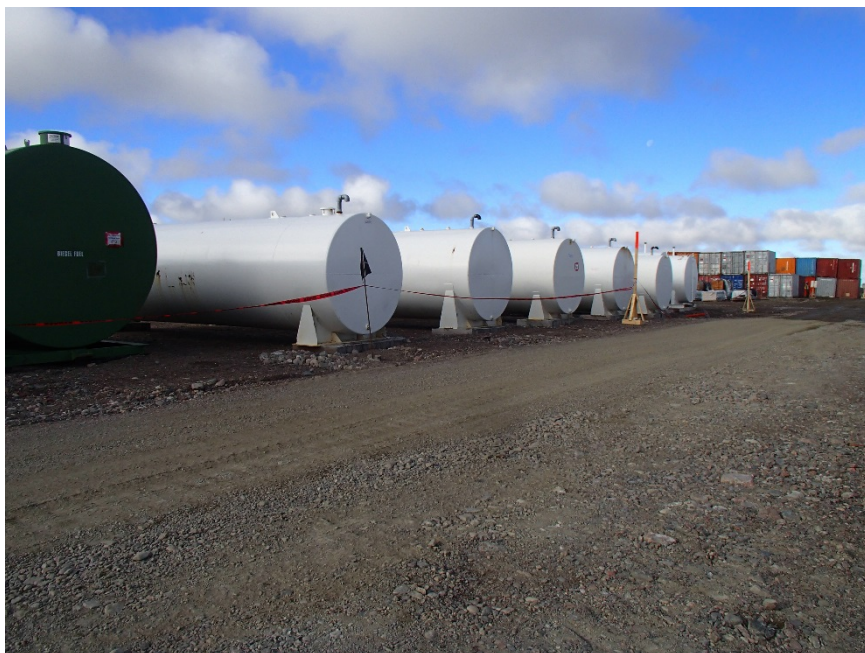
Photograph G4-2 Amaruq Tank Farm

Description: From the northeast side of the Tanks looking west toward the Amaruq Tank Farm.

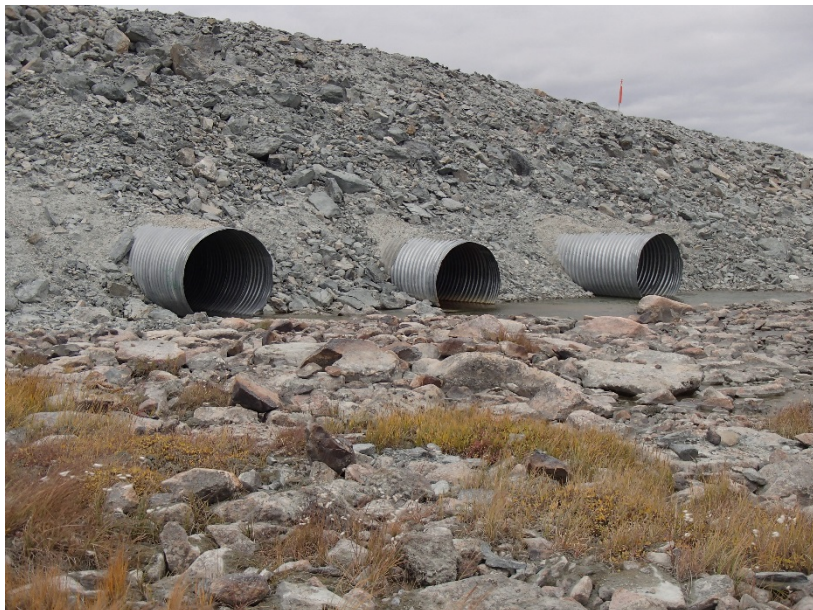
Photograph H1-1 Vault Road Culverts

Description: Looking at the outlet of the three culverts located on Vault Road at 640964E/7217466N. All of them are deformed in the middle.

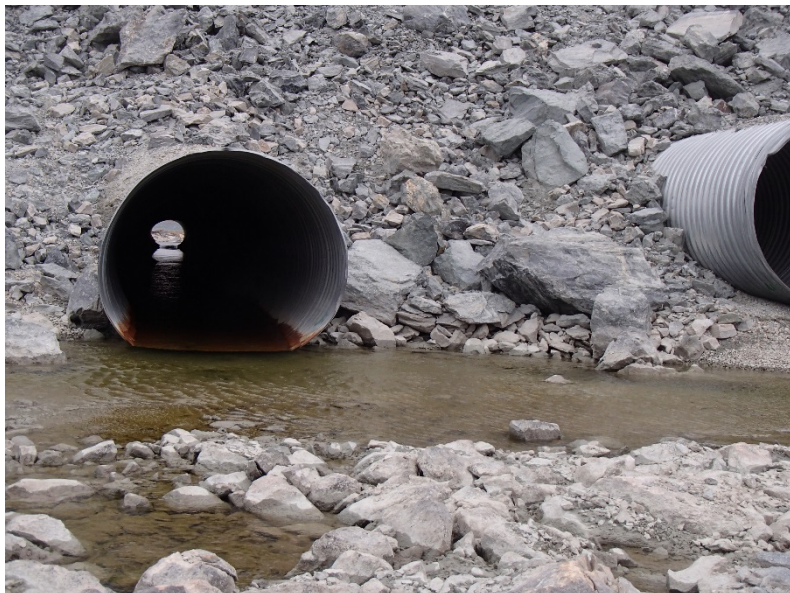
Photograph H1-3 Vault Road Culverts

Description: From the inlet side of the three culverts located on Vault Road at 640964E/7217466N. Looking inside the central culvert. The culvert is slightly deformed on top in the middle.

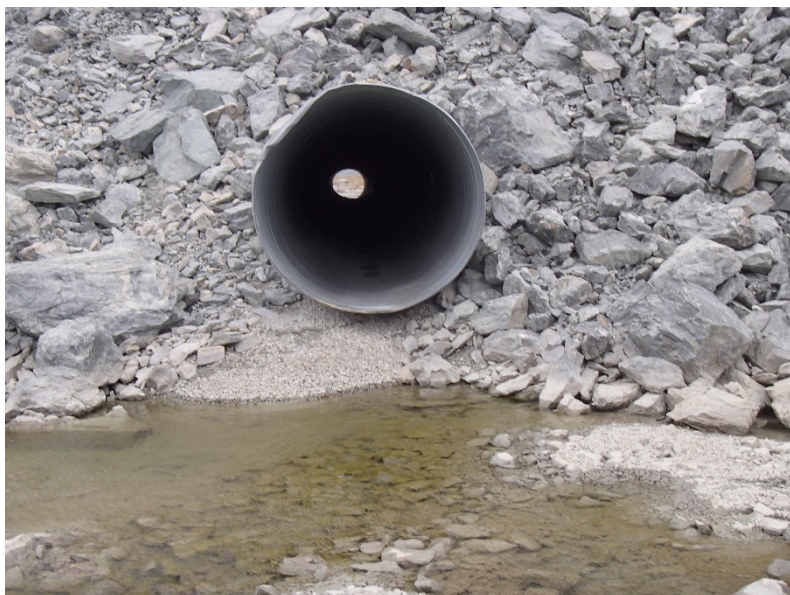
Photograph H1-4 Vault Road Culverts

Description: From the inlet side of the three culverts located on Vault Road at 640964E/7217466N. Looking inside the northern culvert. The culvert is slightly deformed on top in the middle.
