Bay-Goose Dike Photographic Log and Record of Inspection

**2017 ANNUAL GEOTECHNICAL INSPECTION
MEADOWBANK GOLD MINE, NUNAVUT**

APPENDIX A3 RECORD OF DAM INSPECTION

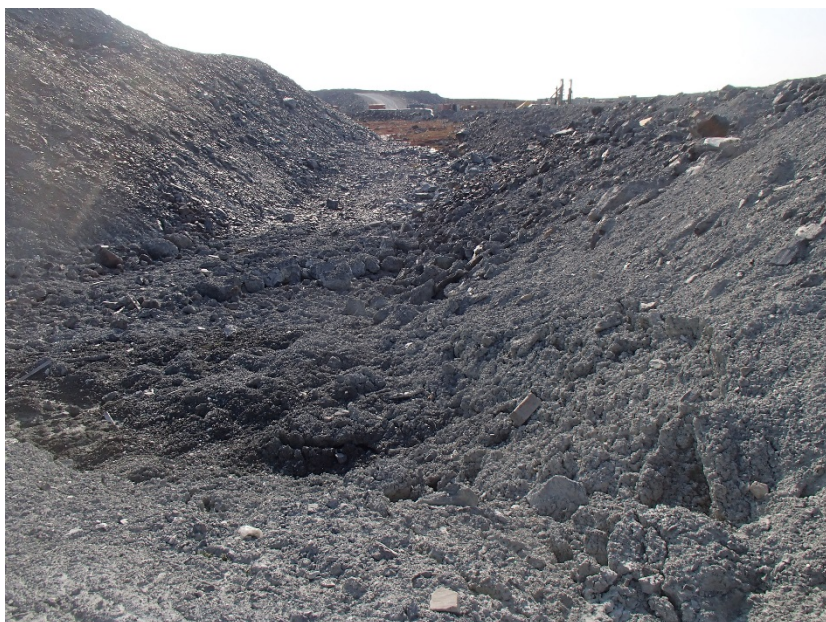
Photograph A2-5 South Camp Dike

Description: From the north abutment, looking south at the downstream slope.

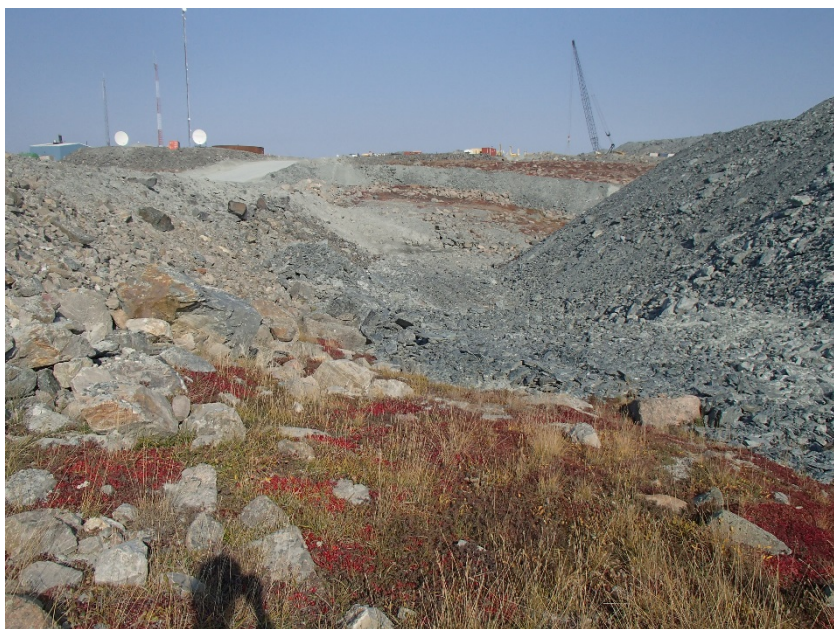
Photograph A2-6 South Camp Dike

Description: From the south abutment, looking north at the downstream slope.

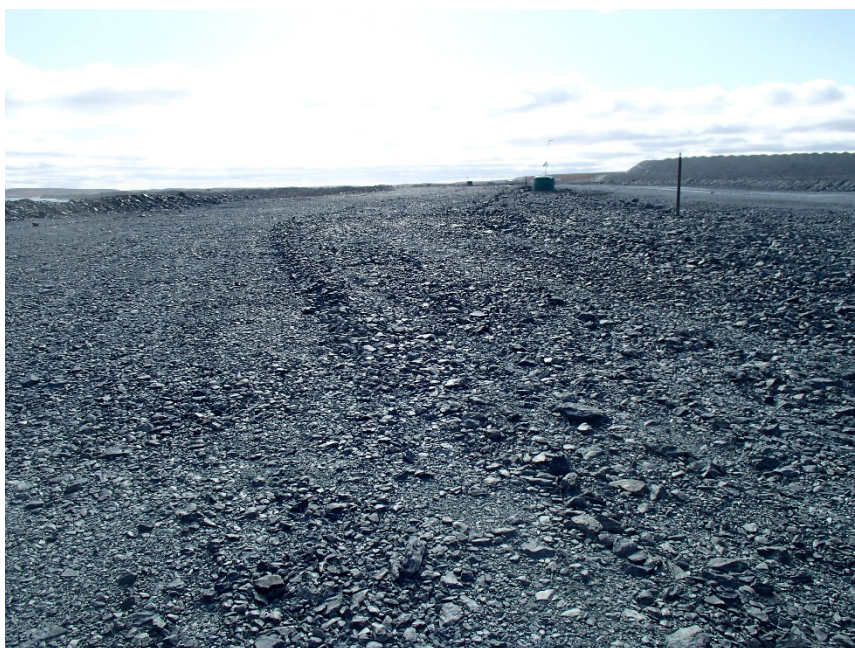
Photograph A3-1 Bay Goose Dike

Description: From approximately Sta. 30+142 (north abutment) looking southwest at the crest.

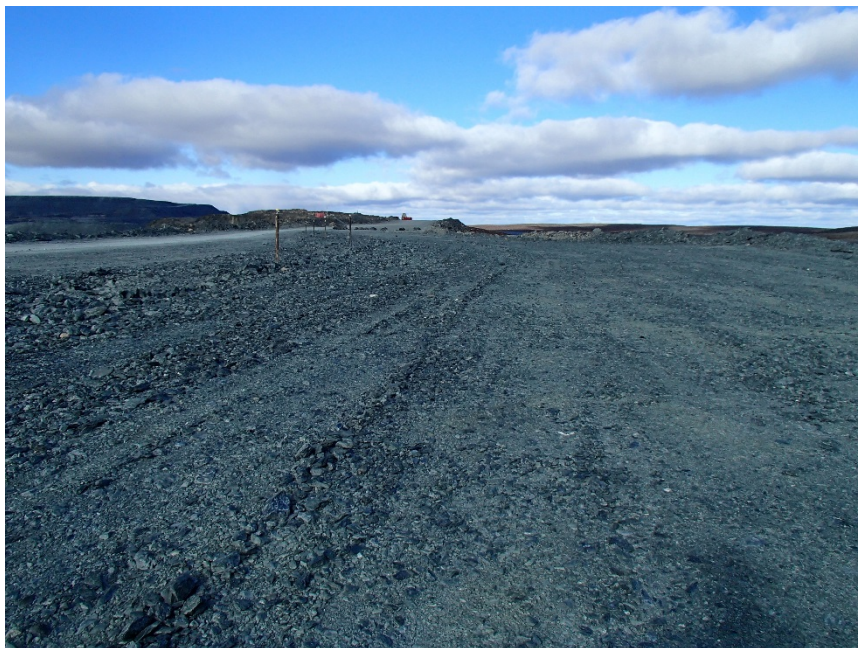
Photograph A3-2 Bay Goose Dike

Description: From approximately Sta. 30+130 (north abutment), looking north at the crest.

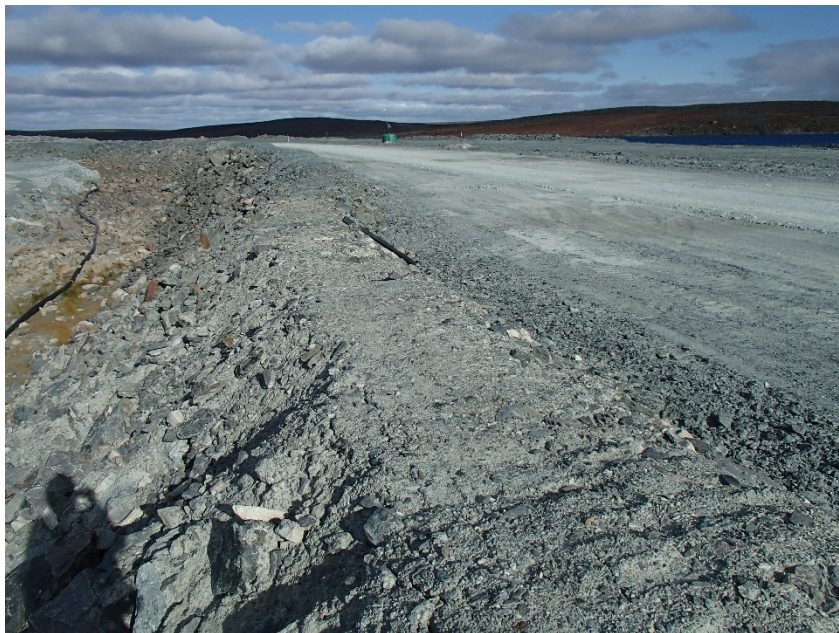
Photograph A3-3 Bay Goose Dike

Description: From approximately Sta. 30+340 on the crest, looking northeast at the dam crest and downstream slope

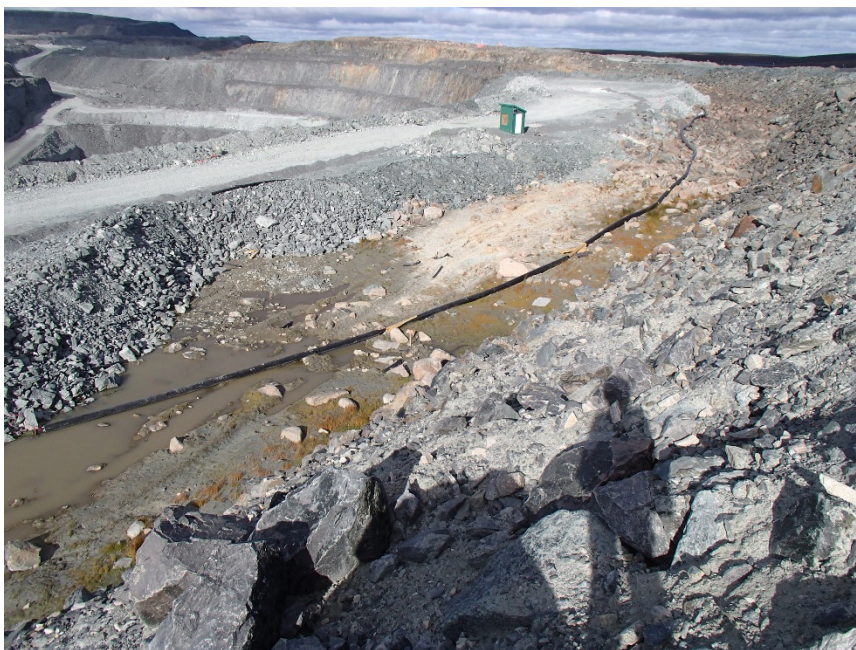
Photograph A3-4 Bay Goose Dike

4.1 Seepage from dike	Yes		Seepage zone observed as well as water pond. The seepage is being monitored by the mine and does not show signs of aggravation.
	North Channel	325, 329	Monitored by stations 8 (30+420) and 9 (30+380). Water flowing was observed during the inspection.
	Central Shallow	319	Presence of 2 seepage channels at 30+650 and 30+625. Flow was observed during inspection at 30+650. Monitored by station 7.

Description: From approximately Sta. 30+340, looking northwest at the north seepage channel.

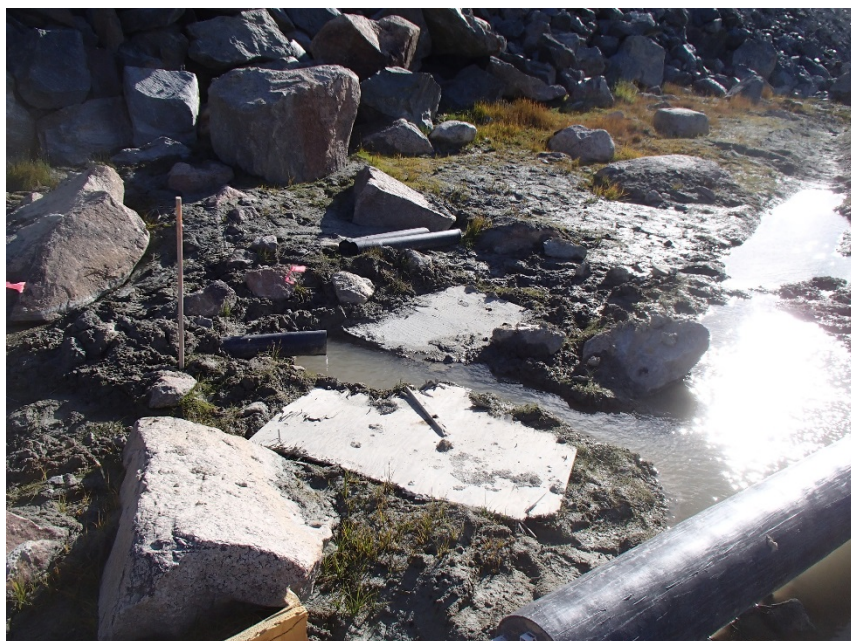
Photograph A3-5 Bay Goose Dike

Description: From approximately Sta. 30+325 downstream, looking southwest at the North Channel.

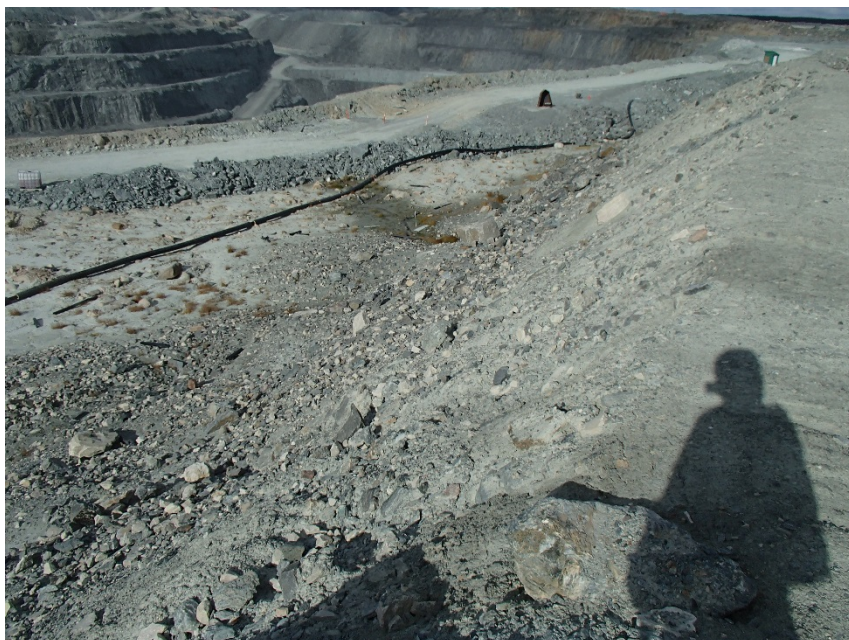
Photograph A3-6 Bay Goose Dike

Description: From approximately Sta. 30+450, looking north at the crest and the downstream slope.

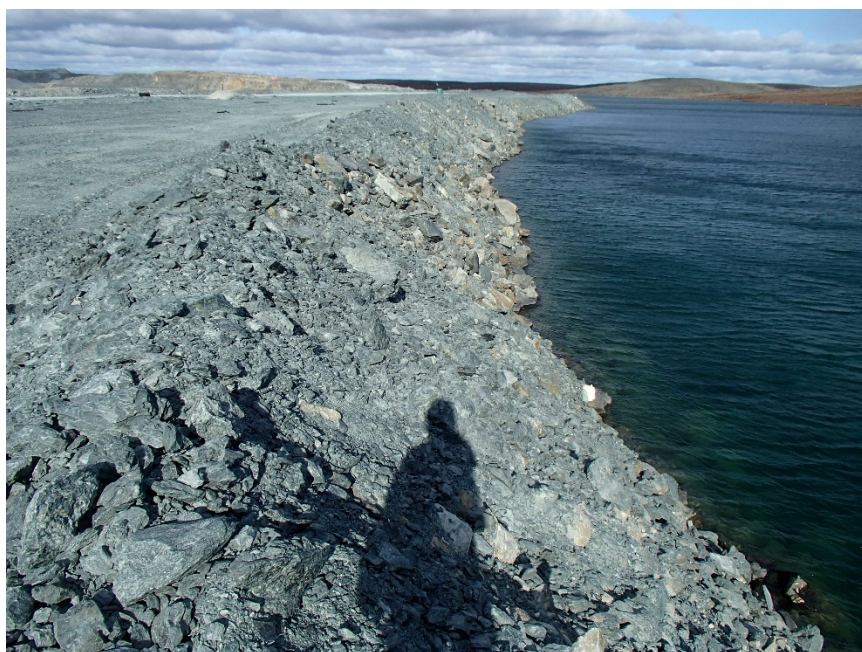
Photograph A3-7 Bay Goose Dike

Description: From Sta. 30+500, looking northeast at the crest and the upstream slope.

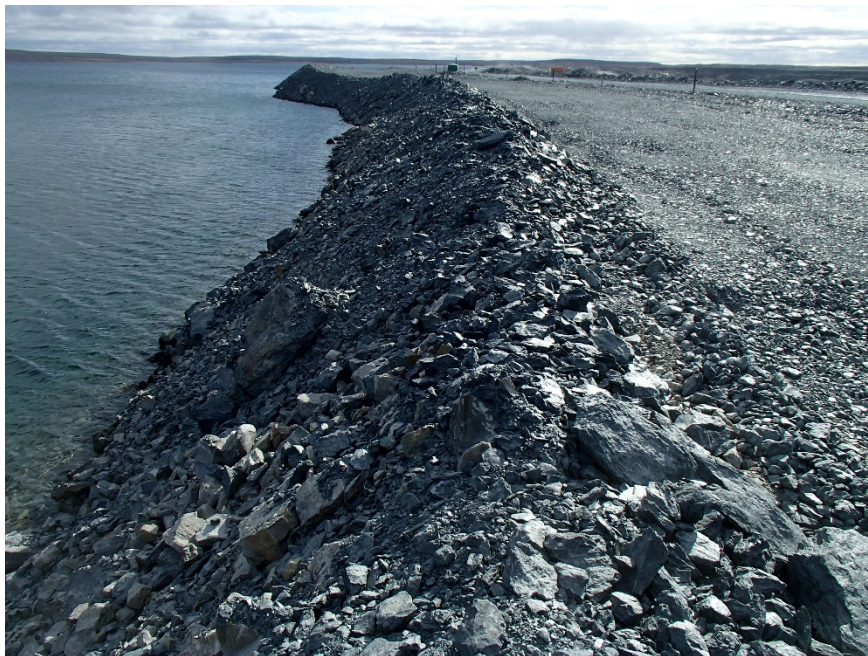
Photograph A3-8 Bay Goose Dike

Description: From Sta. 30+500, looking south at the crest and the upstream slope.

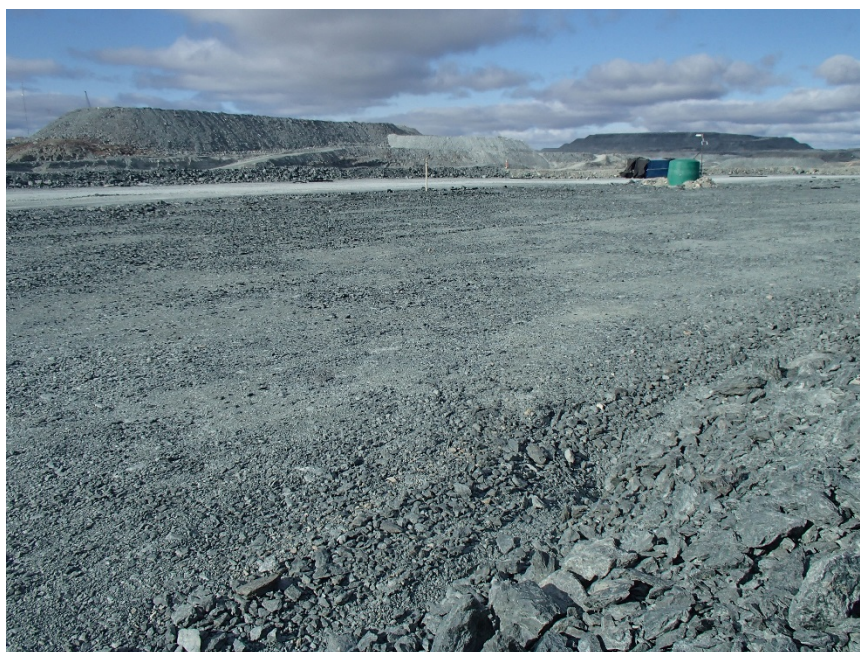
Photograph A3-9 Bay Goose Dike

Description: From Sta. 30+500, looking west at the downstream slope.

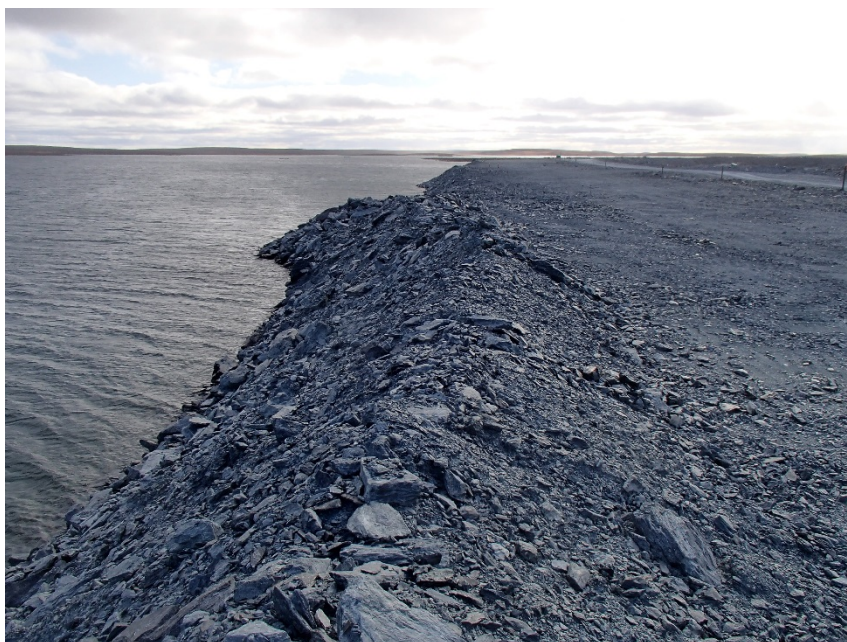
Photograph A3-10 Bay Goose Dike

Description: From Sta. 30+700, looking south at the crest and the upstream slope.

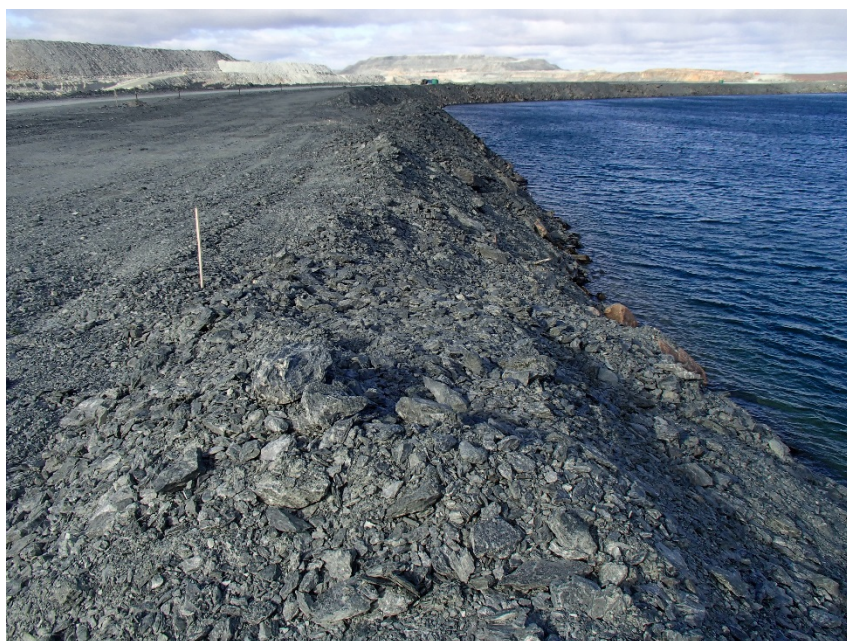
Photograph A3-11 Bay Goose Dike

Description: From approximately Sta. 30+680, looking north at the crest and the upstream slope.

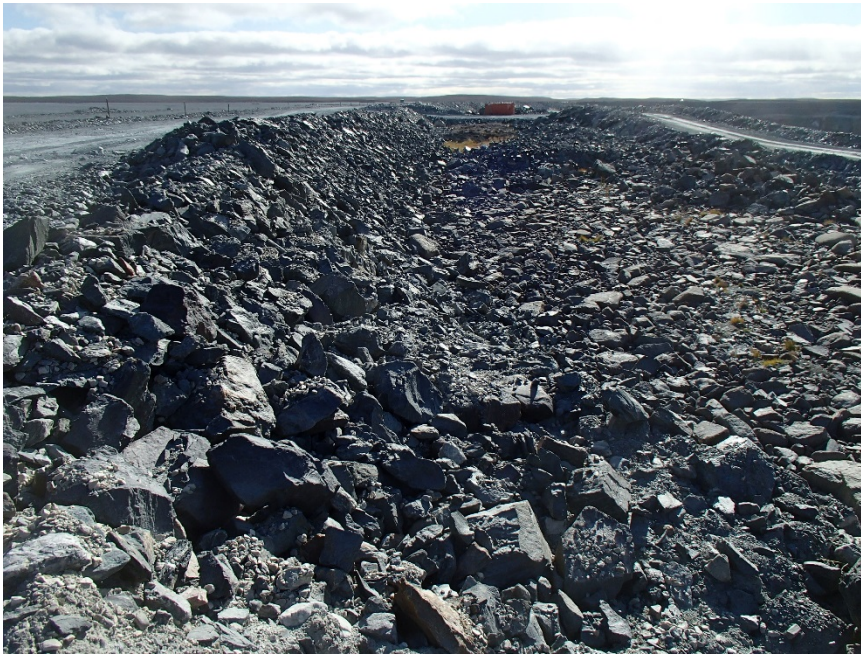
Photograph A3-13 Bay Goose Dike

Description: From approximately Sta. 30+680 on the crest, looking south at the downstream slope and toe.

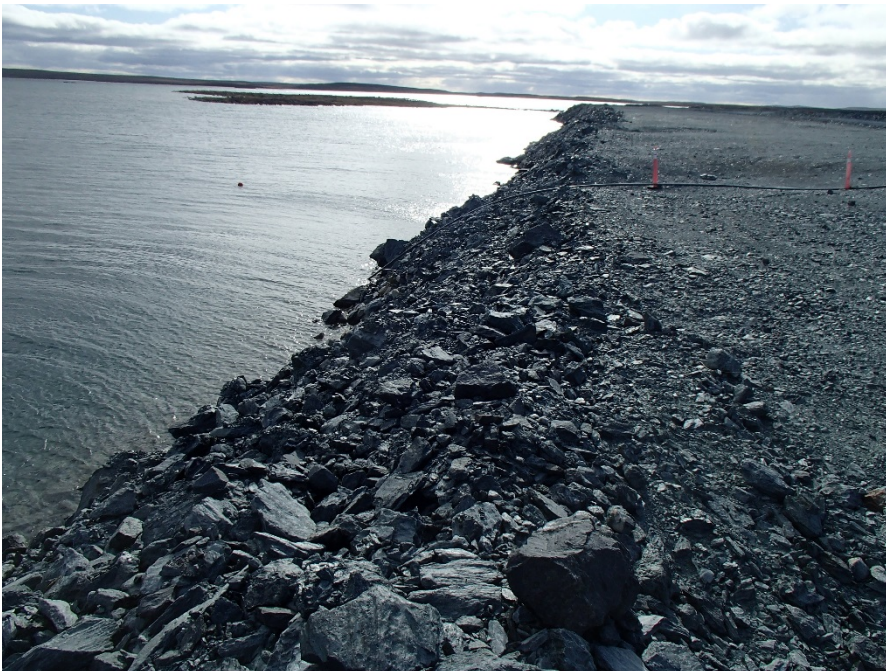
Photograph A3-14 Bay Goose Dike

Description: From approximately Sta. 31+130, looking south at the crest and upstream slope.

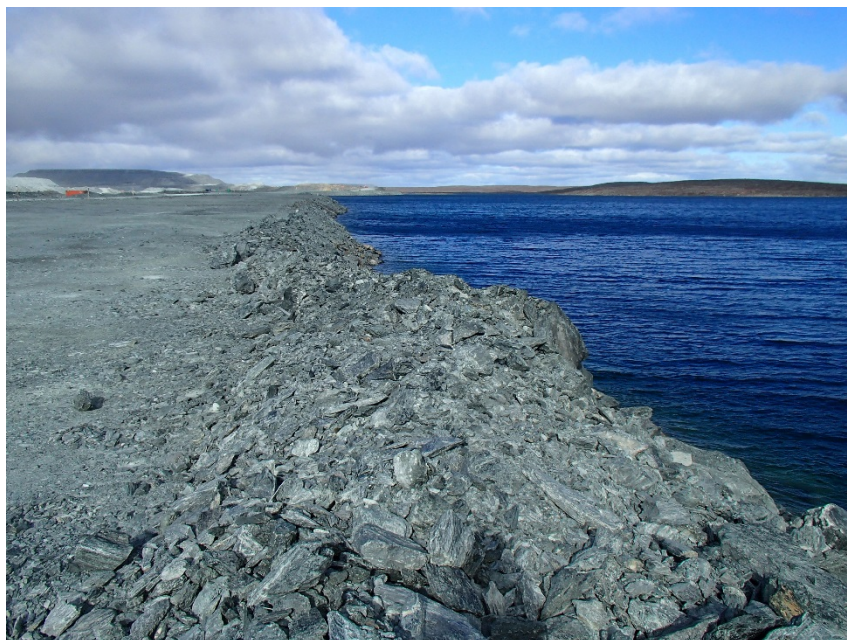
Photograph A3-15 Bay Goose Dike

Description: From approximately Sta. 31+130, looking north at the crest and upstream slope.

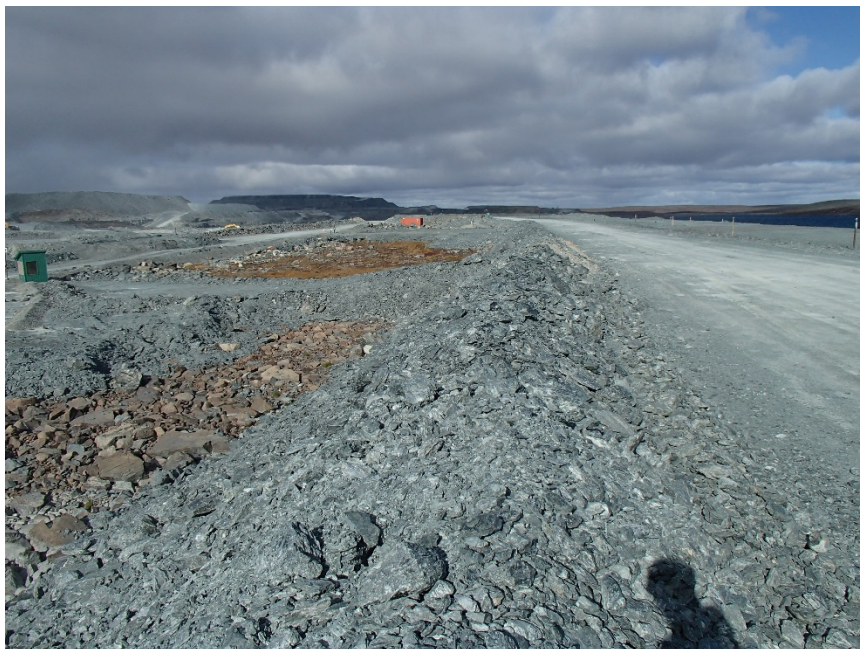
Photograph A3-16 Bay Goose Dike

Description: From approximately Sta. 31+080 on the crest, looking north at the downstream slope and toe.

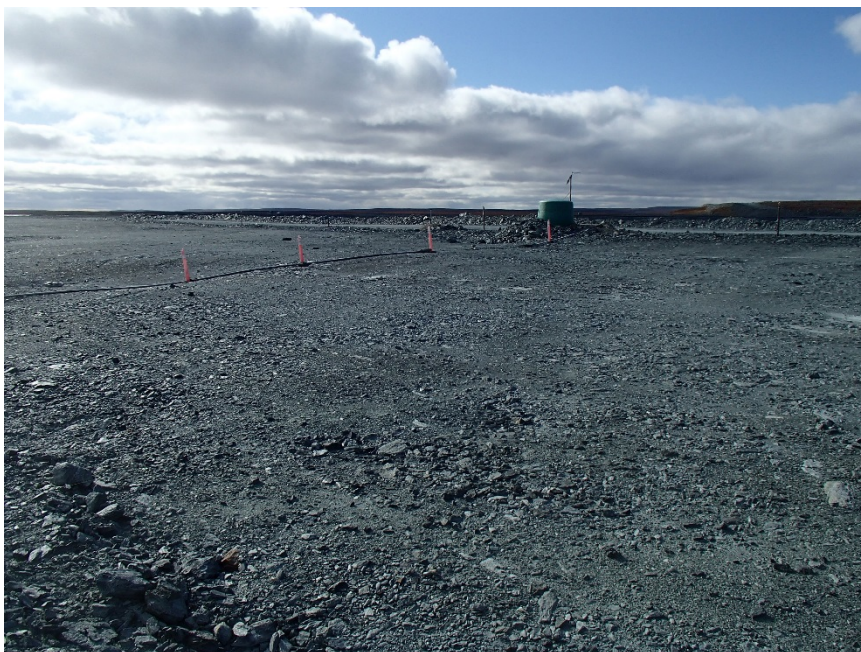
Photograph A3-18 Bay Goose Dike

Description: From approximately Sta. 31+130, looking southwest at the crest.

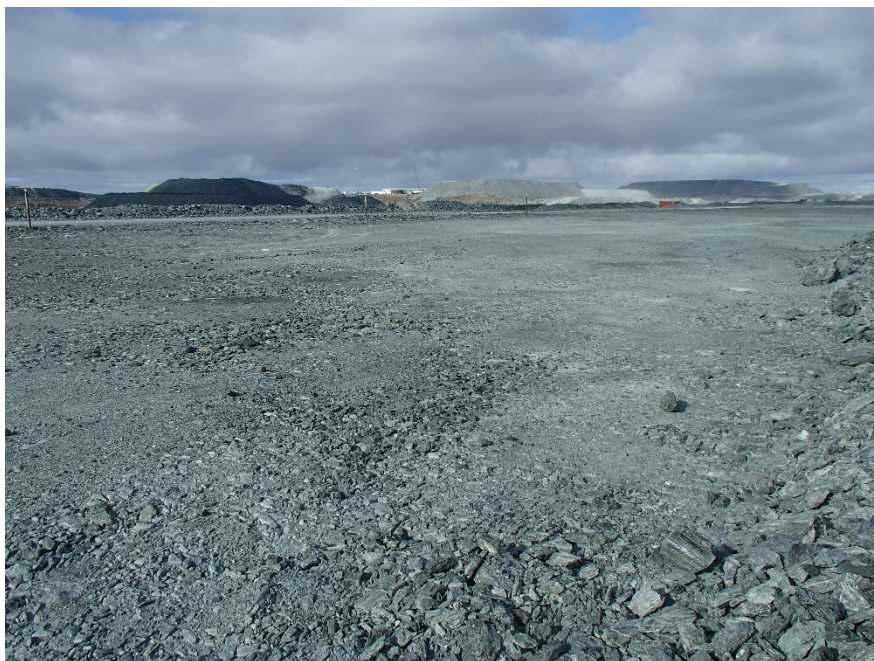
Photograph A3-19 Bay Goose Dike

Description: From approximately Sta. 31+130, looking north at the crest.

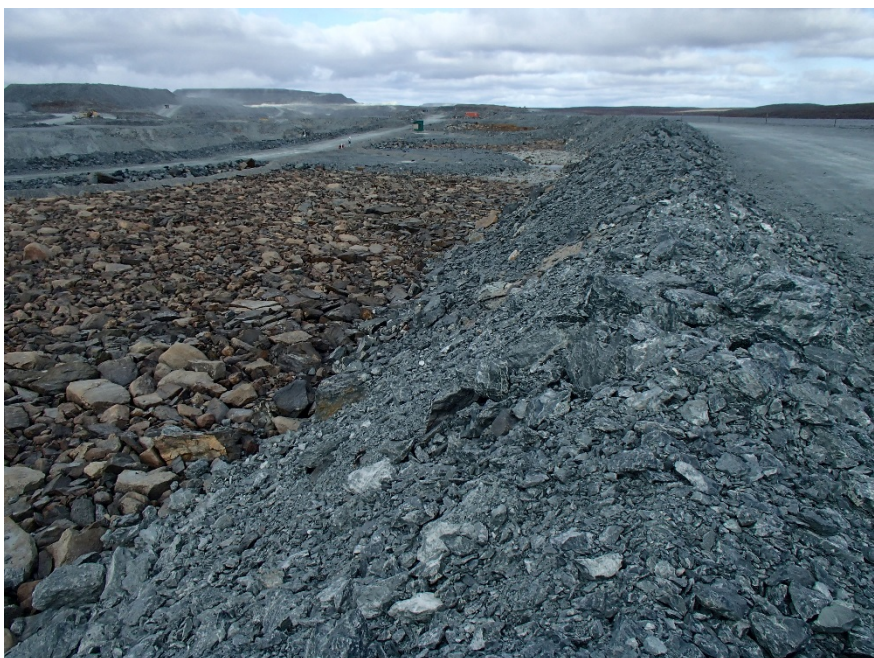
Photograph A3-20 Bay Goose Dike

Description: From approximately Sta. 31+280 on the crest, looking north at the downstream slope and toe area.
