SADDLE DAM 1 PHOTOGRAPHIC LOG

Saddle Dam 2 Photographic Log and Record of Inspection

Stormwater Dike Photographic Log and Record of Inspection

2017 ANNUAL GEOTECHNICAL INSPECTION
MEADOWBANK GOLD MINE, NUNAVUT

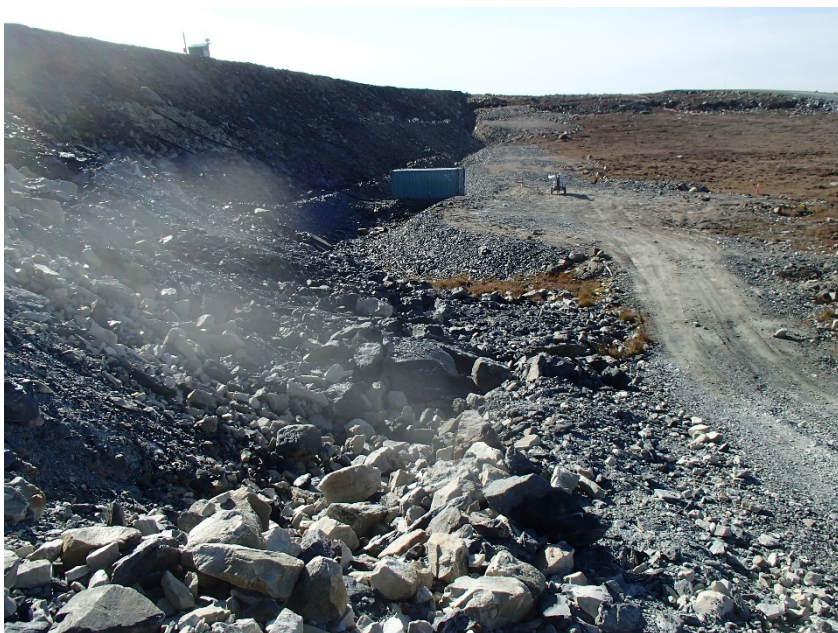
Photograph B2-2 Saddle Dam 1

Description: From Sta. 0+150 looking south at the downstream face. Notice the sea-can container where a sump is installed.

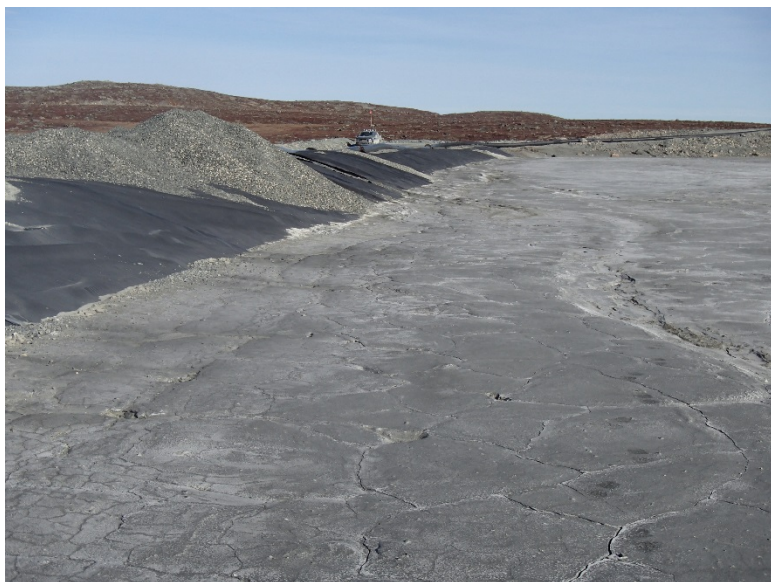
Photograph B2-7 Saddle Dam 1

Description: From approximately Sta. 0+195 upstream, looking north at the upstream slope. Adequate tailings beach against SD1.

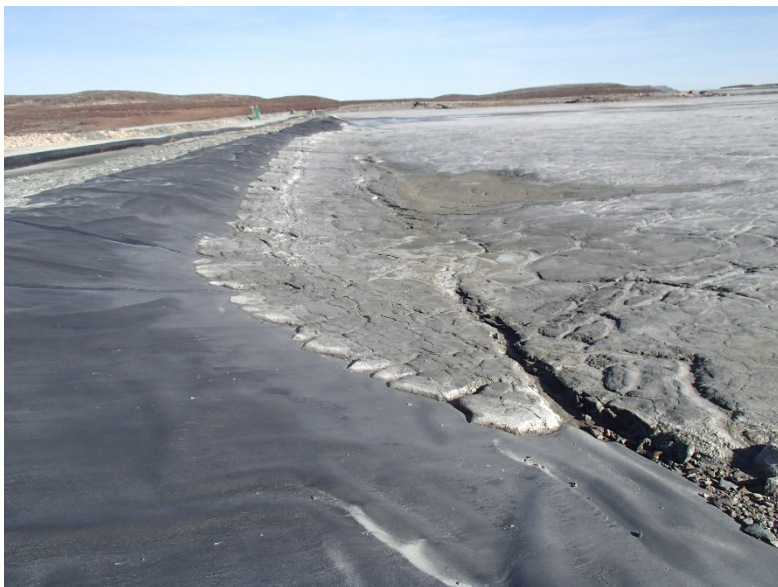
Photograph B2-8 Saddle Dam 1

Description: From the south abutment looking north at the upstream slope. Adequate tailings beach against SD1.

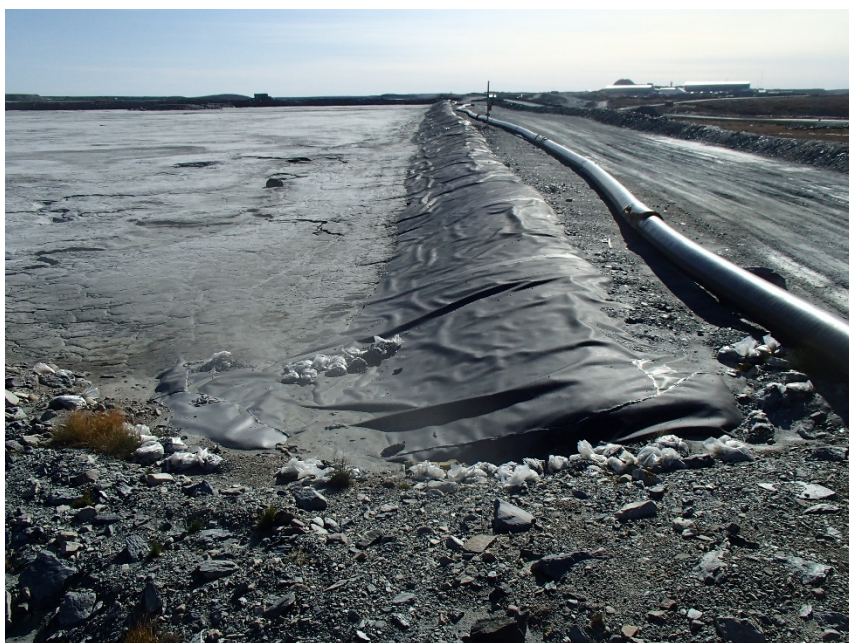
Photograph B3-1 Saddle Dam 2

Description: From Saddle Dam 2 (approximately Sta. 20+110) looking southeast at the crest and upstream slope of Saddle Dam 2. The tailings beach against SD2 is adequate.

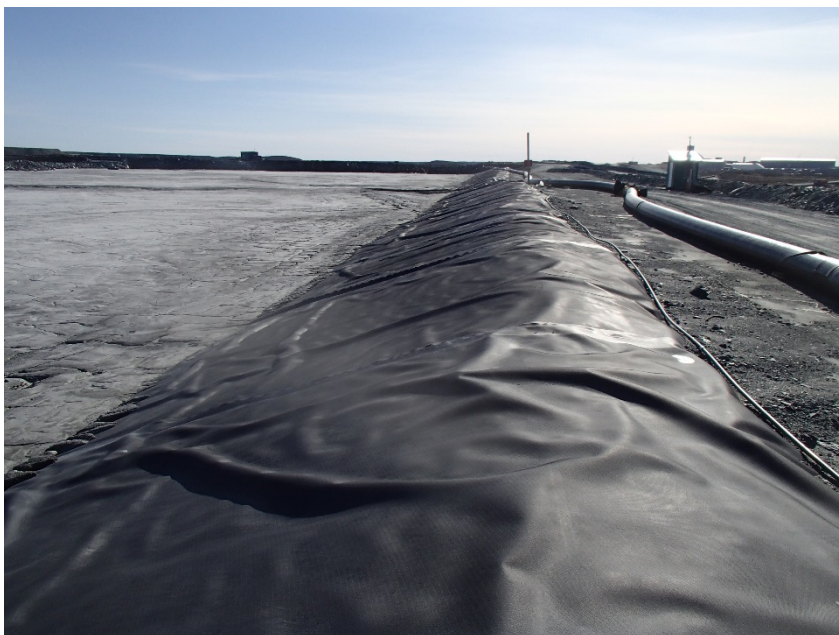
Photograph B3-2 Saddle Dam 2

Description: From approximately Sta. 20+370 looking southeast at the crest and upstream slope.

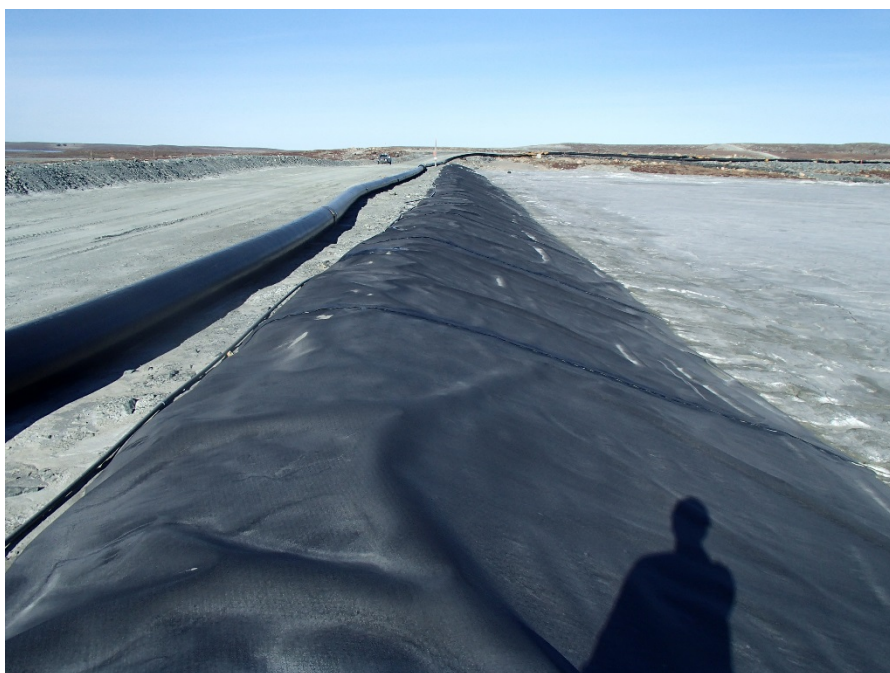
Photograph B3-3 Saddle Dam 2

Description: From approximately Sta. 20+370 looking northwest at the crest and upstream slope.

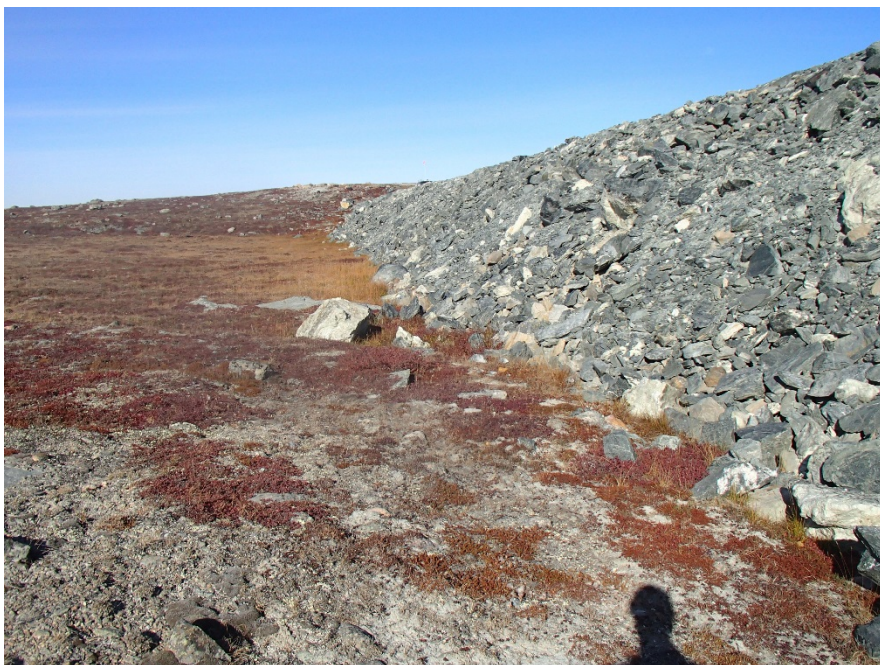
Photograph B3-4 Saddle Dam 2

4.6 Other unusual conditions	Yes		Water is still ponding within the rockfill embankment between 20+275 to 20+475 approximately.
5. ABUTMENTS			
5.1 Seepage at contact zone (abutment/embankment)	None observed

Description: From approximately Sta. 20+210 downstream, looking northwest at the downstream toe.

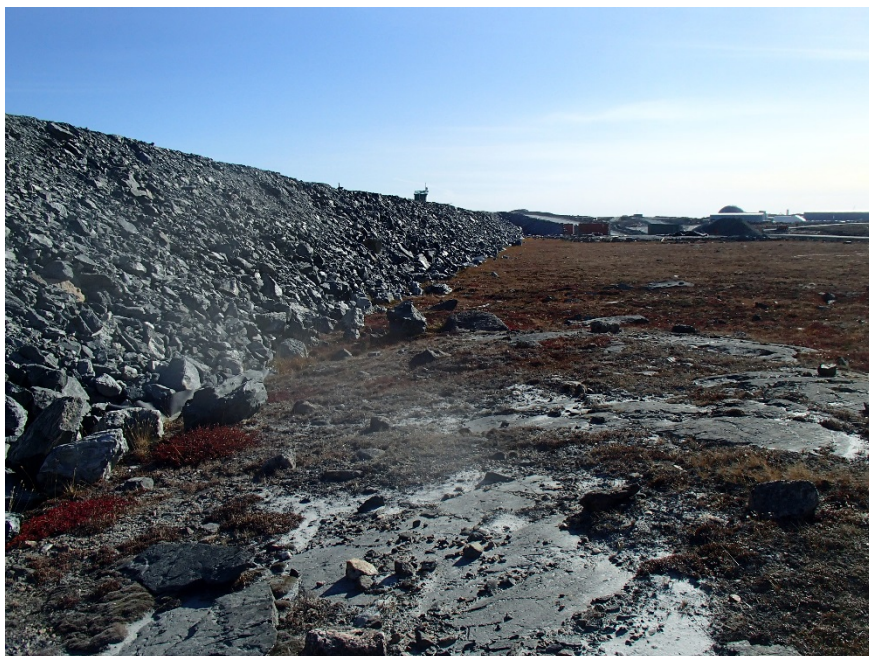
Photograph B3-5 Saddle Dam 2

Description: From approximately Sta. 20+210 downstream, looking southeast at the downstream toe.

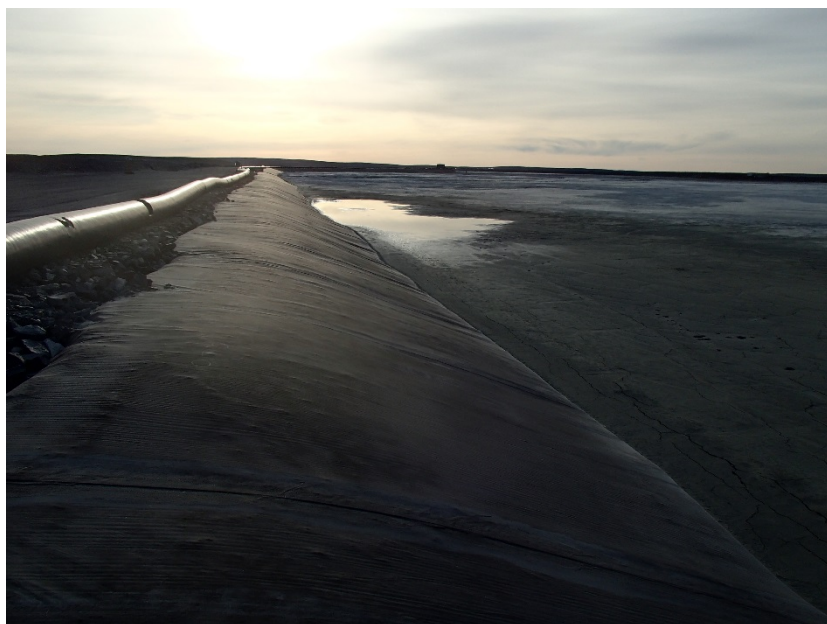
Photograph B4-1 Stormwater Dike

1.3 Distance to tailings pond (if applicable)	Adequate (North Cell)		Adequate beach in place all along the dike on North Cell. Some shallow water ponding against dike in some places (from 10+550 to 10+950 approximately). Water has reached the toe of the structure in the South Cell.

Description: From the east abutment (11+100 approximately), looking west at the upstream face. Shallow water ponding against portion of the dike (less than 30 cm deep). The tailings beach is considered adequate.

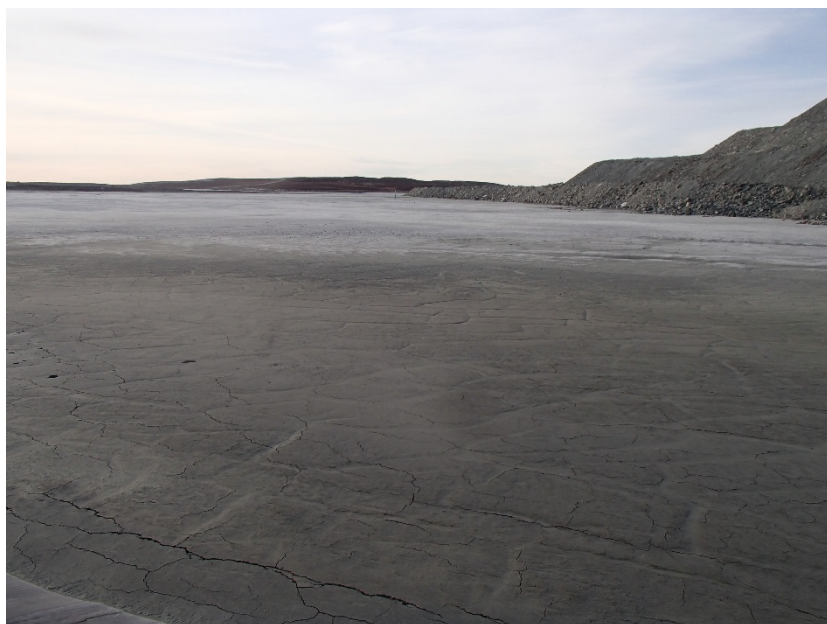
Photograph B4-2 Stormwater Dike

Description: From the east abutment (11+100 approximately), looking northwest at the North Cell.

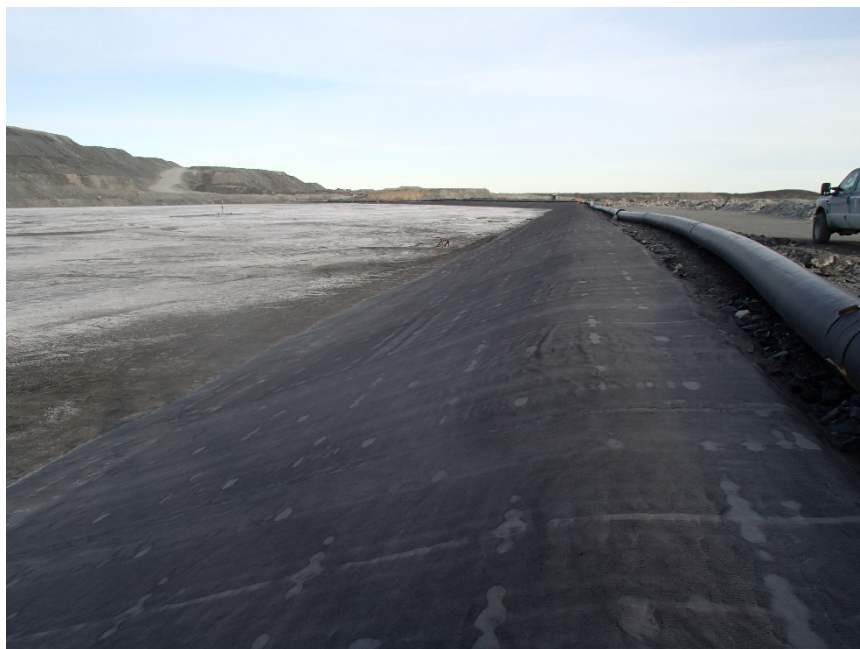
Photograph B7-5 Stormwater Dike

Description: From approximately Sta. 10+450 looking east at the upstream slope. Adequate tailings beach.

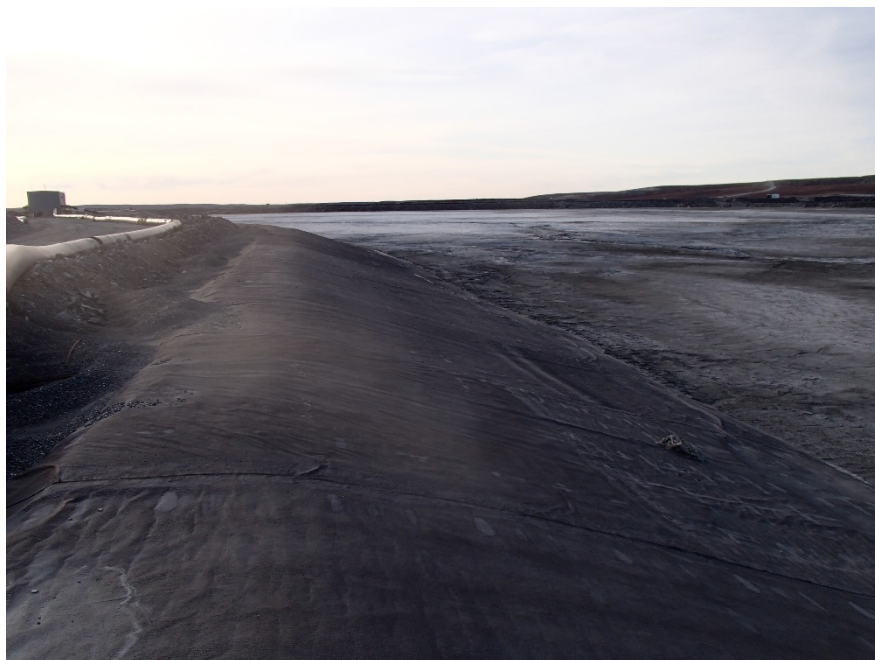
Photograph B7-6 Stormwater Dike

Description: From approximately Sta. 10+450 looking west at the upstream slope. Adequate tailings beach.

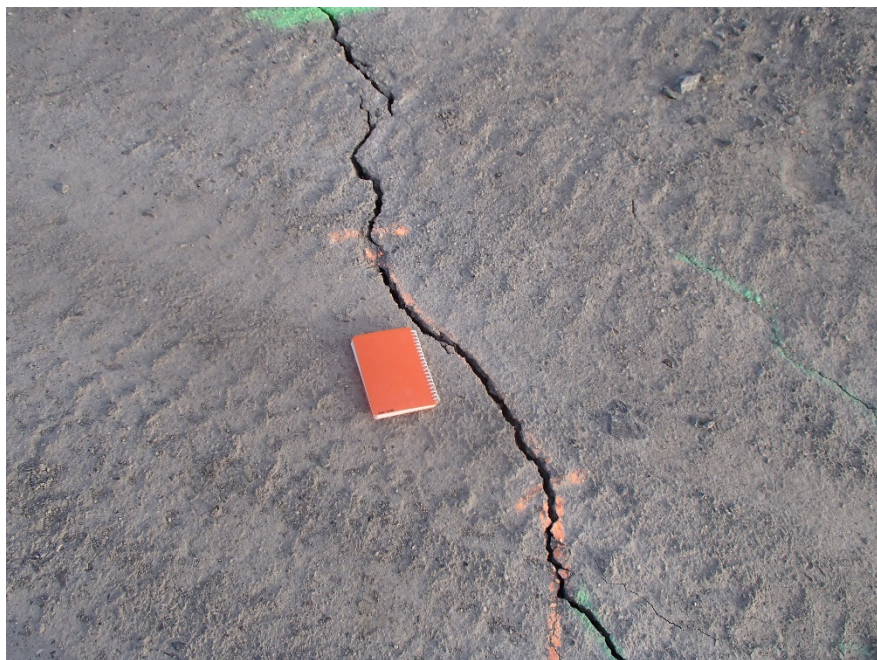
Photograph B7-8 Stormwater Dike

1.4 Surface cracking	Yes	619	Tension cracks and unexpected movement were observed (oblique tension cracks extending side to side). They are concentrated from 10+850 to 11+025 and appeared in late June after the freshet. No movement has been observed in the zone where a buttress was constructed at the toe in the South Cell. The buttress is covered by the pond.

1.5 Unexpected settlement	Yes (approx. 300 mm)		
1.6 Lateral movement	Yes		
1.7 Other unusual conditions			
2. UPSTREAM SLOPE		610, 611, 612, 613, 616	
2.1 Slope angle	Approx. 3H:1V		Rockfill

Description: From approximately Sta. 10+875. Depression of about 300 mm with several fractures oblique to the dike.

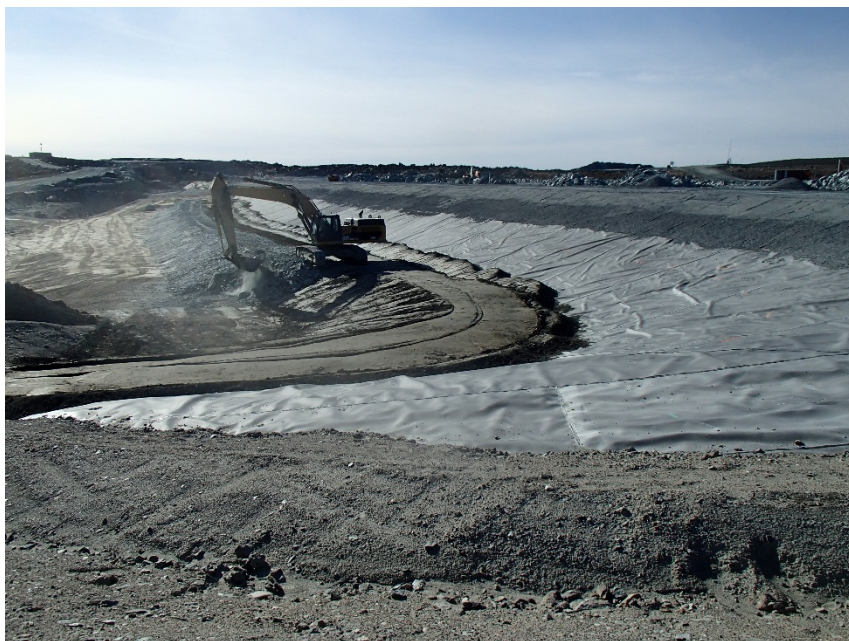
Photograph B5-1 Saddle Dam 3

Description: From approximately Sta. 20+610 looking south at the upstream slope.

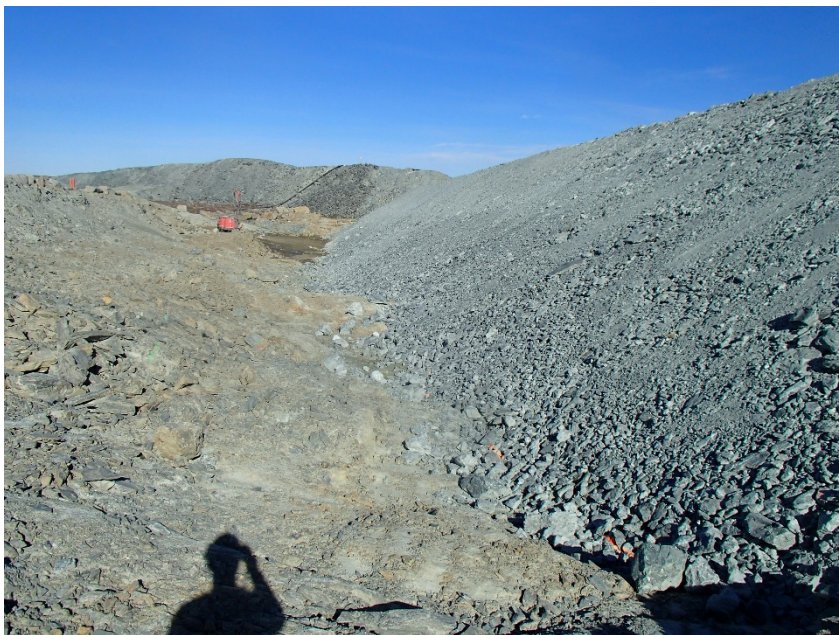
Photograph B5-2 Saddle Dam 3

4.6 Other Conditions	Yes		A sump was constructed on the downstream side to collect the ponding water, so its level does not exceed the elevation of the granular layer of the upstream toe liner tie-in.

Description: From Sta. 20+750, looking northwest at the downstream slope and toe.

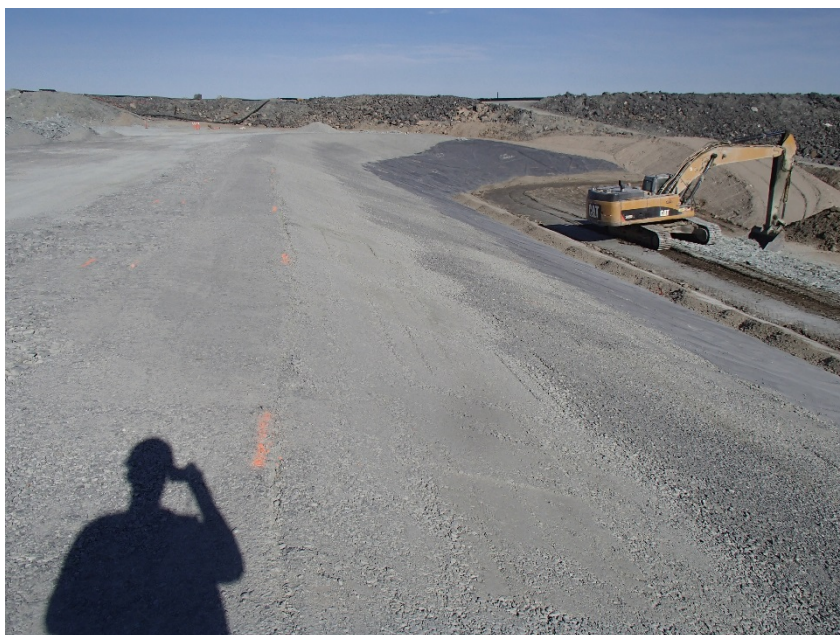
Photograph B5-4 Saddle Dam 3

Description: From Sta. 20+700, looking northwest at the crest and the upstream slope.
