APPENDIX B6

Saddle Dam 4 Photographic Log and Record of Inspection

APPENDIX B6 RECORD OF DAM INSPECTION

Client: AEM **By:** Yves Boulianne
Project: Meadowbank **Date:** September 13, 2017
Location: Saddle Dam 4 **Reviewed:** Yves Boulianne

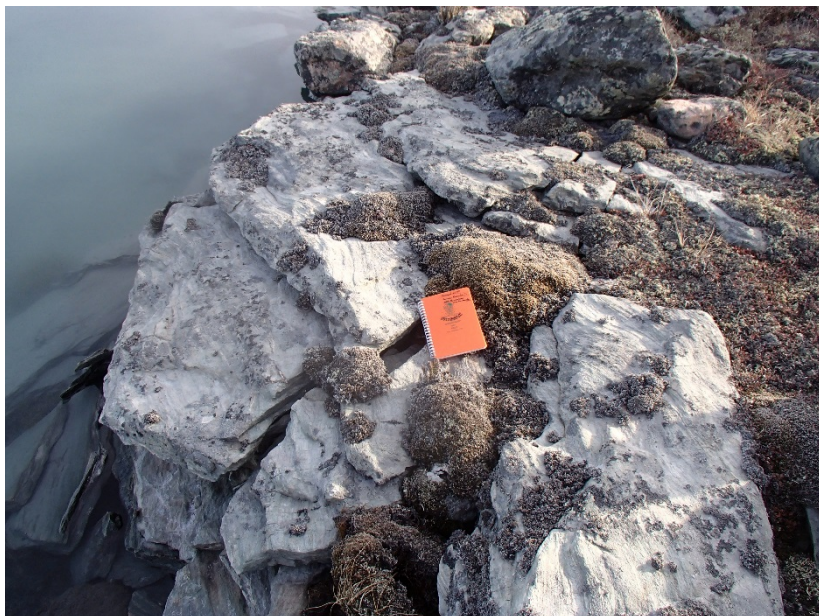
Photograph B6-8 Saddle Dam 4

5. ABUTMENTS		606, 607	
5.1 Seepage at contact zone (abutment/embankment)	None observed	607	Highly fractured bedrock observed at the western abutment.
5.2 Signs of Erosion	None observed

Description: View of the bedrock on the northwestern extremity Saddle Dam 4. Important surface cracks are visible.
