THERMISTOR 545-P1

MDRB # 22 P3 – STORMWATER DIKE UPDATE

Patrice Gagnon
September 4th 2017

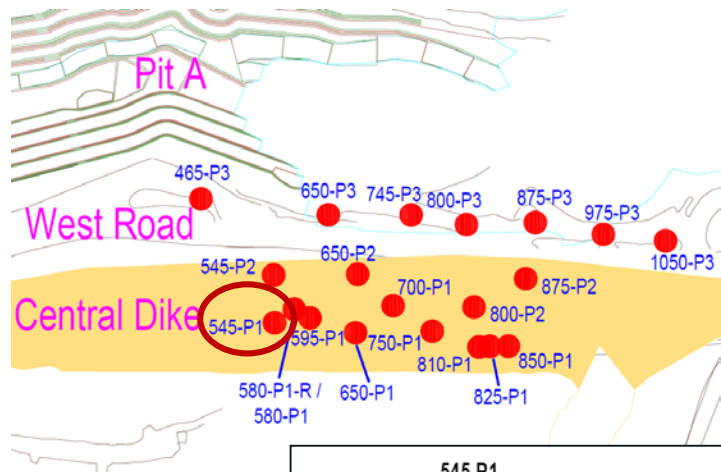
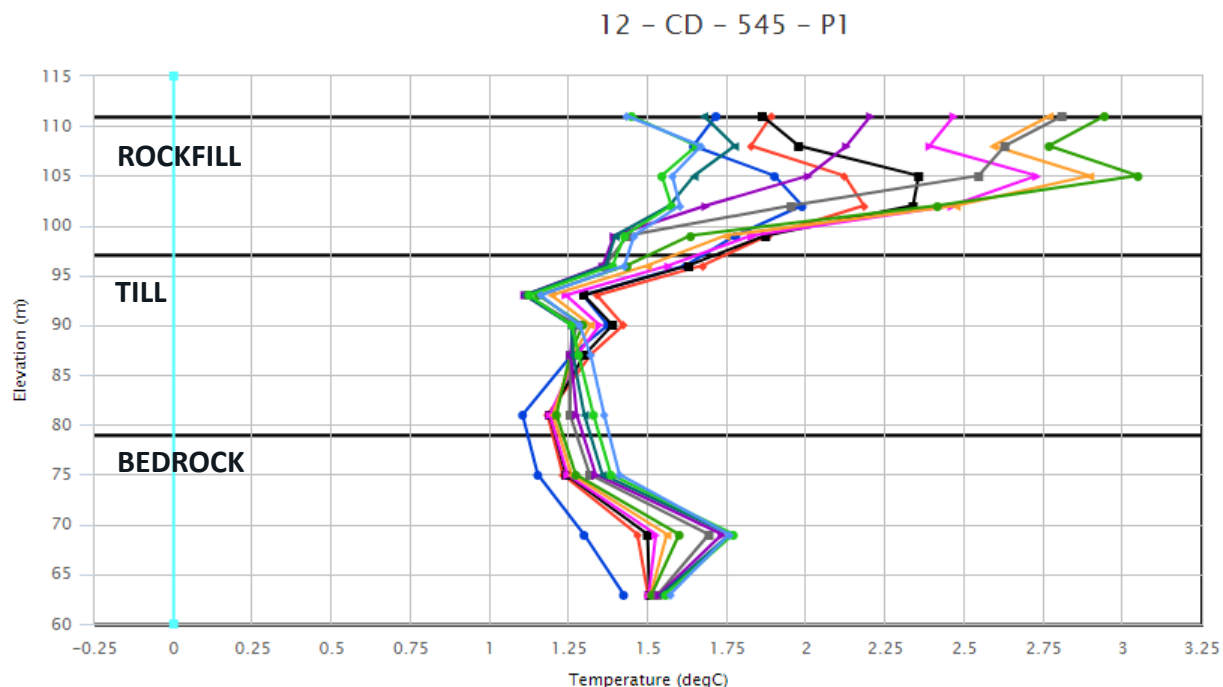
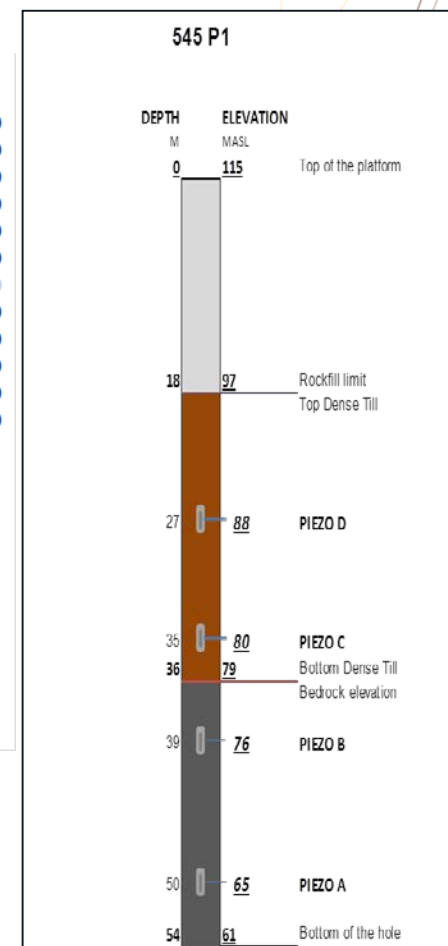
- 545-P1 thermistor is showing the same temperature profile than last year. Warmer peak observed at elevation 70m since the installation.
- Temperature in the bedrock/till unit is in between 1.1 and 1.75° C.

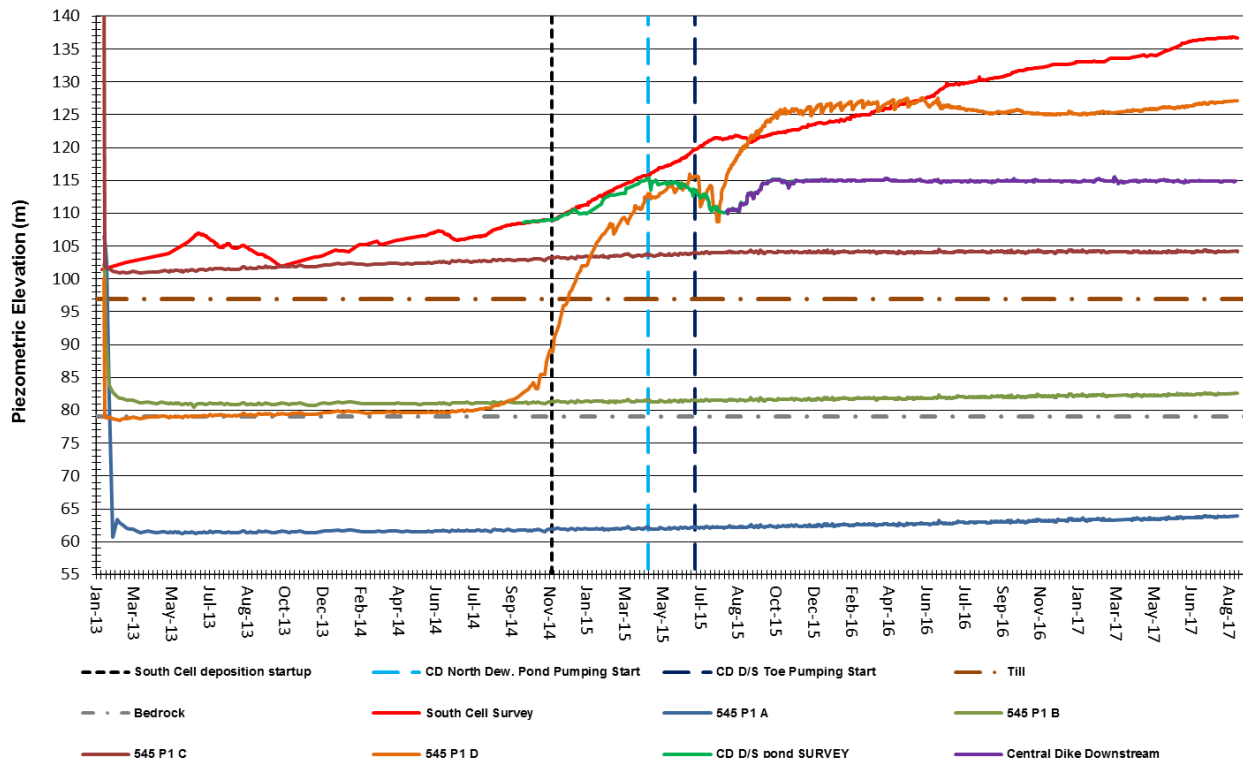
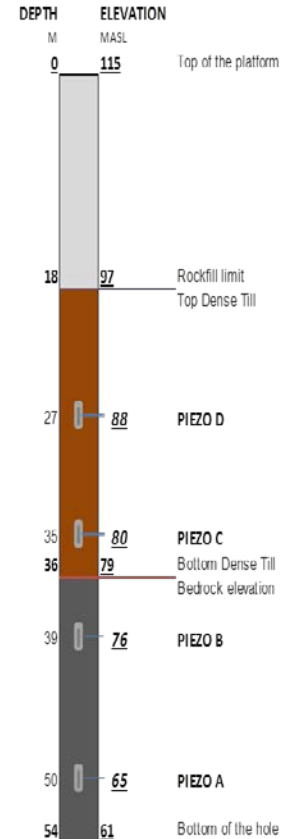
545-P1 Hole - Piezometrics Elevation and Attenuation Pond Elevation vs Time

- Piezometer D still constant, no change since August 2015
- Piezometer A is recording suction since its installation
- Identification of the piezo on the field is confusing. Interpretation of the readings must be done with precaution.

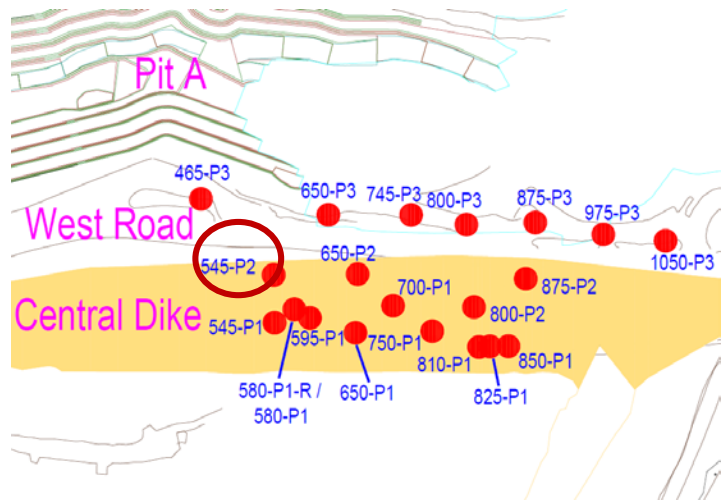
THERMISTOR 545-P2

- Temperature peak observed on the bead located at El. 96m from January 2015 to March 2017;
- In January 2015 readings was switched from manual to automatic;
- In March 2017, AVW multiplexer was changed and temperature profile was back to its original profile;
- Investigation still on going – interpretation of data must be done with precaution.

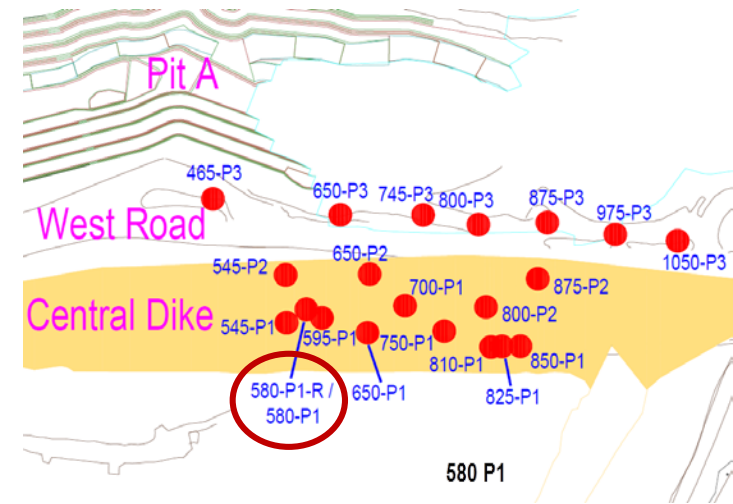
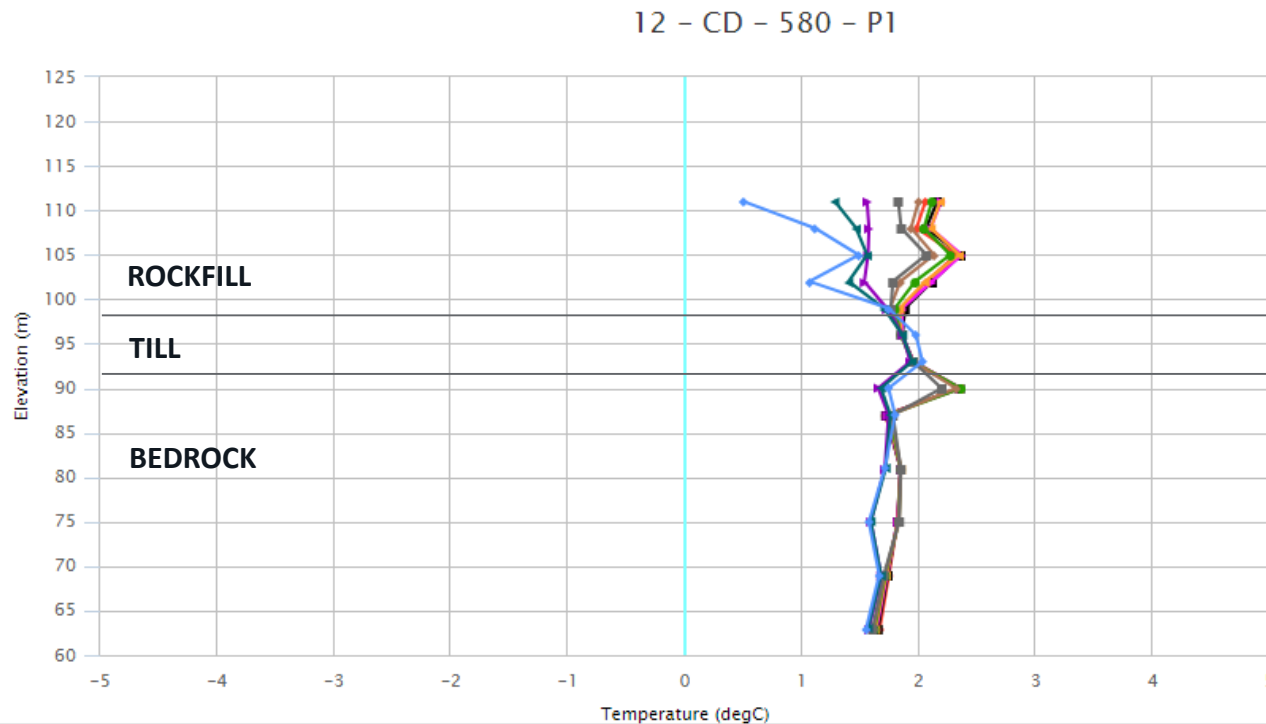
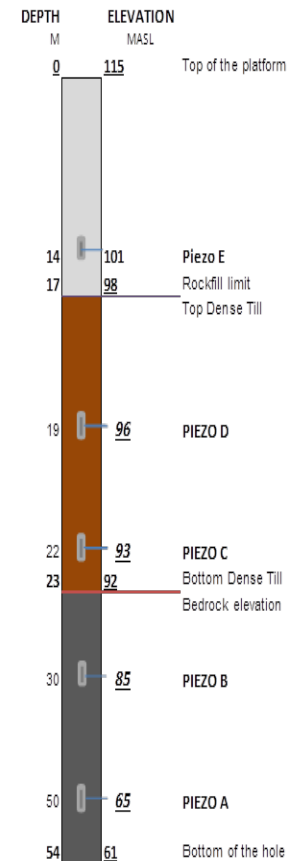
580-P1

- Piezometer and thermistance readings are not functional since July 2016
- Replacement hole 580-P1R drilled during 2017 campaign

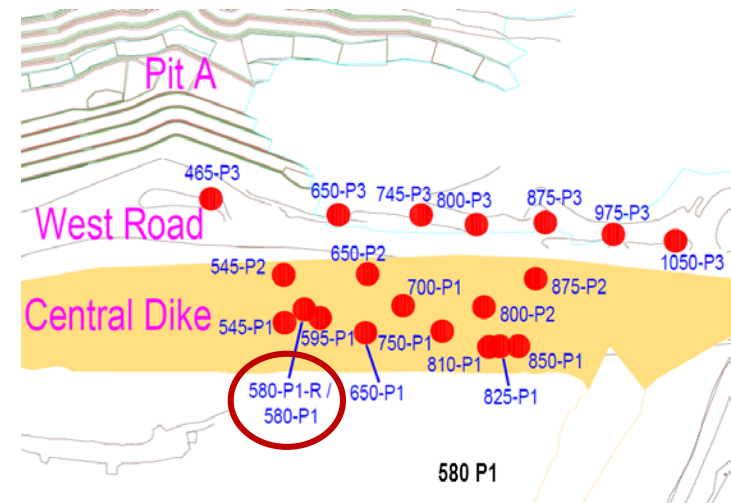
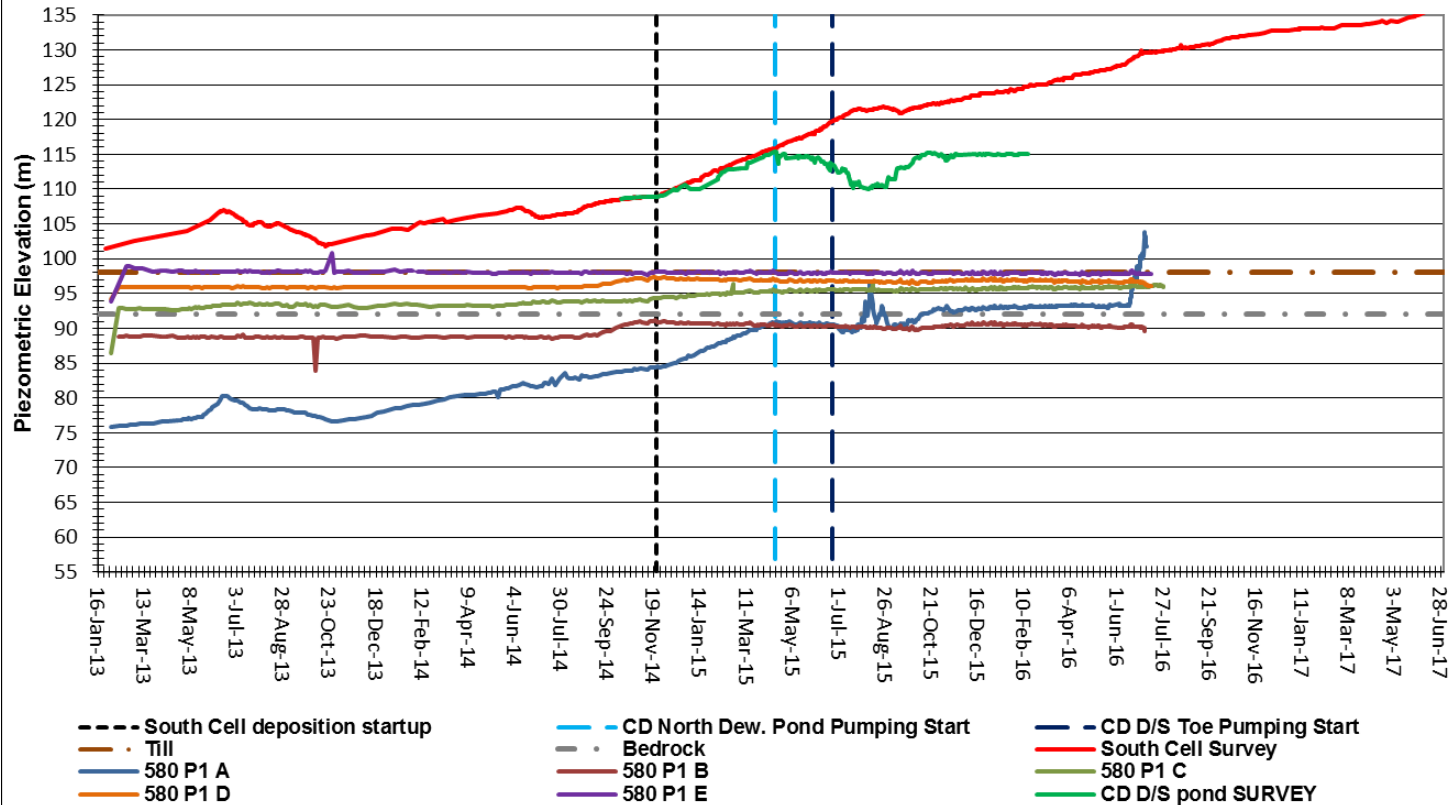
580-P1 Hole - Piezometrics Elevation and Attenuation Pond Elevation vs Time

- Piezometer and thermistor readings are not functional since July 2016
- Replacement hole 580-P1R drilled during 2017 campaign

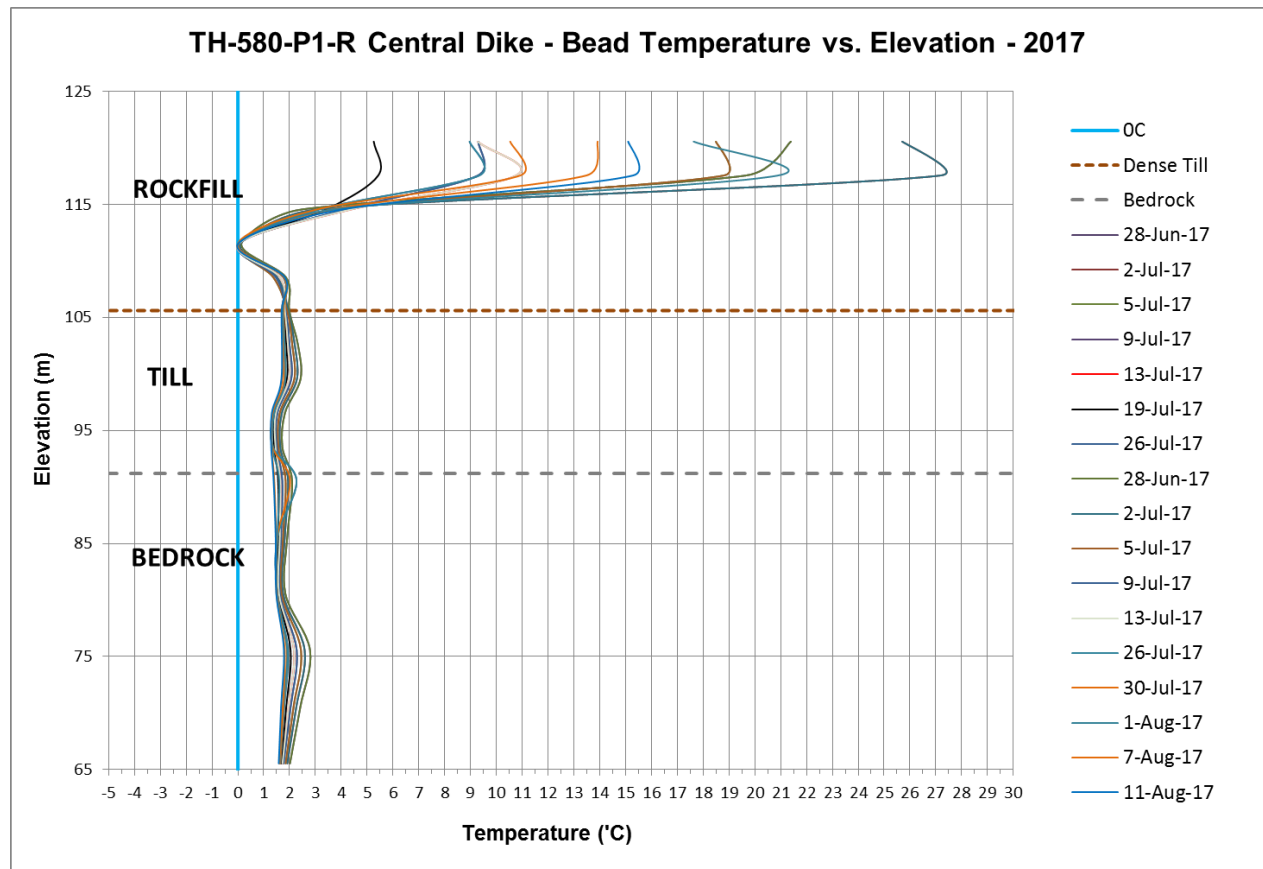
THERMISTOR 580-P1R

- Stabilisation in progress
- Temperature readings above 0°C
- Similar temperature readings range than 580-P1

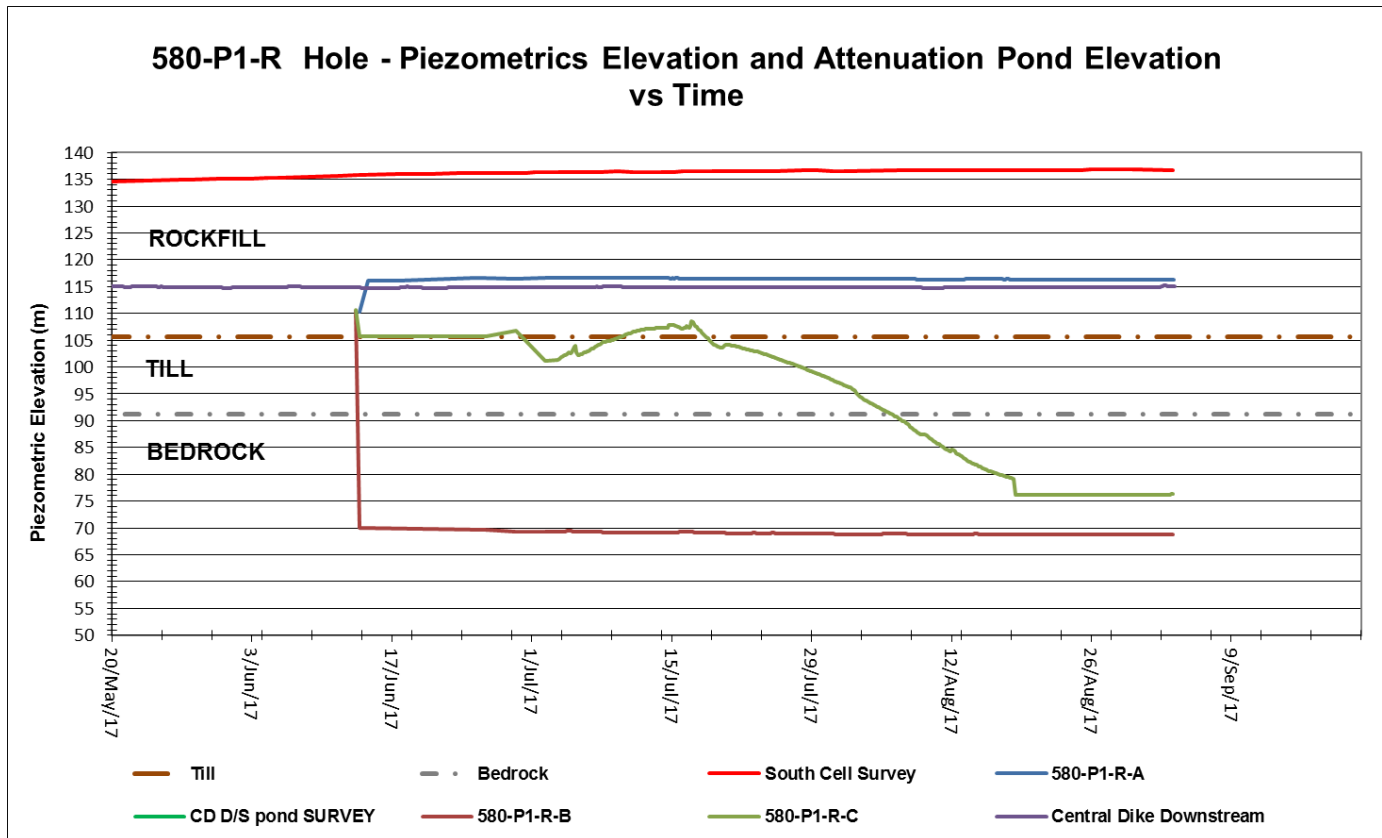
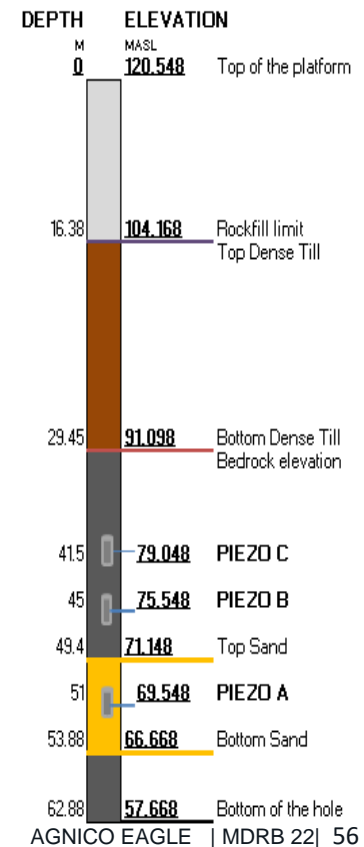
PIEZOMETER 580-P1R

- Piezo A is located in a sand layer and pressure readings are following the D/S pond regime
- Decrease in piezometric elevation ongoing for Piezo B
- Small data GAP

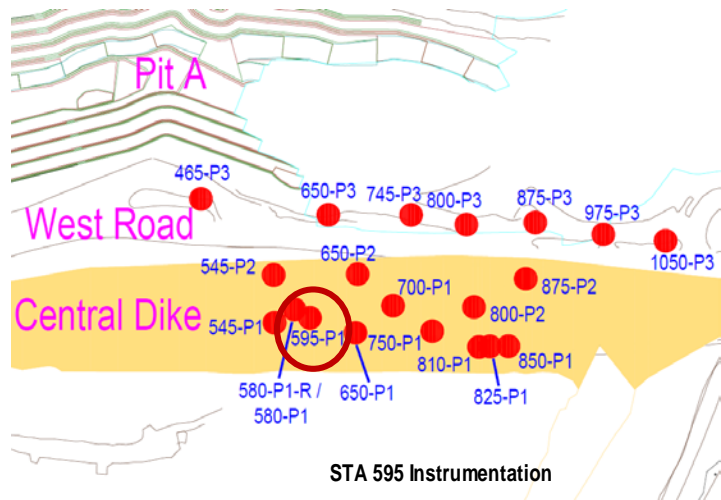
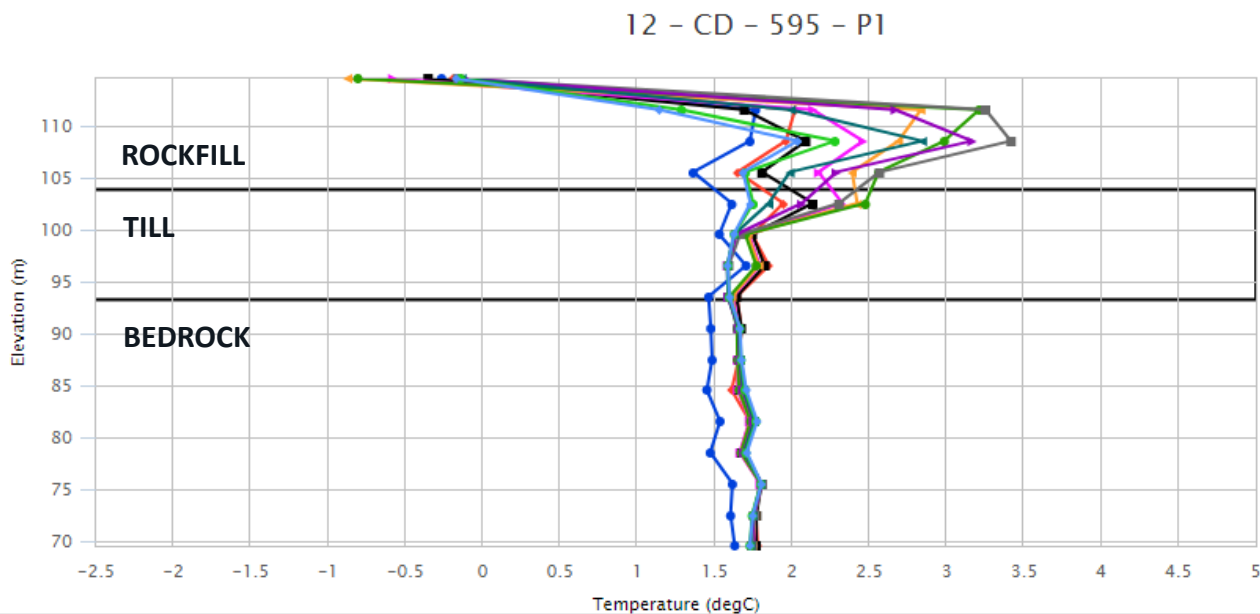
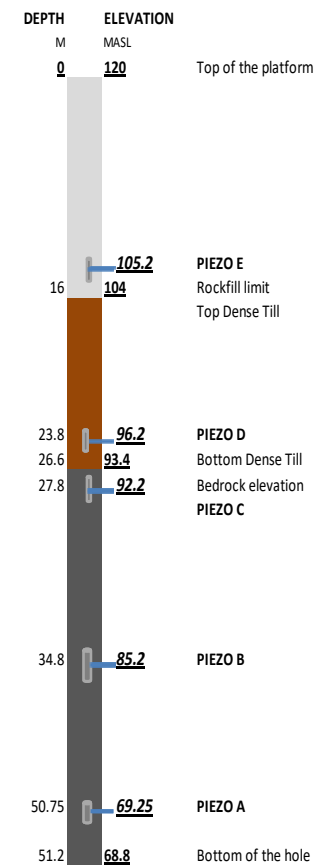
THERMISTOR 595-P1

- Temperature in the bedrock/till unit is in between 1.5 and 1.75° C.
- Glitch of 0.25° C could be caused by the automatization works done in August 2017.

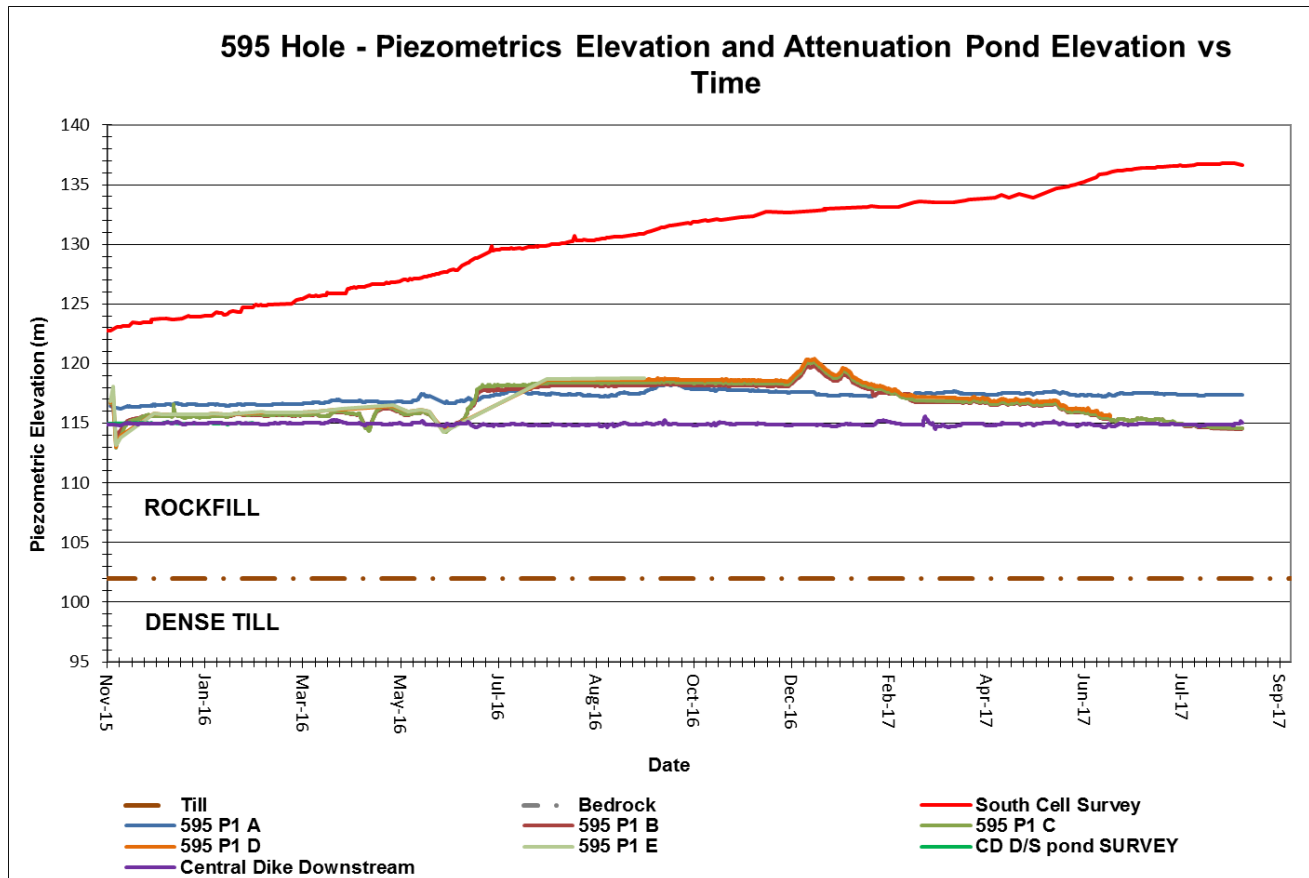
PIEZOMETER 595-P1

➔ Piezometric readings are fluctuating around D/S pond elevation since the installation.

➔ **Piezo C to E was installed in casing**

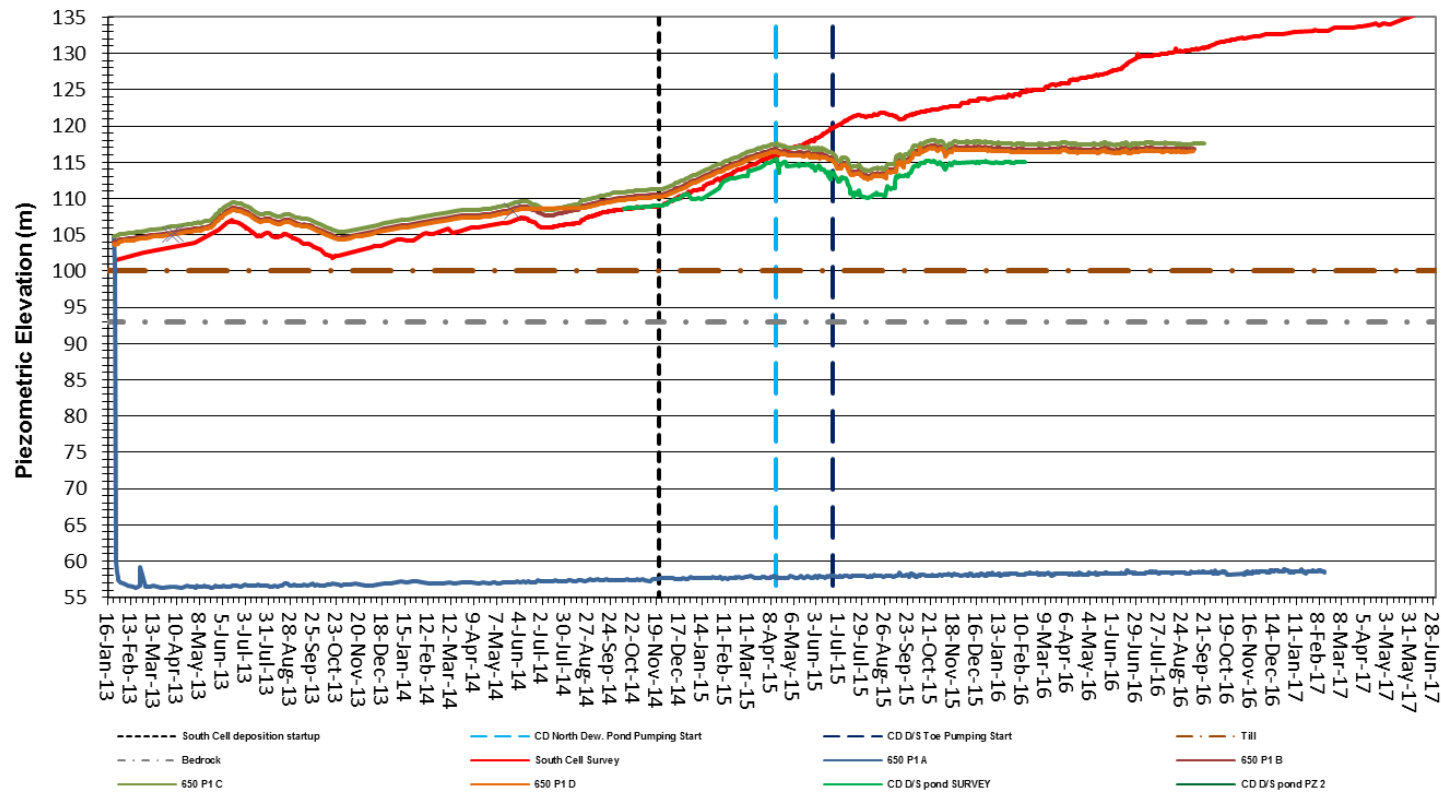
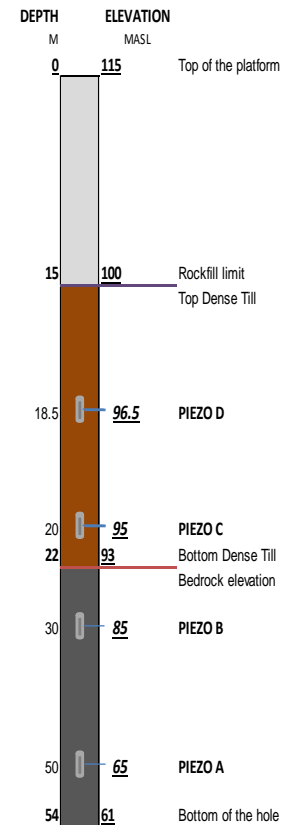
650-P1 Hole - Piezometrics Elevation and Attenuation Pond Elevation vs Time

- Piezometer reading not functional since February 2017
- Piezo A was in suction and piezo B to D were following D/S pond regime with readings around 117m.

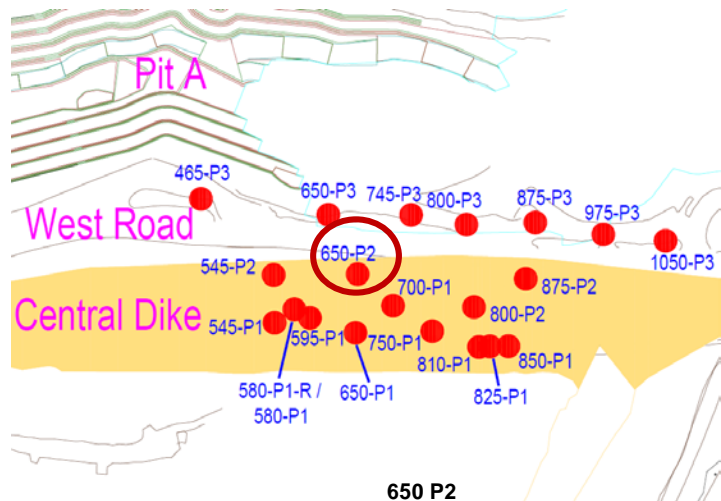
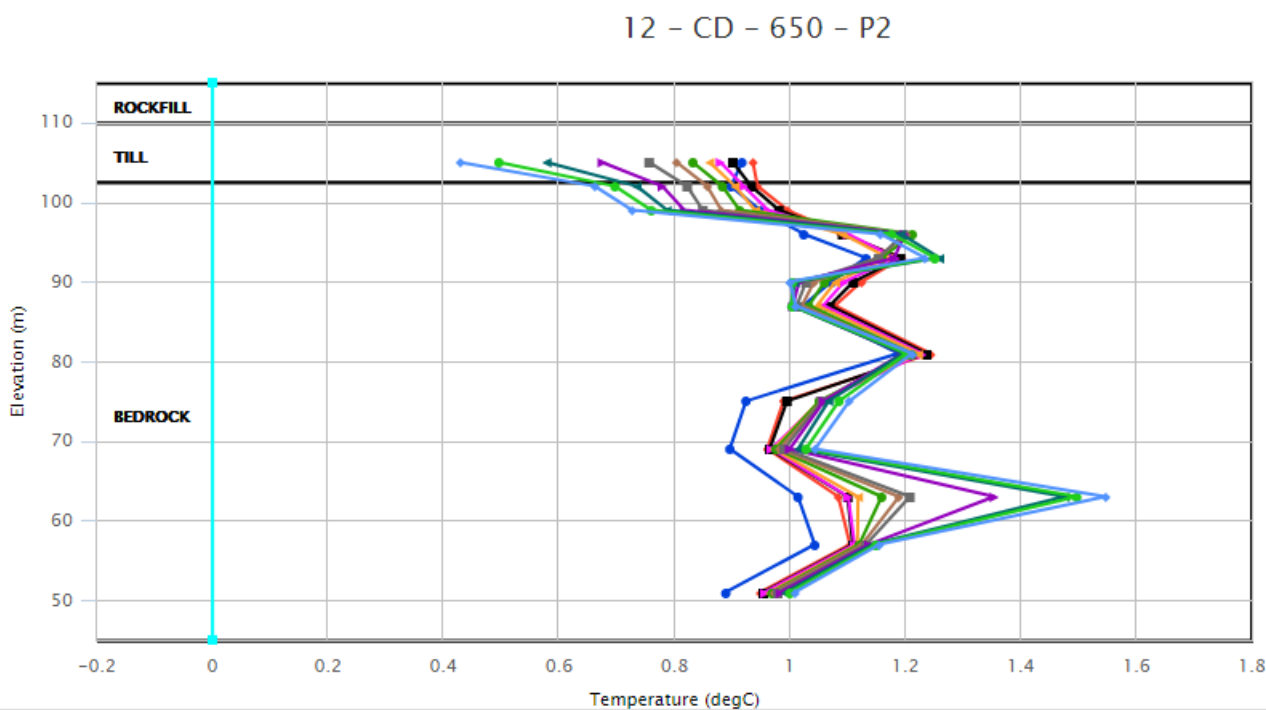
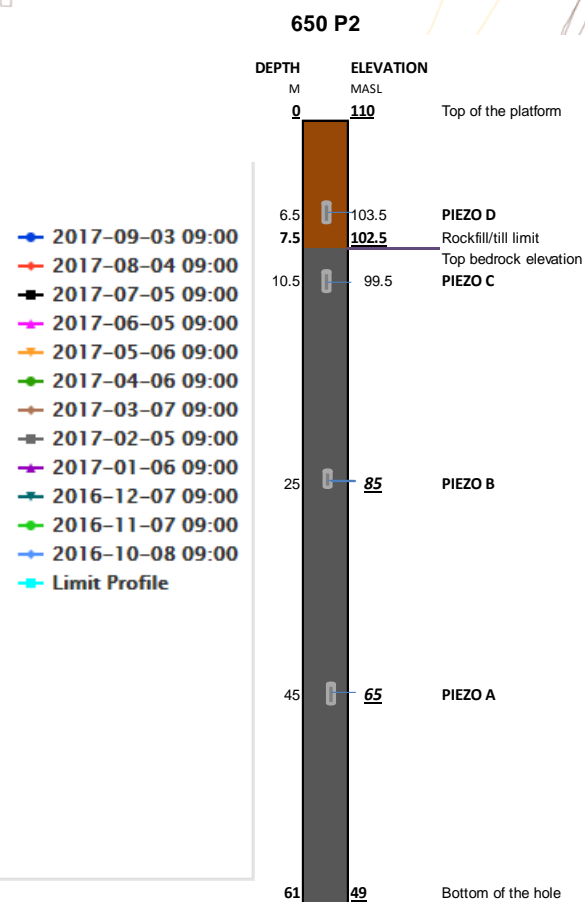
THERMISTOR 650-P2

- ➡ Cooling trend observed below El. 80 similar to 2016 readings.

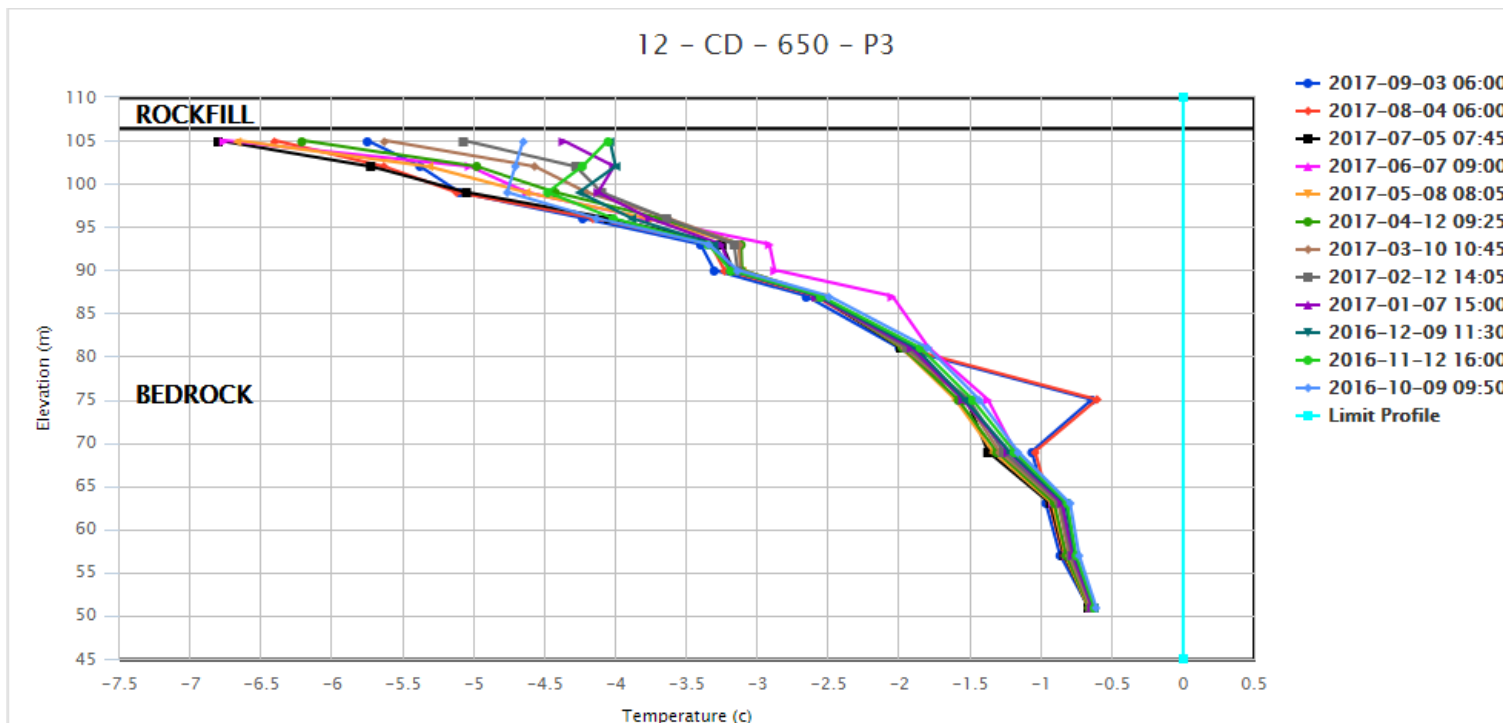
THERMISTOR 650-P3

- Bedrock Below 0° C at 650-P3
- Temperature spike at El. 75 m is related to capacitance effect on this specific bead.

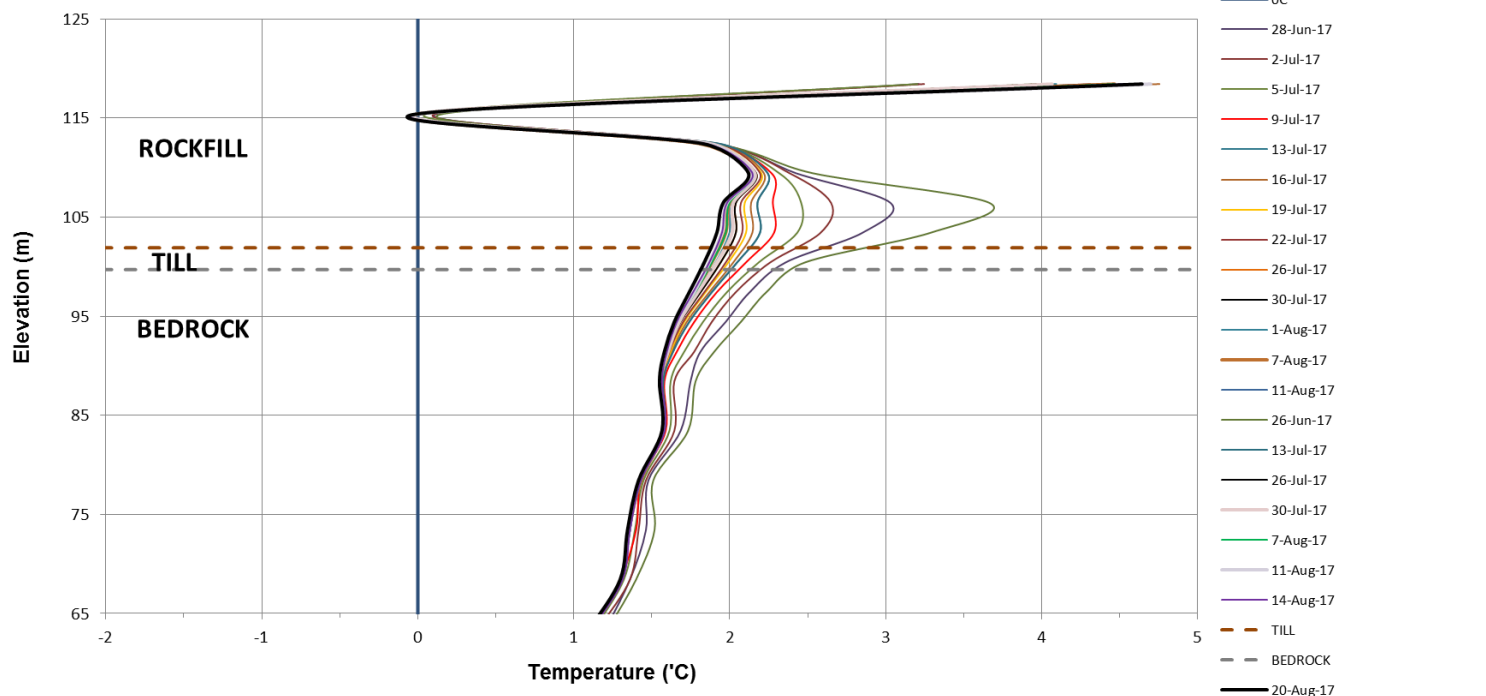
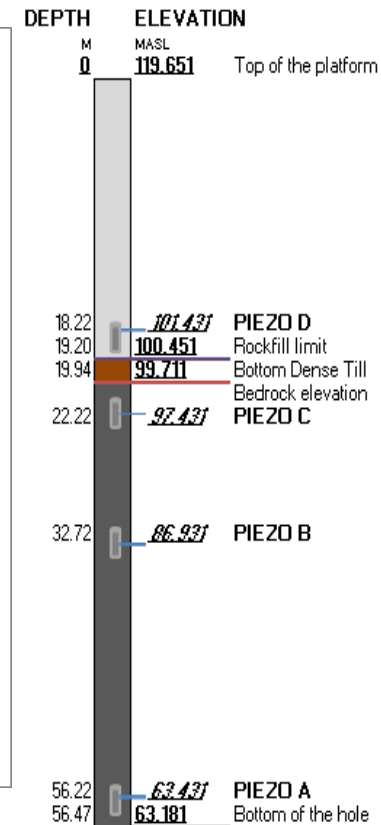
TH-700-P1 Central Dike - Bead Temperature vs. Elevation - 2017

- New instrument installed in 2017
- Stabilisation of temperature ongoing
- Till and bedrock temperature readings above 0° C

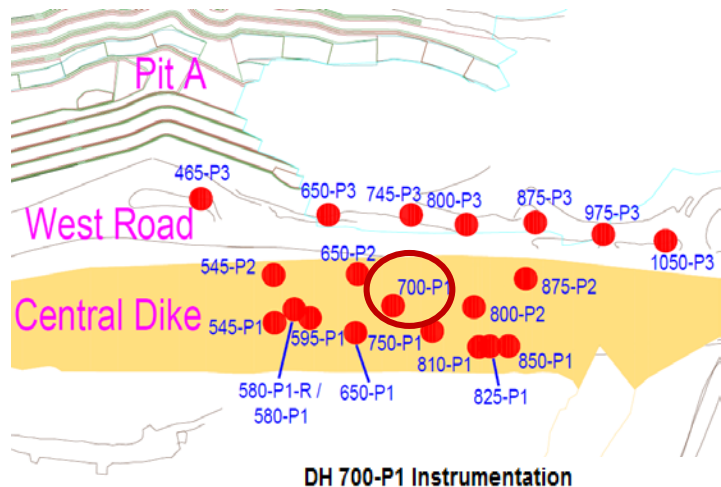
PIEZOMETER 700-P1

- New instrument installed in 2017
- Stabilization of temperature ongoing
- Reading automatization occurred on the date of the small bump observed on the piezo B
- Piezo A.C and D are showing reading similar to the D/S pond.

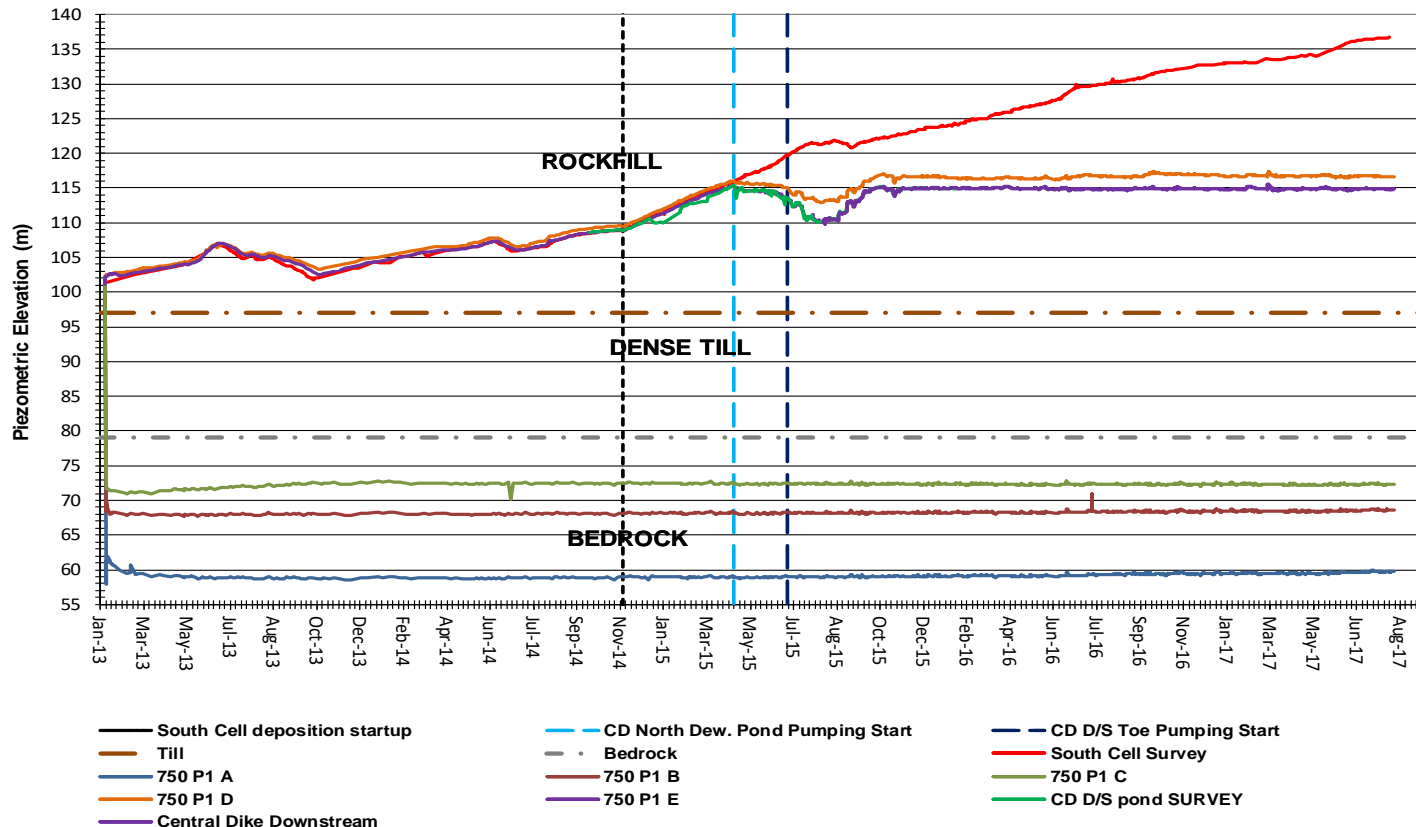
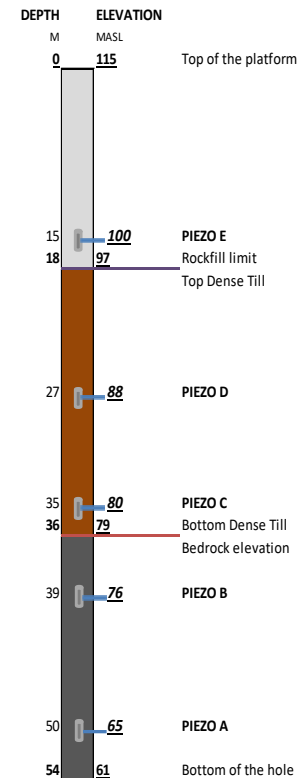
750-P1 Hole - Piezometrics Elevation and Attenuation Pond Elevation vs Time

- Piezo A, B and C are in suction
- Piezo D is have a direct reaction to any variation in elevation observe in the D/S pond.

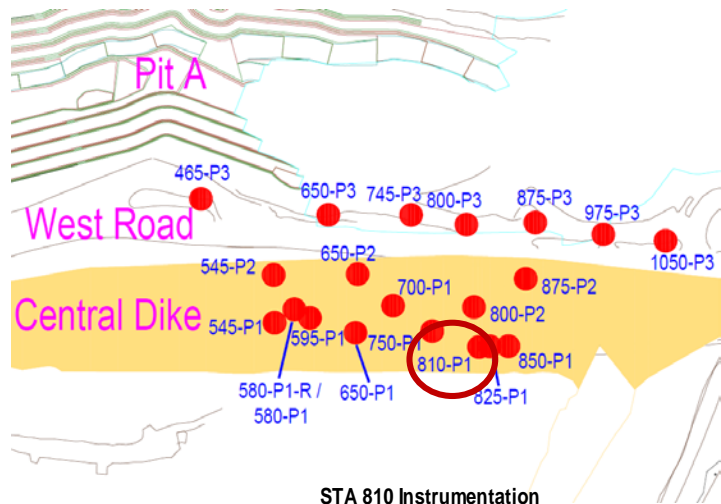
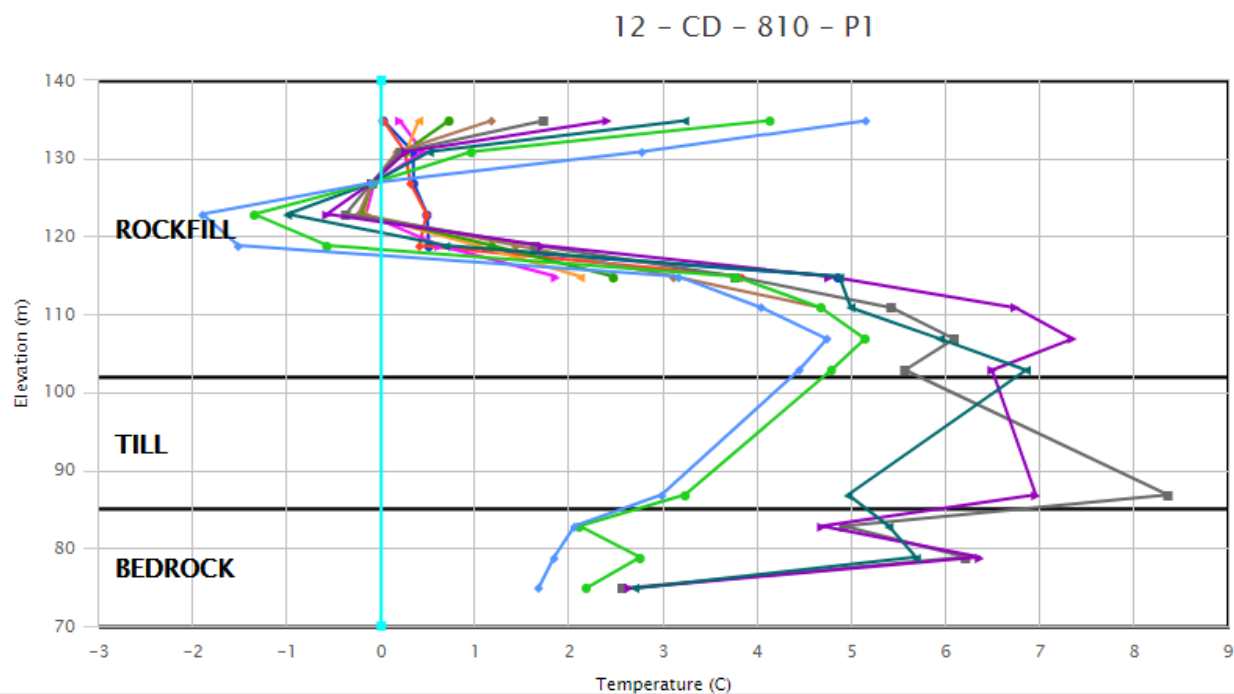
THERMISTOR 810-P1

- Bead below El. 114.84 m stop working in February 2017
- Higher temperature observed in this hole (might be the instrument progressively failing)

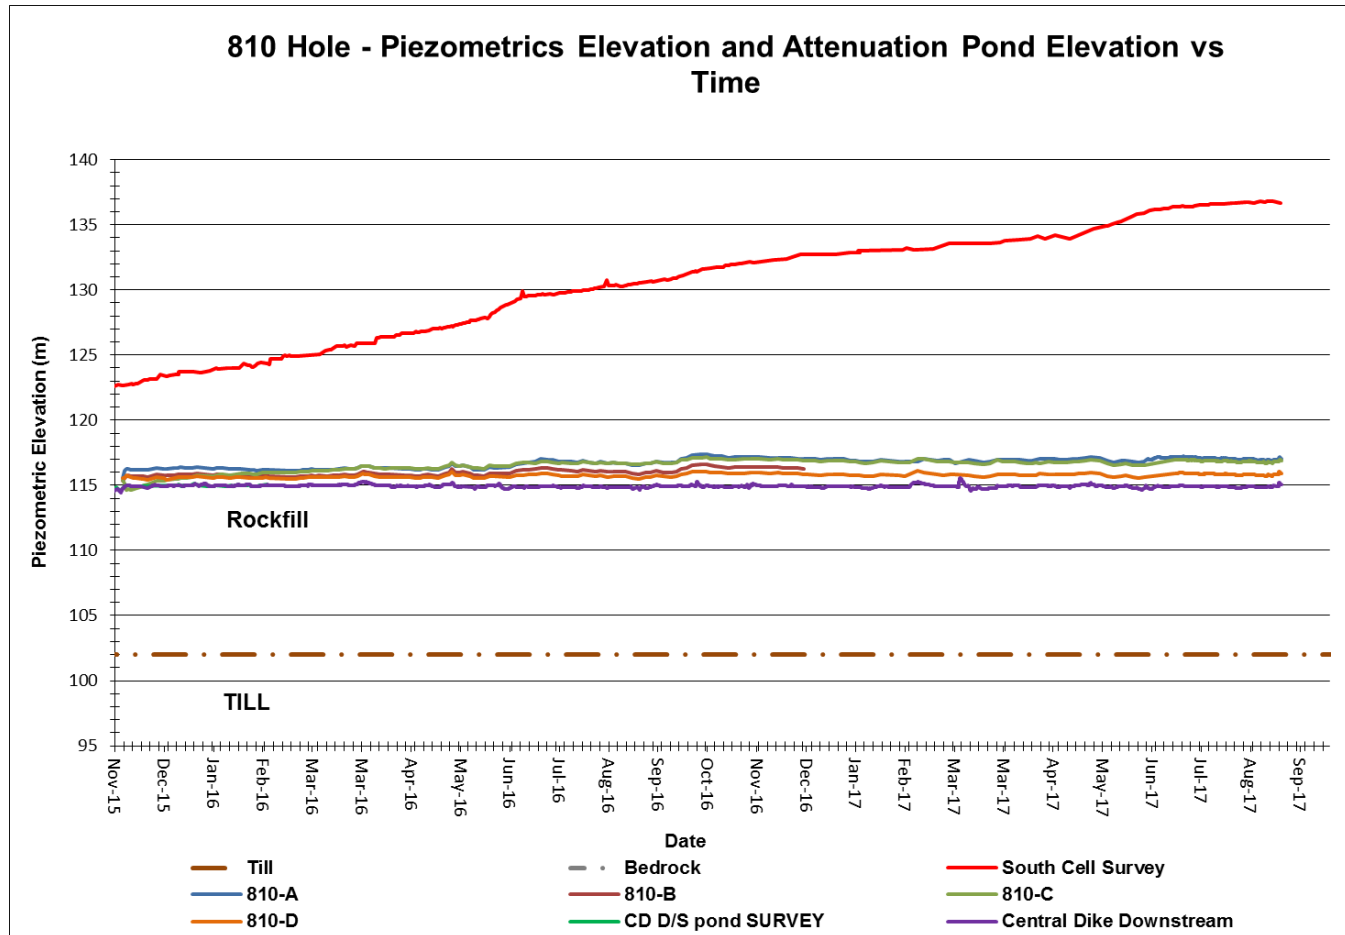
STA 810 Instrumentation

- ➔ Piezo B stop working in January 2017
- ➔ Piezo A, C & D are following the elevation change of the D/S pond
