THERMISTOR 545-P1

MDRB # 22 P3 – STORMWATER DIKE UPDATE

Patrice Gagnon
September 4th 2017

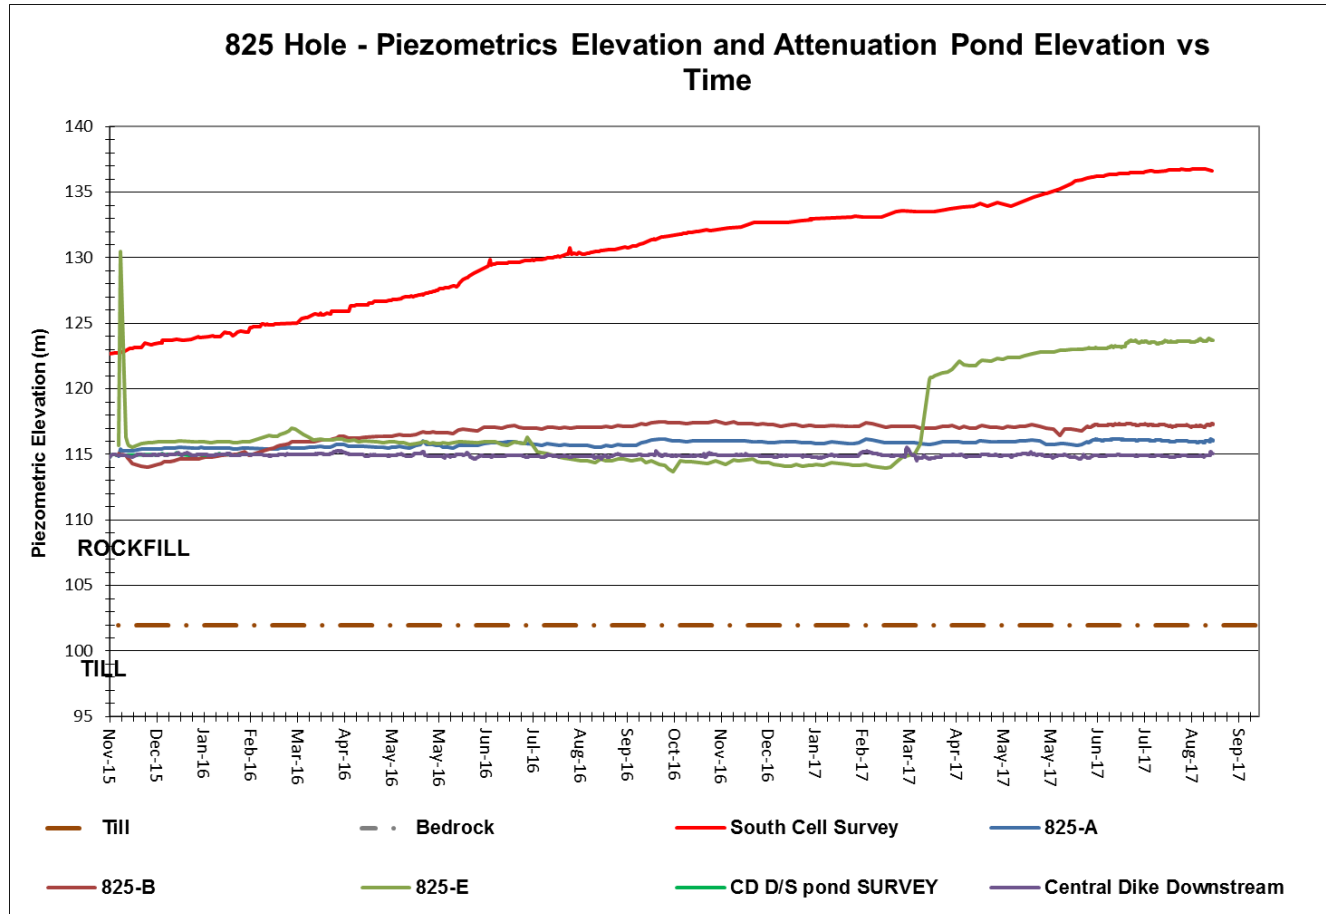
PIEZOMETER 825-P1

- Increased in piezometric elevation of Piezo E since April 2017. Seem to be connected now with South Cell.
- Piezo A and B showing readings similar to the D/S pond and are reacting directly with elevation change.

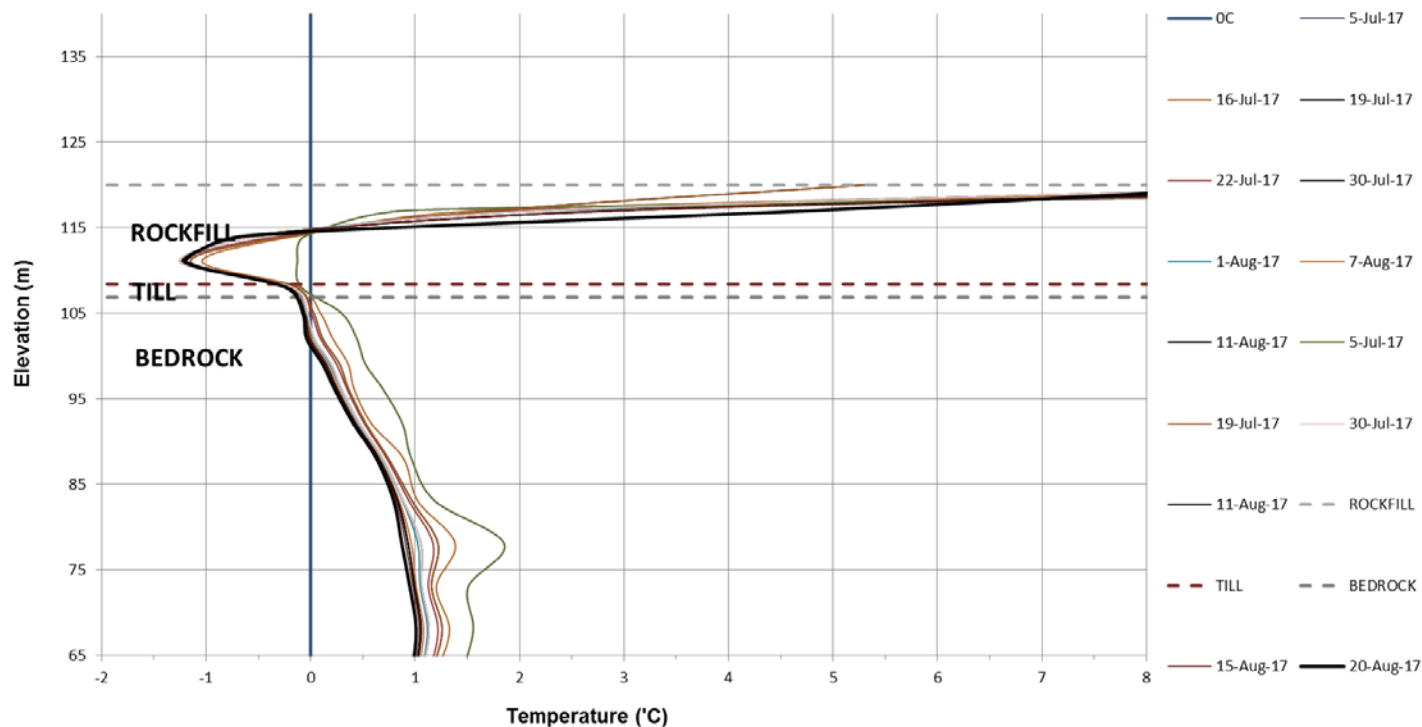
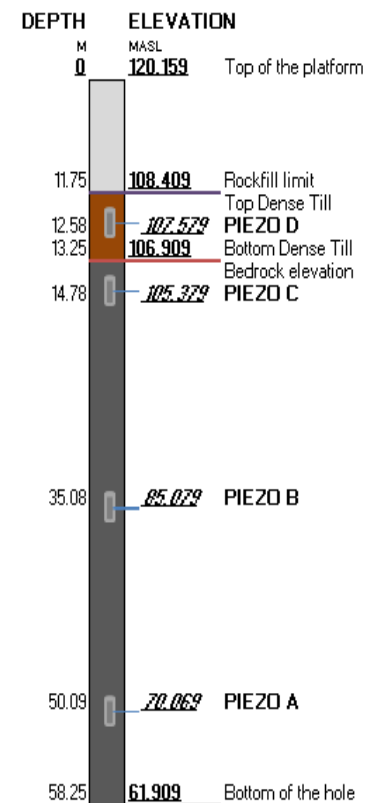
TH-875-P2 Central Dike - Bead Temperature vs. Elevation - 2017

- New thermistor installed in 2017
- Stabilisation of temperature ongoing
- Bedrock temperature above 0° C

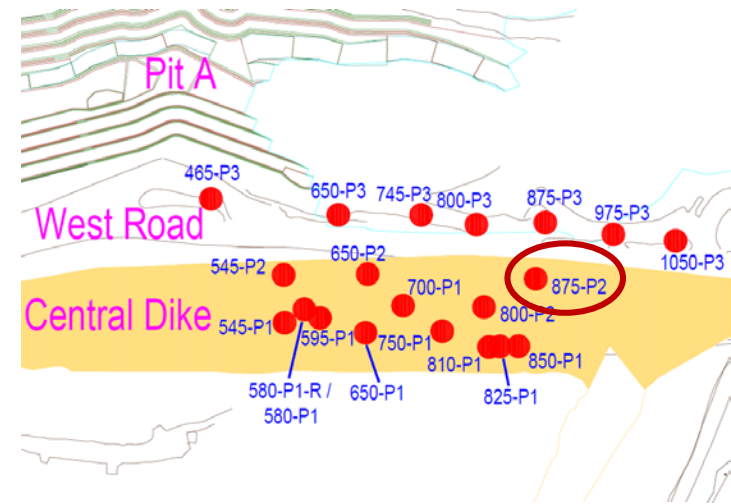
875-P2 Hole - Piezometrics Elevation and Attenuation Pond Elevation vs Time

- All piezometer are following the trend of the D/S pond regime
- Small glitch in the data was observed when automatization of the system was completed

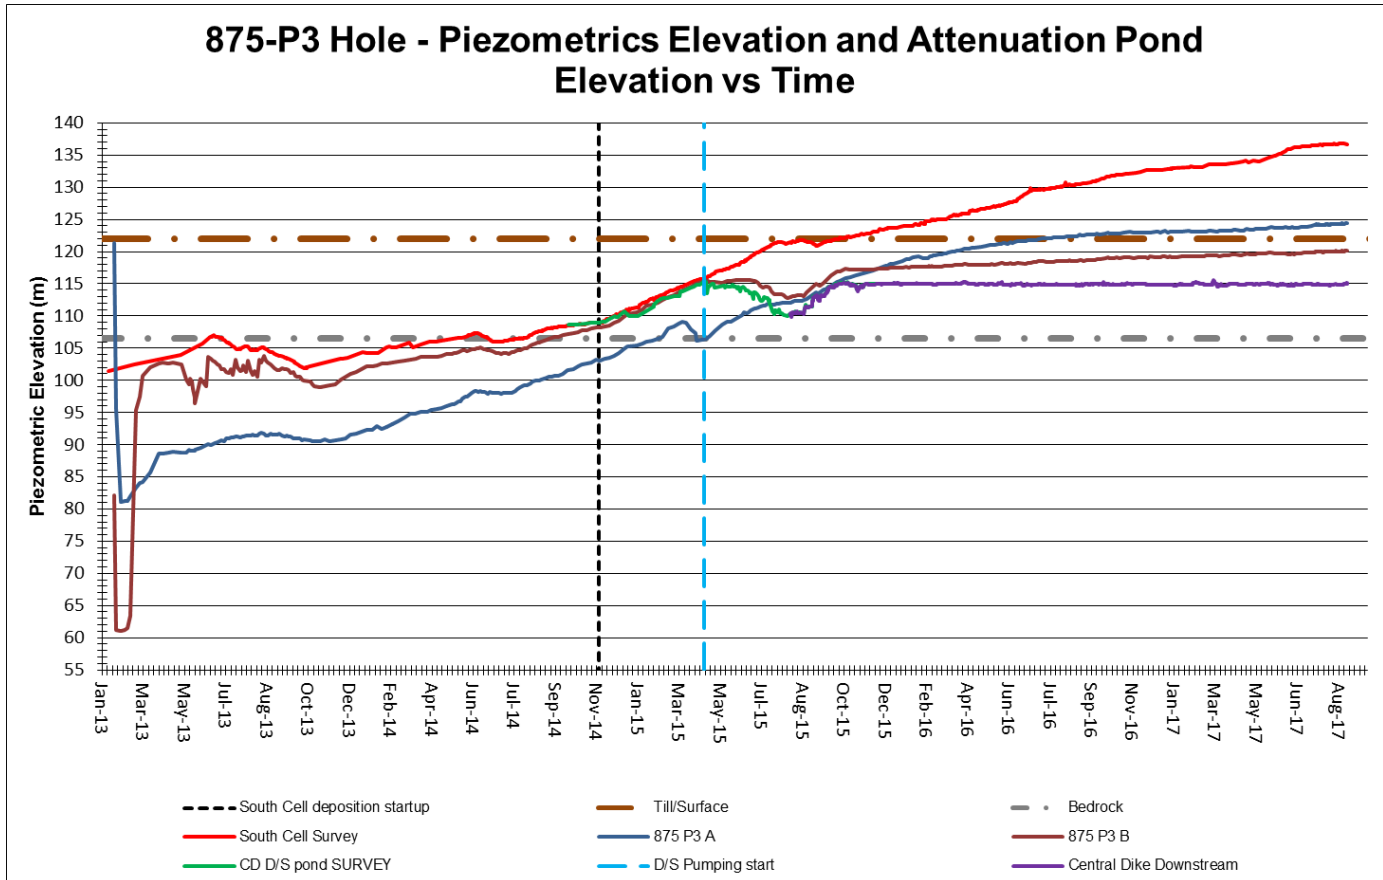
PIEZOMETER 875-P3

- ➔ Piezometer at 875-P3 are in bedrock and are impacted by increase in South Cell head

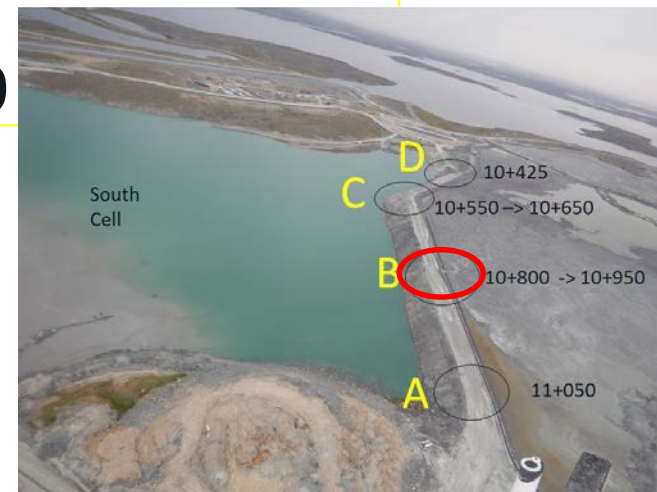
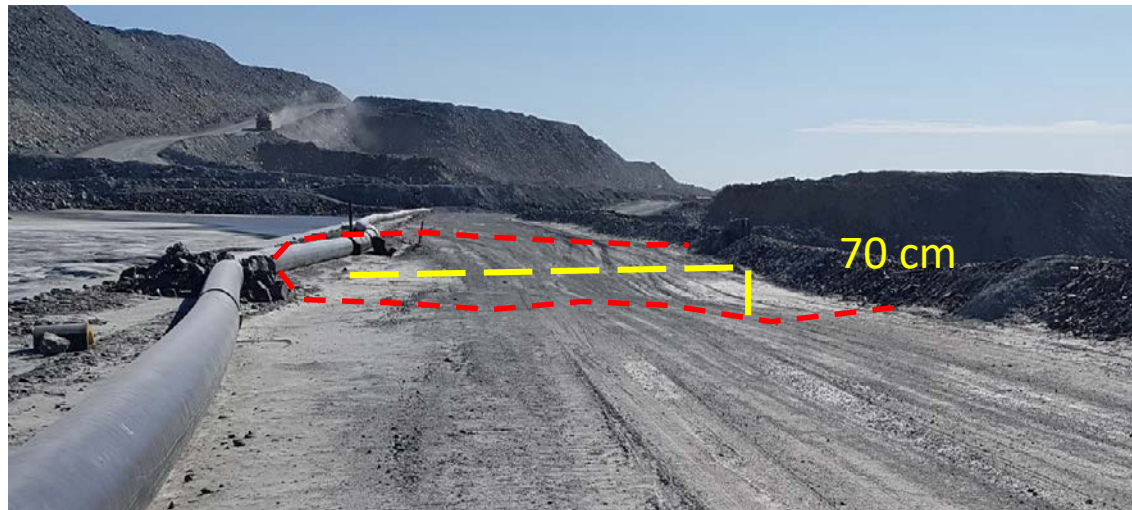
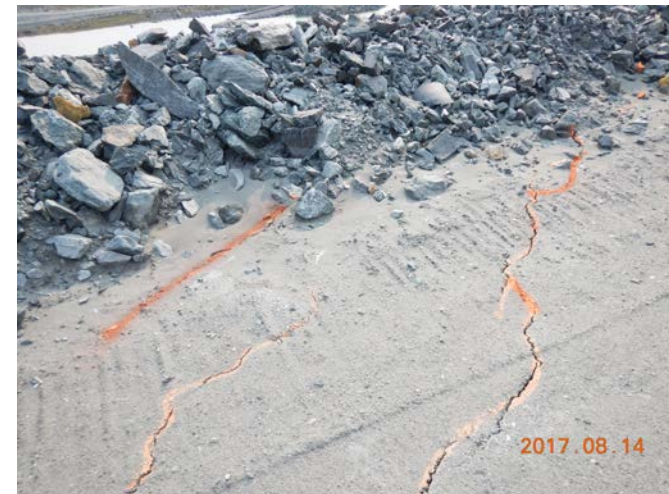
AREA OF MOVEMENT-10+800 TO 10+950

- Observed initially on July 5th 2017
- Depression present in previous year but deeper and larger amplitude this year
- Cracks were not present before

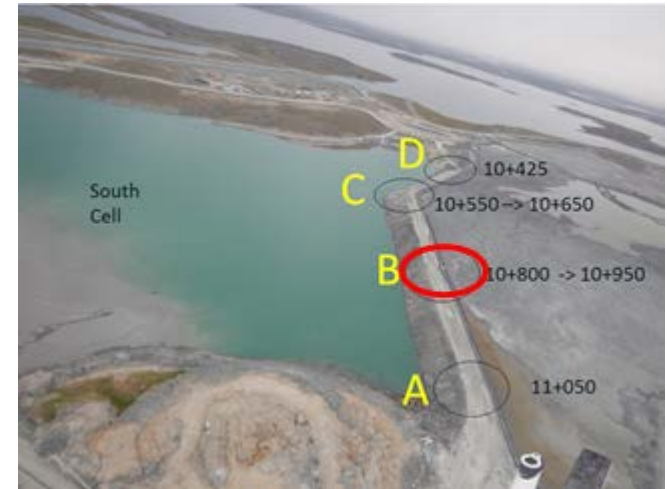
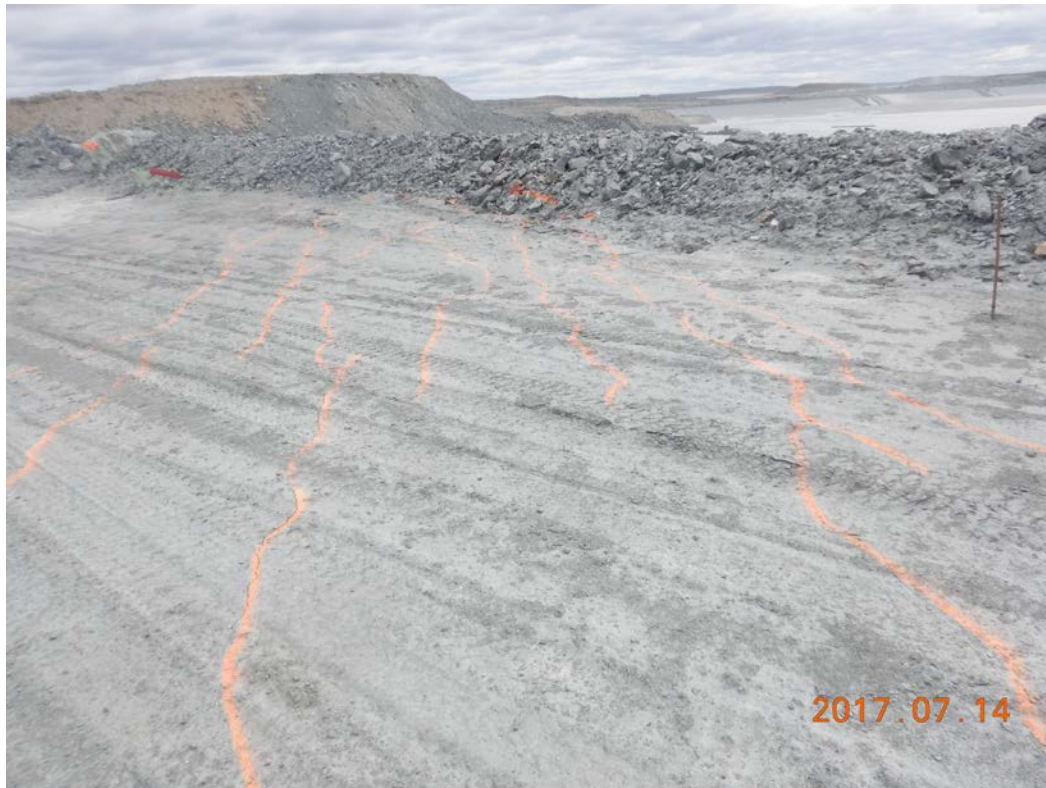
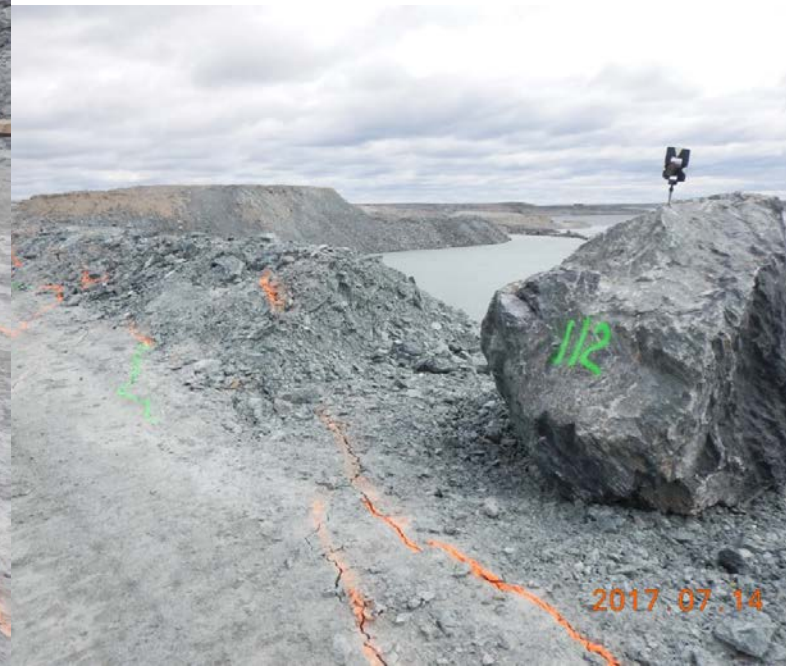
PICTURE OF MOVEMENT – 10+800 TO 10+950

- Cracks crossing the crest at 40° from CL
 - Did not progressed much during summer
- Longitudinal cracks along the crest
 - Constantly opened to up to 5cm wide

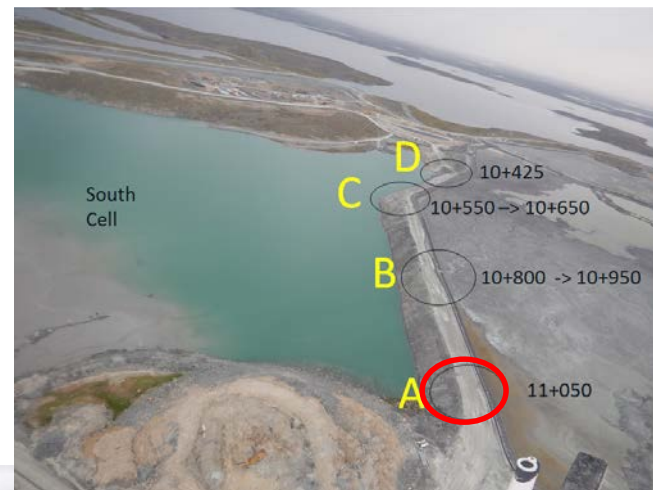
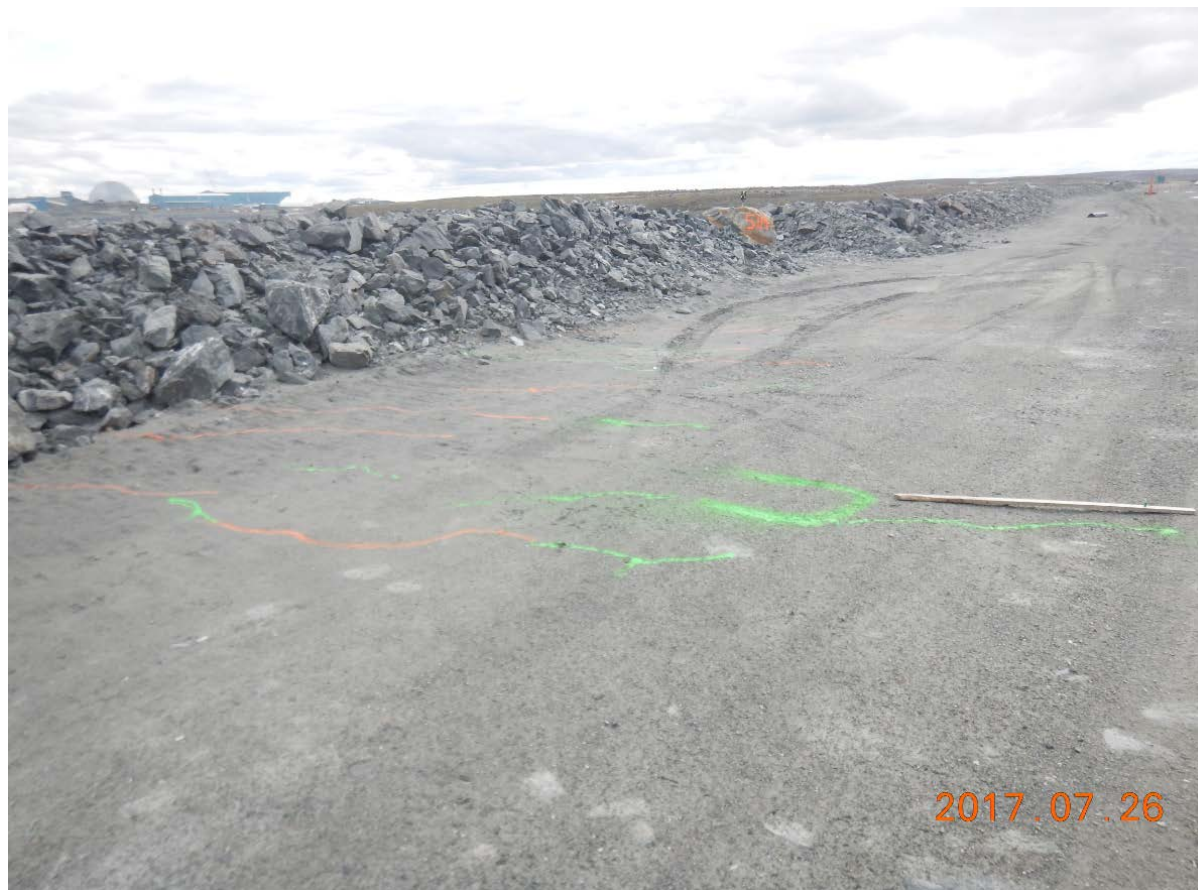
PICTURE OF MOVEMENT – 11+050

- Observed initially on July 15th 2017
- Appeared when water reached the toe in the area
- Crack width relatively small (<1cm)
- Cracks did not progressed
