Meadowbank 2018 TSF As-built report

2018 CONSTRUCTION SEASON AS-BUILT REPORT TAILINGS STORAGE FACILITY MEADOWBANK GOLD PROJECT, NUNAVUT

1897439-1578-R-Rev0

November 2018

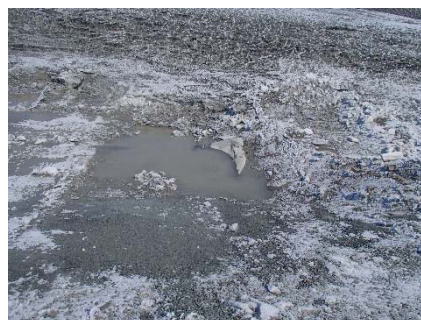
SD3-302 (2018-05-18), looking NE from Sta. 20+595/-42 m. View of water ponding on the first compacted sieved till layer of upstream toe liner tie-in. A portion of exposed damaged LLDPE liner is visible.

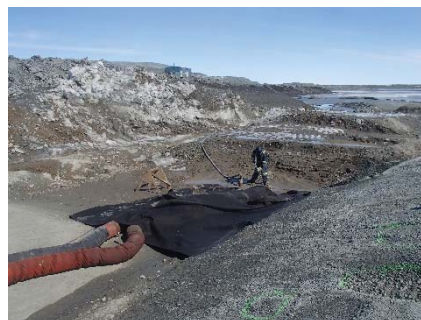
SD3-305 (2018-06-05), looking NE from Sta. 20+590/-48 m. Dewatering of the water ponding on the first compacted sieved till layer of upstream toe liner tie-in. A Genset Frost-fighter is heating the sieved till layer and a pump is evacuating the water.

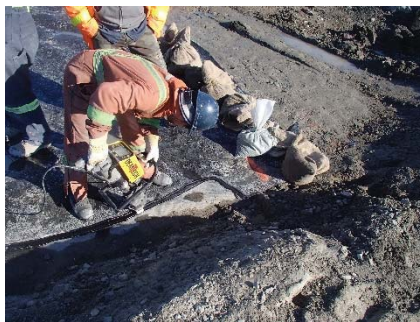
SD3-316 (2018-06-09), looking NW from Sta. 20+610/-45 m. Repairs on the extrusion fillet seam between LLDPE panel 965 and the existing LLDPE panel at Sta. 20+600 m (approx.).

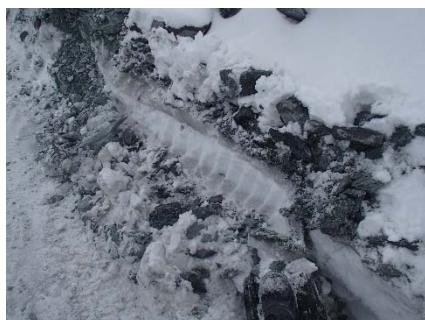
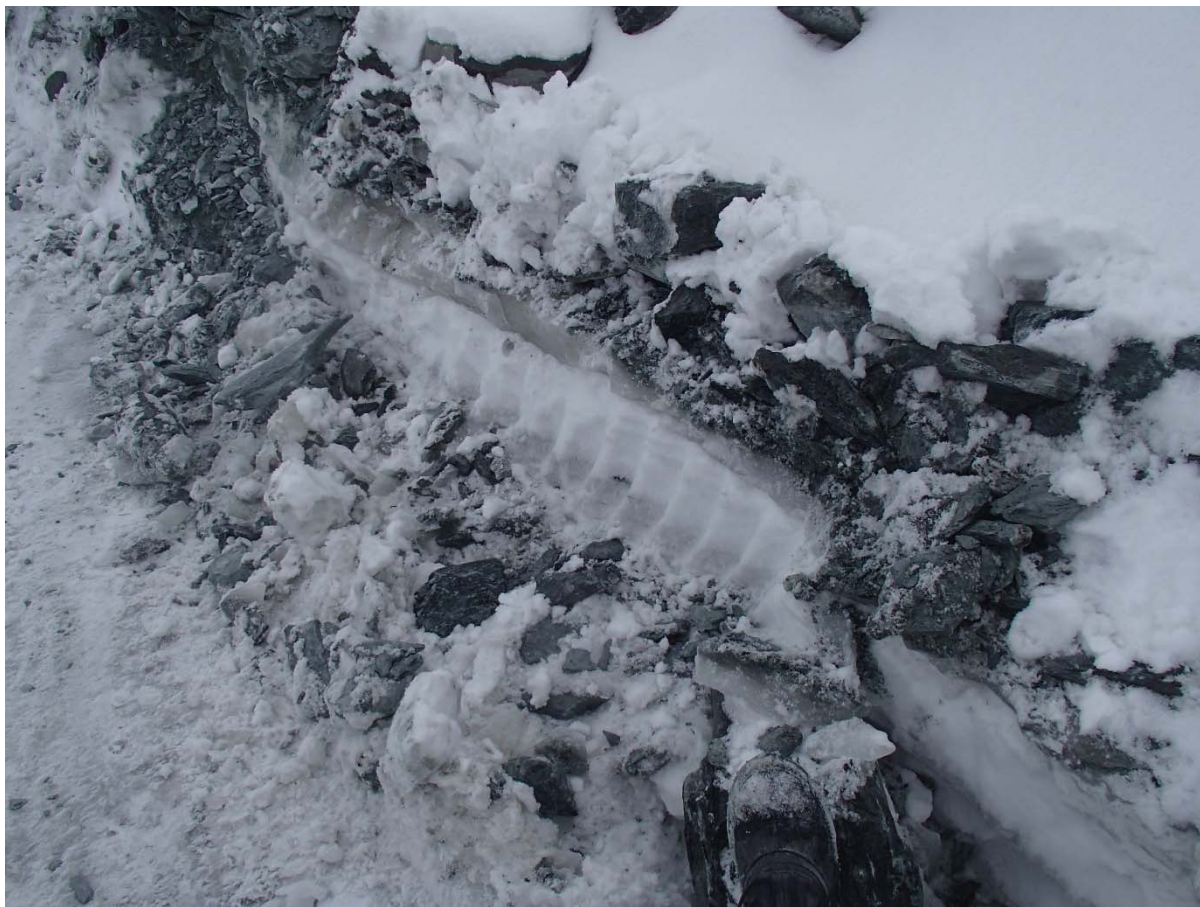
NCIS-004 (2018-05-19). View of the scraped upstream side of the UM rockfill lift at El. 152 m further to the north: the snow layer is only observed at the toe and is approximately 0.5 m thick.

Photograph NCIS-004: View of the scraped upstream side of the UM rockfill lift at El. 152 m further to the north: the snow layer is only observed at the toe and is approximately 0.5 m thick.

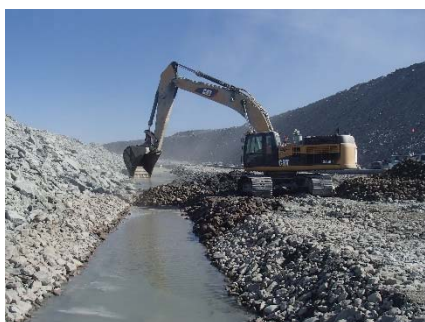
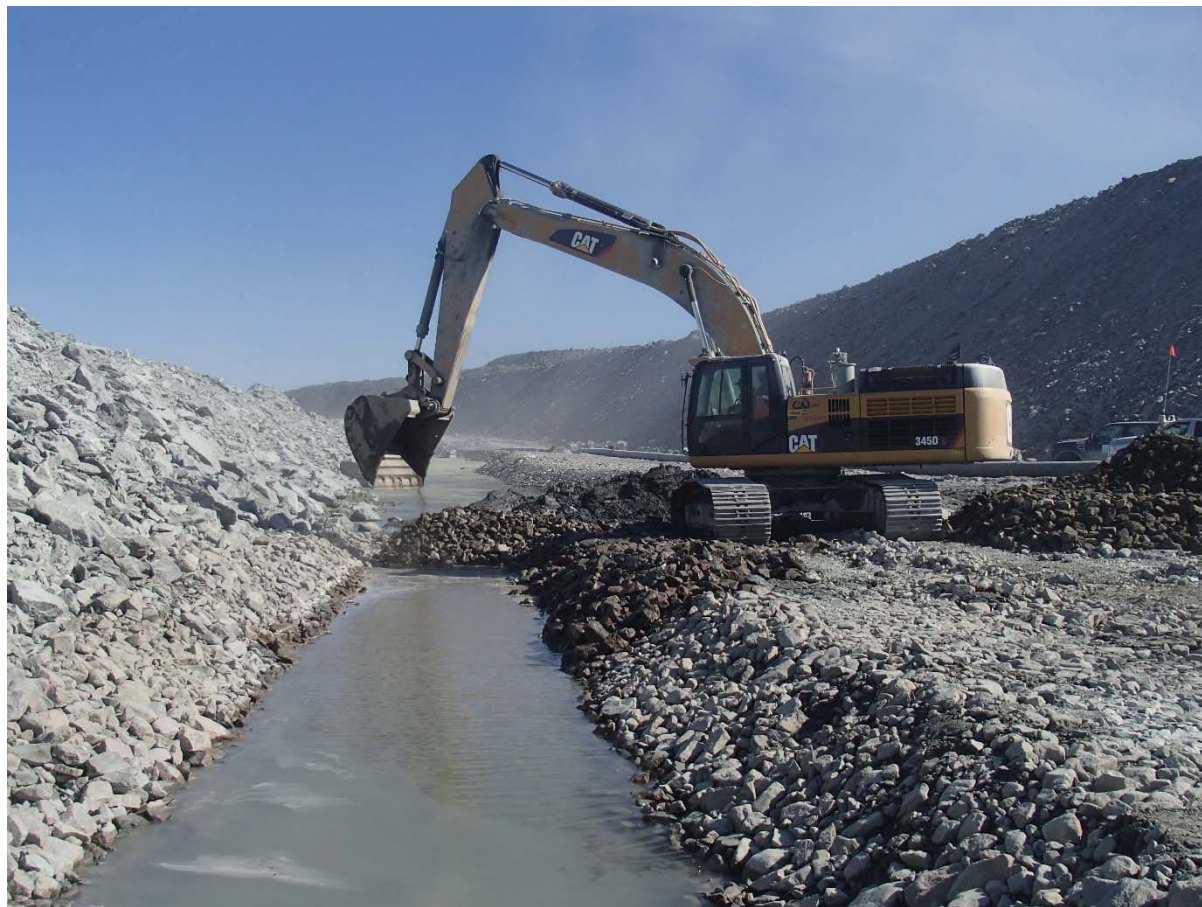
NCIS-125 (2018-07-27), looking NE from Sta. 3+050/+26 m (approx.). Corrections to the north sump: removal of approx. 0.5 m of tailing and till sieving reject material on the bottom of the excavation. The erosion protection material was replaced.

Photograph NCIS-125: From Sta. 3+050/+26 m (approx.), looking NE. Corrections to the north sump: removal of approx. 0.5 m of tailing and till sieving reject material on the bottom of the excavation. The erosion protection material was replaced.

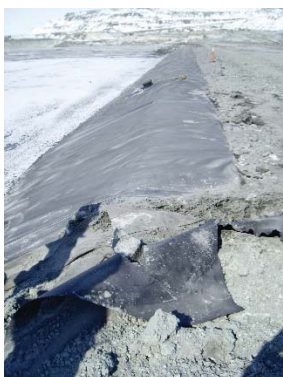
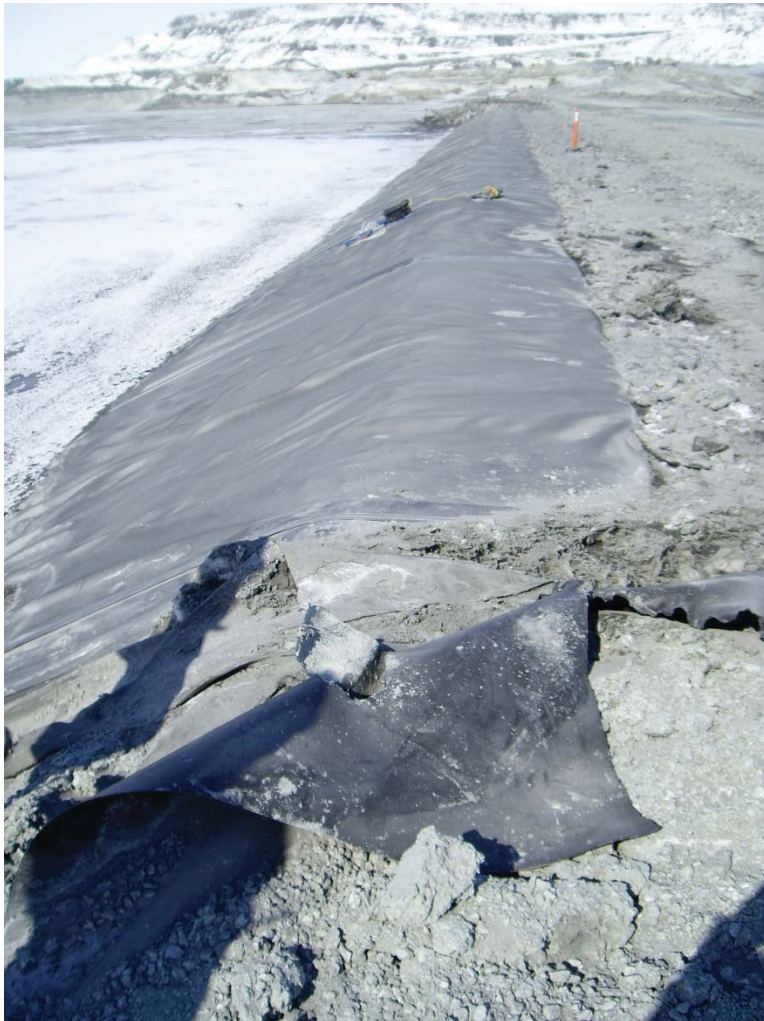
CD-1796 (2018-04-23), looking N from Sta. 0+650/-28 m. Damaged geomembrane near a deposition finger on Central Dike.

Photograph CD-1796: From Sta. 0+650/-28 m, looking N. Damaged geomembrane near a deposition finger on Central Dike.

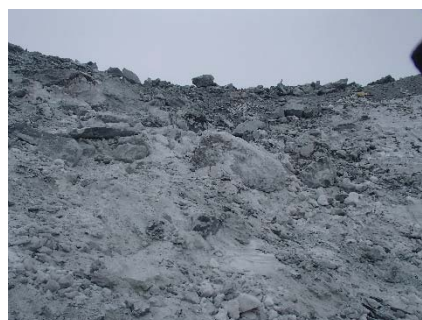
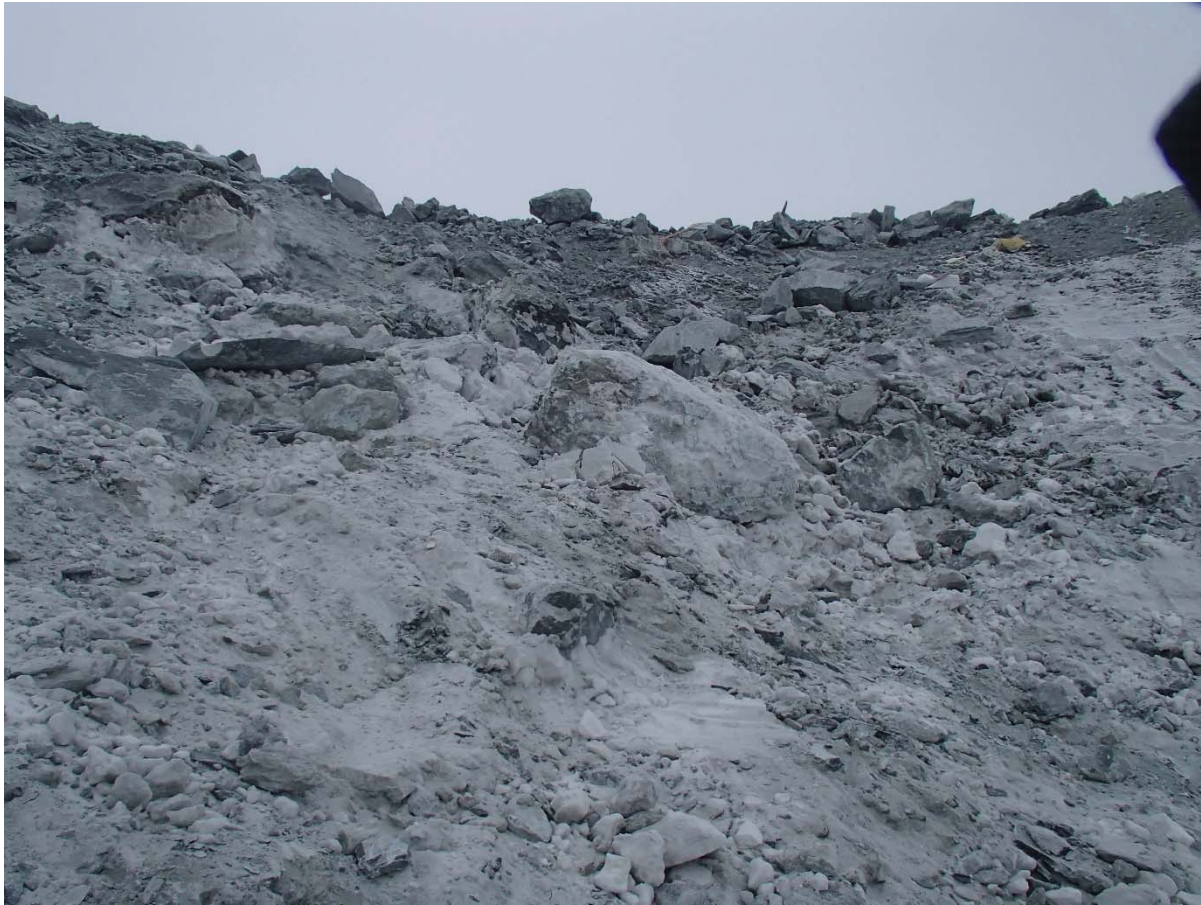
CD-1804 (2018-04-28), looking S from Sta. 40+790/-2 m. Presence of oversized boulders on the existing slope at the junction between SD5 and Central Dike.

Photograph CD-1804: From Sta. 40+790/-2 m looking S. Presence of oversize boulders on the existing slope at the junction between SD5 and Central Dike.

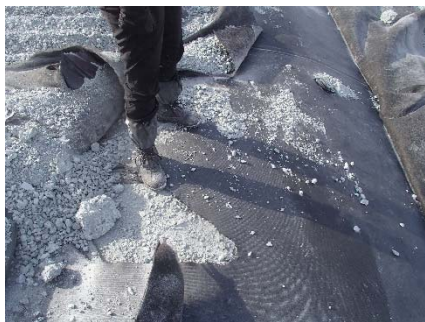
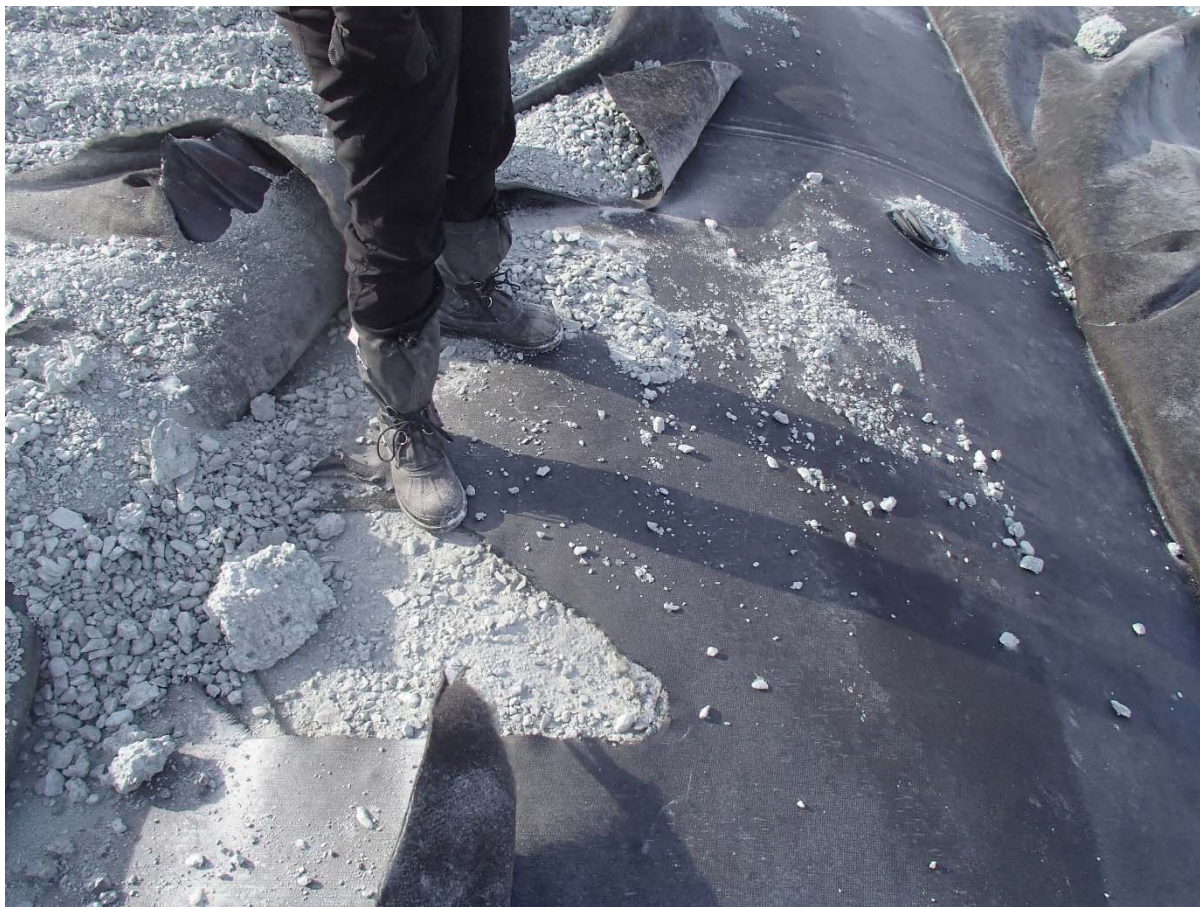
CD-1833 (2018-05-07), looking S from Sta. 0+390/-25 m. Damaged geomembrane near a deposition finger on Central Dike at Sta. 0+390 m.

Photograph CD-1833: From Sta. 0+390/-25 m, looking S. Damaged geomembrane near a deposition finger on Central Dike at Sta. 0+390 m.

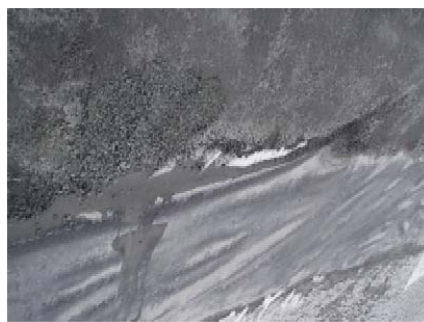
CD-1858 (2018-05-21), looking S from Sta. 0+970/-45 m. View of the bottom of the fine filter upstream slope. Some material is missing to achieve a smooth slope.

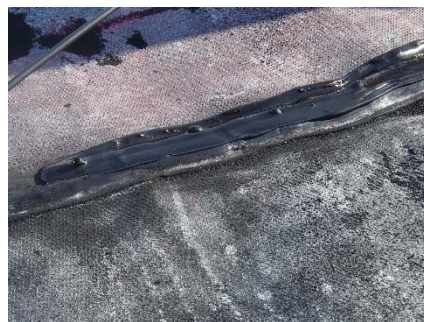
CD-1864 (2018-05-25), looking from Sta. 40+700/-38 m. View of bubbles formed in the extrusion weld because of humidity.

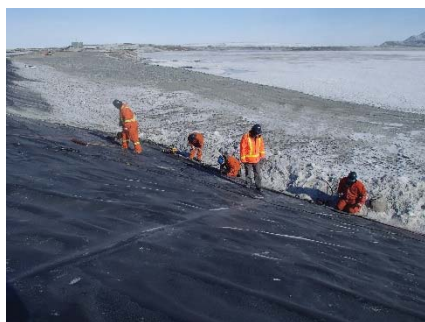
CD-1865 (2018-05-25), looking NW from Sta. 40+740/-35 m. Repairs on the extrusion fillet seam at the bottom of the LLDPE liner panels between Sta. 40+680 m and 0+950 m, on panels 802 to 807, and 811 to 813.

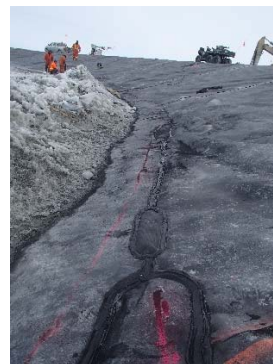
CD-1867 (2018-05-25), looking E from Sta. 40+680/-37 m. View of repair patches on the extrusion weld at the bottom of the panels.

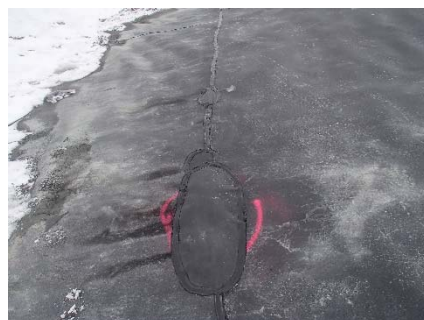
CD-1876 (2018-05-30), looking N from Sta. 0+820/-26 m. View of repair patches on the extrusion weld at the bottom of the panel 838.

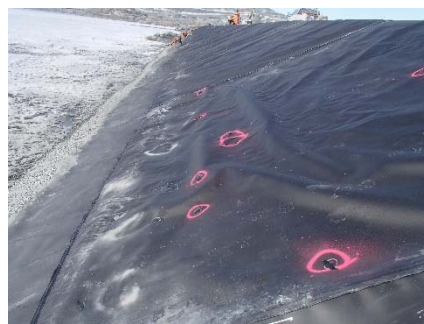
CD-1879 (2018-06-01), looking N from Sta. 0+735/-28 m. View of the repaired holes on panel 850.

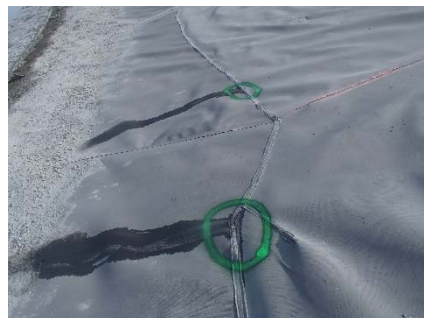
CD-1891 (2018-06-05), looking NE from Sta. 0+960/-28 m. View of leaking extrusion fillet seams before their repair on panel 816 and 818.

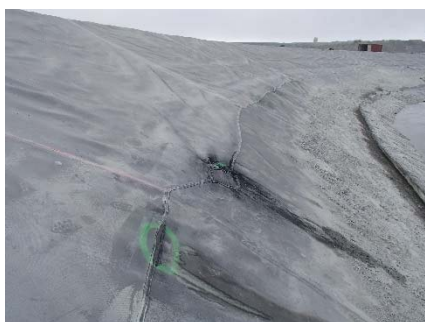
CD-1893 (2018-06-06), looking SW from Sta. 0+950/-27 m. View of repair patches on the extrusion weld at the bottom of the panels 803, 807, 808, 810, 814, 815, 816 and 818.

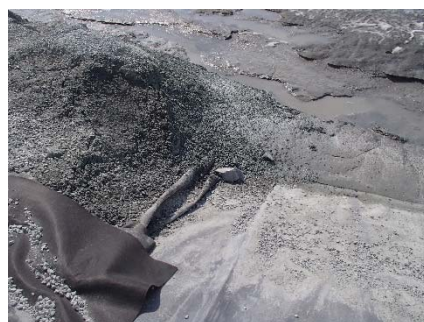
CD-1894 (2018-06-10), looking W from Sta. 0+800/-28 m. View of a block in direct contact with the LLDPE liner following the construction of the deposition fingers on Central Dike.
