Meadowbank and Whale Tail 2022 Annual Geotechnical Inspection

REPORT**2022 Annual Geotechnical Inspection***Meadowbank Complex, Nunavut*

1617-2146800622-5000-RA-Rev0

16 December 2022

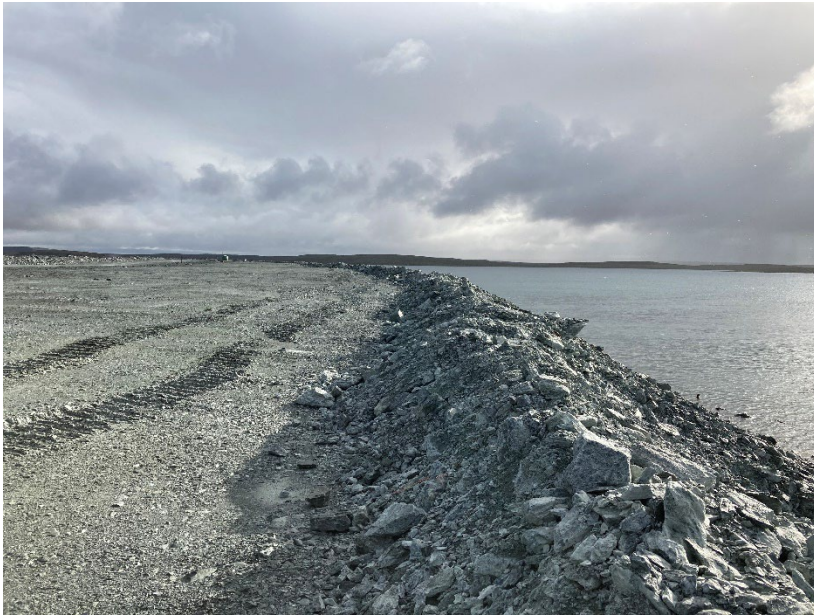
Photograph A3-19 Bay Goose Dike

Description: From approximately Sta. 31+475, looking west at the crest. Old cracks are disappearing.

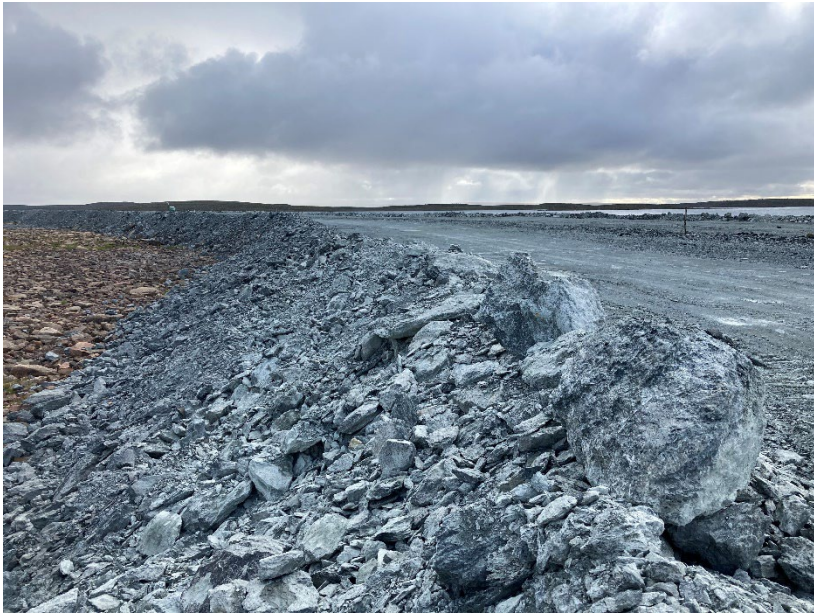
Photograph A3-20 Bay Goose Dike

Description: From approximately Sta. 31+475, looking northeast at the crest. Old cracks are disappearing.

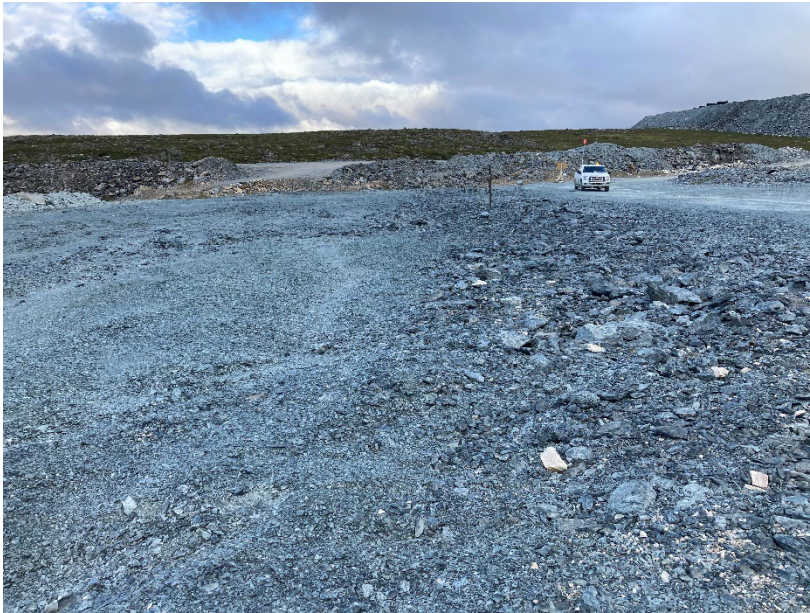
Photograph A3-37 Bay Goose Dike

Description: From approximately Sta. 32+025 (south abutment) looking east at the crest and upstream slope. Zone of high magnitude settlement in the ultramafic cap. The tension cracks seem no longer active.

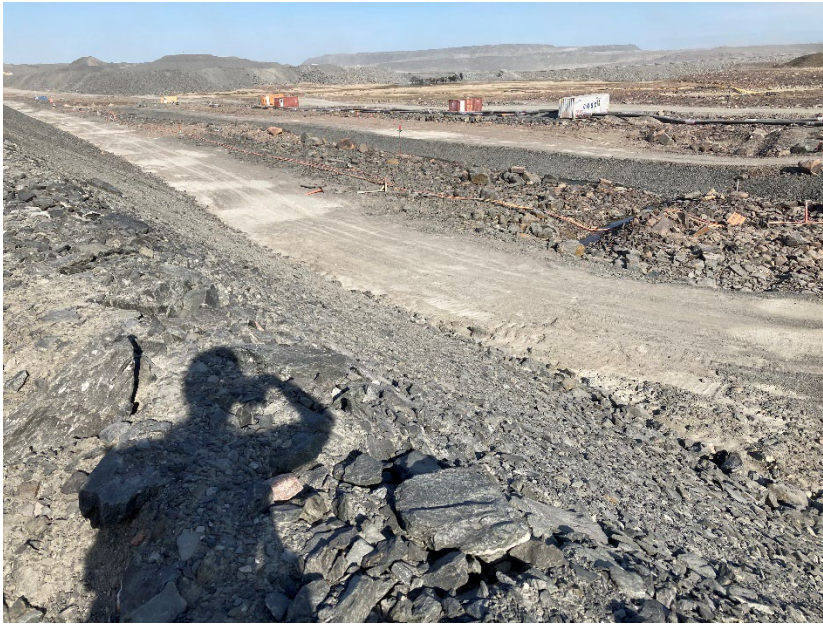
Photograph A5-25 Whale Tail Dike

Description: From approx. Sta. 0+225 on the crest, looking northeast at the crest platform. Presence of a healing longitudinal tension crack.

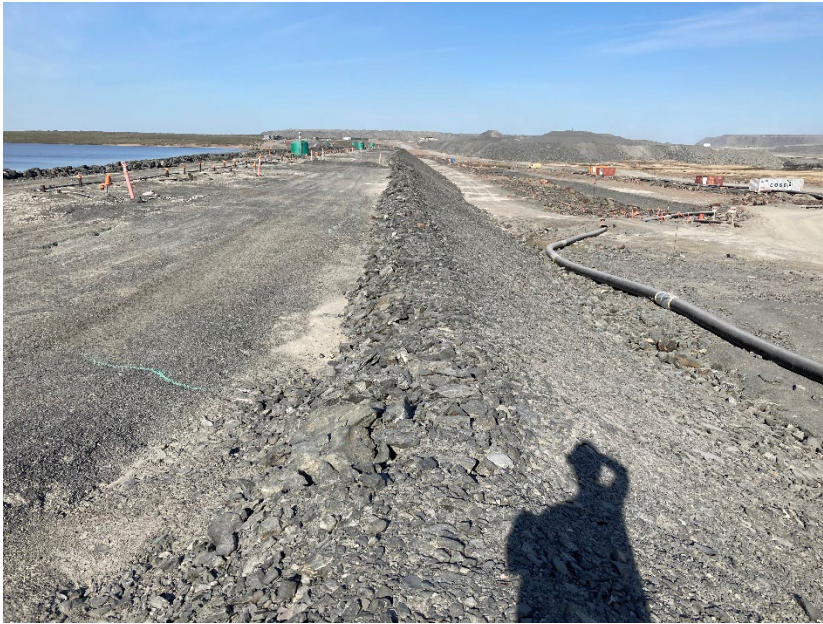
Photograph A5-27 Whale Tail Dike

Description: From approx. Sta. 0+775 upstream, looking west at the crest platform. Presence of tension crack along upstream crest berm.

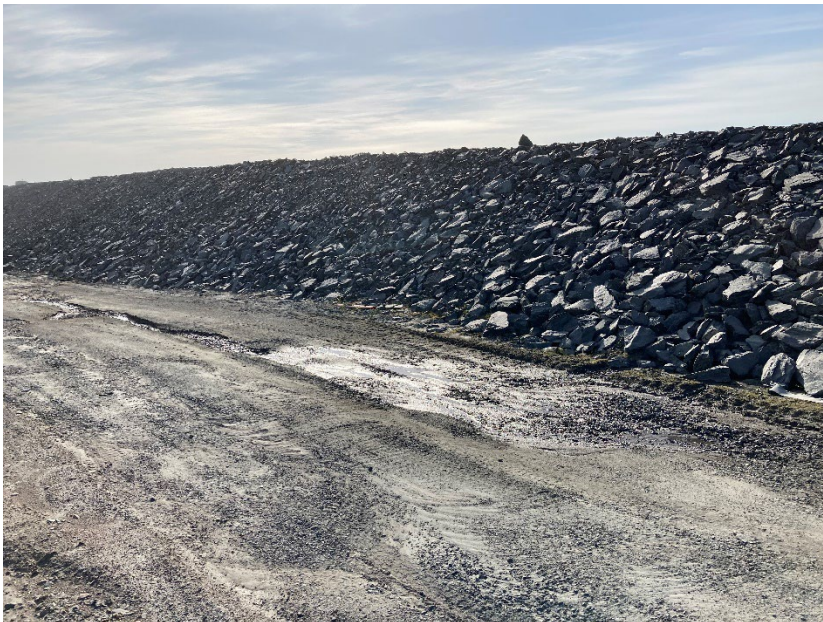
Photograph A5-28 Whale Tail Dike

Description: From approx. Sta. 0+775 downstream, looking west at the downstream crest and slope. Presence of a tension crack perpendicular to the dike.

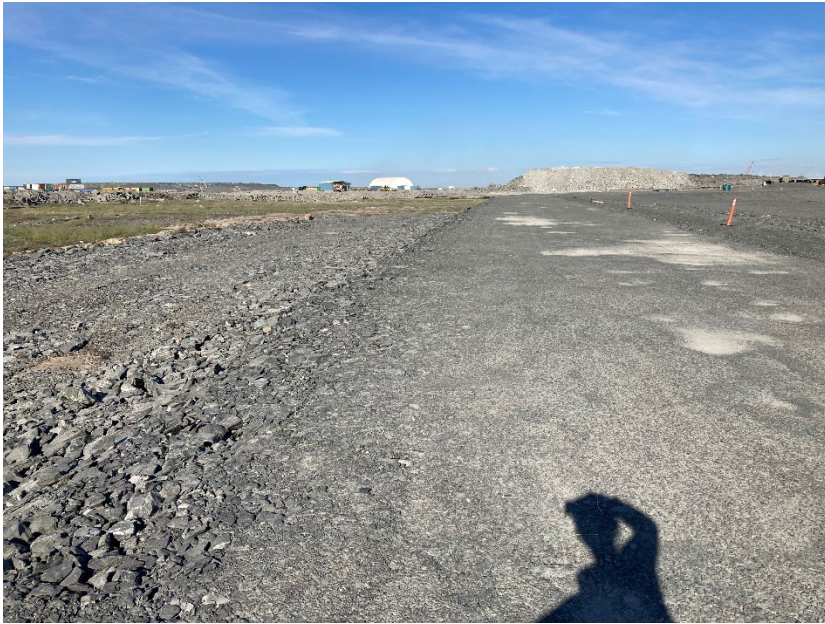
Photograph A6-5 IVR Dike D-1

Description: From approx. Sta. 0+430, looking west at the crest and upstream slope. Presence of old tension cracks.

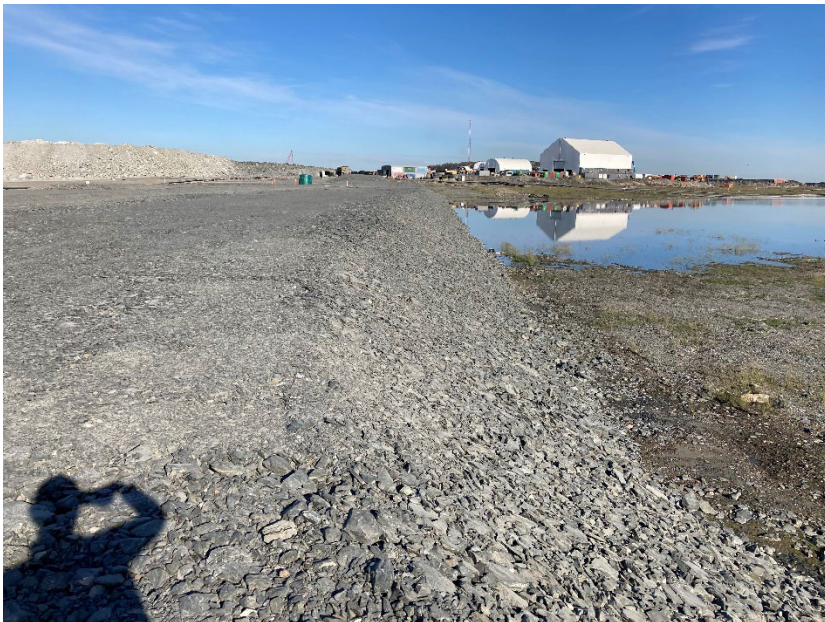
Photograph A6-6 IVR Dike D-1

Description: From approx. Sta. 0+430, looking west at the crest and downstream slope. Presence of tension cracks.

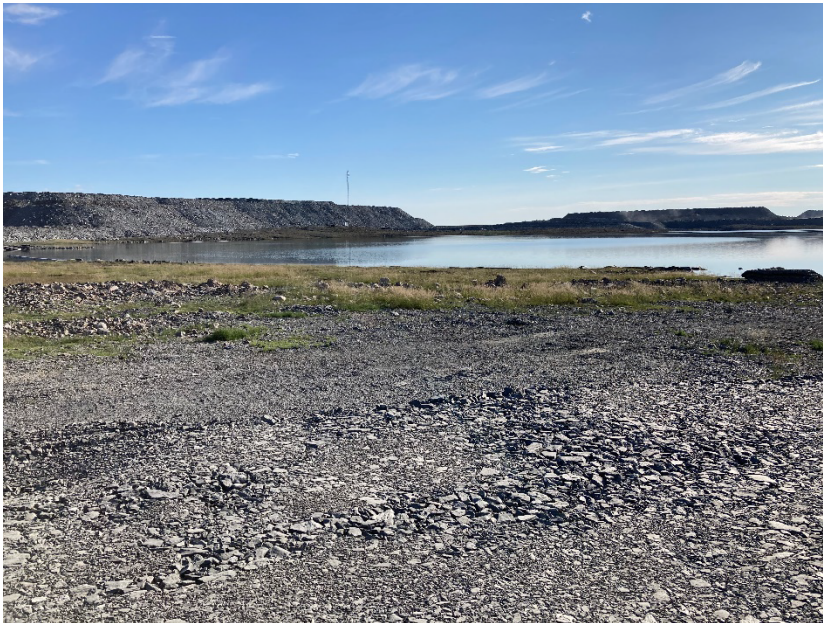
Photograph A6-12 IVR Dike D-1

Description: From approx. Sta. 0+395, looking west at the crest. Presence of tension cracks (1-2 m long).

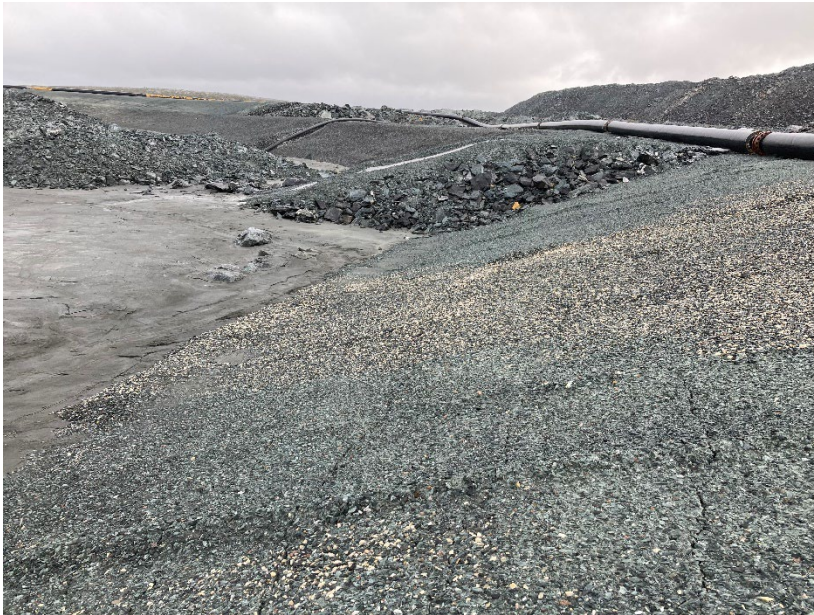
Photograph B1-9 Tailings Storage Facility

Description: From the North Cell Internal Structure at approx. Sta. 2+400, looking northwest at the upstream slope. Presence of tension crack on upstream slope (approx. 10-20 mm wide)

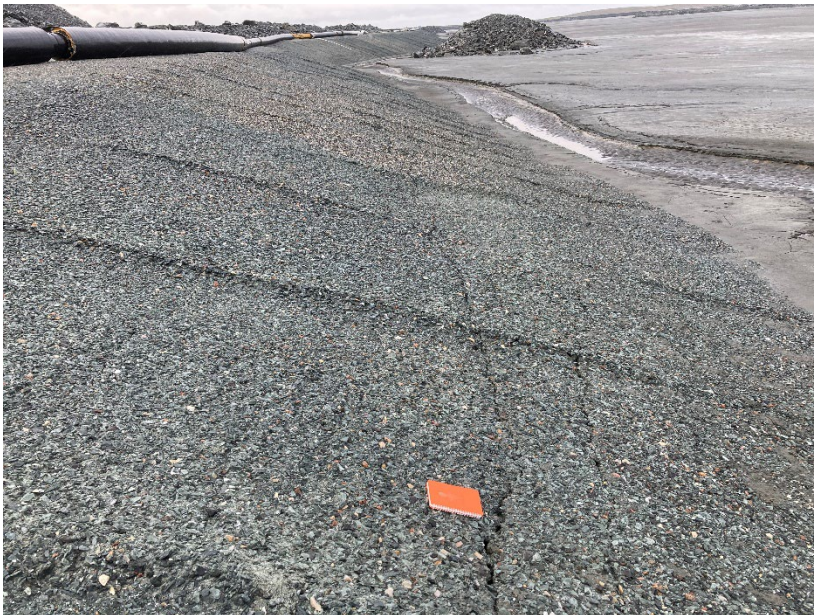
Photograph B1-10 Tailings Storage Facility

Description: From the North Cell Internal Structure at approx. Sta. 2+700, looking northwest at the upstream slope. Presence of tension crack on upstream slope (approx. 10-20 mm wide)

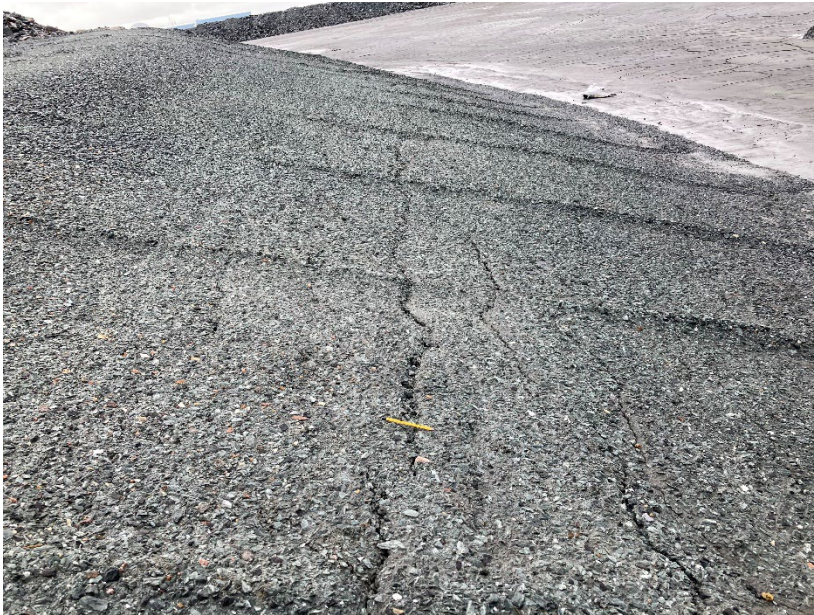
Photograph B1-11 Tailings Storage Facility

Description: From the North Cell Internal Structure at approx. Sta. 2+700, looking northwest at the upstream slope. Presence of tension crack on upstream slope (approx. 10-20 mm wide)

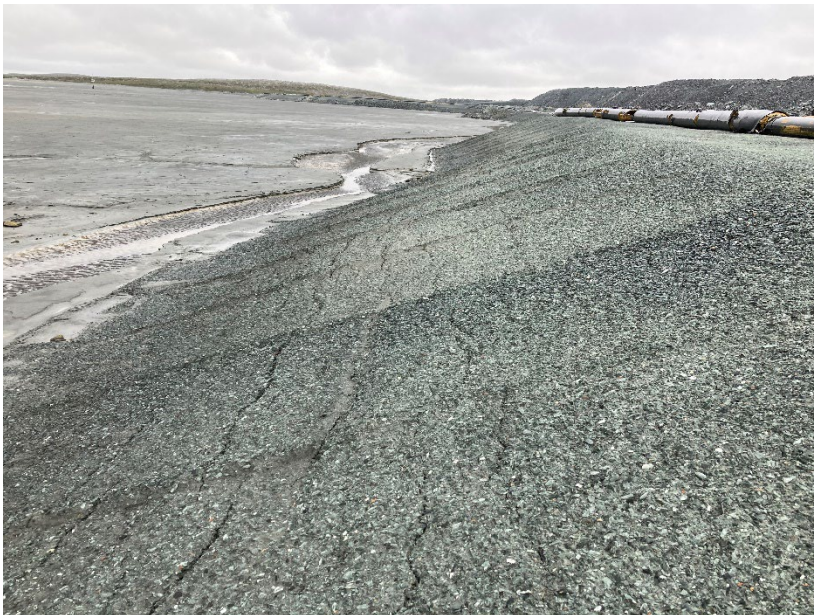
Photograph B1-12 Tailings Storage Facility

Description: From the North Cell Internal Structure at approx. Sta. 3+100, looking southwest at the upstream slope. Presence of tension crack on upstream slope (approx. 10-20 mm wide)
