Whale Tail 2022 Annual Open Pit Geomechanical Inspection

March 17, 2023

**RE: Meadowbank Complex - Amaruq Site - 2022 Annual Open Pit
Geomechanical Inspection**

Meadowbank Complex - Amaruq Site - 2022 Annual Open Pit Geomechanical Inspection

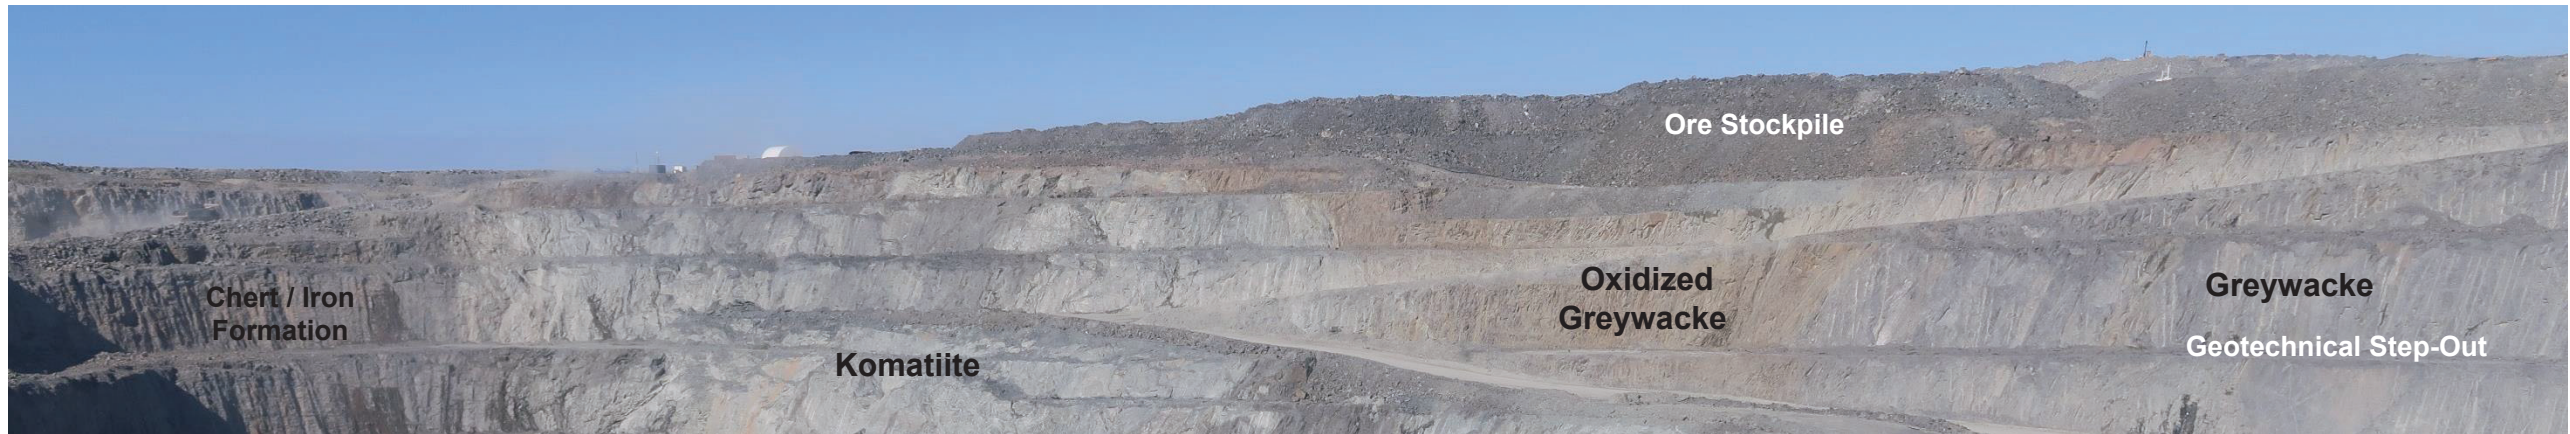
- Final wall in Design Sector A1/A1K.
- No mining has occurred in this area and there have been no slope failures since the last annual inspection.
- The benches are generally performing well.
- The Oxidized Greywacke is thought to be associated with a talik zone below what was the western end of Whale Tail Lake. It is of lower rock mass quality than the Greywacke and prone to ravelling. The exposures along the ramp are limited in height and rockfall has not been a concern to date. If ravelling increases, a rockfall berm could be constructed along the inside of the ramp through this unit.

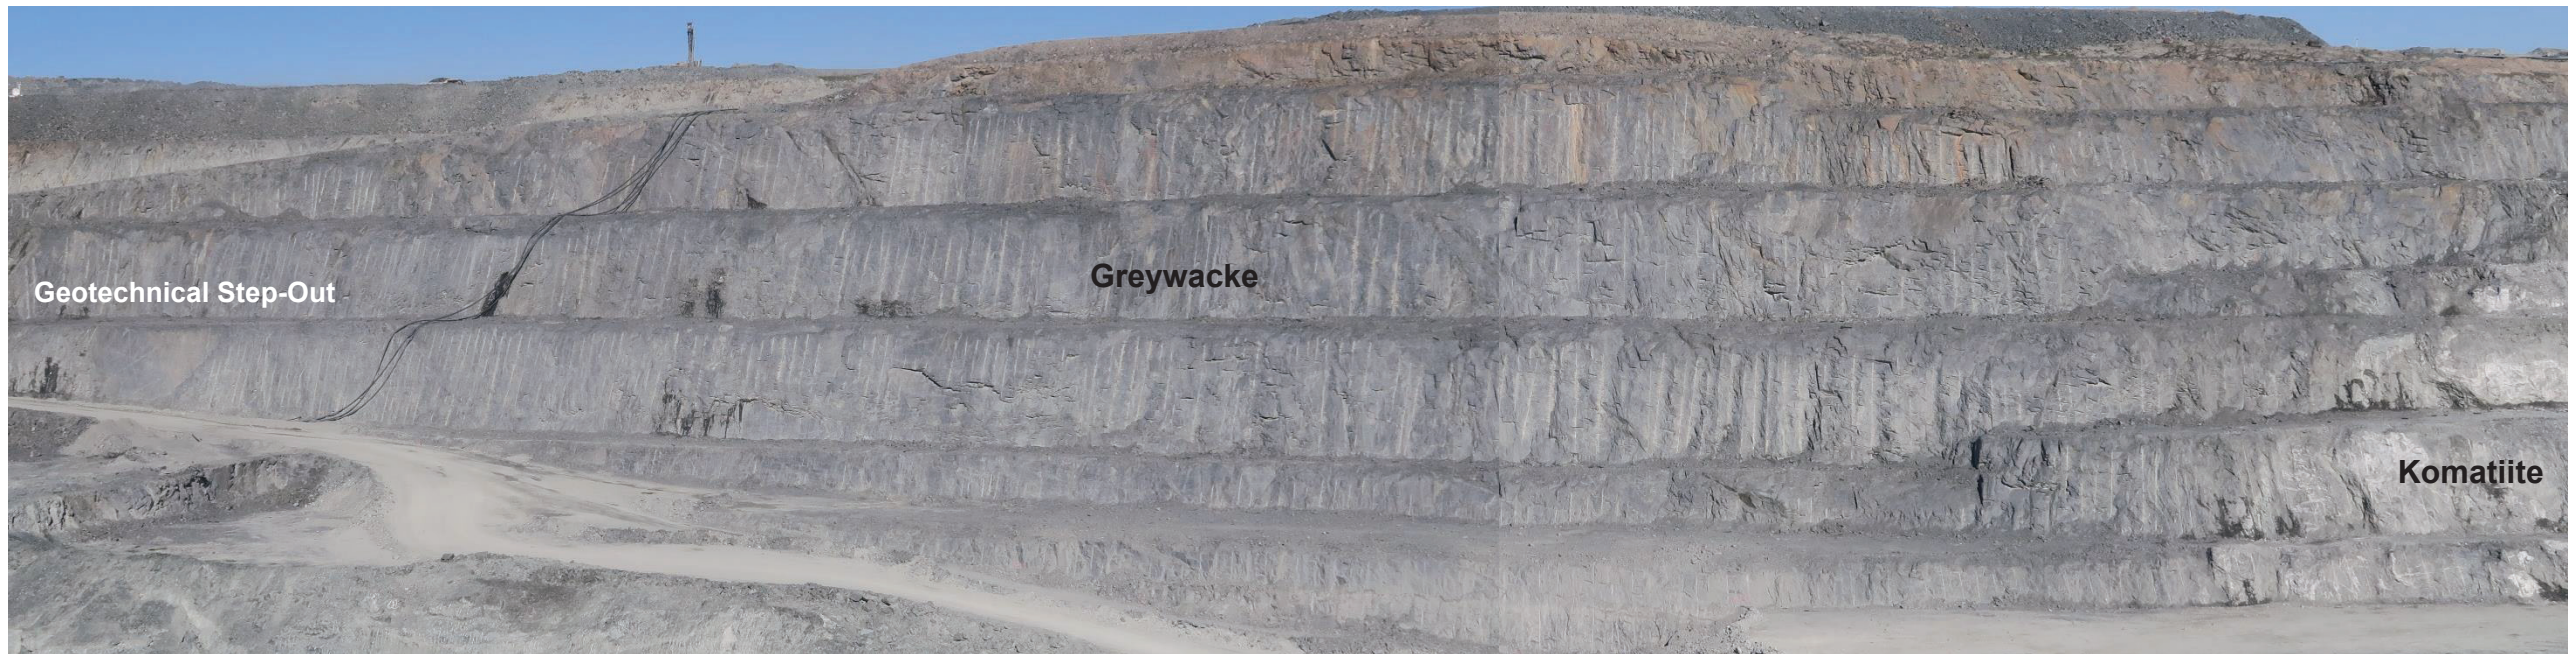
- Final wall in Design Sector B1.
- Limited mining has occurred in this area and there have been no slope failures since the last annual inspection.
- The benches are performing better than expected, with the bench face often standing steeper than the foliation.
- The 2021/2022 design review found that many of the pre-shear drillholes have been drilled at an angle shallower than the planned 60°, reducing the effective bench width. Comments on drill and blast quality control are provided later in this presentation.

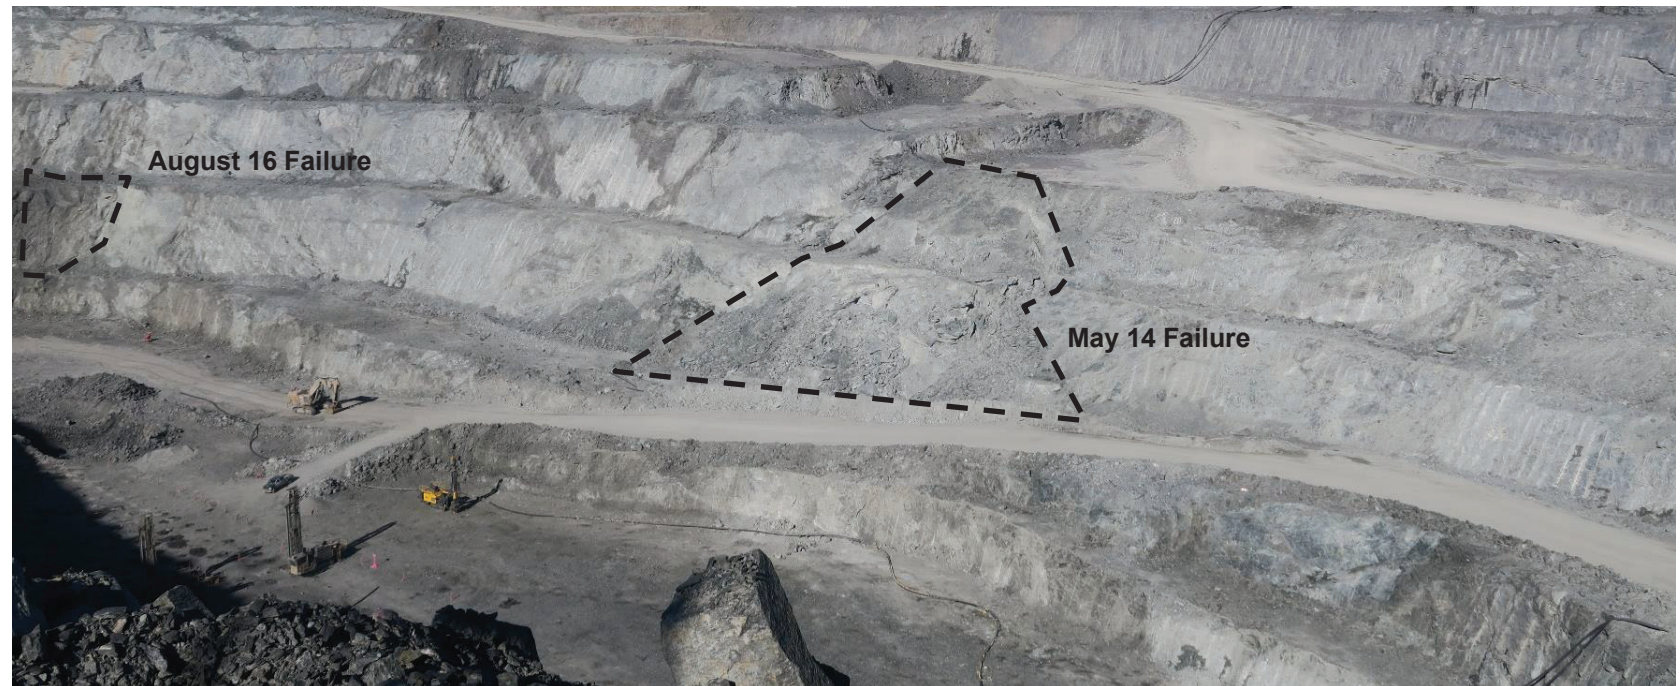
- Interim wall in Phase 1. Phase 1 has been the focus of production over the past year.
- The wall was established in the Komatiite, parallel to the foliation. As expected, a series of bench-scale failures have occurred in areas where the foliation locally dips at a shallower angle than the bench face.

- The implementation of a 55° pre-shear has improved slope performance and half barrels are visible in many areas. Bench-scale failures have and will continue to occur. AEM continues to complete extensive scaling in this sector in order to remove potential hazards and reduce the likelihood of a failure. This is endorsed.

- The bench failures almost always occur during freshet or the summer months.
- As a result, the development of the ramp along the this wall was prioritized during the 2021-2022 winter in order to minimize the rockfall risk to personnel. A berm was installed along the inside of the ramp prior to freshet.

- Two areas of instability have developed along this wall in 2022 (outlined in the image at right) and are described on the following slides.

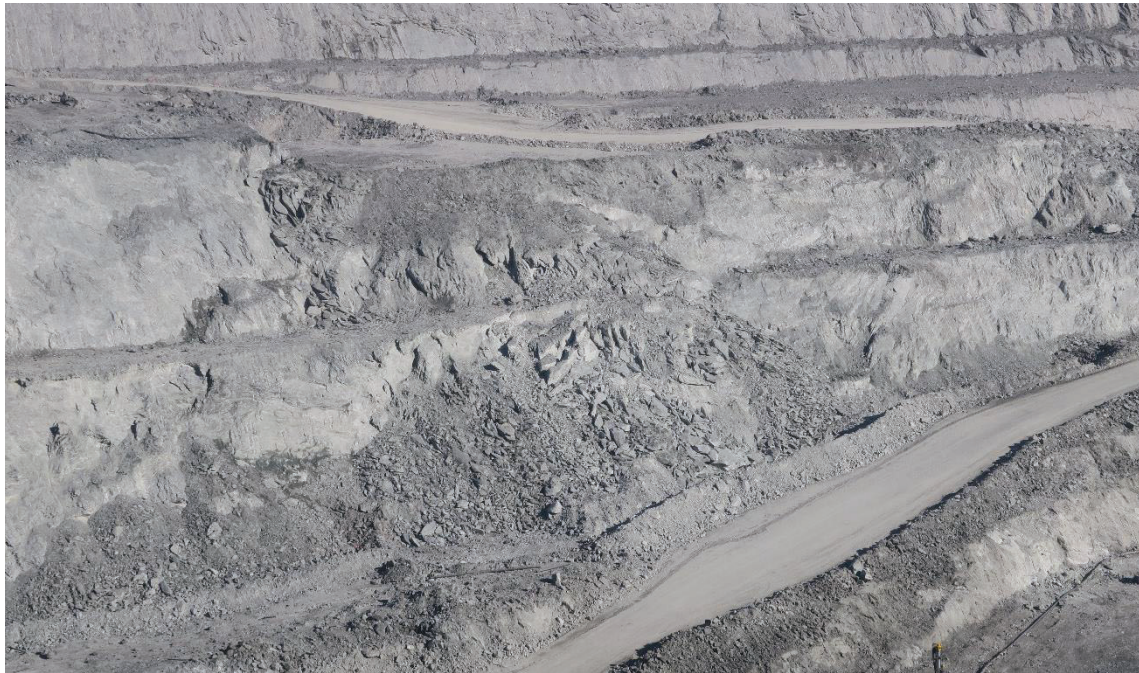
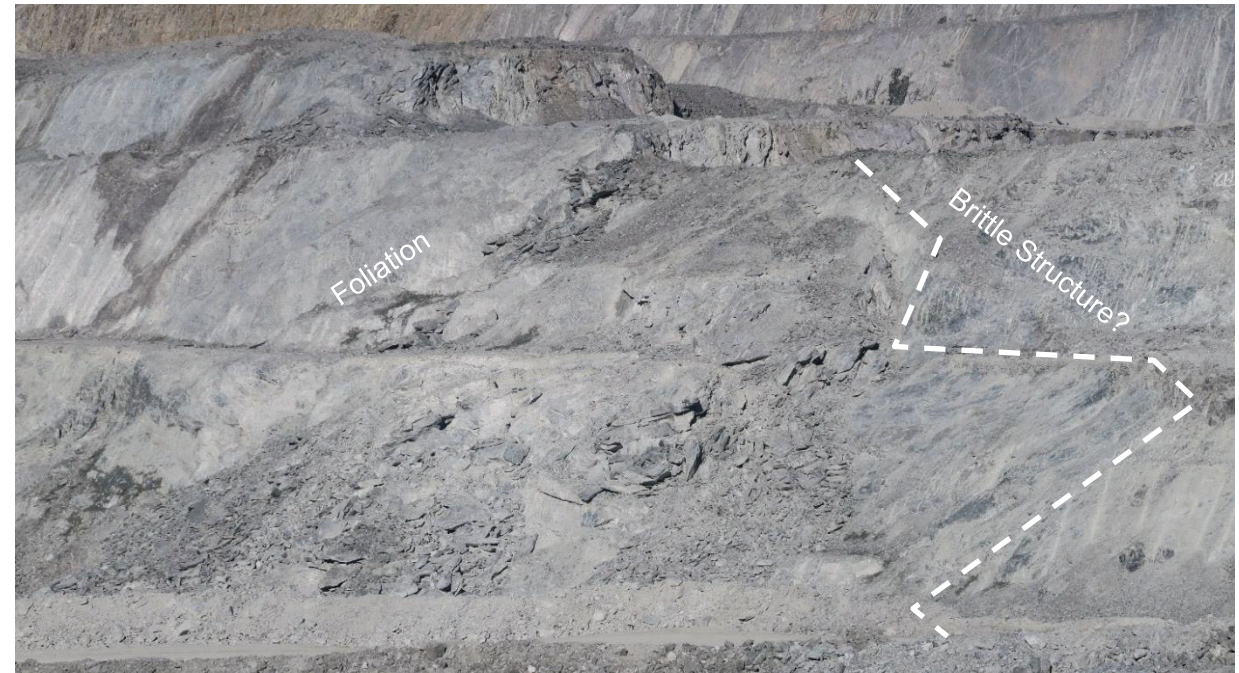
- A multi-bench failure has occurred progressively within the Komatiite over multiple events between May 14 and July 16, 2022.
- The area was identified as a potential instability during development and a berm constructed below the wall prior to freshet.
- The failure appears to be bounded by persistent structures. This could represent an undulation in the foliation, as similar geometries have resulted in bench scale failures in the past. The eastern contact appears to be more linear and may be a Brittle Structure.
- The failure mass continues to exhibit steady, gradual deformation in the radar data, in the order of 5 to 6 mm/day.

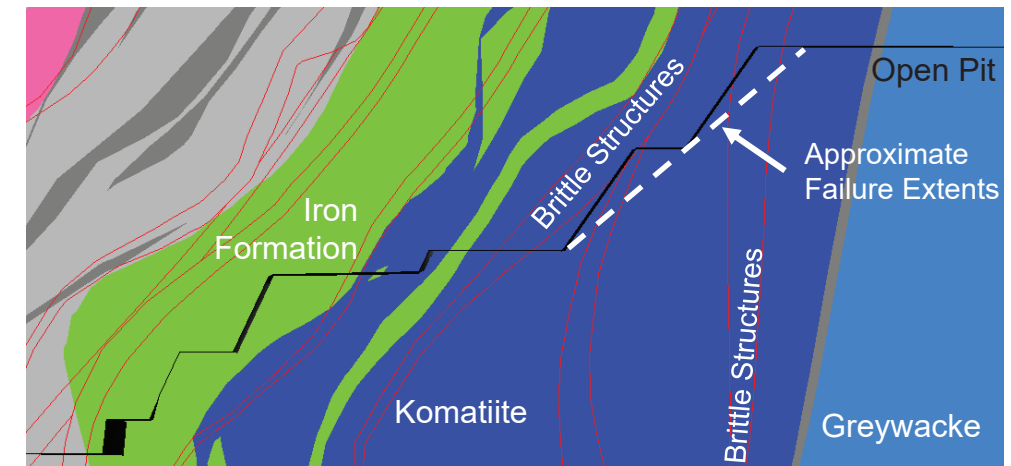
- A review of the lithology model suggests that the failure is unlikely to propagate significantly further back behind the crest due to the presence of the Greywacke.

- The potential for the failure to continue to propagate with depth was discussed as the structure defining the eastern boundary of the failure daylights below the ramp. The failure is larger than others along the Phase 1 North Wall and should be reviewed in greater detail to better understand the failure mechanism, likely contributing factors, and the potential for the failure to continue below the ramp. It may be possible to use the radar data to better understand the possible structural controls on the failure. A Maptek scan is recommended to document the failure geometry in detail.

- The Phase 1 pit will be used as a sump for managing water into 2024. Personnel will be travelling on the ramp below this failure during that time.
- Options for reducing the risk to personnel if the failure continues to progress were discussed. These include:

- Buttressing the failure. This would limit the ramp to single lane traffic but that is expected to be manageable.
 - Allowing the water level to rise a point on the ramp above the failure. This would allow the pumps to be located above the failure, removing the requirement for personnel to travel below the failure. However, the infiltration of water into the toe of the failure mass would like adversely influence the performance of the failure. The potential risks associated with storing this much water above the underground workings would also need to be reviewed.

- The failure should continue to be monitored with the radar and the berm maintained.
- Once mining of Phase 1 is complete, the risks associated with on-going access below the failure should be reviewed and mitigation measures implemented as appropriate.

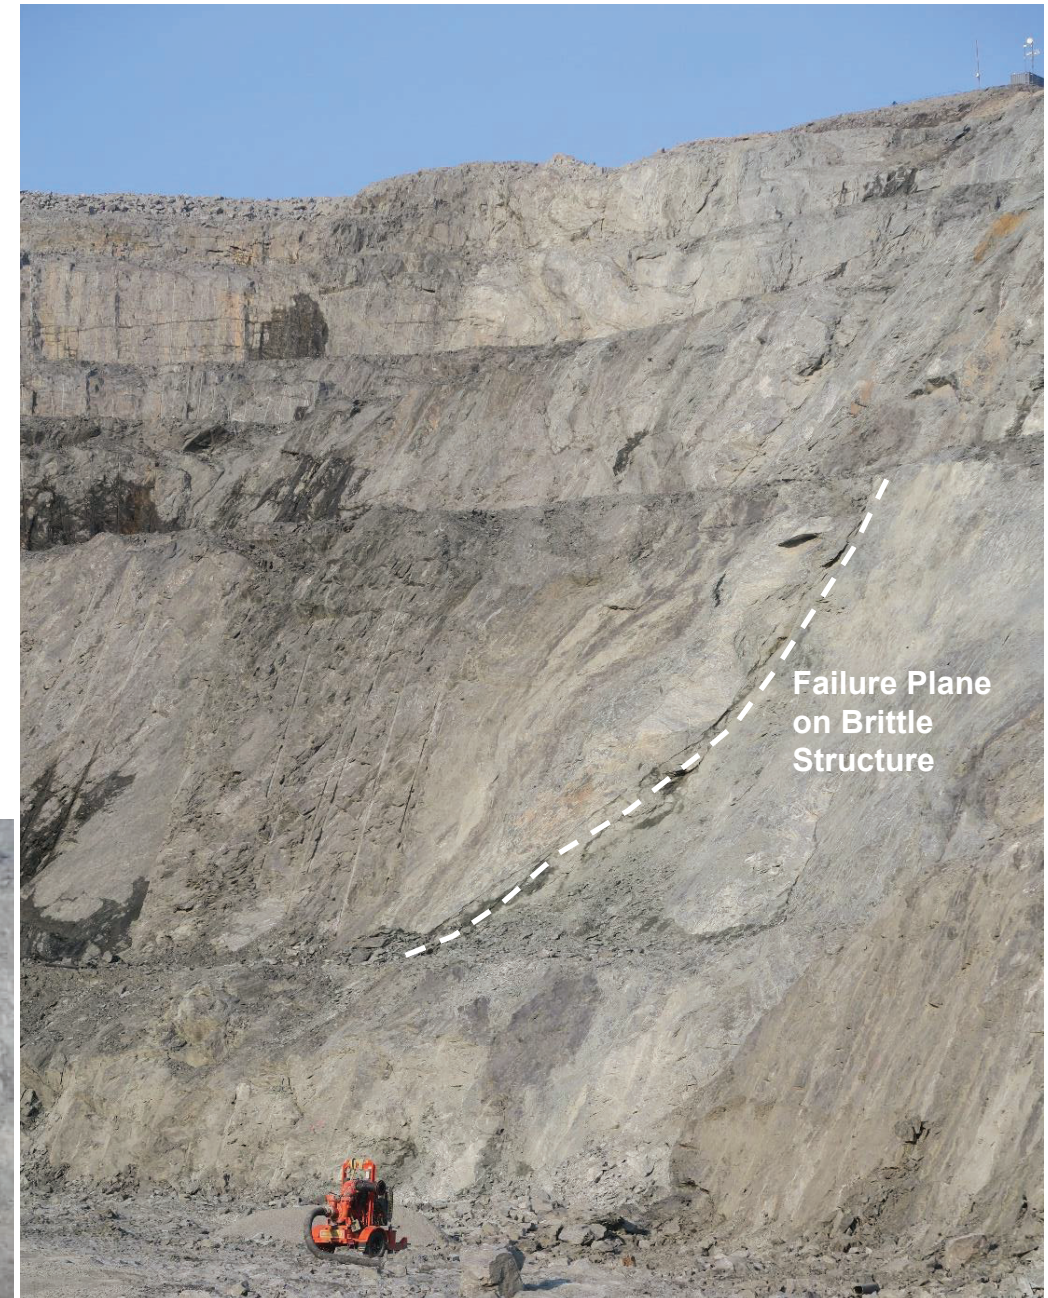
- During the site visit, a possible instability at the western end of the wall was identified based on trends in the radar monitoring data.
- A wedge is present on the wall, formed by a brittle structure and a cross-cutting structure (likely Joint Set D). The rock mass below the brittle structure is Komatiite but it is not clear if the wedge itself is Komatiite.
- The area was barricaded and access prevented. Due to the timing of the event, the pump shown in the photo was left within the barricaded area.
- After the site visit, a portion of the wedge failed in place on August 16 (see inset below). A small step-in with a berm has been left below the failure to allow mining to continue in the area.
The area should continue to be monitored.
- The failure will be mined out when Phase 1 is pushed back to the final pit configuration.

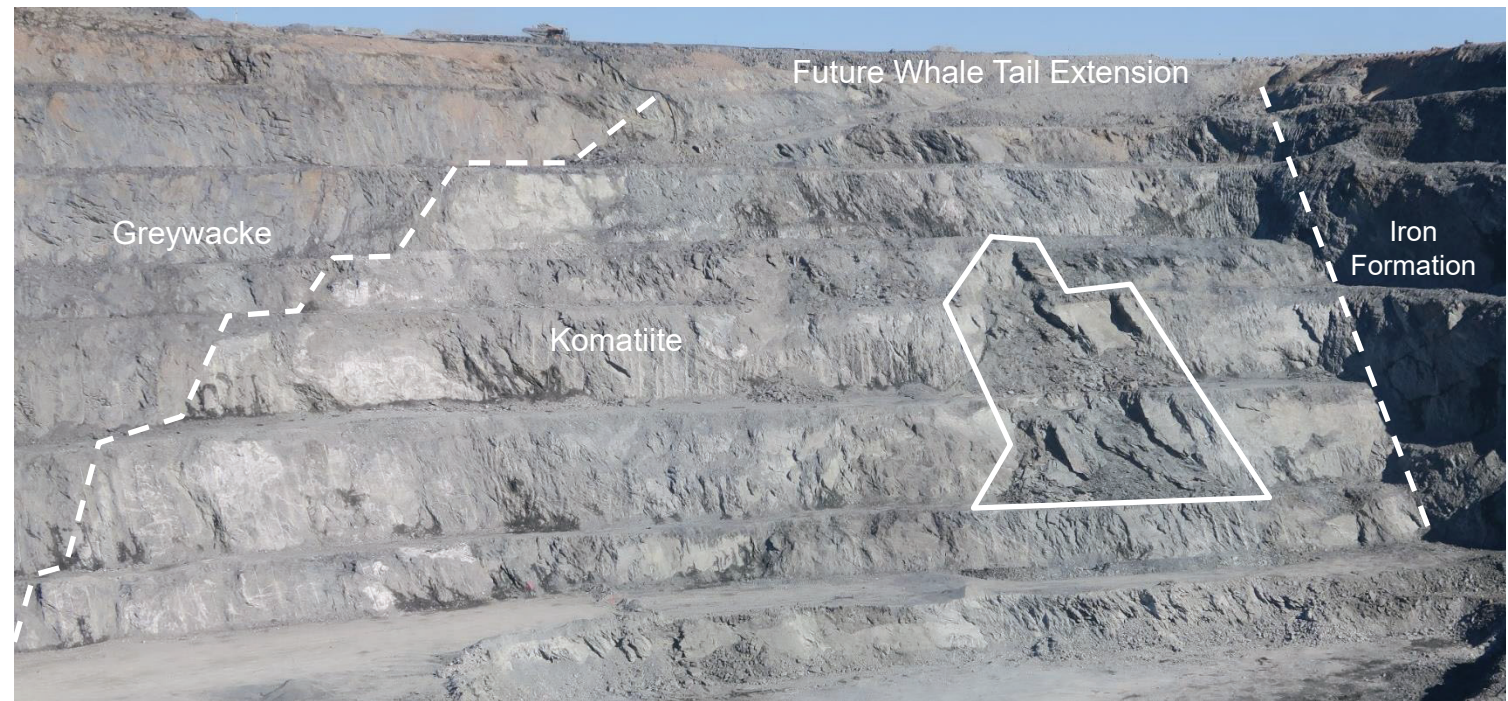
- Final wall in Design Sector D4K.
- This sector is within the Komatiite and has been characterized by a series of bench scale failures. The failures are currently understood to be a hybrid of failure on the foliation and failure of the weak rock mass, influenced by water (i.e., a combination of seepage within the talik and surface runoff) and the Brittle Structures.

- A revised slope design was developed in December 2021 and a pushback of the upper two benches completed to re-establish the slope. The pushback will eventually form part of the planned Whale Tail Extension to the northeast.

- The wall continues to be a focus for the Rock Mechanics team. Assessments of the overall slope stability using a numerical model and of the planned lower wall using kinematics are in progress.

- The performance of the benches has improved with the revised slope design. Several bench-scale failures have occurred and will continue to occur.
- A series of bench-scale failures have occurred at the eastern end of the sector (outlined at right). The failures have almost, but not yet, linked up. This area is discussed on the following slide.

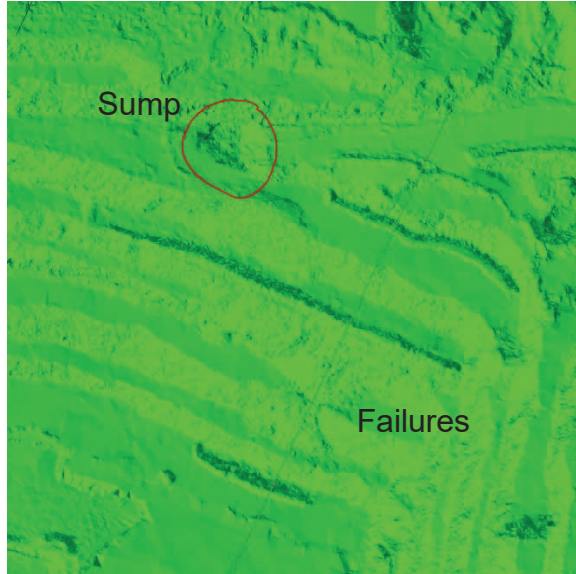
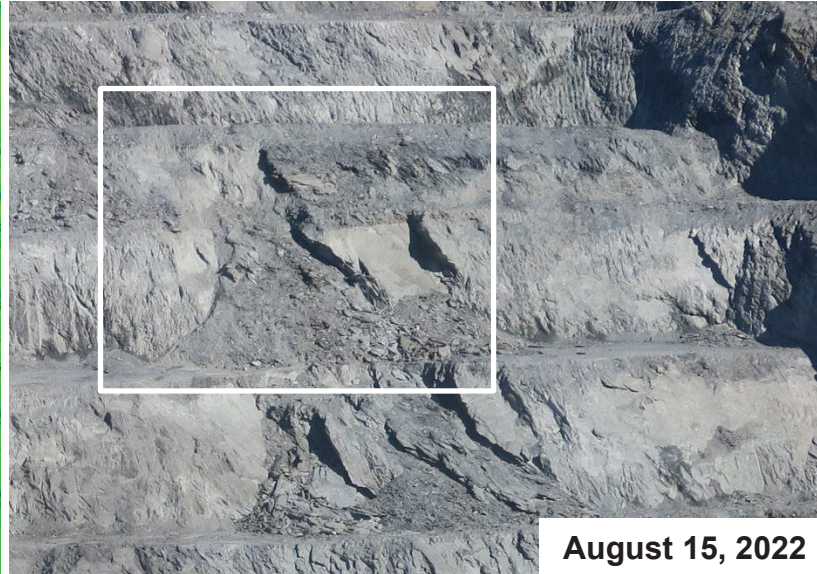
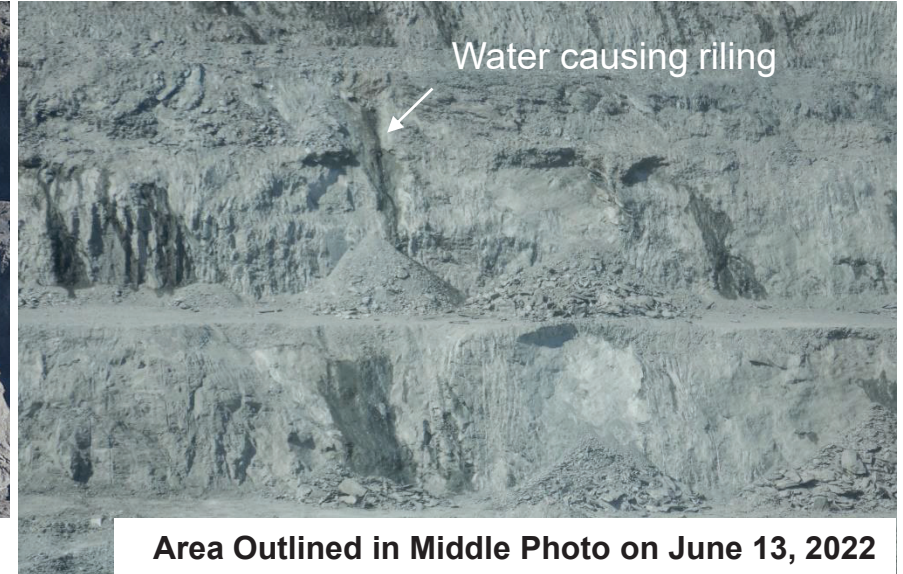
- The site team believes that the infiltration of surface water and the erosion of brittle structures in the bench face likely contributed to the initial failure in May.

- The pushback is located within the drainage for what was the northeastern lobe of Whale Tail lake and water reports to the area. An unlined sump has been established at the base of the pushback at the top of the slope (left photo). The sump is on the Komatiite-Greywacke contact, which is likely promoting infiltration.

- Photos prior to the failures show surface water running across the bench face and eroding the weak rock mass (right photo). The water appears to be concentrated along the potential structure bounding the western edge of the failures.

- It seems reasonable that water is contributing to the failures. It is recommended that surface water be diverted away from the area to the extent possible and that the sump be lined.

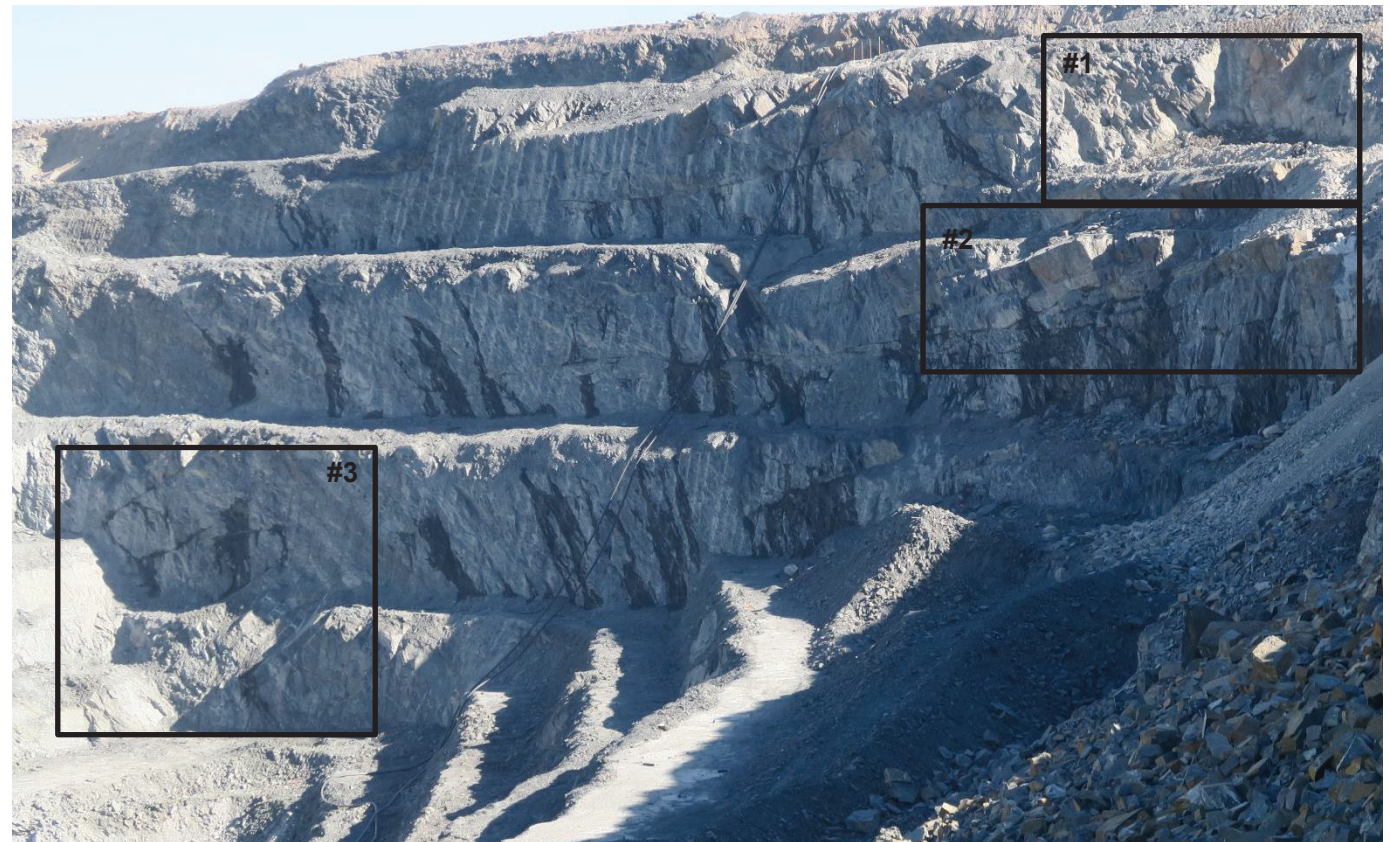
- Final wall in Design Sector E4.
 - Limited mining has occurred along this wall since the 2021 review. Specific areas of note are listed below and outlined on the photo.

1. Material from a former in-pit dump remains on the face of the upper bench. A rockfall berm was constructed to retain ravelling material. No significant changes have been observed.

2. The Greywacke near the Diorite has experienced crest loss and previous rockfall events. A temporary step-out has been left below the area to reduce the exposure to personnel. The intention is to scale the area, clean the catch benches and recover the step-out as part of the Phase 3 pushback. This is endorsed. Several potentially unstable blocks were previously identified and should continue be monitored as part of the visual inspections. The drone should be used to supplement these inspections.

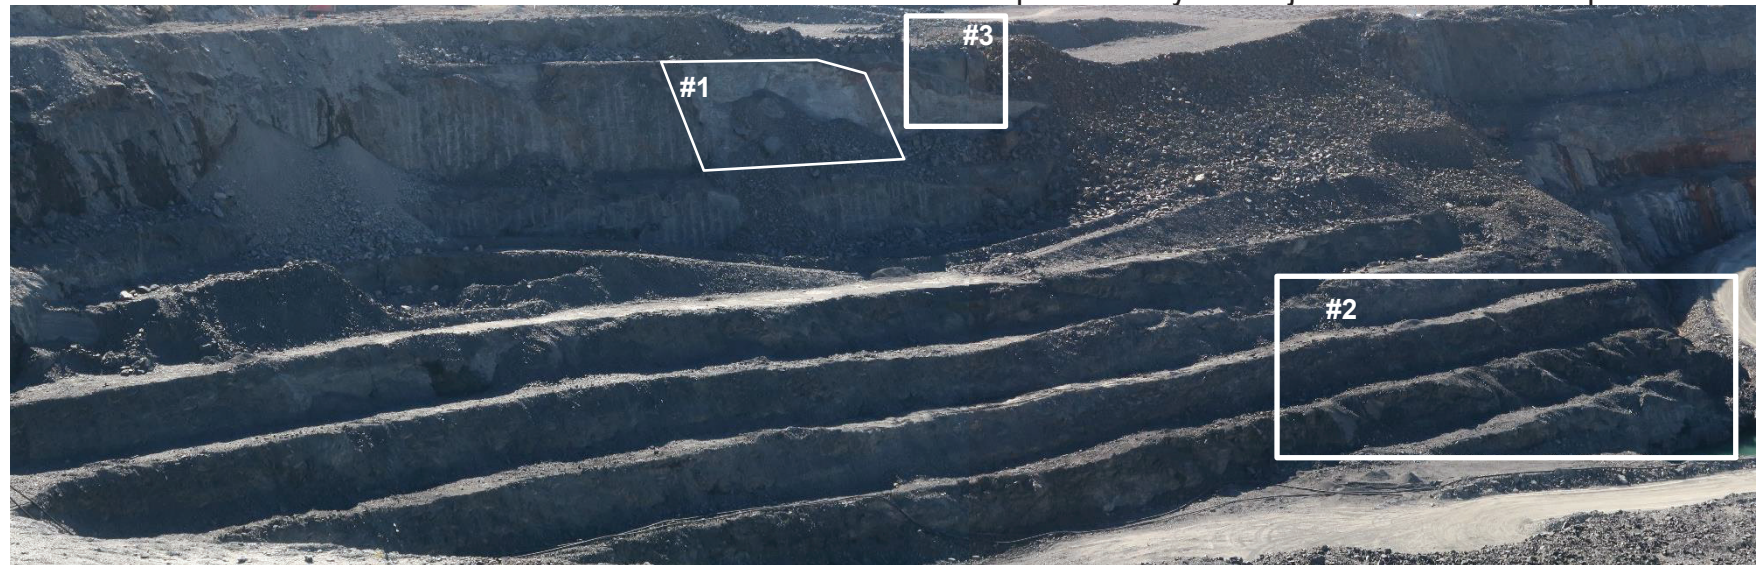
- Interim wall approximately within Design Sector G5. Also referred to as Phase 2 South (G5).
 - The lower portion of the wall has been developed with single benches. This was initiated due to the rockfall hazard at the transition with the East Wall.

- The wall is in the process of being mined out as part of the Phase 3 pushback. Spillover from the pushback is accumulating on the uppermost catch benches. The single benches have been effective and material has not yet reached the lower benches or the pit floor. This should continue to be monitored.

- Specific areas of note are listed below and outlined on the photo.
1. A bench-scale failure occurred along a sub-vertical contact between the Komatiite and the Greywacke in 2021. The failure will be mined out by the pushback. It is likely that localized bench-scale failures will occur on adversely oriented contacts as mining progresses.

3. A potentially unstable block is present at the edge of the pushback. See comments on next slide.

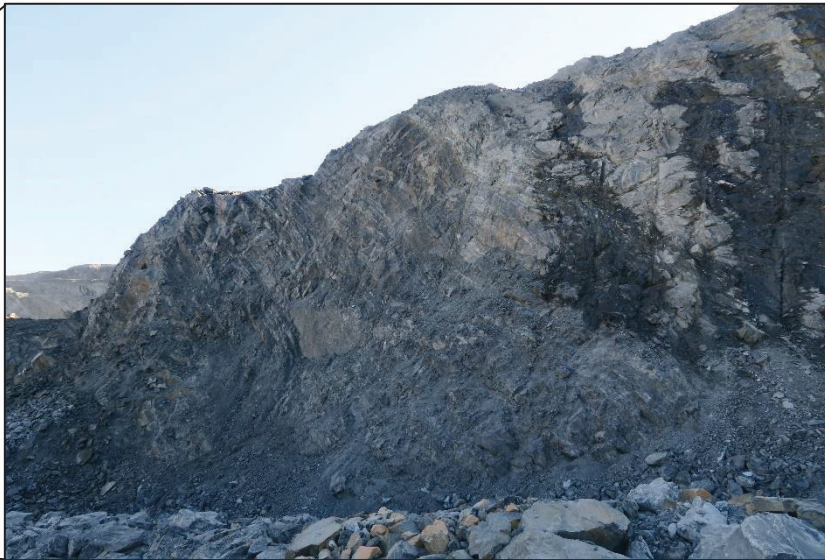
- A Brittle Structure was observed at the western end of the wall, adjacent the Phase 2 ramp.
- This structure (#3) is modelled along the northern contact of the South Limb Komatiite. The observed position, orientation, and thickness of the structure agree well with the 3D structural model.
- No particular stability concerns were noted.
- In general, the 3D structural model has not been validated against the exposures in the open pit. Recommend doing so to build confidence in the model as it is being used to inform key design decisions.

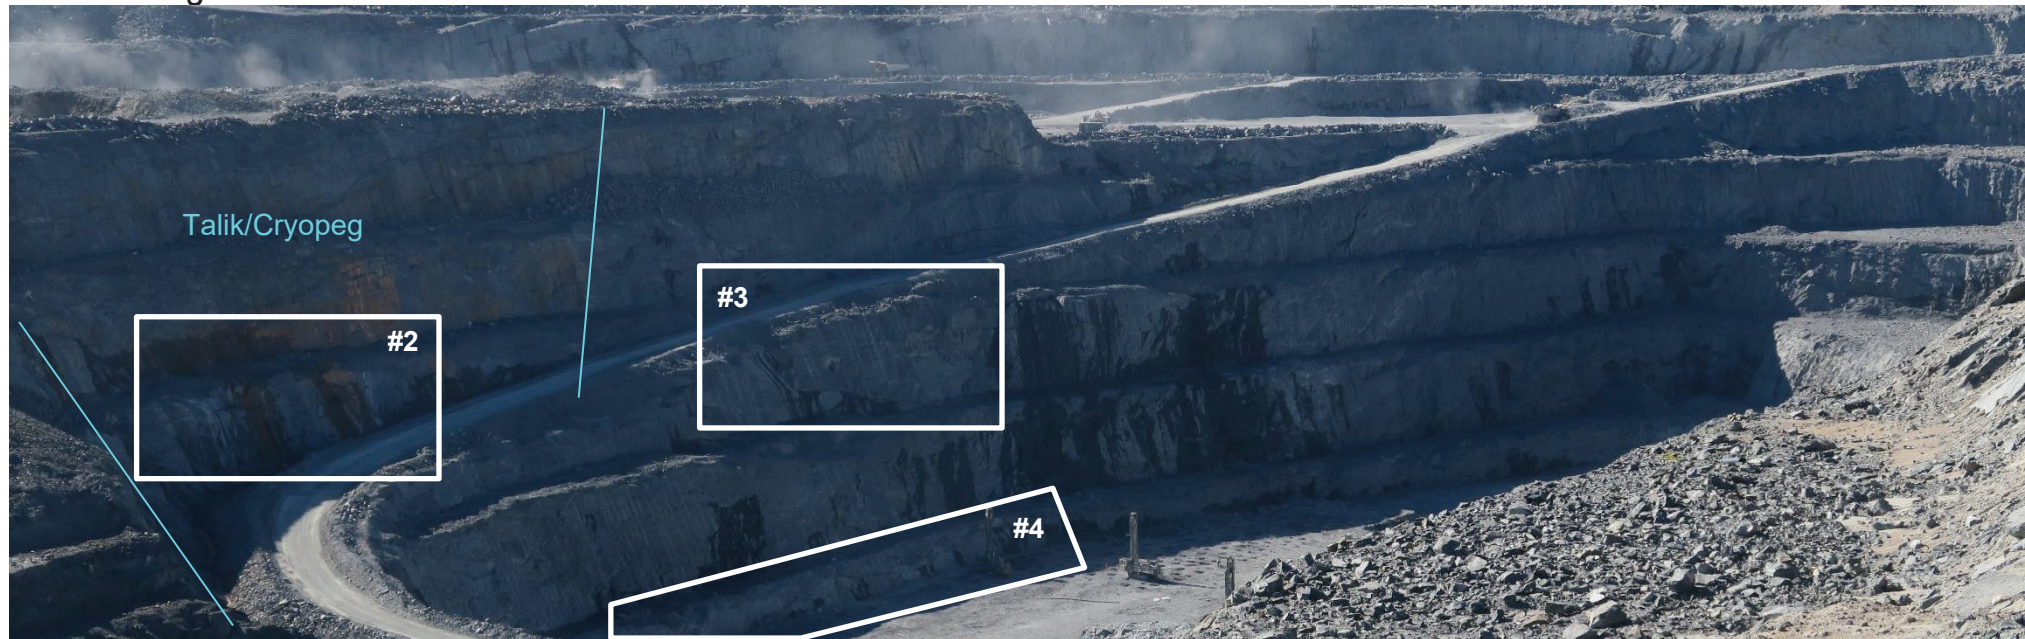
- Interim wall approximately within Design Sector H5. Also referred to as Phase 2 South (H5).
- The wall is generally performing well. Specific areas of note are listed below and discussed on the following slides.
 1. Spillover from the Phase 3 pushback has created a rockfall hazard along the Phase 1 ramp (not numbered below as it occurs throughout).
 2. Seepage within the talik associated with Whale Tail Lake.
 3. A possible unstable block was previously identified below the ramp.
 4. Poor scaling of the lowermost bench has created a rockfall hazard.

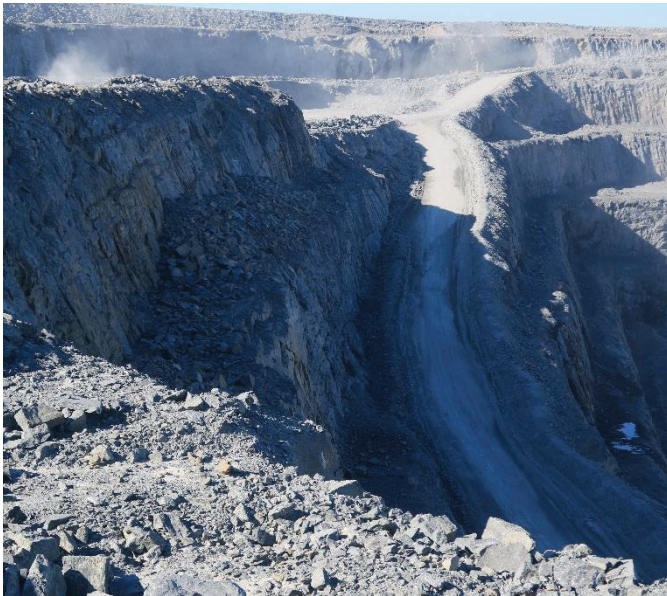
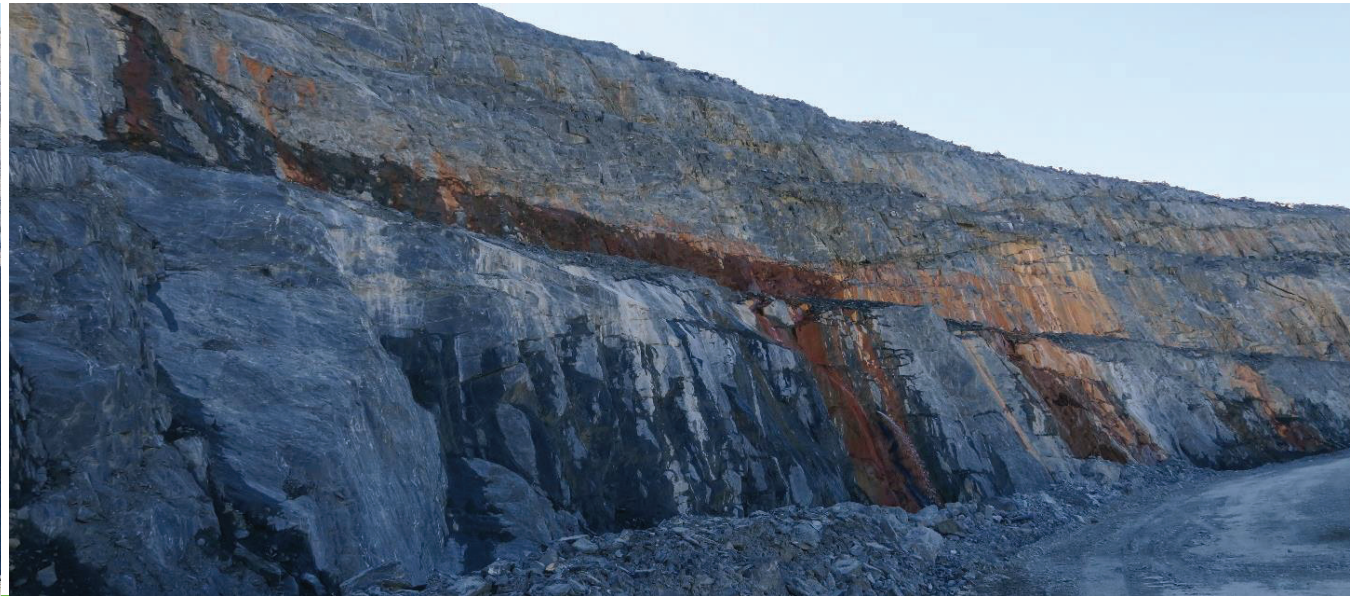
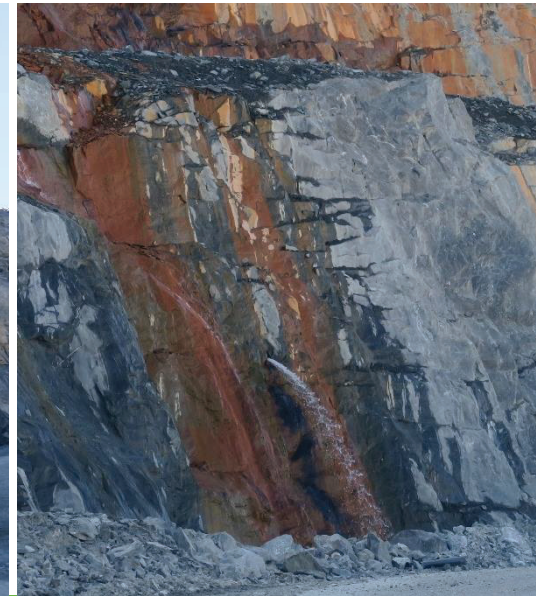
2. Prominent seeps are present in the lower South Wall, concentrated along sub-horizontal structures (centre photo). The seepage resulted in an ice wall but no significant ice falls occurred and the mine was able to manage this successfully. A water-management pushback has been planned to help mitigate this risk, which is endorsed. A test horizontal drain hole was completed (right photo) and has both consistently made water (including over the winter) and influenced the seeps on the wall. This suggests that horizontal drains may be viable in intercepting and managing seepage.

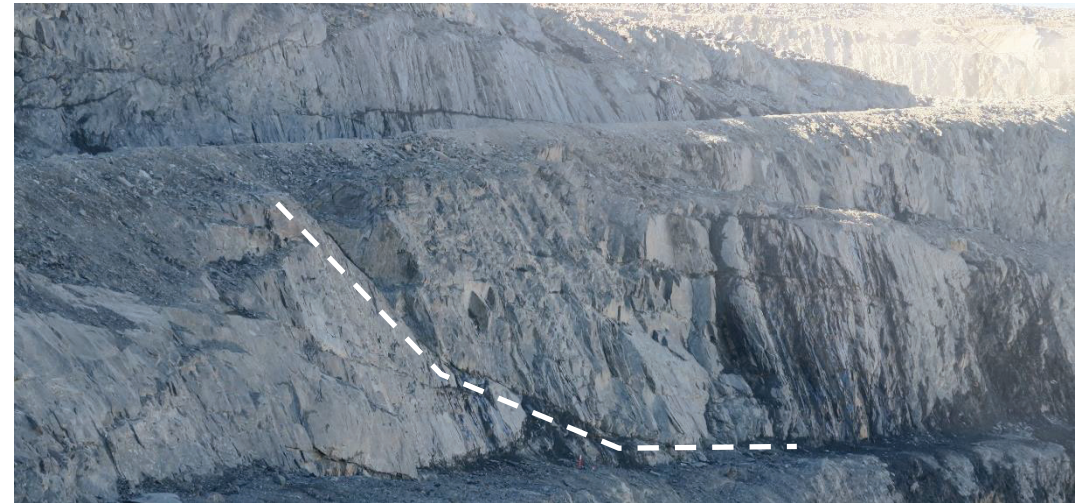
- As the wedge undercuts the ramp, it was recommended that instrumentation be installed to monitor any displacement. This has not been done. The fracture defining the eastern end of the wedge appears to have dilated (photo at lower right). Given the size and position of the block, the installation of instrumentation (e.g., wireline extensometer) to supplement the radar coverage continues to be recommended.

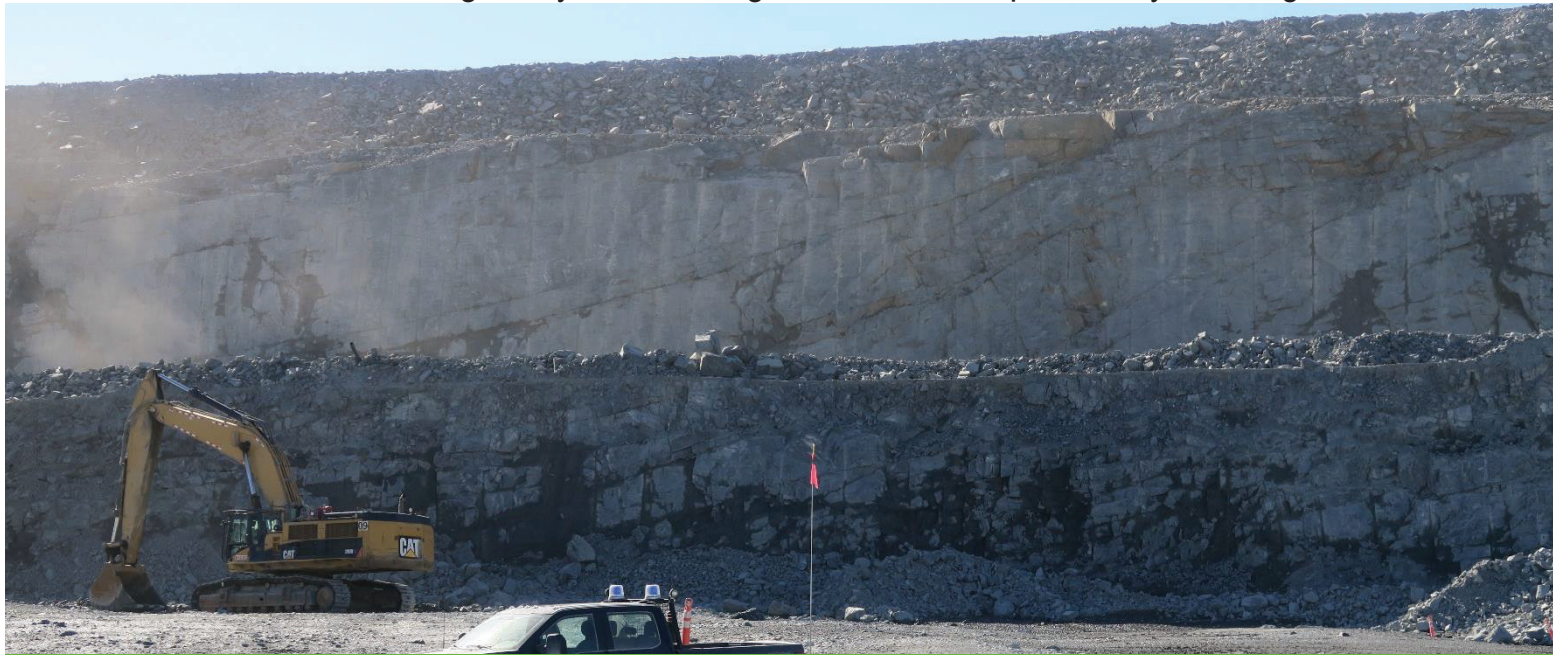
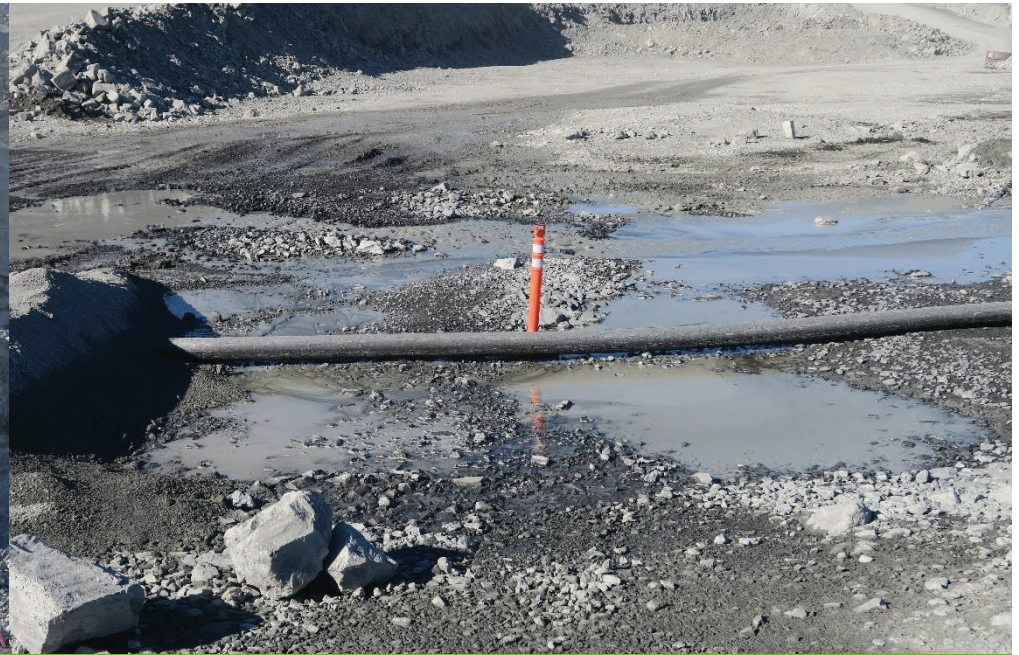
- Final wall within the Phase 3 Pushback (Design Sectors H6 and I6). The wall is predominantly Diorite.
- The area is a focus of current mining activity.
- Curvilinear structures are prominent in the wall and have locally contributed to crest loss (see left photo).
- Seepage from the lower bench face and floor was observed in the active mining area (see right photo). It is understood that this is a relatively recent development and is thought to be linked to a change in the blast pattern design, which now leaves a rock ridge between the pushback and the Phase 2 crest; the ridge may be retaining water that was previously draining into Phase 2.

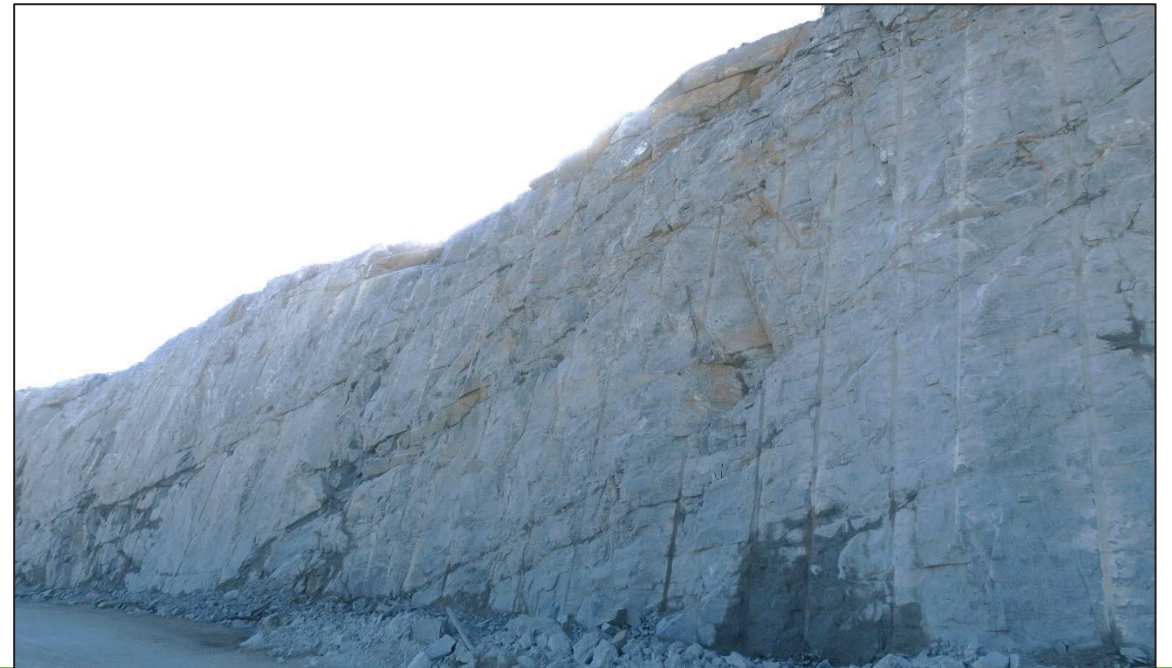
- The rock mass characteristics of the Diorite exposed in the upper benches is variable. Some areas are characterized by few discontinuities forming large blocks (photo at right). In other areas, more discontinuities and numerous small blocks are present (example on previous slide). The areas of lowest rock mass quality (photo at left) appear to be concentrated below the footprint of Whale Tail lake.
- In general, this variation in rock mass quality has not strongly influenced bench performance but has resulted in increased scaling or local rockfall hazards. Rockfall berms have been constructed below some of the blocky areas thought to represent the greatest hazard. This is endorsed.
