Whale Tail 2022 Annual Open Pit Geomechanical Inspection

March 17, 2023

**RE: Meadowbank Complex - Amaruq Site - 2022 Annual Open Pit
Geomechanical Inspection**

Meadowbank Complex - Amaruq Site - 2022 Annual Open Pit Geomechanical Inspection

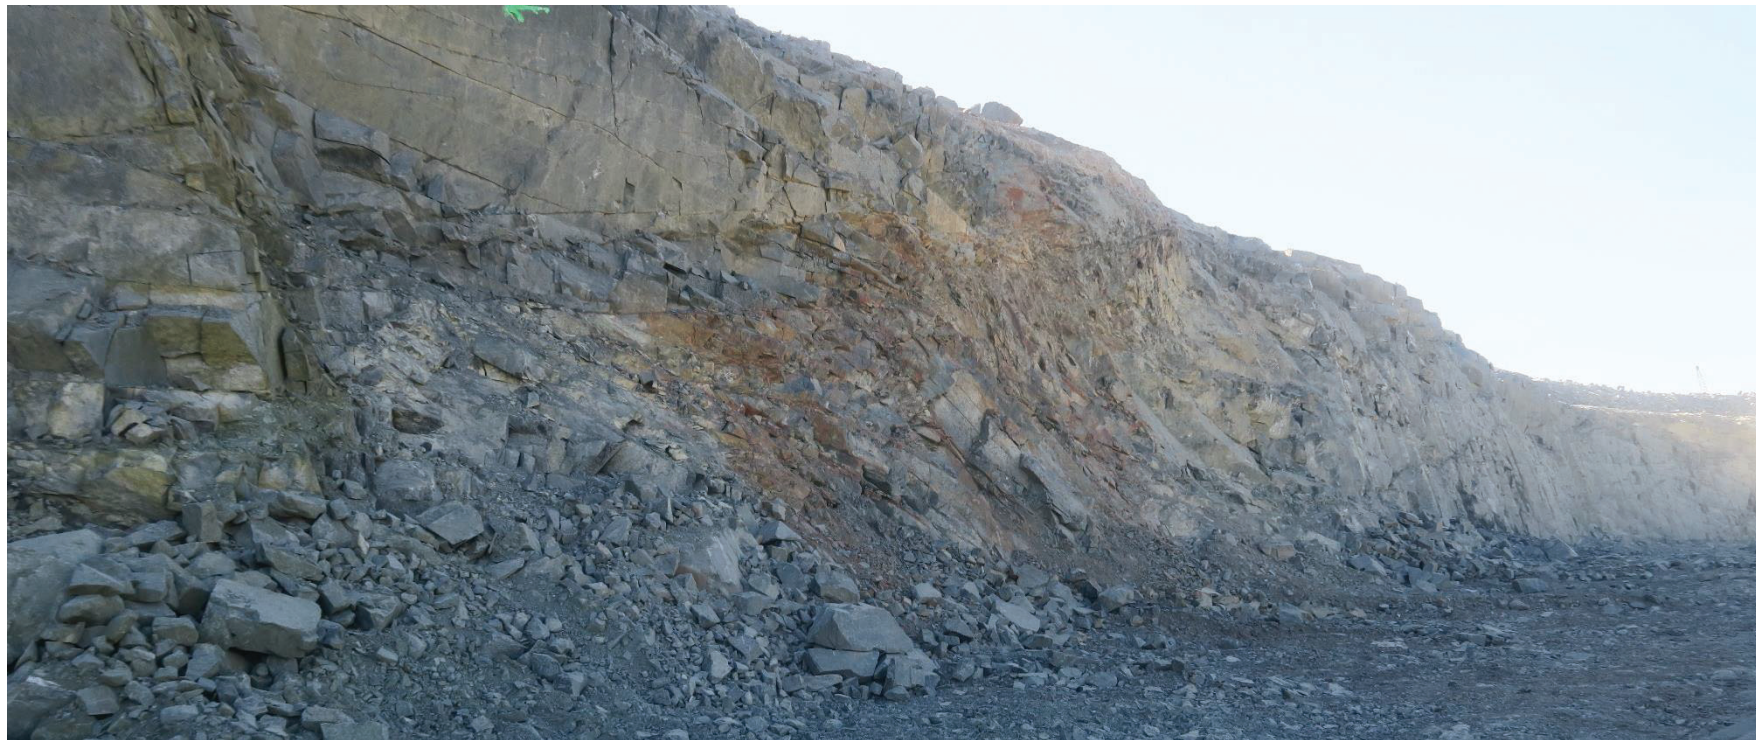
- The mine has recently switched to double-benching using 10.5 m flitches in the Diorite instead of triple-benching using 7 m flitches.
- This reduces the overall exposure of personnel working near the face but makes scaling more difficult as the excavator must work from a muck pad to reach the crest. As part of this transition, carefully monitoring the scaling and placing additional emphasis on the Bench Approval process is recommended to ensure that hazards are managed.

- A prominent fault, believed to be the Ramp Fault, has been exposed in the southeast wall of the Phase 3 Pushback.
- The fault is associated with a zone of reduced rock mass quality 1 to 2 m thick and 10 to 20 cm of gouge.
- A considerable amount of loose was present on the wall. It is understood that the wall had not yet been approved and that additional scaling will be recommended. This is endorsed.

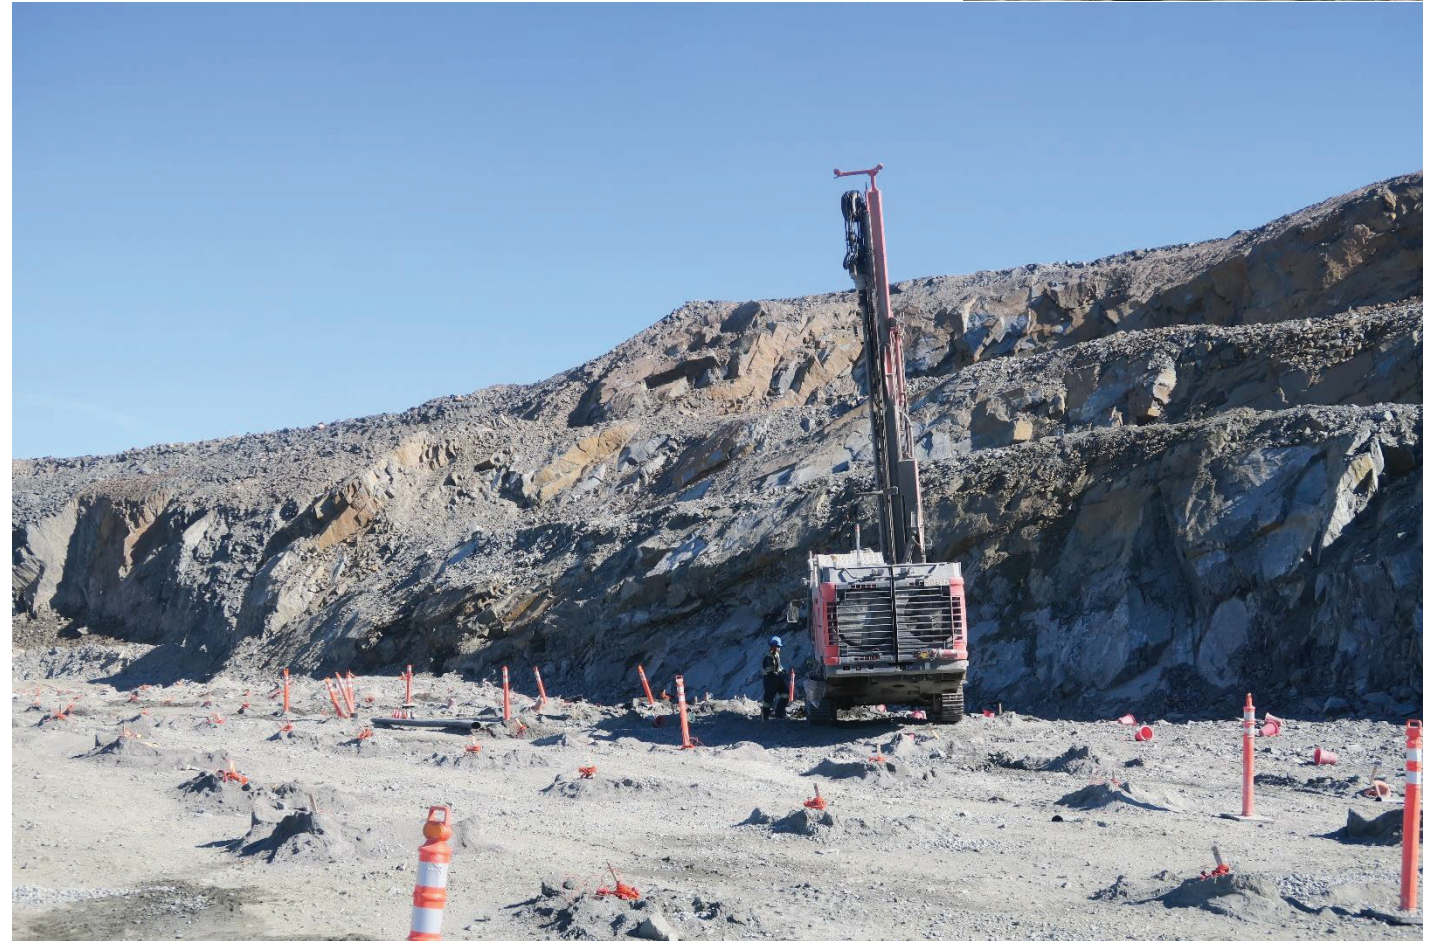
- Final wall in Design Sector F6.
- The slope geometry recommendations for this sector were adjusted in late 2021 as the strike of the sector had changed, increasing the potential for planar failure on Joint Set C.
- The achievable bench geometry is sensitive to both the persistence of Joint Set C and blasting and scaling practices. With careful blasting and scaling, a BFA of 75° and IRA of 44° could be achievable if the persistence is limited to 10 m or less, though with backbreak in the order of 8 m. However, if these practices are not used or are not effective, a BFA of 50° and IRA of 39° will be required.
- Geotechnical inspections and Bench Approvals were identified as a critical control for managing potential crest loss, rockfall and bench-scale failures.
- These are the first benches established in this sector and it is important to validate the bench design and implementation.

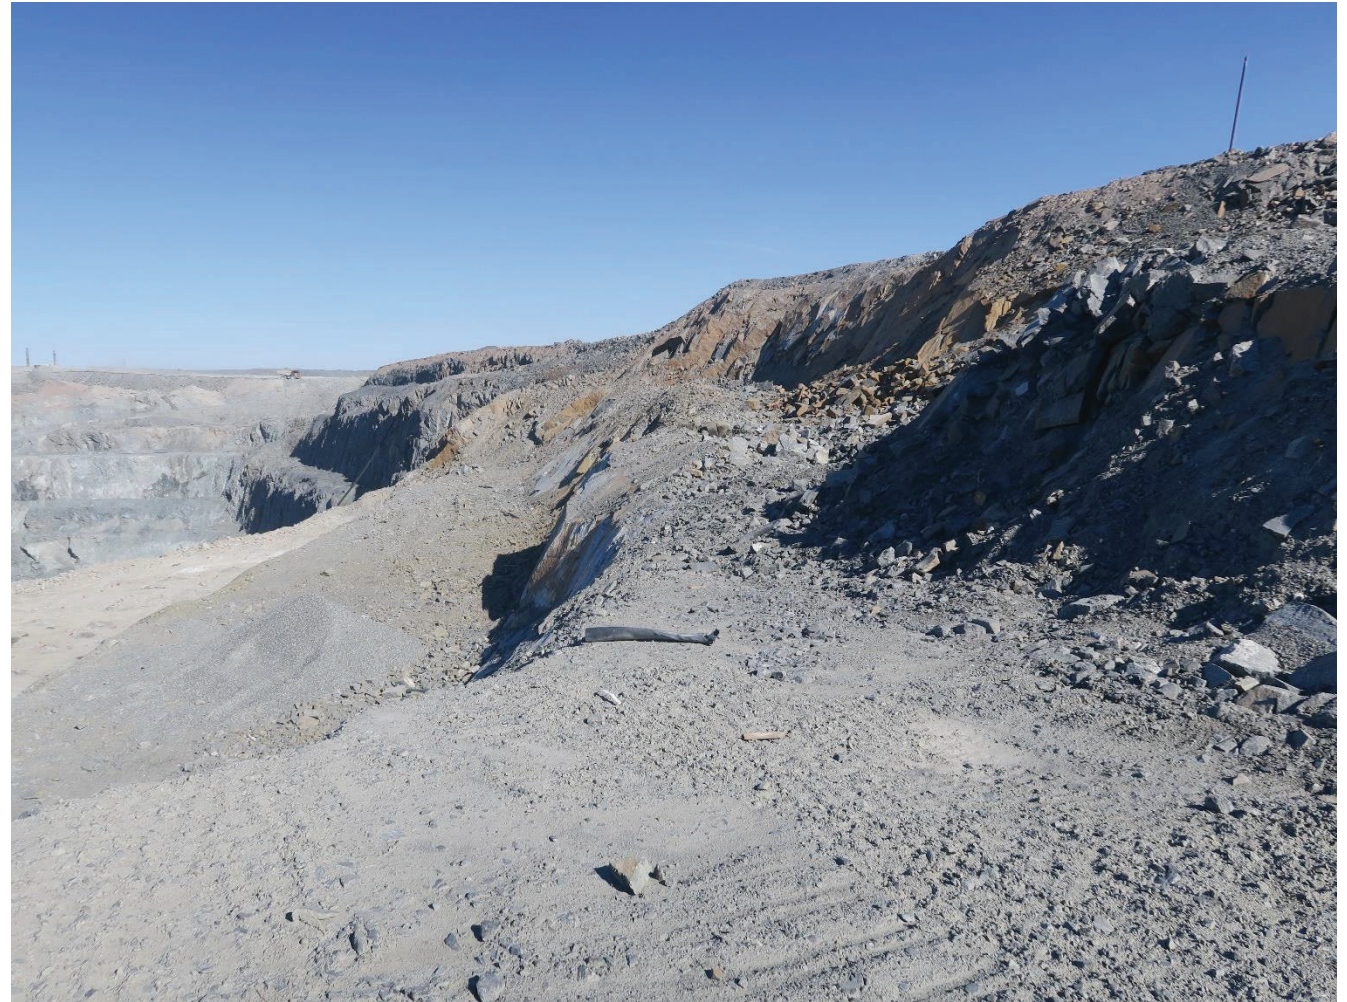
- The first two benches were established as single 7m high benches without pre-shear. The reason for this is not clear.
- The bench faces have broken back to Joint Set C. The resulting catch bench width appears to be less than the 8 m minimum in at least some areas.

- The design bench geometry will not be achievable if the approach used for these two benches is continued. Mining practices have improved for the third bench, which is discussed on the next slide.

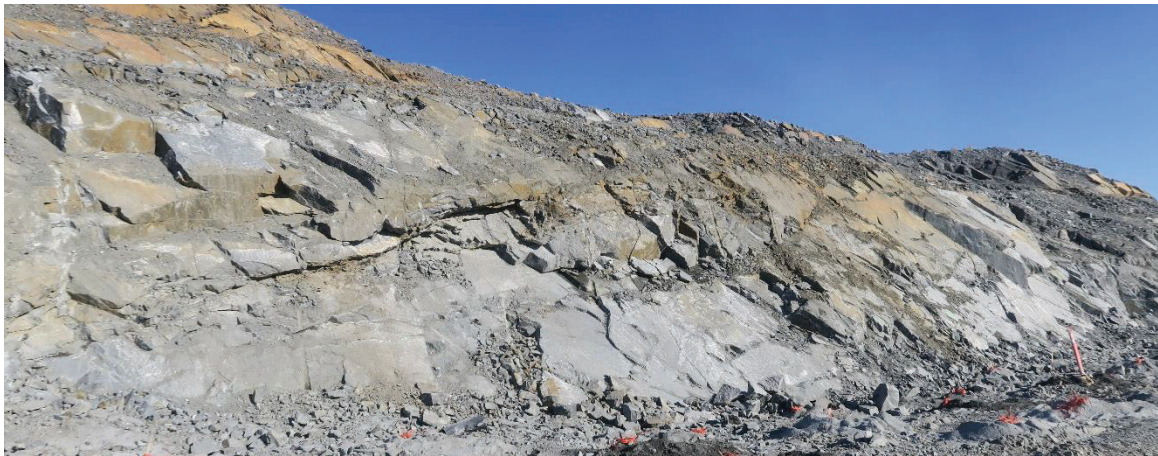
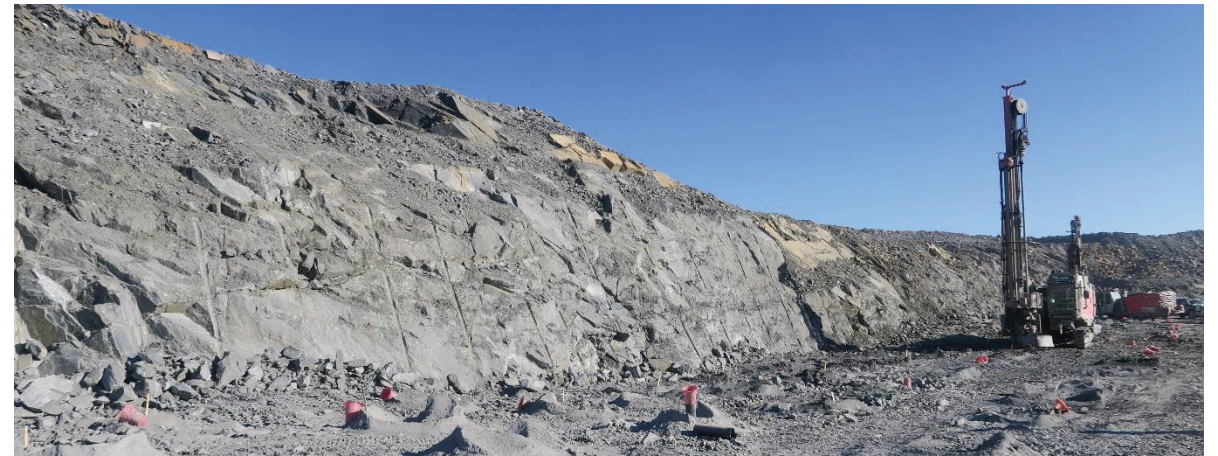
- The central portion of the bench has performed reasonably well (photo at right). Some crest loss, but half barrels visible over most of the face.
- The eastern portion of the bench has failed back to Joint Set C over almost the full height of the bench (photo at left). It is understood that this portion of the bench was scaled heavily, however some loose slabs were observed on the face that should be removed.

- It is not clear if the design BFA of 75° will be achievable for this sector. The remaining flitches of this bench need to be monitored and their performance documented. Once the bench is complete, a review should be completed to assess if the bench design is achievable or if it needs to revert to the shallower geometry (i.e., BFA of 50°).

- It is understood that the Rock Mechanics student was tasked to do the Bench Approvals for this sector. Given the importance and challenging nature of this sector, it is recommended that the Bench Approvals for this area only be done by experienced personnel.

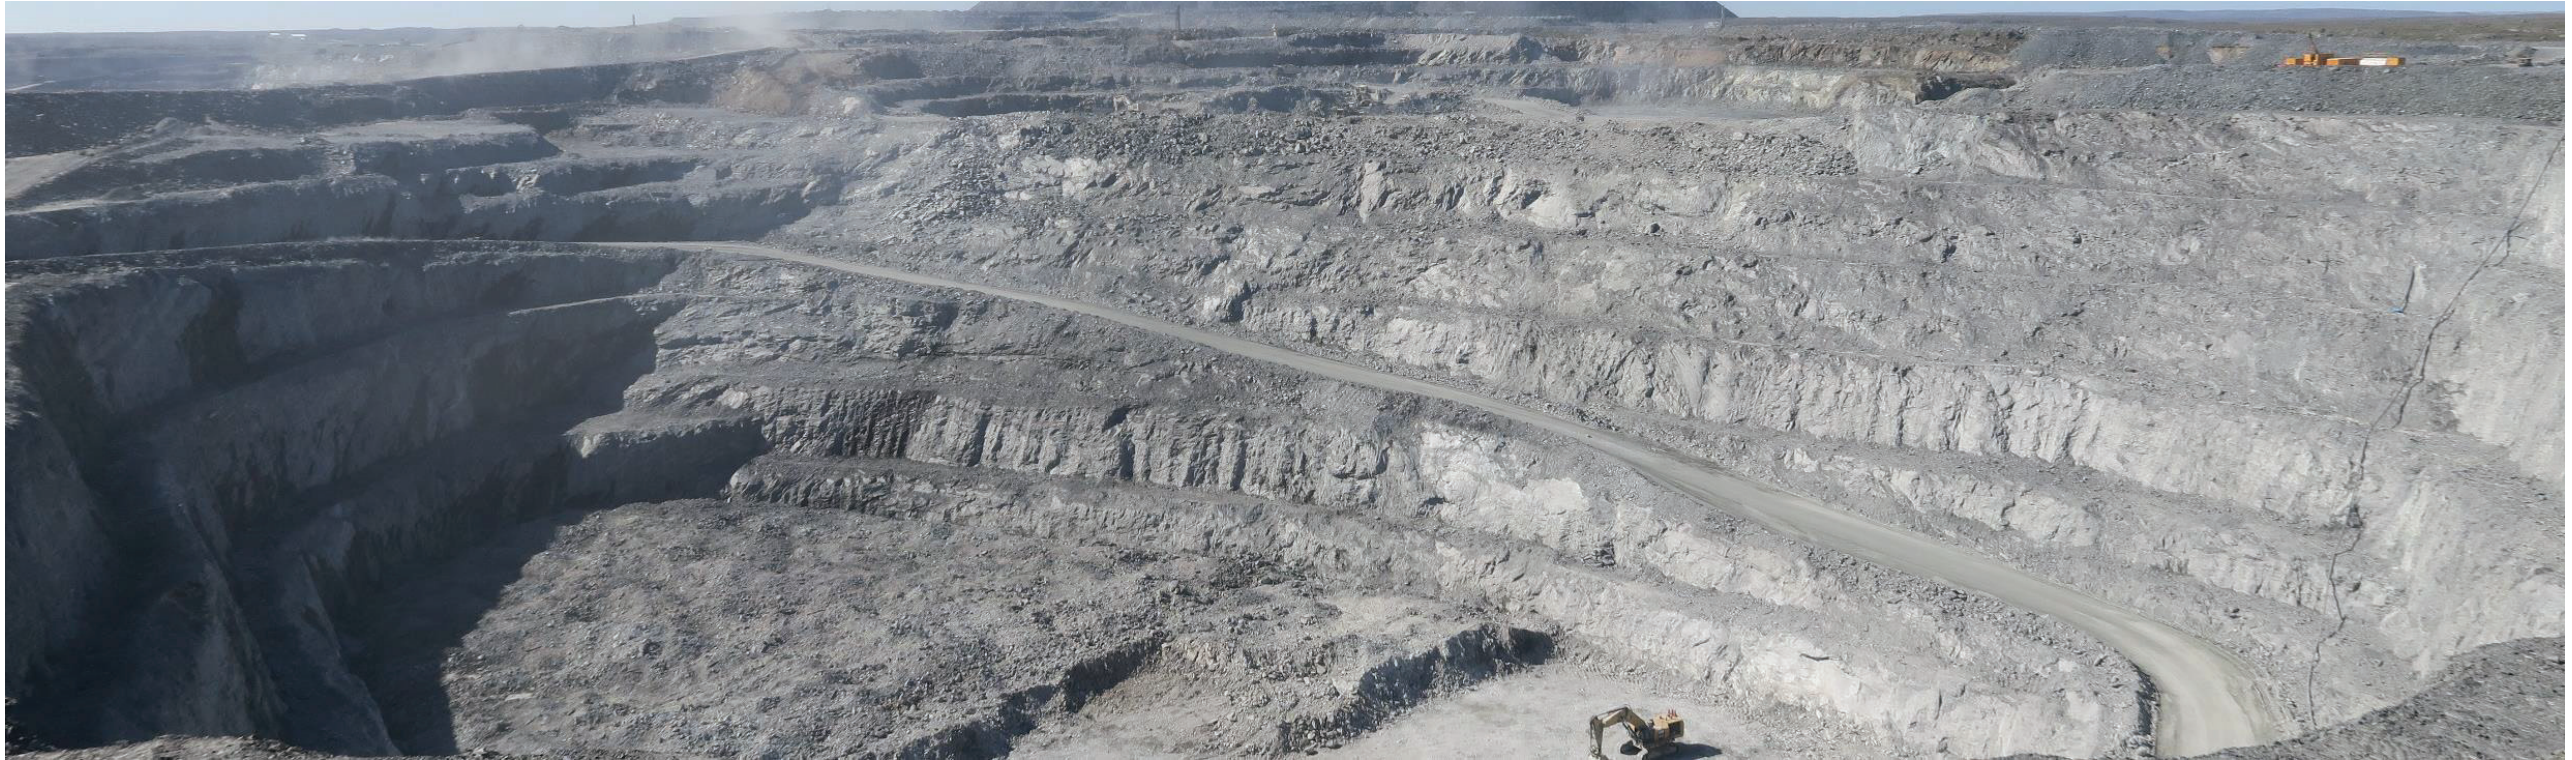
- Final wall in Design Sector V0A. This sector encompasses the footwall of the deposit.
- The slope geometry was expected to be controlled by the potential for bench and inter-ramp scale planar failures on the foliation (Joint Set A).
- Specific comments are provided on the following slides.

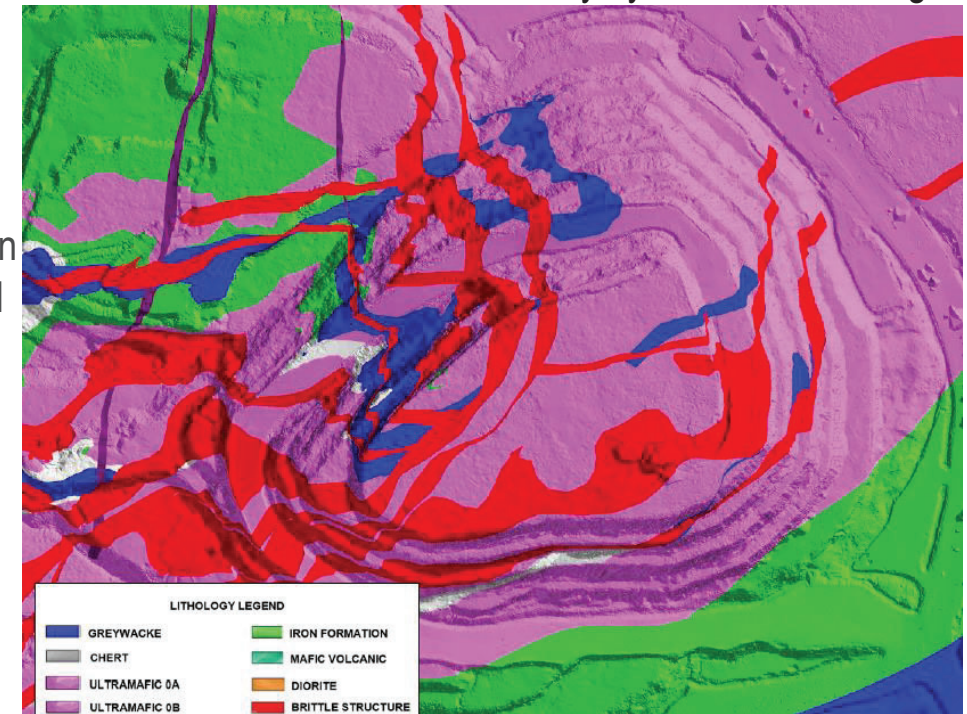
- **Foliation Orientation:** The foliation was expected to be parallel to the wall. Where this has occurred (e.g., the upper benches at the eastern end of the wall), the foliation has typically defined the bench face. However, the strike of the foliation was observed to vary by at least 60° along the wall and this has contributed to variable bench performance.

- Recommend documenting the lithology, rock mass structure, and bench performance at regular intervals along the Northeast Wall in order to better understand the controls on the wall performance. While relatively few benches remain in the IVR V2 pit, the results are relevant to the footwall of the IVR V1 pit.

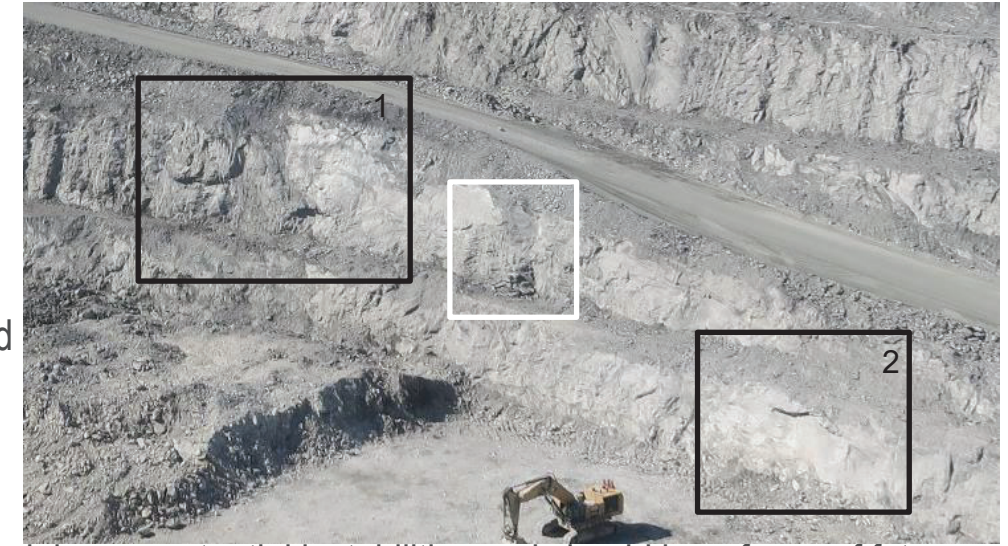
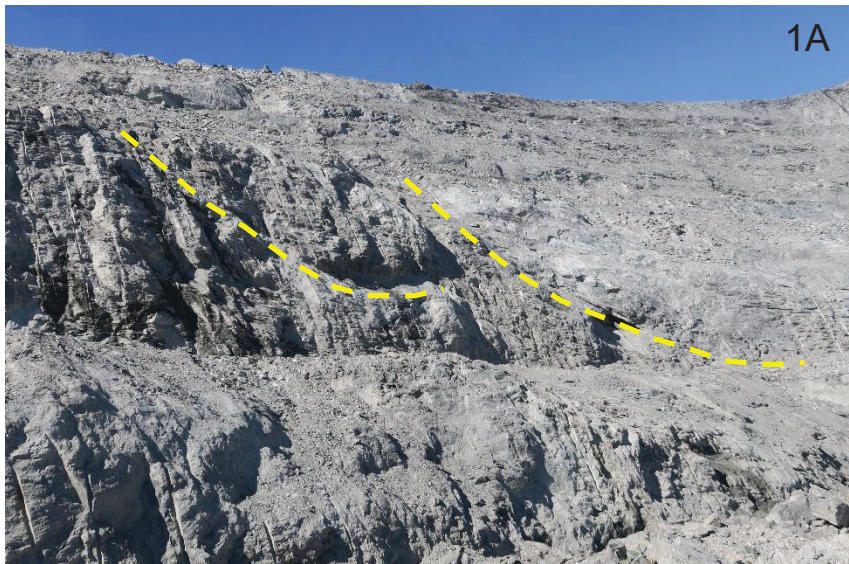
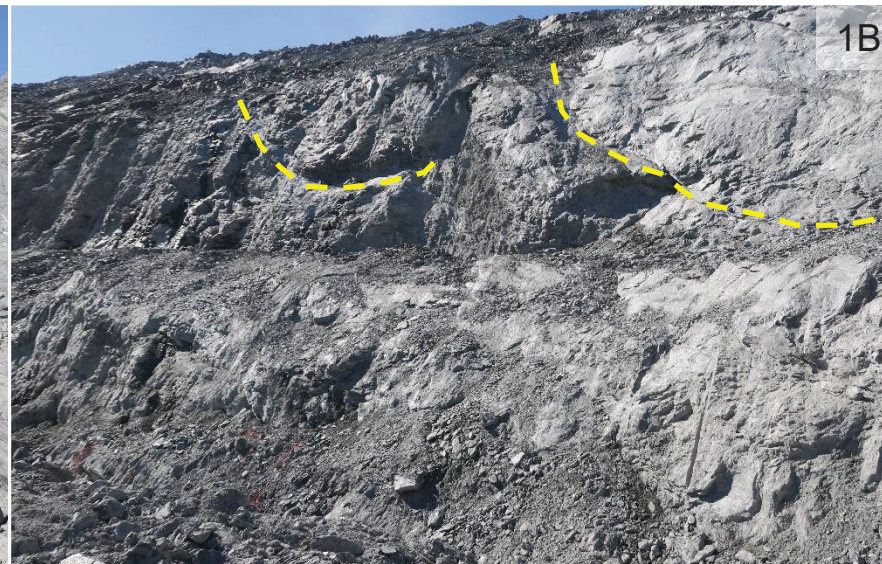
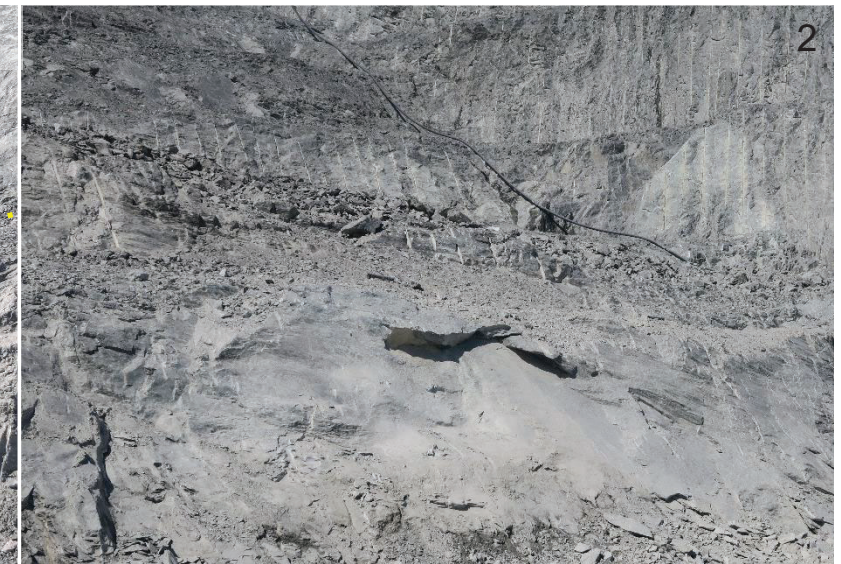
- In May, a 100 tonne wedge failure occurred directly below the ramp on the foliation and a cross-cutting structure (outlined in white). This was part of the 65° BFA trial.
- Several hazards were observed on the eastern end where the 65° BFA was used:
 1. The foliation has formed two slabs on the bench face of the second lowest bench (Photos 1A and 1B below), separated by what appears to be a brittle structure. These slabs are potential instabilities and should be a focus of future monitoring. It is understood that several rockfalls occurred in this area after the annual inspection.
 2. There is a local overhang on the lowest bench (Photo 2 below). Recommend scaling it down.
