IVR V1 Open Pit

Observations - Northeast Wall

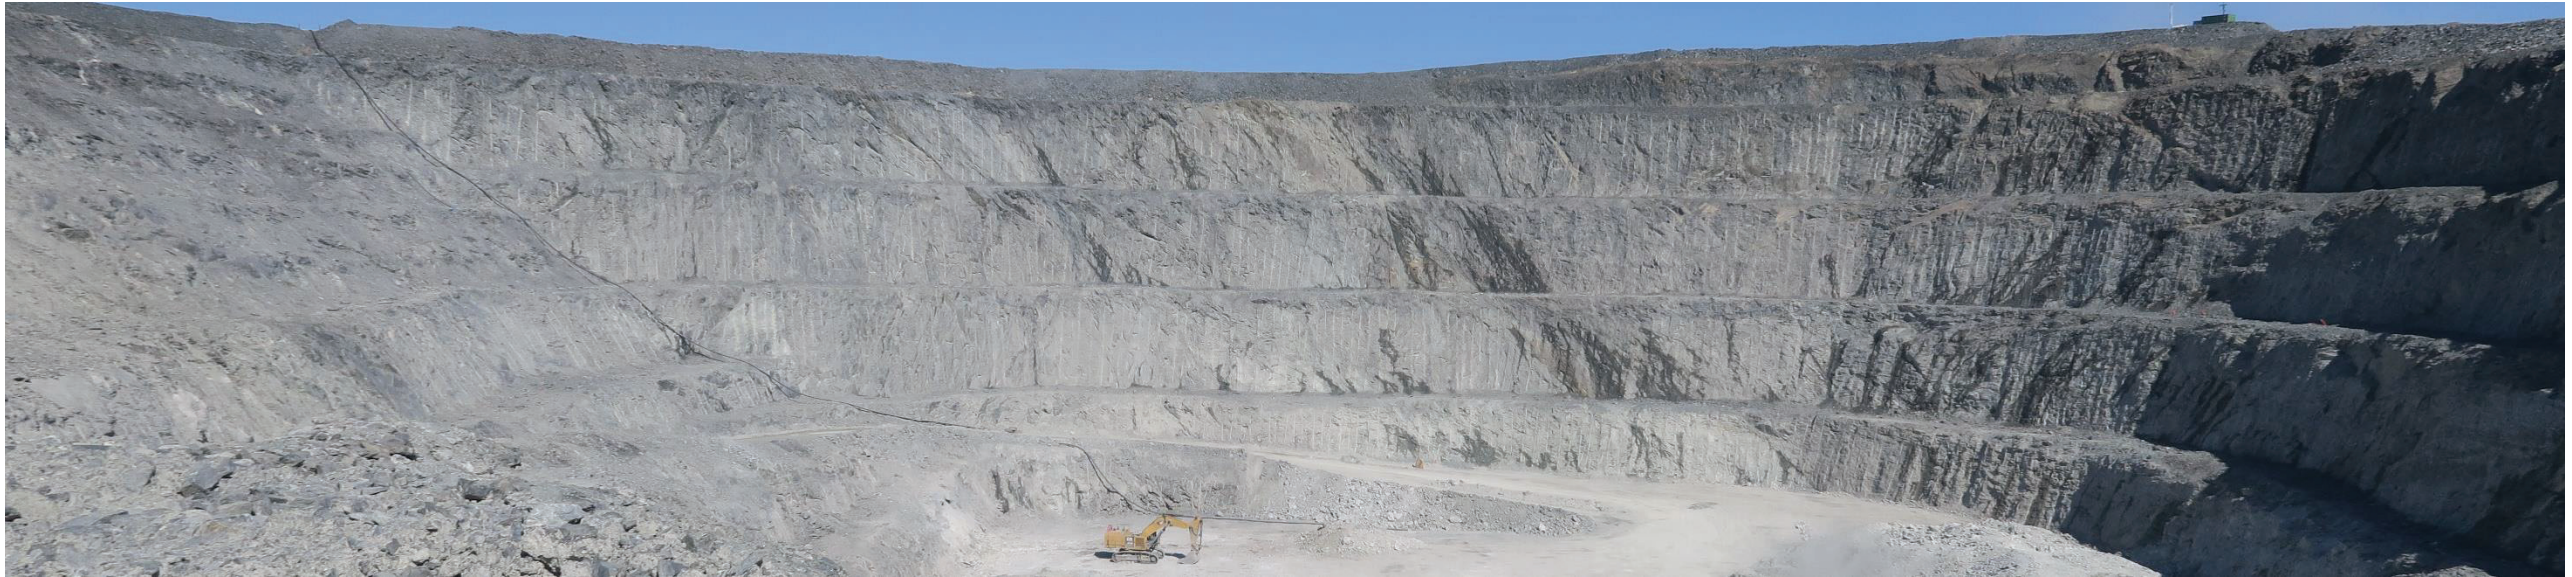
- Final wall in Design Sector V0B.
- The wall is performing well. Half-barrels are visible. The foliation is oriented perpendicular to the wall.
- Cross-cutting structures resulted in numerous small wedges in the upper benches and significant scaling was required when the benches were established. There was a concern that the benches would ravel over time. However, to date, very little material has accumulated on the catch benches.
- No evidence of movement has been observed on several potential wedges identified during the 2021 inspection.

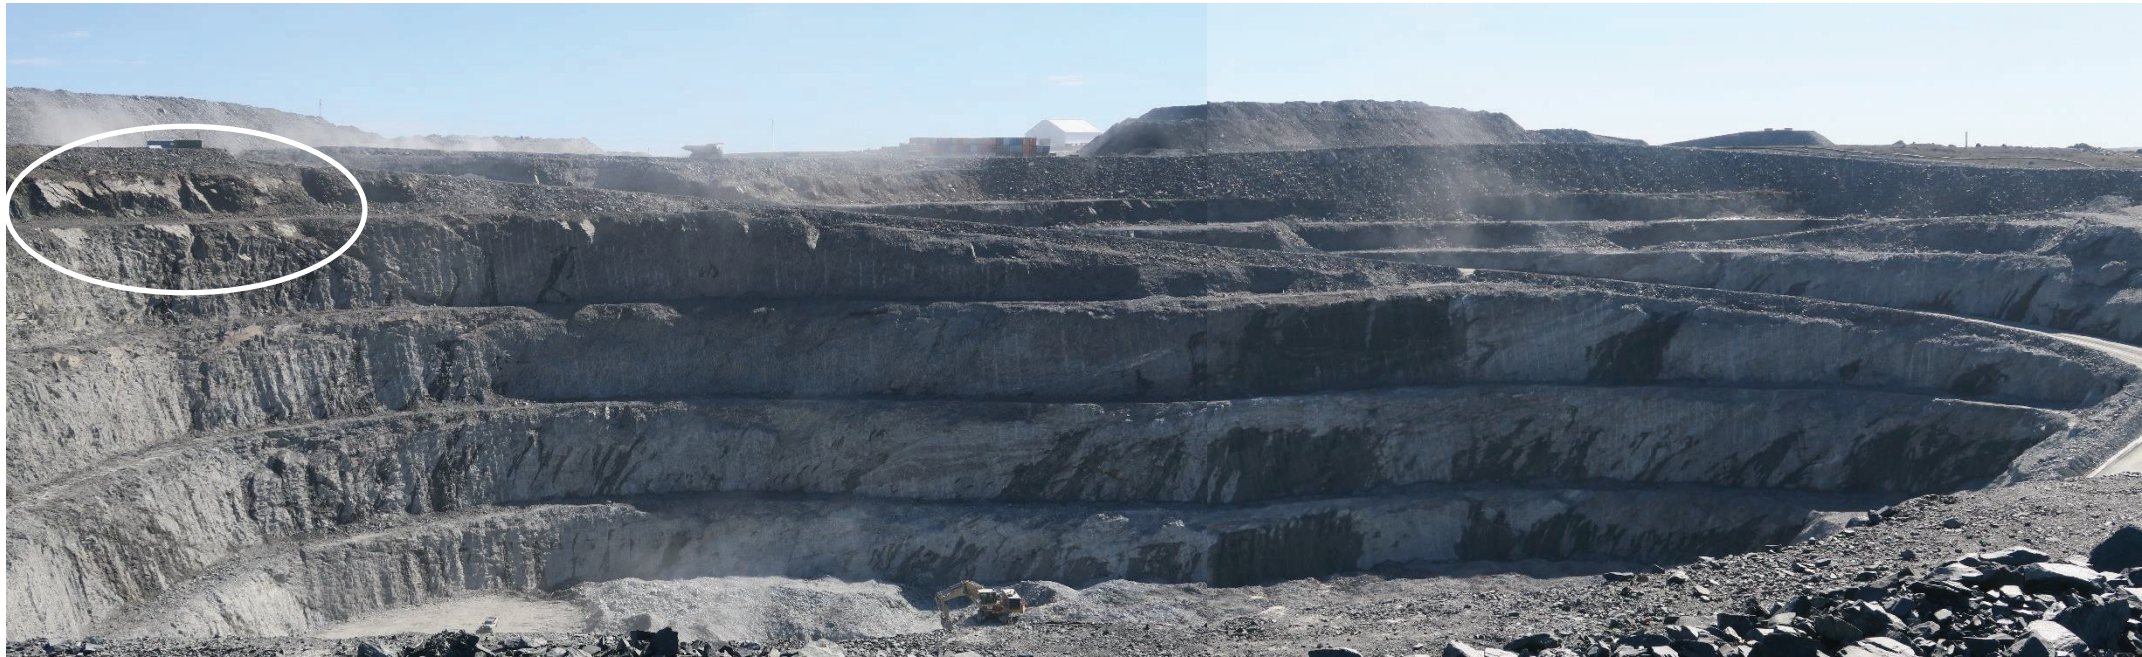
Observations - Southeast Wall

- Final wall in Design Sector V0C.
- The wall is performing well. Half barrels are visible and very little material is present on the catch benches.
- Several persistent cross-cutting features were identified during the 2021 inspection (examples circled below). These structures were not prominent in the structural data underlying the design of the open pit and there was a concern that they could impact the achievable slope geometry. It now appears that these structures were localized as they have not influenced the bench performance at depth.

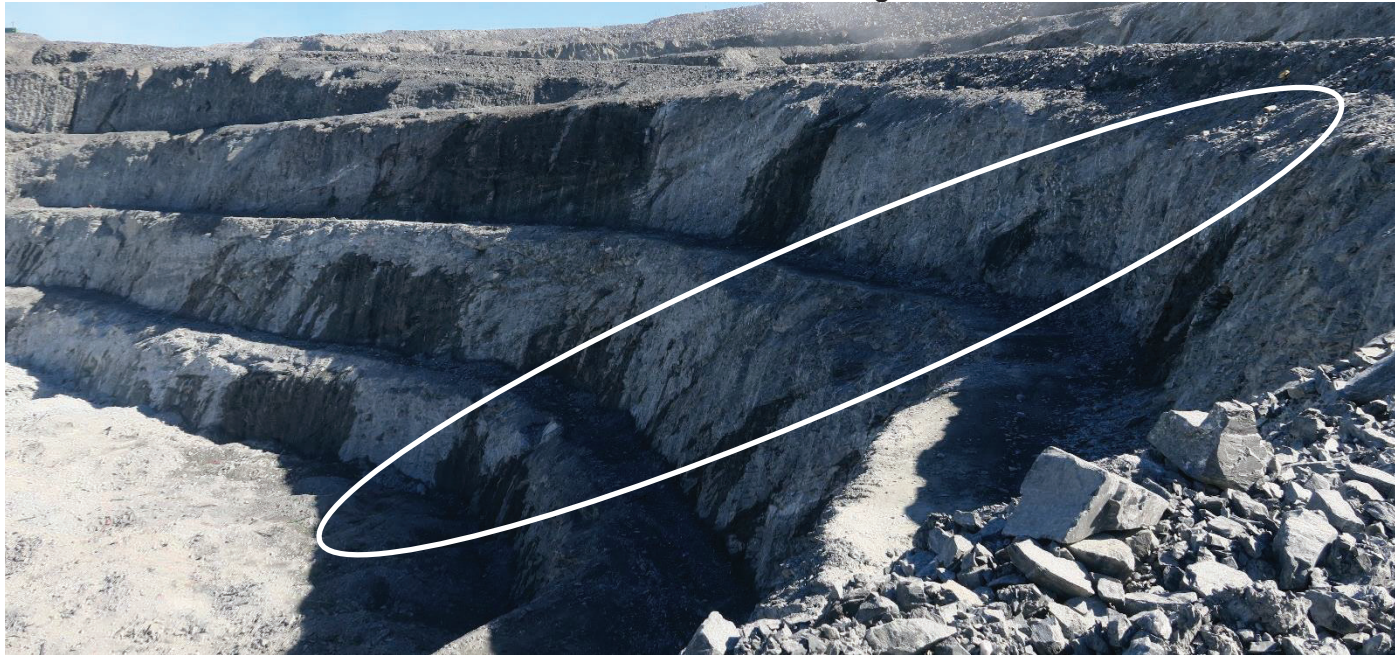
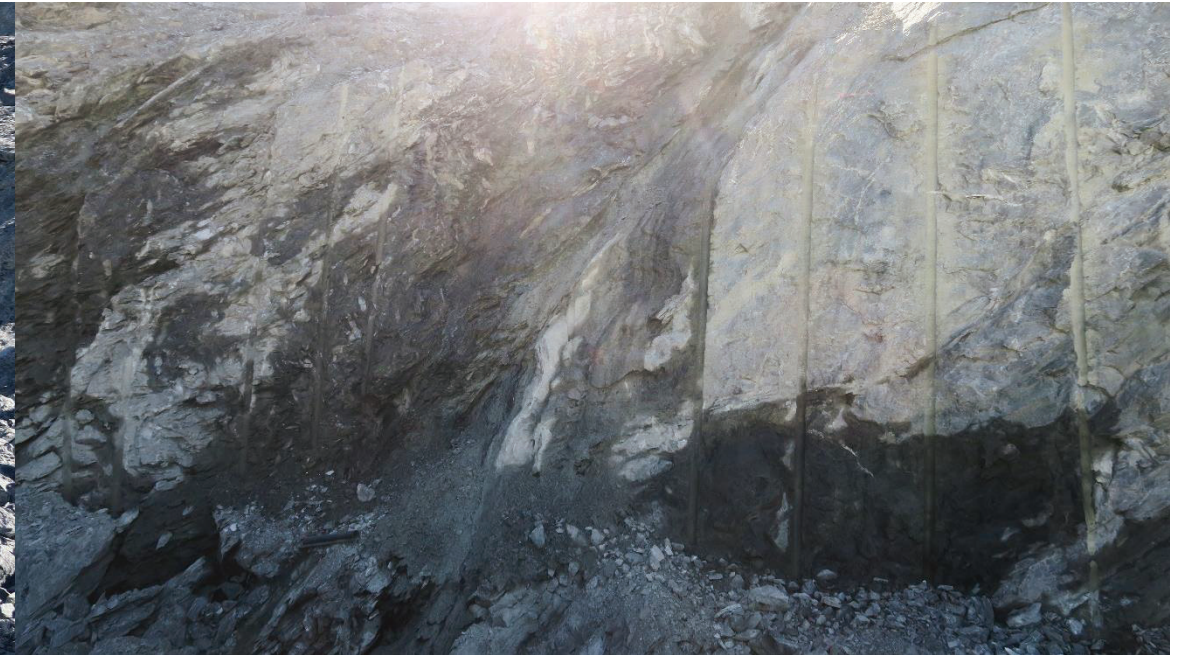
Observations - Southwest Wall

- Final wall in Design Sector V0D.
- The wall is generally performing well. While the benches are primarily within the Komatiite and Brittle Structures, the wall is oriented perpendicular to the foliation.
- Numerous seeps are present in the wall. As the pit is thought to be entirely within permafrost, the seeps are assumed to be in the active layer.
- In the southwest corner of the pit, the seepage is sufficient to have caused a prominent Brittle Structure to erode (circled at left with close-up at right). The area should be monitored for ravelling over time.

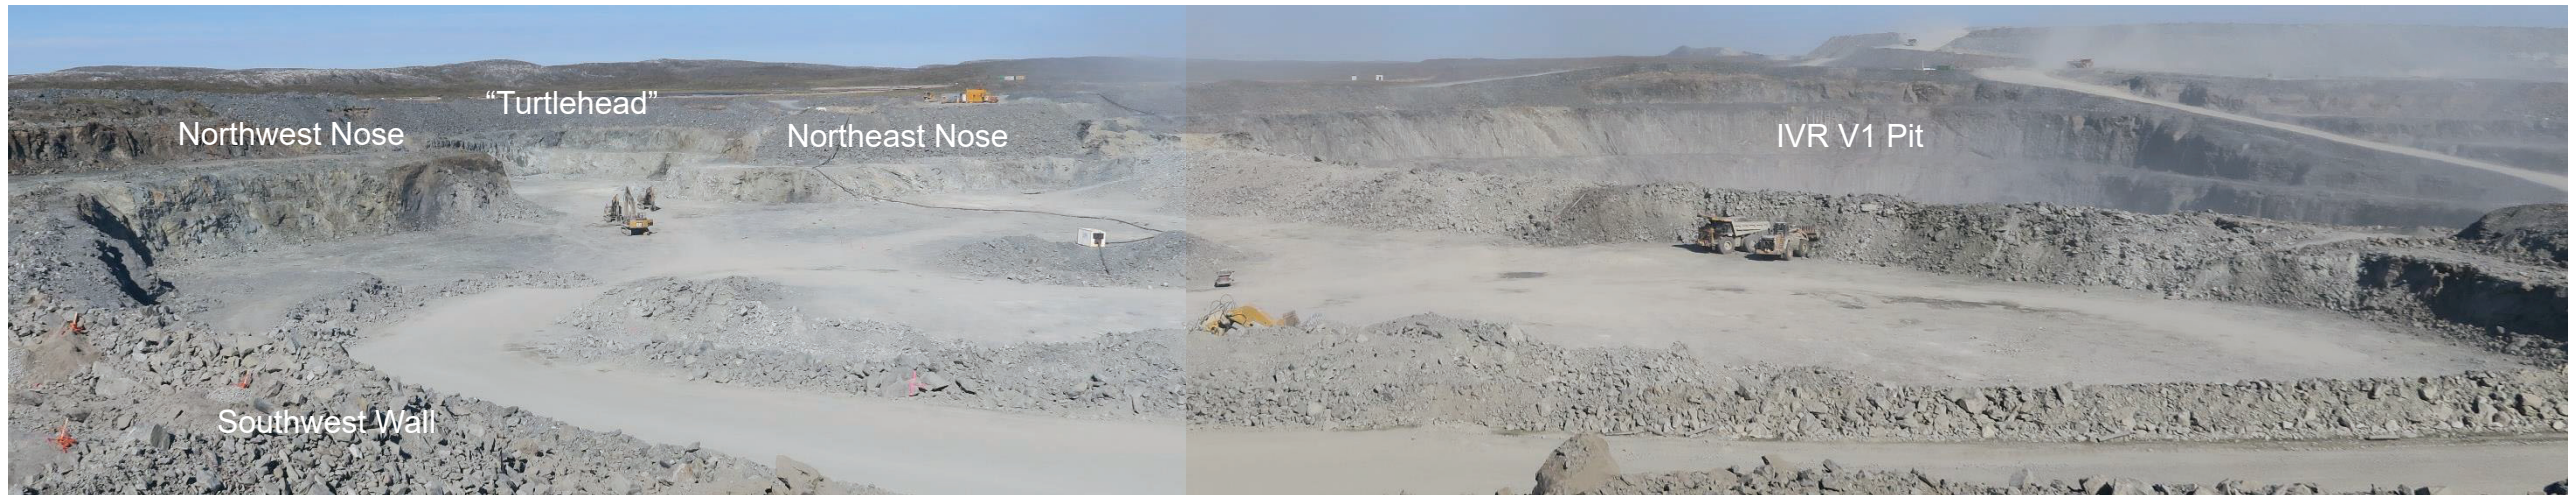
Observations - General

- The IVR V2 open pit is in the early stages of mining; approximately two benches have been established.
- These initial benches represent an important opportunity to validate the rock mass characterisation and slope geometry recommendations that underpin the open pit design. Recommend documenting the bench performance and key rock mass characteristics and comparing them to expectations.
- As noted earlier, managing spillover from the IVR V2 pit to the IVR V1 pit is an on-going challenge. The mine has adapted the blasting sequence to leave a small ridge adjacent the IVR V1 pit and then blasts the ridge into the V2 pit. This has been effective at reducing spillover.
- Comments on specific locations within the pit are provided on the following slides.

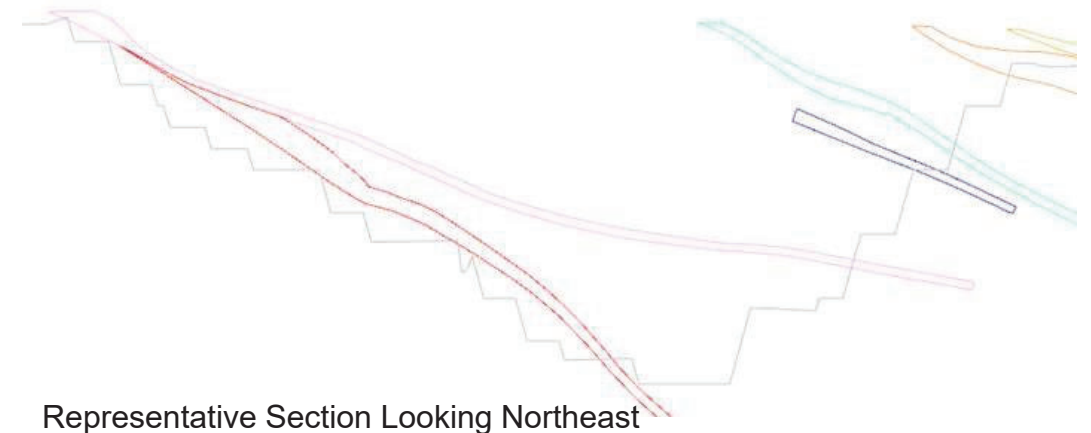
Representative Section Looking Northeast

Observations - North Wall

- The north wall is located along the footwall of the deposit.
- Based on the results of the stability analyses, a decision was made to push back the wall so that it was located within the Mafic Volcanics rather than the Komatiite. This is expected to reduce the potential for bench- and multi-bench scale planar failures on the foliation. It also reduces the potential for inter-ramp scale planar failures on the brittle structures (see representative section below). If it is not possible to establish the wall in the Mafic Volcanics, it is likely that a much shallower slope will be required.
- It is important to verify that the slope is in fact being established in the Mafic Volcanics and below/behind the Brittle Structure expected along the contact between the Mafic Volcanics and the Komatiite.
- The performance of the initial two benches in this wall has been reasonable to date.

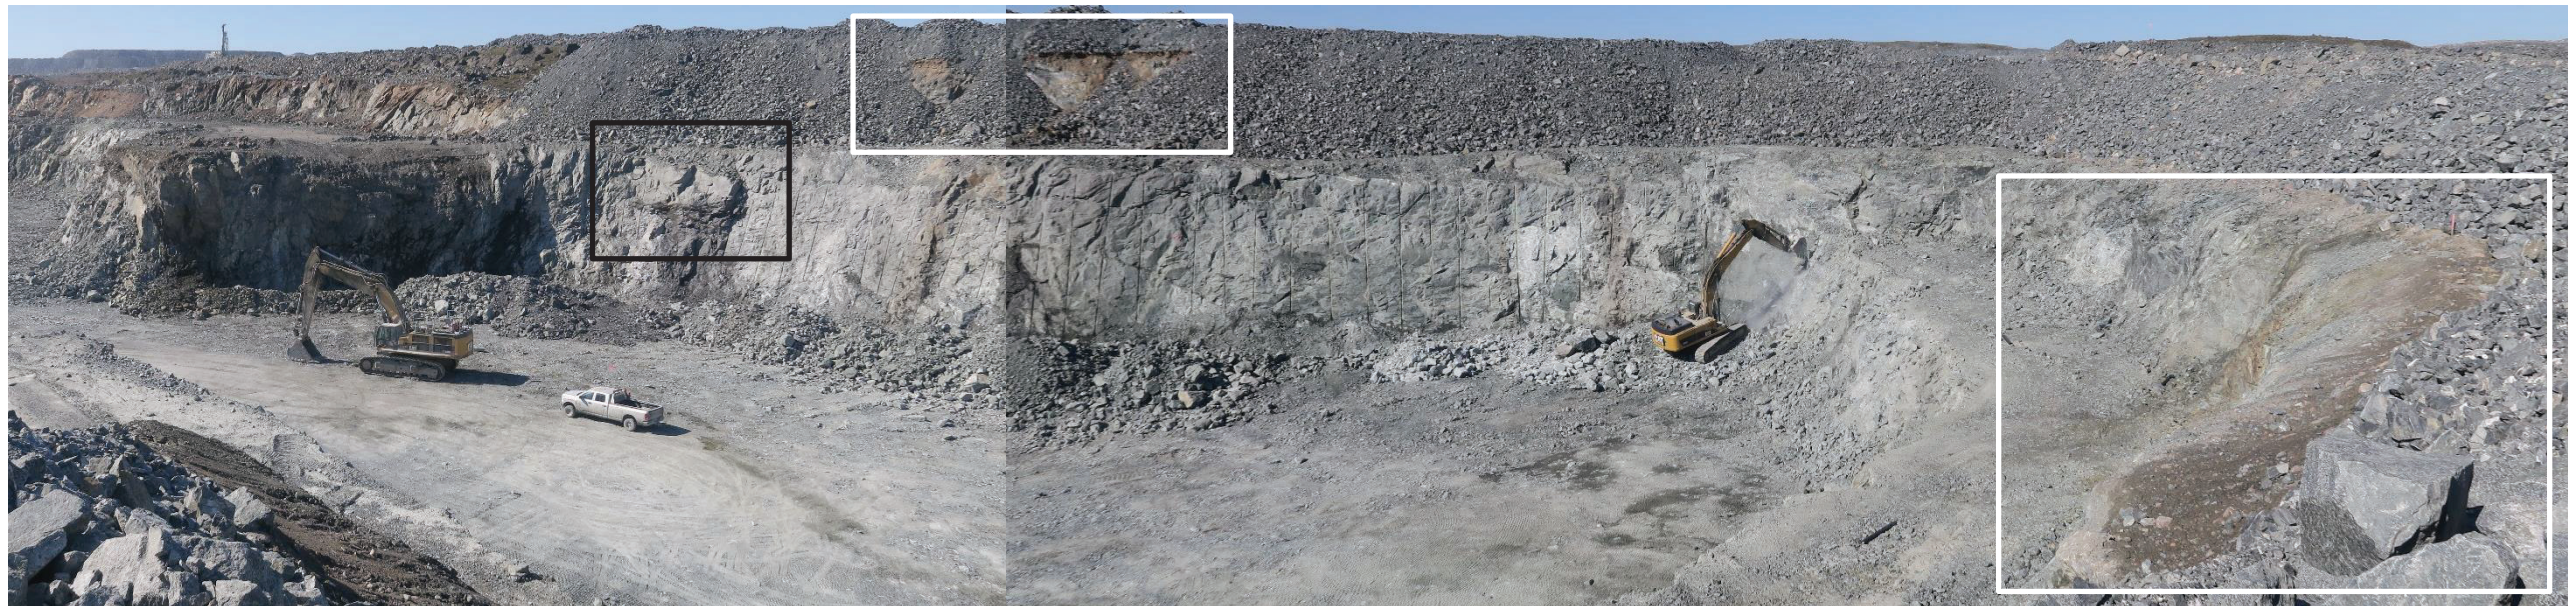
Observations - North Wall “Turtlehead”

- The overburden in this area was thicker than expected, resulting in a large thermal cap. There are gaps in the thermal cap (outlined below in white) and exposed overburden is present along the crest of the upper bench. The overburden is likely to ravel over time. Section 1.135 of the Nunavut Mine Health and Safety Act requires unconsolidated material to be excavated back a minimum of 2 m from the crest. The thermal cap should be remediated in this area.

- Scaling of the end wall was in progress at the time of the inspection. Frequent hard toes were noted by the operator. The foliation is perpendicular to the wall in that area and significant scaling was required due to the presence of numerous small wedges/blocks. A potentially unstable block was observed on the wall (outlined below in black).

- A portion of the safety berm was missing at the end of the crest road where the photos below were taken. The berm should be re-established.

- e) Nose between IVR V1 and IVR V2
 - f) Loose on the North and East walls of the IVR West 2 open pit
2. Remediate the thermal cap in the IVR V2 “Turtlehead”.

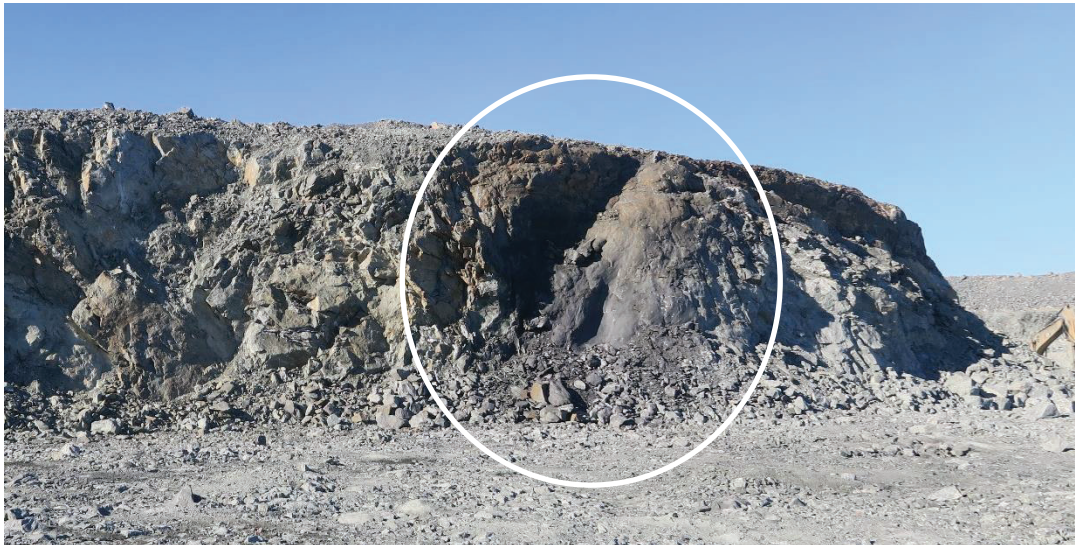
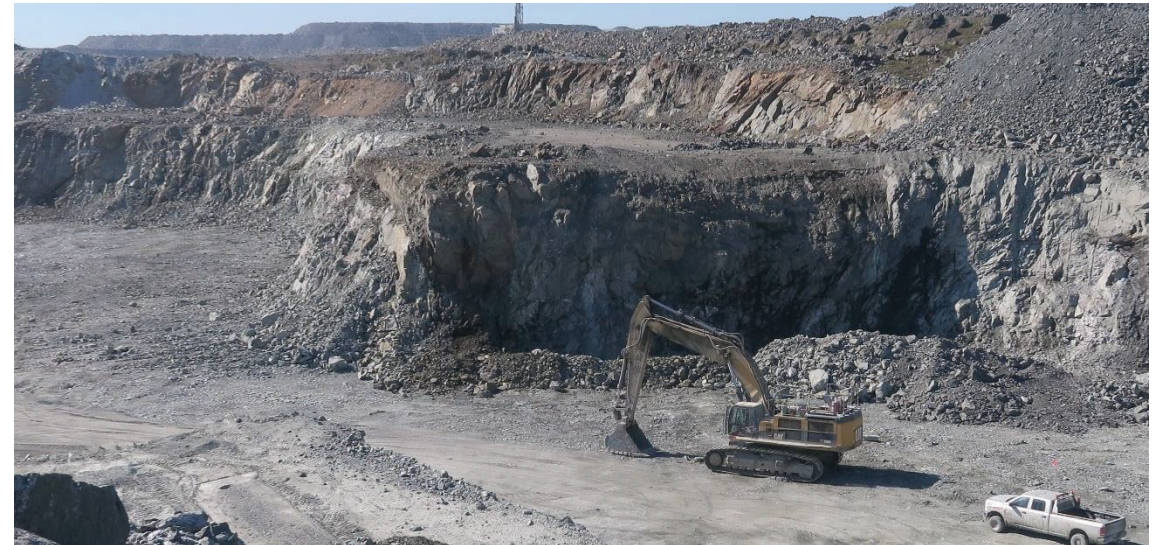
Observations - North Wall Noses

- A nose has been left in the final north wall adjacent the “Turtlehead” (shown in the photos below). The nose is intersected by a lens of Graphitic Chert aligned parallel to the north wall (circled in lower left photo).
- The creation of small, abrupt noses like this one should be avoided, particularly through contacts. The reduced confinement acting on the rock mass increases the potential for ravelling and instabilities over time.
- The nose may deteriorate further over time and should be specifically included in the visual inspection of the open pit.

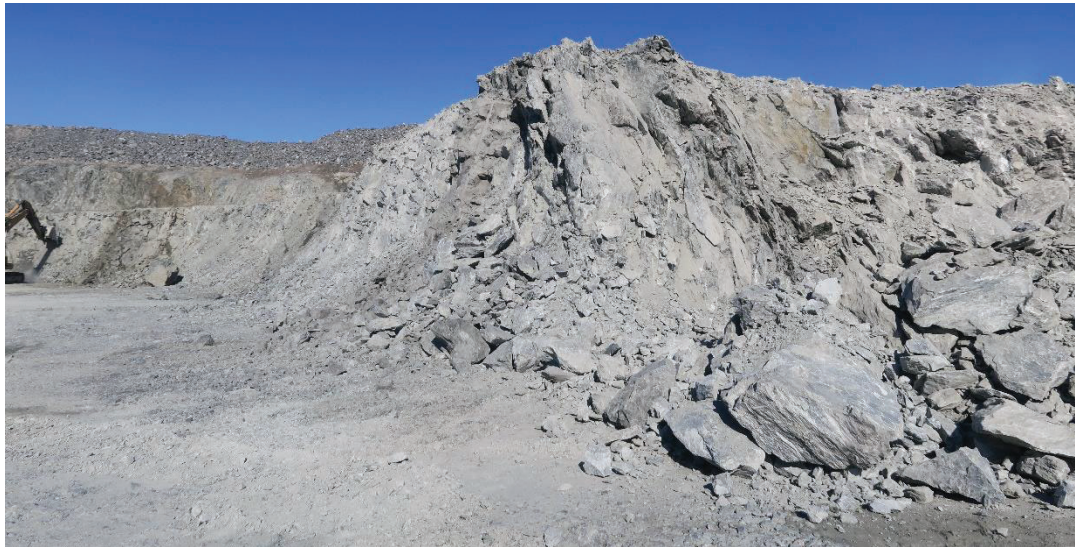
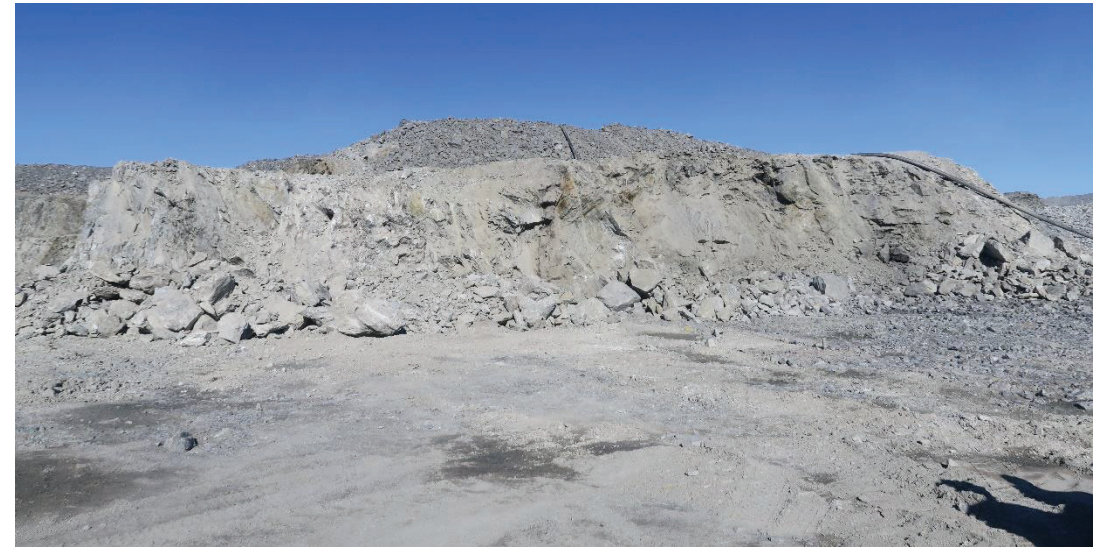
Observations - Nose between IVR V1 and IVR V2

- A nose will be left on the uppermost bench at the point where the two open pits meet.
- The nose is in poor condition and had not been fully scaled at the time of the inspection. It should be scaled to reduce the rockfall hazard.
- The nose may deteriorate further over time and should be specifically included in the visual inspection of the open pit.

- i) The nose between the IVR V1 and IVR V2 open pits
2. Review the risks associated with future access below the failure in the Phase 1 North Wall of the Whale Tail open pit for water management purposes. Implement mitigation measures as appropriate.

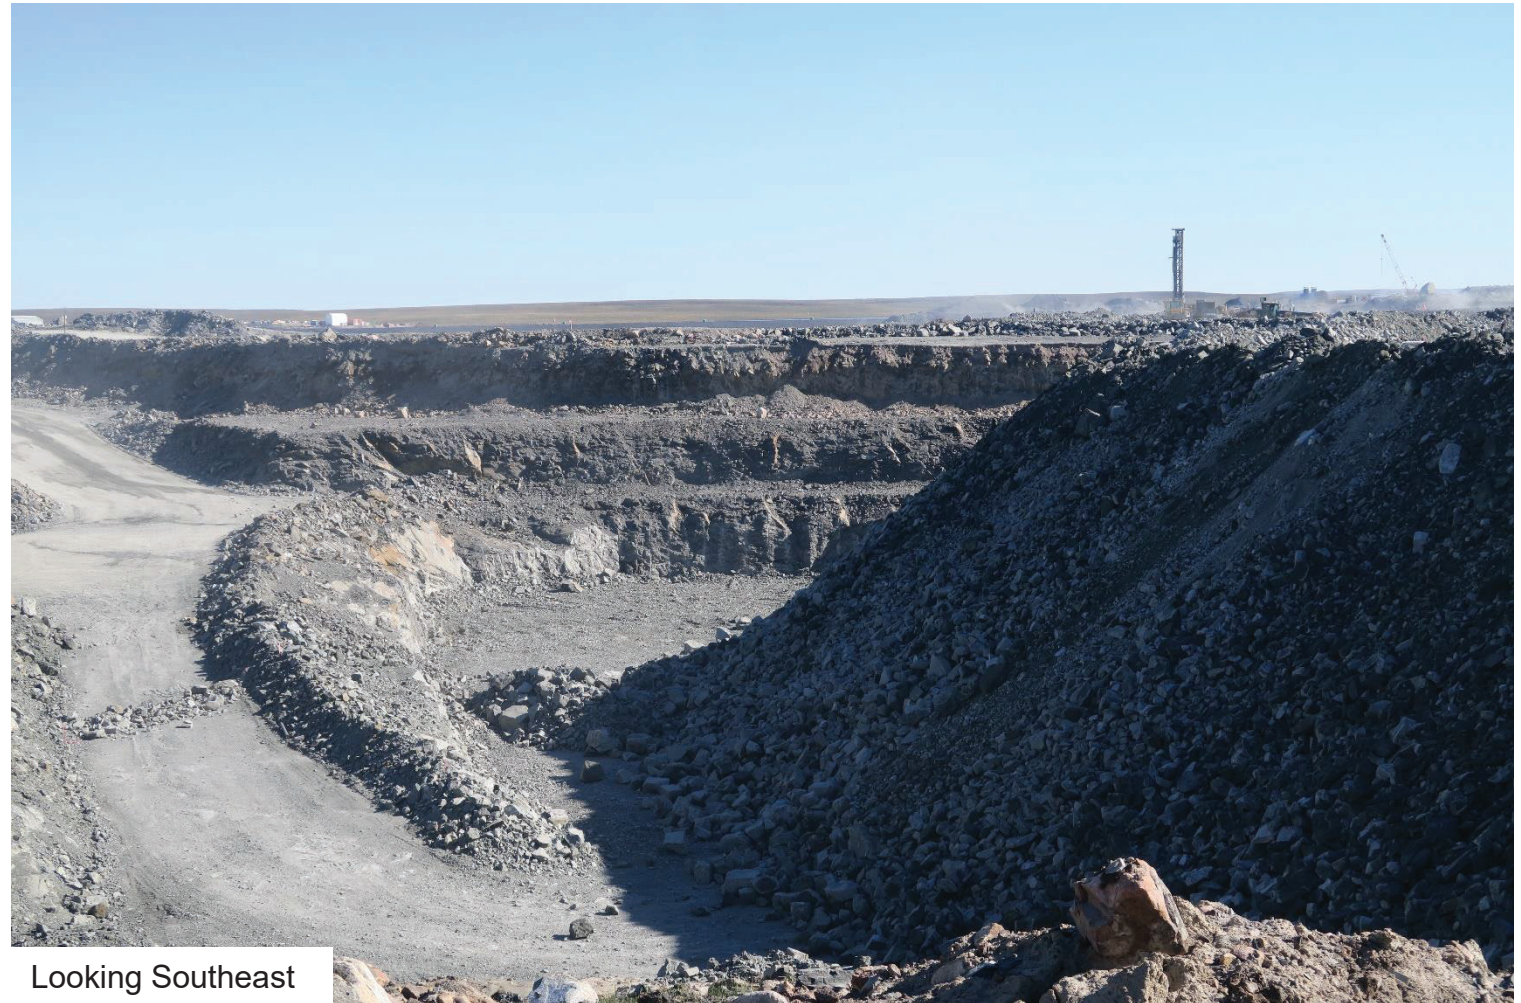
Looking Southeast

Observations - IVR West 1

- Mining of the IVR West 1 pit is complete.
- A total of three single benches and one double bench were mined.
- The open pit is being backfilled with waste rock placed by end-dumping from the crest.
- A berm has been constructed on the ramp to prevent access to the open pit.
- The controls in place appear to be adequate to manage the expected hazards.

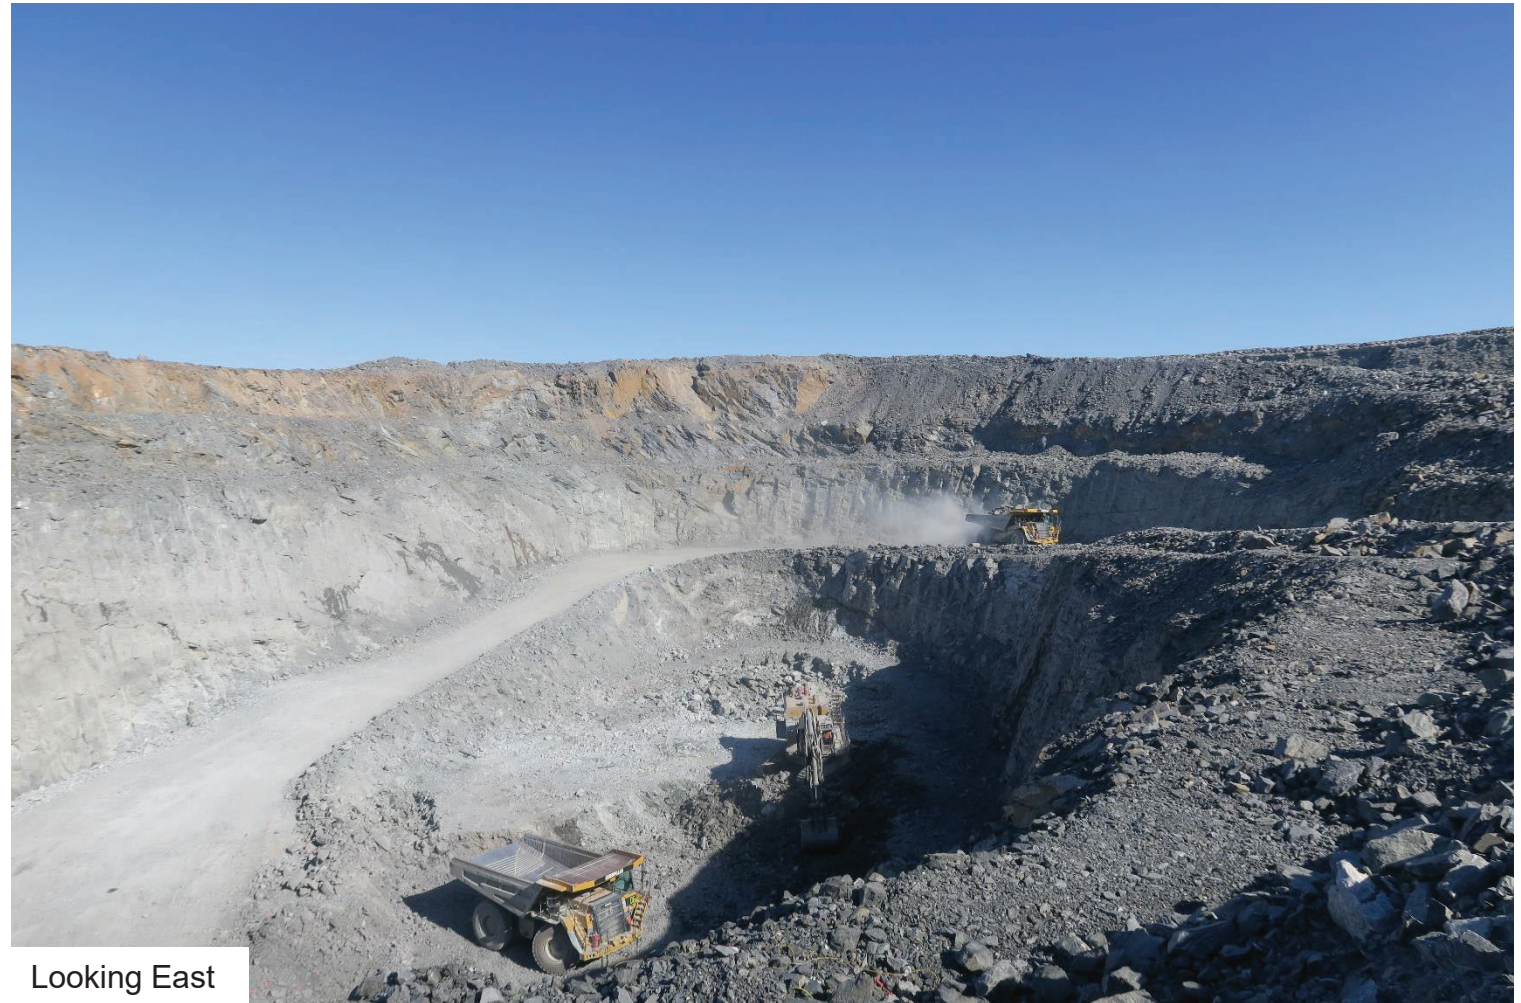
Observations - IVR West 2

- Mining of the IVR West 2 pit was nearing completion at the time of the inspection, with mining of the final bench in progress.
- The upper two benches are single benches. The lower bench is planned to be a triple bench, with a good-bye cut.
- As the pit will be used for on-going water management, safe access will need to be maintained once mining is complete.
- The rock mass structure within the open pit is complex, with the orientation of prominent structures changing over relatively short distances.
- The benches have generally performed well. Several rockfall hazards were observed and are shown on the following slide.

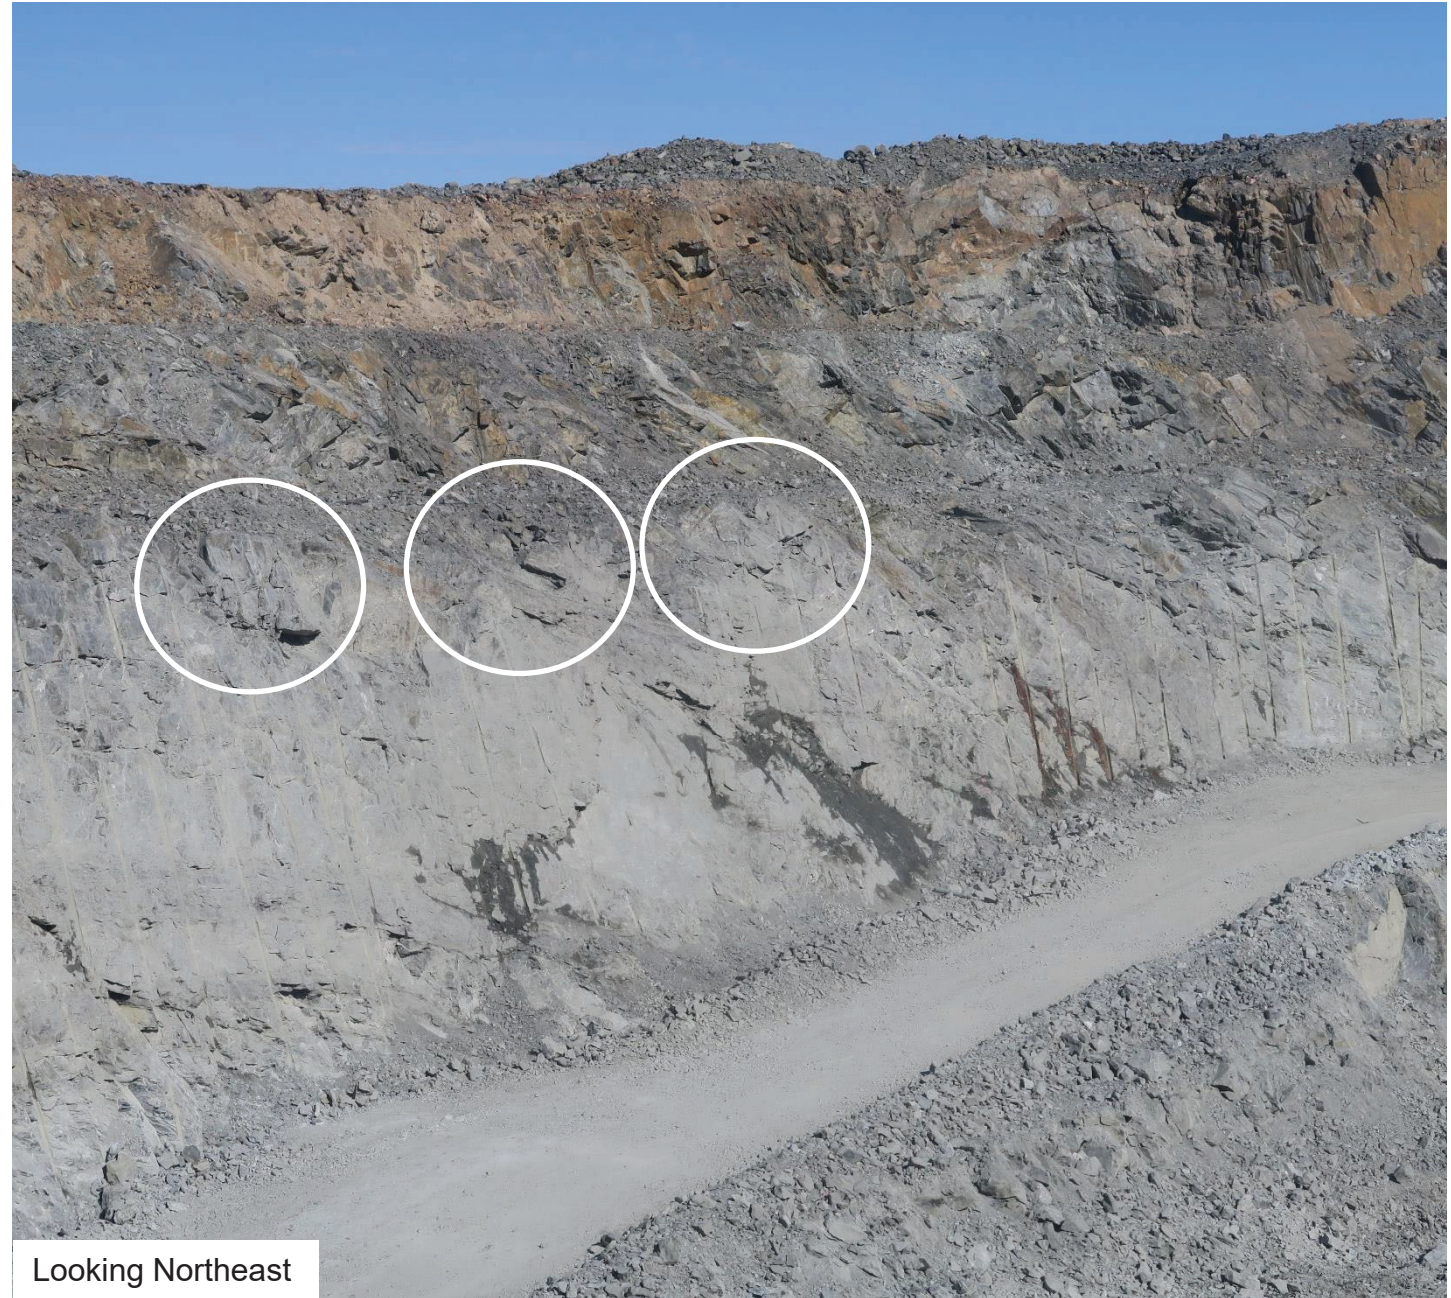
Observations - IVR West 2

- Several rockfall hazards were observed along the northeast wall, above the ramp (circled at right).
- A thermal cap has not been constructed for the overburden between IVR West 1 and IVR West 2, and the overburden has started to slough. It is currently manageable, but if it progresses it could become a rockfall hazard.
- Recommend scaling the wall and constructing a rockfall berm along the inside of the ramp.
- The IVR V2 Extension is planned to merge with the east wall of this pit. The rockfall risk associated with spillover from blasting and the potential creation of noses at the breakthrough will need to be reviewed and managed.

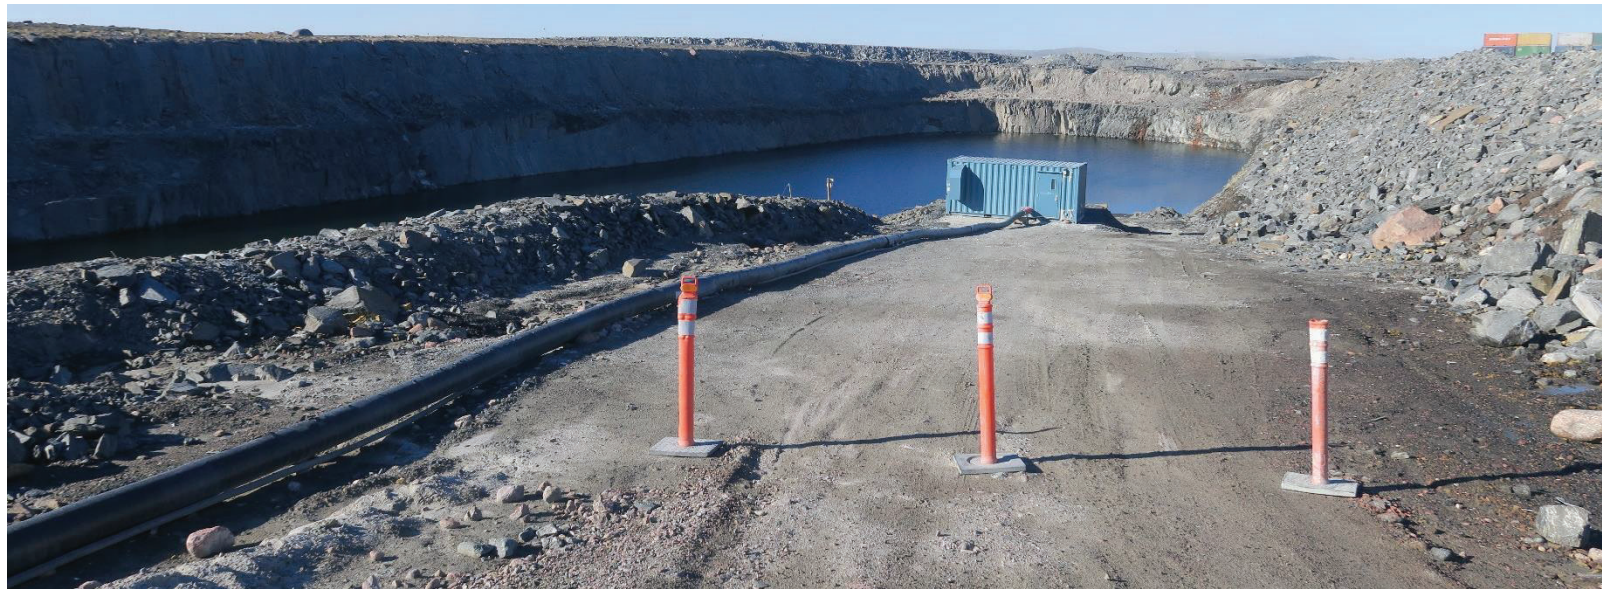
Observations

- Attenuation Pond 5 is a former quarry located to the east of the WHL open pit that is now used for water management. The pond was inspected on August 15, 2022.
- The pond is partially flooded, with one to two benches exposed above the pond water level. As a result, a detailed inspection could not be completed.
- No stability concerns were identified in the exposed slopes.
- Pumps were present at the time of the inspection. Access to the ramp and pit was unrestricted, but pylons were installed during the inspection.
