Whale Tail 2022 Thermal Monitoring Report

WHALE TAIL MINE

Thermal Monitoring Report 2022

Prepared by:
Agnico Eagle Mines Limited – Meadowbank Division

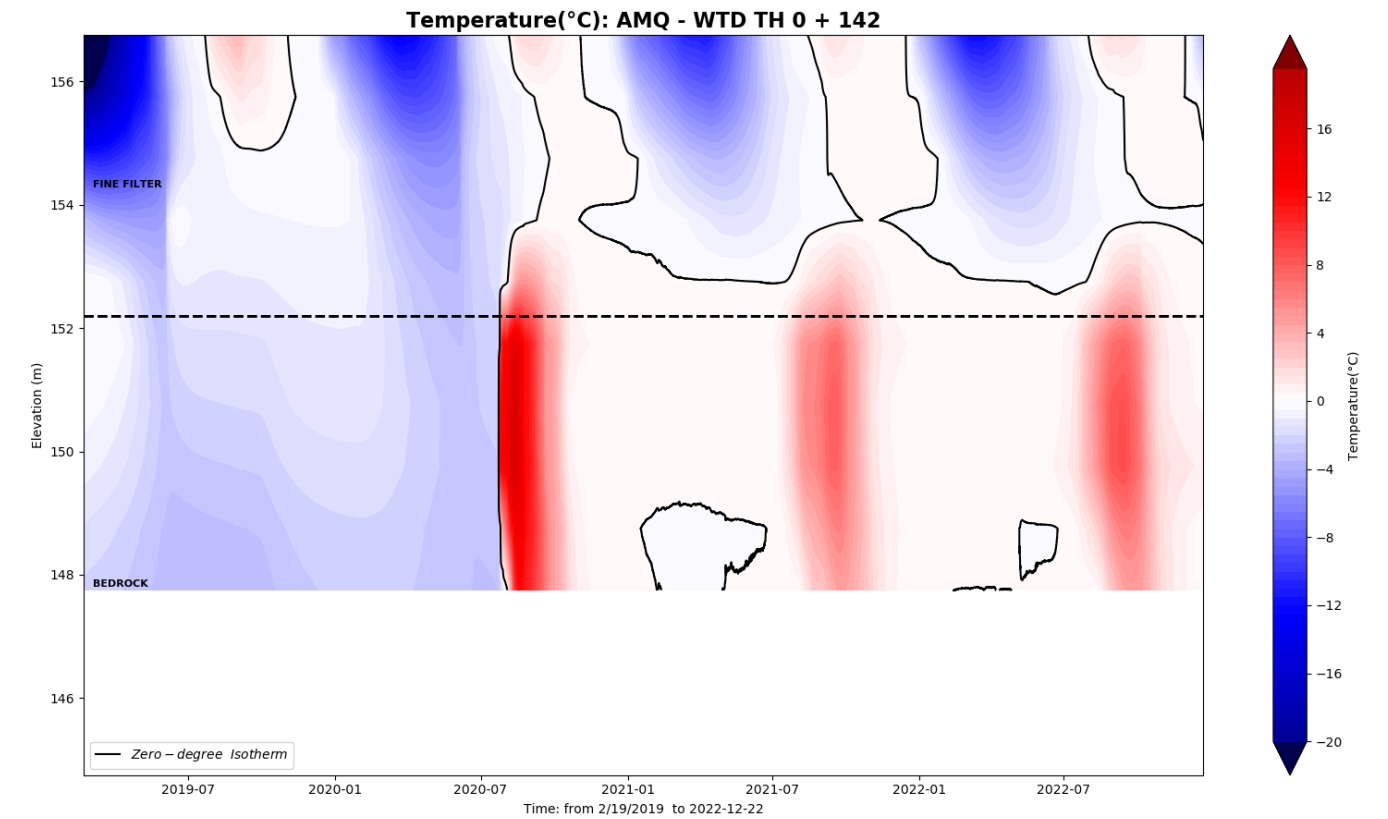
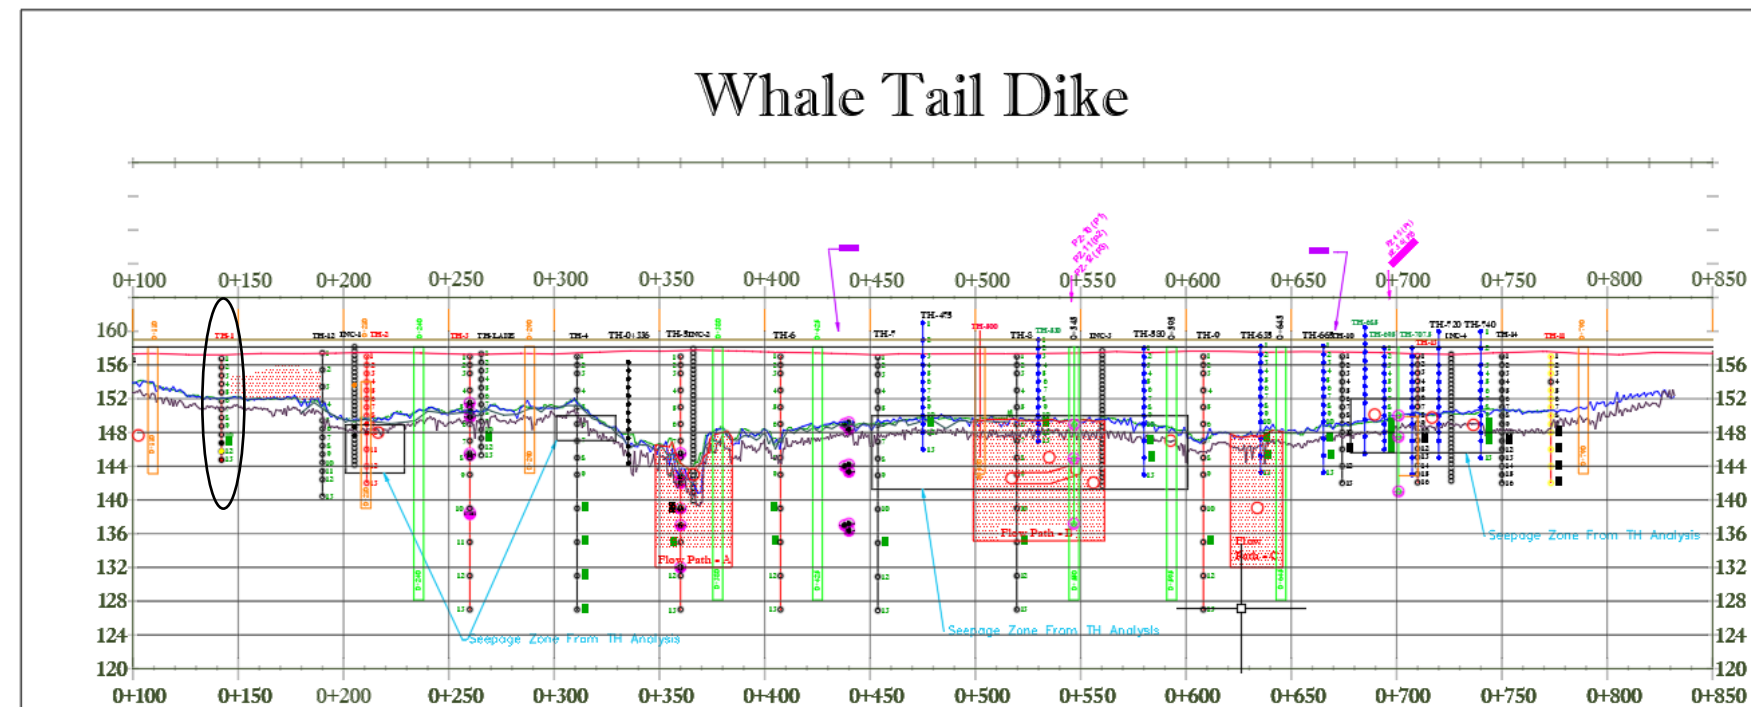
WTD-TH 0+142

Bead #12 and #13 removed

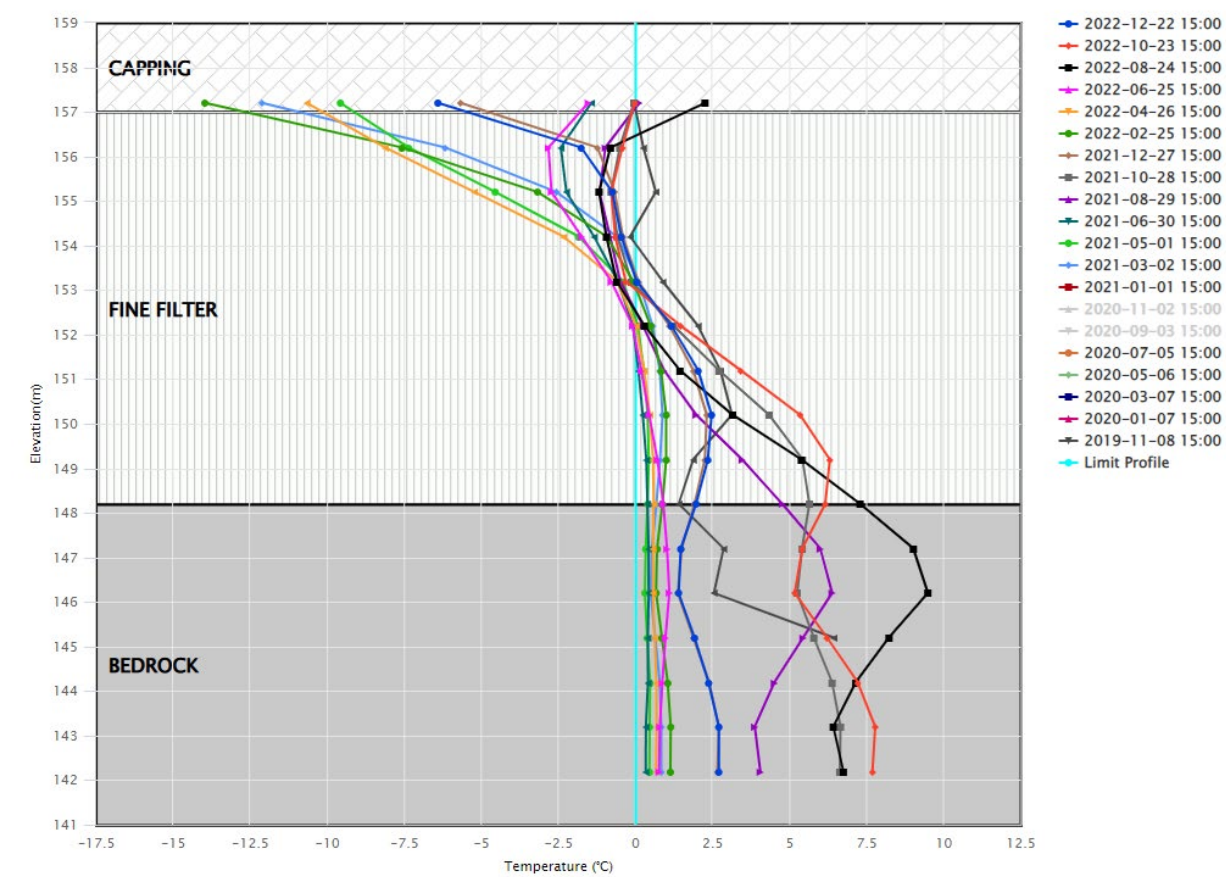
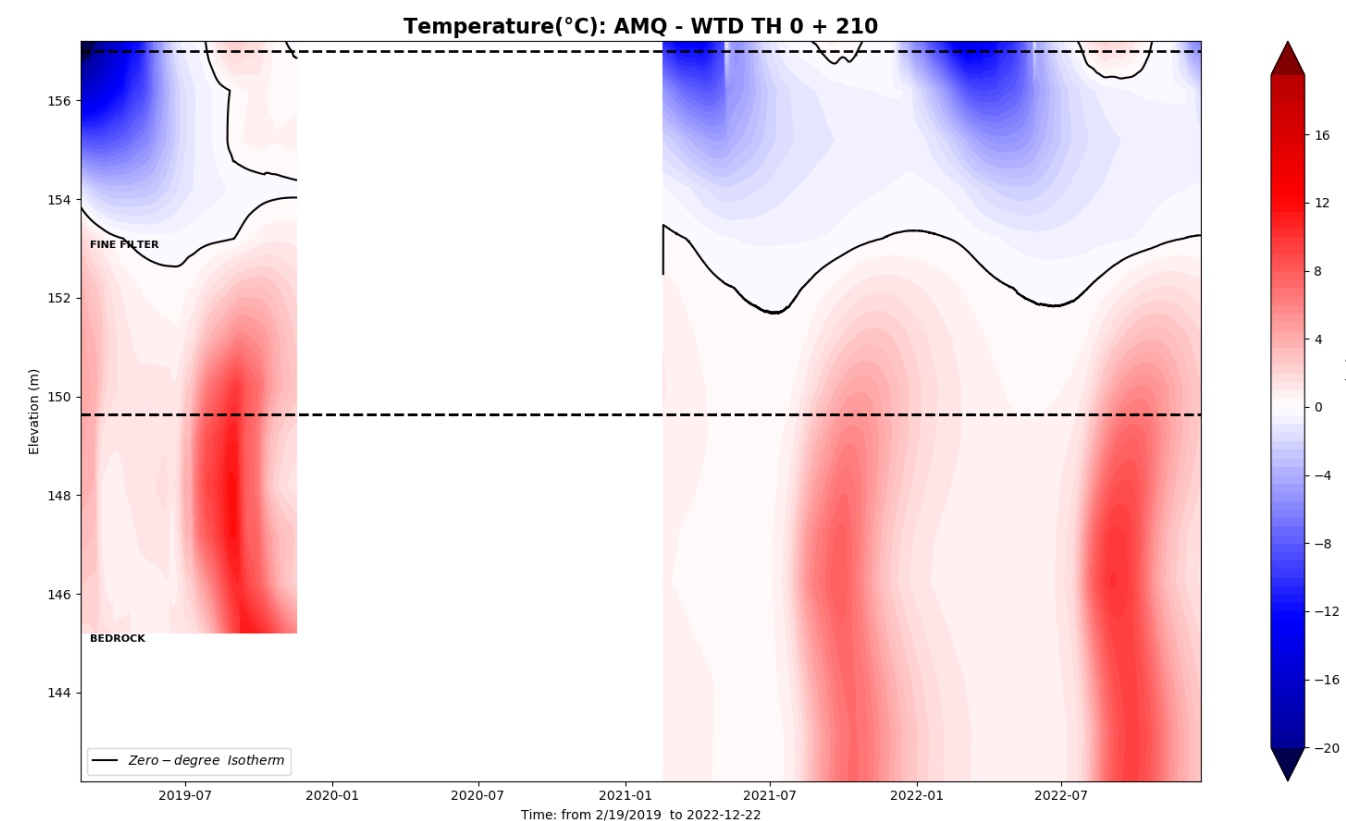
WTD-TH 0+210

Thermistor string damaged by drilling. No dataset between Oct 2019 and February 2021. TH replaced

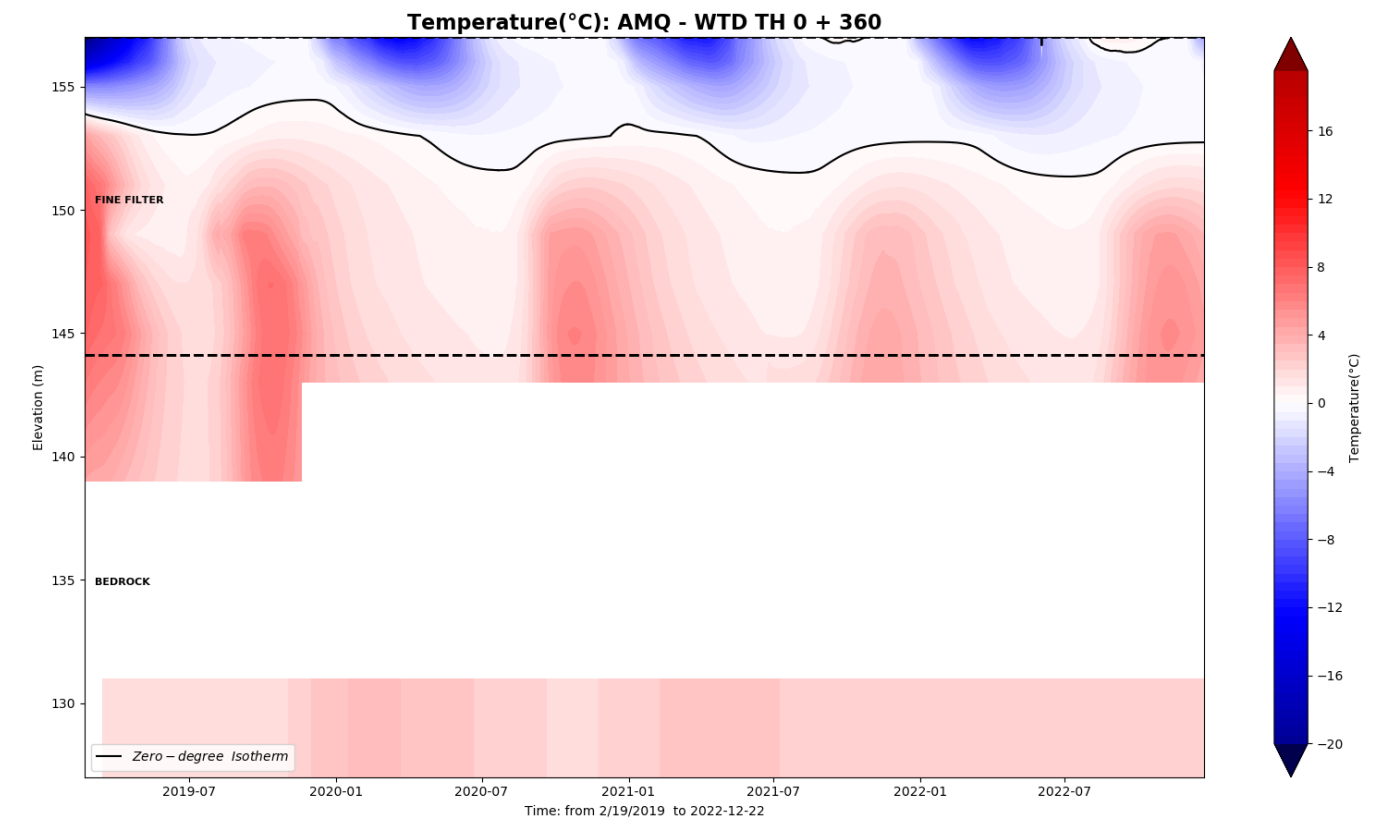
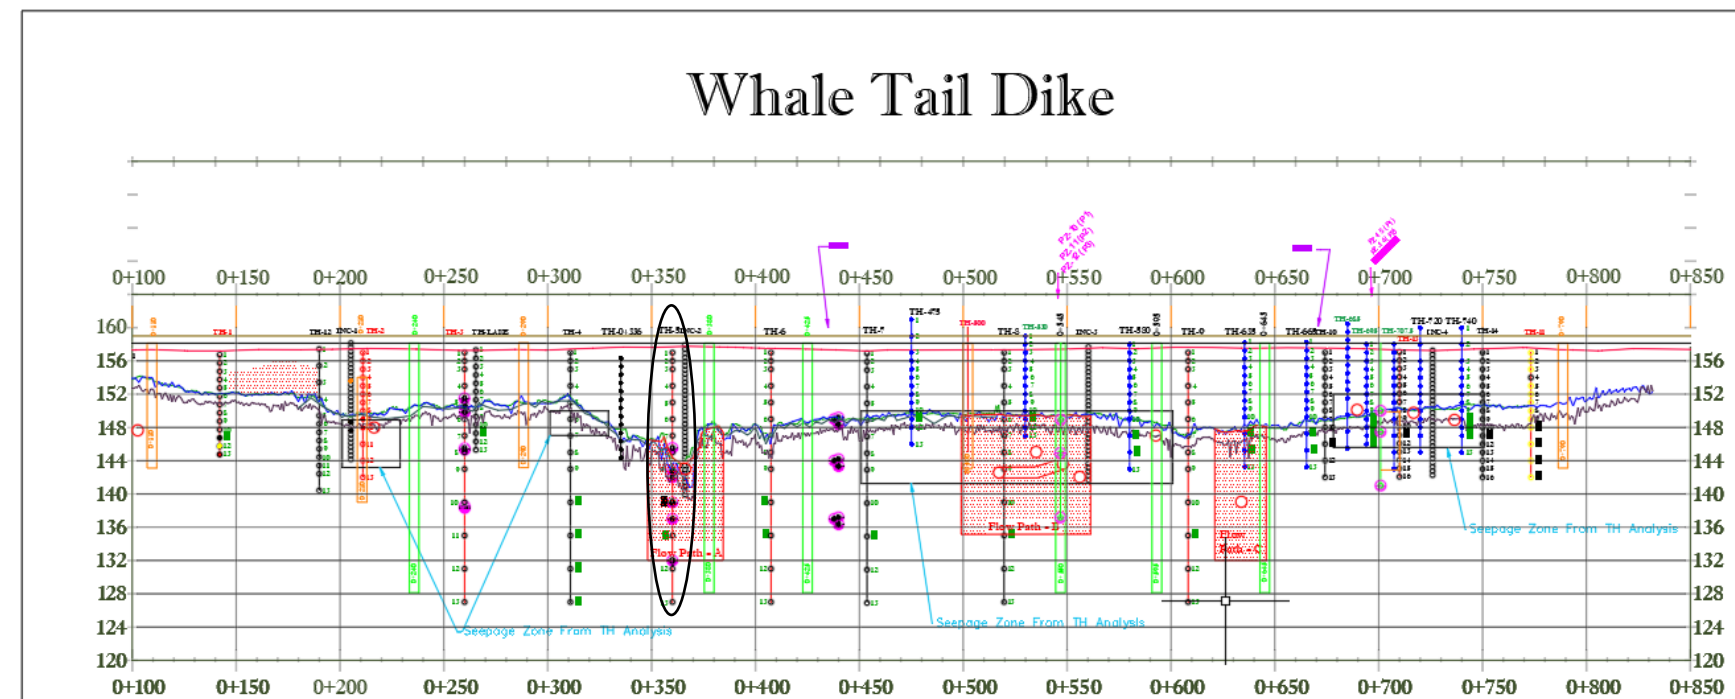
WTD-TH 0+360

Bead #10 to #12 removed

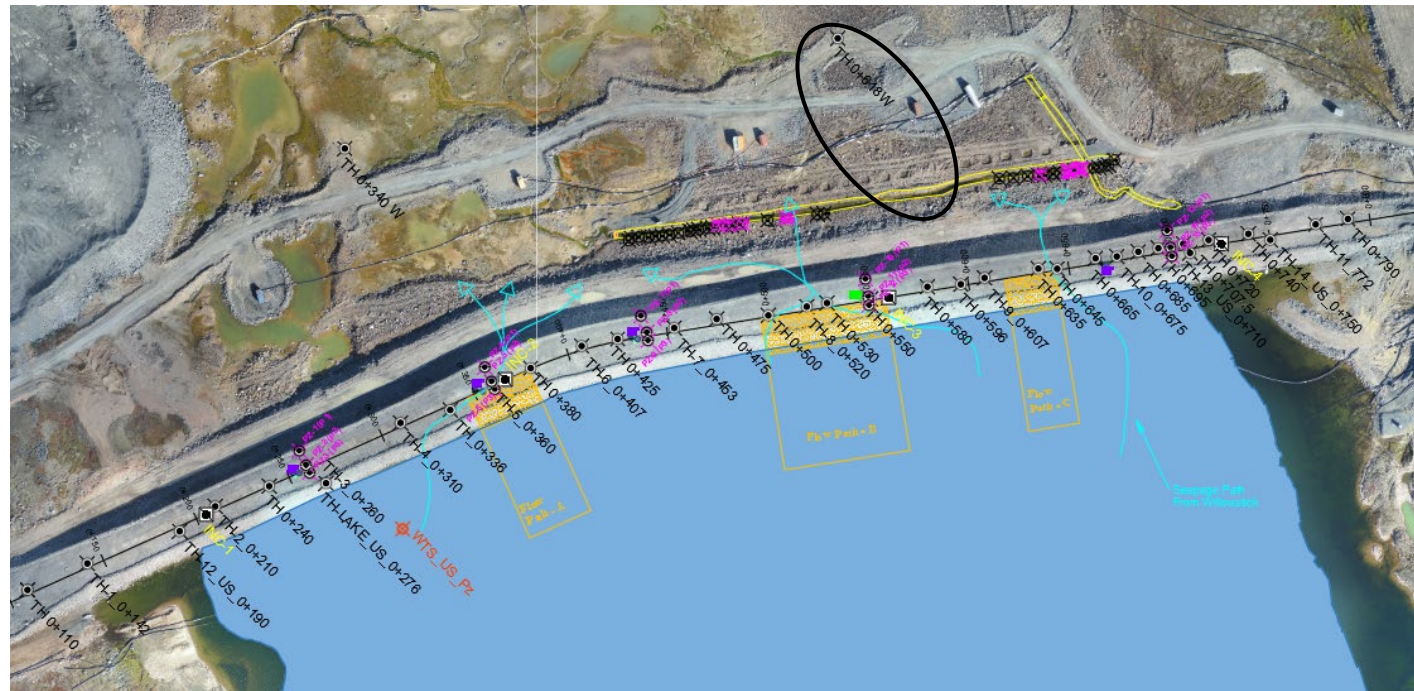
WTD-TH 0+618 DSE

Beads #10 to #16 are damaged.

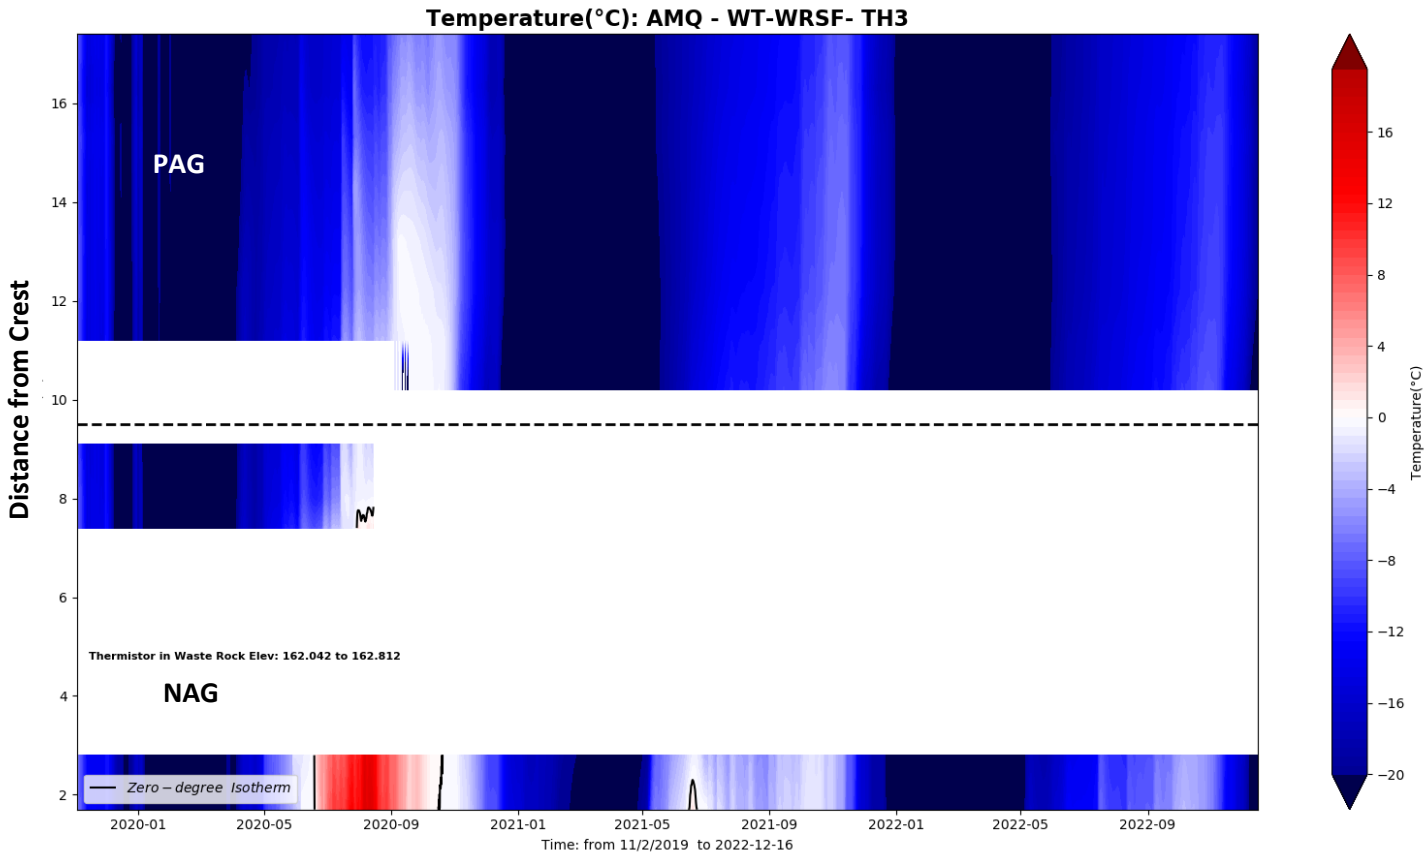
WT WRSF TH3

This instrument is installed horizontally and chart needs to be read accordingly
Beads 3 to 10 are not working

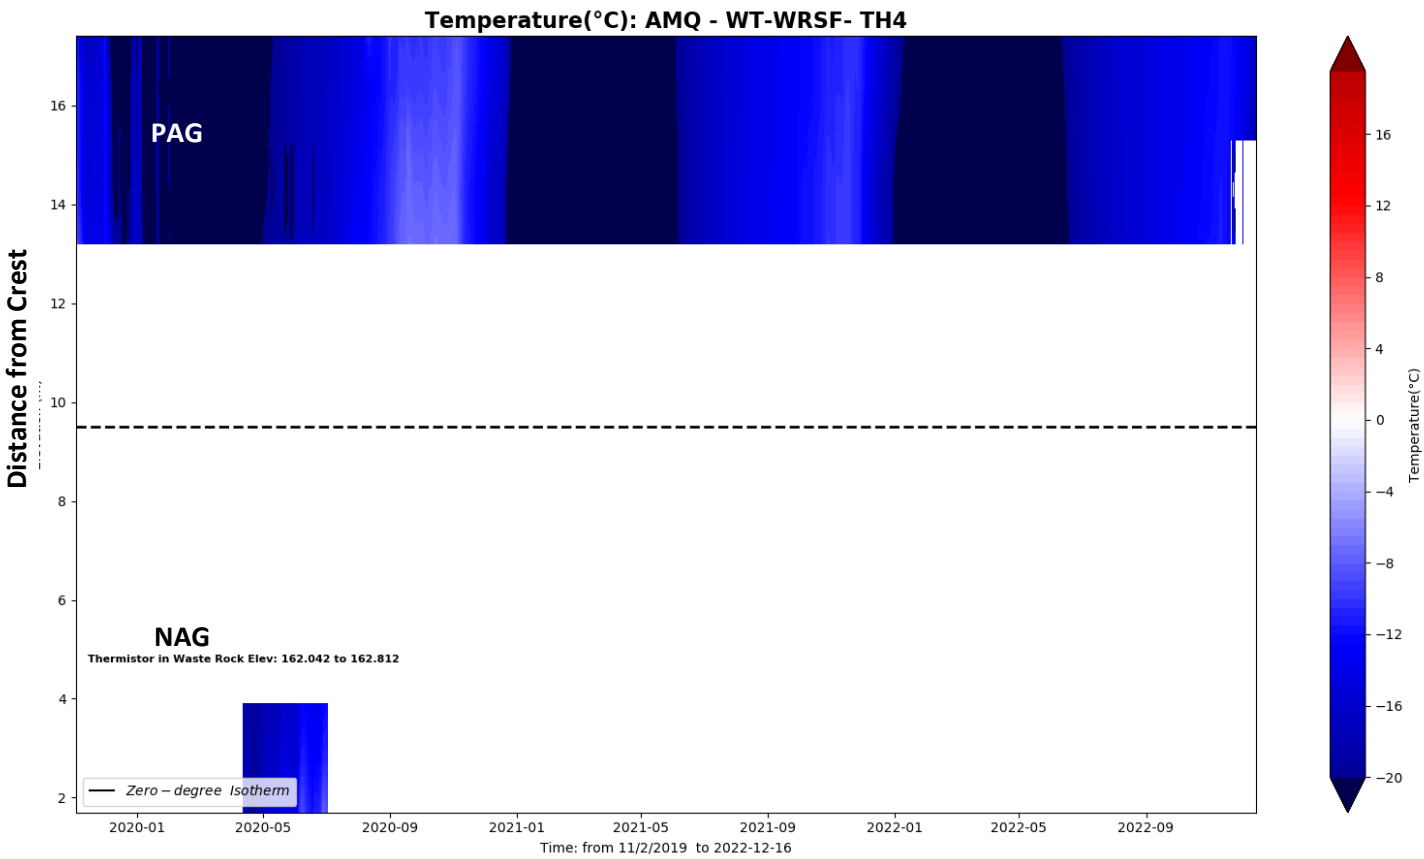
WT WRSF TH4

Beads 3 to 10 are not working
