### **Meadowbank and Whale Tail 2022 Annual Geotechnical Inspection**

**REPORT****2022 Annual Geotechnical Inspection***Meadowbank Complex, Nunavut*

**Golder Associés Ltée**

1617-2146800622-5000-RA-Rev0

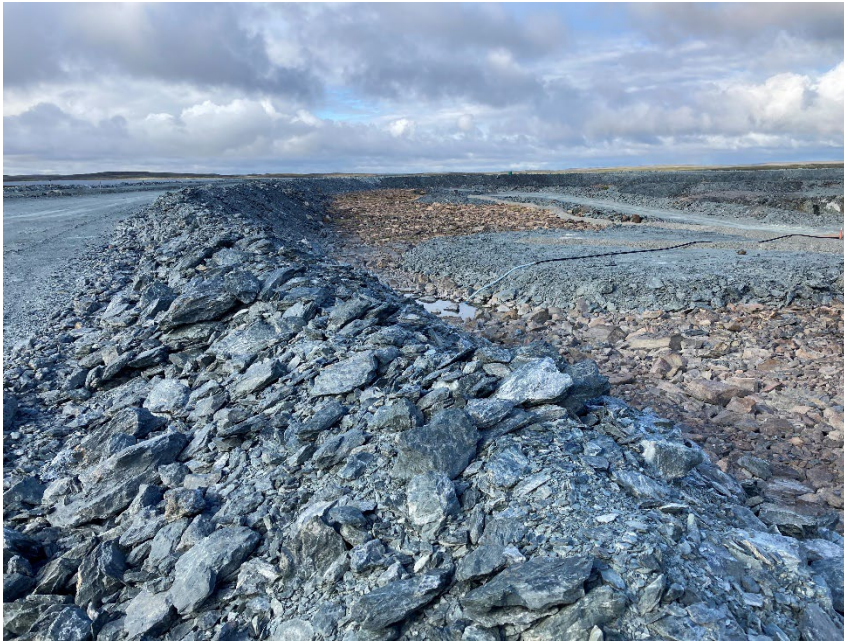
**Photograph A3-11 Bay Goose Dike**

**Description:** From approximately Sta. 31+080 on the crest, looking southwest at the pond of water at Central Channel seepage at Sta. 31+165.
