Wail-Tail Dike

Client:	AEM	By:	Marion Habersetzer
Project:	Whale Tail Project	Date:	July 27, 2022
Location:	Whale Tail Dike	Reviewed:	Yves Boulianne

IVR Dike D-1

Client: AEM **By:** Marion Habersetzer
Project: Whale Tail Project **Date:** July 26, 2022
Location: IVR Dike **Reviewed:** Yves Boulianne

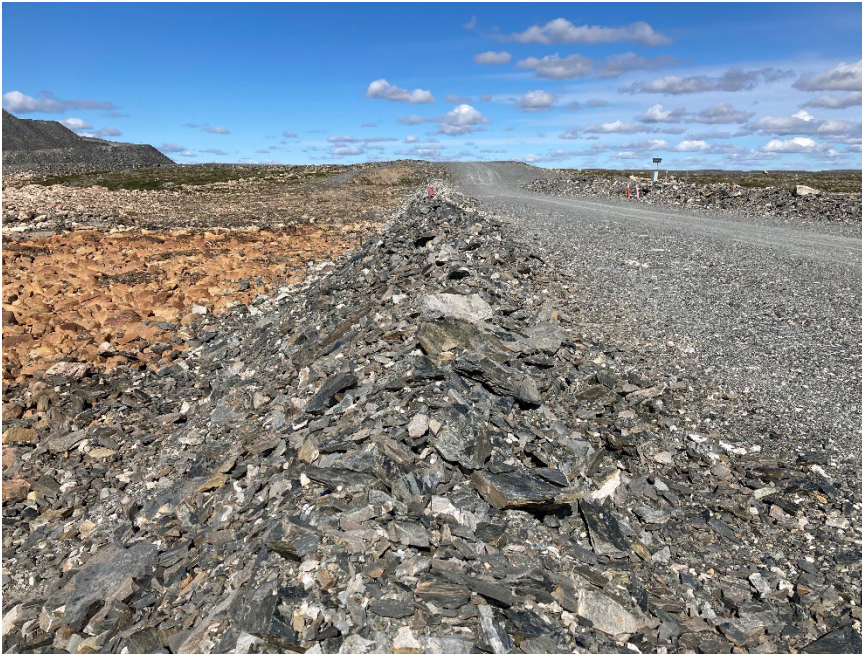
Photograph A4-3 Vault Dike

Description: From downstream, looking northwest at the downstream toe.

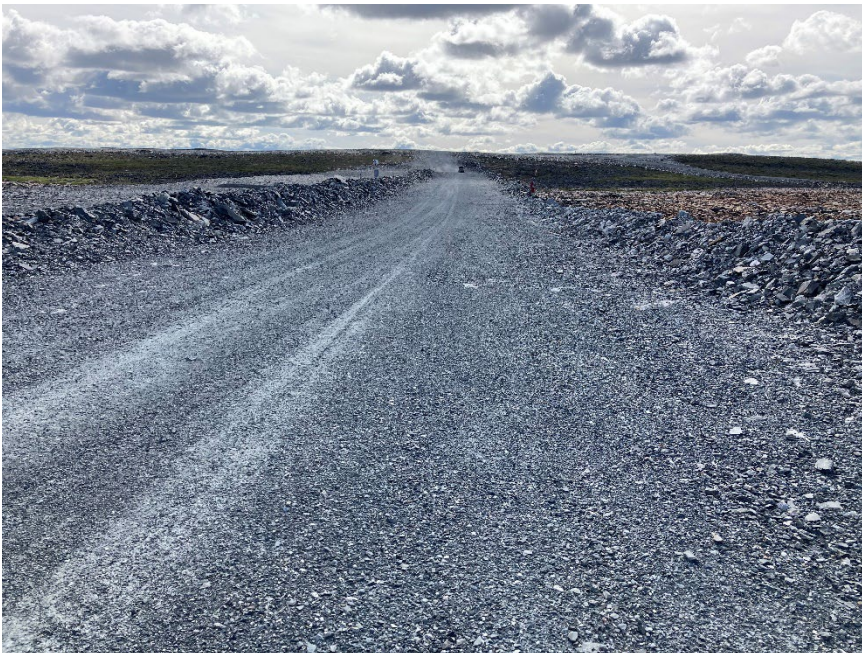
Photograph A4-4 Vault Dike

Description: From the west abutment, looking southeast at the crest.

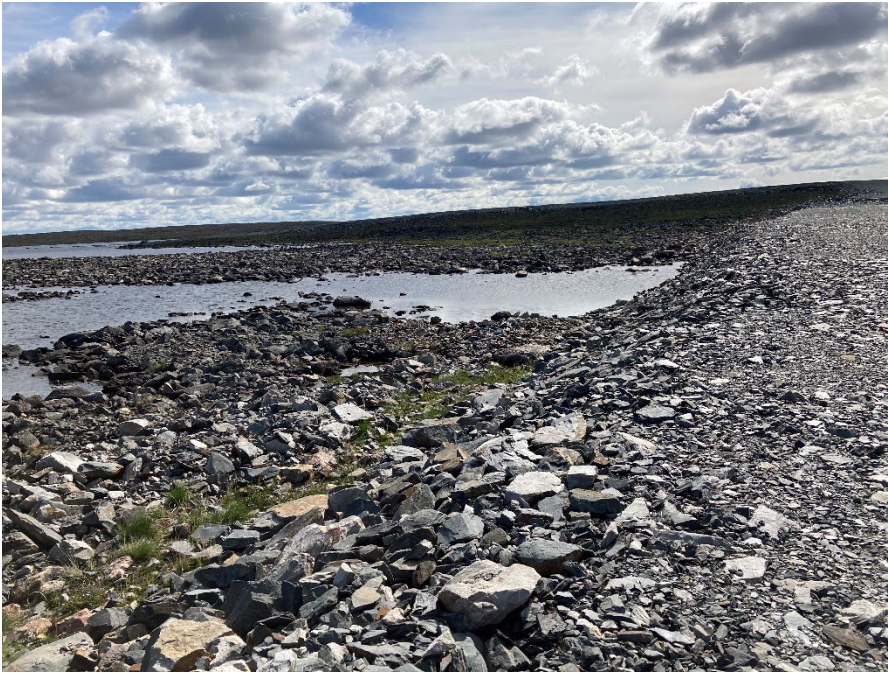
Photograph A4-5 Vault Dike

Description: From the upstream side, looking southeast at the upstream slope.

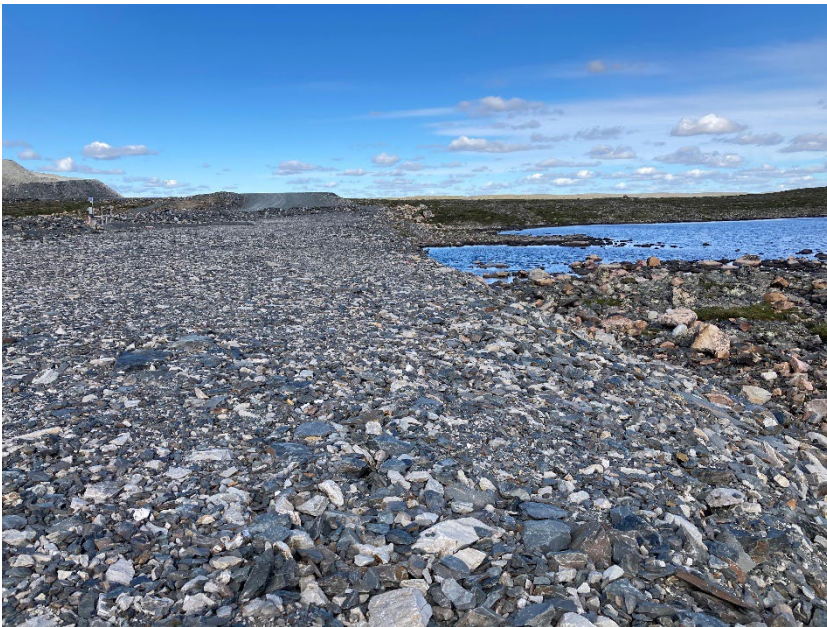
Photograph A4-6 Vault Dike

Description: From the upstream side, looking northwest at the upstream slope.

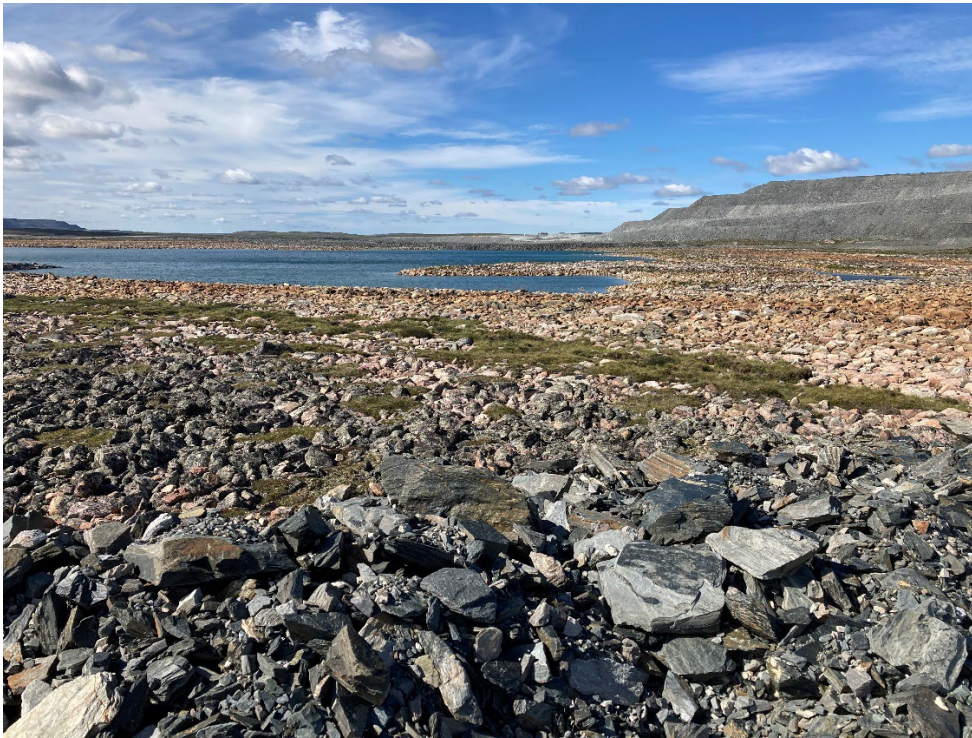
Photograph A4-7 Vault Dike

Description: From the downstream side, looking southwest towards Vault Lake.

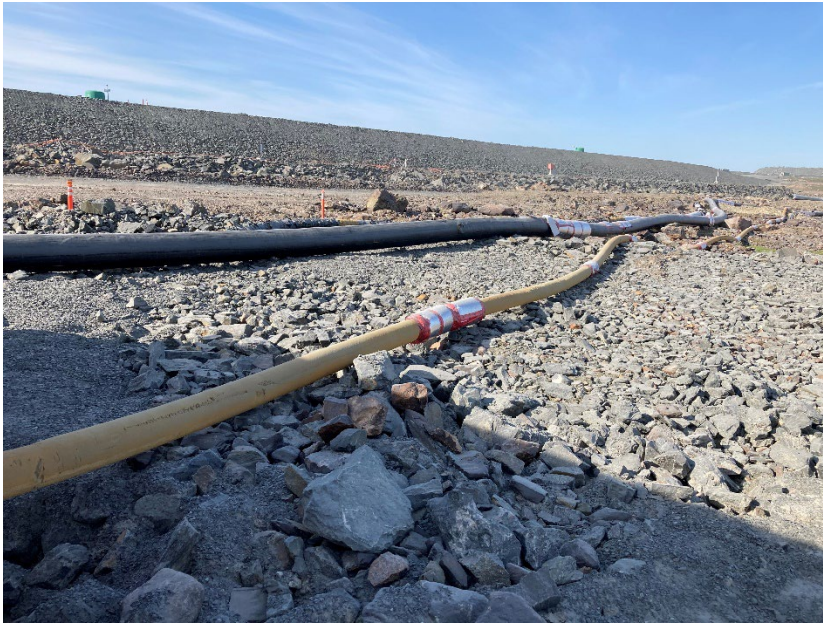
Photograph A5-3 Whale Tail Dike

Description: From approx. Sta. 0+600 downstream (P1 pumping station), looking southwest.

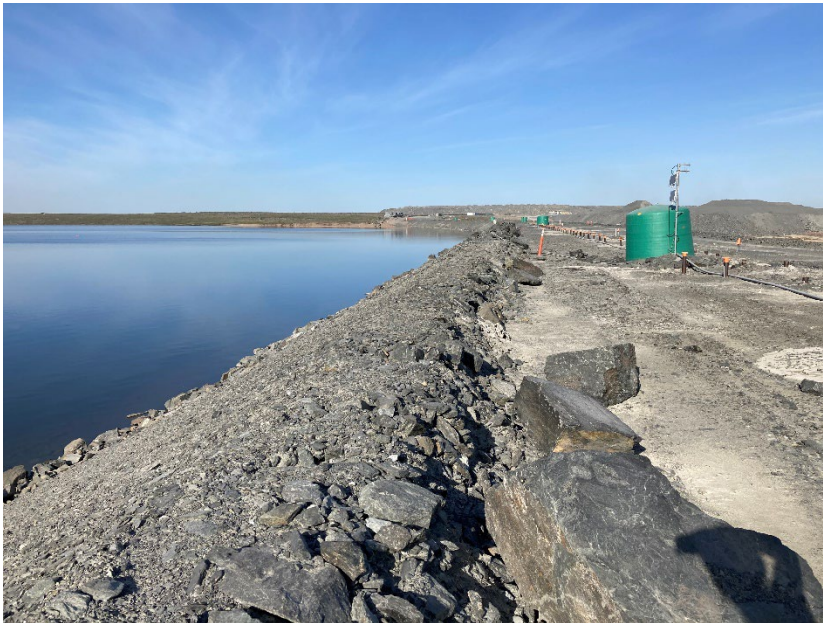
Photograph A5-4 Whale Tail Dike

Description: From approx. Sta. 0+725 (east abutment), looking southwest at the upstream slope.

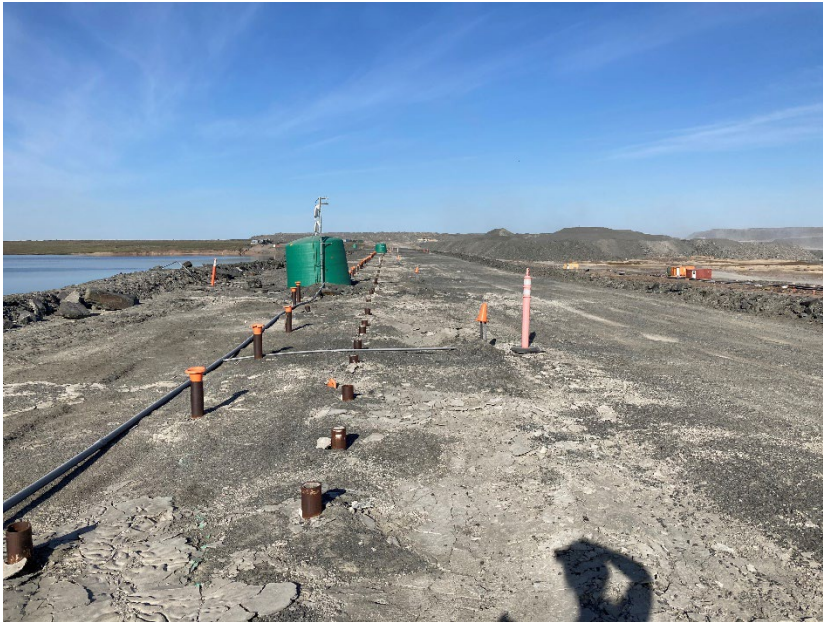
Photograph A5-5 Whale Tail Dike

Description: From approx. Sta. 0+725 (east abutment), looking west at the crest.

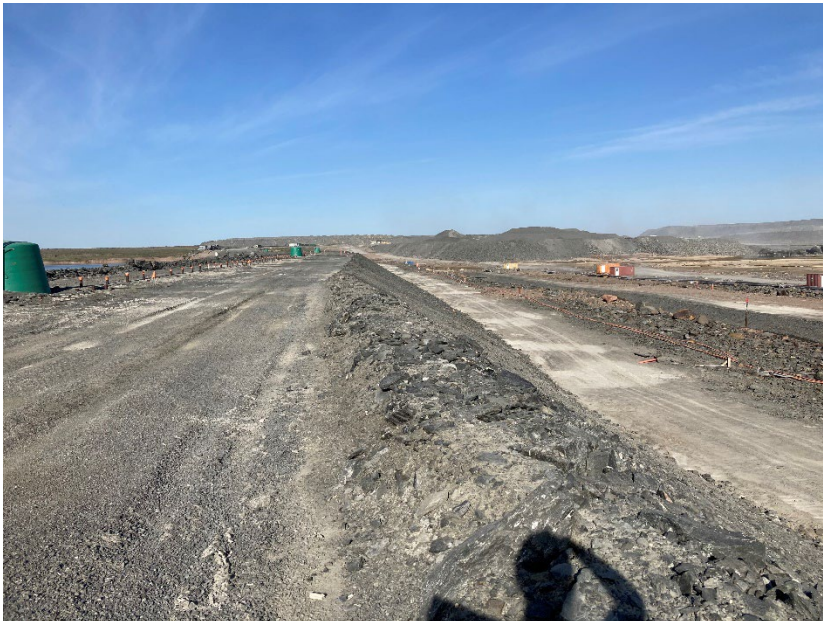
Photograph A5-6 Whale Tail Dike

Description: From approx. Sta. 0+725 (east abutment), looking west at the downstream slope.

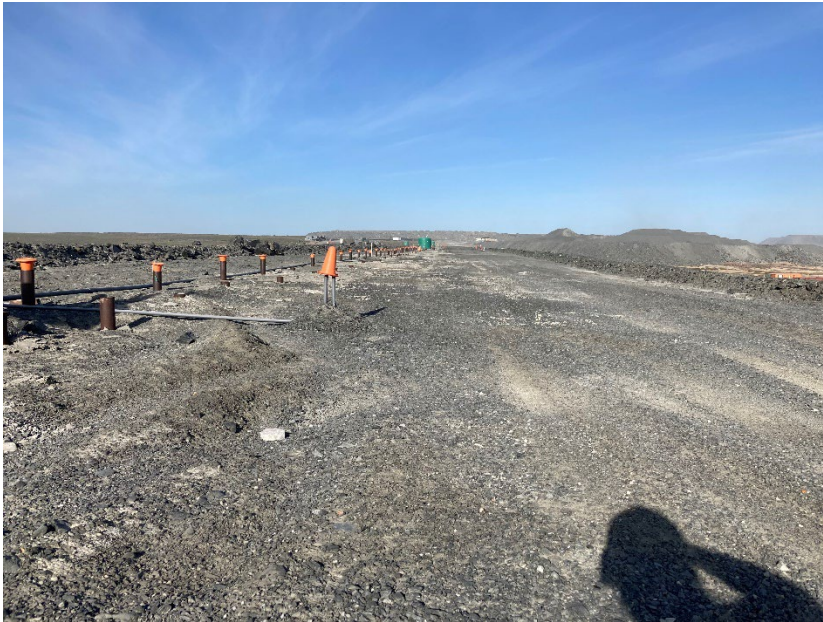
Photograph A5-7 Whale Tail Dike

Description: From approx. Sta. 0+700 (east abutment), looking west at the crest.

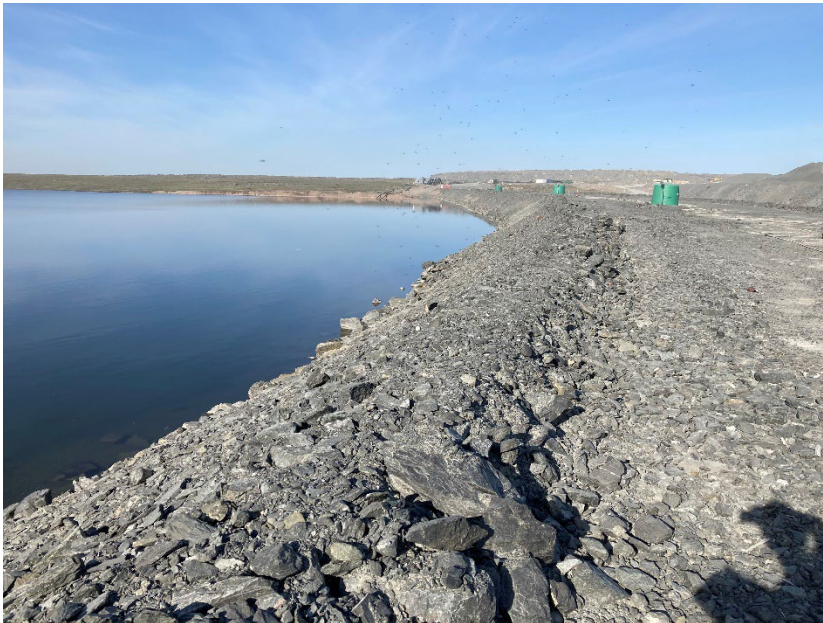
Photograph A5-8 Whale Tail Dike

Description: From approx. Sta. 0+575, looking west at the upstream slope.

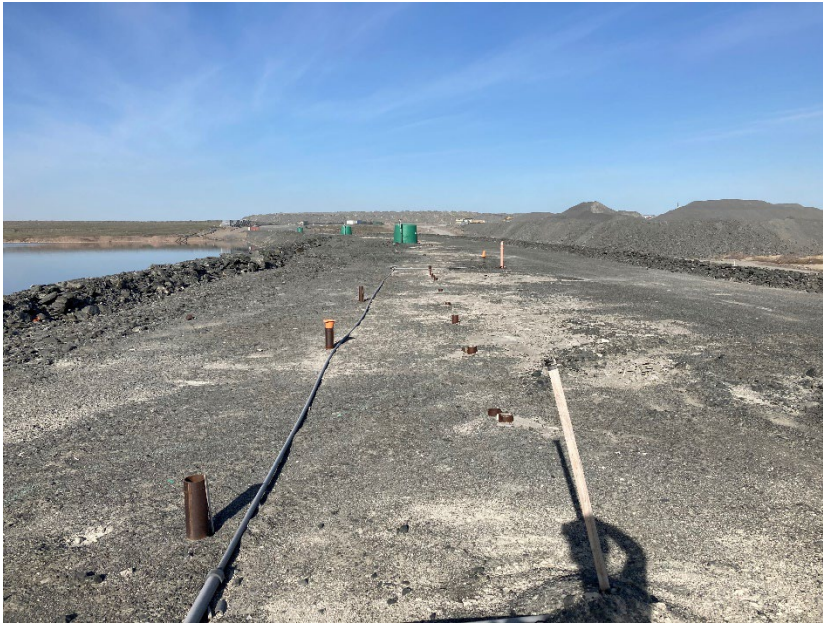
Photograph A5-9 Whale Tail Dike

Description: From approx. Sta. 0+575, looking west at the crest.

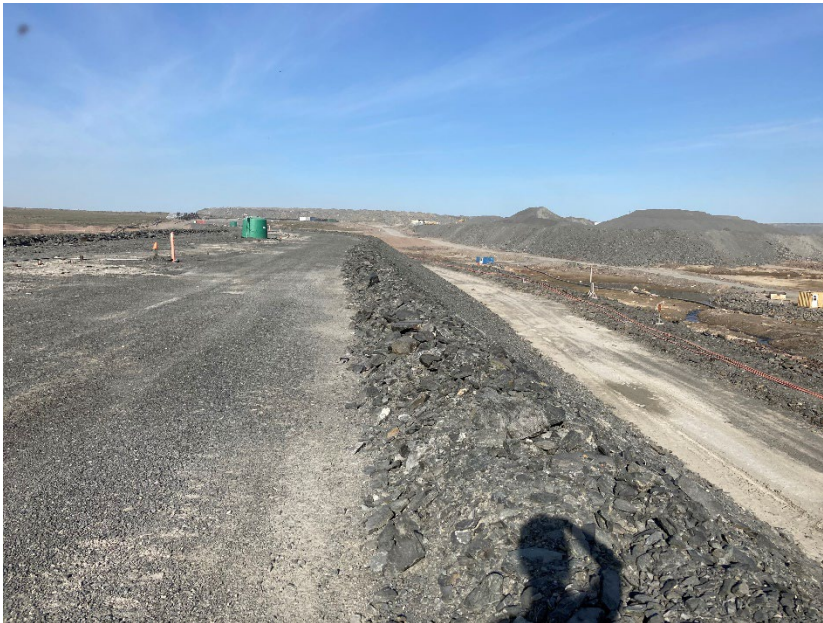
Photograph A5-10 Whale Tail Dike

Description: From approx. Sta. 0+575, looking west at the downstream slope and downstream platform.

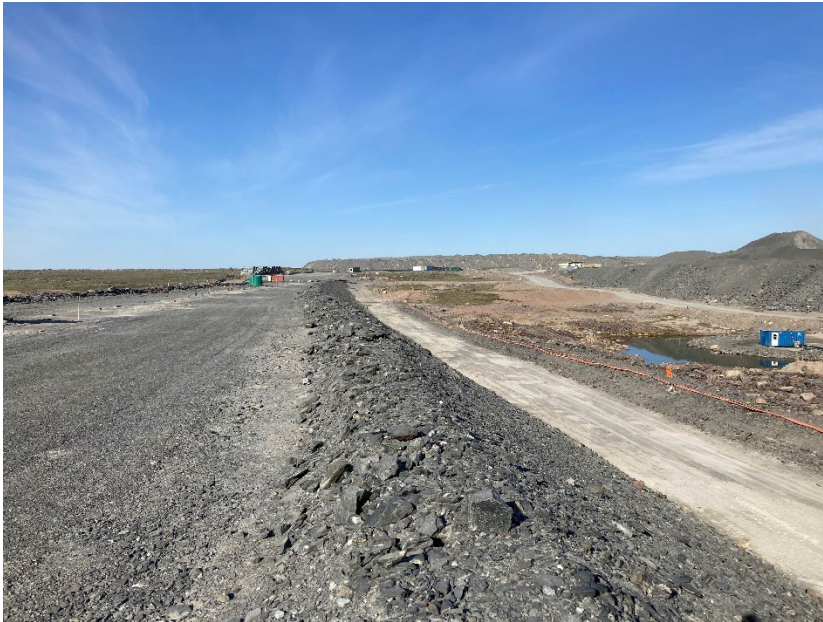
Photograph A5-11 Whale Tail Dike

Description: From approx. Sta. 0+400, looking west at the downstream slope and downstream platform.

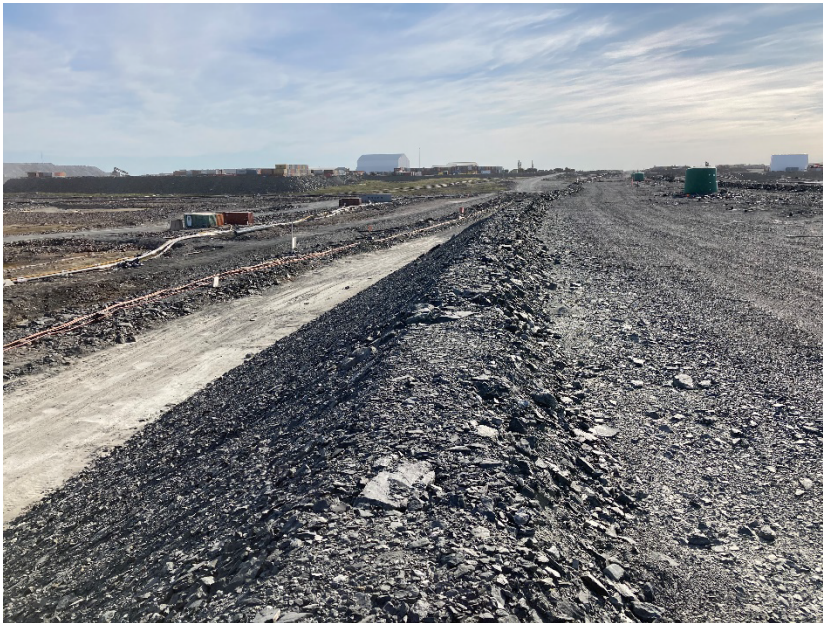
Photograph A5-12 Whale Tail Dike

Description: From approx. Sta. 0+400, looking east at the downstream slope and downstream platform.

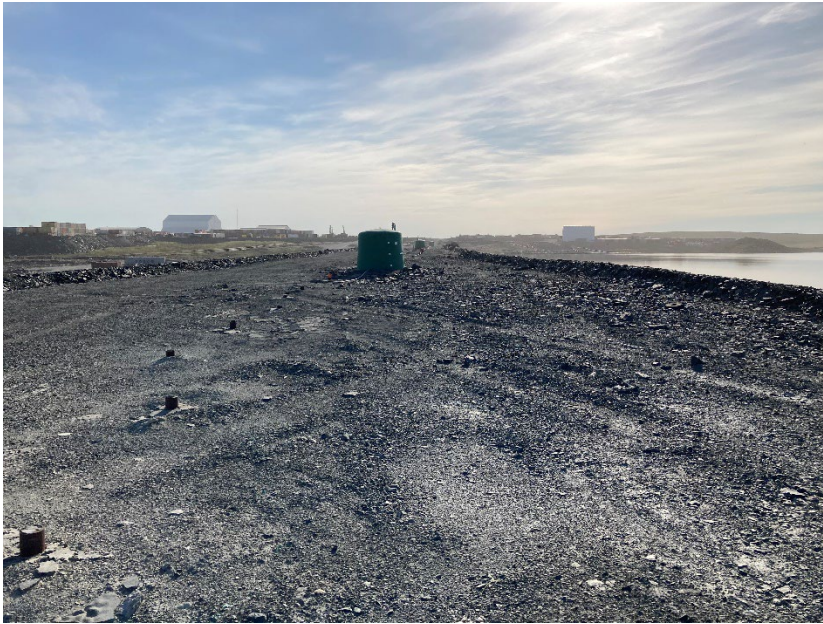
Photograph A5-13 Whale Tail Dike

Description: From approx. Sta. 0+400, looking west at the crest.

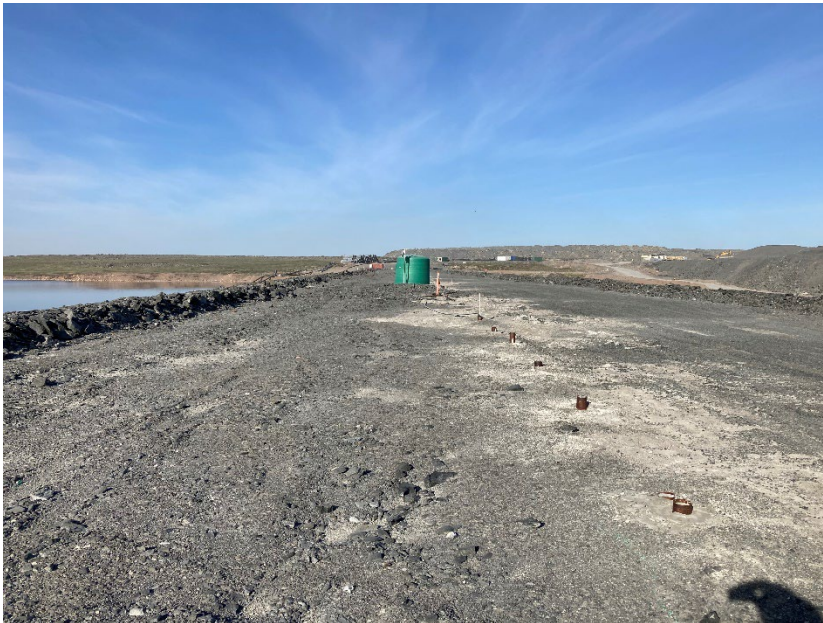
Photograph A5-14 Whale Tail Dike

Description: From approx. Sta. 0+400, looking east at the crest.

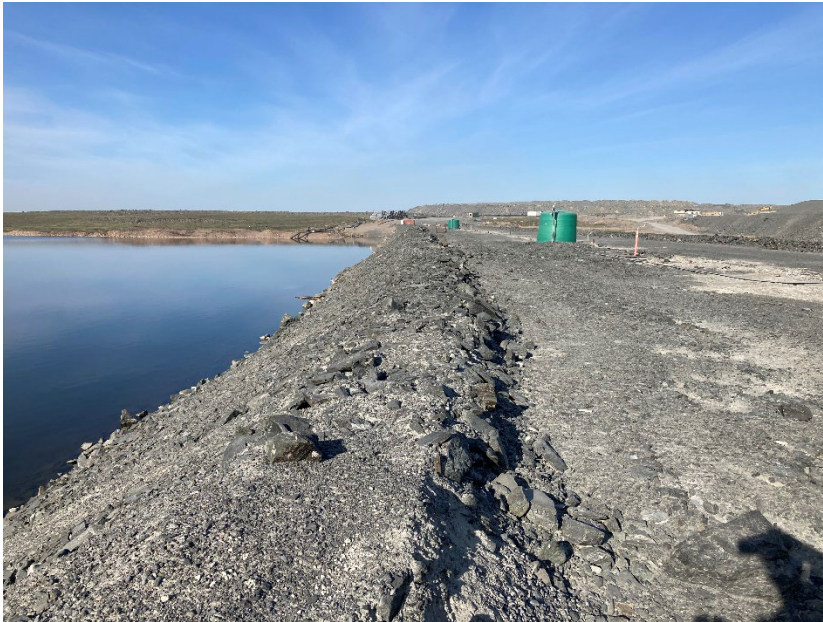
Photograph A5-15 Whale Tail Dike

Description: From approx. Sta. 0+400, looking west at the upstream slope.

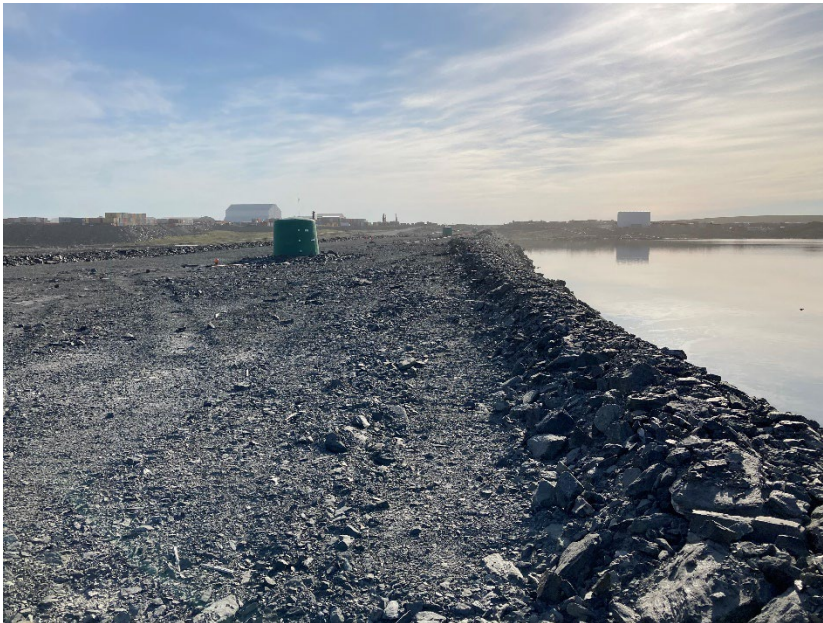
Photograph A5-16 Whale Tail Dike

Description: From approx. Sta. 0+400, looking east at the upstream slope.

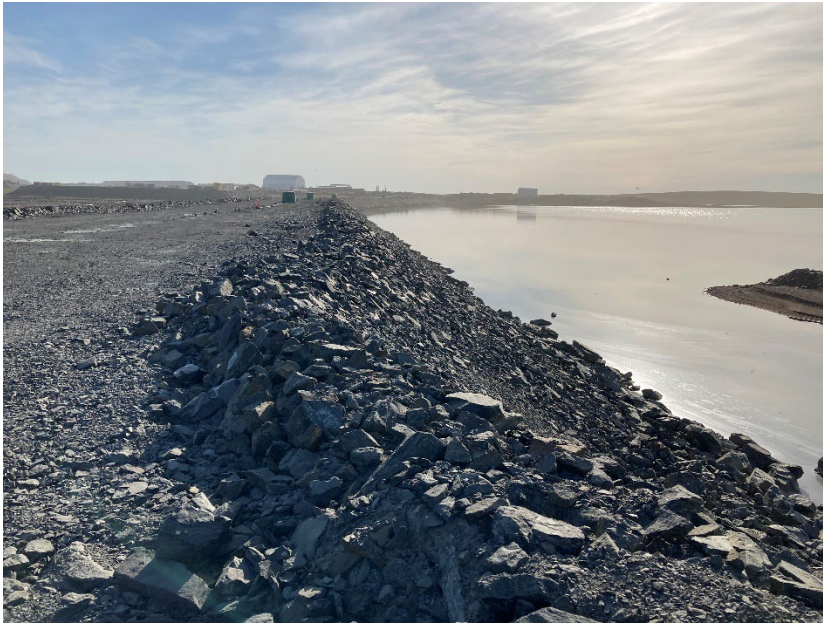
Photograph A5-17 Whale Tail Dike

Description: From approx. Sta. 0+200 (west abutment), looking northeast at the upstream slope.

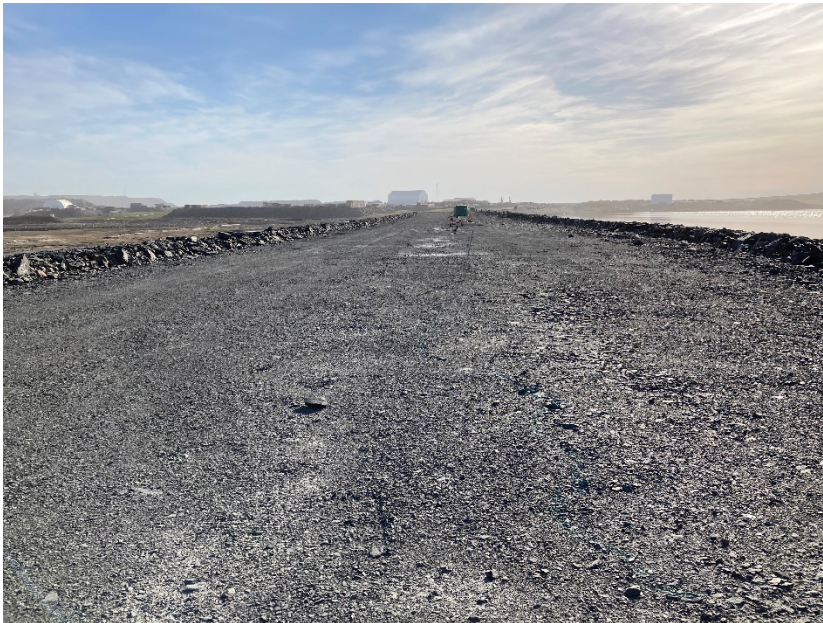
Photograph A5-18 Whale Tail Dike

Description: From approx. Sta. 0+200 (west abutment), looking northeast at the crest.

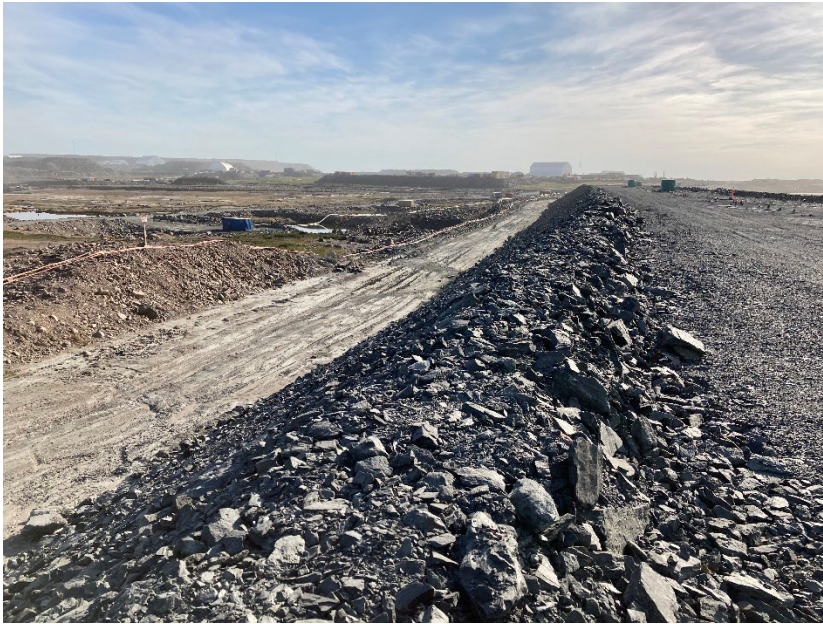
Photograph A5-19 Whale Tail Dike

Description: From approx. Sta. 0+200 (west abutment), looking northeast at the downstream slope and downstream platform.

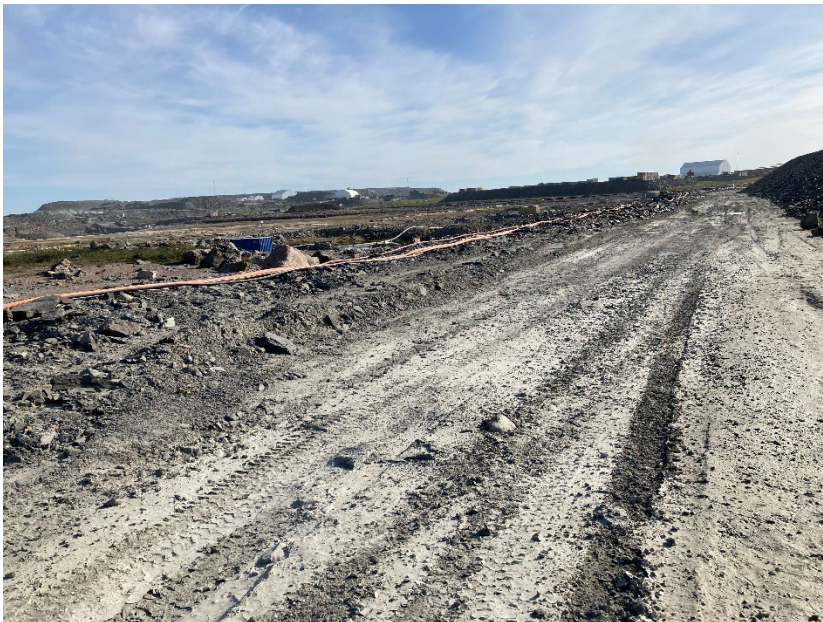
Photograph A5-20 Whale Tail Dike

Description: From approx. Sta. 0+200 on the downstream platform, looking northeast at the downstream slope and platform.

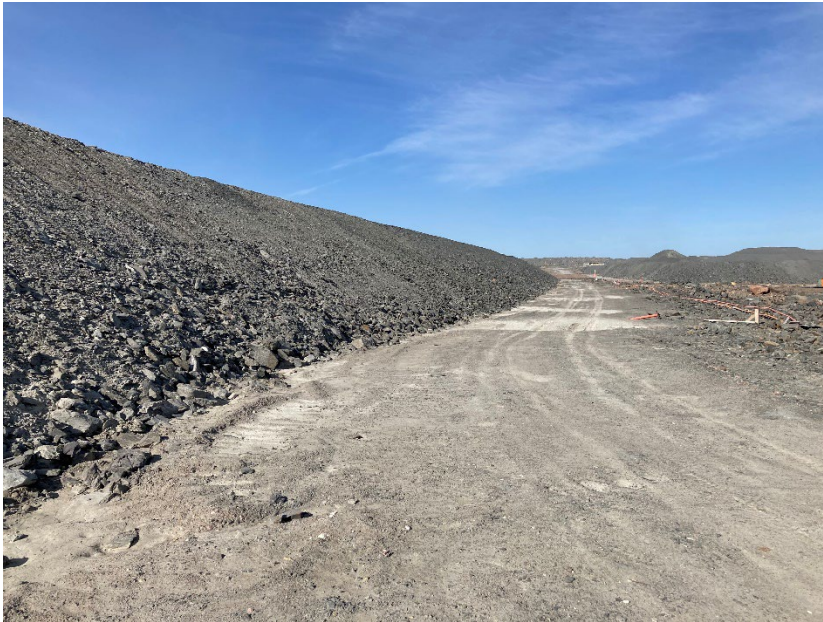
Photograph A5-23 Whale Tail Dike

Description: From approx. Sta. 0+675 downstream, looking west at the downstream slope and platform.

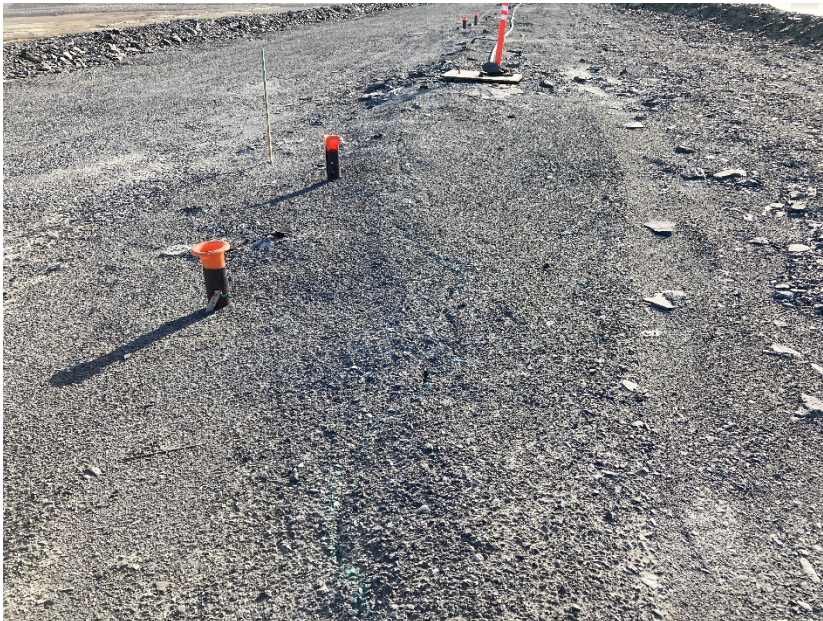
Photograph A5-24 Whale Tail Dike

Description: From approx. Sta. 0+225 on the crest, looking northeast at the crest platform. Presence of a healing longitudinal tension crack.

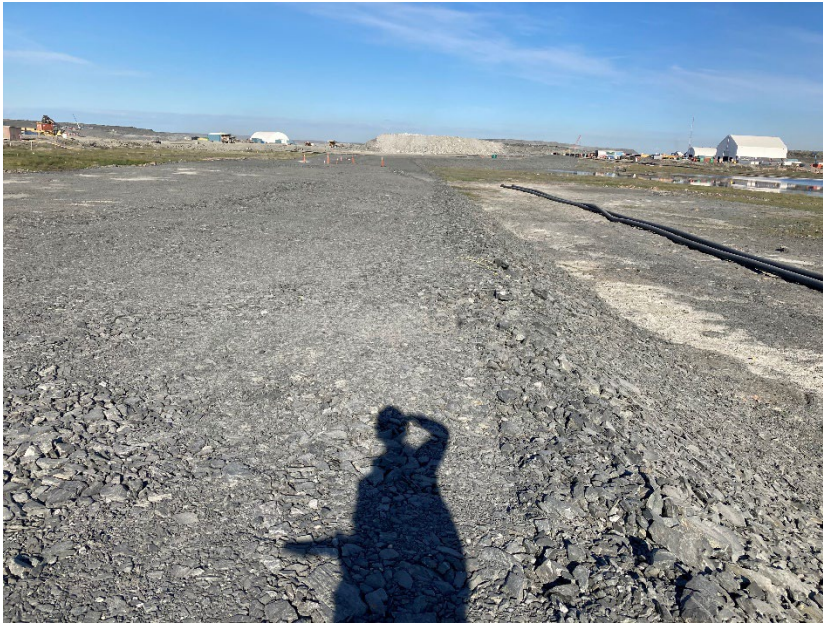
Photograph A6-1 IVR Dike D-1

Description: From approx. Sta. 0+540 (east abutment), looking west at the crest (thermal cap) and upstream slope.

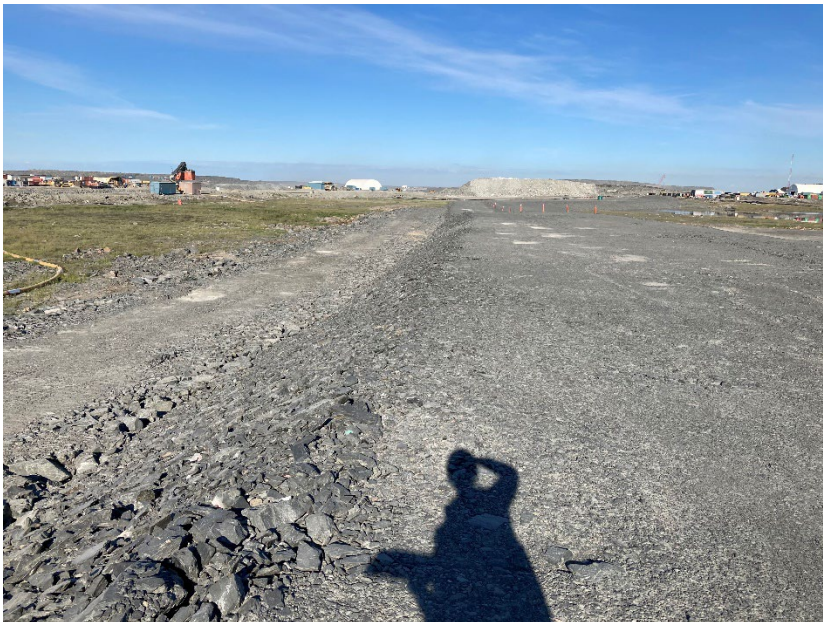
Photograph A6-2 IVR Dike D-1

Description: From approx. Sta. 0+540 (east abutment), looking west at the crest (thermal cap) and downstream slope.

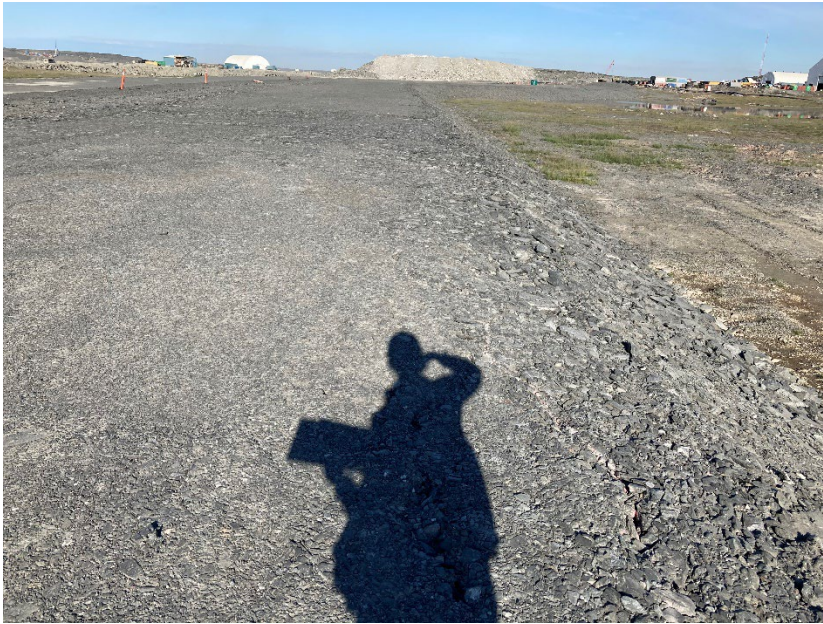
Photograph A6-3 IVR Dike D-1

Description: From approx. Sta. 0+480, looking west at the crest (thermal cap) and upstream slope.

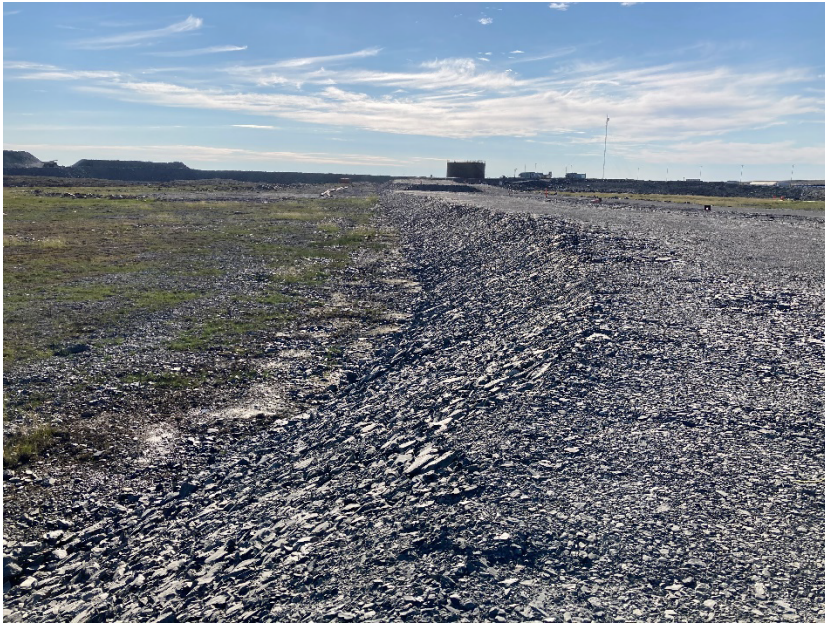
Photograph A6-7 IVR Dike D-1

Description: From approx. Sta. 0+300, looking east at the crest and upstream slope.

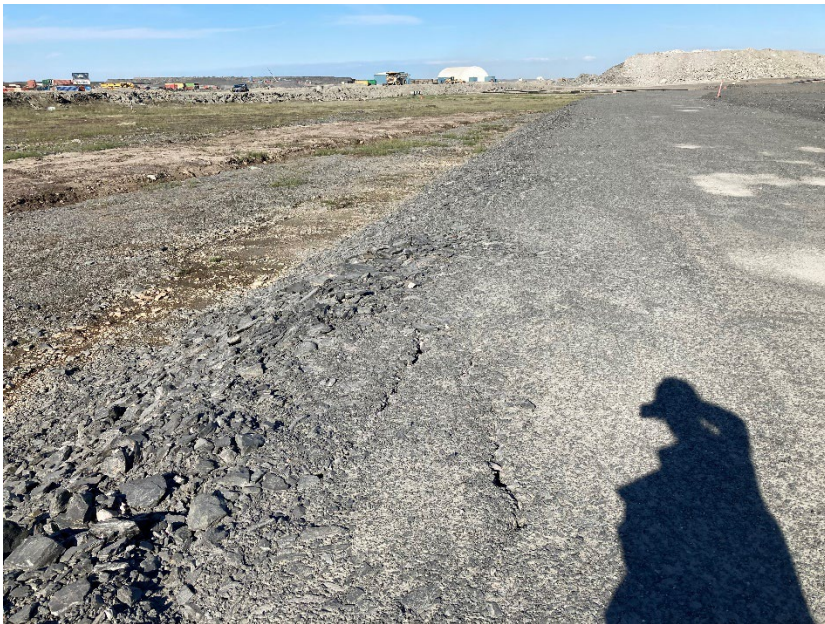
Photograph A6-11 IVR Dike D-1

Description: From approx. Sta. 0+395, looking west at the crest. Presence of tension cracks (1-2 m long).

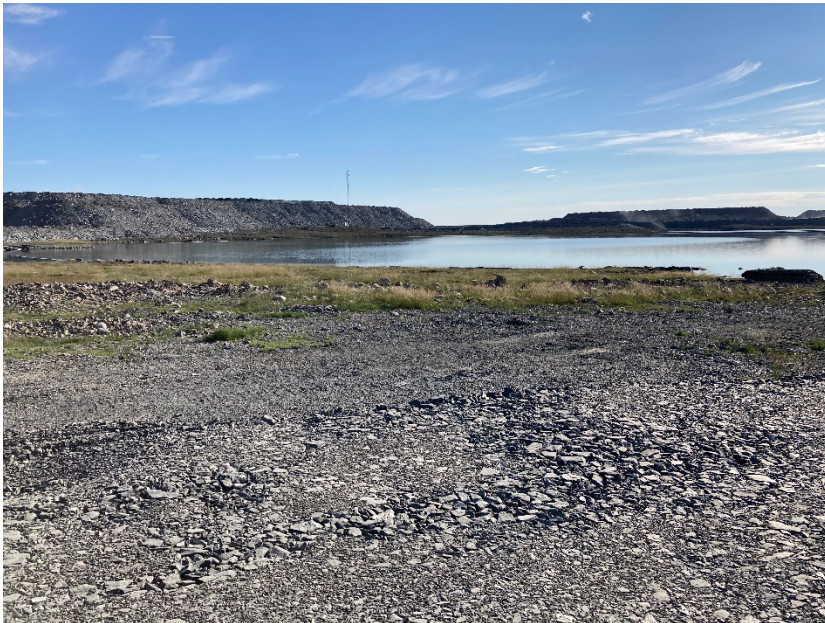
Photograph A6-12 IVR Dike D-1

Description: From approx. Sta. 0+070, looking northeast at the downstream toe and the attenuation pond.

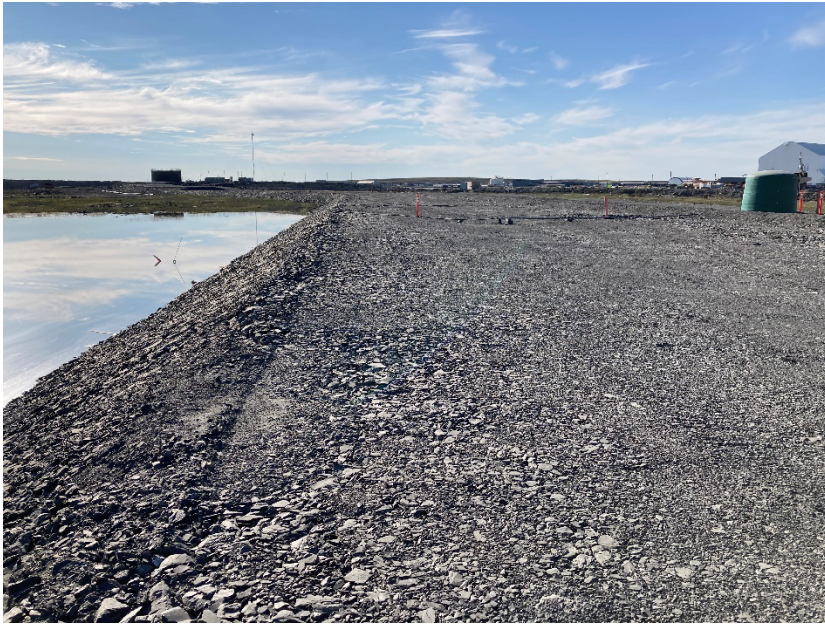
Photograph A6-13 IVR Dike D-1

Description: From approx. Sta. 0+070, looking southeast at the crest and downstream slope.
