**Appendix A-7**

# Waste Rock Storage Facility I Dike

| <b>Project:</b> | Whale Tail Project | <b>Date:</b> | July 26, 2022 |

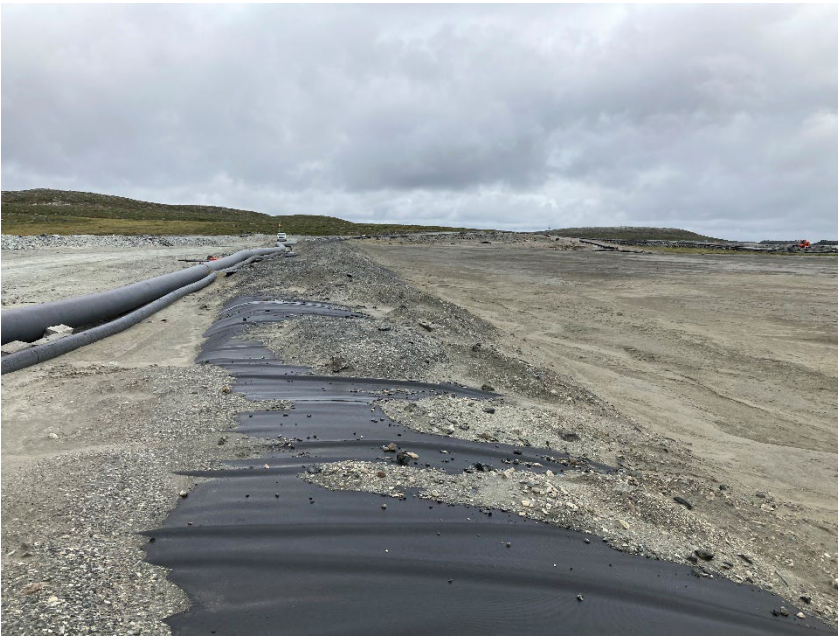
**Photograph B2-5 Saddle Dam 1**

**Description:** From approximately Sta. 0+195 upstream, looking north at the upstream slope. Adequate tailings beach against SD1.
