**APPENDIX B-3**

**Saddle Dam 2**

<b>Client:</b>	AEM	<b>By:</b>	Marion Habersetzer
<b>Project:</b>	Meadowbank	<b>Date:</b>	July 29, 2022
<b>Location:</b>	Saddle Dam 2	<b>Reviewed:</b>	Yves Boulianne

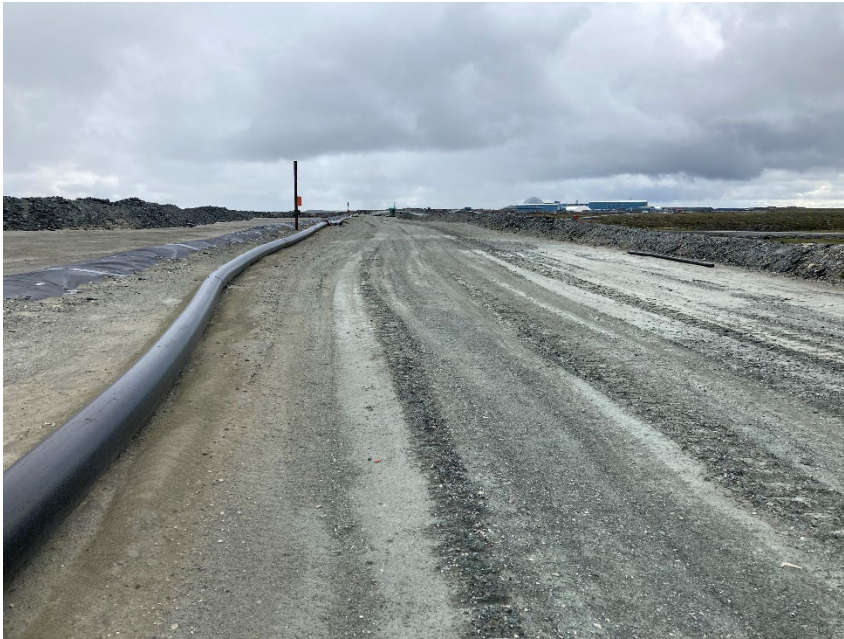
**Photograph B3-1 Saddle Dam 2**

**Description:** From Saddle Dam 2 (approximately Sta. 20+110) looking southeast at the crest and upstream slope.

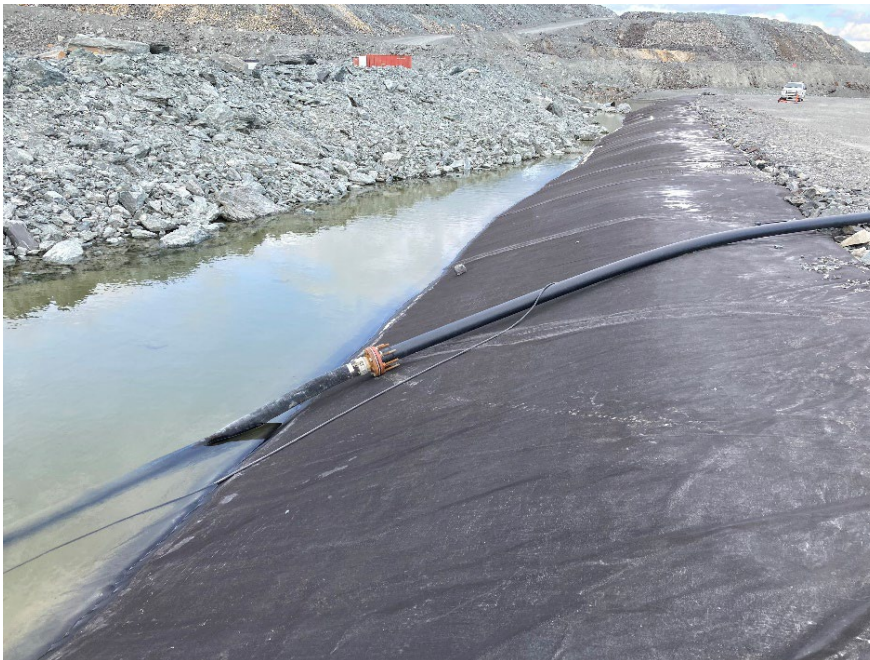
**Photograph B4-4 Stormwater Dike**

**Description:** From the crest (10+950 approximately), looking east at the downstream slope. Presence of a pipe with a metallic connector on the liner.

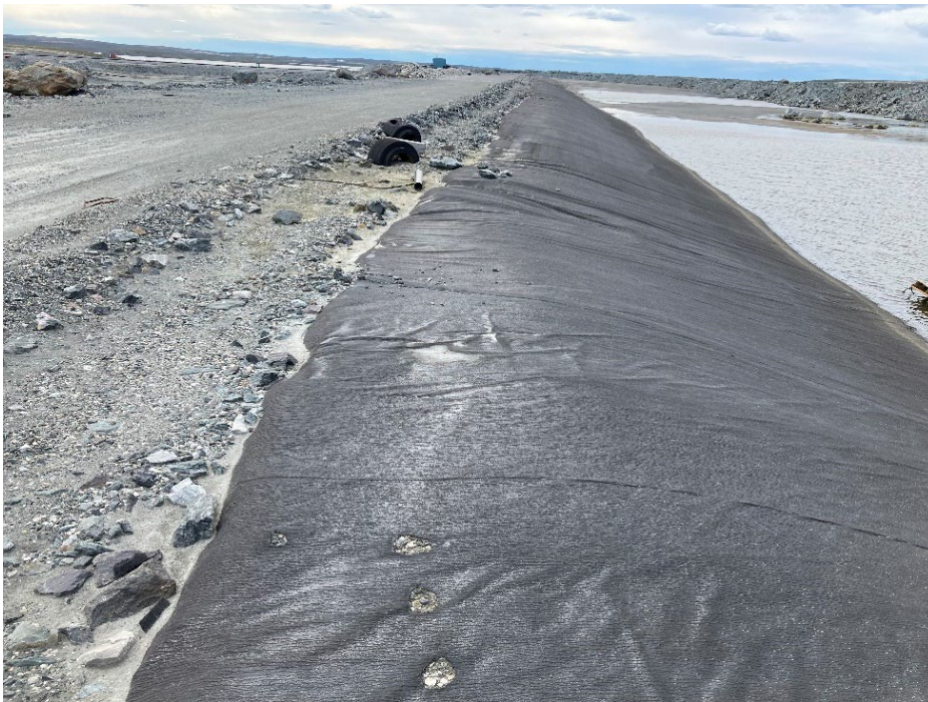
**Photograph B4-6 Stormwater Dike**

**Description:** From Sta. 10+650 looking west at the crest and upstream slope. Shallow water against portion of Stormwater Dike.

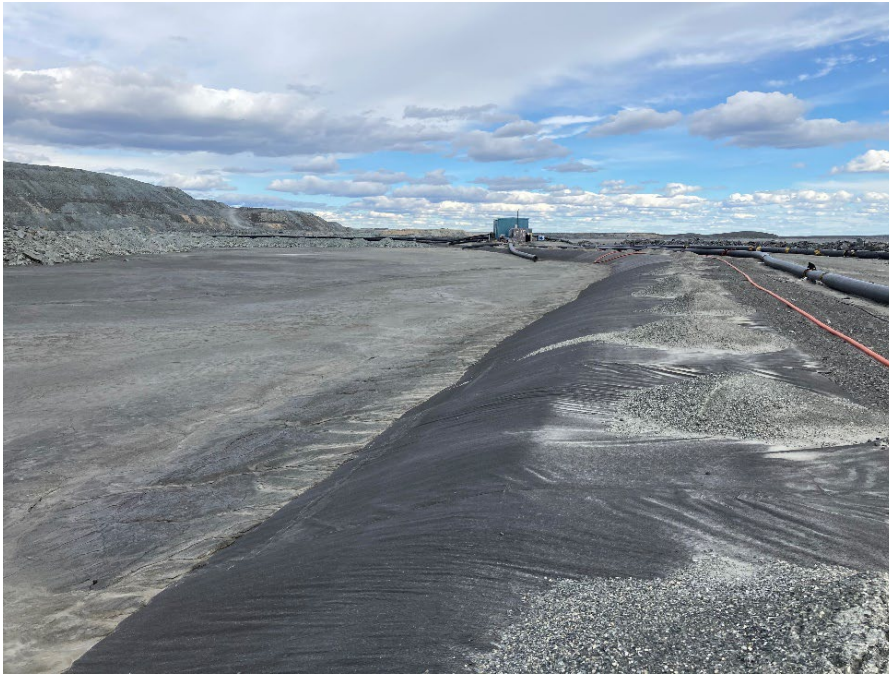
**Photograph B4-9 Stormwater Dike**

**Description:** From Sta.10+175, looking east at the upstream slope. The tailings beach is adequate.

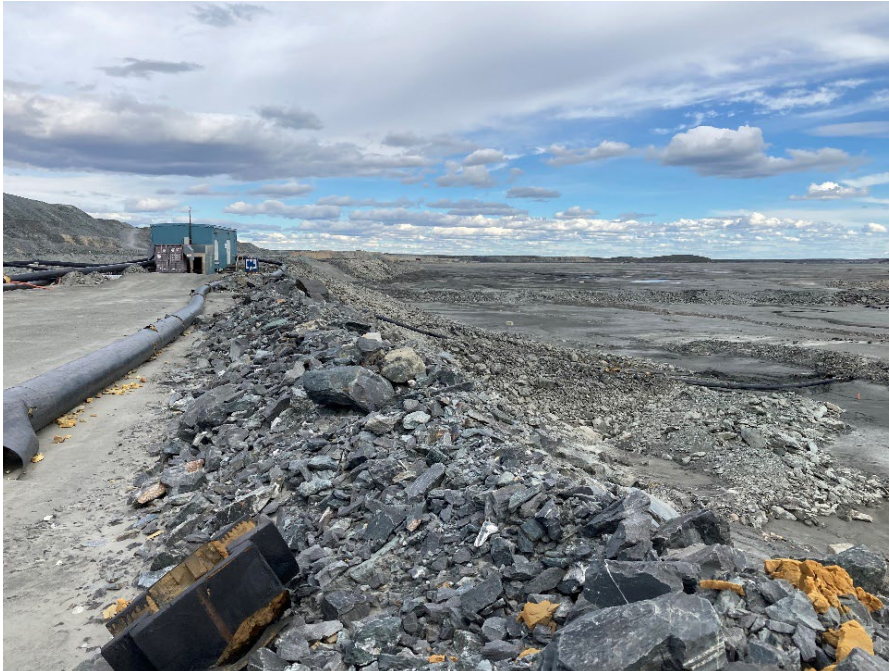
**Photograph B4-10 Stormwater Dike**

**Description:** From Sta.10+250, looking east at the downstream slope and the South Cell. The downstream toe is covered with water in this section.

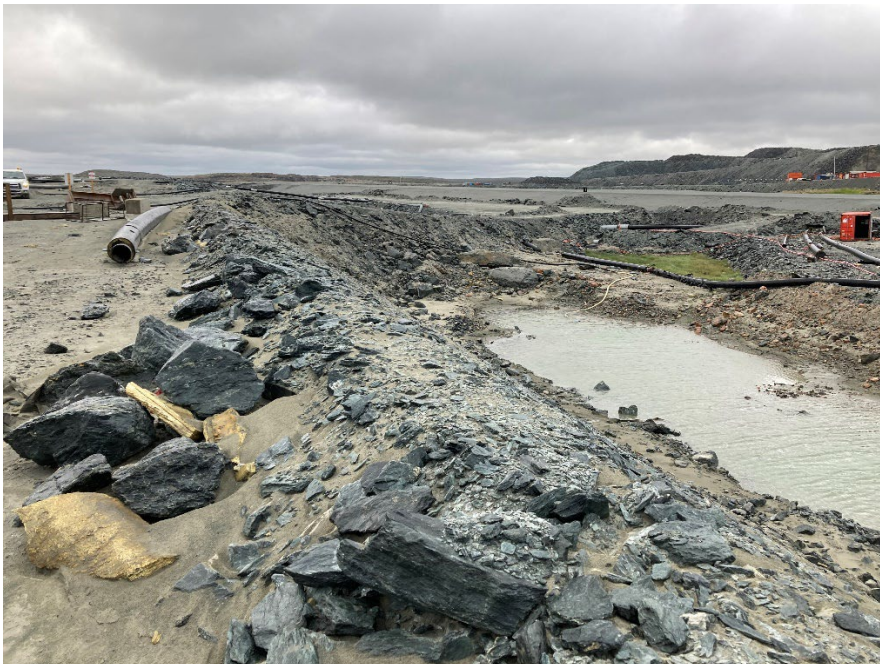
**Photograph B6-8 Saddle Dam 4**

**Description:** From 40+450 approximately, looking southeast at the crest and the downstream slope and toe. A large amount of water is ponding at the toe.

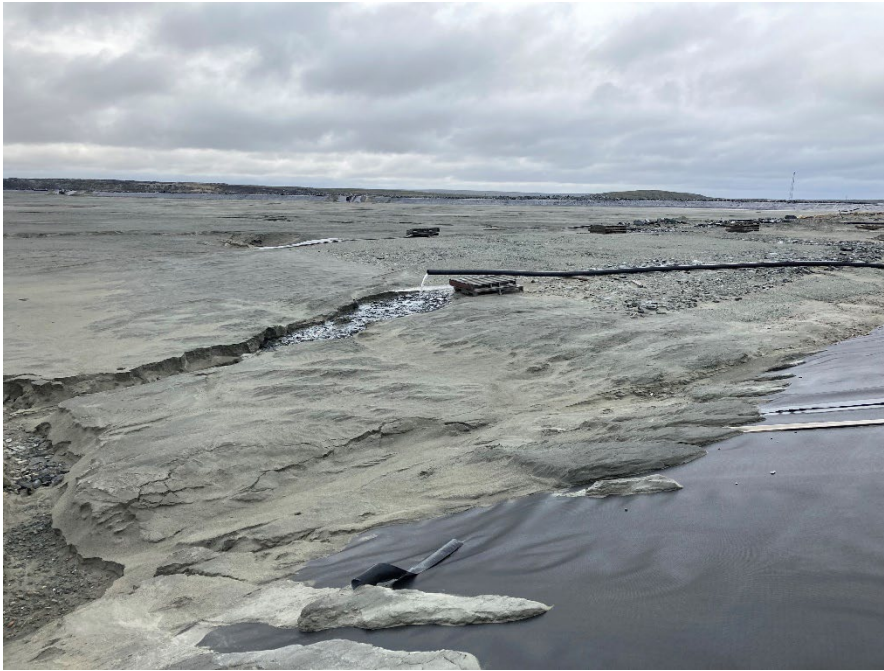
**Photograph B6-9 Saddle Dam 4**

**Description:** From the eastern abutment, looking northeast at the upstream toe area. Water discharged on the liner tie-in are eroding the tailings but the granular materials of the tie-in cover are in good condition.

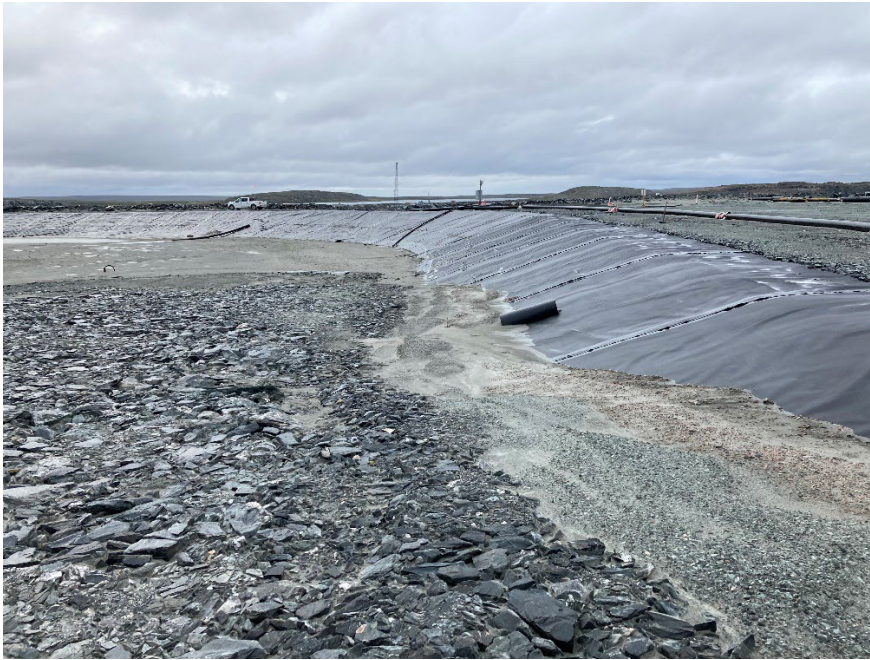
**Photograph B7-15 Central Dike and Saddle Dam 5**

**Description:** From approximately Sta. 1+000 looking east at the upstream slope of SD5 and Central Dike. Water is ponding against the liner.

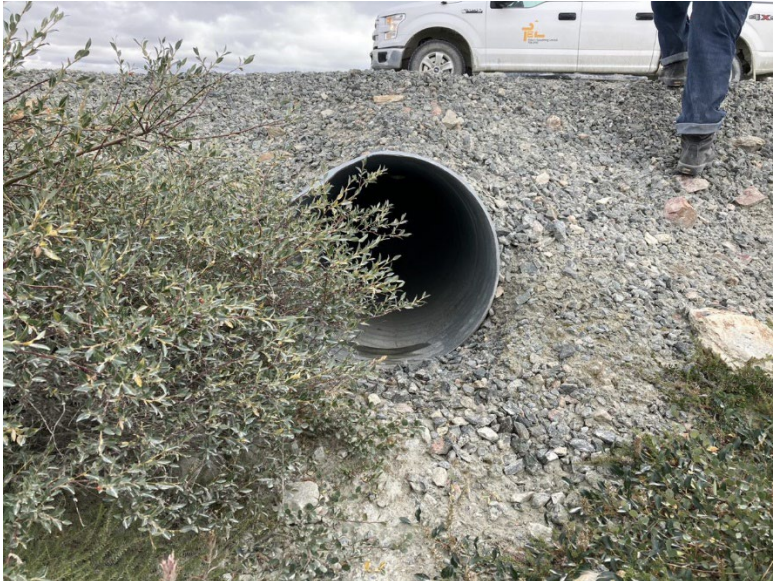
**Photograph D2-2: PC-11 km 39+552**

**Description:** View of the culvert inlet. Installed high but in good condition.

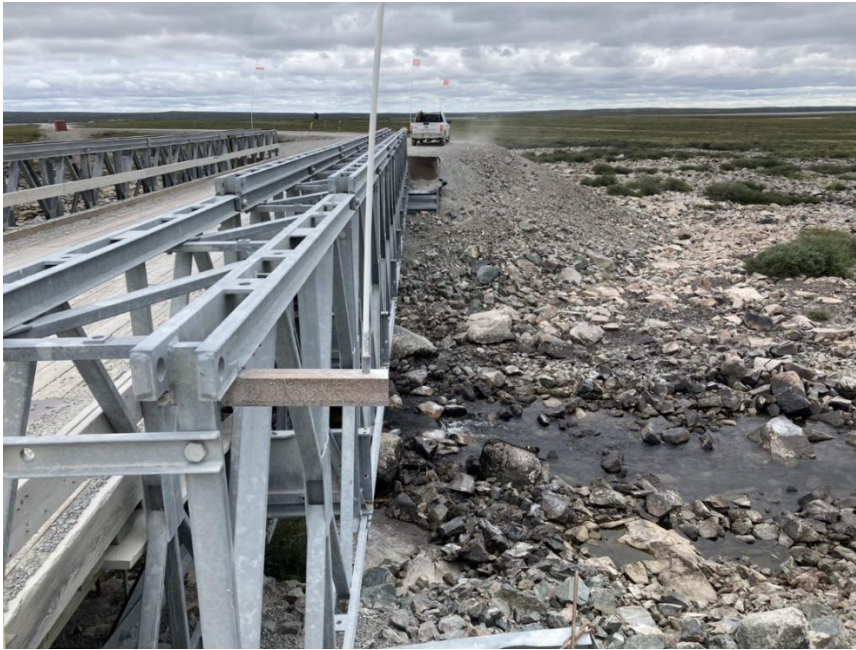
**Photograph D3-1 Bridges 1 – R02 km 8+750**

**Description:** Looking at the north abutment. The corrugated steel bin shows deformation under the weight of the bridge.

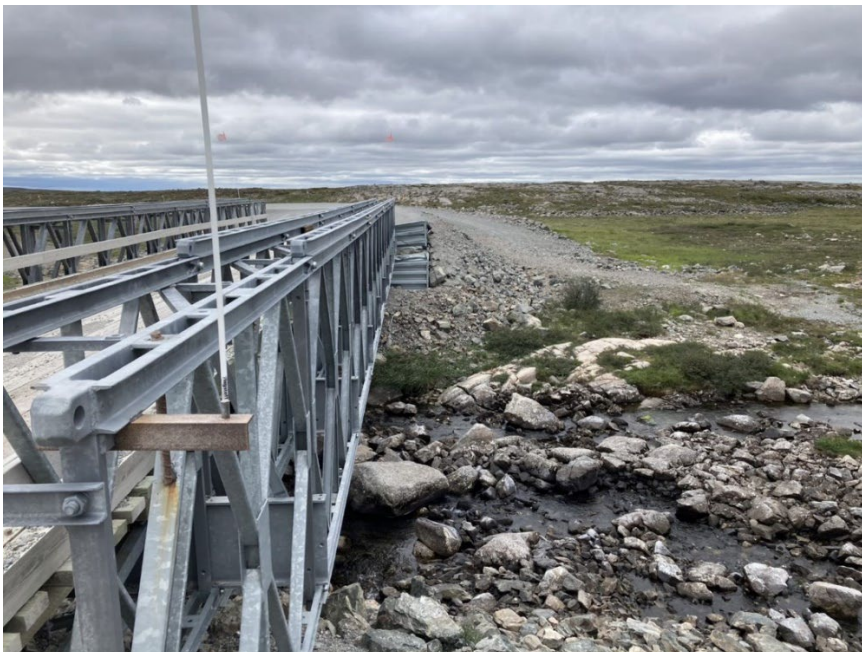
**Photograph D3-2 Bridges 1 – R02 km 8+750**

**Description:** Looking at the south abutment. The corrugated steel bin shows deformation under the weight of the bridge.

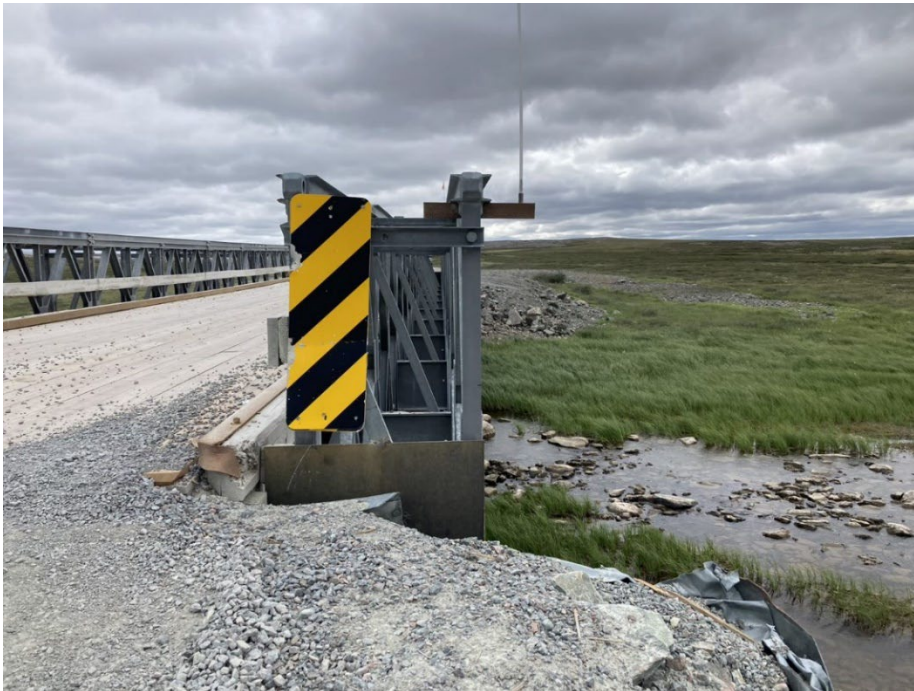
**Photograph D3-4 Bridges 2 – R05 km 17+600**

**Description:** Looking at the south abutment. Minor damage to the bin wall.

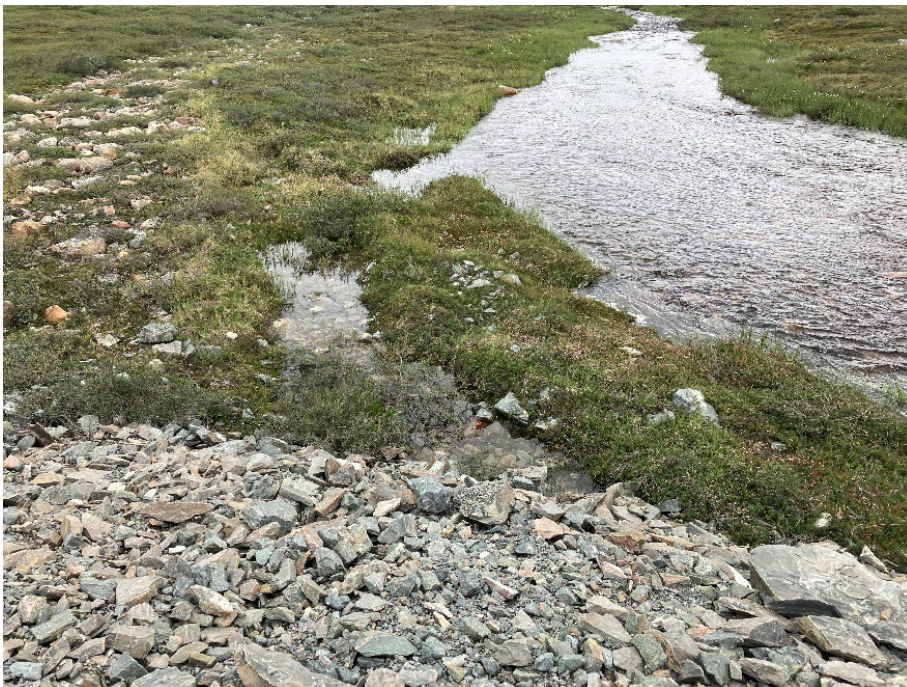
**Photograph D3-8 Bridges 4 – R09 km 48+500**

**Description:** Looking from the northeast abutment. Water is flowing under the abutment, no erosion.

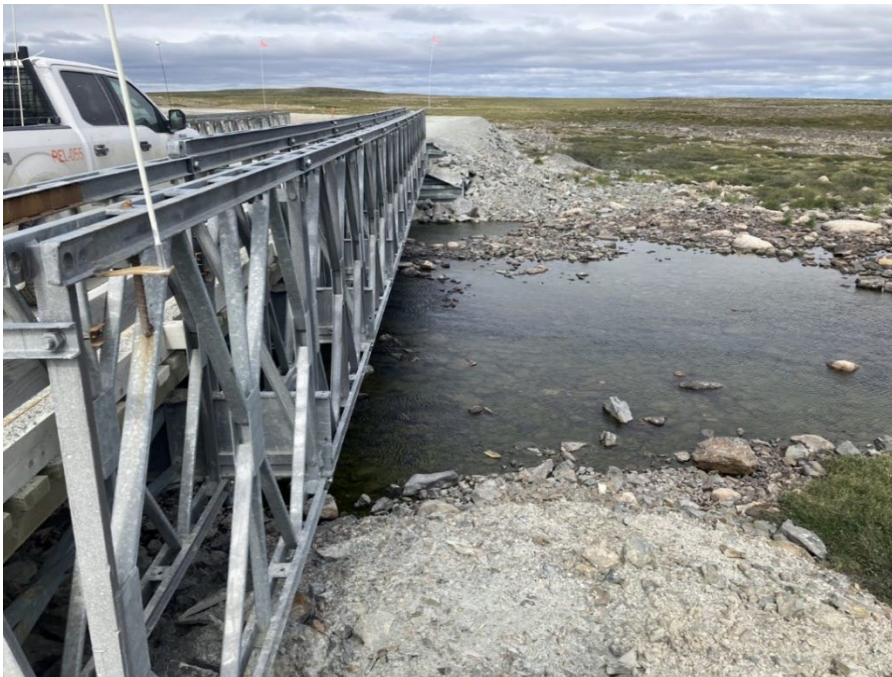
Photograph D3-12 Bridges 6 – R15 km 69+200

**Description:** Looking at the north abutment. Damage to the bin wall likely caused during snow removal activities. Bridge is tipping toward the west side on the abutment.

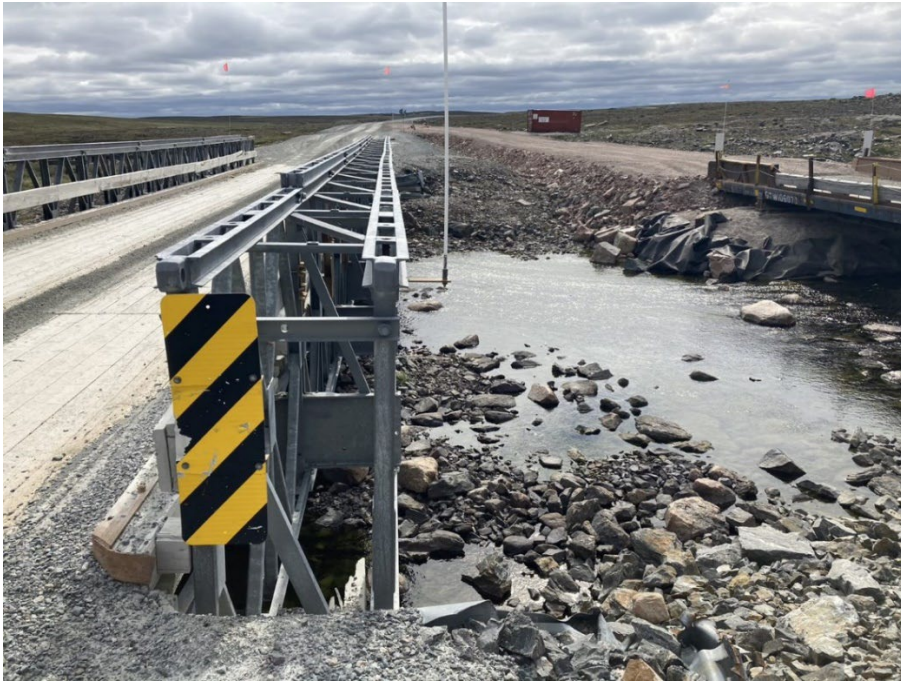
**Photograph D3-13 Bridges 6 – R15 km 69+200**

**Description:** Looking at the south abutment. Damage to the bin wall likely caused during snow removal activities. Bridge is tipping toward the west side on the abutment.

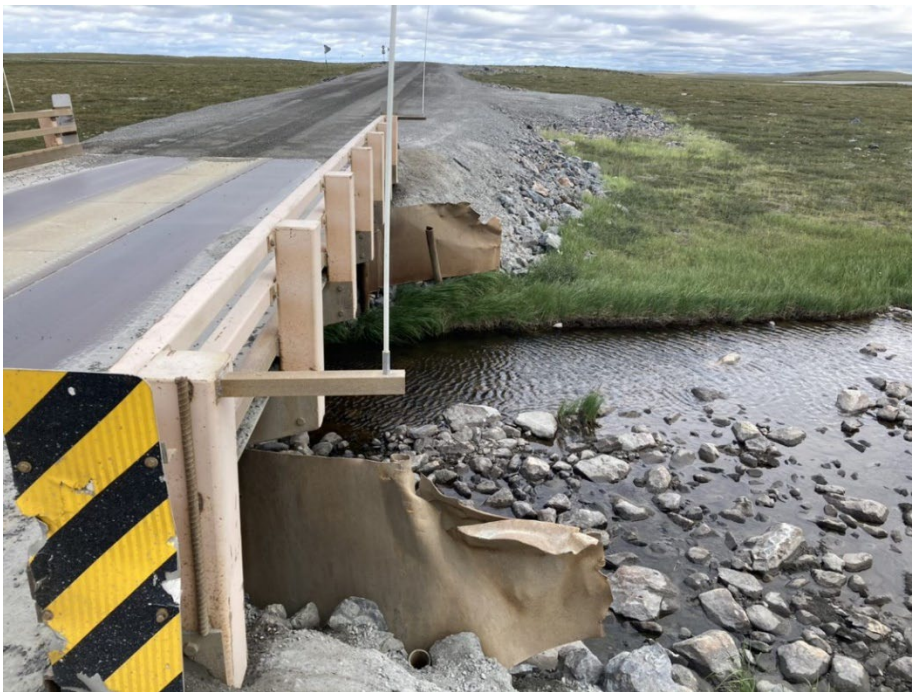
Photograph D3-18 Bridges 9 – R19 km 83+150

**Description:** Looking at the north abutment. Minor damage to steel plate due to snow removal activity.
